QUARTERLY GROUNDWATER
MONITORING REPORT
DOÑA ANA DAIRIES
MESQUITE, NEW MEXICO

February 2021

EA Project No. 1464107.04

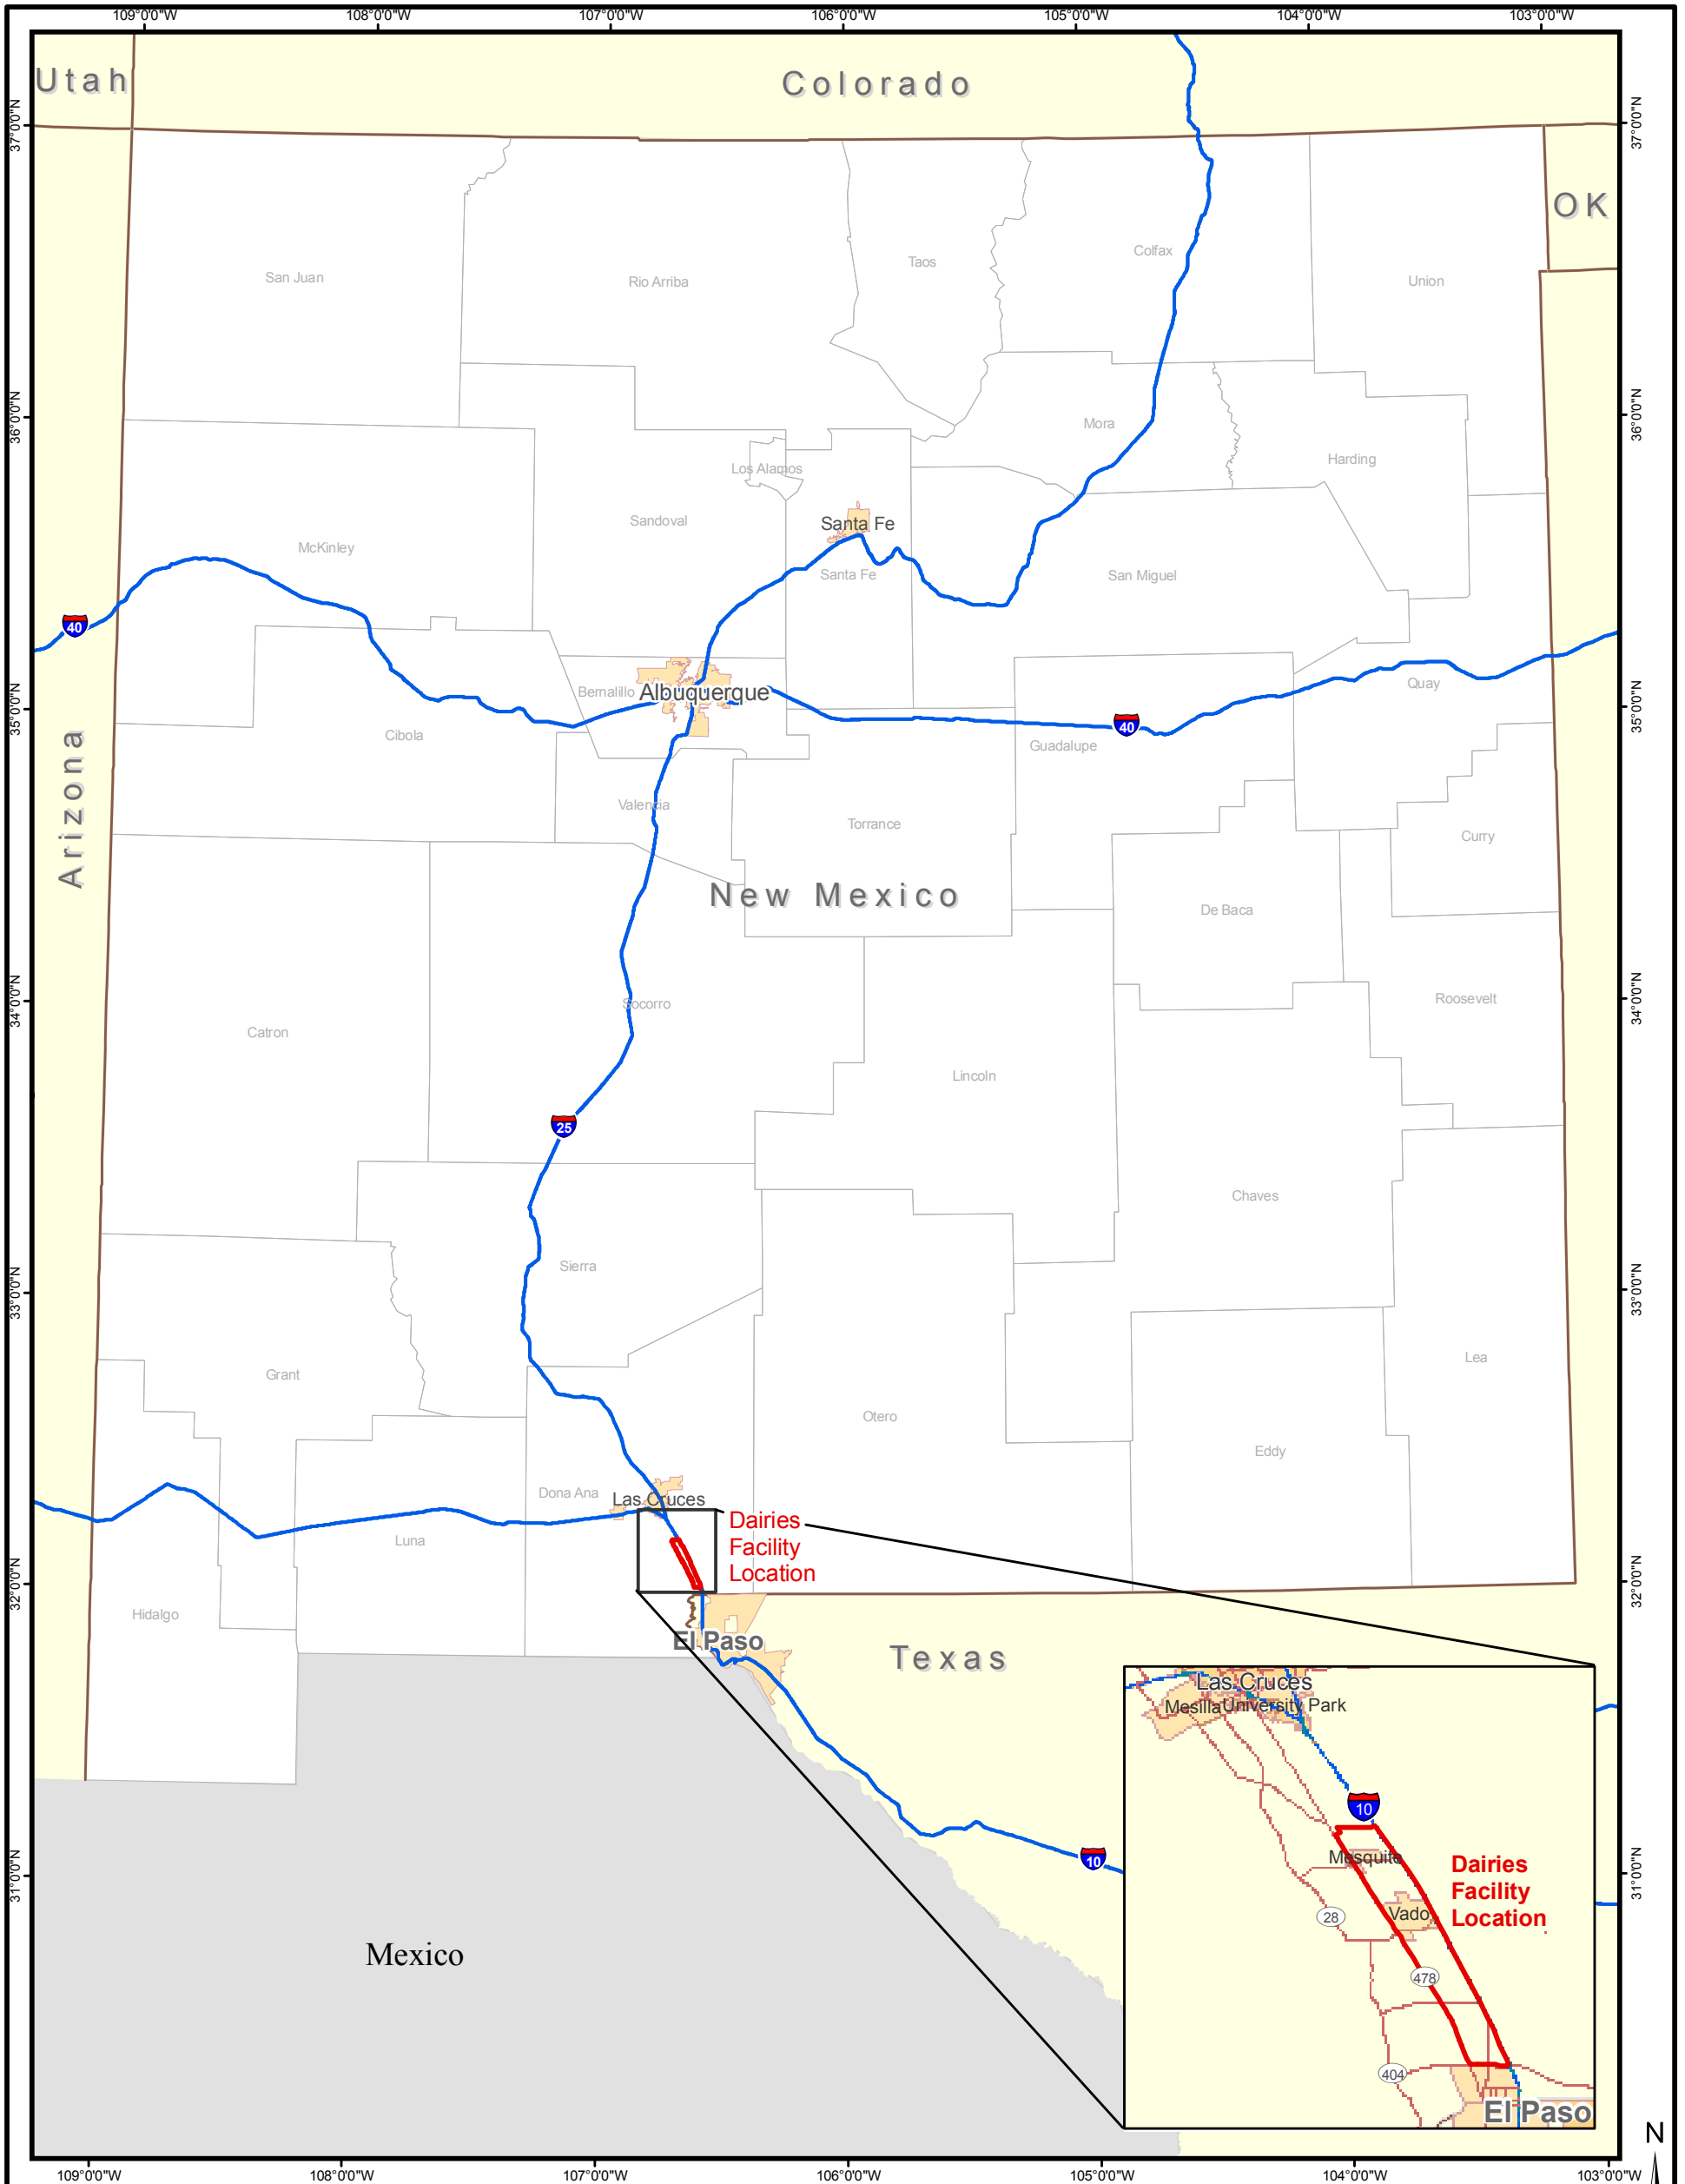
DATE:	PROJECT NO.:	SCALE:	FIGURE:
			3

Potentiometric surface maps were completed using the monitoring well gauging data for the northern, central, and southern portions (perched and regional aquifers) of the Dairies. Groundwater elevation data are provided in Table 1 and potentiometric surface maps are provided as Figures 2, 3, 4, and 5. Hydrographs were completed for select monitoring wells in each area and are provided in Appendix D. On average, groundwater elevations increased by one-half foot in the northern area. In the central area, groundwater elevations were on average similar to last quarter; however, many individual wells showed groundwater levels as higher or lower than the previous quarter with the southwest and eastern portions generally showing increased groundwater levels. In the southern area, groundwater elevations decreased by an average of one-half foot. Water levels in select monitoring wells in the southern perched aquifer are significantly higher than historical water levels as a result of a suspected water line leak located at the intersection of E O'Hara Road and Anthony Drive.

During the most recent gauging event, groundwater flow direction at the north and south ends of the northern area were to the southeast, but groundwater in the center of the northern area was flowing to the east. In the central and southern areas of the regional aquifer, groundwater flow direction was generally to the southeast. Flow direction in the southern perched aquifer is radiating out from the southwest corner of Del Oro Dairy to the west and south.

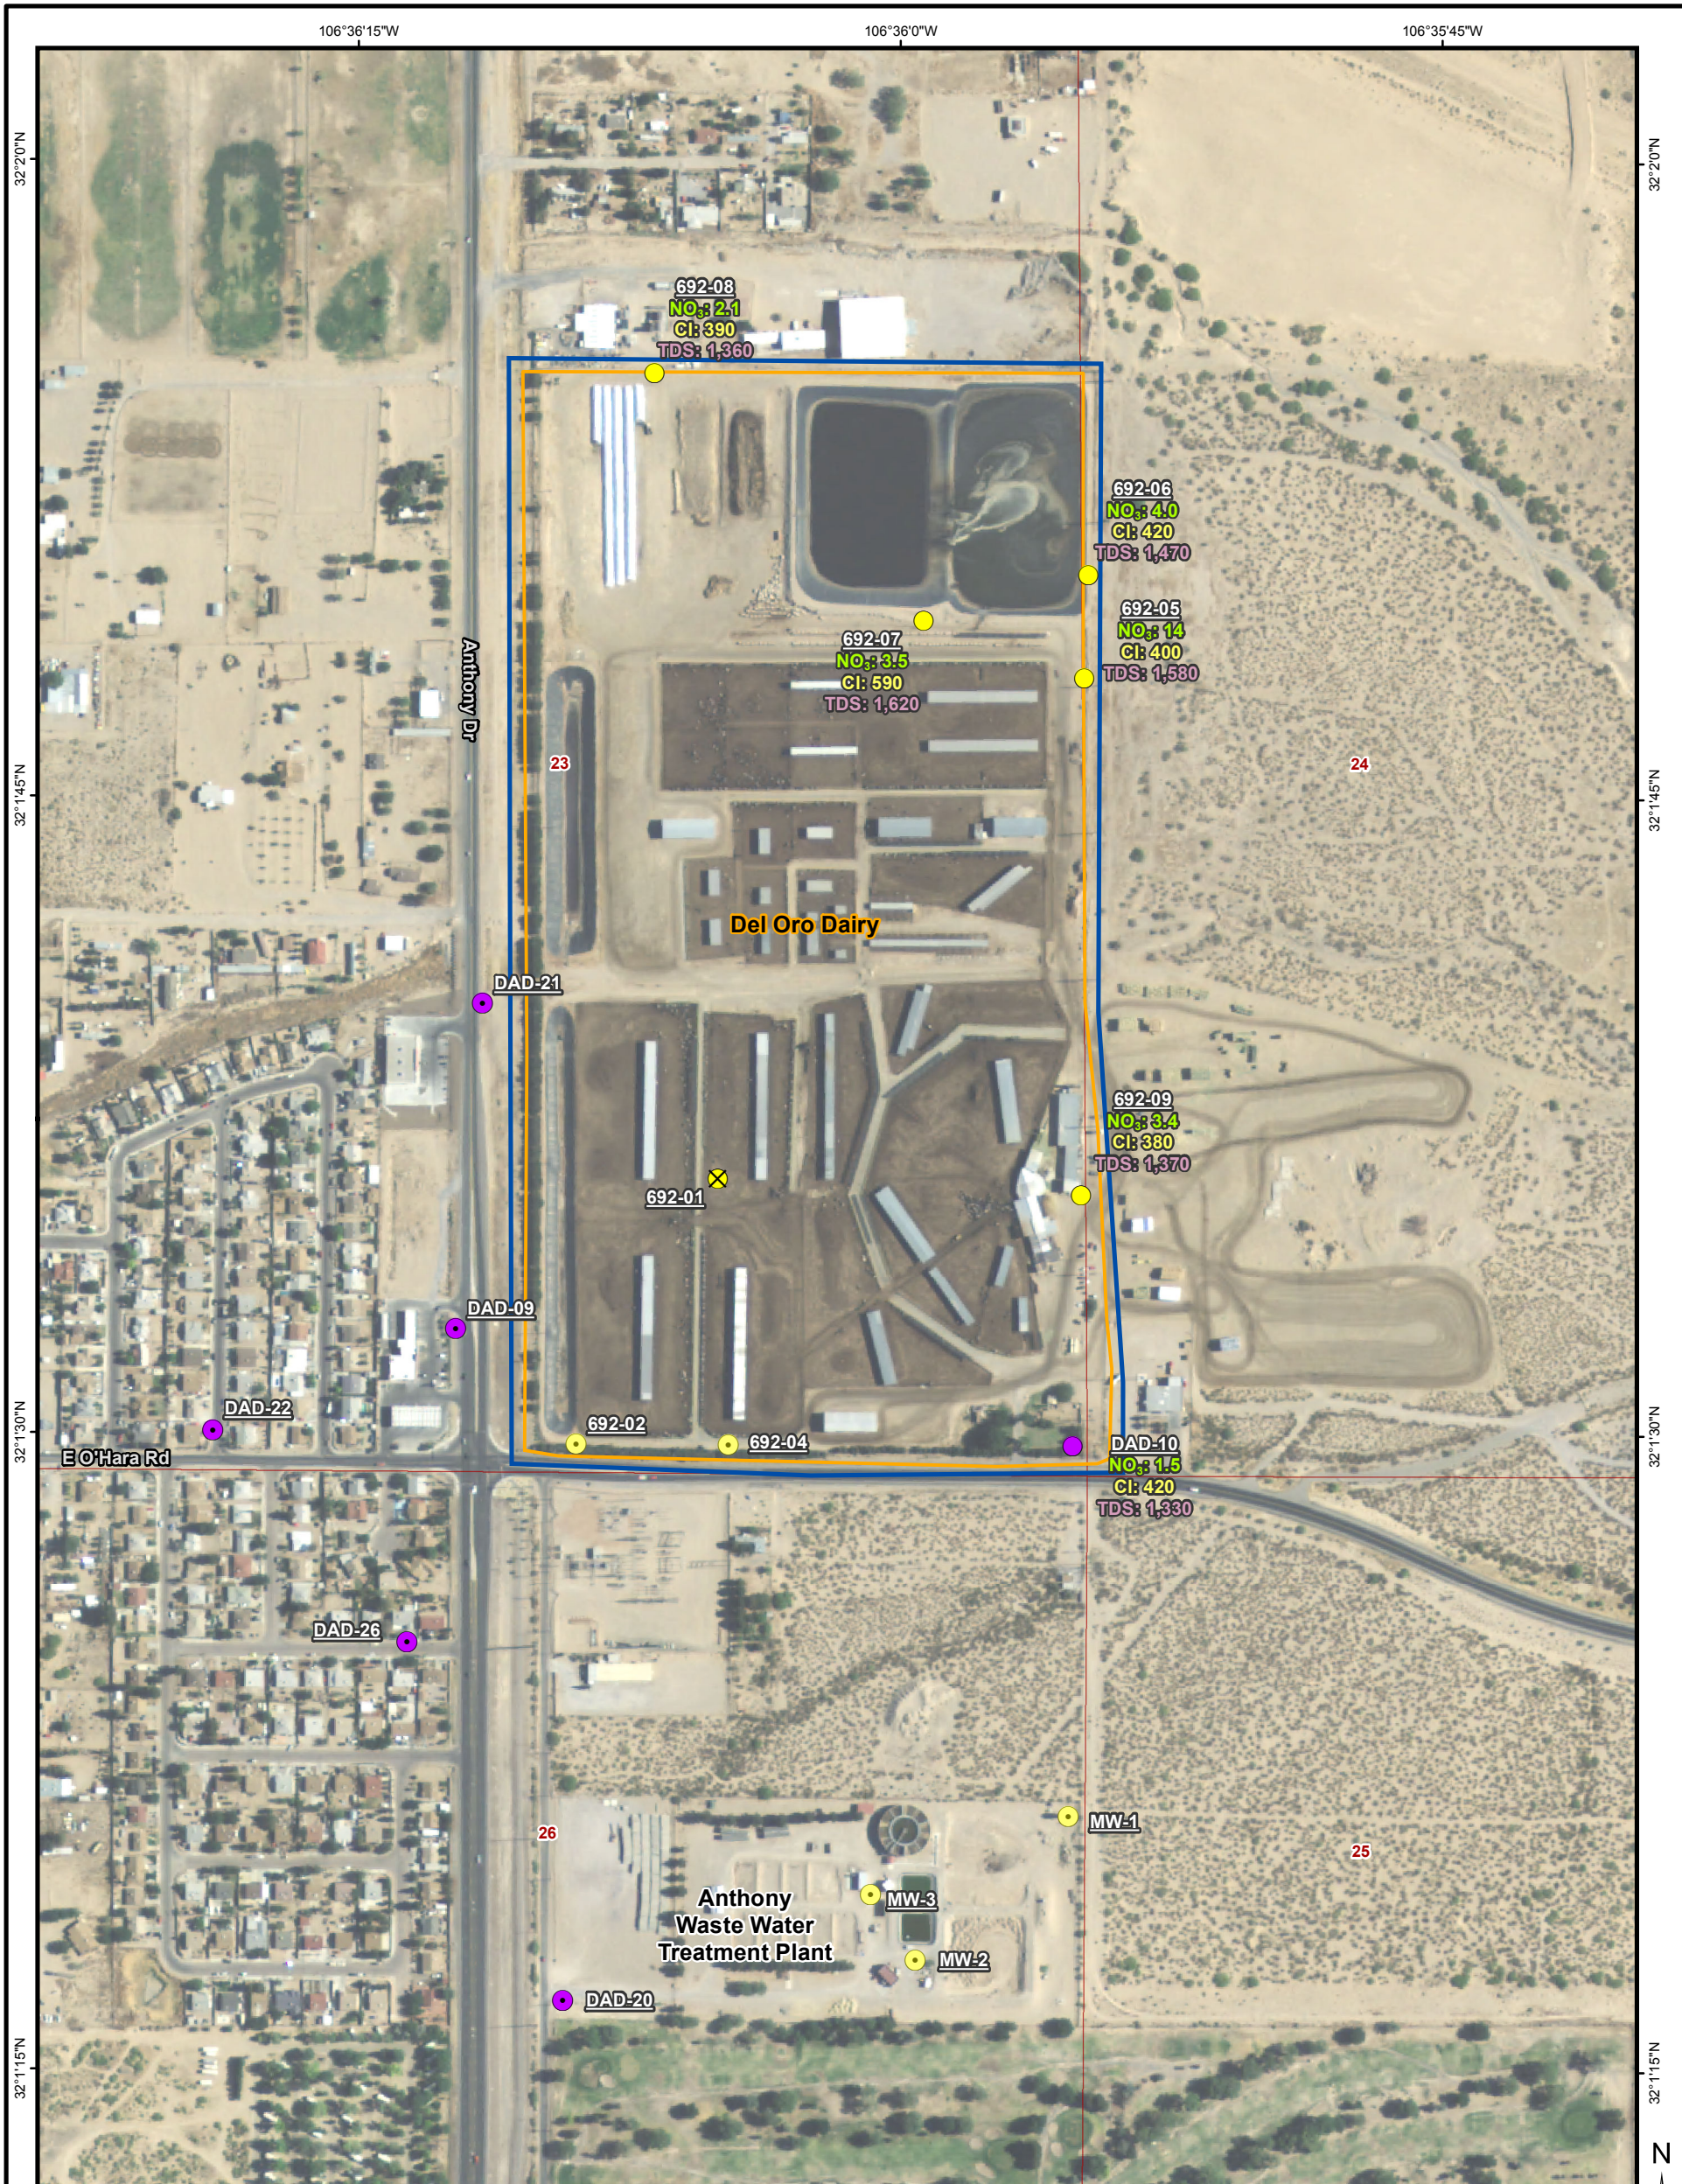
PROJECT			
DOÑA ANA DAIRIES MESQUITE, NEW MEXICO			
TITLE			
GROUNDWATER ANALYTICAL RESULTS NOVEMBER/DECEMBER 2020 SOUTHERN PORTION, REGIONAL AQUIFER			
	PROJECT No.	1464107.04	Fig8SouthRegionAq_Analytical.mxd
	DESIGN	NA	SCALE AS SHOWN
	GIS	RM	REV 0
	CHECK		
REVIEW			
			FIGURE 8

Wells completed in the regional aquifer in the southern portion of the dairies include AP well DAD-10 and Del Oro wells 692-05 through 692-09 (Figure 8). All of the sampled wells in the regional aquifer were below the NMWQCC standard for nitrate except for Del Oro well 692-05 which had a concentration of 14 mg/L, which remains the same as the previous quarter. Chloride concentrations were above the NMWQCC standard and ranged from 380 mg/L in Del Oro Dairy well 692-09 to 590 mg/L in Del Oro Dairy well 692-07. TDS ranged from 1,330 mg/L in AP well DAD-10 to 1,620 mg/L in Del Oro well 692-07.

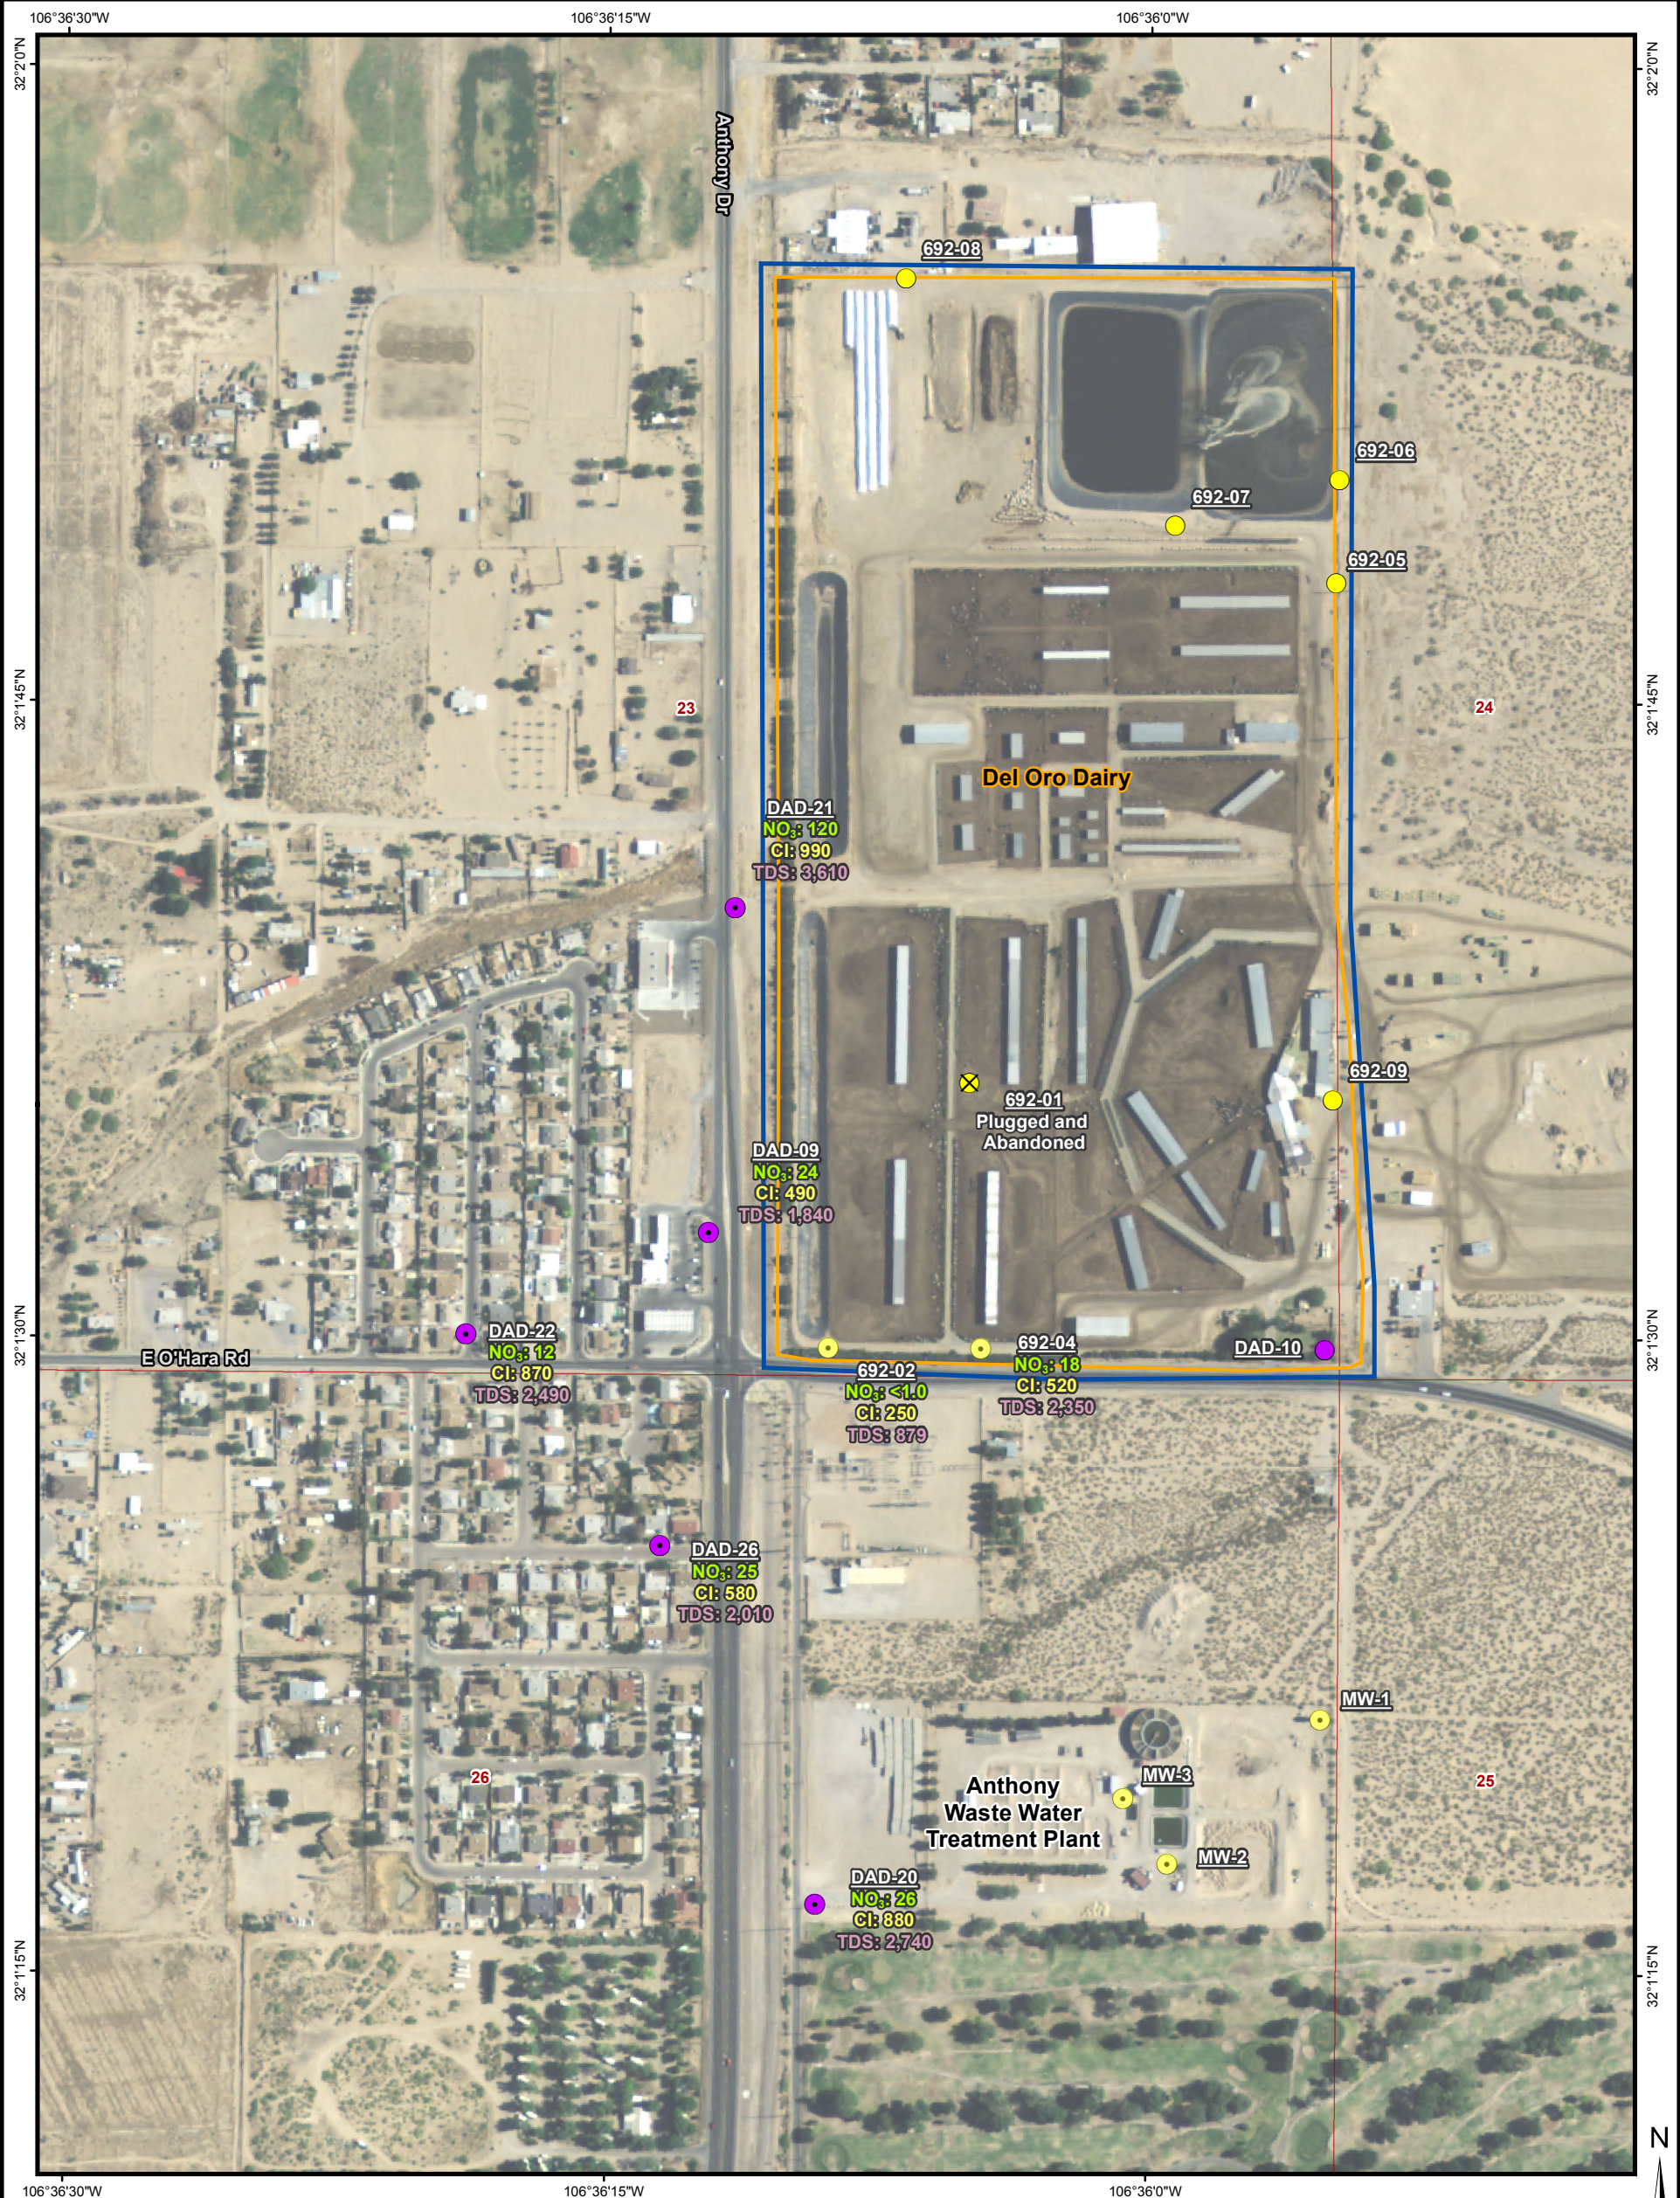
Wells completed in the perched aquifer in the southern portion that are sampled on a quarterly basis by DAD include wells 692-02, 629-04, DAD-09, DAD-20, DAD-21, DAD-22, and DAD-26 (Figure 9). A water line located at the intersection of East O'Hara Road and Anthony Drive is suspected to be compromised. Based on groundwater elevation and groundwater concentration data, it is likely the water line started to leak before May 2019.

Nitrate was above the standard in monitoring wells in the perched aquifer with the exception of Del Oro well 692-02, which is located near the suspected water line leak. The highest concentration was detected at AP well DAD-21 with a concentration of 120 mg/L. The downgradient extent of the plume is not defined. A modified Abatement Plan proposal to address this has been submitted to NMED. Chloride concentrations ranged from 250 mg/L in Del Oro well 692-02 to 990 mg/L in AP well DAD-21. TDS in the perched aquifer ranged from 879 mg/L in Del Oro well 692-02 to 3,610 mg/L in AP well DAD-21.

- Elevated water levels in the southern perched aquifer are likely the result of a water line leak.
- Anomalous TDS concentrations found in Buena Vista Dairy II wells 74-01 and 74-02 will continue to be monitored.

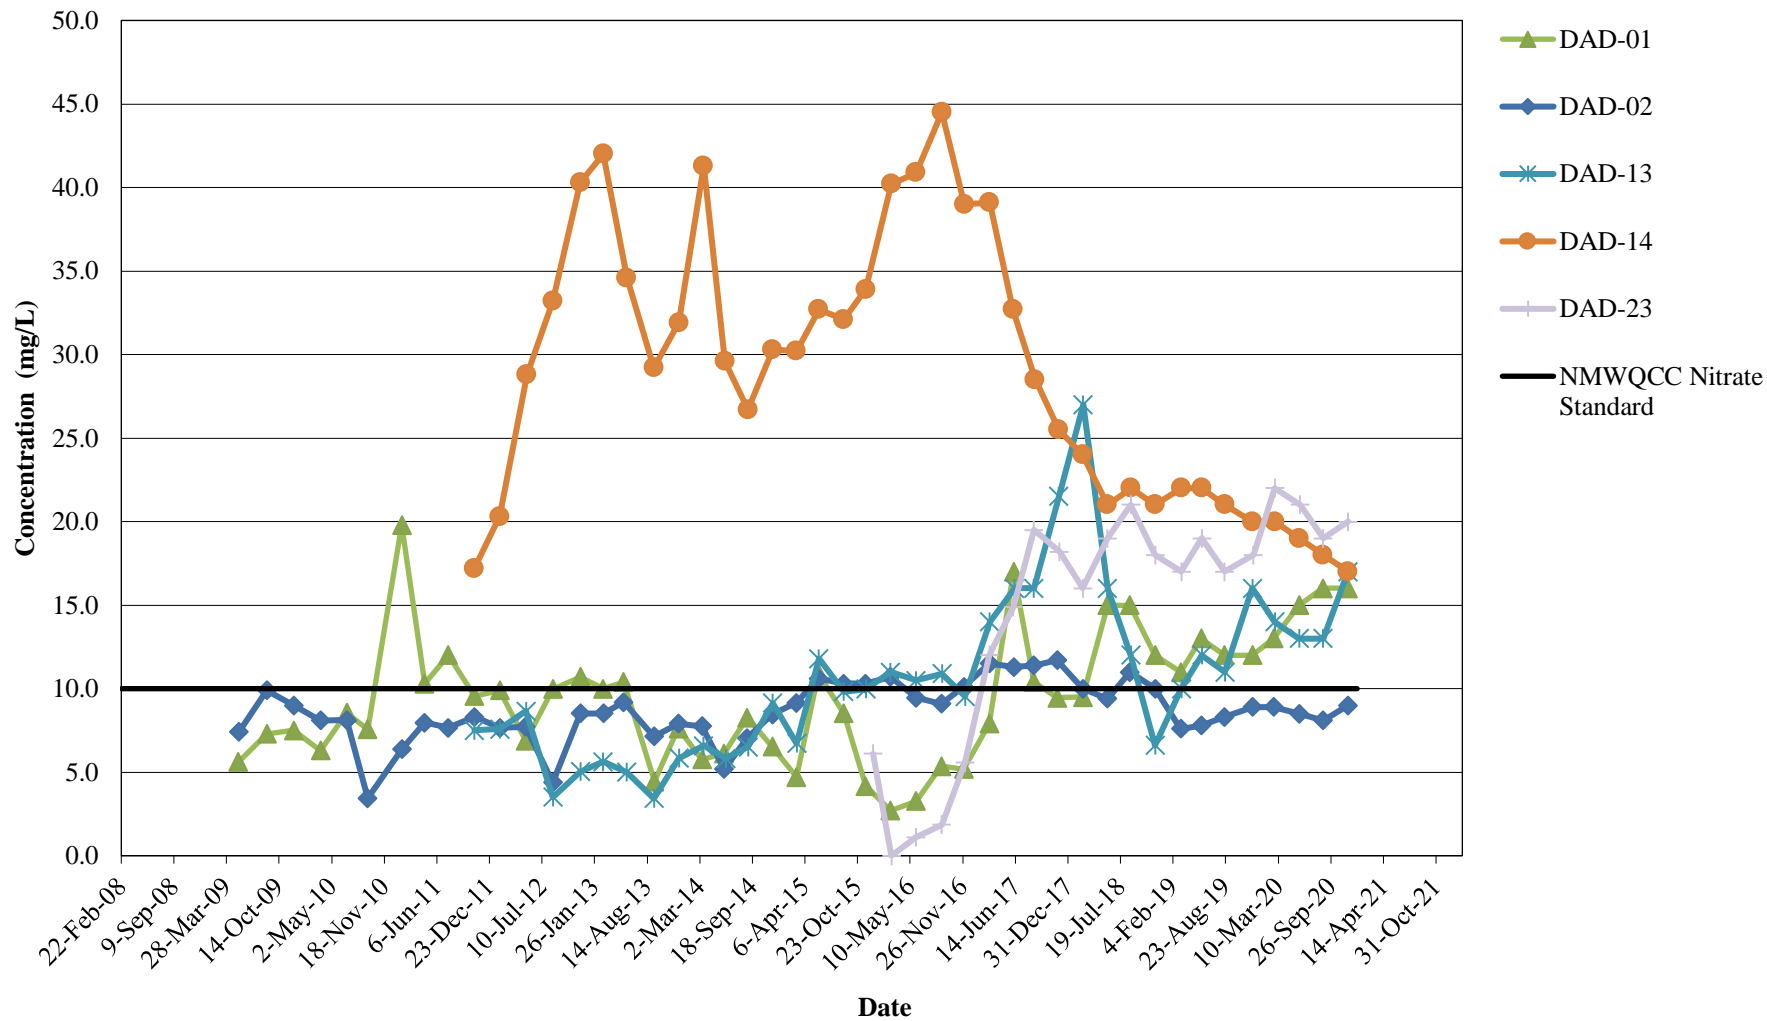
**NITRATE CONCENTRATION TRENDS
NORTHERN ABATEMENT PLAN MONITORING WELLS
DONA ANA DAIRIES, DONA ANA COUNTY, NEW MEXICO**

Upgradient well 86/340-01 (located to the north) has been below the nitrate standard since February 2018; historically, concentrations in this well were consistently above the nitrate standard. Upgradient well 70/86/340-01 (Northern Land Application area well) remained above the nitrate standard of 10 mg/L at a concentration of 12 mg/L, which is within the range of

historical results. Groundwater collected from upgradient Organ well 126-12 (located to the west) contained nitrate at a concentration below the standard at 8.9 mg/L. The nitrate concentration in the southern most AP well DAD-02 was below the NMWQCC standard of 10 mg/L at a concentration of 9.0 mg/L. Downgradient wells 42-10, 42-11, and 42-12 (located to the east) were also below the nitrate standard with a maximum detection of 1.4 mg/L in Dominguez 2 well 42-10; downgradient AP wells DAD-01 and DAD-13 (located to the east) contained nitrate above the standard at concentrations of 16 mg/L and 17 mg/L, respectively. The nitrate plume is delineated in all directions except to the east in the vicinity of DAD-01 and DAD-13.

The highest nitrate concentration in the northern portion was observed in Dominguez Dairy #2 well 42-06 with a concentration of 190 mg/L.

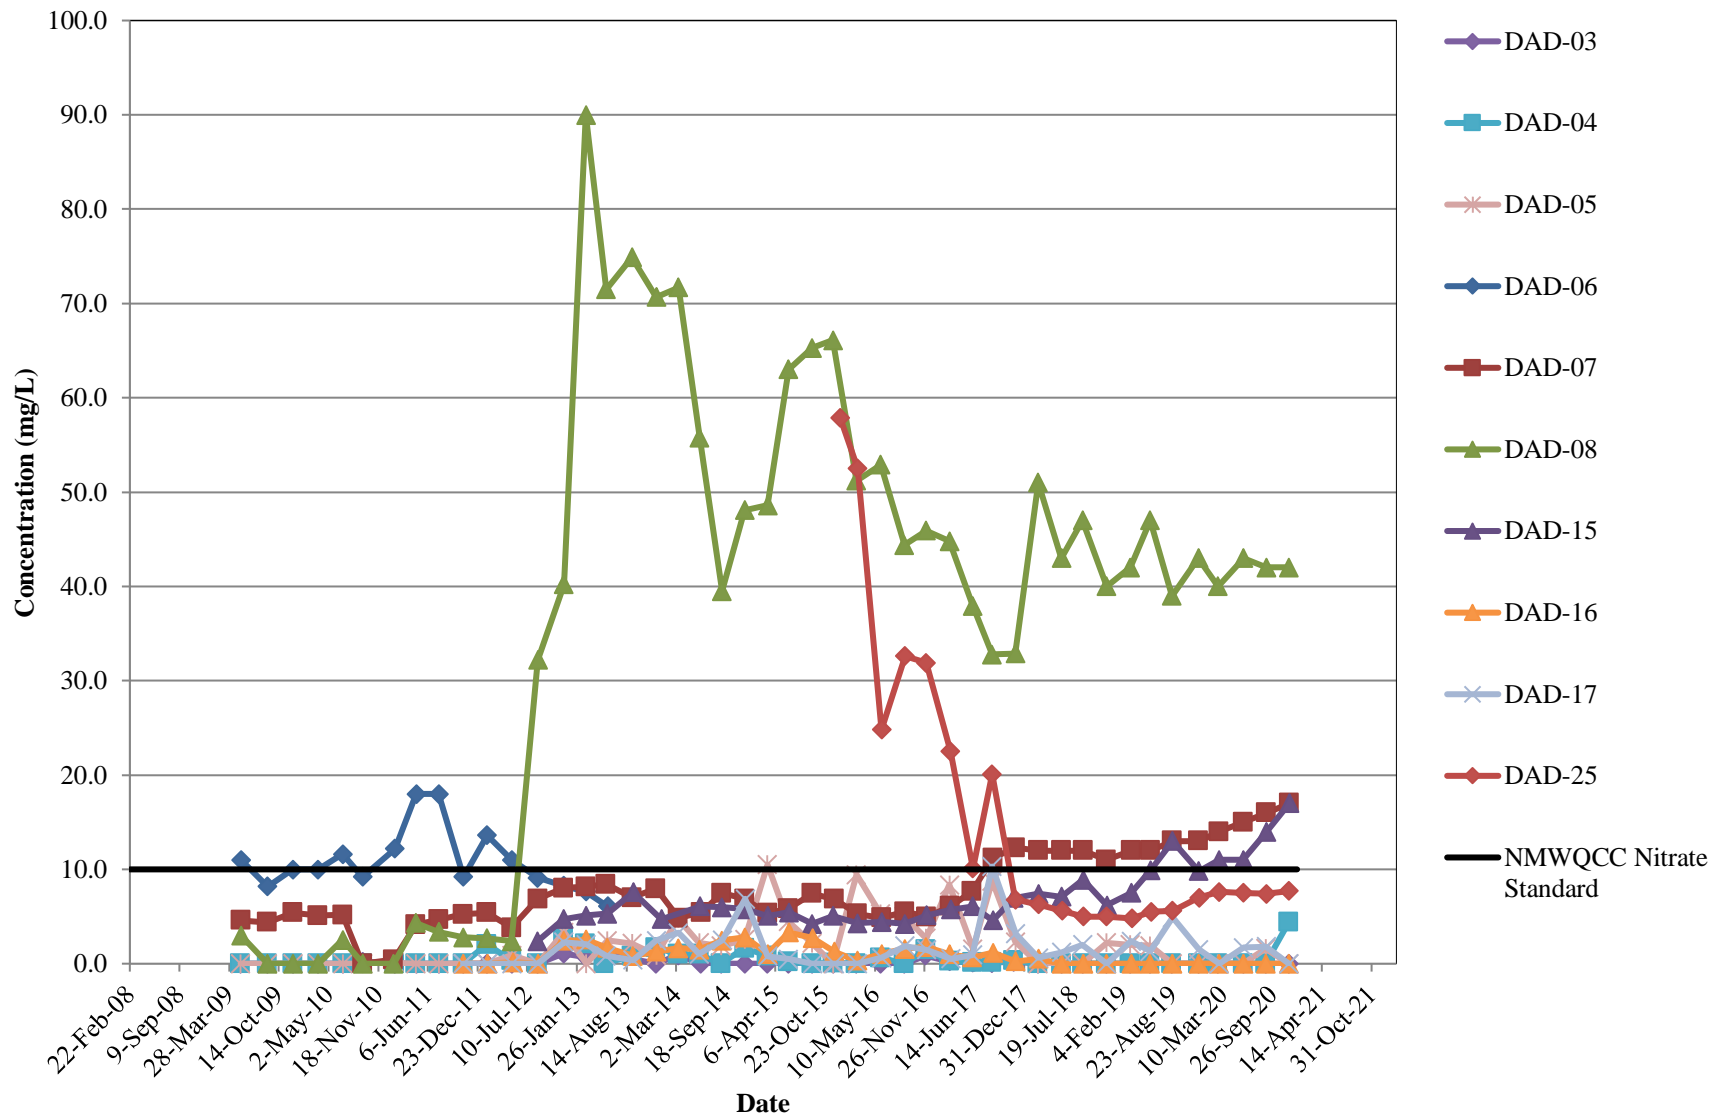
**NITRATE CONCENTRATION TRENDS
CENTRAL ABATEMENT PLAN MONITORING WELLS
DONA ANA DAIRIES, DONA ANA COUNTY, NEW MEXICO**

The highest nitrate concentration in the central portion was 89 mg/L, observed in Big Sky Dairy well 833-02. The upgradient extent of the central portion nitrate plume is defined by Buena Vista Dairy II well 74-03 where nitrate was not detected above the laboratory RL. The downgradient extent is defined by Las Cruces Community Farms (formerly McAnally Enterprises) well MW-4, with a below-standard concentration of 1.1 mg/L. Historically, the eastern cross-gradient extent of the plume was defined by wells DAD-07 and DAD-15. Nitrate in these wells exceeded the standard at a concentration of 17 mg/L in both wells. The western extent is defined by AP wells DAD-04 and DAD-16; nitrate concentrations remain below the standard in these wells.

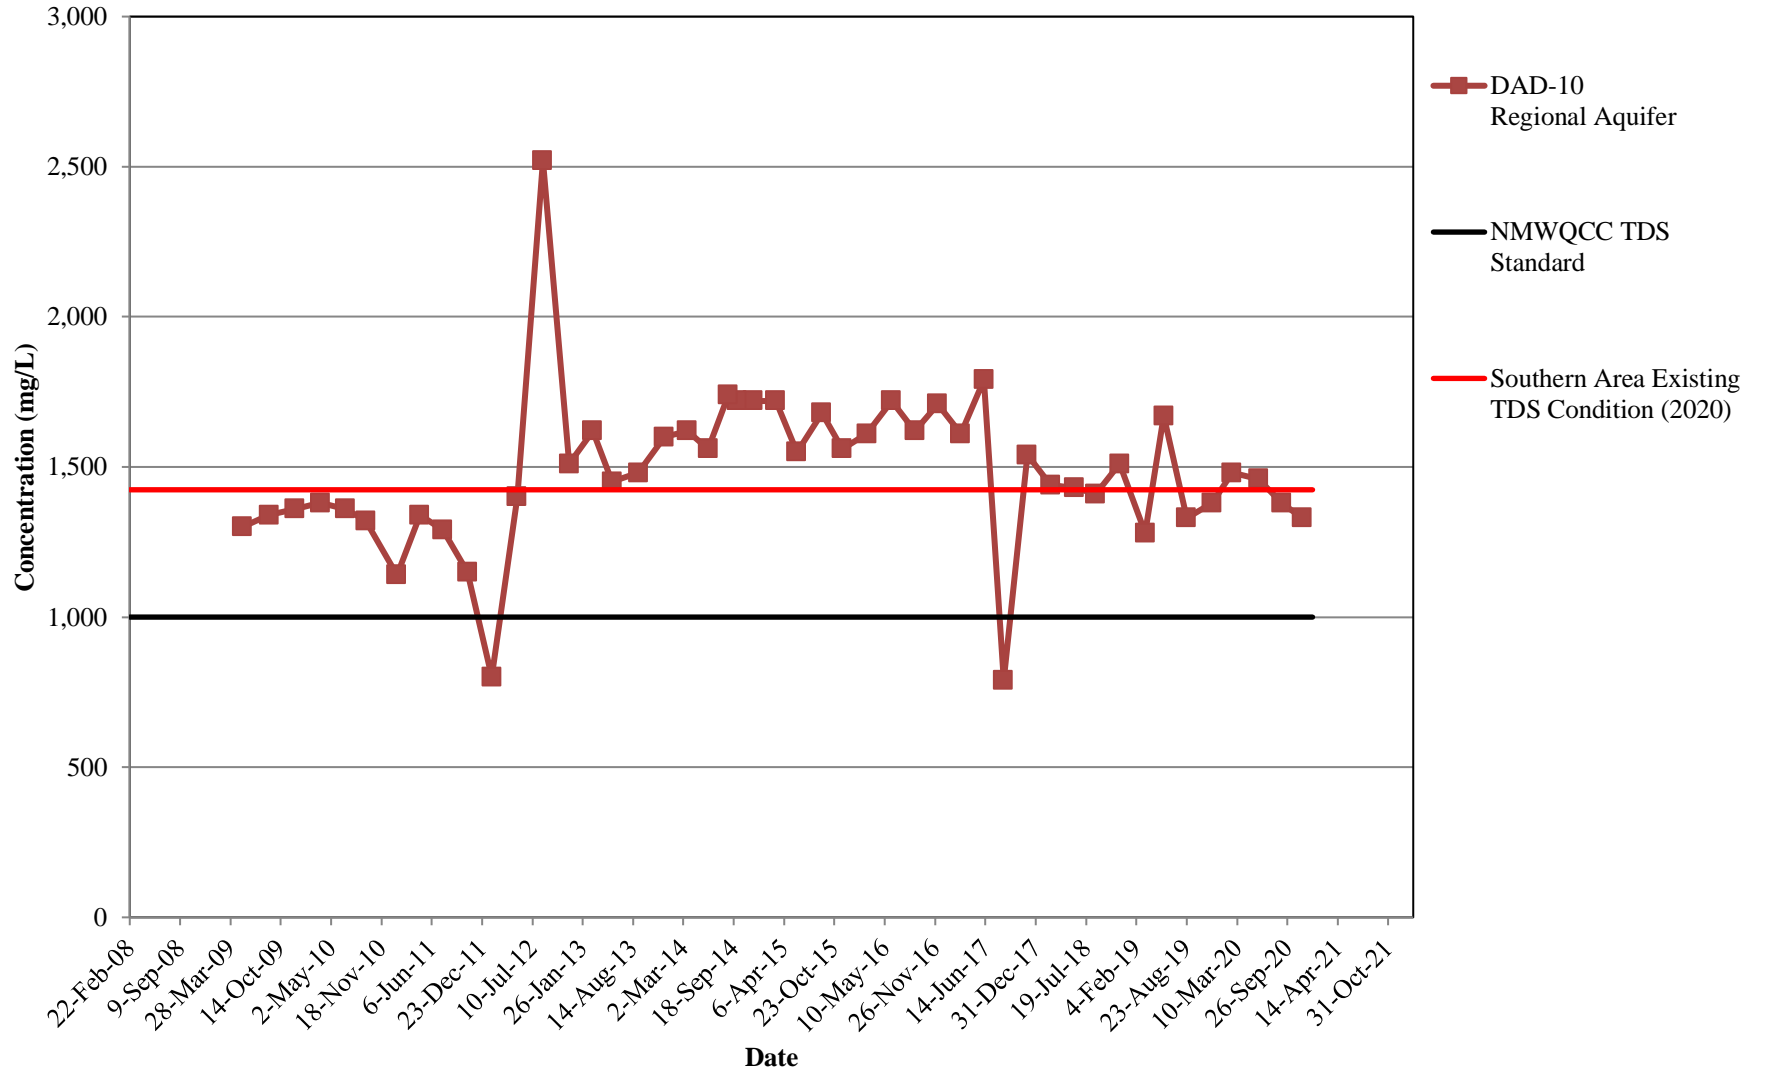
**TDS CONCENTRATION TRENDS
SOUTHERN ABATEMENT PLAN MONITORING WELLS
IN THE REGIONAL AQUIFER
DONA ANA DAIRIES, DONA ANA COUNTY, NEW MEXICO**
