# Abandoned Uranium Mine Assessment for the Becky Site (NM0244)

## FINAL REPORT

November 05, 2010

NM0244

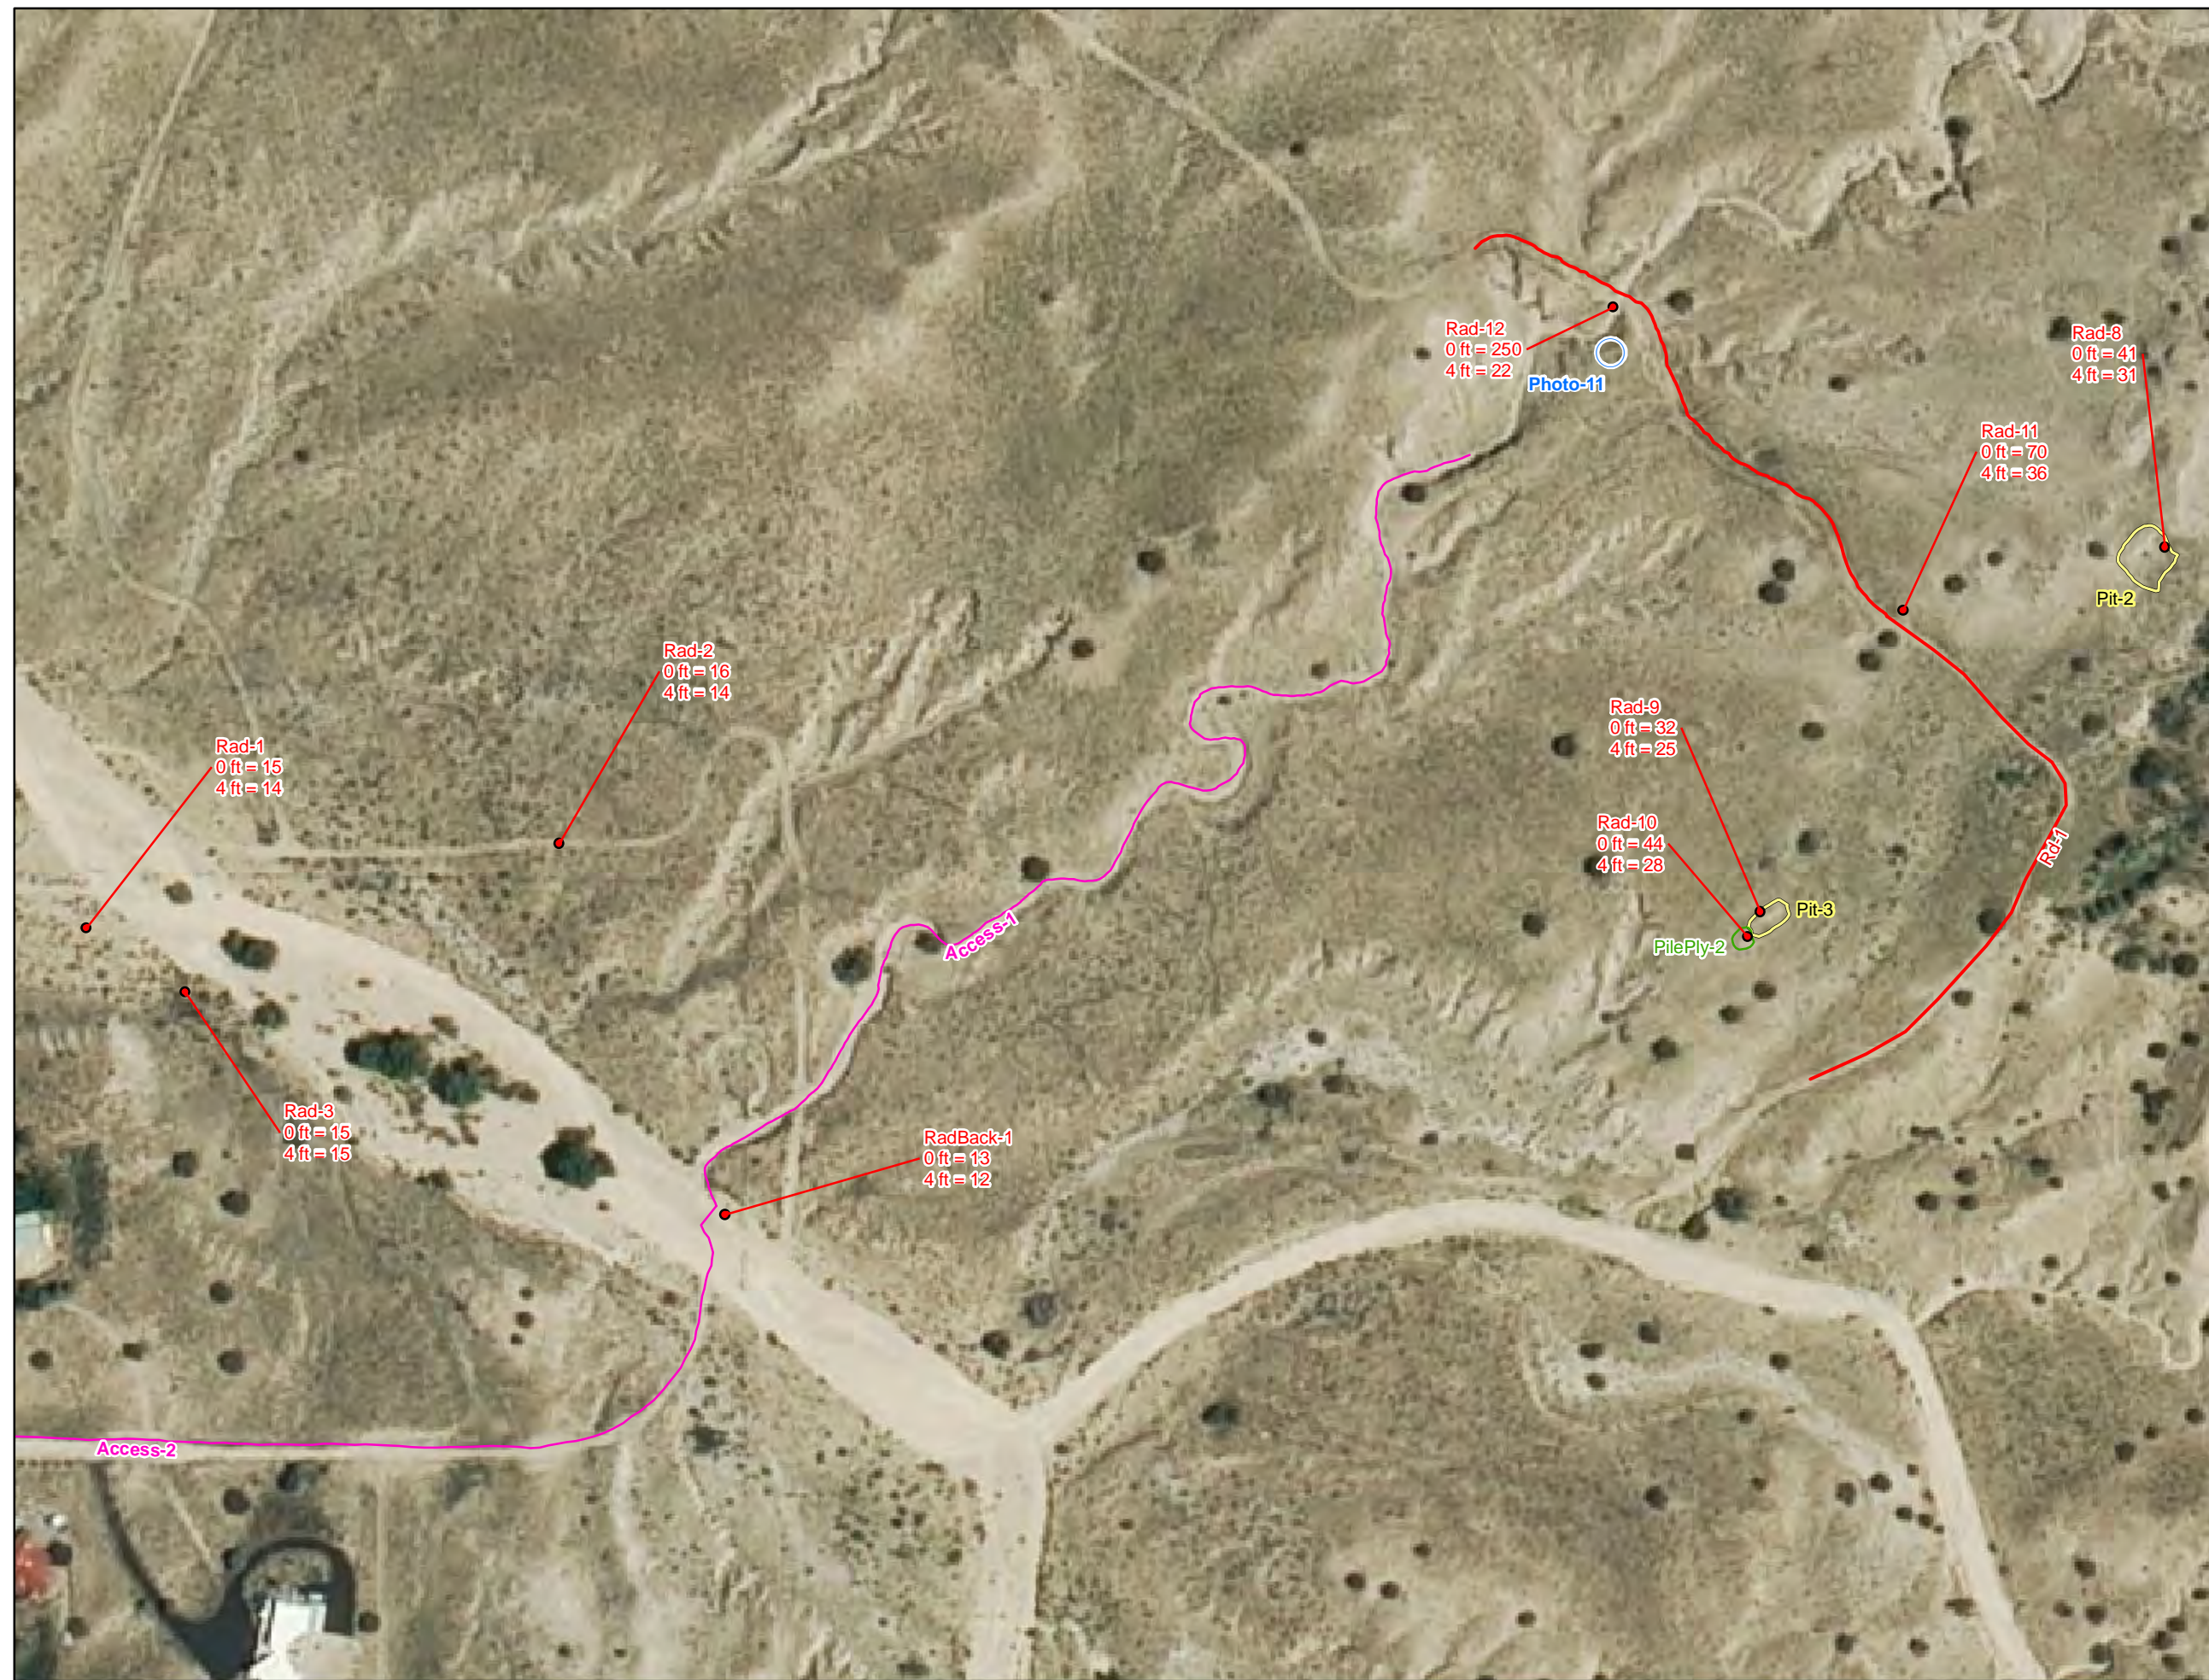
**Figure 4a**  
**Site Map on**  
**Aerial Photo**  
**NM0244-Becky**  
**Northern Area**  
 Abandoned Uranium  
 Mine Assessment

In the southern area of the AUM Site one cut (CutLn-1) and one pit (Pit-1) were found and two pits (Pit-2 and Pit-3) were found in the northern area (please see Figures 4a, 4b, 5a and 5b). The cut (CutLn-1) is a surface excavation along the side of a low hill in the southern area (see Photo 6 in Appendix A). It is approximately 5 ft high and 70 ft long and exposes loosely consolidated Santa Fe Group sediments. Pit-1 was also found in the southern area and is a bulldozer excavation into surface alluvium (see Photo 3 in Appendix A). Pit-2 and Pit-3, found in the northern area, are also excavations into surface alluvium (see Photos 7 and 8 in Appendix A). The maximum gamma radiation for these feature measured 100  $\mu\text{R/hr}$  (microroentgens per hour) at 0 ft above ground at radiation survey point Rad-7 on CutLn-1 (see Table 2).

Two waste piles were found onsite; one in the southern area and one in the northern area (see Figures 4a, 4b, 5a, and 5b). PilePly-1, in the southern area, and PilePly-2, in the northern area, are waste piles composed of soil excavated from Pit-1 and Pit-3, respectively. Both piles are approximately 3 ft tall, 10 ft wide and 20 ft long (see Photos 2 and 9 in Appendix A). The maximum gamma radiation measurement on these features was 44  $\mu\text{R/hr}$  at 0 ft above ground at radiation survey point Rad-10 on PilePly-2 in the northern area.

One mine road (Rd-1) was found onsite. This road is located in the northern area of the AUM Site and extends northwest to southeast (see Figure 4a).

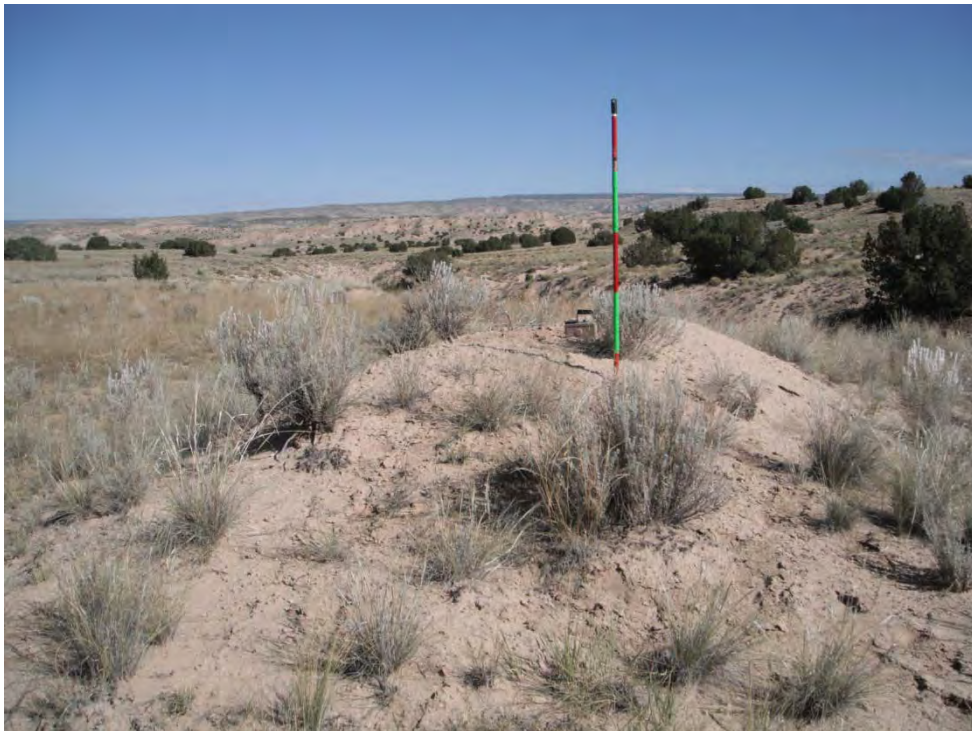
Photo 2-Looking north at PilePly-1.

1130 - Going south to other features.  
PilePly-1 - 3' tall, 10' wide, 20' long, 30"

Rad 4 - PilePly-1, Om-19  $\mu\text{R/h}$ ; 1m-18  $\mu\text{R/h}$

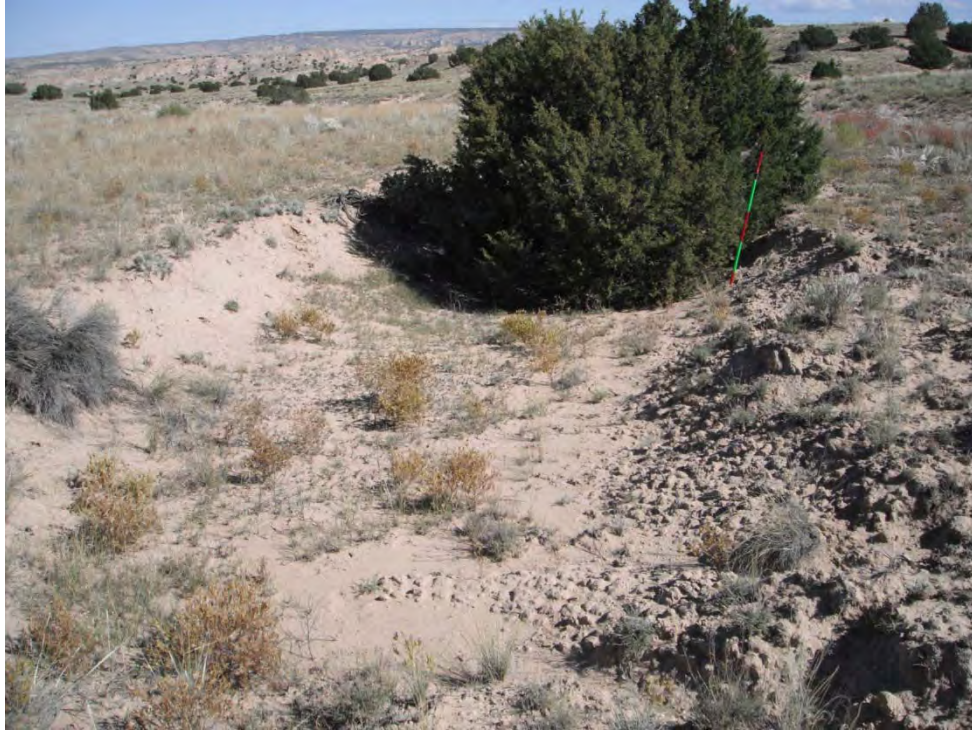
Photo 3-Looking north at Pit-1.

Pit-1 - 4' deep, 15' wide, 35' long; bulldozer cut, no exposed bedrock

Rad 5 - Pit-1; Om-17  $\mu\text{R/h}$ ; 1m-17  $\mu\text{R/h}$

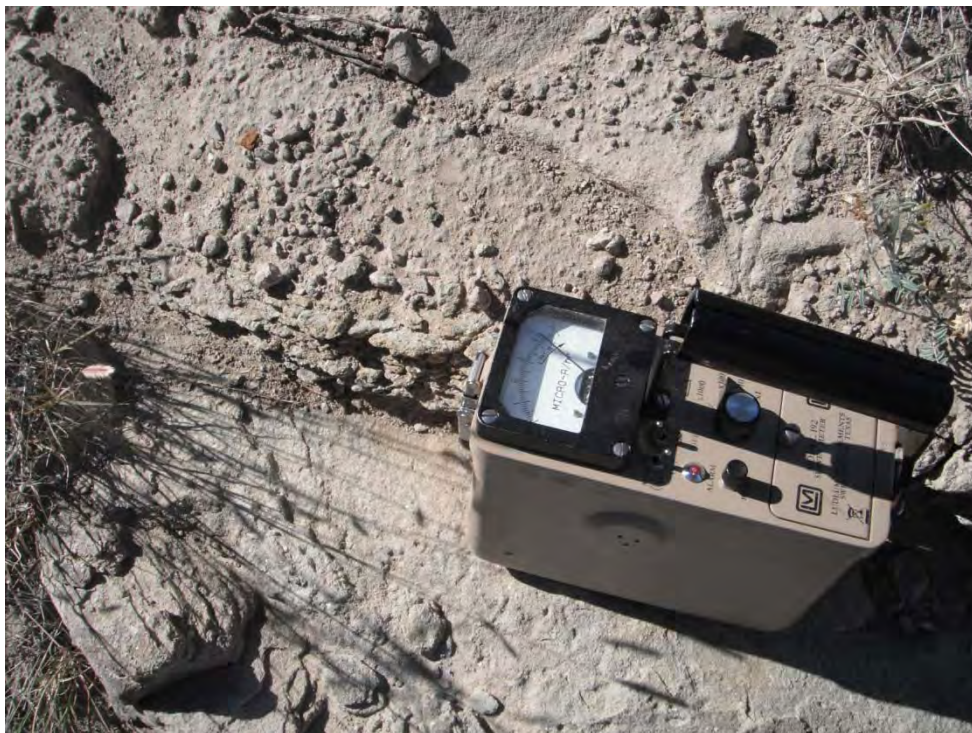
The maximum gamma radiation measured onsite was 440  $\mu\text{R/hr}$  at 0 ft above ground on a sandstone outcrop at radiation survey point Rad-6 in the southern area. In the northern area a gamma radiation measurement taken on an outcrop at radiation survey point Rad-12 recorded 250  $\mu\text{R/hr}$  at 0 ft above ground.

Photo 4-Closeup of rocks at Rad-6.

Rad 6 - cliff wall; Om-49  $\mu\text{R/h}$ ; 1m-70  $\mu\text{R/h}$ ; sandstone

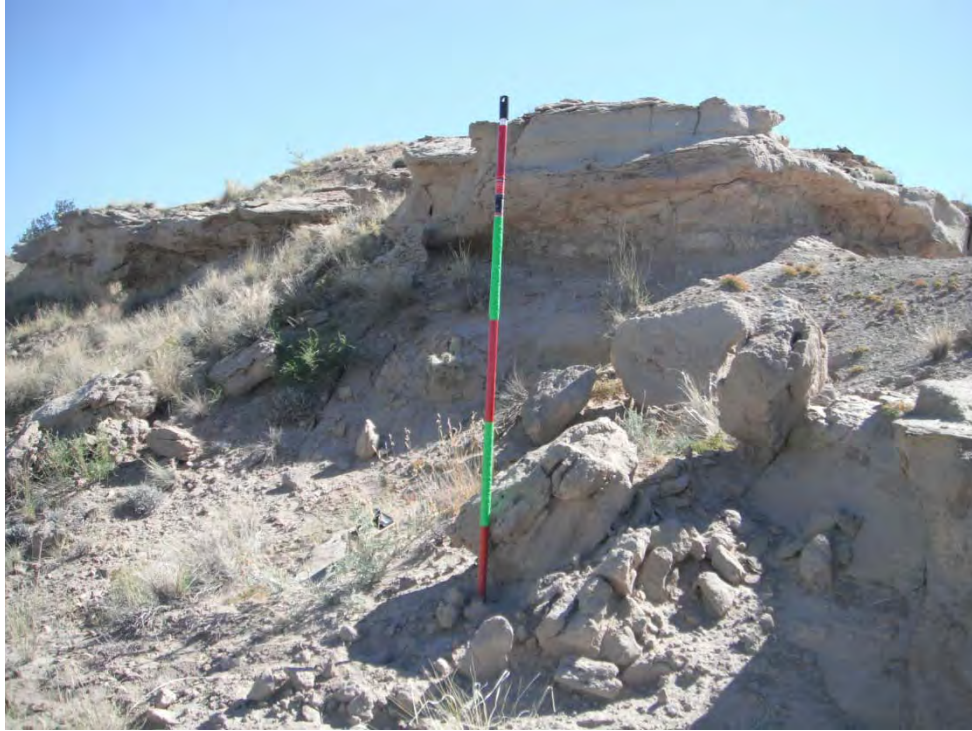
Photo 5-At Rad-6, looking north.

Photo 5 - cliff wall at Rad 6 looking north

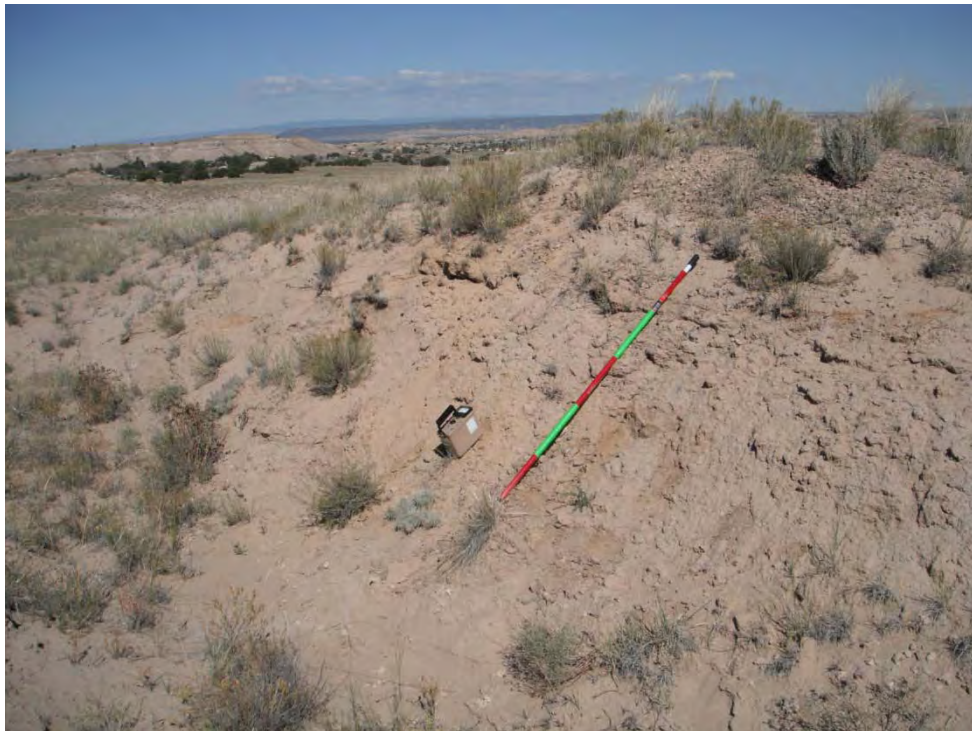
Photo 6-Looking north at CutLn-1.

CutIn-1 - old cut, 5' high, 70' long, 5' wide

Rad 7 - CutIn-1; Om-100  $\mu\text{R/h}$ ; 1m-43  $\mu\text{R/h}$

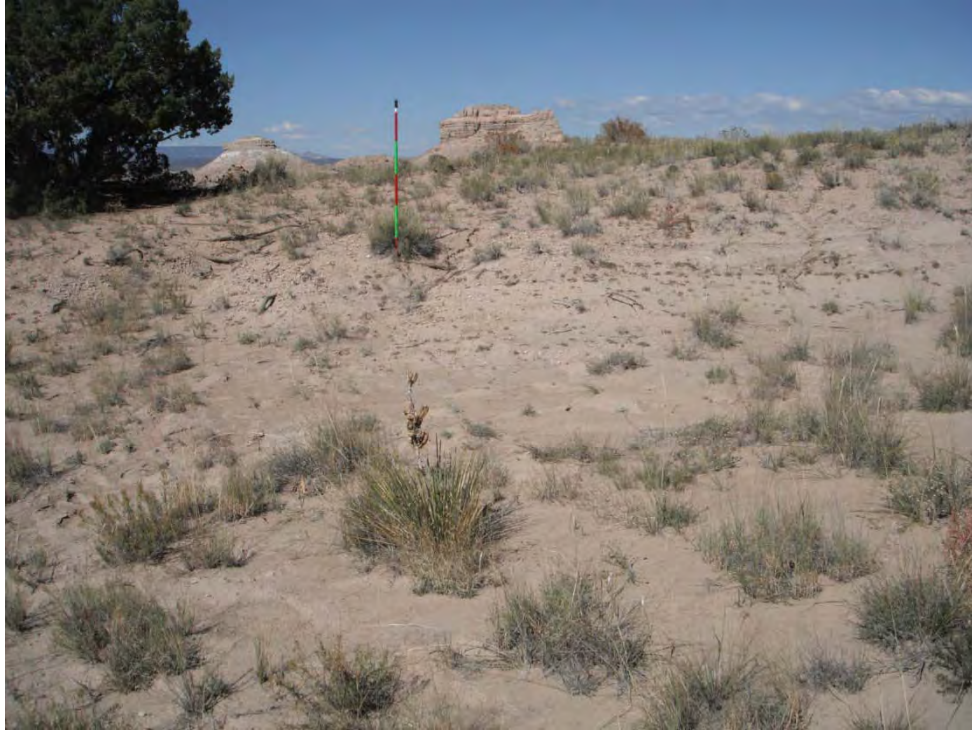
Photo 7-Looking north at Pit-2.

Pit-2 - 4' deep, 30' wide, 40' long

Rad 8 - Pit-2; Om-41  $\mu\text{R/h}$ ; 1m-31  $\mu\text{R/h}$

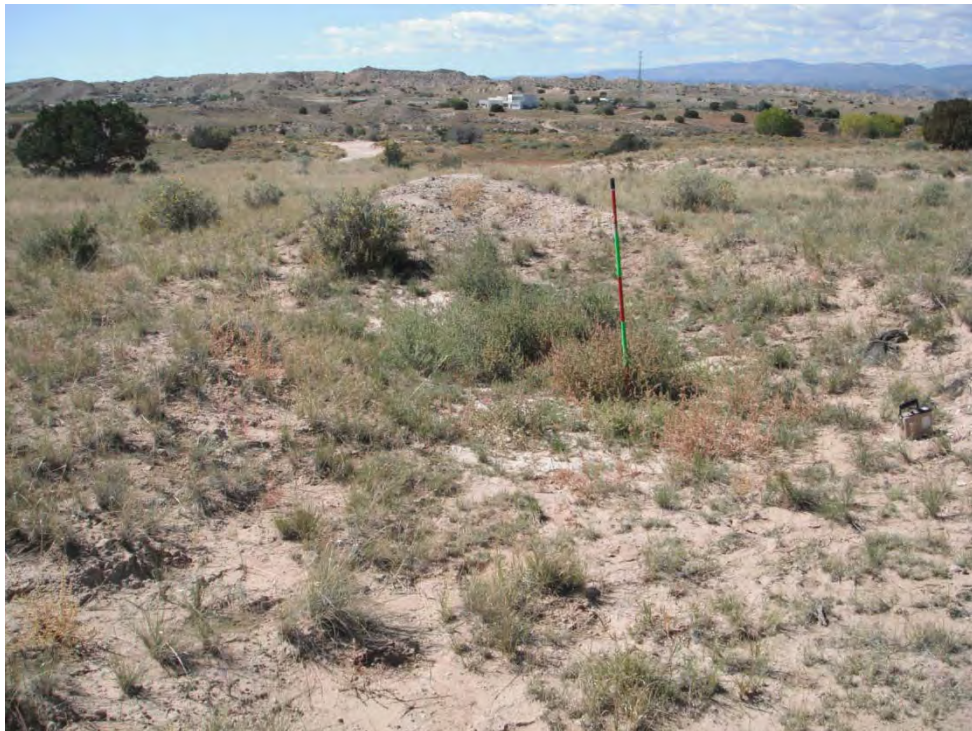
Photo 8-Looking west at Pit-3.

Pit 3 - 2' deep, 30' long, 10' wide; bulldozer cut

Rad 9 - Pit 3; Om-32  $\mu\text{R/h}$ ; 1m-25  $\mu\text{R/h}$

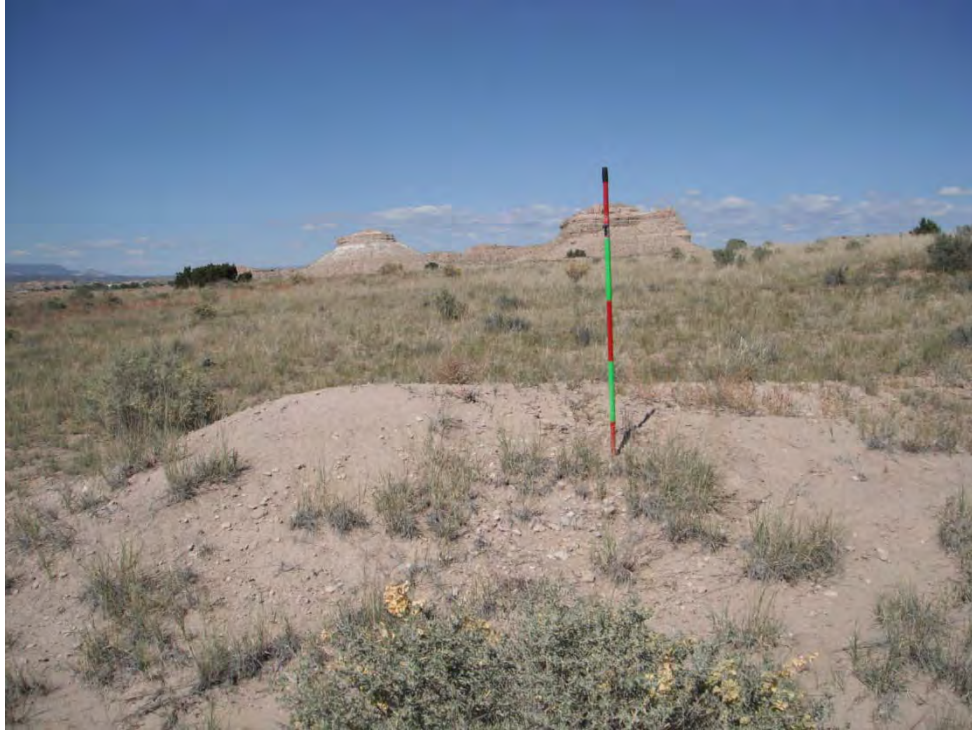
Photo 9-Looking north at PilePly-2.

PilePly-2 - 3' tall, 10' wide, 20' long associated with Pit 3

Rad 10 - PilePly-2; Om-44  $\mu\text{R/h}$ ; 1m-28  $\mu\text{R/h}$

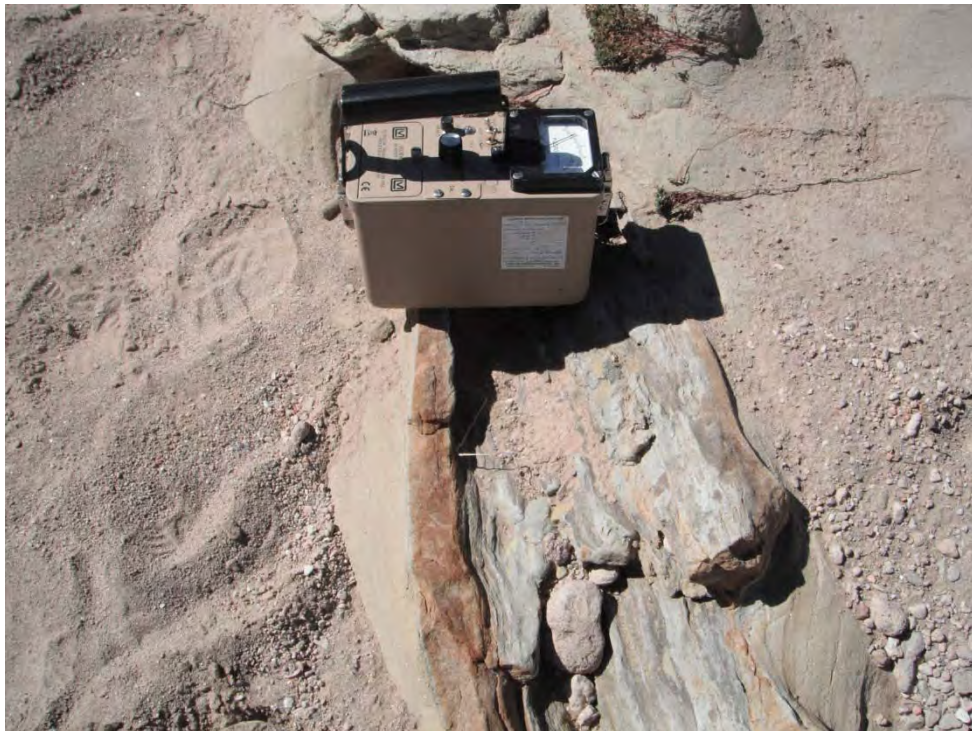
Photo 10-Closeup of rocks at Rad-12.

Rad 12 - outcrop in arroyo; Om-250  $\mu\text{R/h}$ ; 1m-22  $\mu\text{R/h}$
