Abandoned Uranium Mine Site Assessment for the Chill Willis Site (NM0101)

FINAL REPORT

April 20, 2010

NM0101

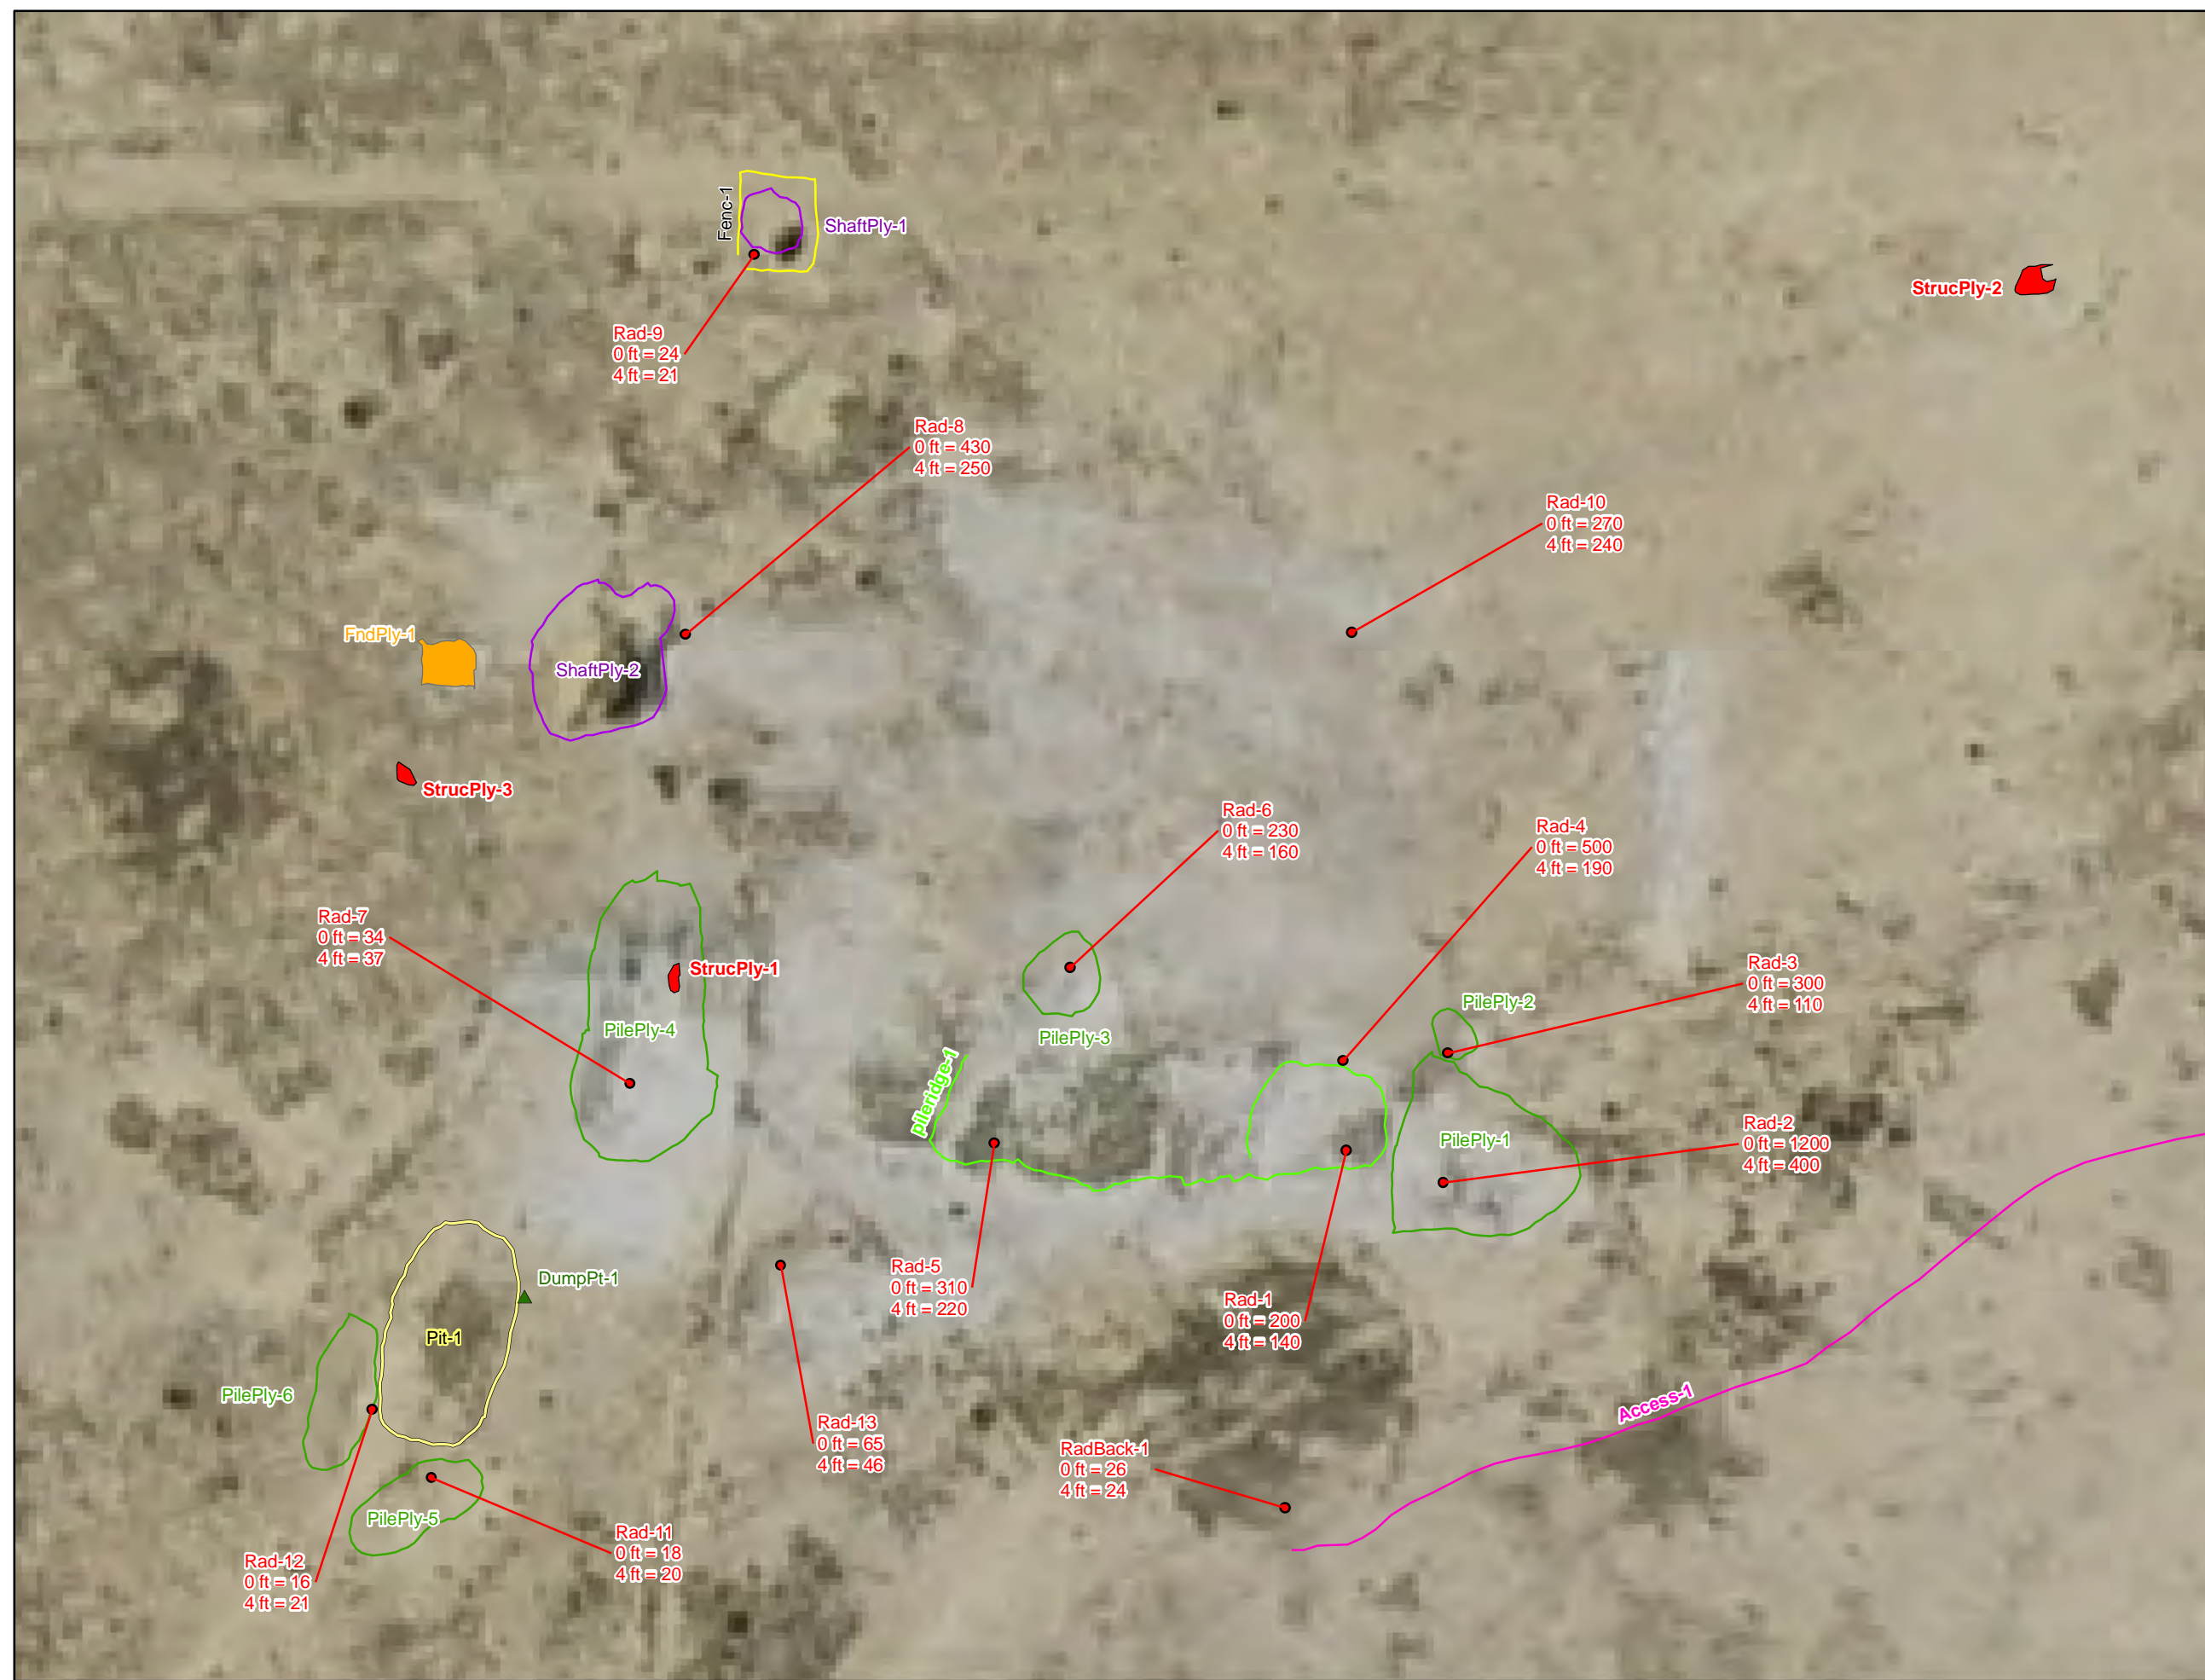
Figure 4a
Site Map on
Aerial Photo
NM0101-Chill Willis
 Abandoned Uranium
 Mine Assessment

photos, Table 1 for a list of all AUM Site features, and Figure 4a and 4b for the locations of the AUM Site features.

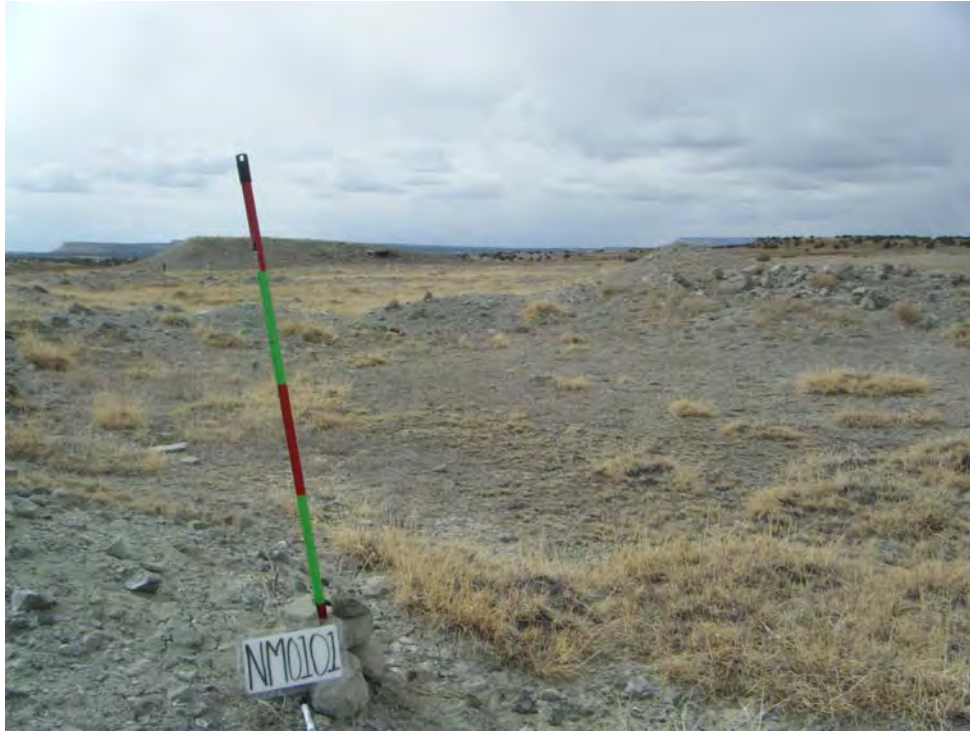
Photo 1-Looking west at the Site.

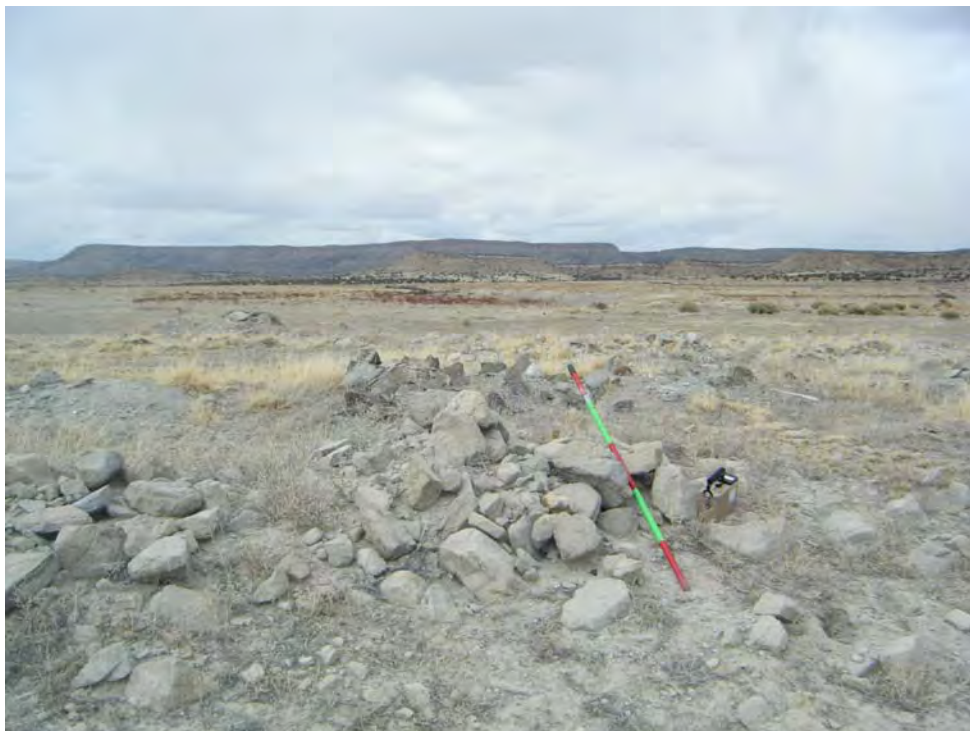
Photo 2-Looking north at waste pile (PilePly-1).

^{AUM} Pile Ply-1 - 25' wide, 40' long, 2' tall; grey ^{AUM} waste rock, ore pile; 10%

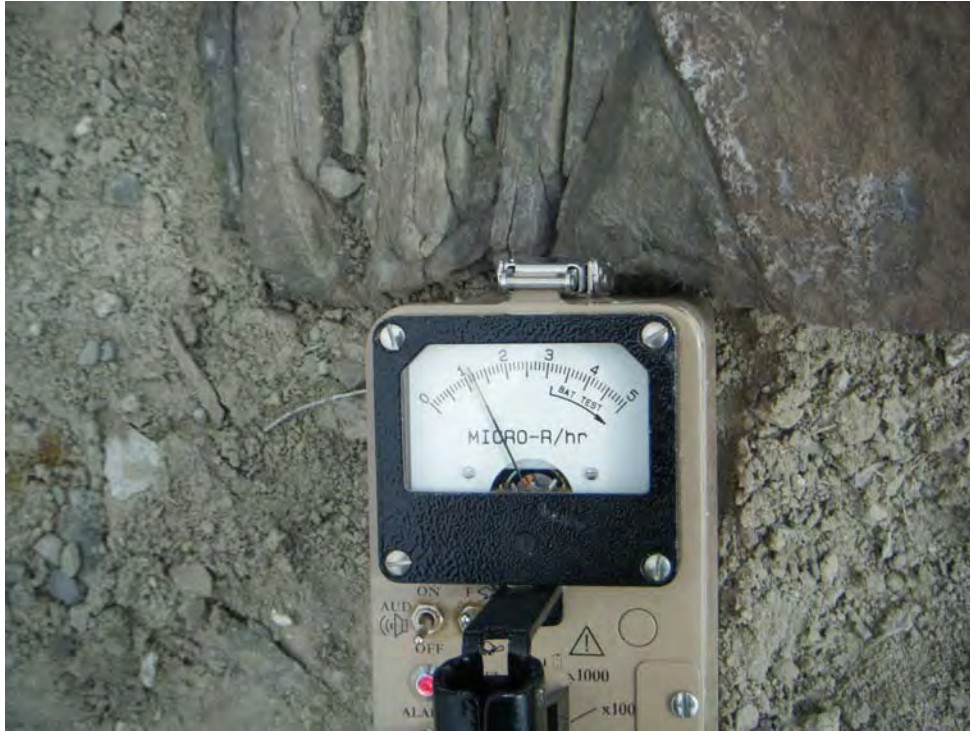
Photo 3-Looking at scintillometer reading on grey rock on PilePly-1 (Rad-2; 1200 μ R/hr at contact).

Rad 2 - Pile Ply-1 - on grey rock; 0m - 1200 μ R/h; 1m - 400 μ R/h

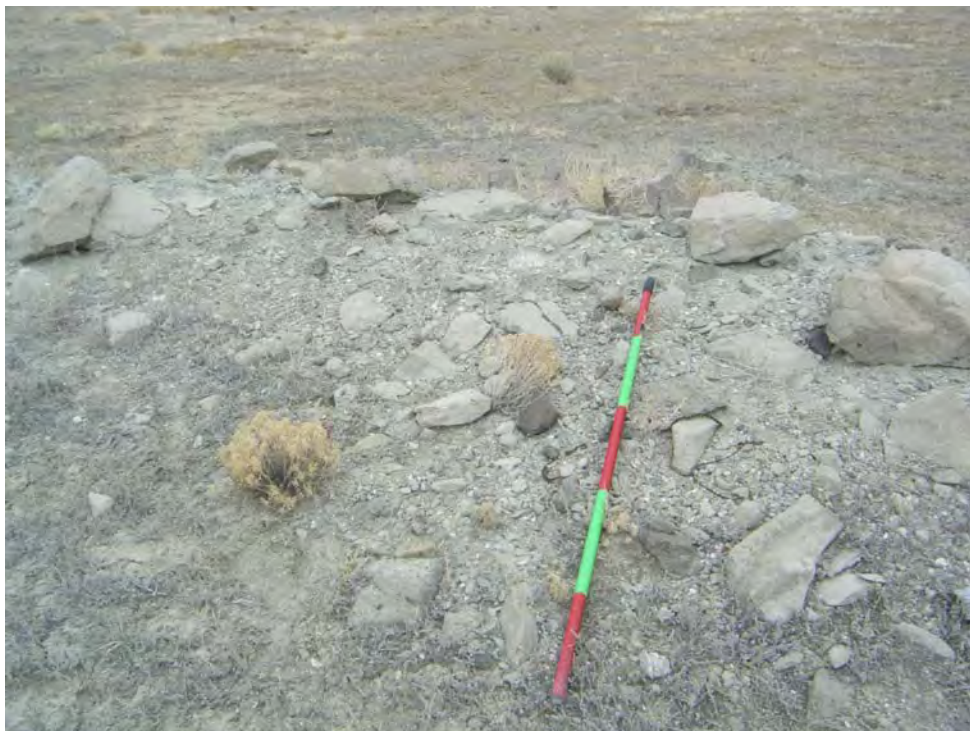
Photo 4-Looking east at waste pile (PilePly-2).

Pile Ply-2 - 15' long, 8' wide, 2' tall; waste rock; 10%

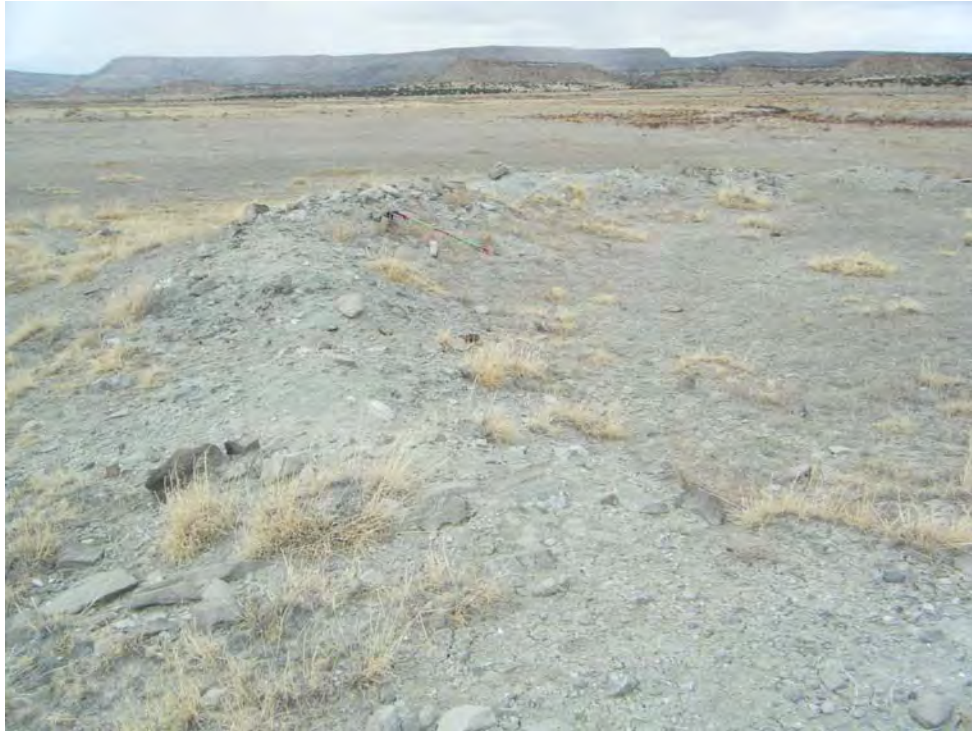
Photo 5-Looking north along a waste pile (PileRidge-1).

Pile Ridge-1 - 5' wide, 3' tall, long 'J'-shape; waste

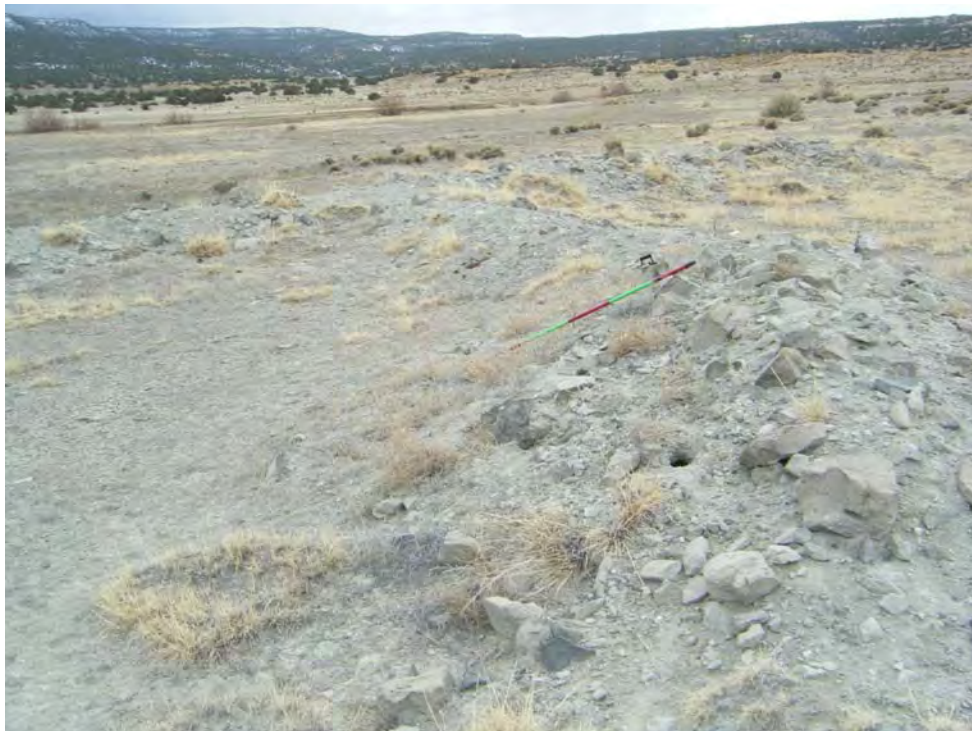
Photo 6- Looking south along PileRidge-1.

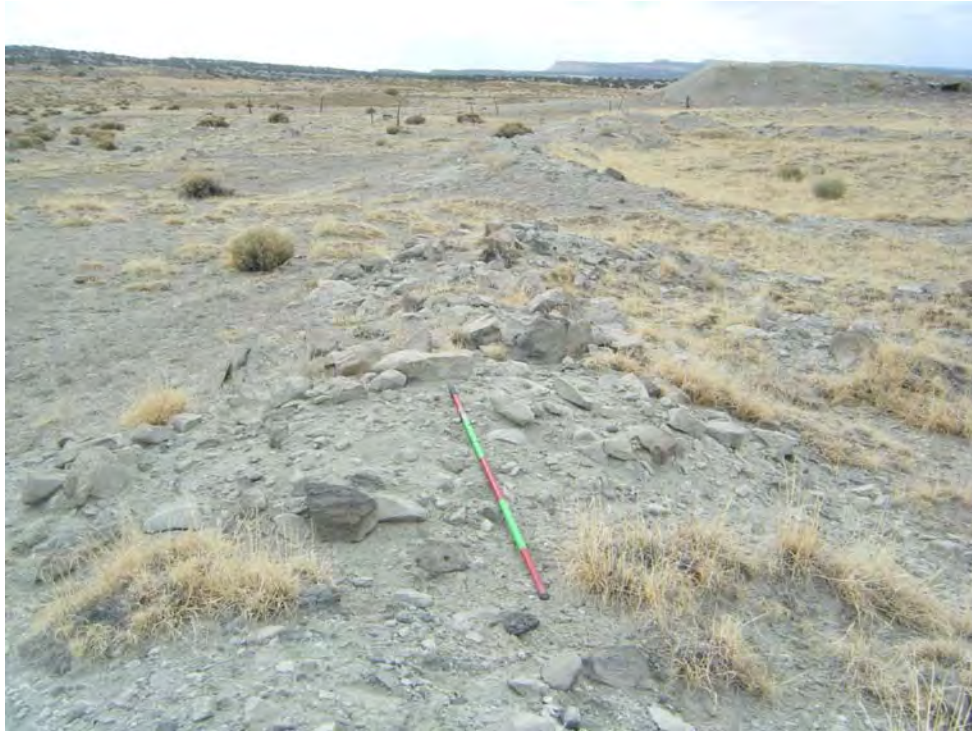
Photo 7- Looking west along PileRidge-1.

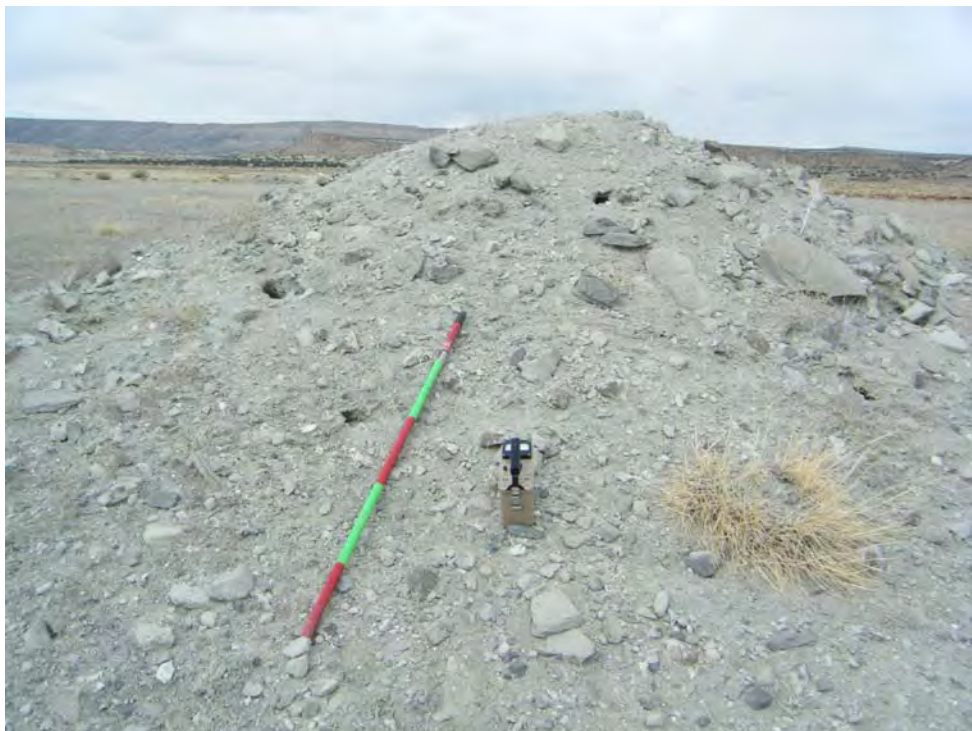
Photo 8- Looking north at PilePly-3.

Pile Ply 3 - 20' x 20'; 6' tall; waste rock; 20%

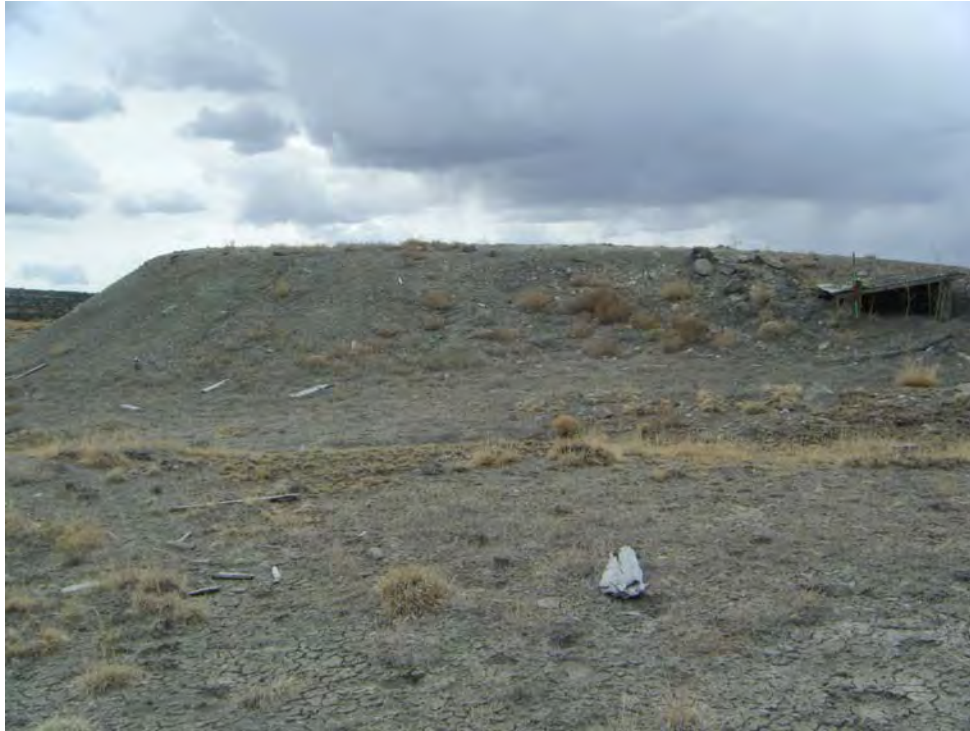
Photo 9-Looking west at PilePly-4 (“Main dump” in Anderson Report) replicating Photo “e” from the Anderson Report.

85' long; 35' wide; 11' tall at south end; 6' tall at north end

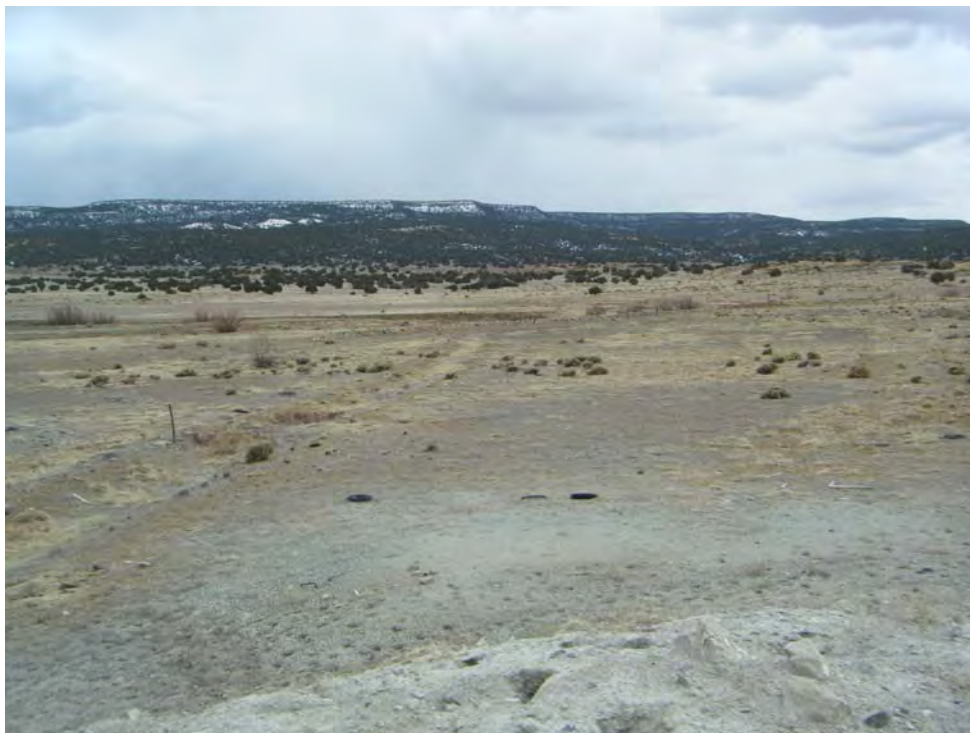
PilePly-4, extends south several hundred feet toward San Mateo Creek; please see Photo 10 (Anderson, 1980).

Photo 10- Looking south from the top of PilePly-4 (“Main dump”) replicating Photo “f” from the Anderson Report.

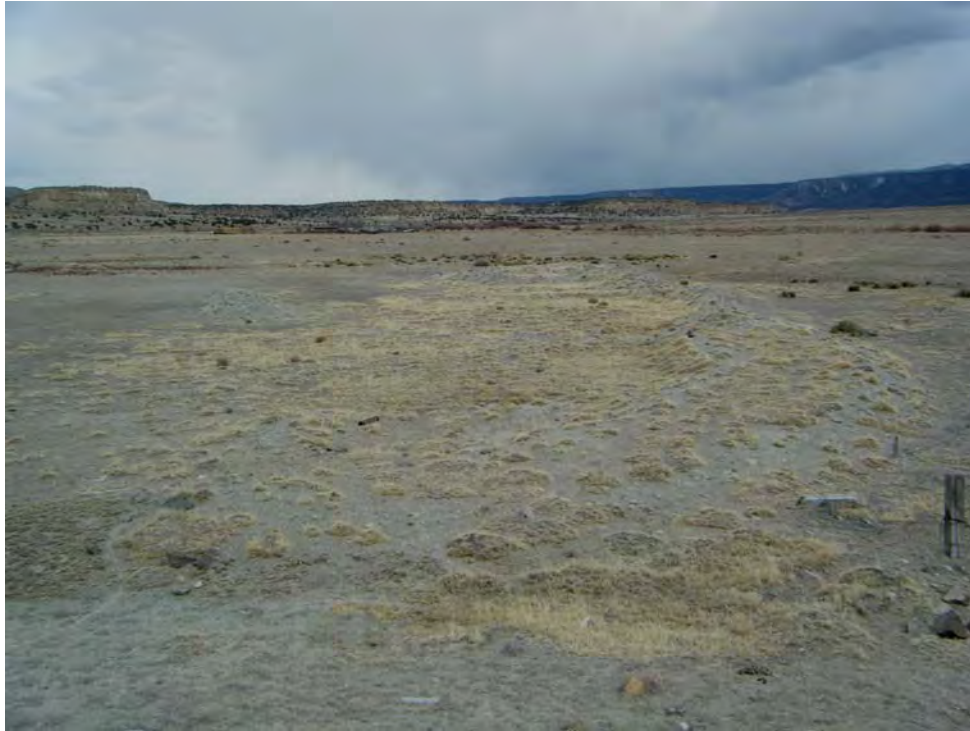
Photo 11- Looking east from the top of PilePly-4 (“Main dump”) replicating Photo “g” from the Anderson Report.

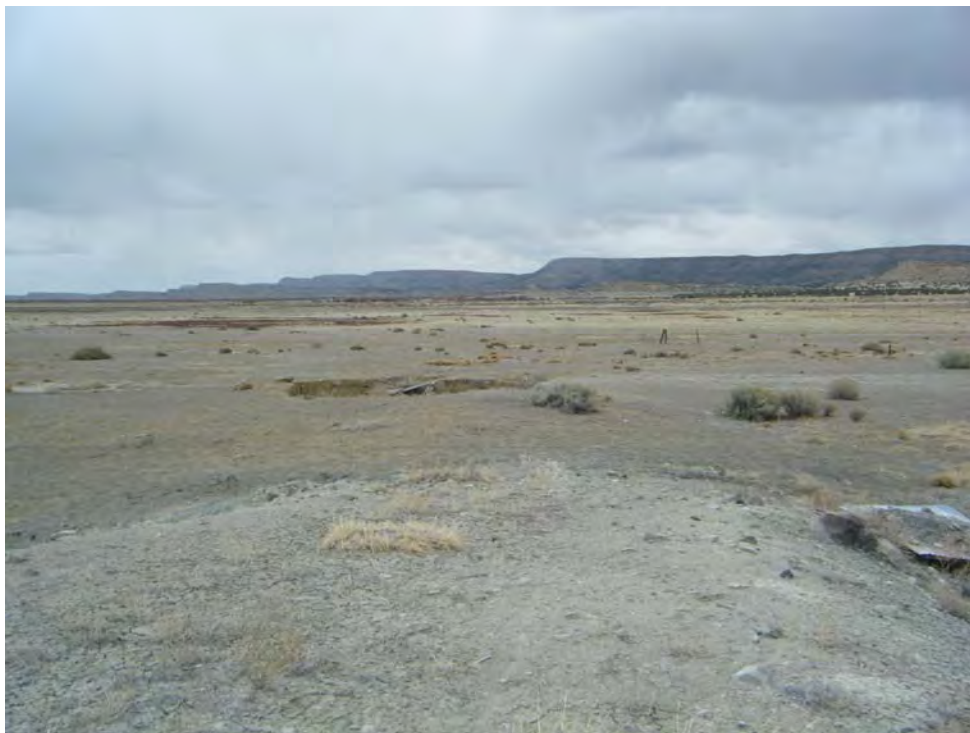
Photo 12- Looking north from the top of PilePly-4 toward the subsidence (SubsidPly-1) and shaft (Shaft-1) replicating Photo “a” from the Anderson Report.

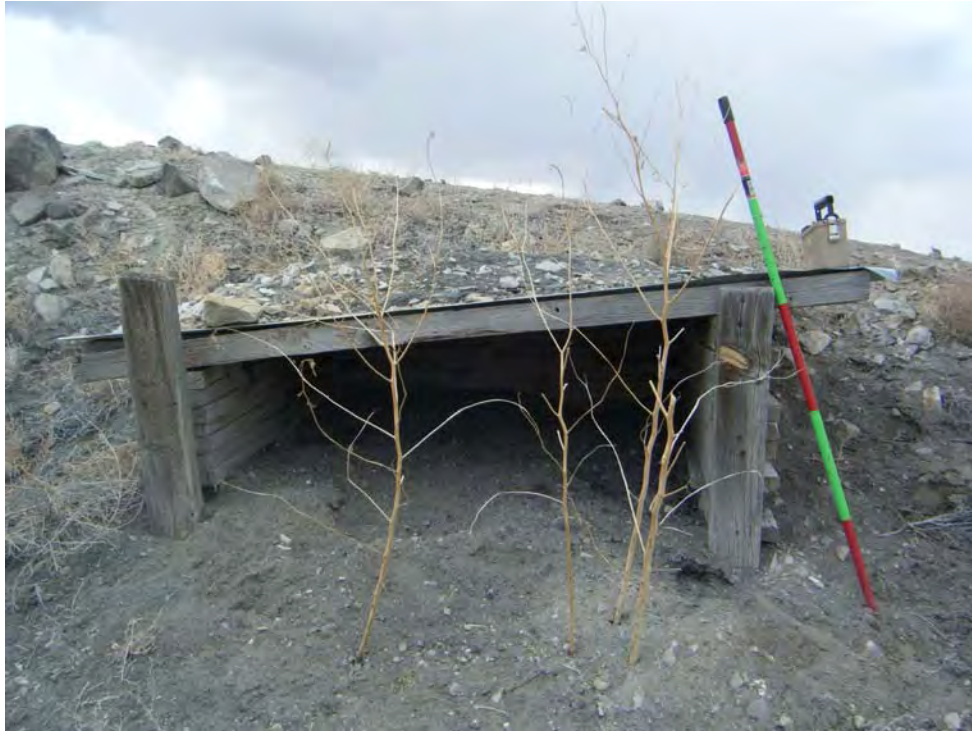
Photo 13-Looking west at the structure (StructPly-1) on the northeast side of PilePly-4.

Structure Ply-1 - 6' long, 4' wide, 3' tall wood 3-sided structure on side of pileply-4 (main dump in Anderson report) tin top

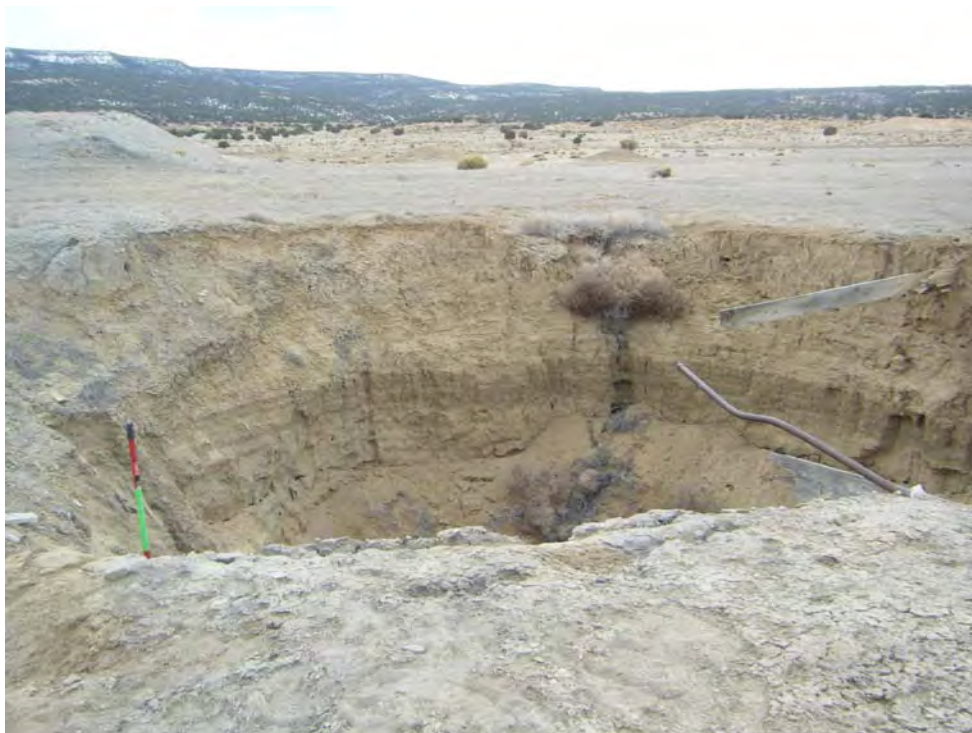
Photo 14-Looking south at ShaftPly-2, referred to the “caved mine shaft” in the Anderson Report.

Subsidence Ply-1 - 40' diameter; 20' deep wood structural supports, may have been shaft - unclear

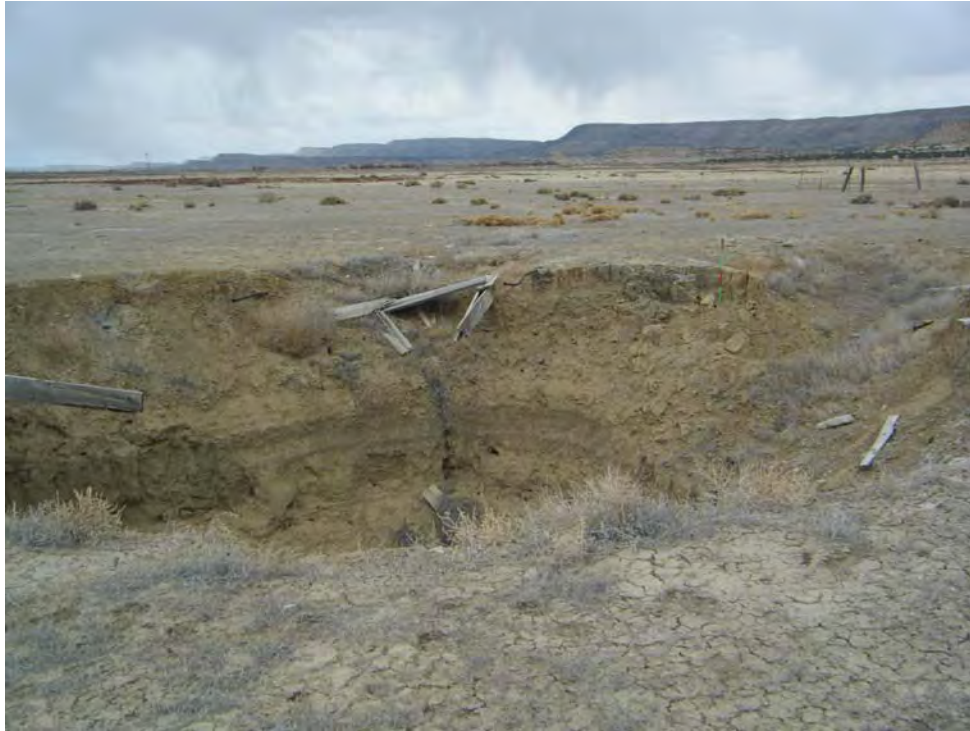
Photo 15-Looking north at the ShaftPly-2 replicating Photo “b” from the Anderson Report.

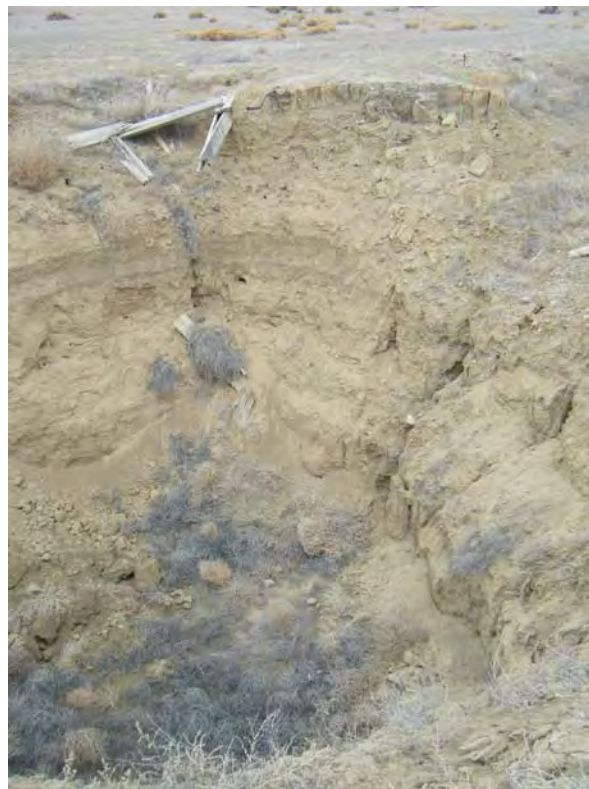
Photo 16-Looking north down into the ShaftPly-2.

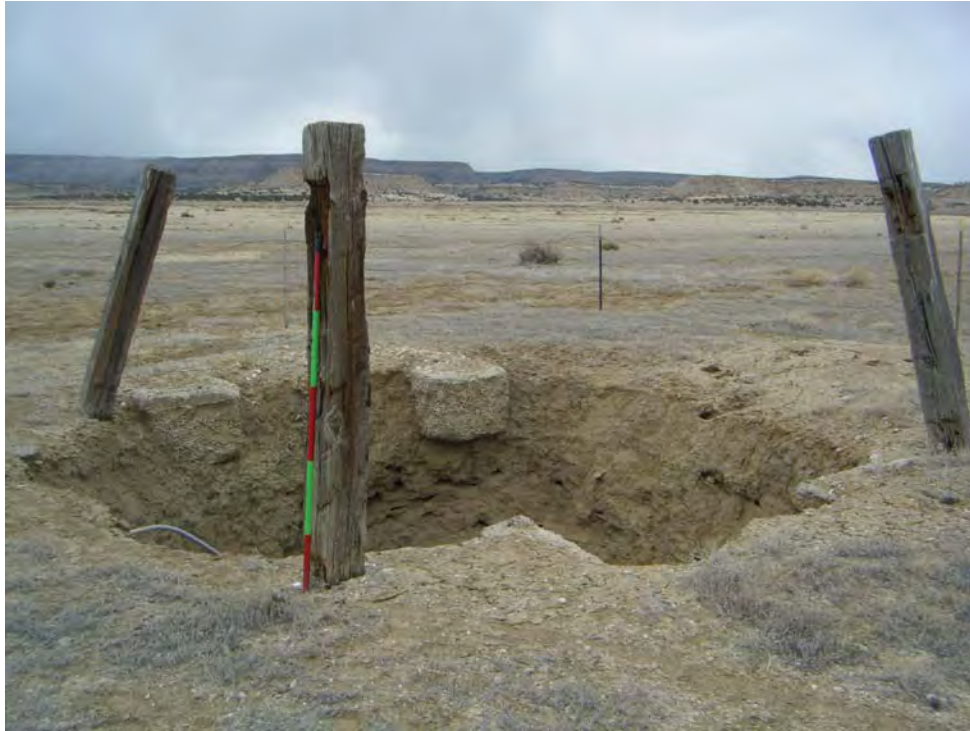
Photo 17-Looking north at a caved mine shaft (ShaftPly-1).

Shaft Ply-1 - 15' diameter; 50' deep, collapsed shaft is reported to be 375-450' deep main shaft; shaft in photo from Anderson report was not main shaft

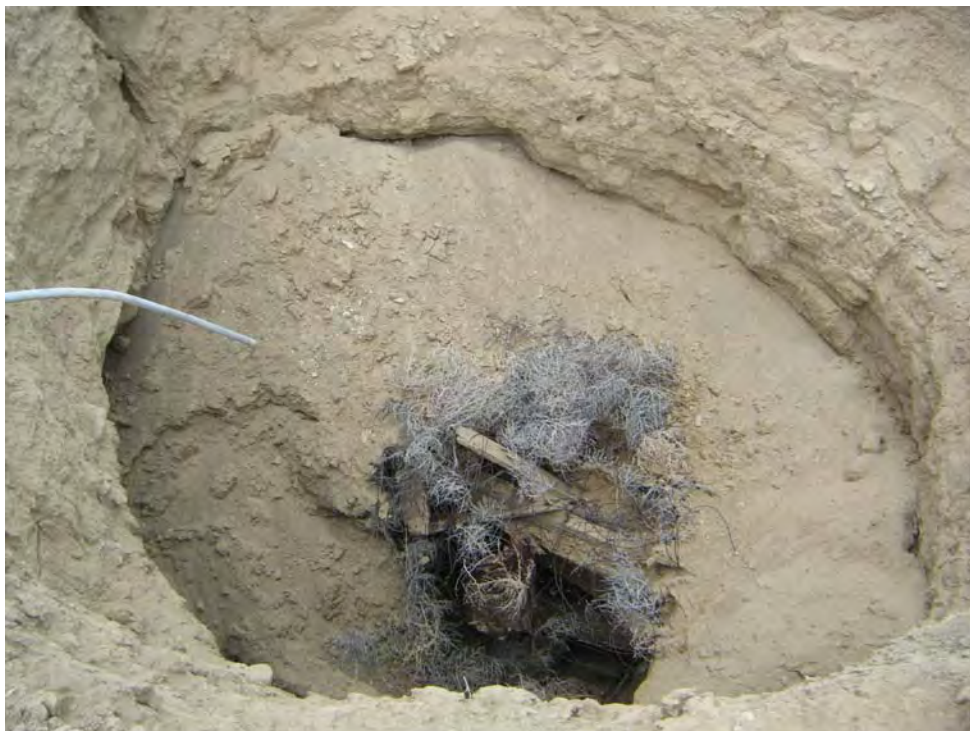
Two shafts were found at the AUM Site. ShaftPly-1 was located at the northern end of the disturbance area and was surrounded by a fence (Fenc-1) put up by the leasee. The shaft is reported to be 375 to 450 feet deep, though collapsed and filled in approximately to a 50 foot depth (Anderson, 1980 and McLemore, 1983). The shaft is approximately 15 feet in diameter and has three wooden beams extending vertically from the shaft opening. Wooden beams can be seen inside the shaft as well. ShaftPly-2 was located approximately 150 feet south of ShaftPly-1. ShaftPly-2 was described as the main shaft in the Anderson Report (Anderson, 1980). The collapsed area associated with ShaftPly-2 is approximately 40 feet in diameter and 70 feet deep. The leasee stated that the collapsed area had deepened in the past year or two.

Photo 18-Looking down into ShaftPly-1, caved depth was approximately 50 feet or more (note timber in center of shaft).

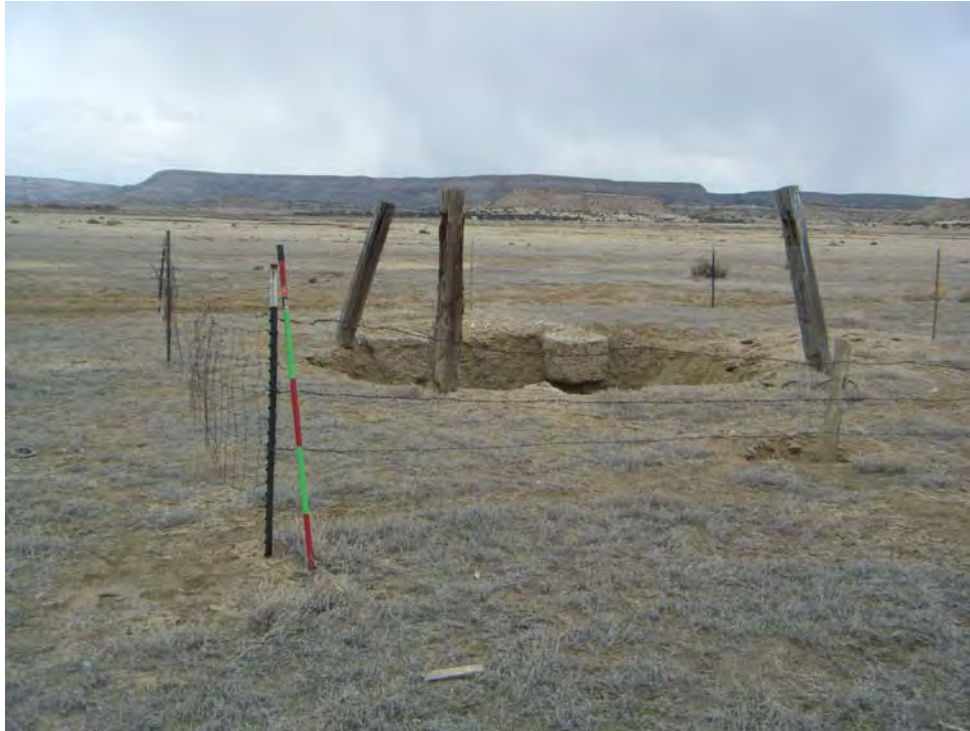
Surrounding ShaftPly-1 is a 20 foot by 20 foot fence, approximately 3 feet high (Fenc-1). The fence was erected by the leasee. Miscellaneous trash was found throughout the AUM Site, however most was south of the mine features (Dumppt-1). The trash included metal car parts, tires, glass, miscellaneous metal, and wood. A small trench, starting near the southeast corner of

Photo 19-Looking north at fence (FenceLn-1) around ShaftPly-1, erected by leasee.

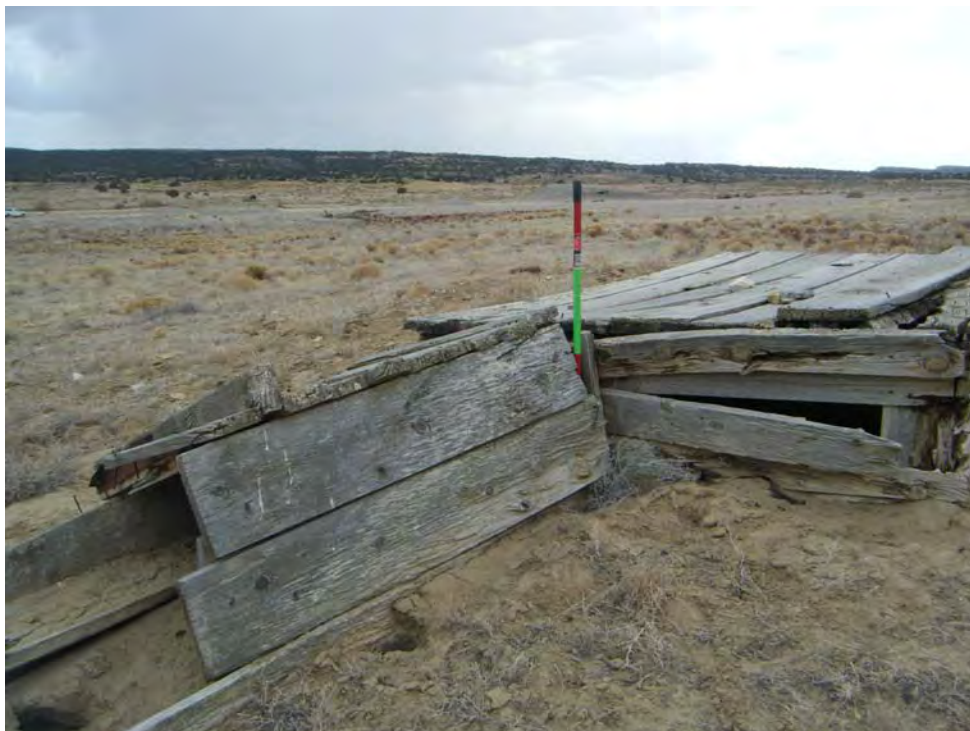
Photo 20-Looking west at StructPly-2, referred to as a “powder magazine” in the Anderson Report.

Struct Ply-2 - mentioned in Anderson Report as powder magazine; wood structure 2' tall; 6' x 8'; inside is ~5' deep

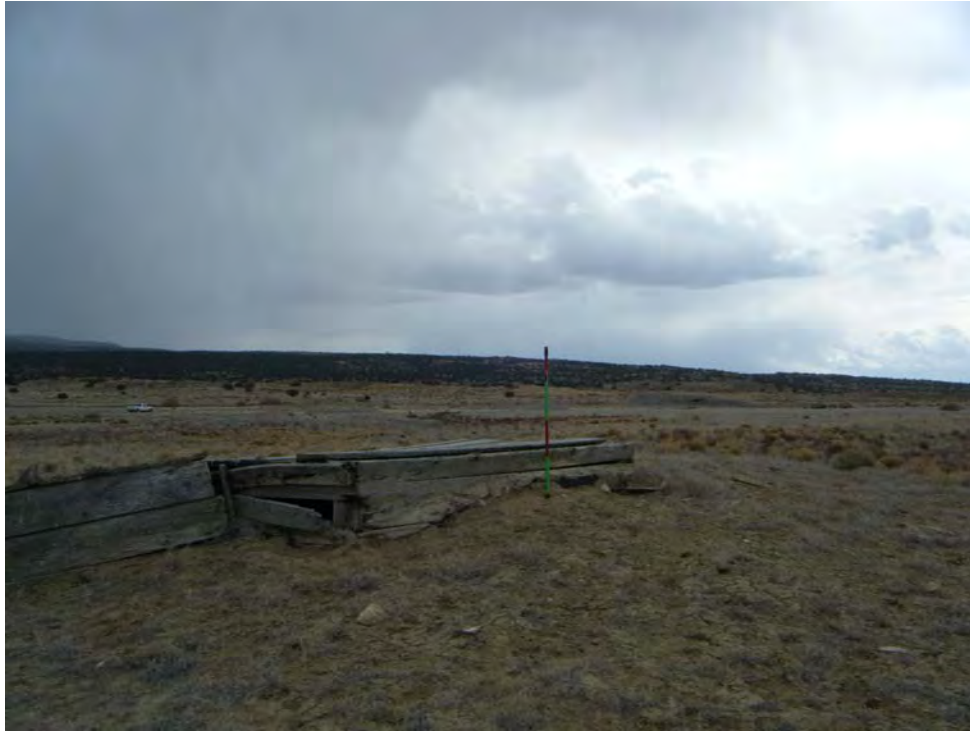
Photo 21-Looking southwest at “powder magazine” (StructPly-2) replicating Photo “d” from the Anderson Report.

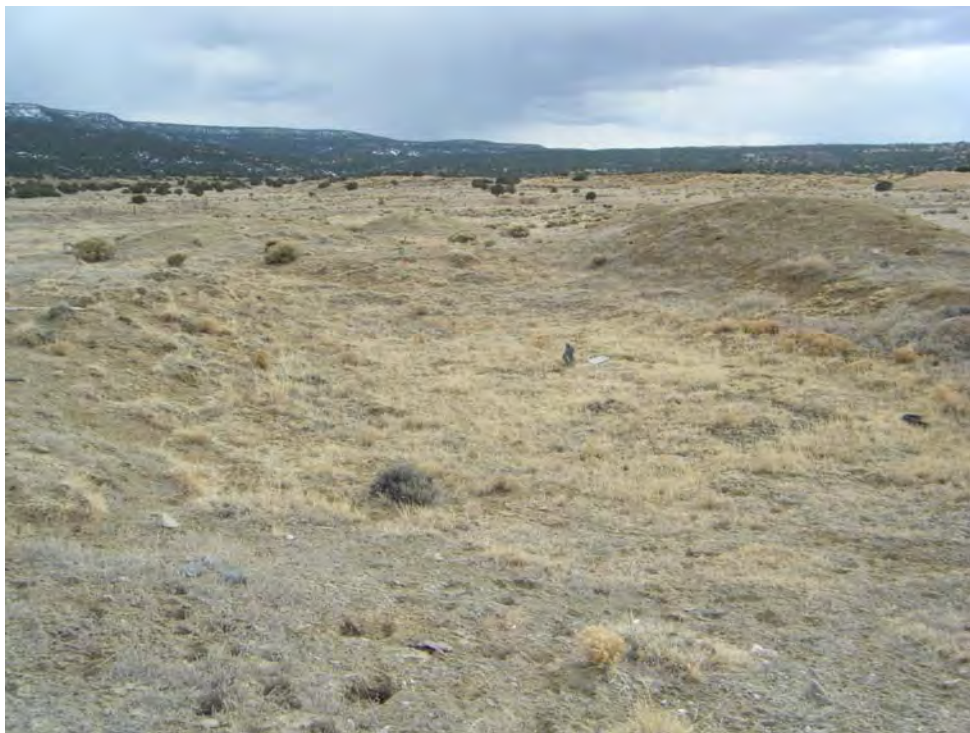
One pit (Pit-1) was identified at the AUM Site. This pit is approximately 20 feet wide, 50 feet long, and 5 feet deep.

Photo 22-Looking south at Pit-1, with PilePly-5 on the left and PilePly-6 on the right in the background.

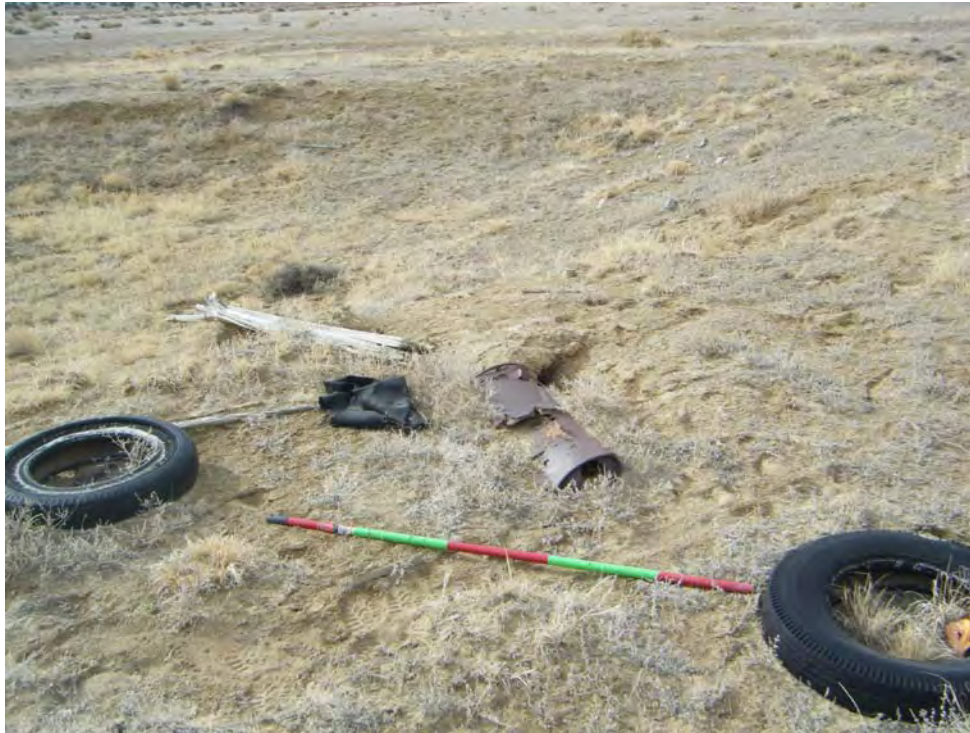
Photo 23-Looking northwest at DumpPt-1, near PitPly-1.

Dump Pt-1 - 2 tires, and 1 muffler, various metal 10 x 3'

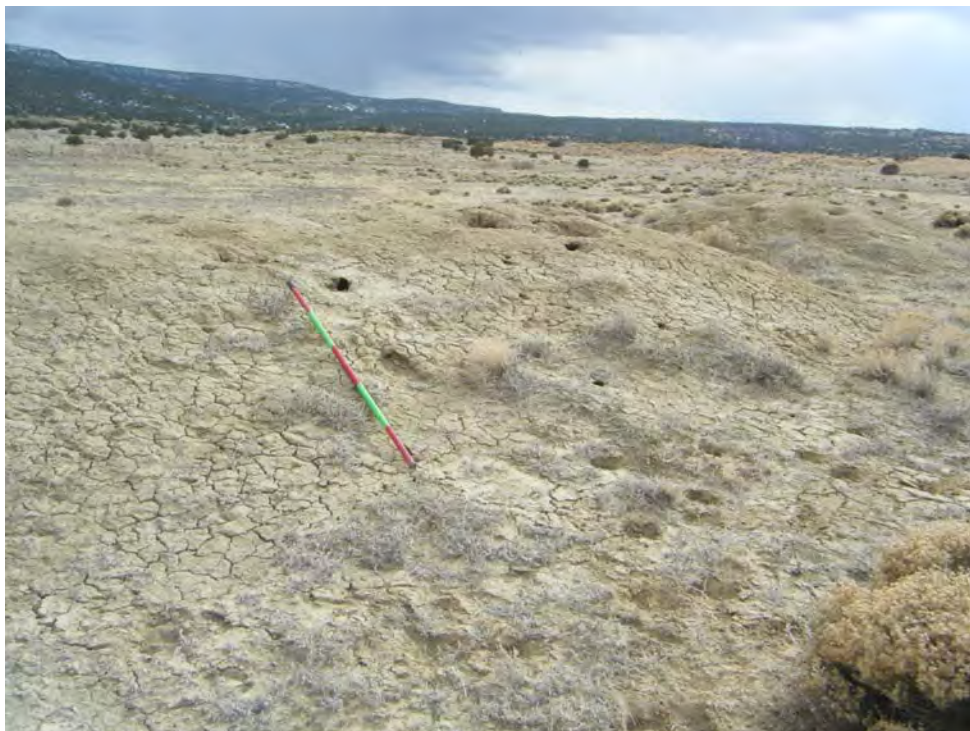
Photo 24-Looking south at PilePly-5.

Pile Ply-5 - 5' tall; 25' long, 12' wide; 15% associated with ~~Dump Pt-1~~^{Pit Ply-1}; dirt from Pit

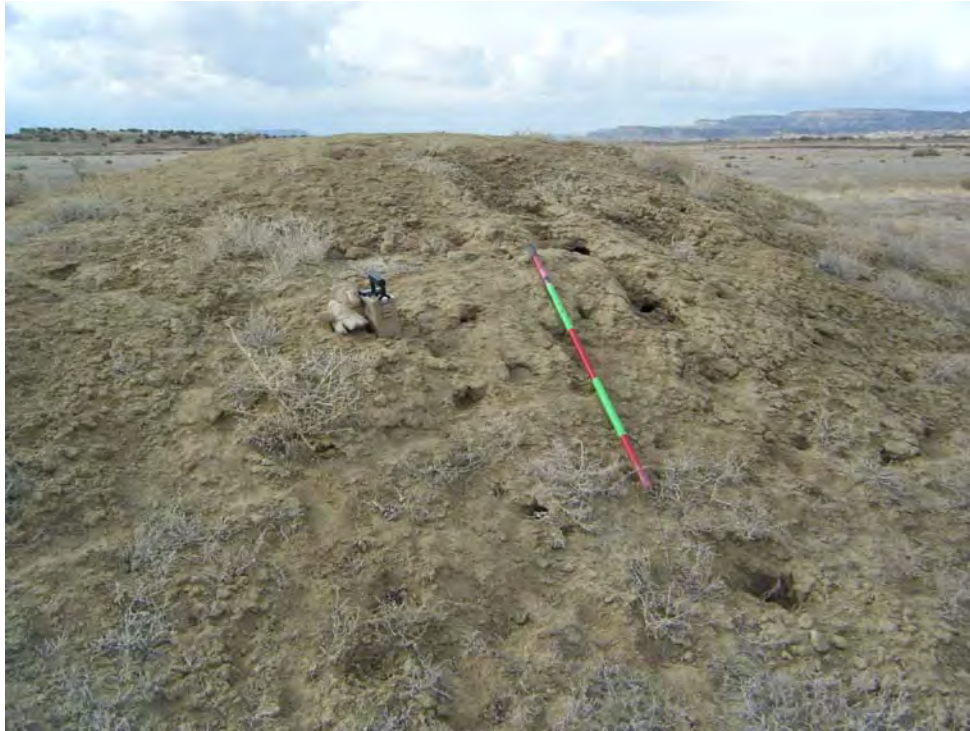
Photo 25-Looking north at PilePly-6.

Pile Ply-6 - 6' tall; 20' wide, 40' long; dirt from Pit Ply-1

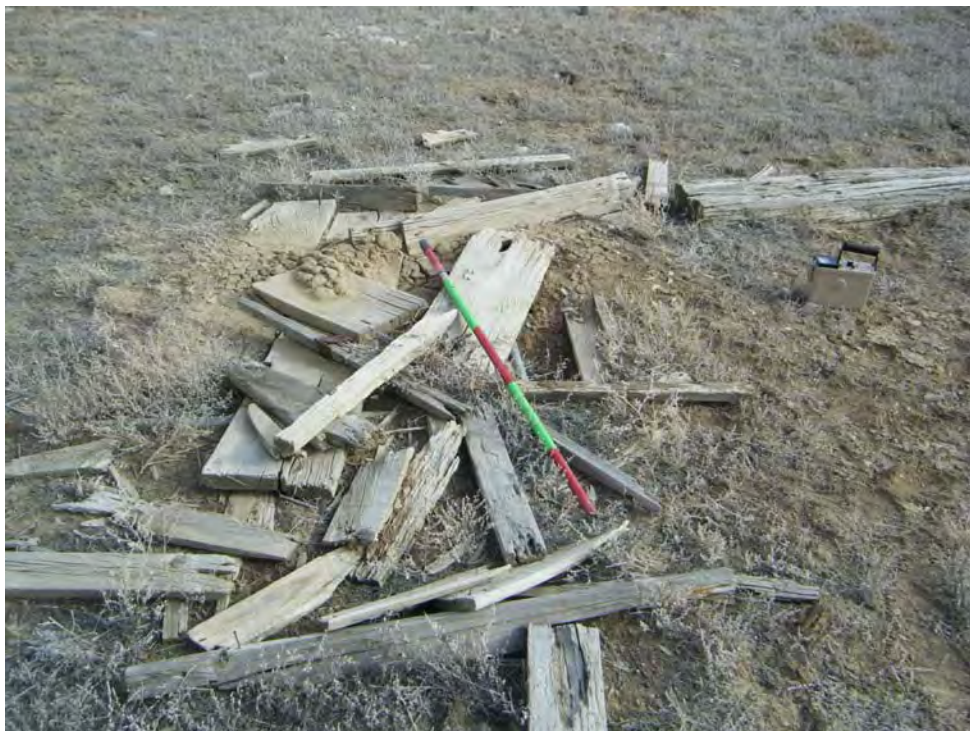
Photo 26-Looking south at collapsed structure (StructPly-3).

Struct Ply-3 - collapsed; 4' x 8'; wood, metal hinges; pipe under wood.
