Abandoned Uranium Mine Site Assessment for the Chill Willis Site (NM0101)

FINAL REPORT

April 20, 2010

NM0101

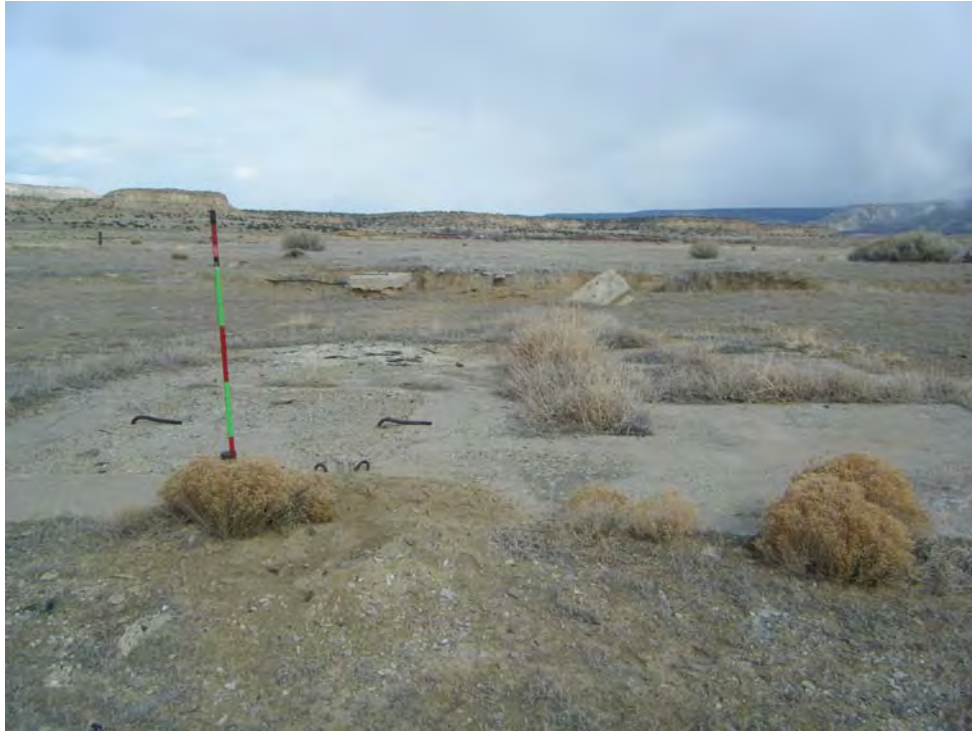
Photo 27-Looking east at a 20 by 30 foot concrete foundation (FndPly-1) with SubsidencePly-1 in the background.

Fnd Ply-1 - cement foundation 20' x 30'; 30 ft. west of Subsidence Ply
