**GROUNDWATER MONITORING AND
MONITOR WELL ABANDONMENT REPORT
LEONARD'S CONOCO
SANTA ROSA, NEW MEXICO**

**Leonard's Conoco
603 Parker Avenue
Santa Rosa, New Mexico
PSTB Facility #29084**

Deliverable ID# 3727-1

April 1, 2014

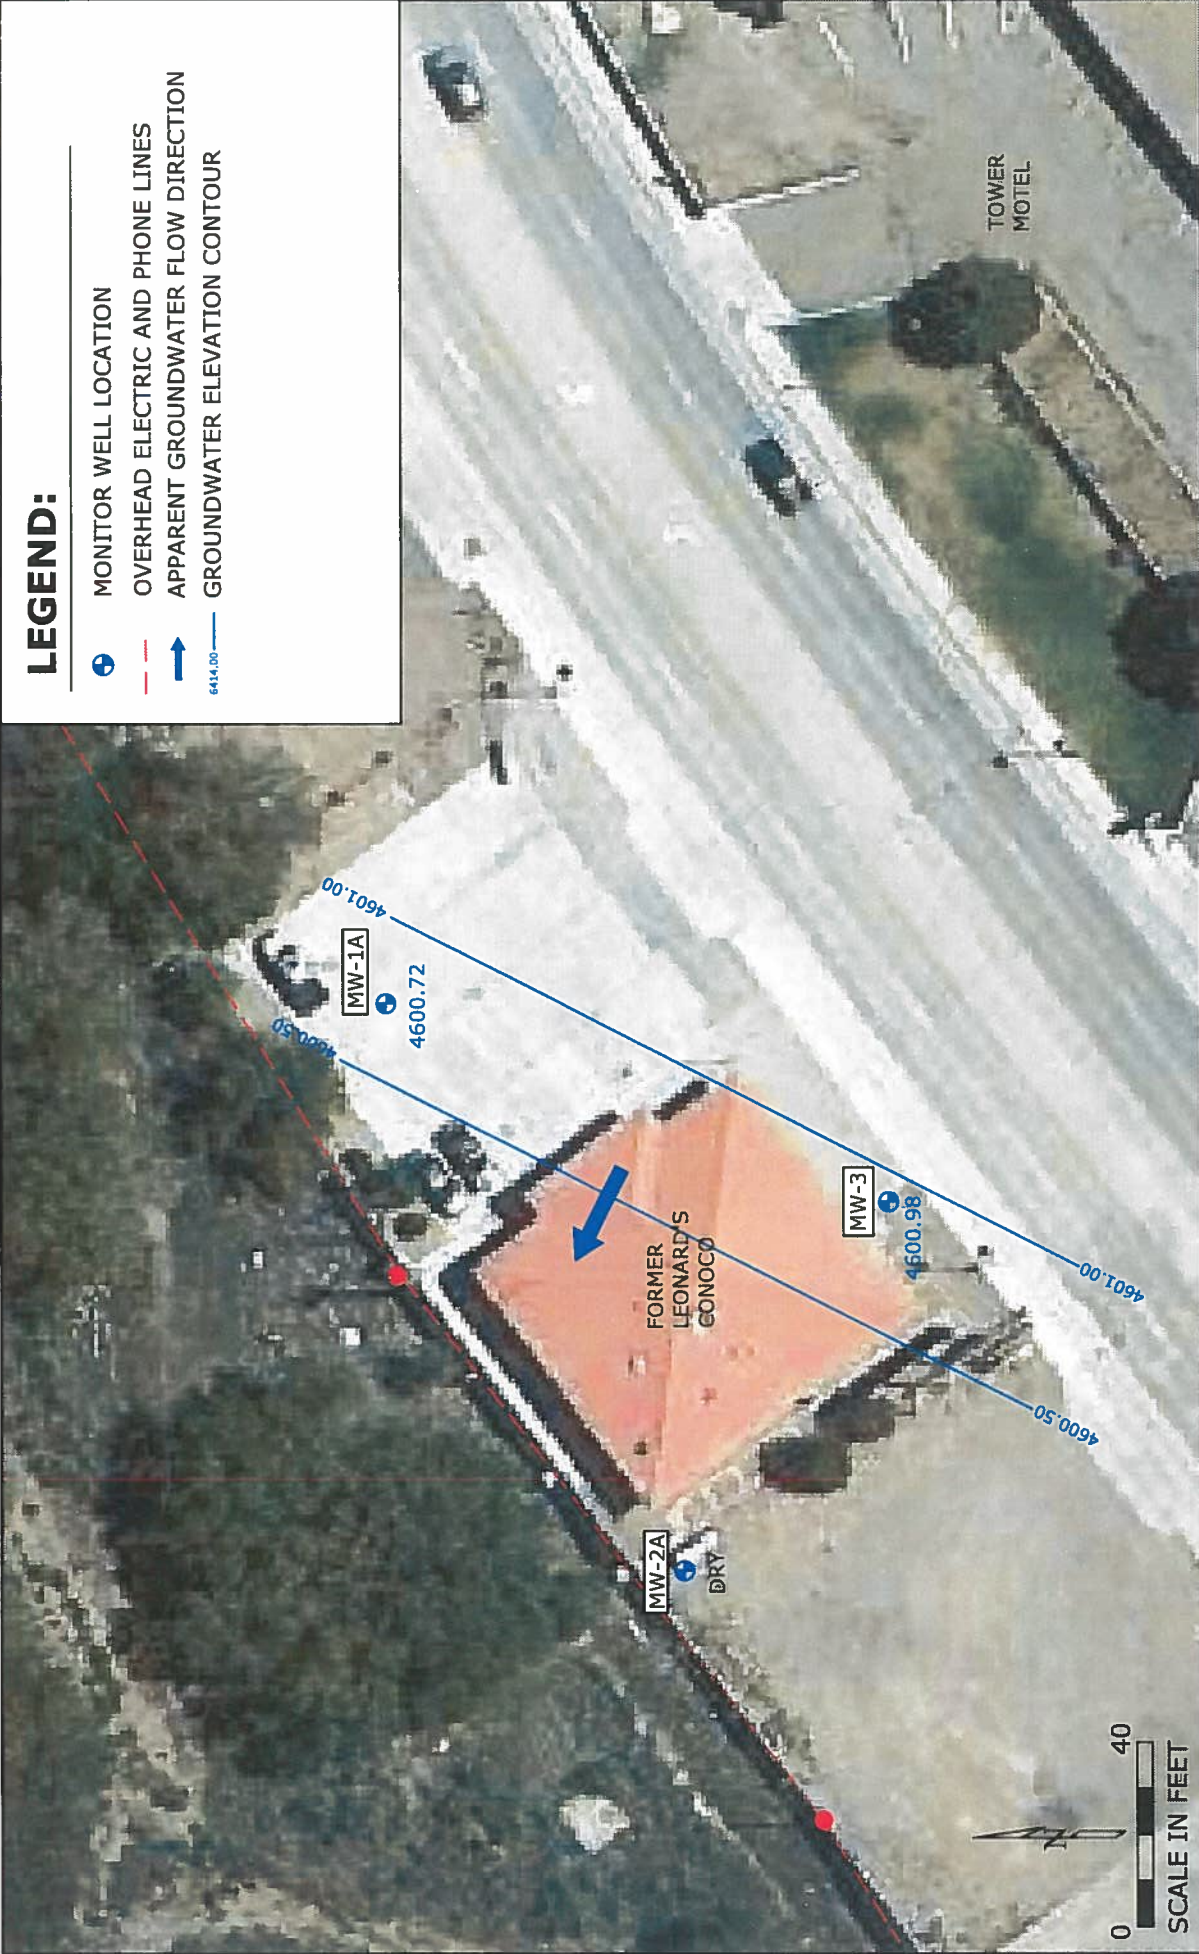
FIGURE
3

Only two of the three monitor wells contained water; therefore, shallow groundwater flow direction and gradient could not be determined. However, groundwater elevations at MW-1A and MW-3 imply an apparent flow direction to the northwest as shown on Figure 3.

WATER TABLE MAP
 MARCH 24, 2014
 LEONARD'S CONOCO
 603 PARKER AVENUE
 SANTA ROSA, NEW MEXICO
 Source: Google Earth Image-2012

Water Levels – Groundwater elevations are within the fluctuation range that was observed between March 1995 and October 2013. Currently, depth to groundwater at the site ranges from 14.04 to 15.30 feet below top of casing. Water levels have declined approximately 1.4 feet since the previous monitoring event in October 2013. Although only two of the three monitor wells contained water during this event, water level elevations imply an apparent flow direction to the northwest, consistent with previous observations.

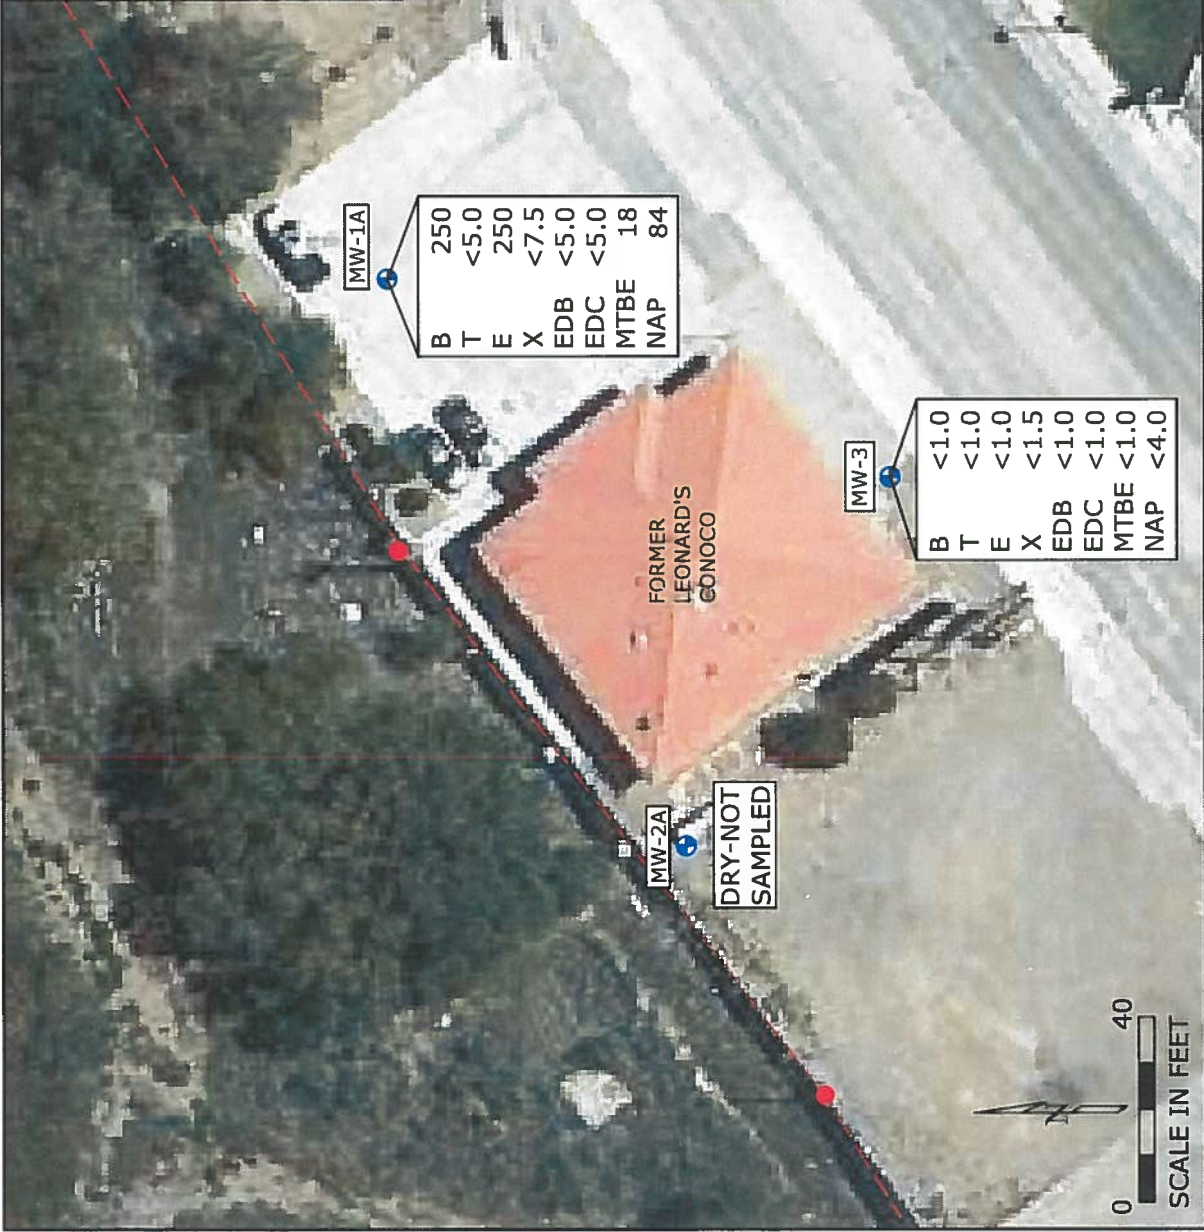
FIGURE

MW-1A

B	250
T	<5.0
E	250
X	<7.5
EDB	<5.0
EDC	<5.0
MTBE	18
NAP	84

MW-3

B	<1.0
T	<1.0
E	<1.0
X	<1.5
EDB	<1.0
EDC	<1.0
MTBE	<1.0
NAP	<4.0

MW-2A
●
DRY-NOT SAMPLED

DISSOLVED ORGANICS RESULTS MAP

MARCH 24, 2014
LEONARD'S CONOCO
603 PARKER AVENUE
SANTA ROSA, NEW MEXICO
Source: Google Earth Image-2012

Petroleum contaminants were not detected in the groundwater sample from MW-3. The groundwater sample from MW-1A exceeded New Mexico Water Quality Control Commission (NMWQCC) standards with 250 micrograms per liter ($\mu\text{g/L}$) of benzene and 84 $\mu\text{g/L}$ of total naphthalenes. Dissolved benzene and naphthalenes have increased since the previous monitoring event in October 2013. Analytical data are summarized in Table 2 and Figure 4. The laboratory report is presented in Appendix E.

Groundwater analytical data and groundwater flow direction indicate off-site migration of dissolved benzene and naphthalenes may be present. However, the lateral extent of off-site migration appears to be limited, based on the relatively low concentrations of benzene (250 µg/L) and naphthalenes (84 µg/L) at MW-1A (Figures 4 and 5).

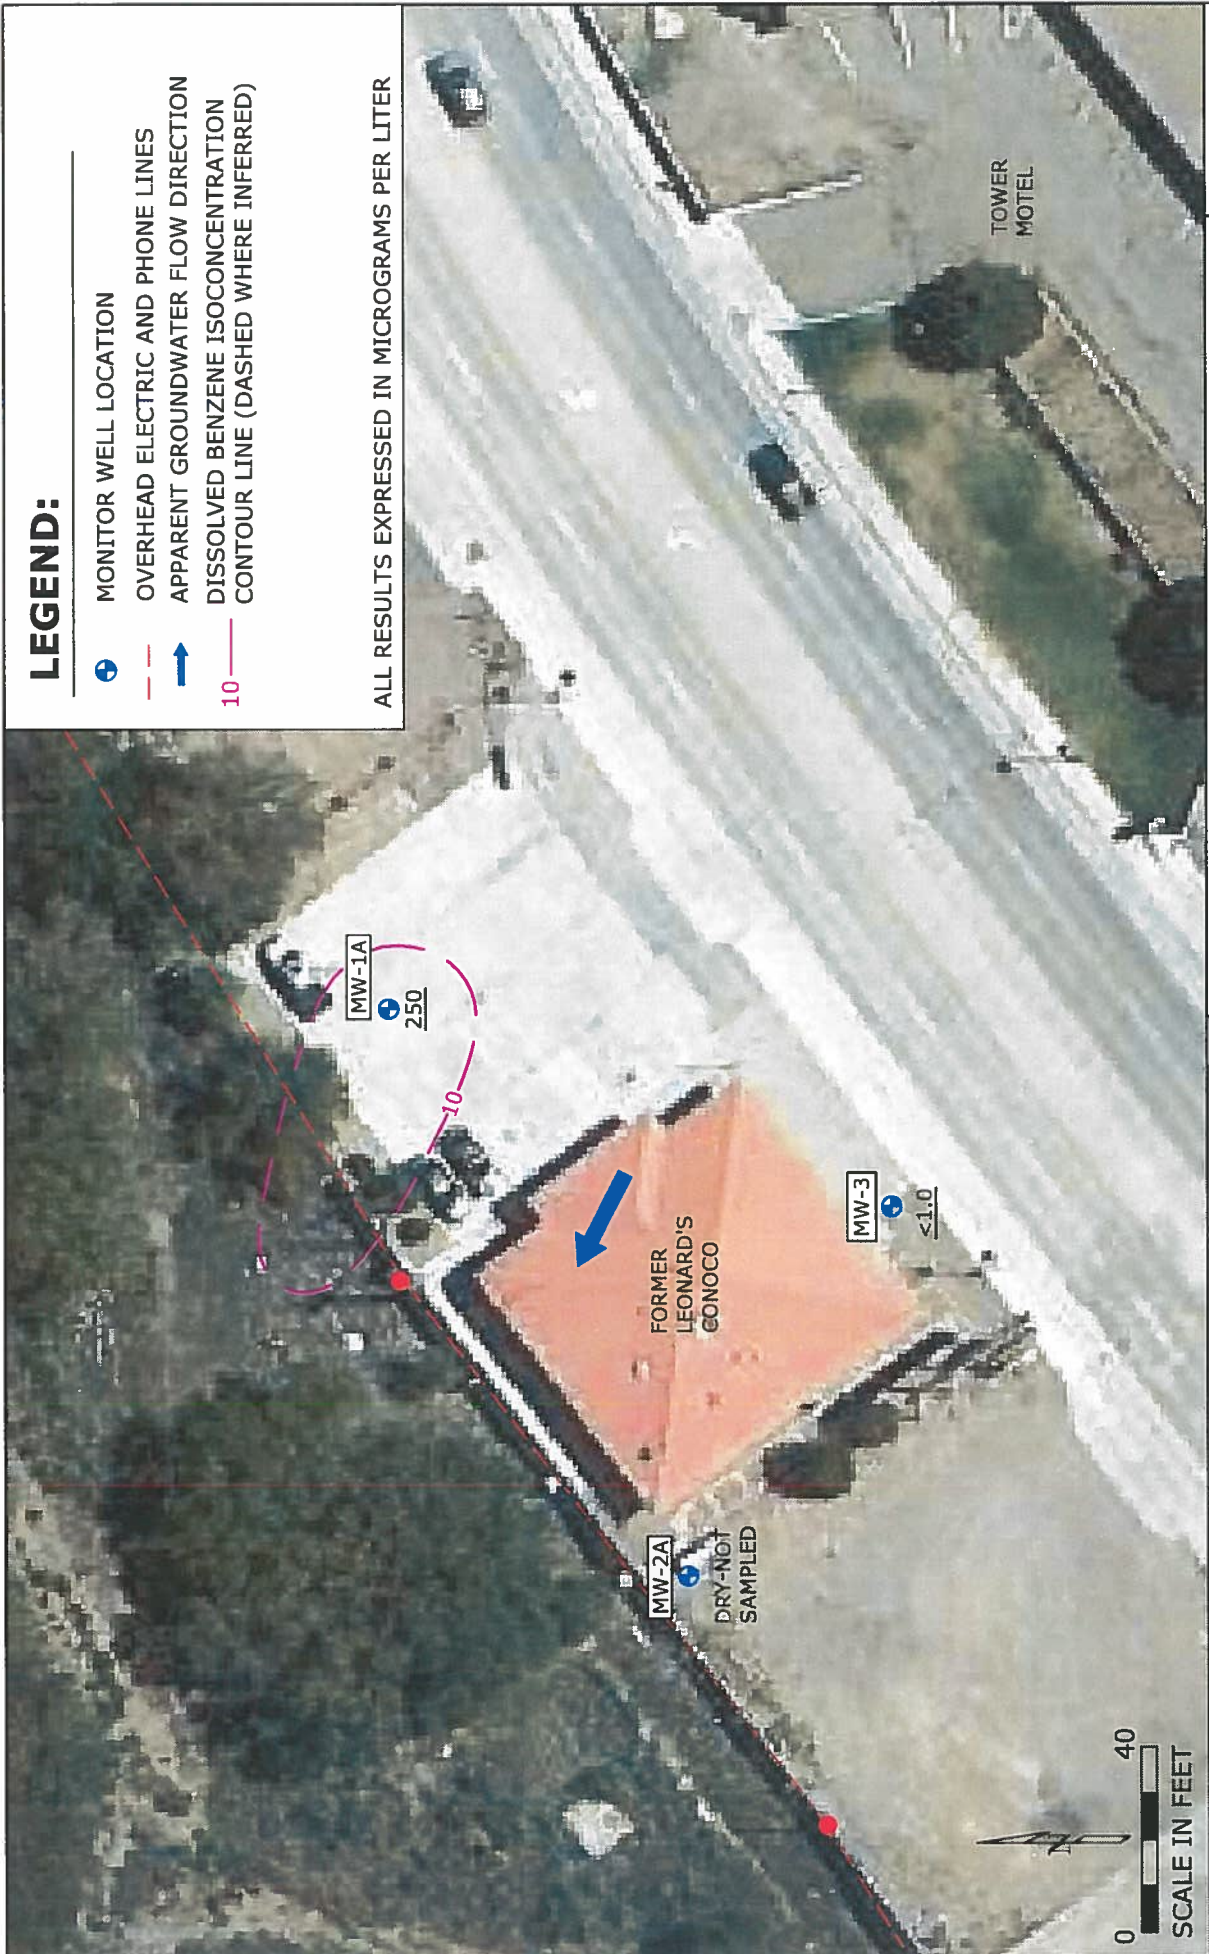
Actionable dissolved benzene and naphthalenes extend northwest from the vicinity of MW-1A. The off-site extent of actionable groundwater contamination appears to be limited, based on the relatively low concentrations of benzene and naphthalenes at MW-1A (Figure 5).

DISSOLVED BENZENE MAP

MARCH 24, 2014
 LEONARD'S CONOCO
 603 PARKER AVENUE
 SANTA ROSA, NEW MEXICO
 Source: Google Earth Image-2012

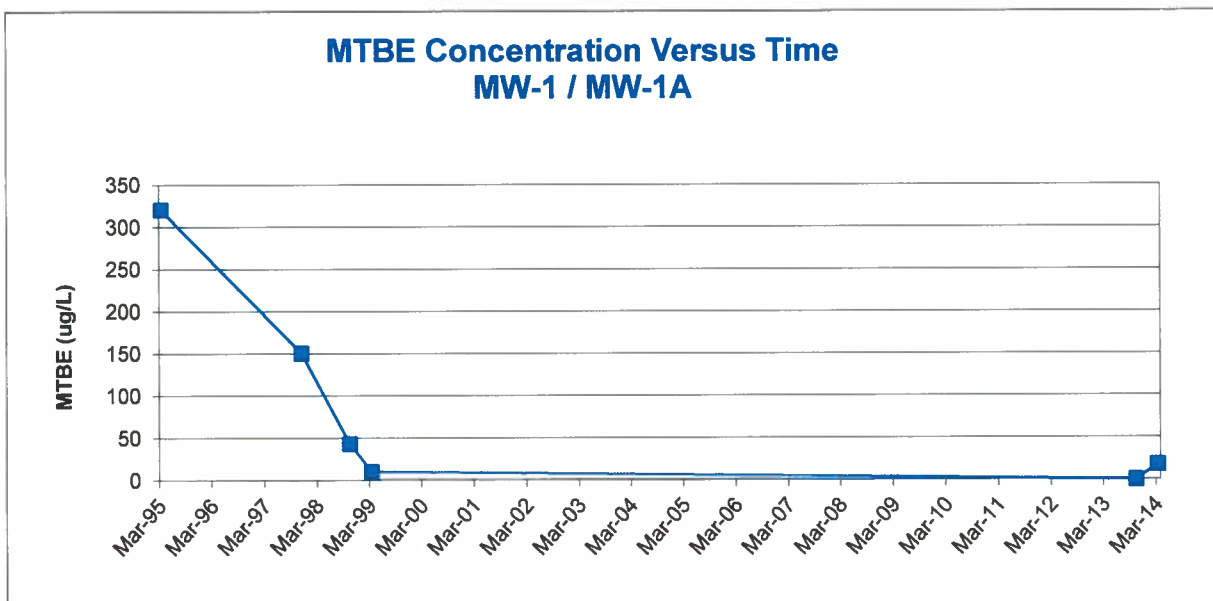
Over the long term, natural attenuation processes have contributed to decreasing groundwater contaminant concentrations at MW-1/MW-1A. Although benzene moderately increased during this event, long term concentrations generally appear to exhibit a very slow declining trend, based on the graph of benzene concentrations versus time (Figure 6).

FIGURE 6
MW-1 / MW-1A BENZENE AND MTBE CONCENTRATIONS VERSUS TIME
LEONARD'S CONOCOCO, SANTA ROSA, NEW MEXICO

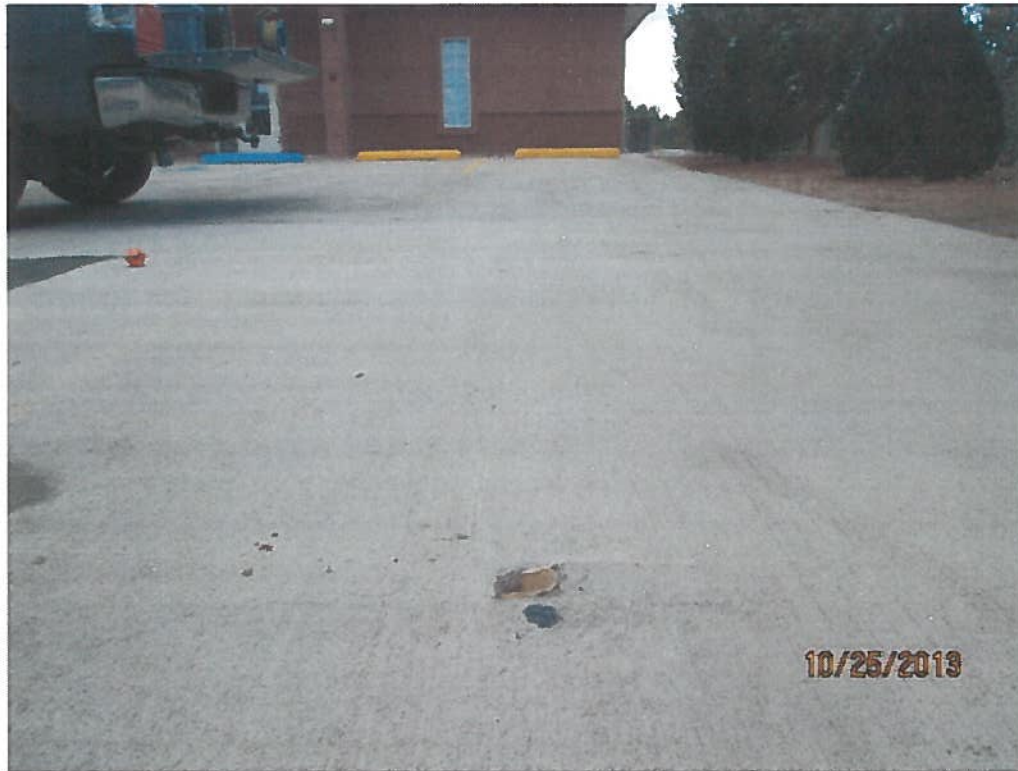
Monitor well MW-1 became partially filled with concrete to a depth of 9.4 feet below ground surface (bgs) during concrete slab construction in 2000. On March 24, 2014, the last 9.4 feet of MW-1 were properly plugged and abandoned. Off-site monitor well MW-4 could not be located during prior attempts, and appears to have been destroyed.

Photograph 1. View of monitor well MW-1 casing in concrete pavement (pre-abandonment).

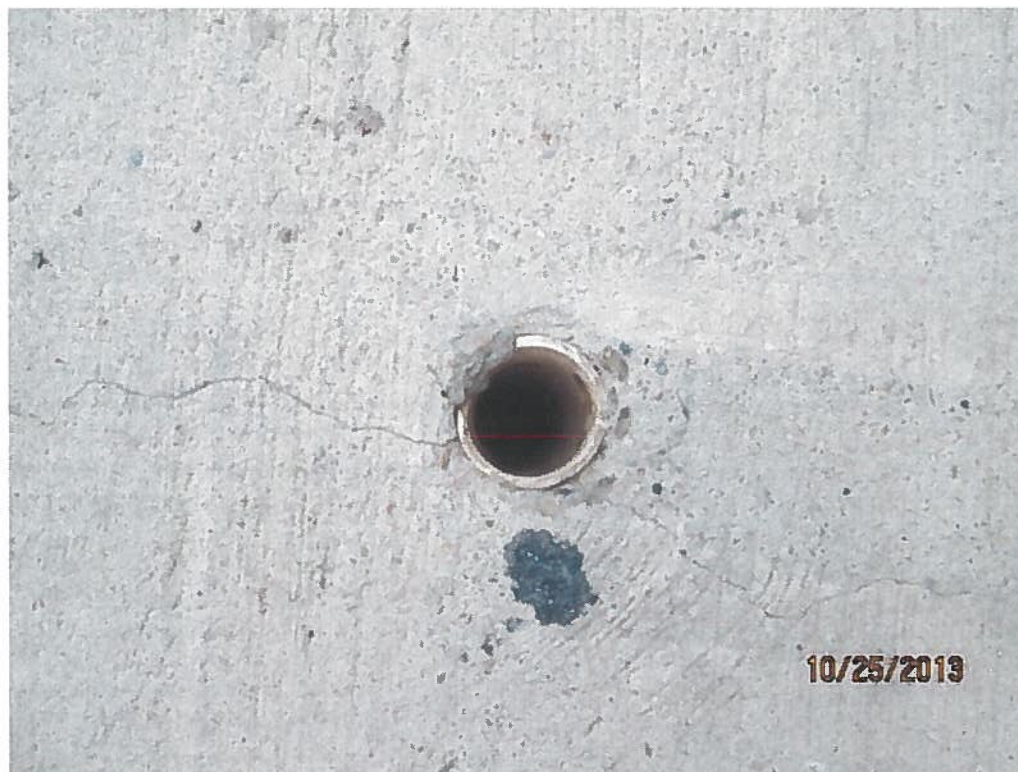
Photograph 2. Close up of MW-1 showing how concrete was poured around casing during concrete pavement construction in 2000.
