Questa Baseline and Pre-mining  
Ground Water Investigation: 11.  
Geochemistry of Composited Material  
from Alteration Scars and Mine-Waste  
Piles

By P.H. Briggs, S.J. Sutley, and K.E. Livo

**U.S. Geological Survey Open-File Report 03-458**

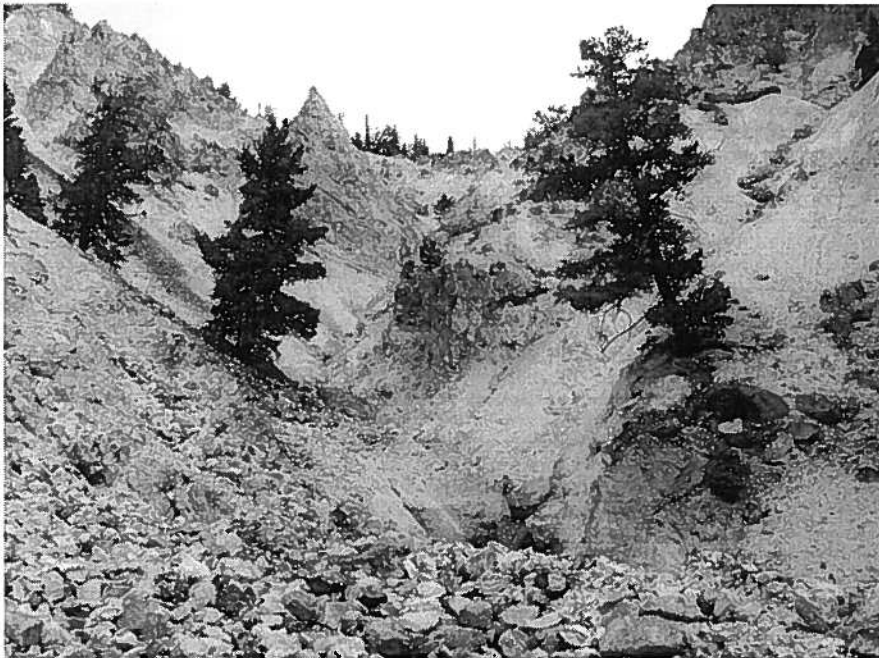
Figure 2a. Photo of Hottentot Ck. alteration scar.

Nine alteration scar composites were collected from the following sites: SW Hansen, Hansen Creek, Straight Creek, SE Straight, Hottentot Creek, June Bug, Goat Hill, Sulphur Gulch and W Goat Hill. One less intensely altered composite was collected in the next drainage (unnamed) west of SW Hansen Creek. . Figures 2a and 2b are representative photos of two alteration scars that were sampled in this study.

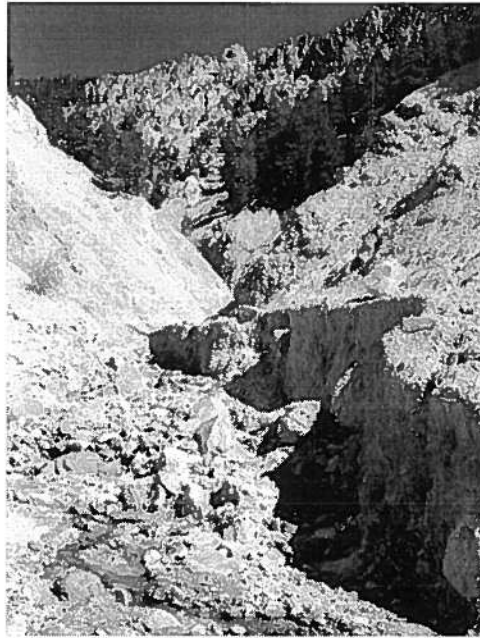
Figure 2b. Photo of the upper reach of Hansen Ck. alteration scar.

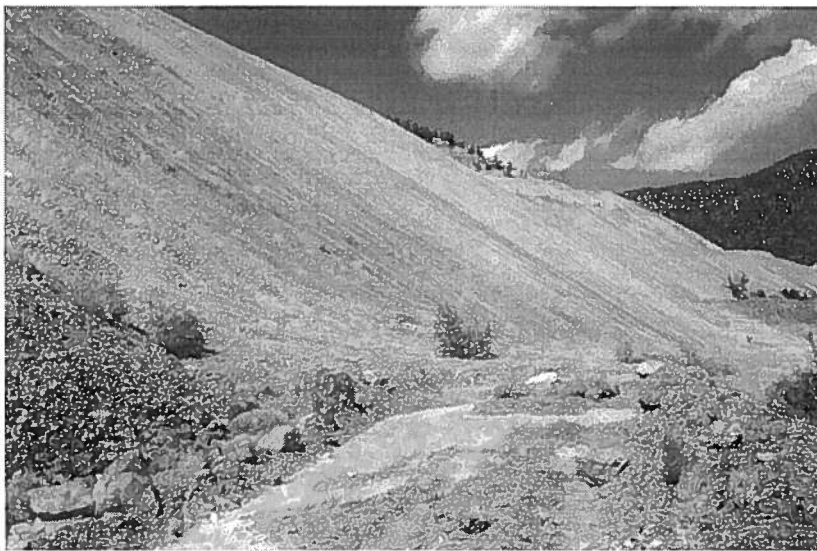
Figure3a. Photo of upper bench of Sugar Shack South waste pile.

Five mine-waste pile composites, were collected from the following sites: Sugar Shack West, Sugar Shack South, Sugar Shack Middle, Old Sulphur Gulch and Capulin. A single traverse of the top bench was sampled for the composite taken from Capulin waste pile. A single traverse along the base of Sugar Shack West waste pile was sampled for the composite. Three traverses were sampled (the base and two benches) for the Sugar Shack South, Sugar Shack Middle and Old Sulphur Gulch composites. The three traverse composites were combined to make one representative composite for each of these waste piles. These composite samples are representative of 72% of the total waste rock produced at the mine site. Figures 3a and 3b are photos of the mine waste piles closest to the Red River.

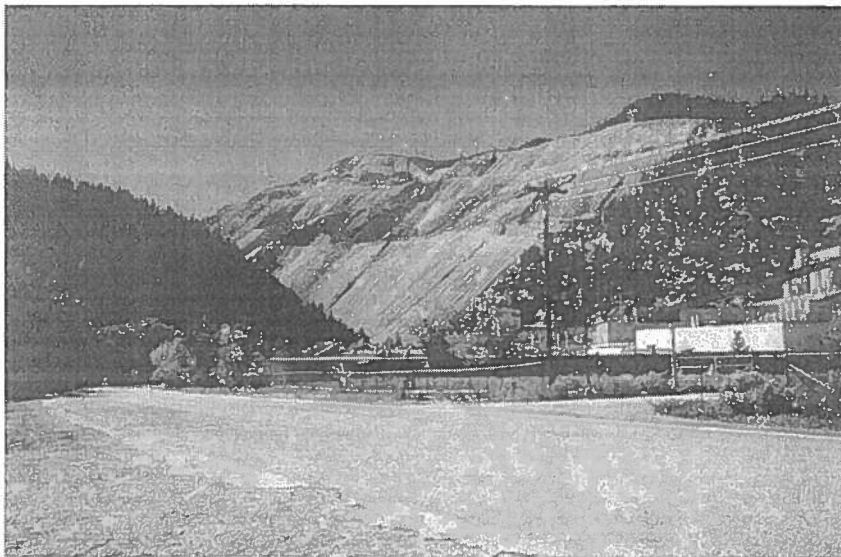
Figure 3b. Photo of Sugar Shack South, Sugar Shack Middle and Sulphur Gulch waste piles taken from highway near the Red River.

The five mine waste piles that were sampled on the mine site are representative of 72% of the total waste rock produced (328 million tonnes). The waste piles adjacent to the Red River are up to 490 m high and are at the angle of repose (Shaw and others, 2002). Tables 3 and 4 contain the ICP-AES and XRD results of the waste pile composite samples. There is a great deal of pyrite oxidation to jarosite that can be observed by the straw-yellow color of the piles. The younger the pile (i.e., less pyrite oxidation) the more gray in color it appears. The XRD identified over 70% of quantifiable material as quartz, amorphous material and sericite (see table 4). The XRD results from the five waste piles shows that the piles are generally made up of similar minerals and in similar quantities. The amount of amorphous material is slightly lower in Sugar Shack South, Sugar Shack Middle and Sulphur Gulch than Capulin and Sugar Shack West. Also, these three piles have mixed-layer clay minerals (smectite/muscovite, smectite/illite, or montmorillonite) that is not observed in the other piles. One possible explanation for this mixed layer effect
