Abandoned Uranium Mine Assessment for the Pineapple Site (NM0186)

FINAL REPORT

NM0186

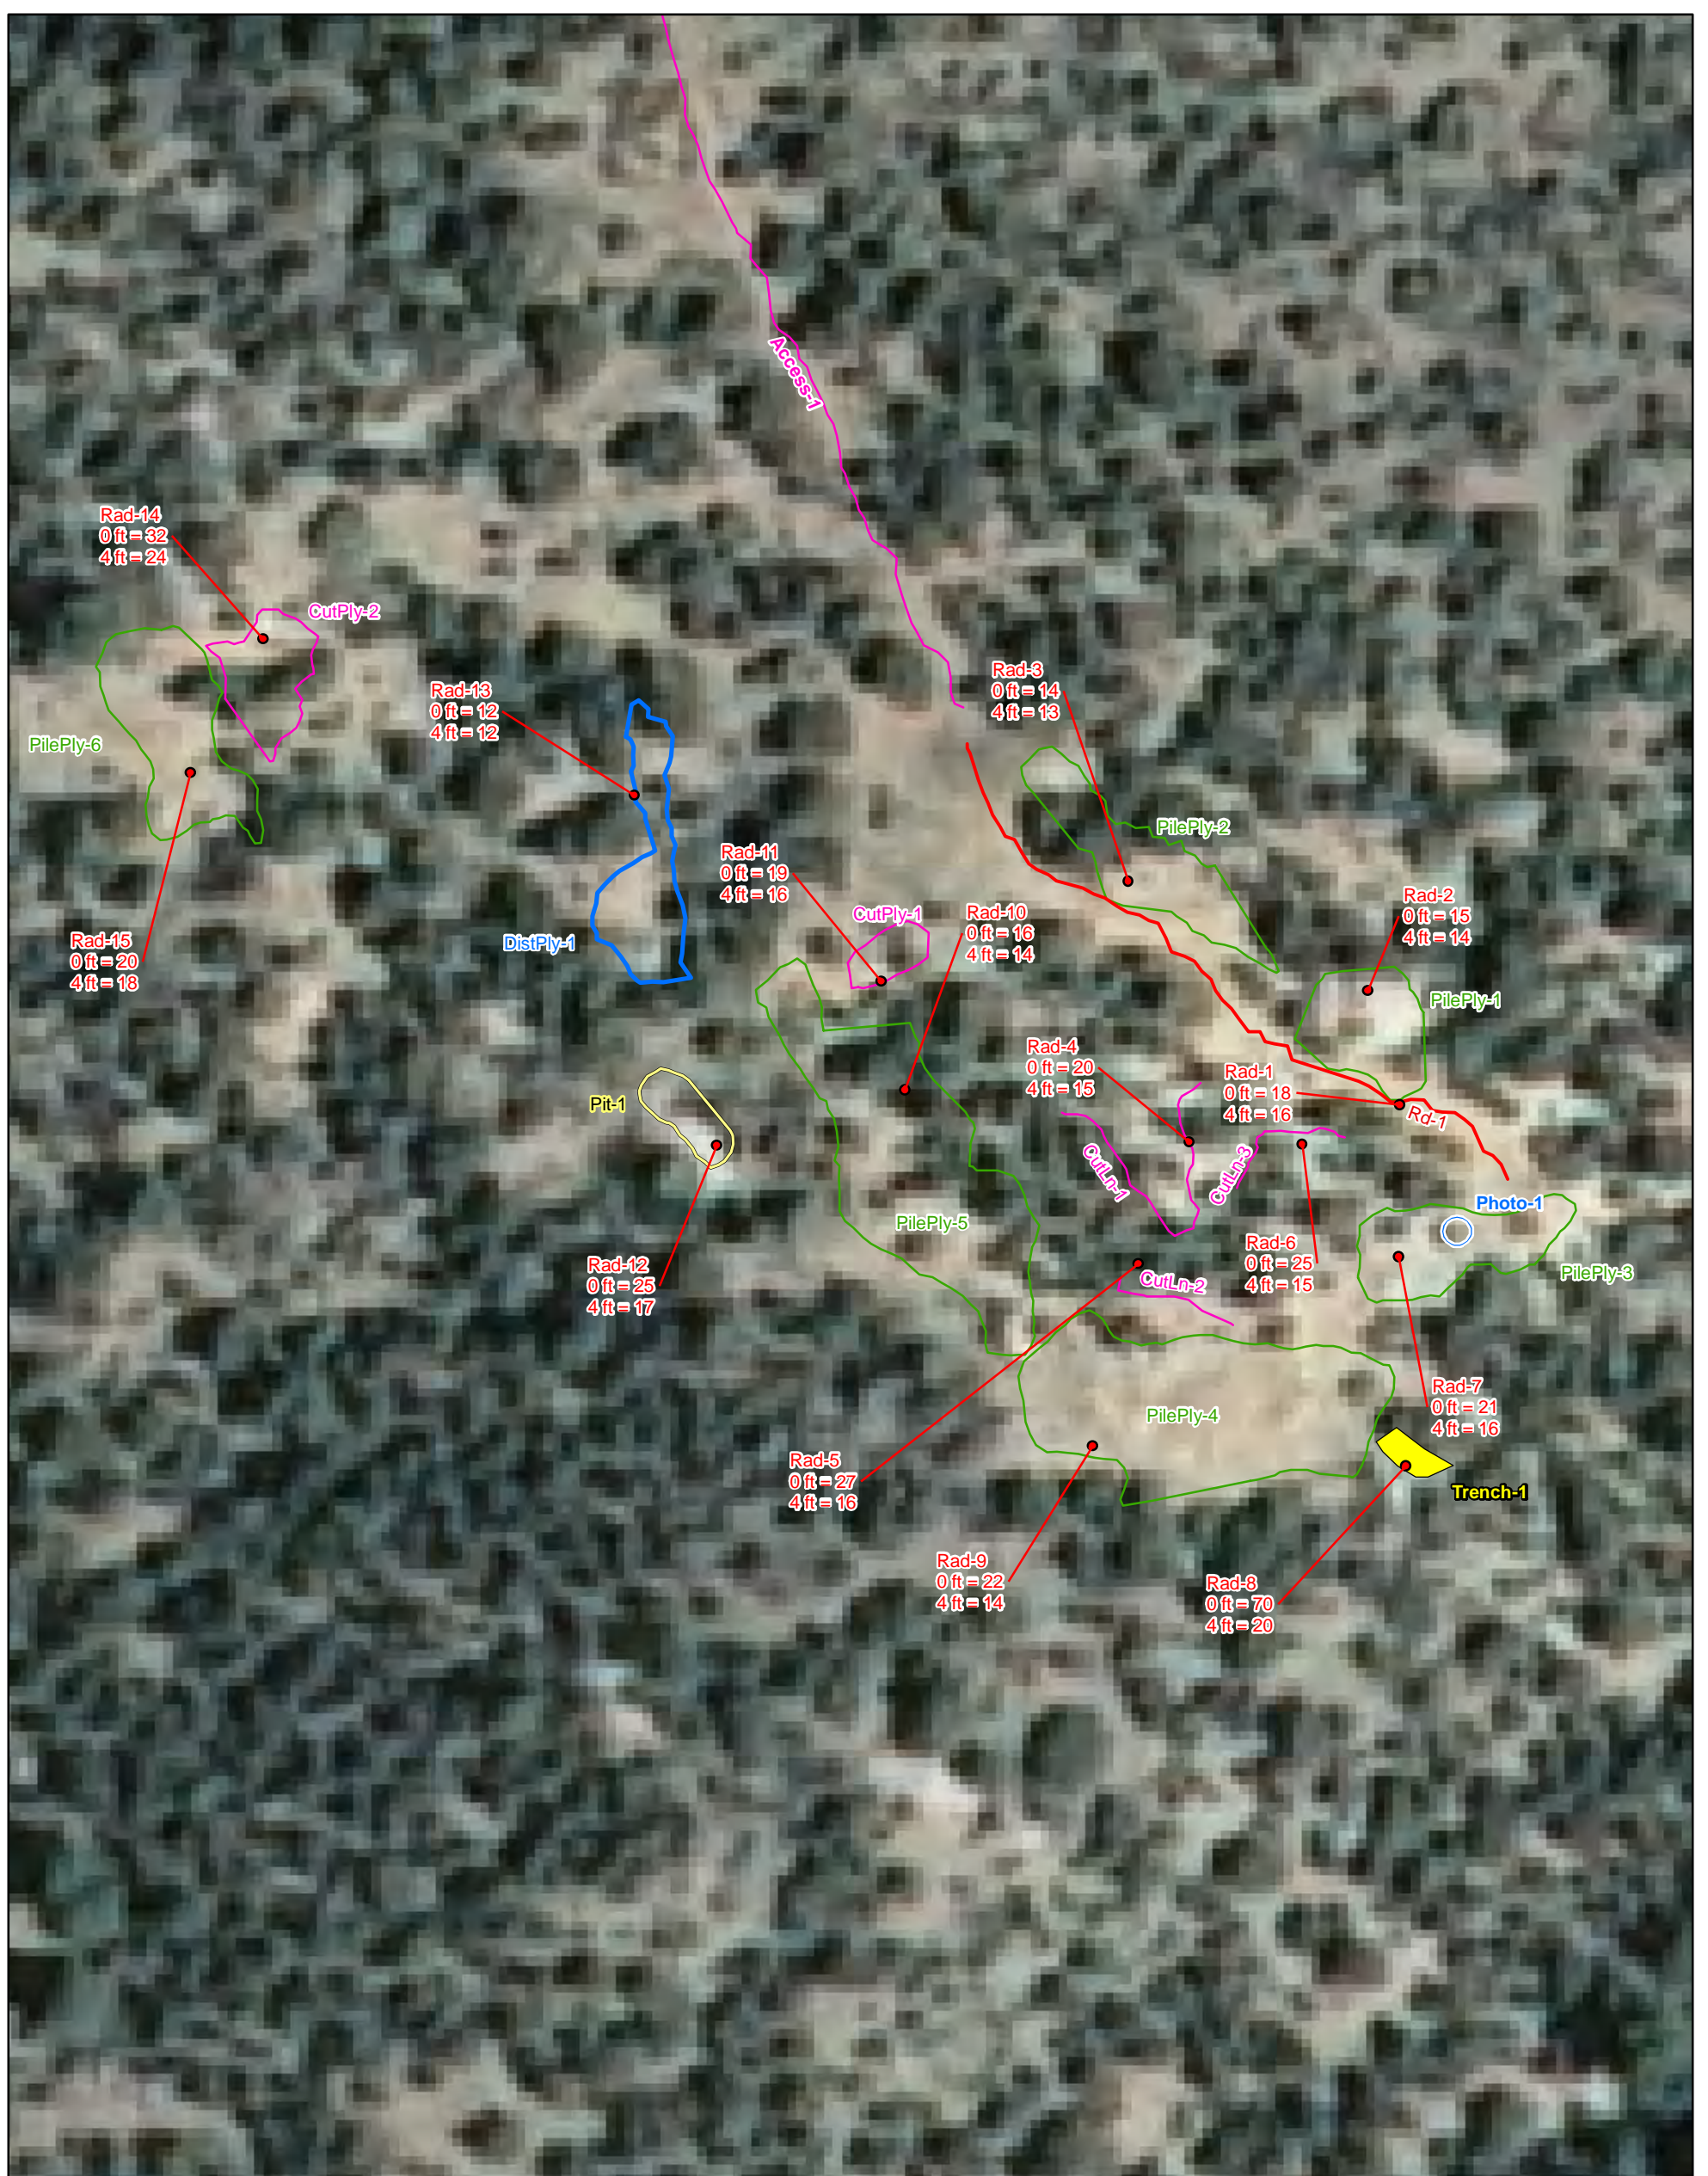
Figure 4a
Site Map on
Aerial Photo
NM0186-Pineapple
 Abandoned Uranium
 Mine Assessment

The mine features described below are based on the features provided to INTERA by MMD in the GIS Data Dictionary (MMD, 2009). INTERA marked the locations of the AUM Site features using a Trimble Global Positioning System (GPS), and entered details about the features into the GPS using the MMD data dictionary. Five open cuts, six waste piles, one pit, one trench, and one disturbed area were found onsite. Please see the Photo Log in Appendix A for photos of the AUM Site features, Table 1 for a list of the AUM Site features, and Figures 4a and 4b for the locations of the AUM Site features.

radiation readings taken at the AUM Site and Figures 4a and 4b for the locations of the radiation readings.

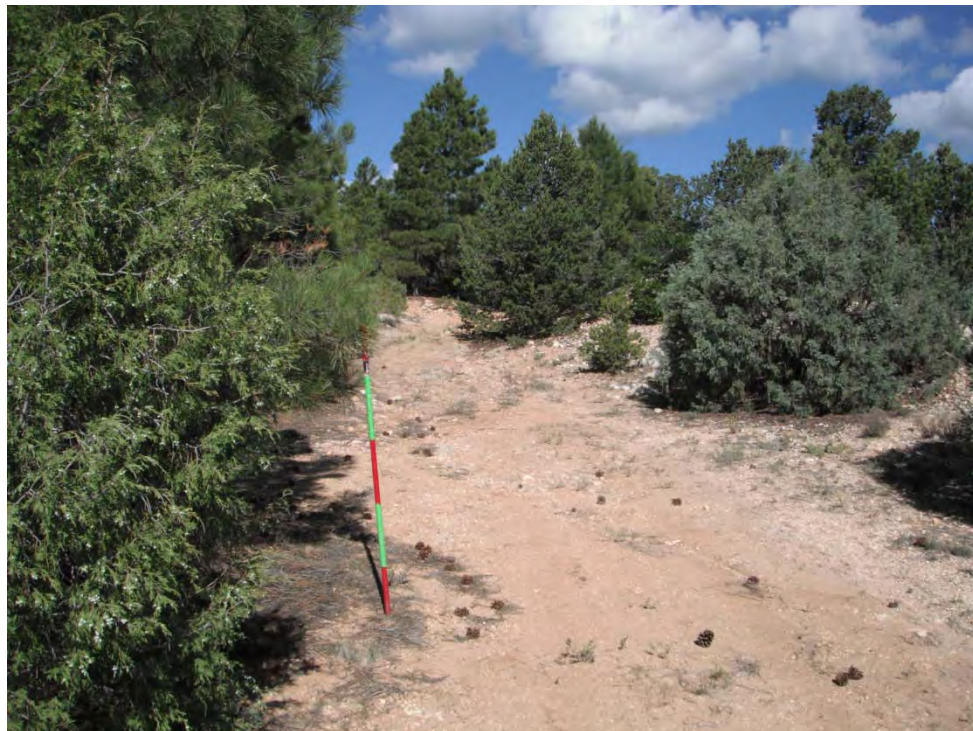
Photo 2-Looking north at Rd-1 and PilePly-1.

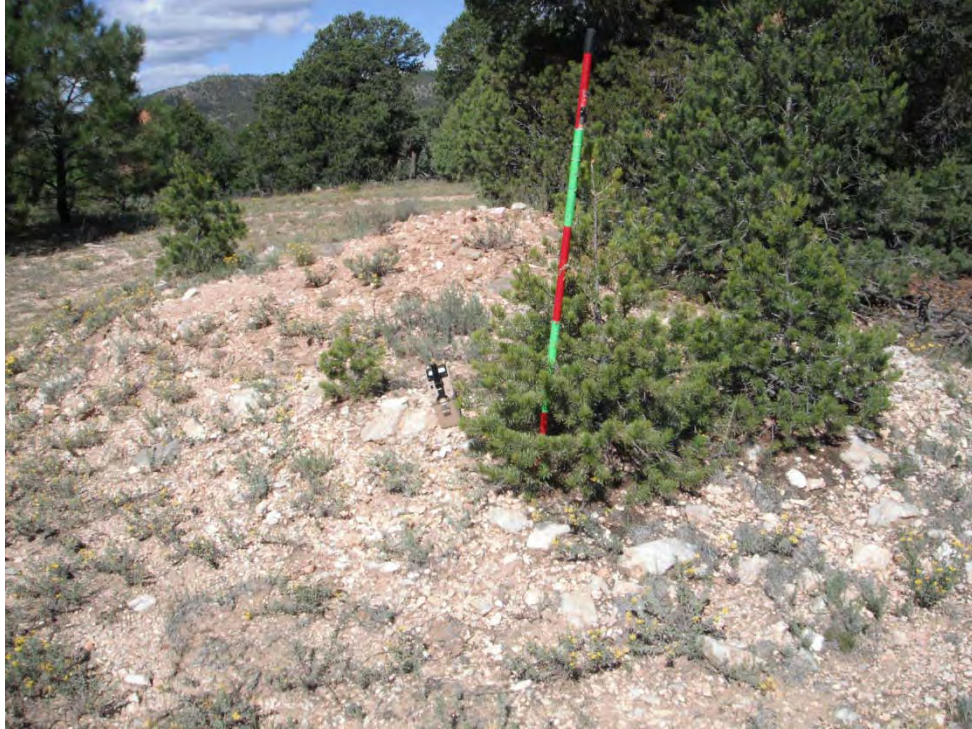
Photo 3-Looking northwest at PilePly-2.

Pileply-2 - series of low piles; 2' tall, 25' wide, 75' long; 20°

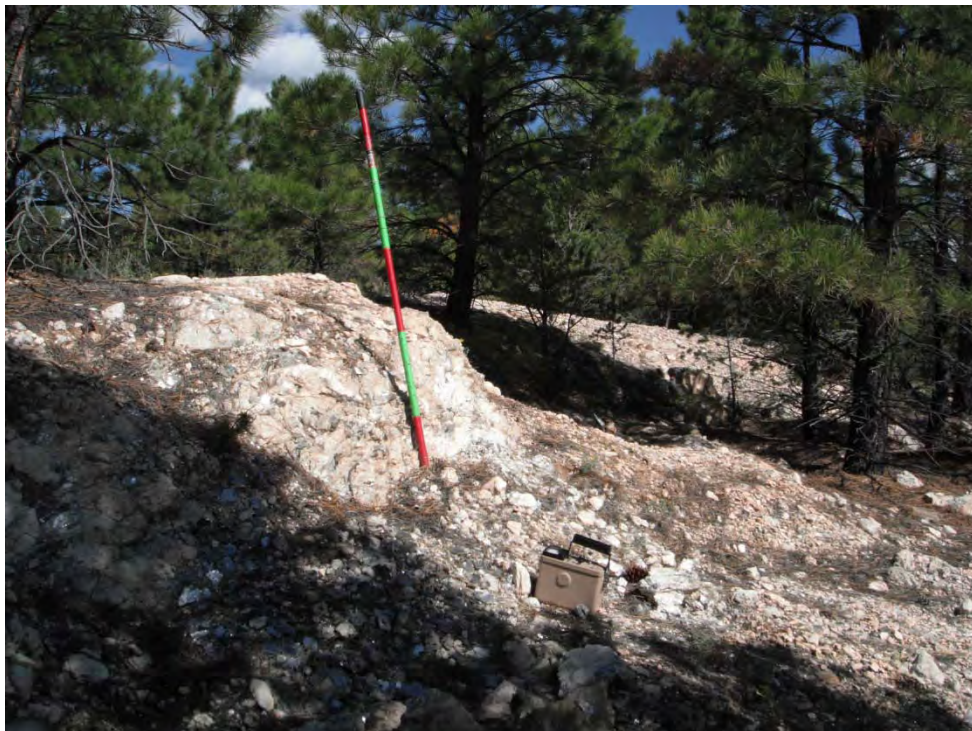
Five open cuts, one pit, and one trench were found at the AUM Site. CutLn-1, CutLn-2, and CutLn-3 are 3-5 ft high and 2-3 ft wide, and are 40-100 ft in length. These cuts are shallow excavations into igneous bedrock exposed at the ground surface. CutPly-1 and CutPly-2 are

Photo 4-Looking north at CutLn-1.

Cutln-1; 3' wide, 100' long, 5' high; bull dozer cut

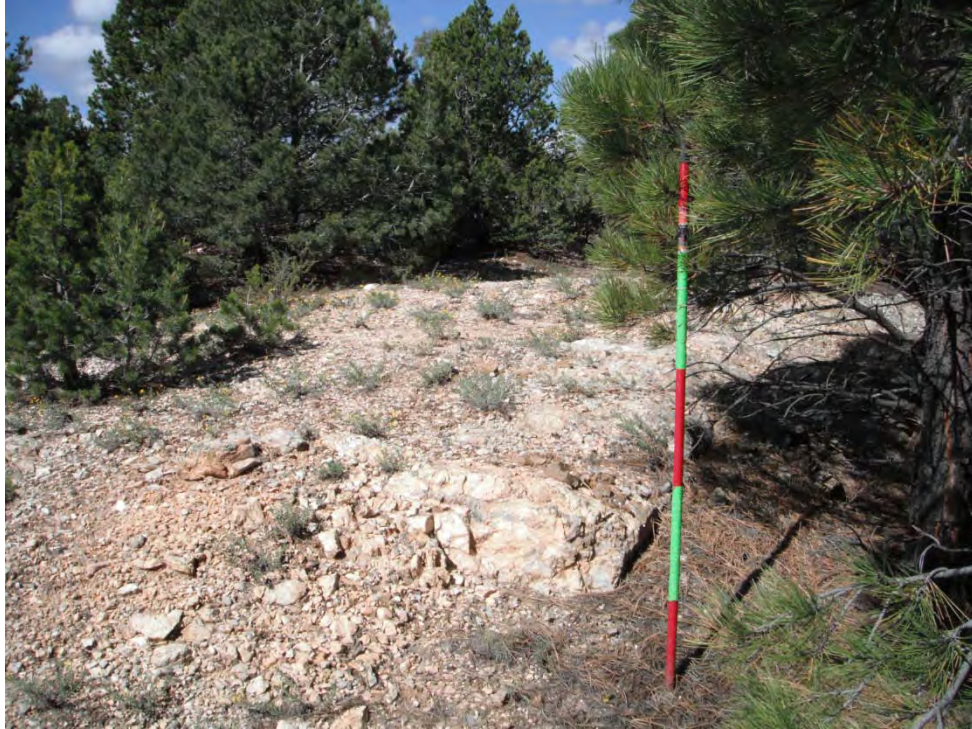
Photo 5-Looking west at CutLn-2.

CutIn-2 - 2' wide; 40' long; 3' high; bull dozer cut

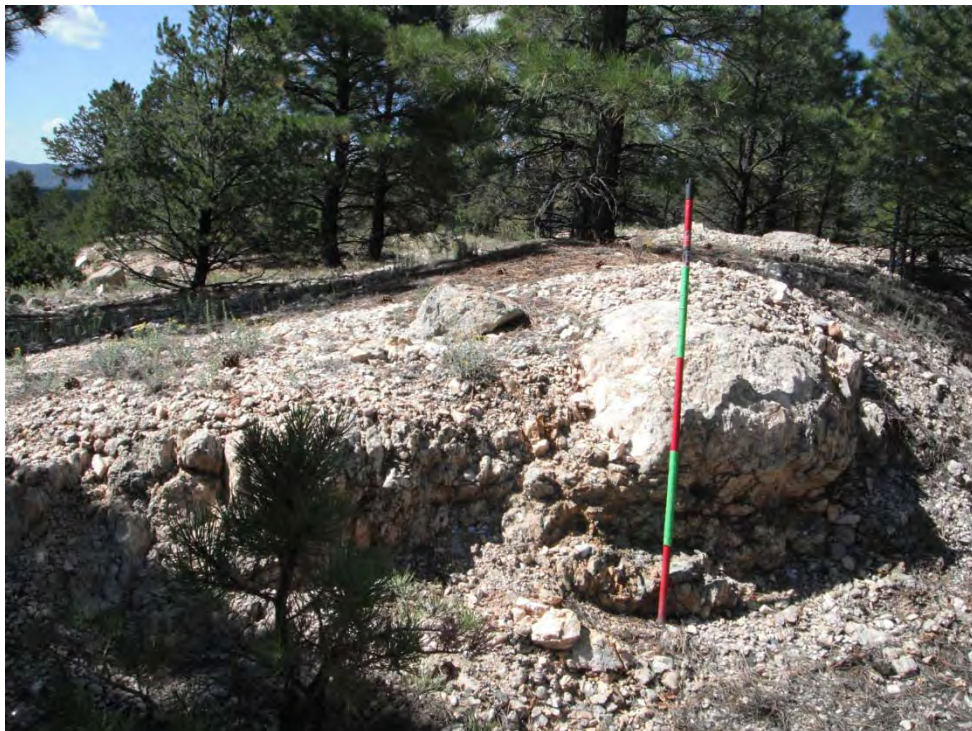
Photo 6-Looking west at CutLn-3.

CutIn-3 - 2' wide; 60' long; 3' high; bull dozer cut

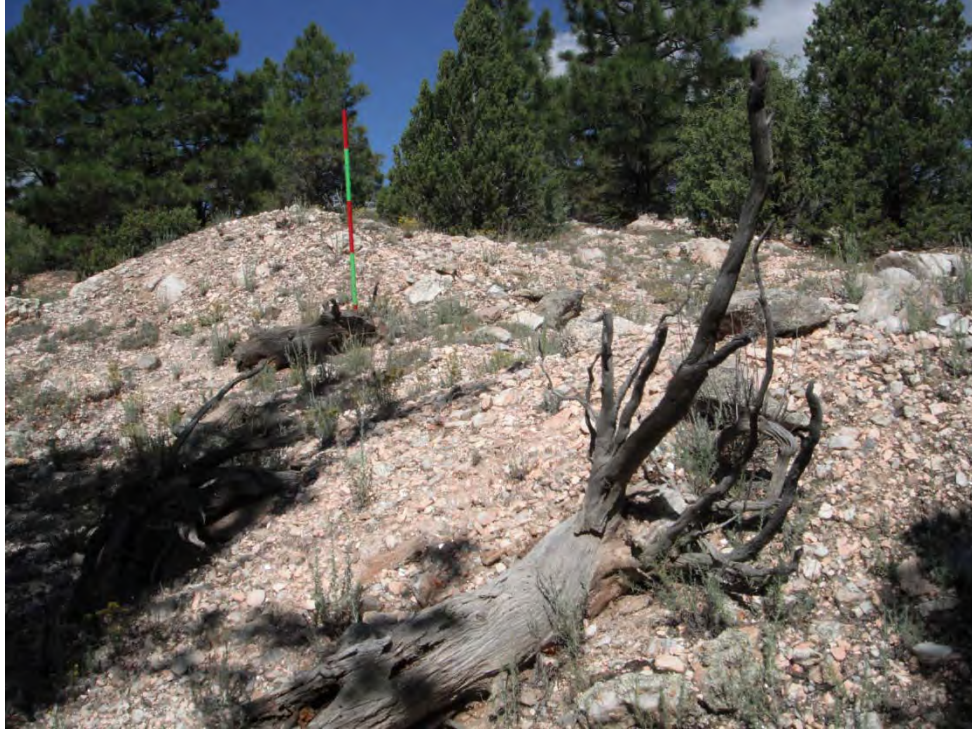
Photo 7-Looking north at PilePly-3.

Pile Ply 3 - 15' tall, 30' wide, 75' long, 50°

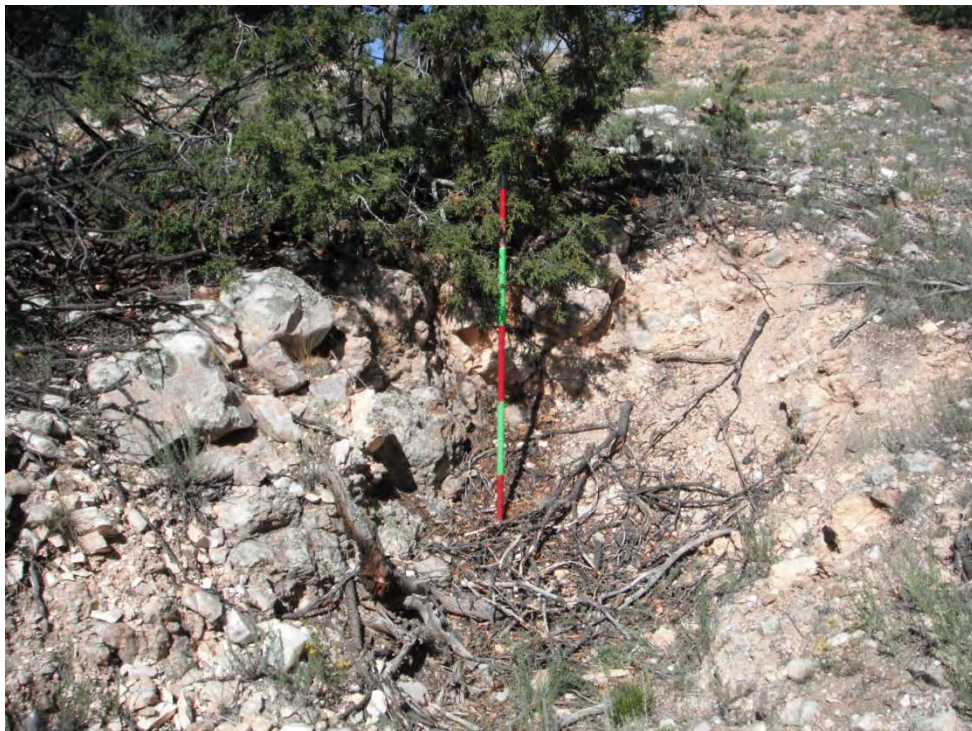
Photo 8-Looking north at Trench-1.

Trench-1 - 5' deep, ~~20~~ ^{ACT} 20' long, 8' wide

Rad 8 - Trench-1 - Om - 70 uR/h; 1m - 20 uR/h

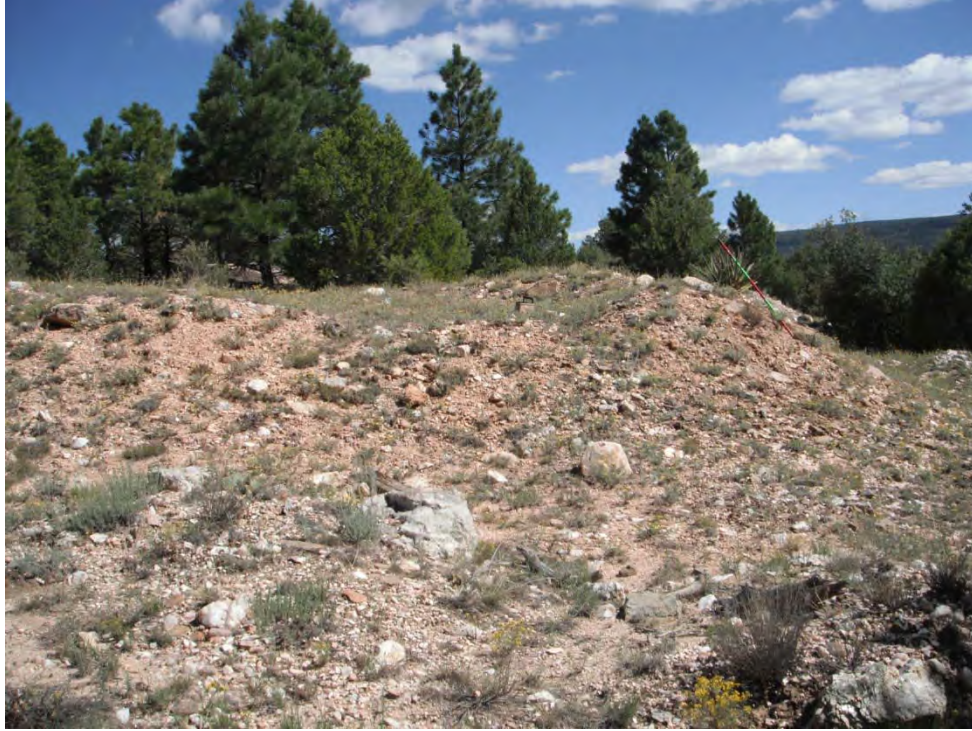
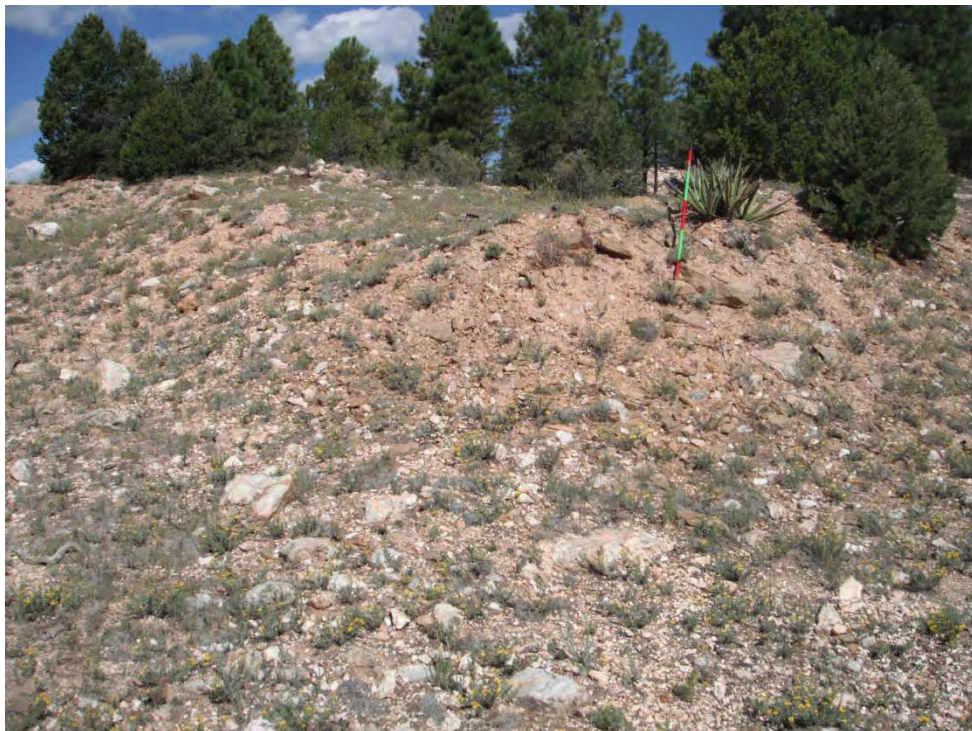
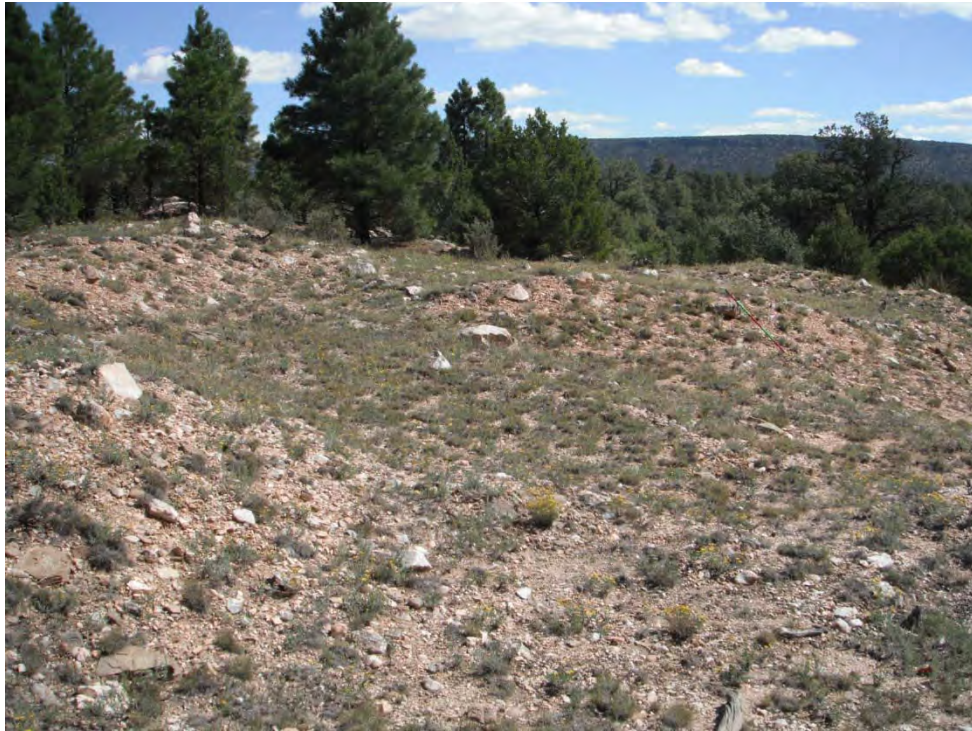
Photo 9-Looking northeast at PilePly-4.

Photo 10-Looking north at PilePly-4, replicating Anderson photo B.

Photo 11-Looking east at PilePly-4.

Pile Ply 4 - Anderson report dump; 20' high, 65' wide, 110' long, 30° ^{ACT} slope, waste rock

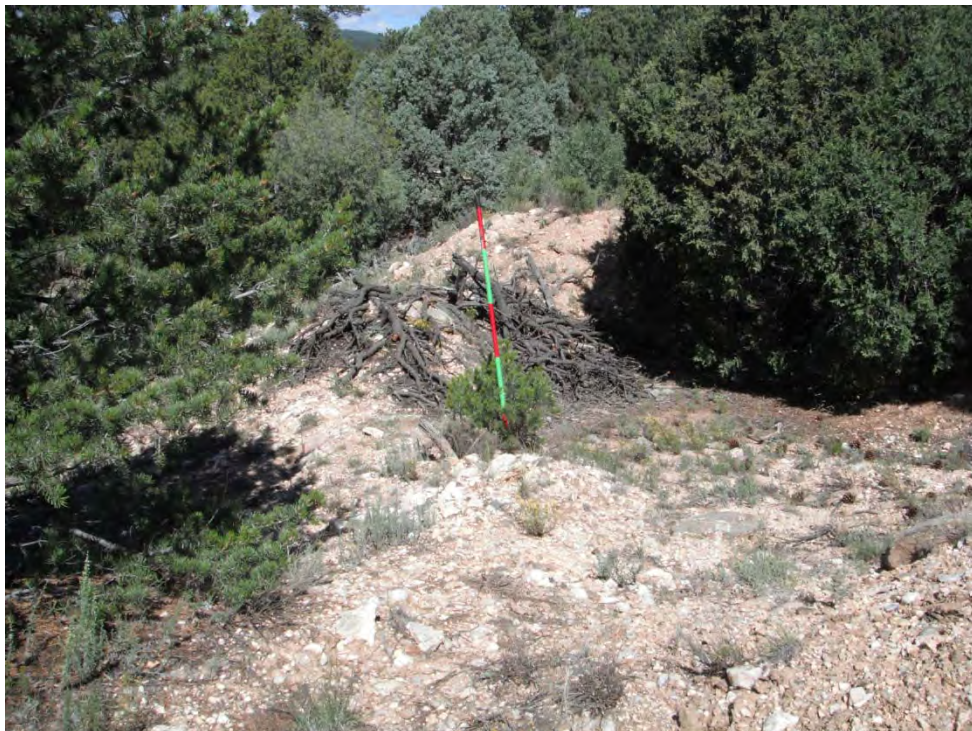
Six waste piles and one disturbed area were found onsite. All of the piles consisted of waste rock. The largest pile, PilePly-5, is 15 ft high, 35 ft wide and 175 ft long and was found down slope to the southwest of the excavation features. DistPly-1 is a bulldozed area, measuring approximately 15 ft x 60 ft. PilePly-2, to the north of the excavation features, contained the highest radiation reading found on these features; the gamma radiation measurement was 22 $\mu\text{R/hr}$ at 0 ft above ground at radiation survey point Rad-9 (see Table 2).

Photo 12-Looking north at PilePly-5.

Pile Ply 5 - 15' tall, 35' wide, 175' long, 35°

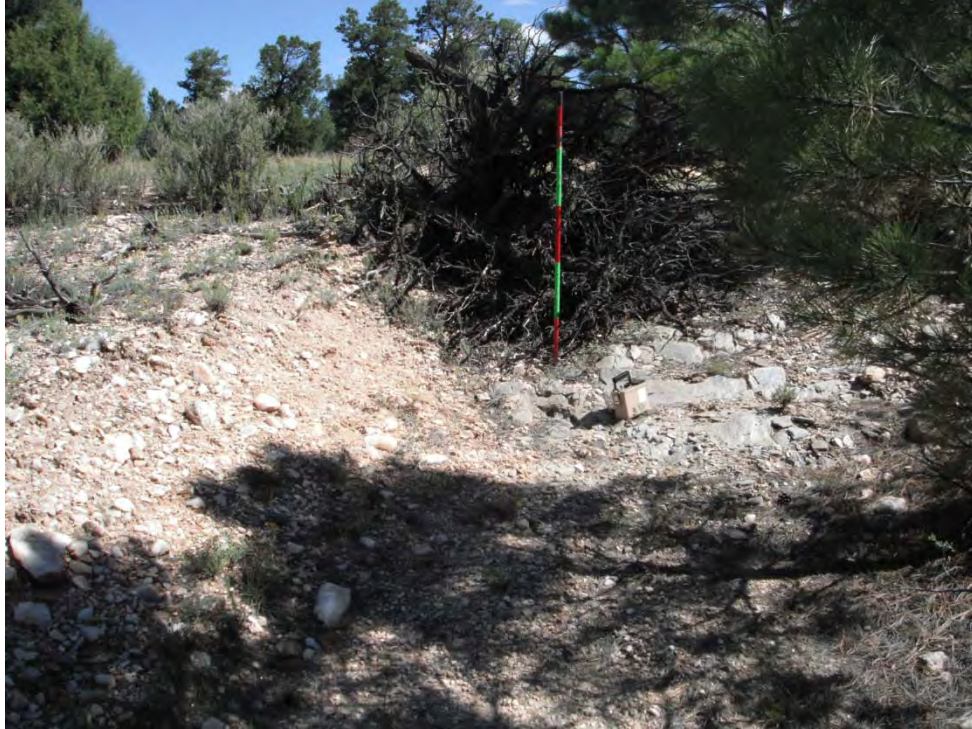
bulldozer scrapings, with CutPly-1 measuring approximately 4 ft deep, 10 ft wide and 20 ft long, and CutPly-2 approximately 6 ft deep, 30 ft wide and 30 ft long. Pit-1 and Trench-1 are also shallow exploration workings within exposed igneous bedrock. Pit-1 is approximately 6 ft deep, 15 ft wide and 40 ft long, and Trench-1 is approximately 5 ft deep, 8 ft wide, and 20 ft long. The maximum gamma radiation measurement on these features was 32 $\mu\text{R/hr}$ at 0 ft above ground at radiation survey point Rad-14 in CutPly-2 (see Table 2).

Photo 13-Looking east at CutPly-1.

Cut Ply-1 - 4' deep, 10' wide, 20' long; bulldozer cut

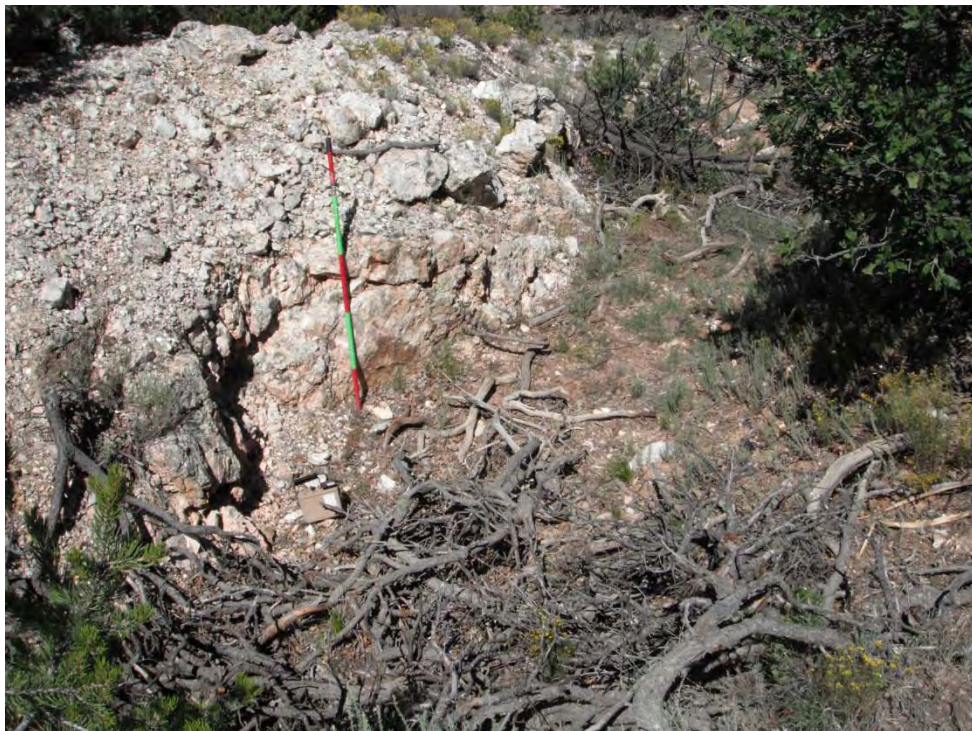
Photo 14-Looking northwest at Pit-1.

Pit-1; 6' deep, ~~30~~ ^{ACT} 15' wide, 40' long

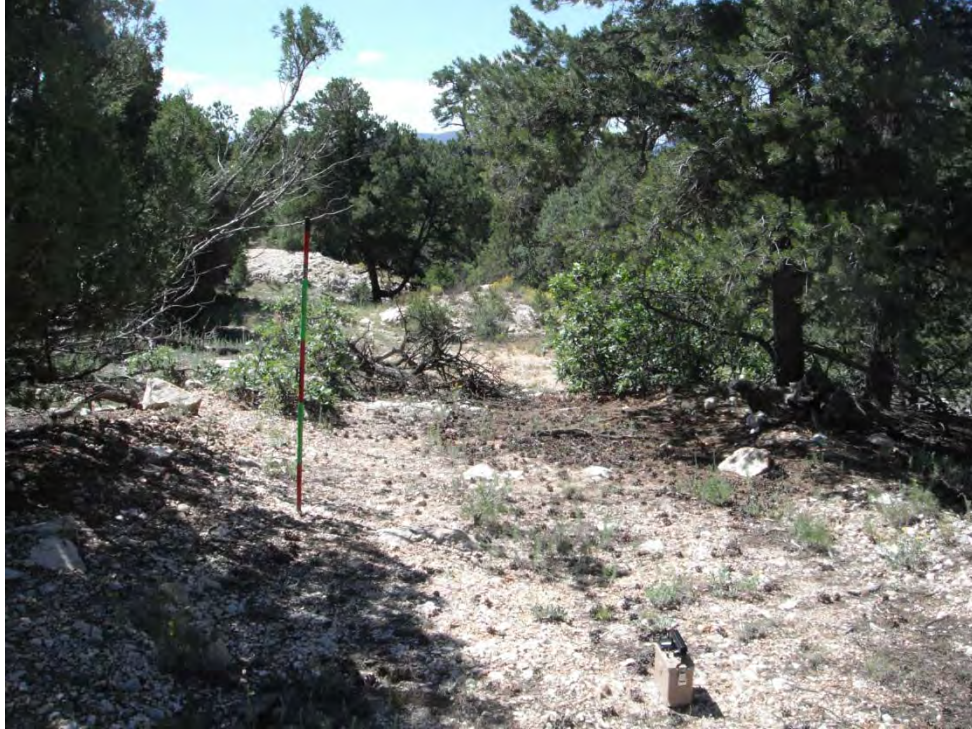
Photo 15-Looking southwest at DistPly-1.

Dist Ply-1 - bulldozer scrapping, may have been for road

1' high; 15' wide; 60' long
Photo ^{15 ACT} 11 - looking southwest at Dist Ply-1

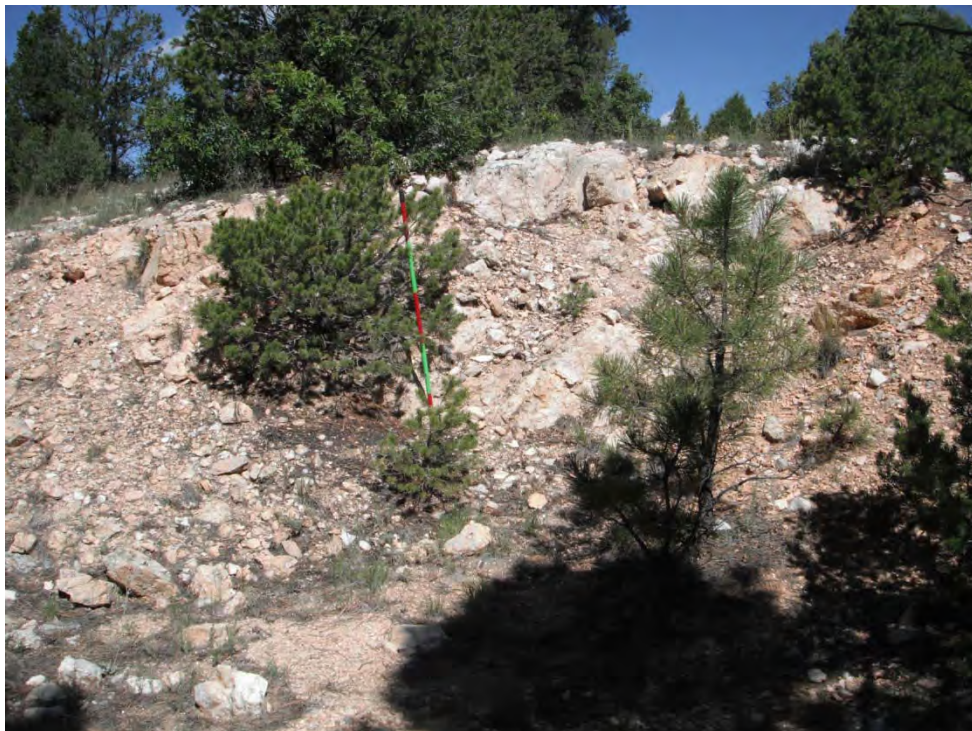
The gamma radiation readings at the AUM Site were not significantly higher than background levels. The maximum gamma radiation measured on site was 70 $\mu\text{R/hr}$ at 0 ft above ground and 24 $\mu\text{R/hr}$ at 4 ft above ground at radiation survey point Rad-14 in CutPly-2.

Photo 16-Looking northeast at CutPly-2.

Cut Ply-2 - 6' tall, 30' wide, 30' long

Rad 14 - Cut Ply-2; Om - 32 uR/h; 1m - 24 uR/h

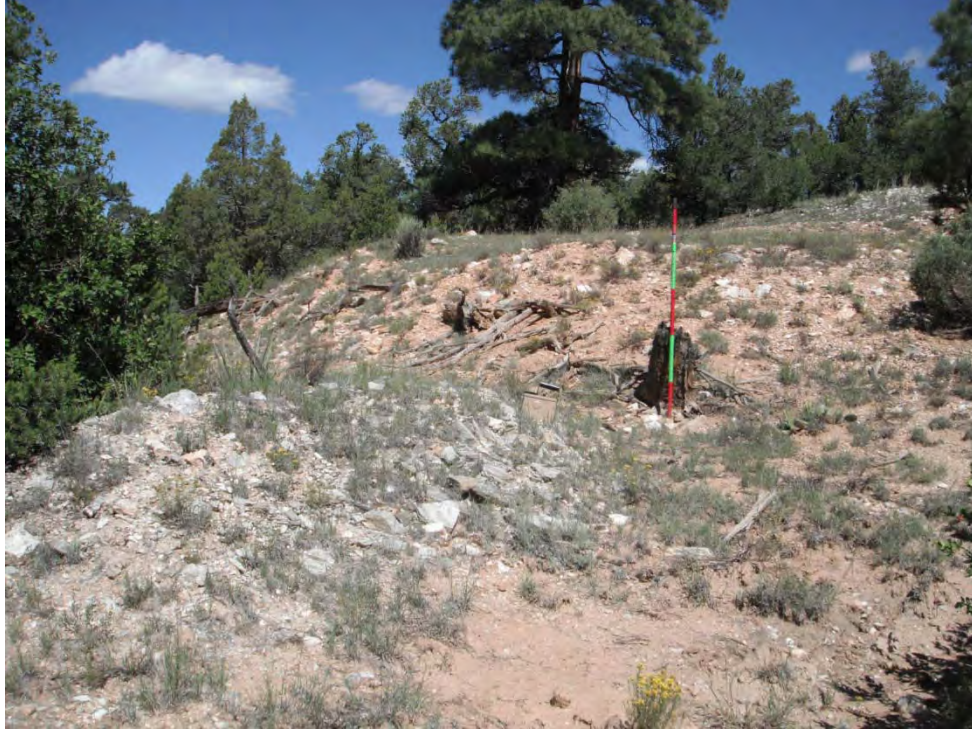
Photo 17-Looking northeast at PilePly-6.

Pile Ply 6 - 5' high, 30' wide, 60' long; 40° slope
