Re: Report of Geophysical Survey  
Fairview Station  
1626 North Riverside Drive  
Española, New Mexico  
Facility # 28779 / Release ID # 4657 / WPID #: 17158  
Terracon Project No. 66127029.5

**Report of Geophysical Survey**

**Geophysical Investigation for Abandoned USTs  
1702 North Riverside Drive  
Española, New Mexico**

A geophysical investigation has been conducted over most of the property identified as 1702 N. Riverside Drive Espanola, New Mexico. The objective of the investigation was to determine if abandoned underground storage tanks (USTs) remained from previous land use.

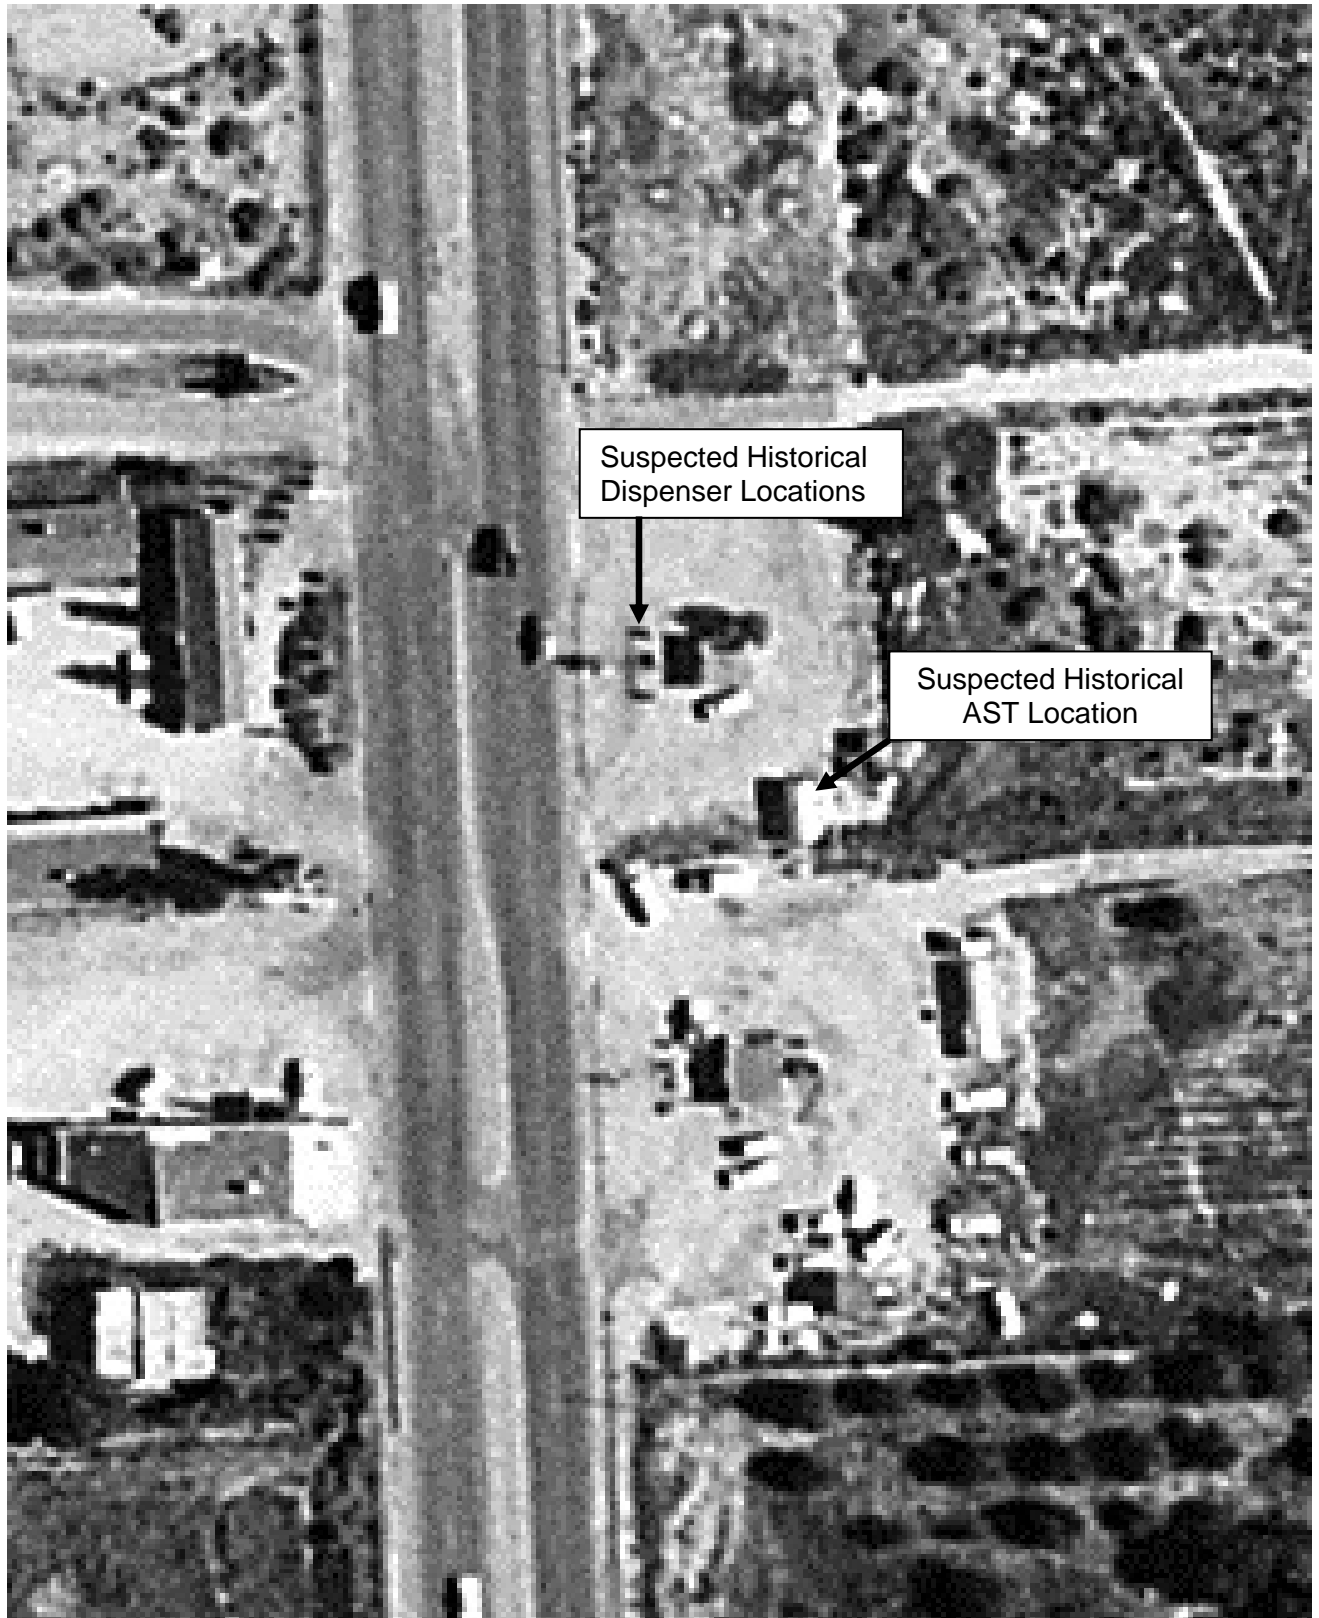
# 1969 AERIAL PHOTOGRAPH

Relic piping was identified in the southwest portion of the property. Based on the locations of the piping relative to historical dispensers and a suspected aboveground storage tank (AST), the relic piping extending north from the southern property boundary and turning to the west, may have been associated with the on-site petroleum storage tank system. Based on the planned locations of proposed soil borings in the locations of the historical dispensers and ASTs, adjustment of the boring locations based on the results of the geophysical survey does not appear warranted. Historical aerial photographs depicting the location of the historical dispensers and AST is included as Exhibits 1 and 2.
