Abandoned Uranium Mine Site Assessment for the Eugenie Site (NM0130)

FINAL REPORT

NM0130

April 14, 2010

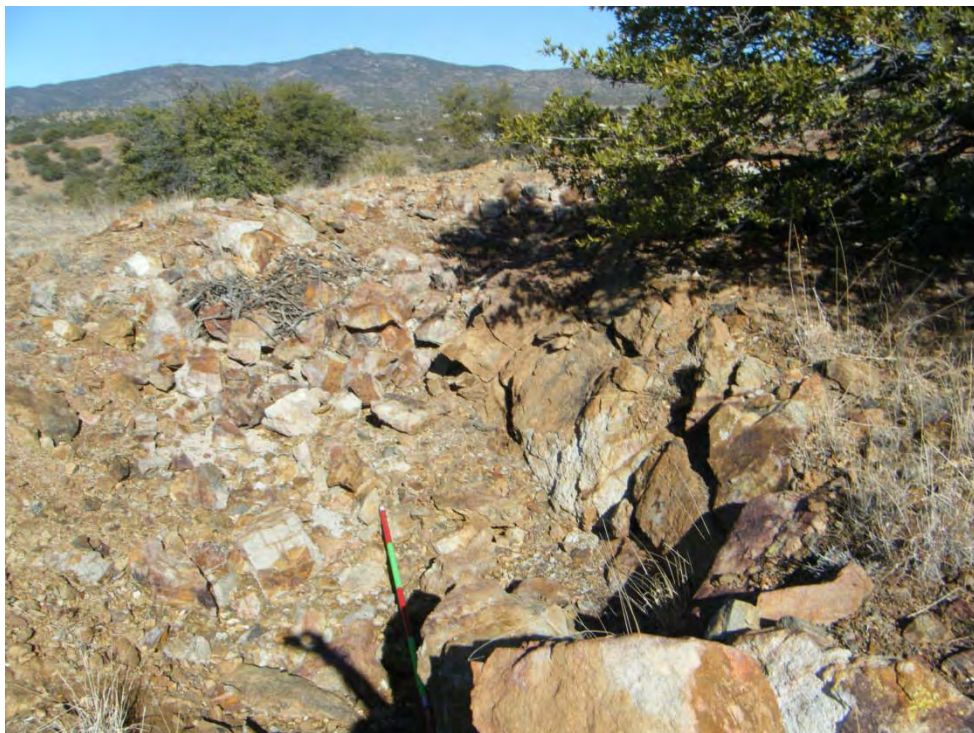
Photo 2-Looking west at Pit-1.

Pit-1 - 4' deep, 15' long, 8' wide

Rad-1 - Pit-1, 0m - 96 uR/h; 1m - ^{ALT} 98 uR/h
37

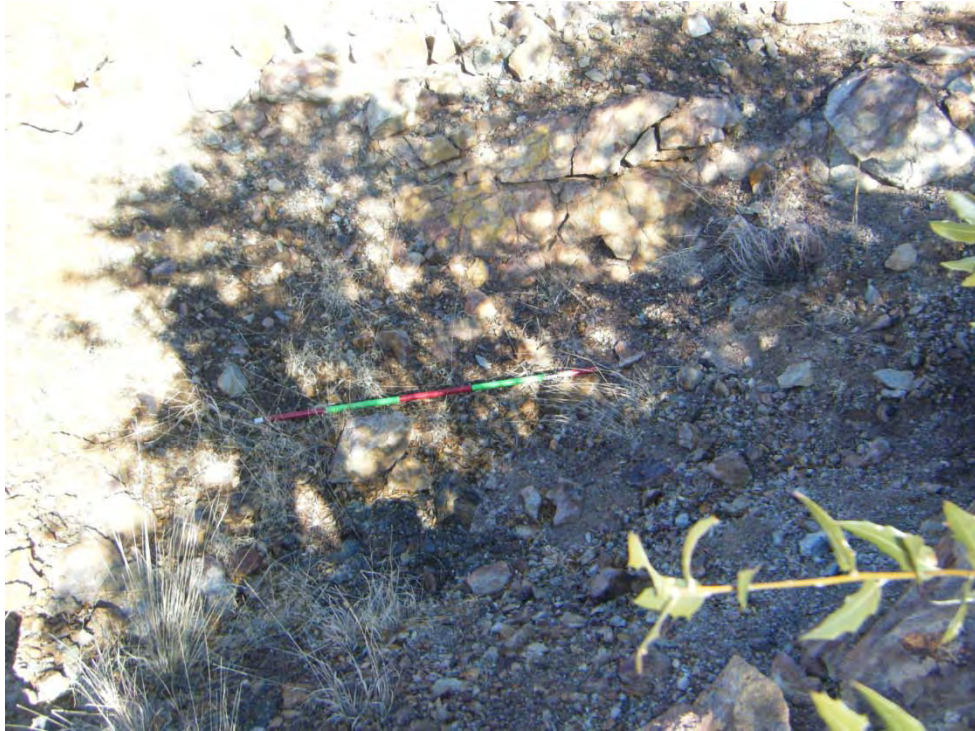
Photo 3-Looking west at Pit-2.

Pit-2 - 6' deep, 25' long, 25' wide - Exploration pit

Rad-2 - Pit-2, 0m - ^{ALT} 58 uR/h, 1m - 39 uR/h
45 uR/h

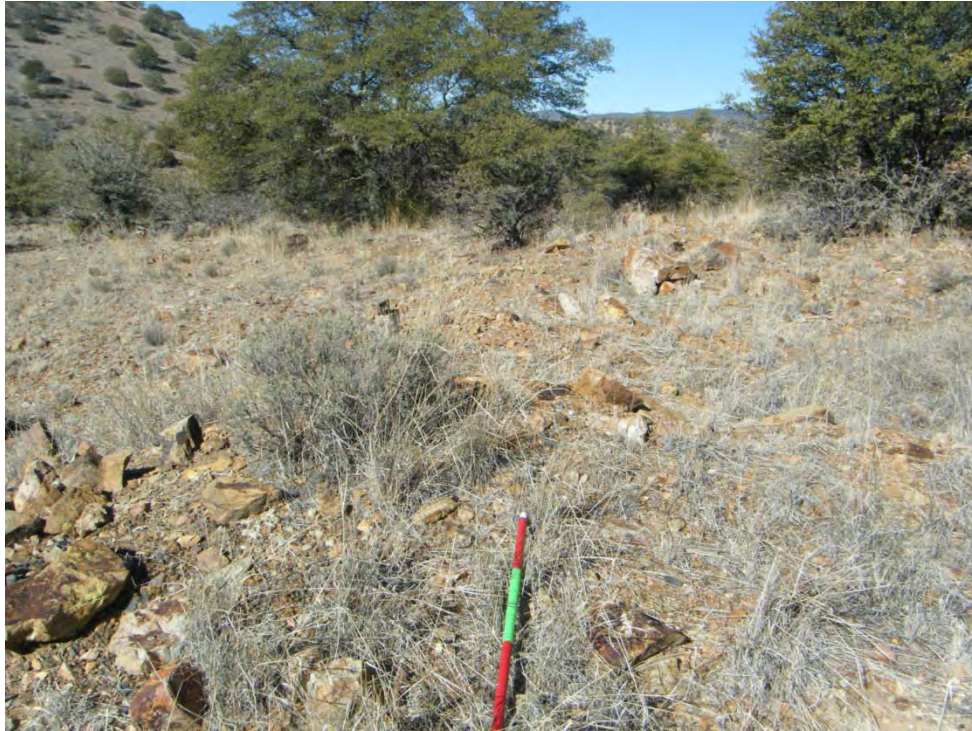
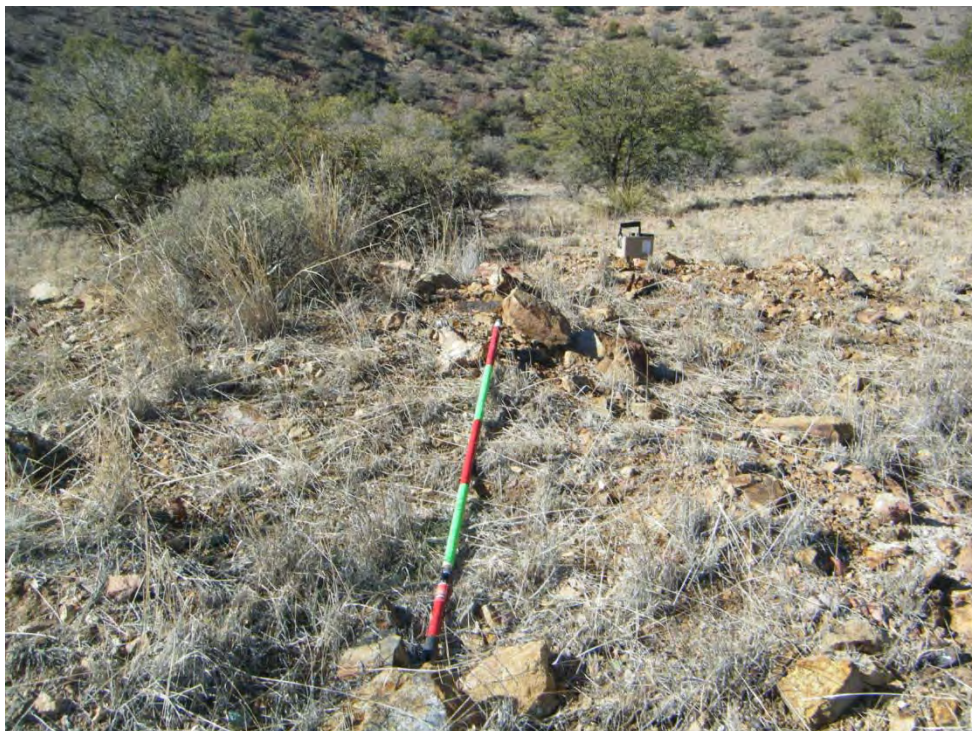
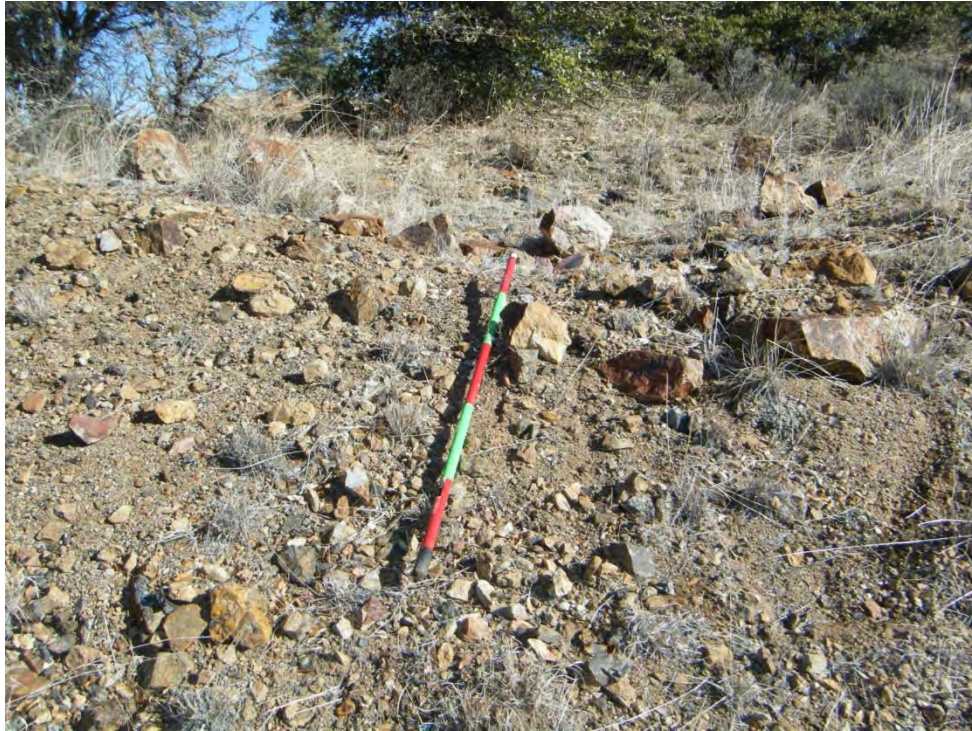
Photo 5-Looking west at Pileridge-1.

Photo 6-Looking south at Pileridge-1.

Photo 7-Looking north at Pileridge-1.

3' high, 35' long, 15' wide

Rad-3, Pile Ridge-1; 0m - 40 uR/h; 1m - 33 uR/h

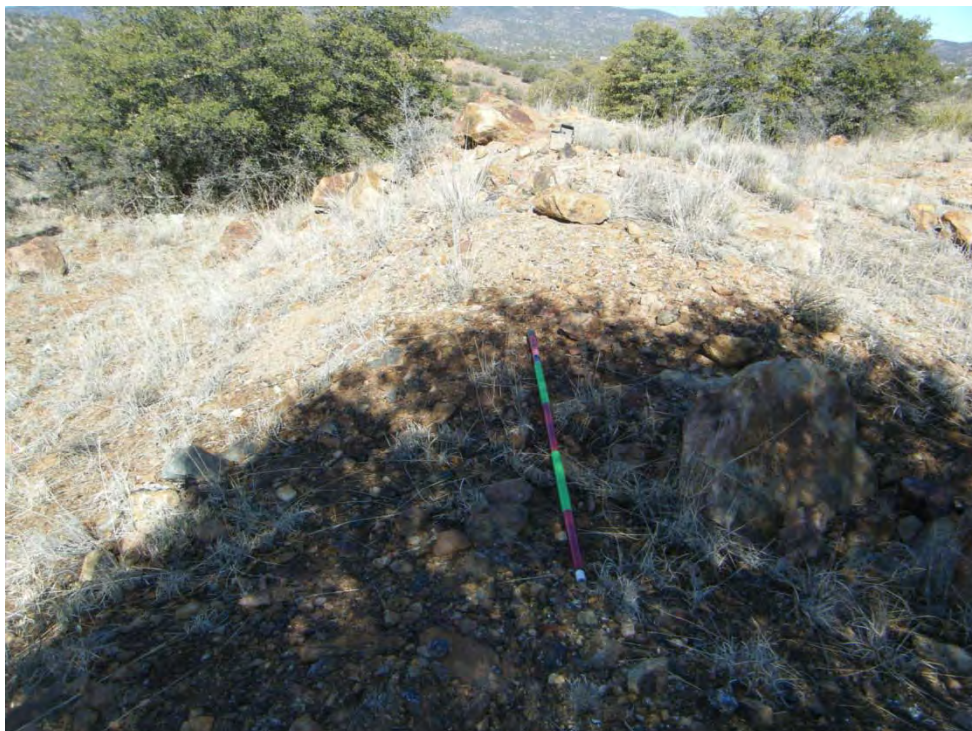
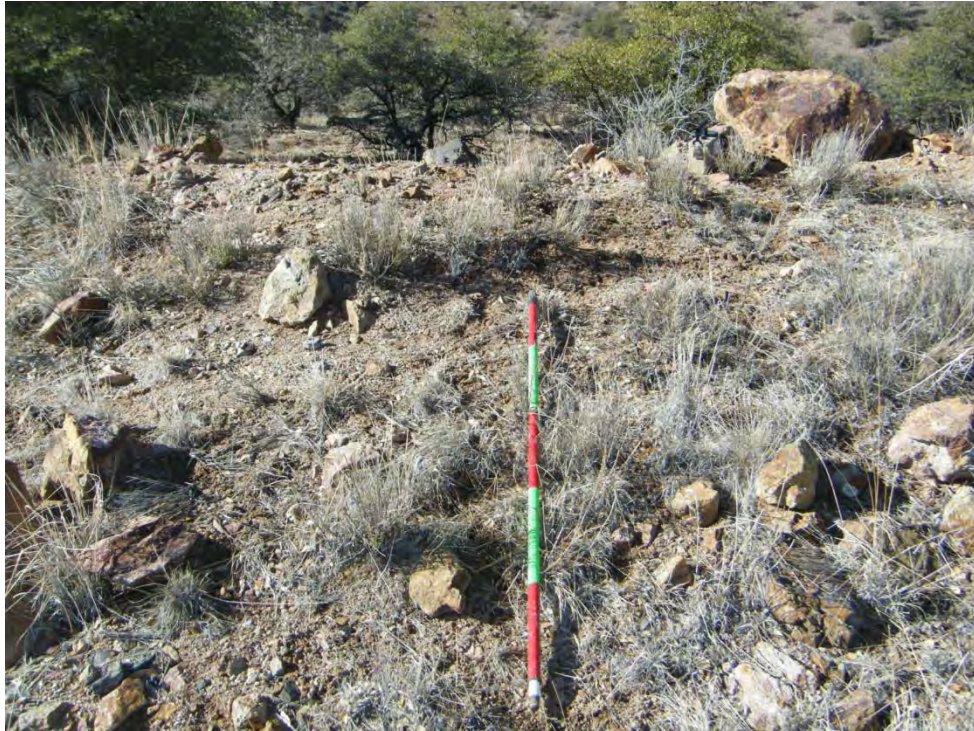
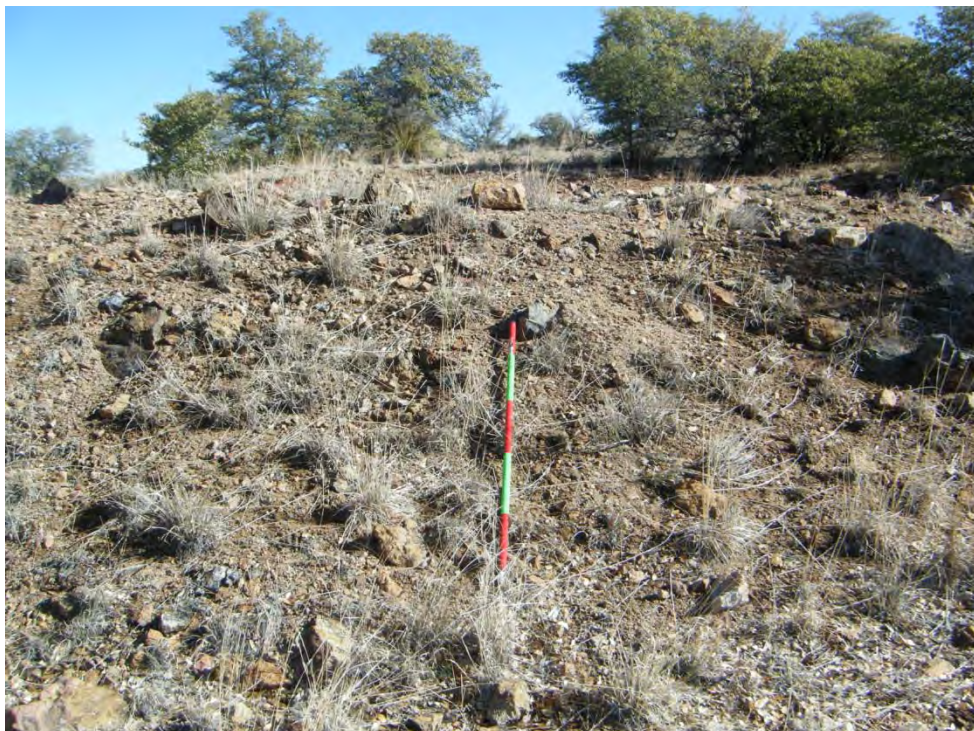
Photo 8-Looking west at Pileridge-2.

Photo 9-Looking south at Pileridge-2.

Photo 10-Looking north at Pileridge-2.

6' high; 65' long; 20' wide

Rad-4 - Pile Ridge-2; 0m - 43 uR/h; 1m - 32 uR/h

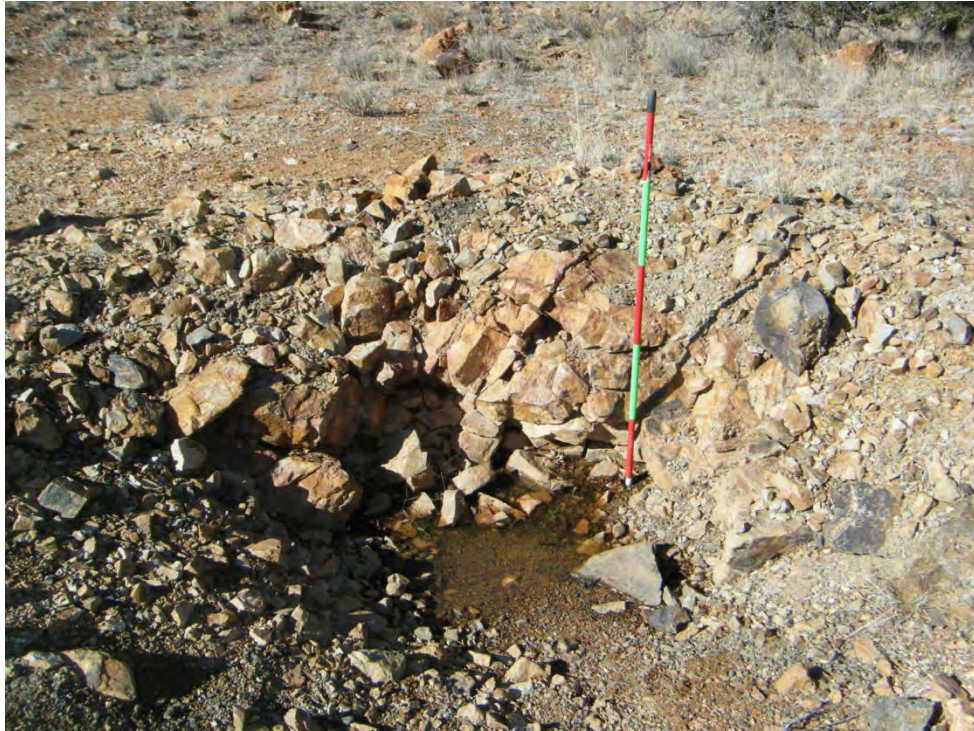
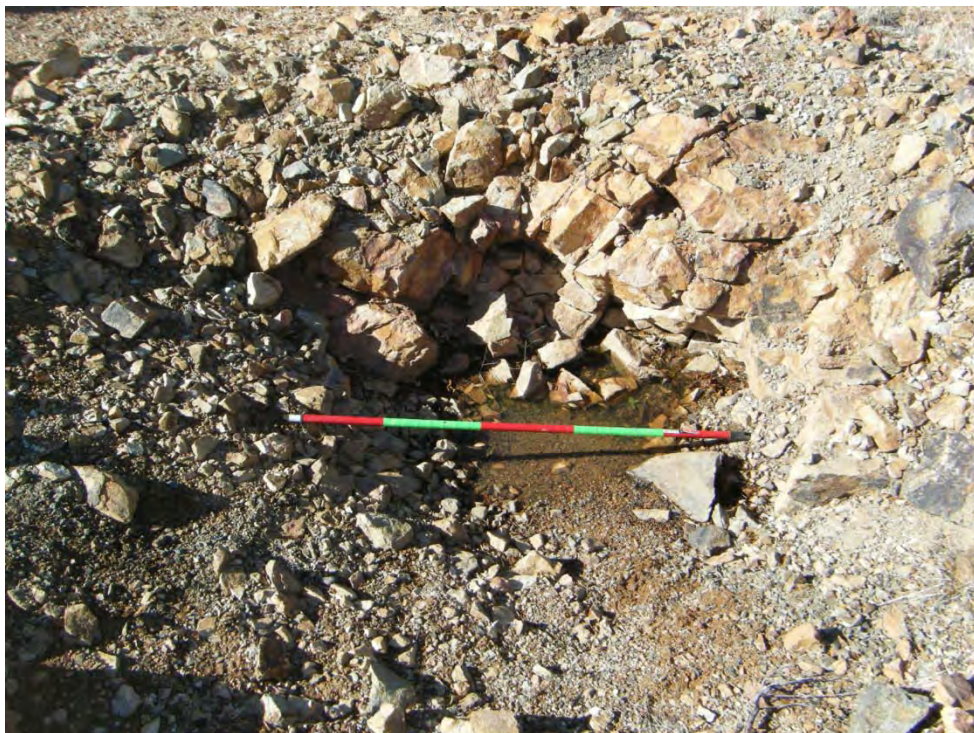
Photo 11-Looking south at Pit-3.

Photo 12-Looking south at Pit-3.

Pit-3 - west of pit-2; 3' deep, 6' wide, 8' long

Rad-5 - Pit-3 - 0m - 44 uR/h; 1m - 32 uR/h

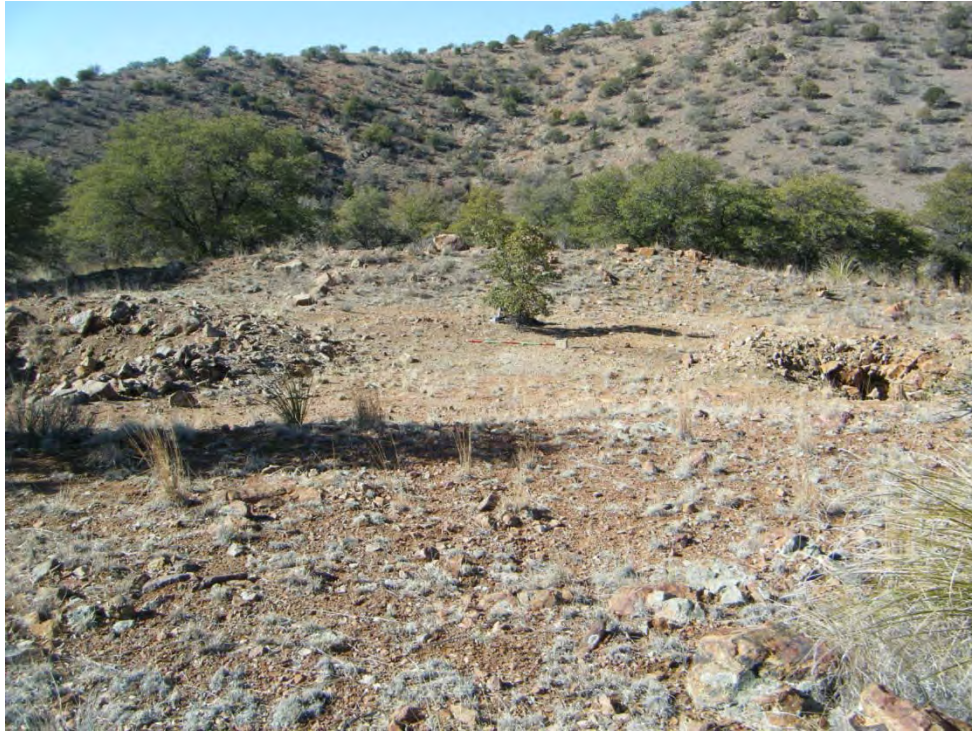
Photo 13-Looking south at DistPly-1, Pit-2 is on the left and Pit-3 is on the right.

Dist Ply-1 - Highest most disturbed area assessed
on slope. 3 pits, 2 pile ridges

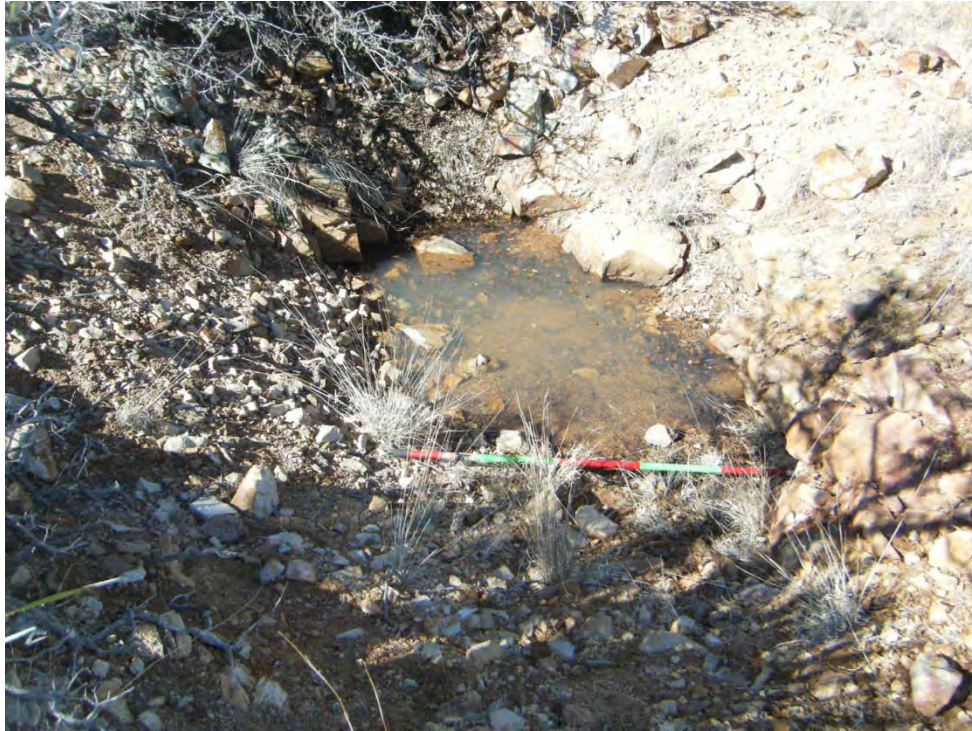
Photo 25-Looking south at Pit-4.

4' deep, 15' long, 10' wide; water in the bottom

Rad 6 - Pit 4; 0m - 30 μ R/hr; 1m - 26 μ R/hr

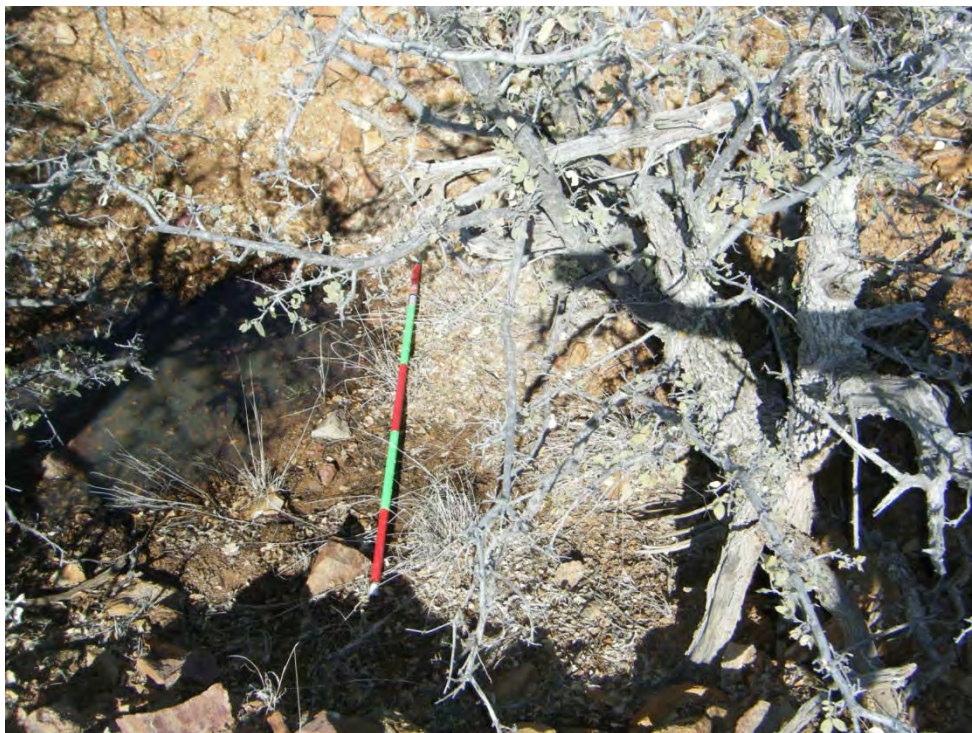
Photo 26-Looking west at Pit-5.

Pit 5 - 2' deep, 12' wide, 10' long; south of Pit 4, water

Rad 7 - Pit 5 - 0m - 30 μ R/hr; 1m - 26 μ R/hr

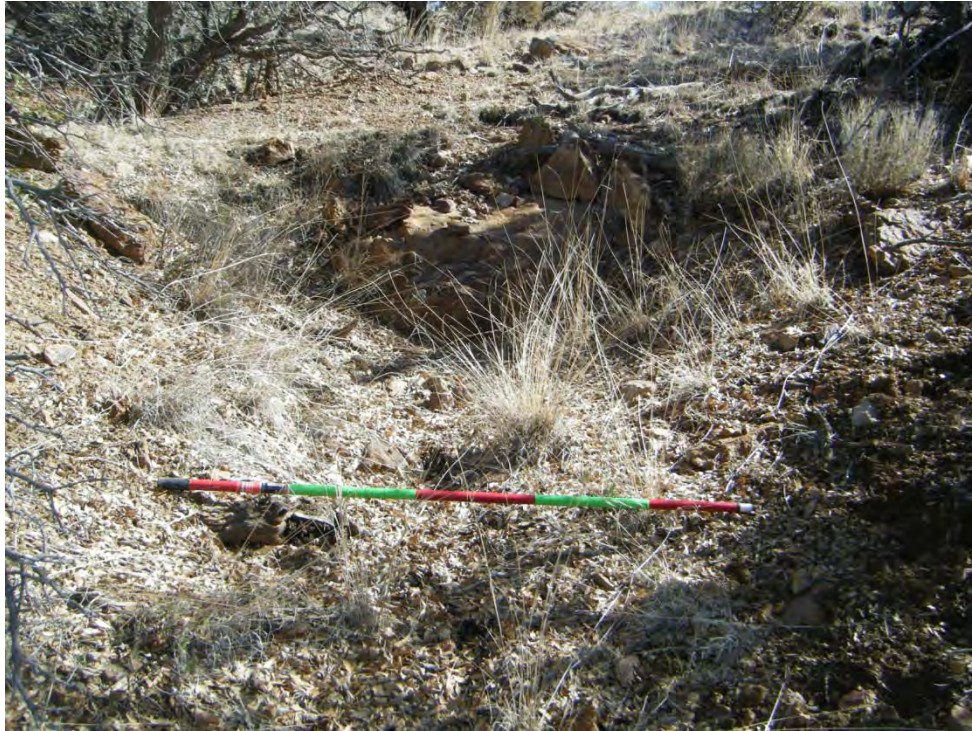
Photo 27-Looking north at CutIn-1.

Cutln 1 - south of Pit 5; 4' deep, 12' wide, 18' long

Rad 8 - Cutln 1; 0m - 32 μ R/h; 1m - 26 μ R/h

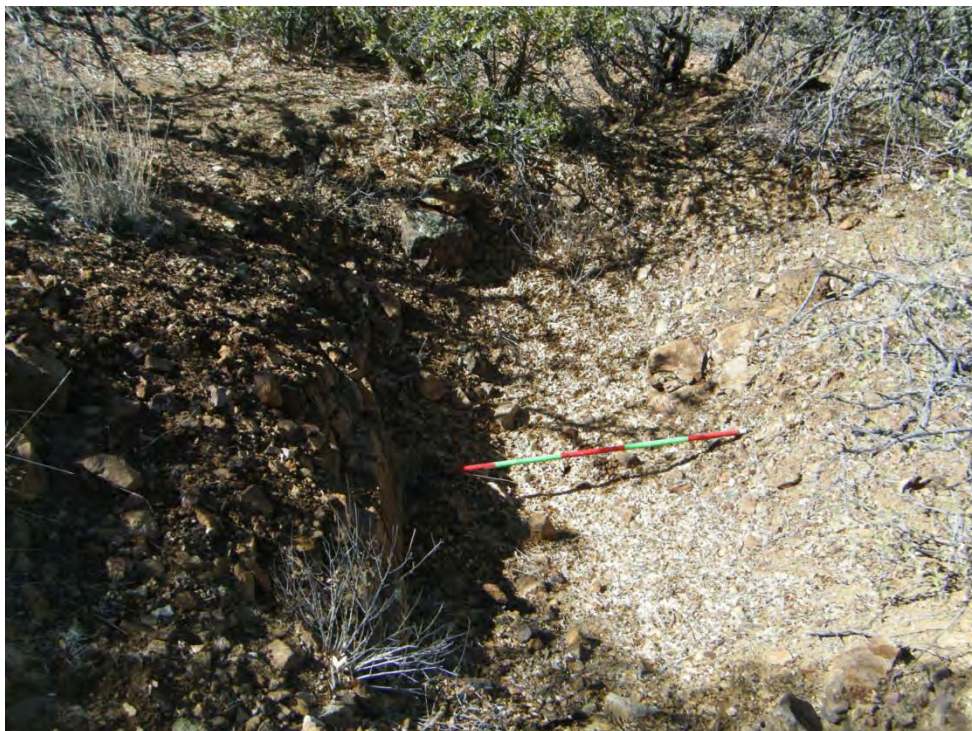
Photo 28-Looking south at Pit-6.

Pit 6 - south cutln 1; 7' deep, 15' long, 10' wide

Rad 9 - Pit 6; 0m - 38 μ R/hr; 1m - 30 μ R/hr

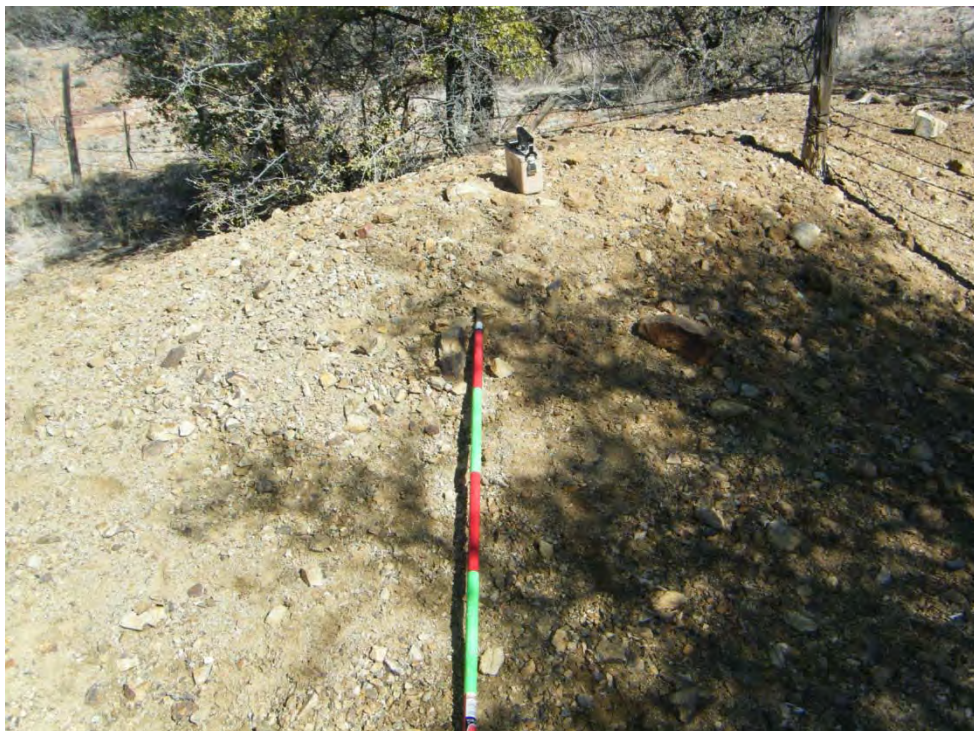
Photo 30- Looking northwest at PilePly-1.

Pile Ply 1 - between cutln 1 and Pit 6; "L" shaped

5' high; 20' wide, 25' length

Rad 10 - Pile Ply 1; 0m - 30 μ R/h; 1m - 28 μ R/h

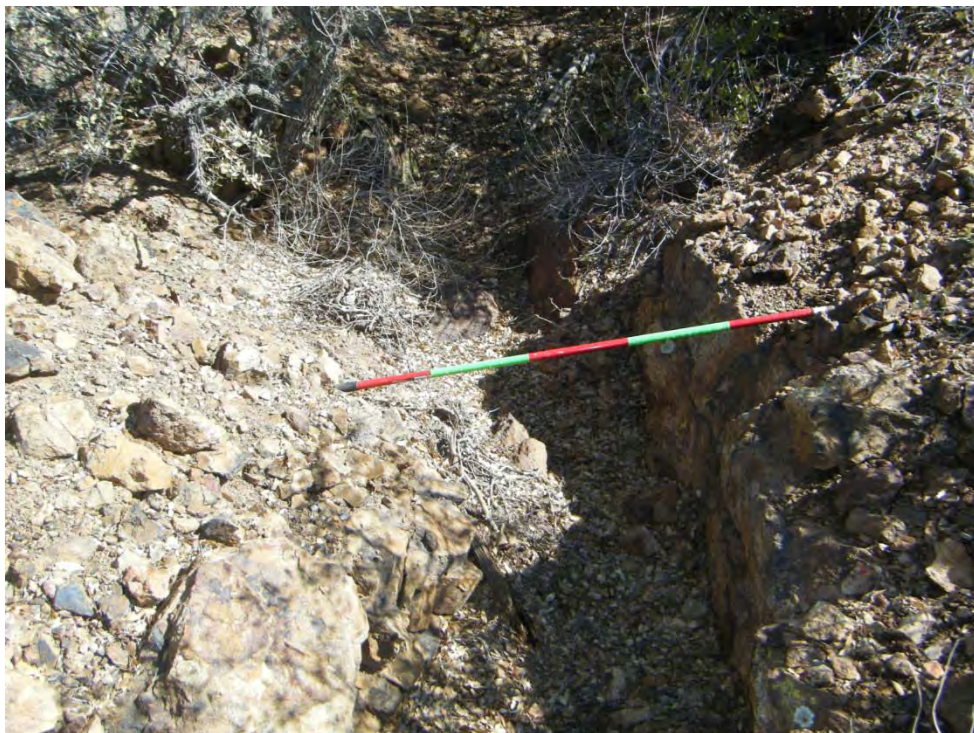
Photo 32-Looking north at CutLn-2.

Cutln 2; 3' deep, 7' wide, 6' long; south Pit 6

Rad 11 - Cutln 2 - 0m - 41 μ R/h; 1m - 31 μ R/h

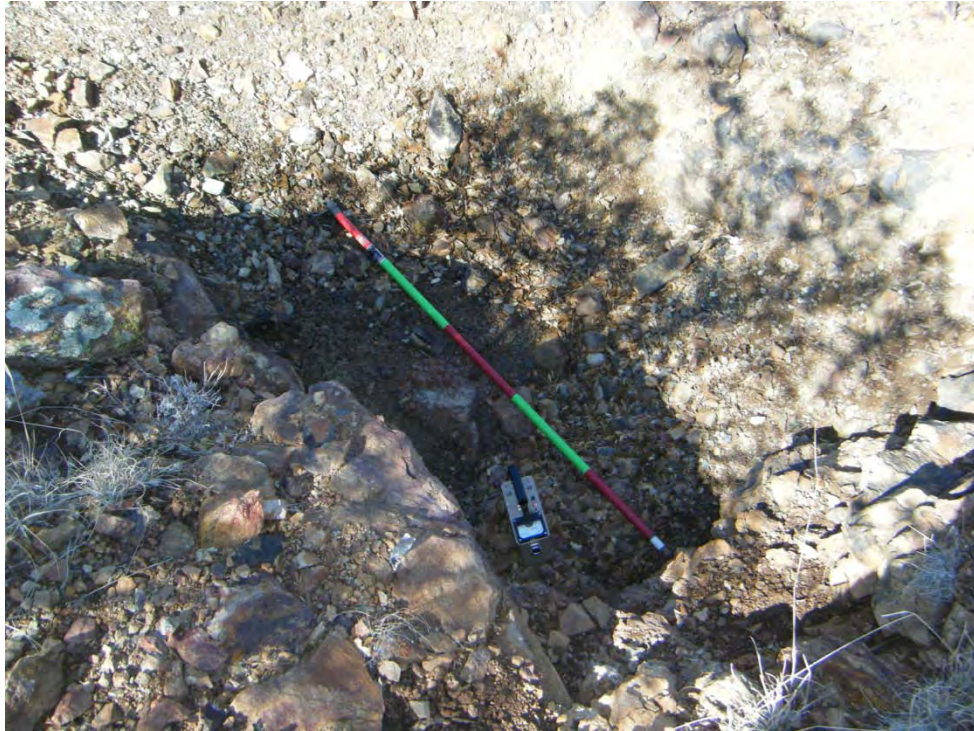
Photo 33-Looking south at Pit-7.

Pit 7; south cutln 2; 2' deep, 7' wide, 10' long

Pit 7 may have been filled in

Rad 12 - Pit 7 - 0m - ~~92~~^{70 ALT} μ R/h; 1m - 41 μ R/h

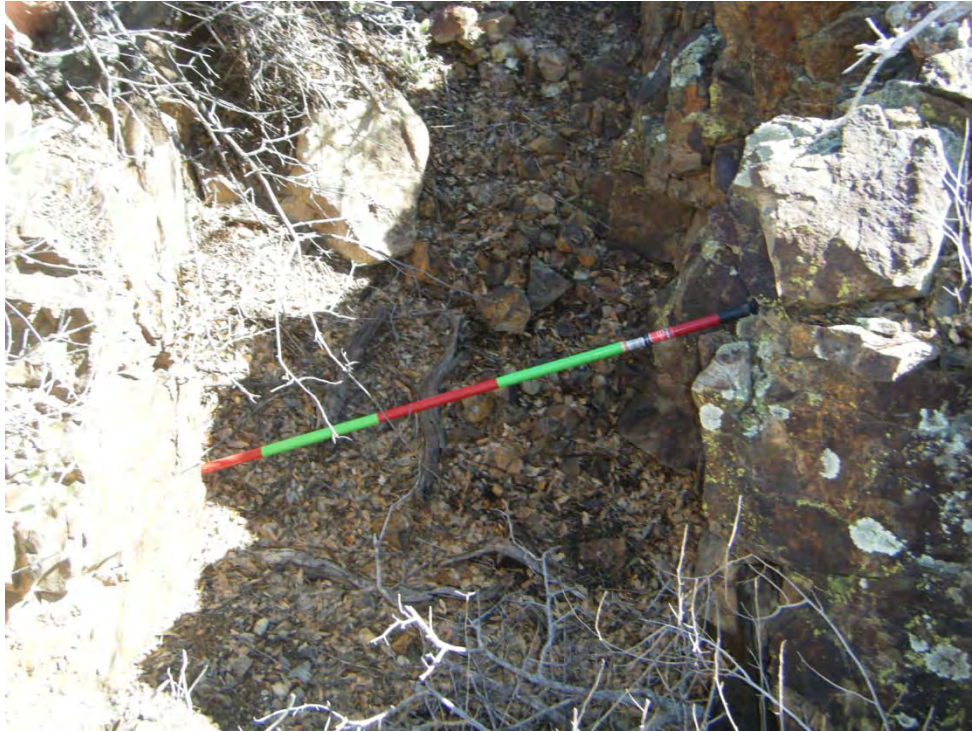
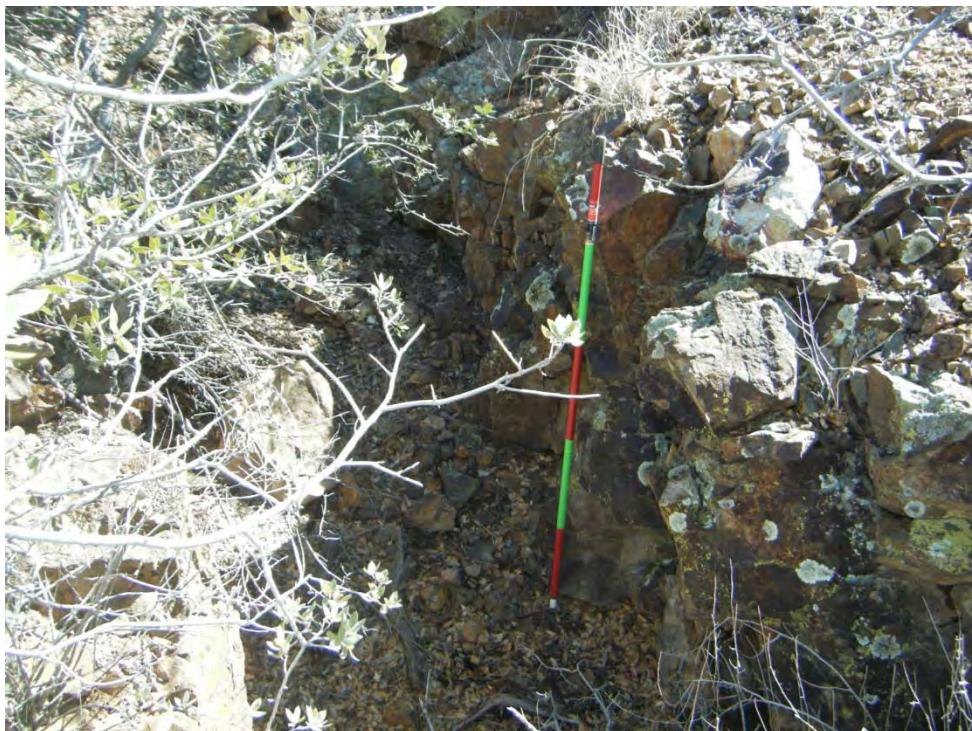
The highest gamma radiation readings at the AUM Site were found in the vicinity of DistPly-2 at the base of the hill. Exploration Pit-8 had gamma radiation readings of $150 \mu\text{R/hr}$ at the ground surface and $40 \mu\text{R/hr}$ at 4 feet above the ground surface (Rad-14). Another gamma radiation reading (Rad-16) taken on PilePly-2 was measured at $110 \mu\text{R/hr}$ at the ground surface and $70 \mu\text{R/hr}$ at 4 feet above the ground surface. The highest reading at the top of the hill (DistPly-1) were measured in Pit-1 and measured $96 \mu\text{R/hr}$ at the ground surface and $37 \mu\text{R/hr}$ at 4 feet above the ground surface. Please see Table 2 for details.

Photo 37-Looking north at Pit-8.

Photo 38-Looking northeast at Pit-8.

Pit 8 - south of Pit 7; 5' deep, 15' long, 6' wide

Rad 14 - Pit 8; 0m - 150 μ R/h; 1m - 40 μ R/h

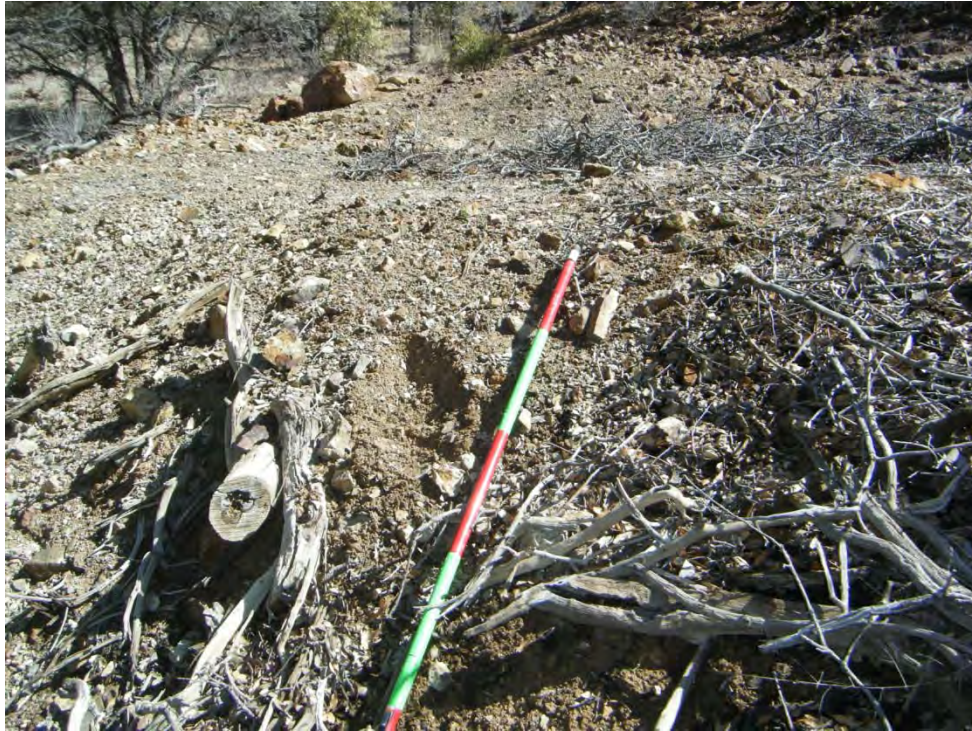
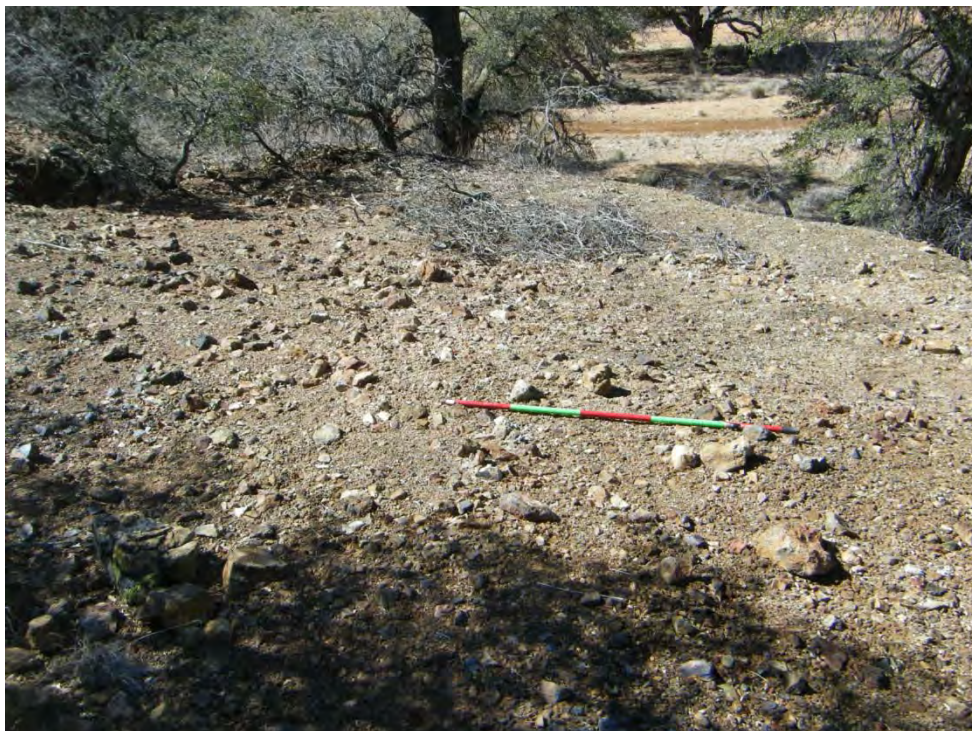
Photo 39-Looking north at PilePly-2.

Photo 40-Looking south at PilePly-2.

Pile Ply 2 - waste rock associated with Cutln 2, Pit 7, and Pit 8; 5' high, 25' wide, 50' long

Rad 16 - Pile Ply 2; om - 110 uR/h; 1m - 70 uR/h

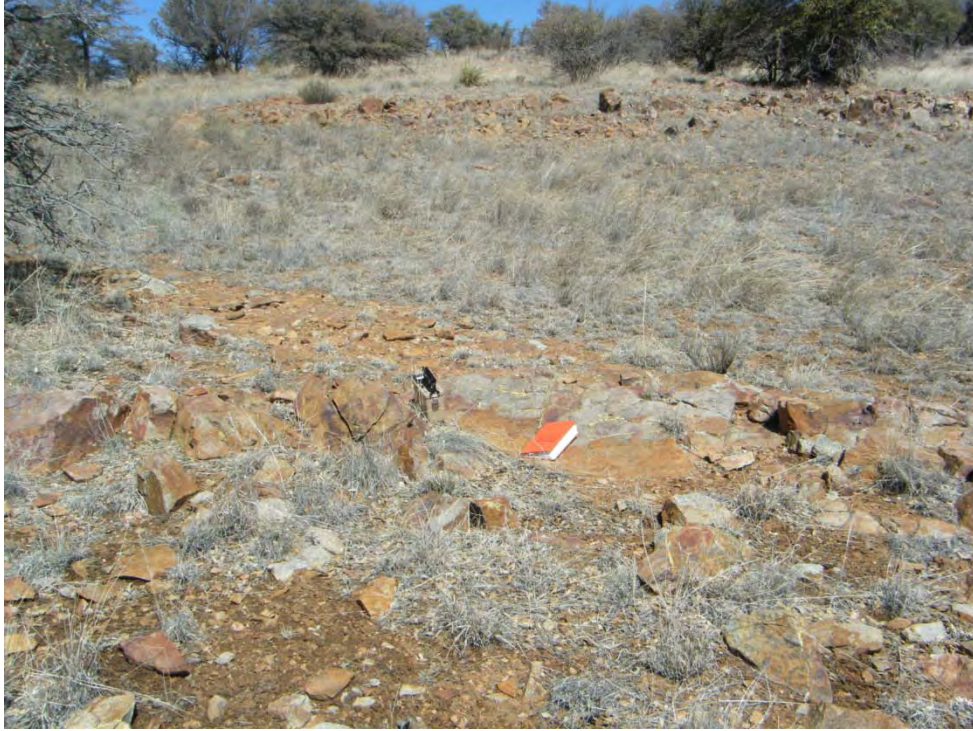
Photo 46-Looking north at the given AUM location, no evidence of mine features.

Rad Back 2 - given AUM Disturbed Poly
om - 30 uR/h, T^{ACT} 1m - 25 uR/h
