**CAMINO REAL LANDFILL
SUNLAND PARK, NEW MEXICO
NMED FACILITY PERMIT NOS. SWM-030738
AND SWM-030738 (SP)**

**APPLICATION FOR PERMIT MODIFICATION
AND RENEWAL**

**VOLUME II OF VI
LANDFILL MANAGEMENT PLANS**

**VOLUME II – LANDFILL MANAGEMENT PLANS
SECTION 1 – PERMIT DRAWINGS**

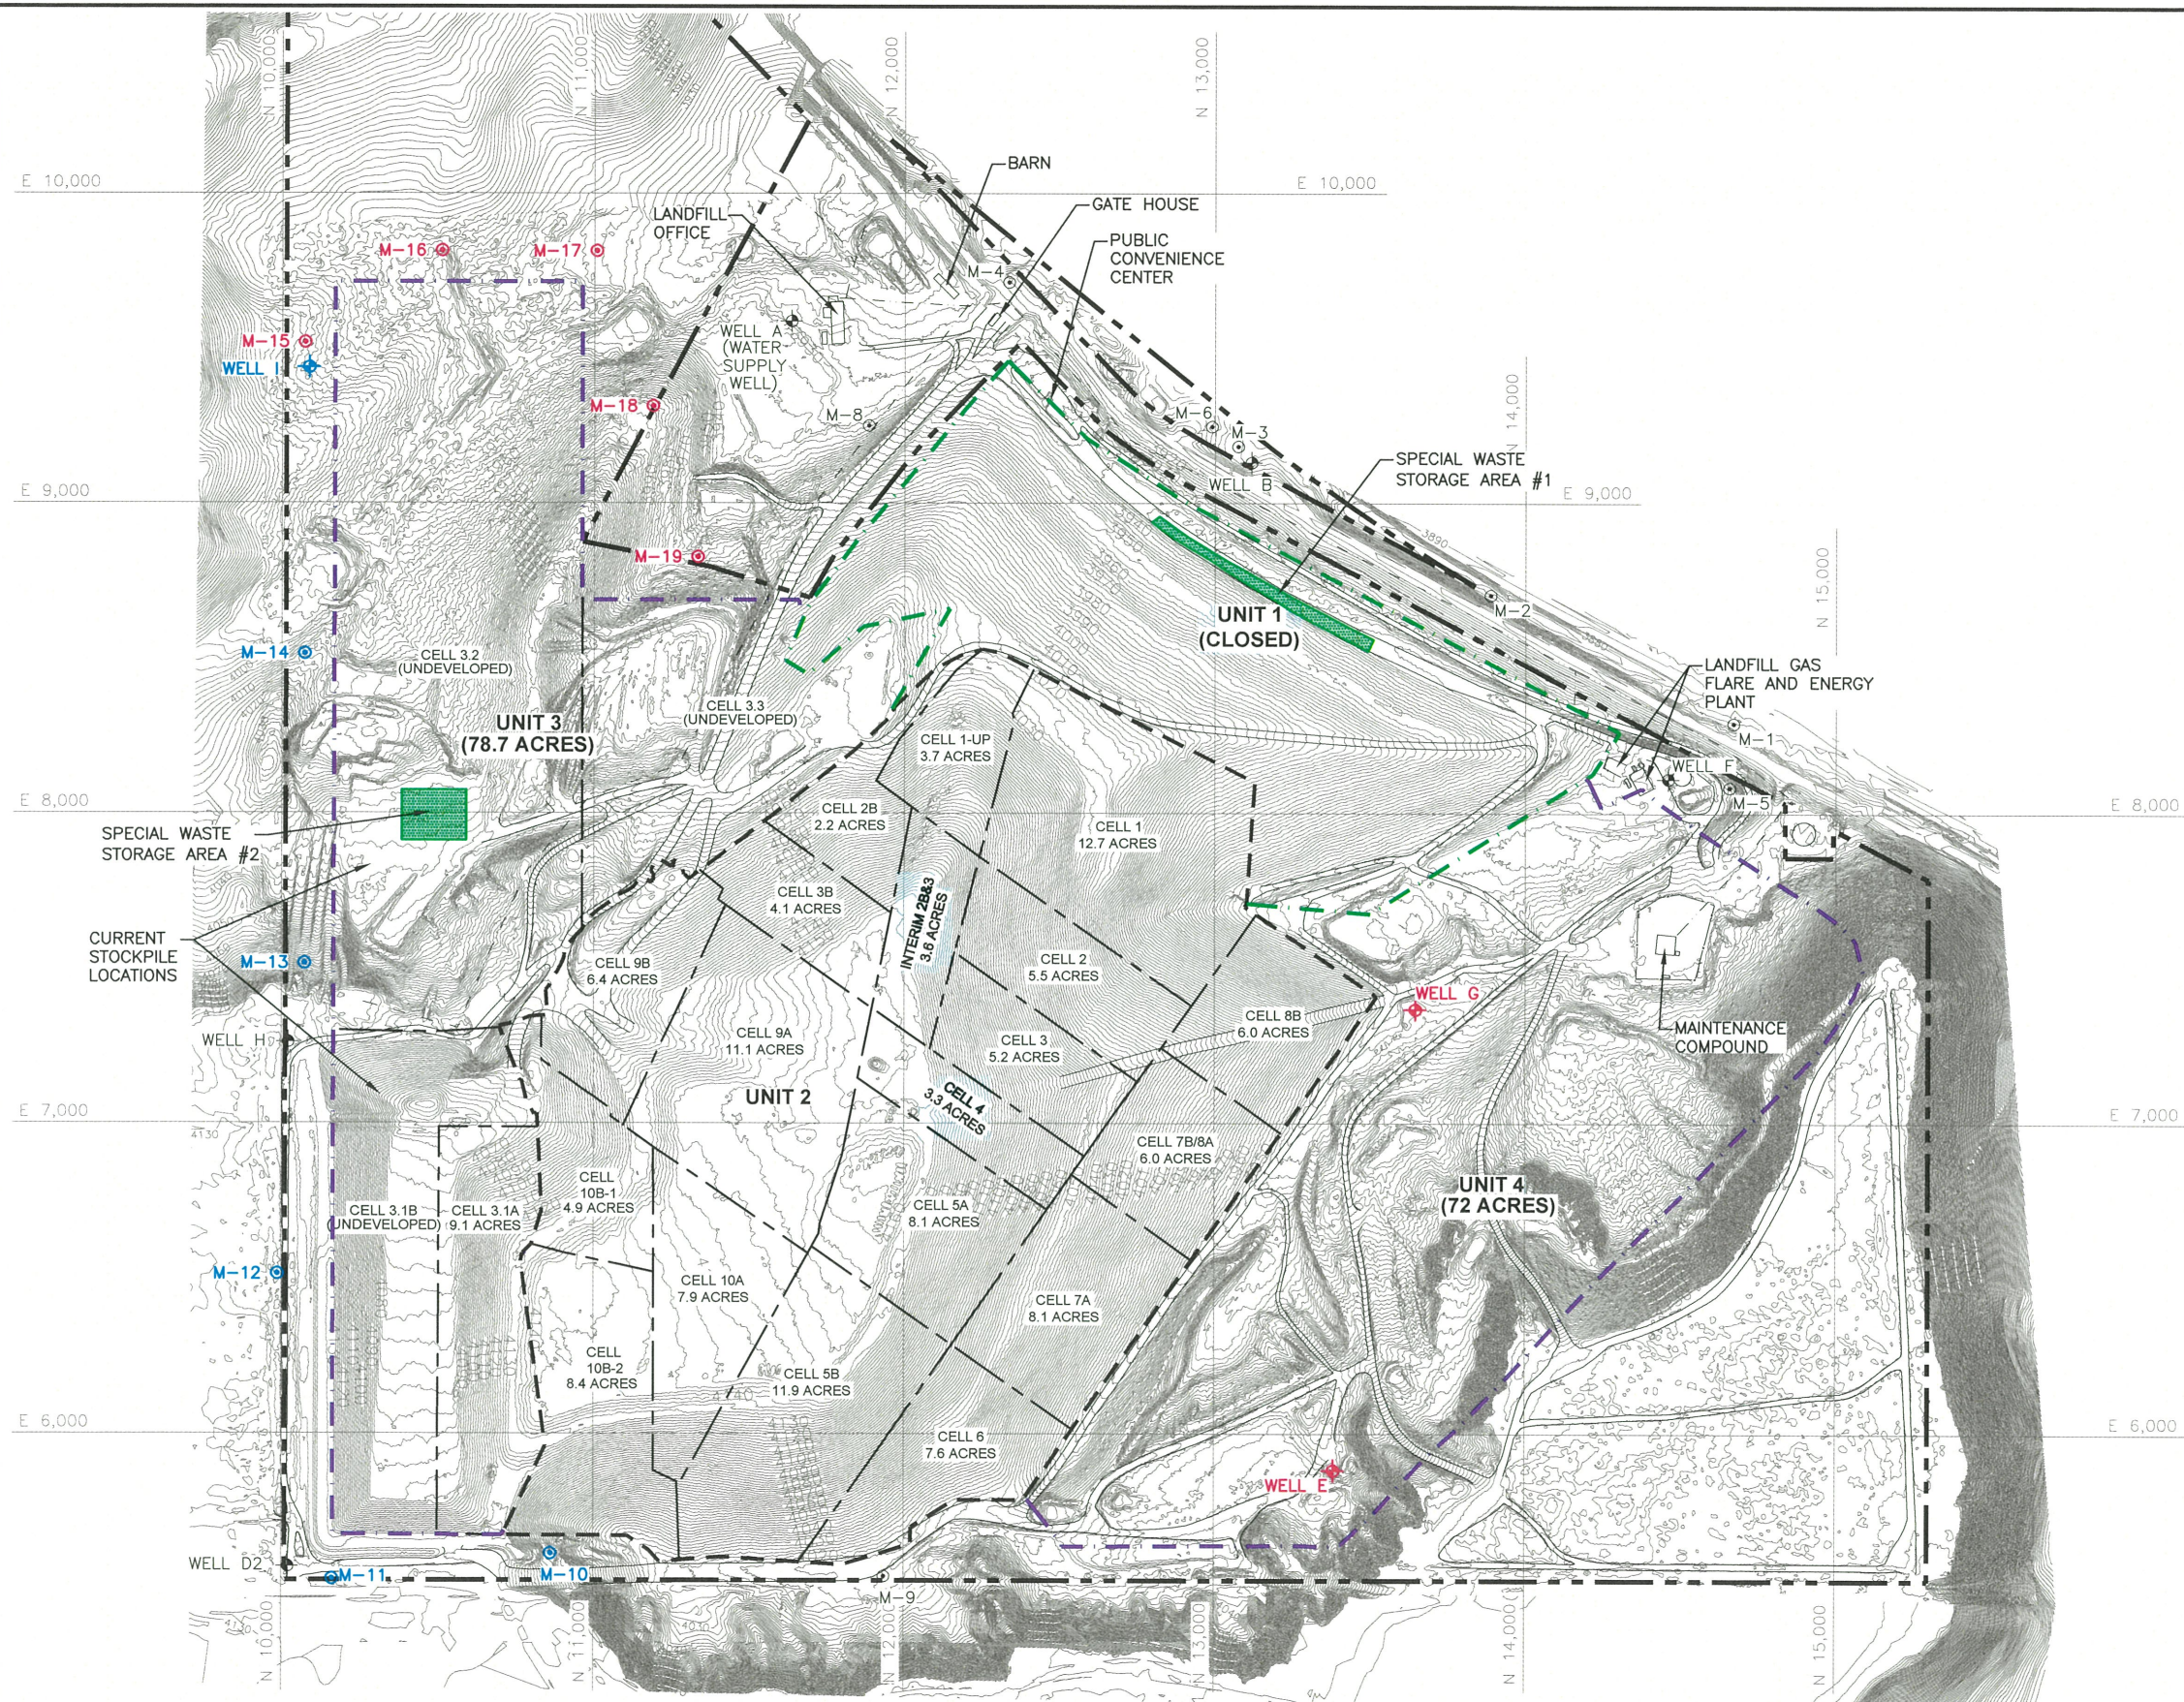
DRAWING NO	DRAWING TITLE	REVISION NO	DATE
1	COVER SHEET	0	09/2022
2	EXISTING SITE PLAN	0	09/2022
3	SITE DEVELOPMENT PLAN	0	09/2022
4	EXCAVATION PLAN	0	09/2022
5	PERMITTED COMPLETION PLAN	0	09/2022
6	PROPOSED COMPLETION PLAN	0	09/2022
7	EXISTING DRAINAGE CONDITIONS	0	09/2022
8	PERMITTED DRAINAGE CONDITIONS	0	09/2022
9	PROPOSED DRAINAGE CONDITIONS	0	09/2022
10	LANDFILL CROSS SECTION A	0	09/2022
11	LANDFILL CROSS SECTION B	0	09/2022
12	LANDFILL CROSS SECTION C	0	09/2022
13	LANDFILL CROSS SECTION D	0	09/2022
14	LINER SYSTEM DETAILS	0	09/2022
15	LEACHATE COLLECTION SYSTEM DETAILS	0	09/2022
16	UNIT 2/4 LINER SYSTEM DETAILS	0	09/2022
17	CLOSURE TURF FINAL COVER DETAILS	0	09/2022
18	ET AFC DETAILS	0	09/2022

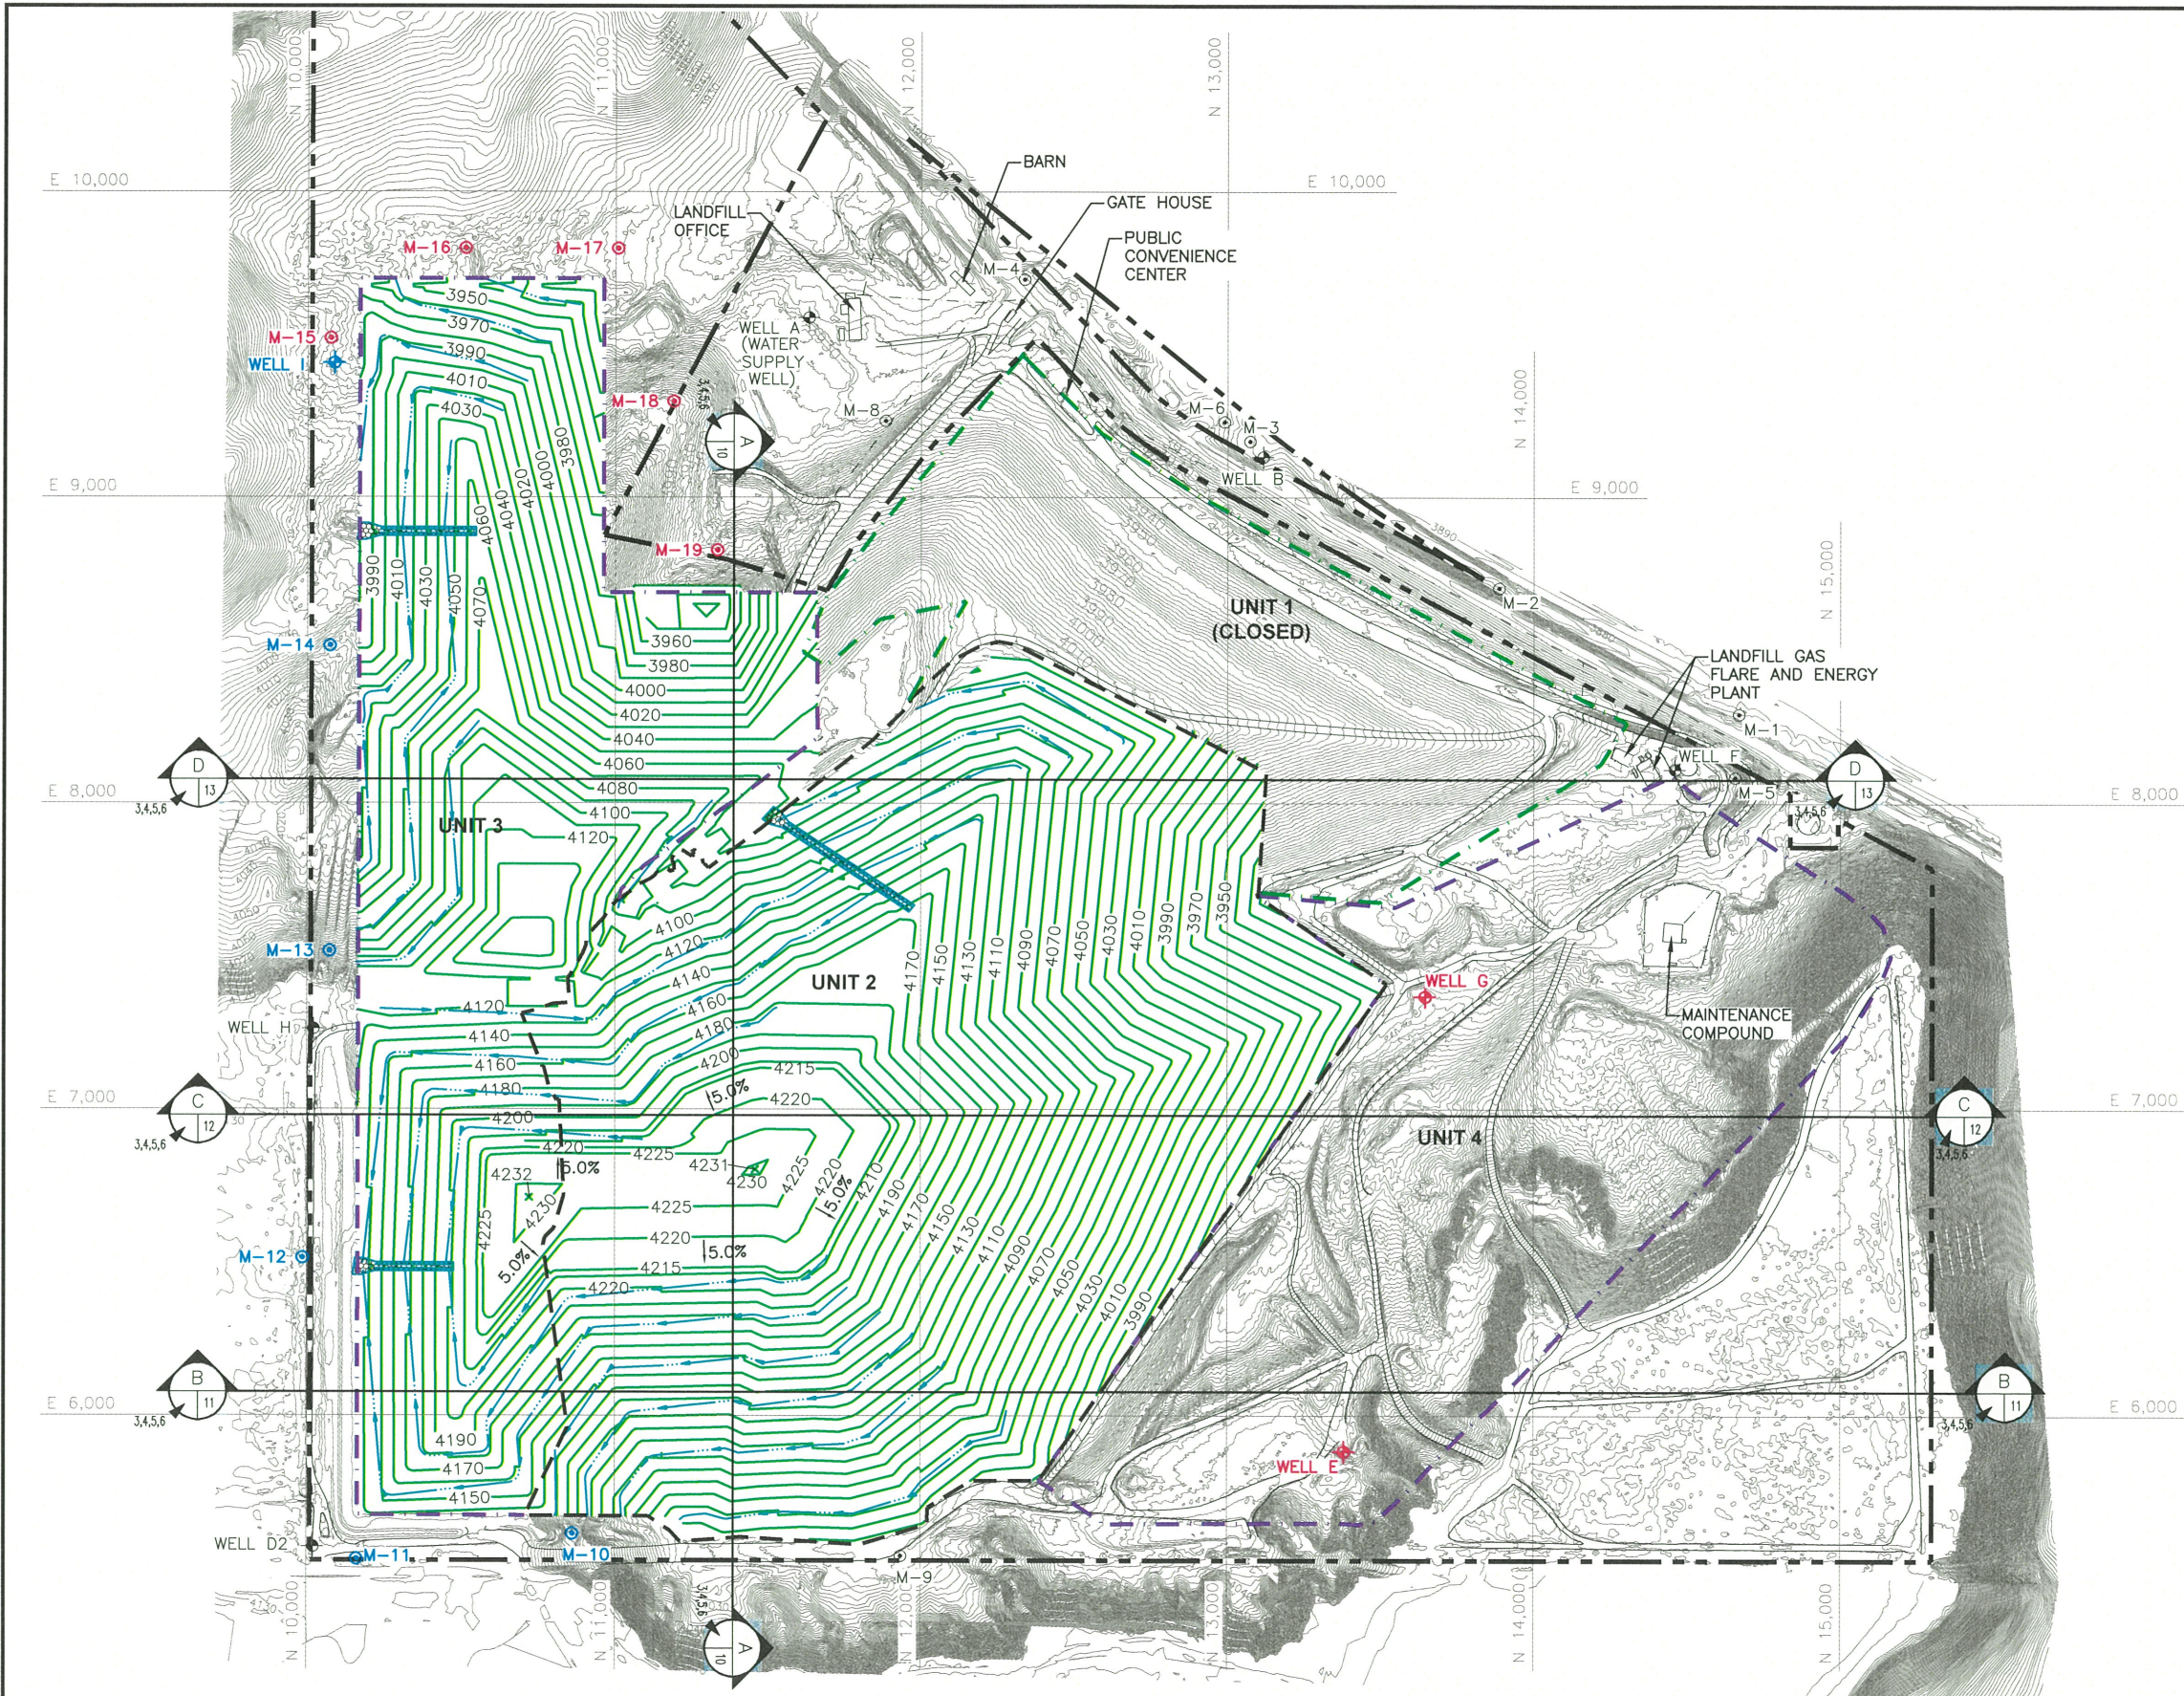
- NOTES:**
1. CONCEPTUAL TOP OF FINAL COVER GRADES BASED ON INTERMEDIATE AND FINAL FILL GRADE CONTOURS FOR UNIT 2 AND UNIT 3 IN THE "INTERMEDIATE COMPLETION PLAN: UNITS 1, 2, AND 3" (GORDON ENVIRONMENTAL, INC. APRIL 2007).
 2. COMPOSITE TOPOGRAPHY IS A COMPOSITE FROM THE 2005 AND 2022 AERIAL SURVEYS.

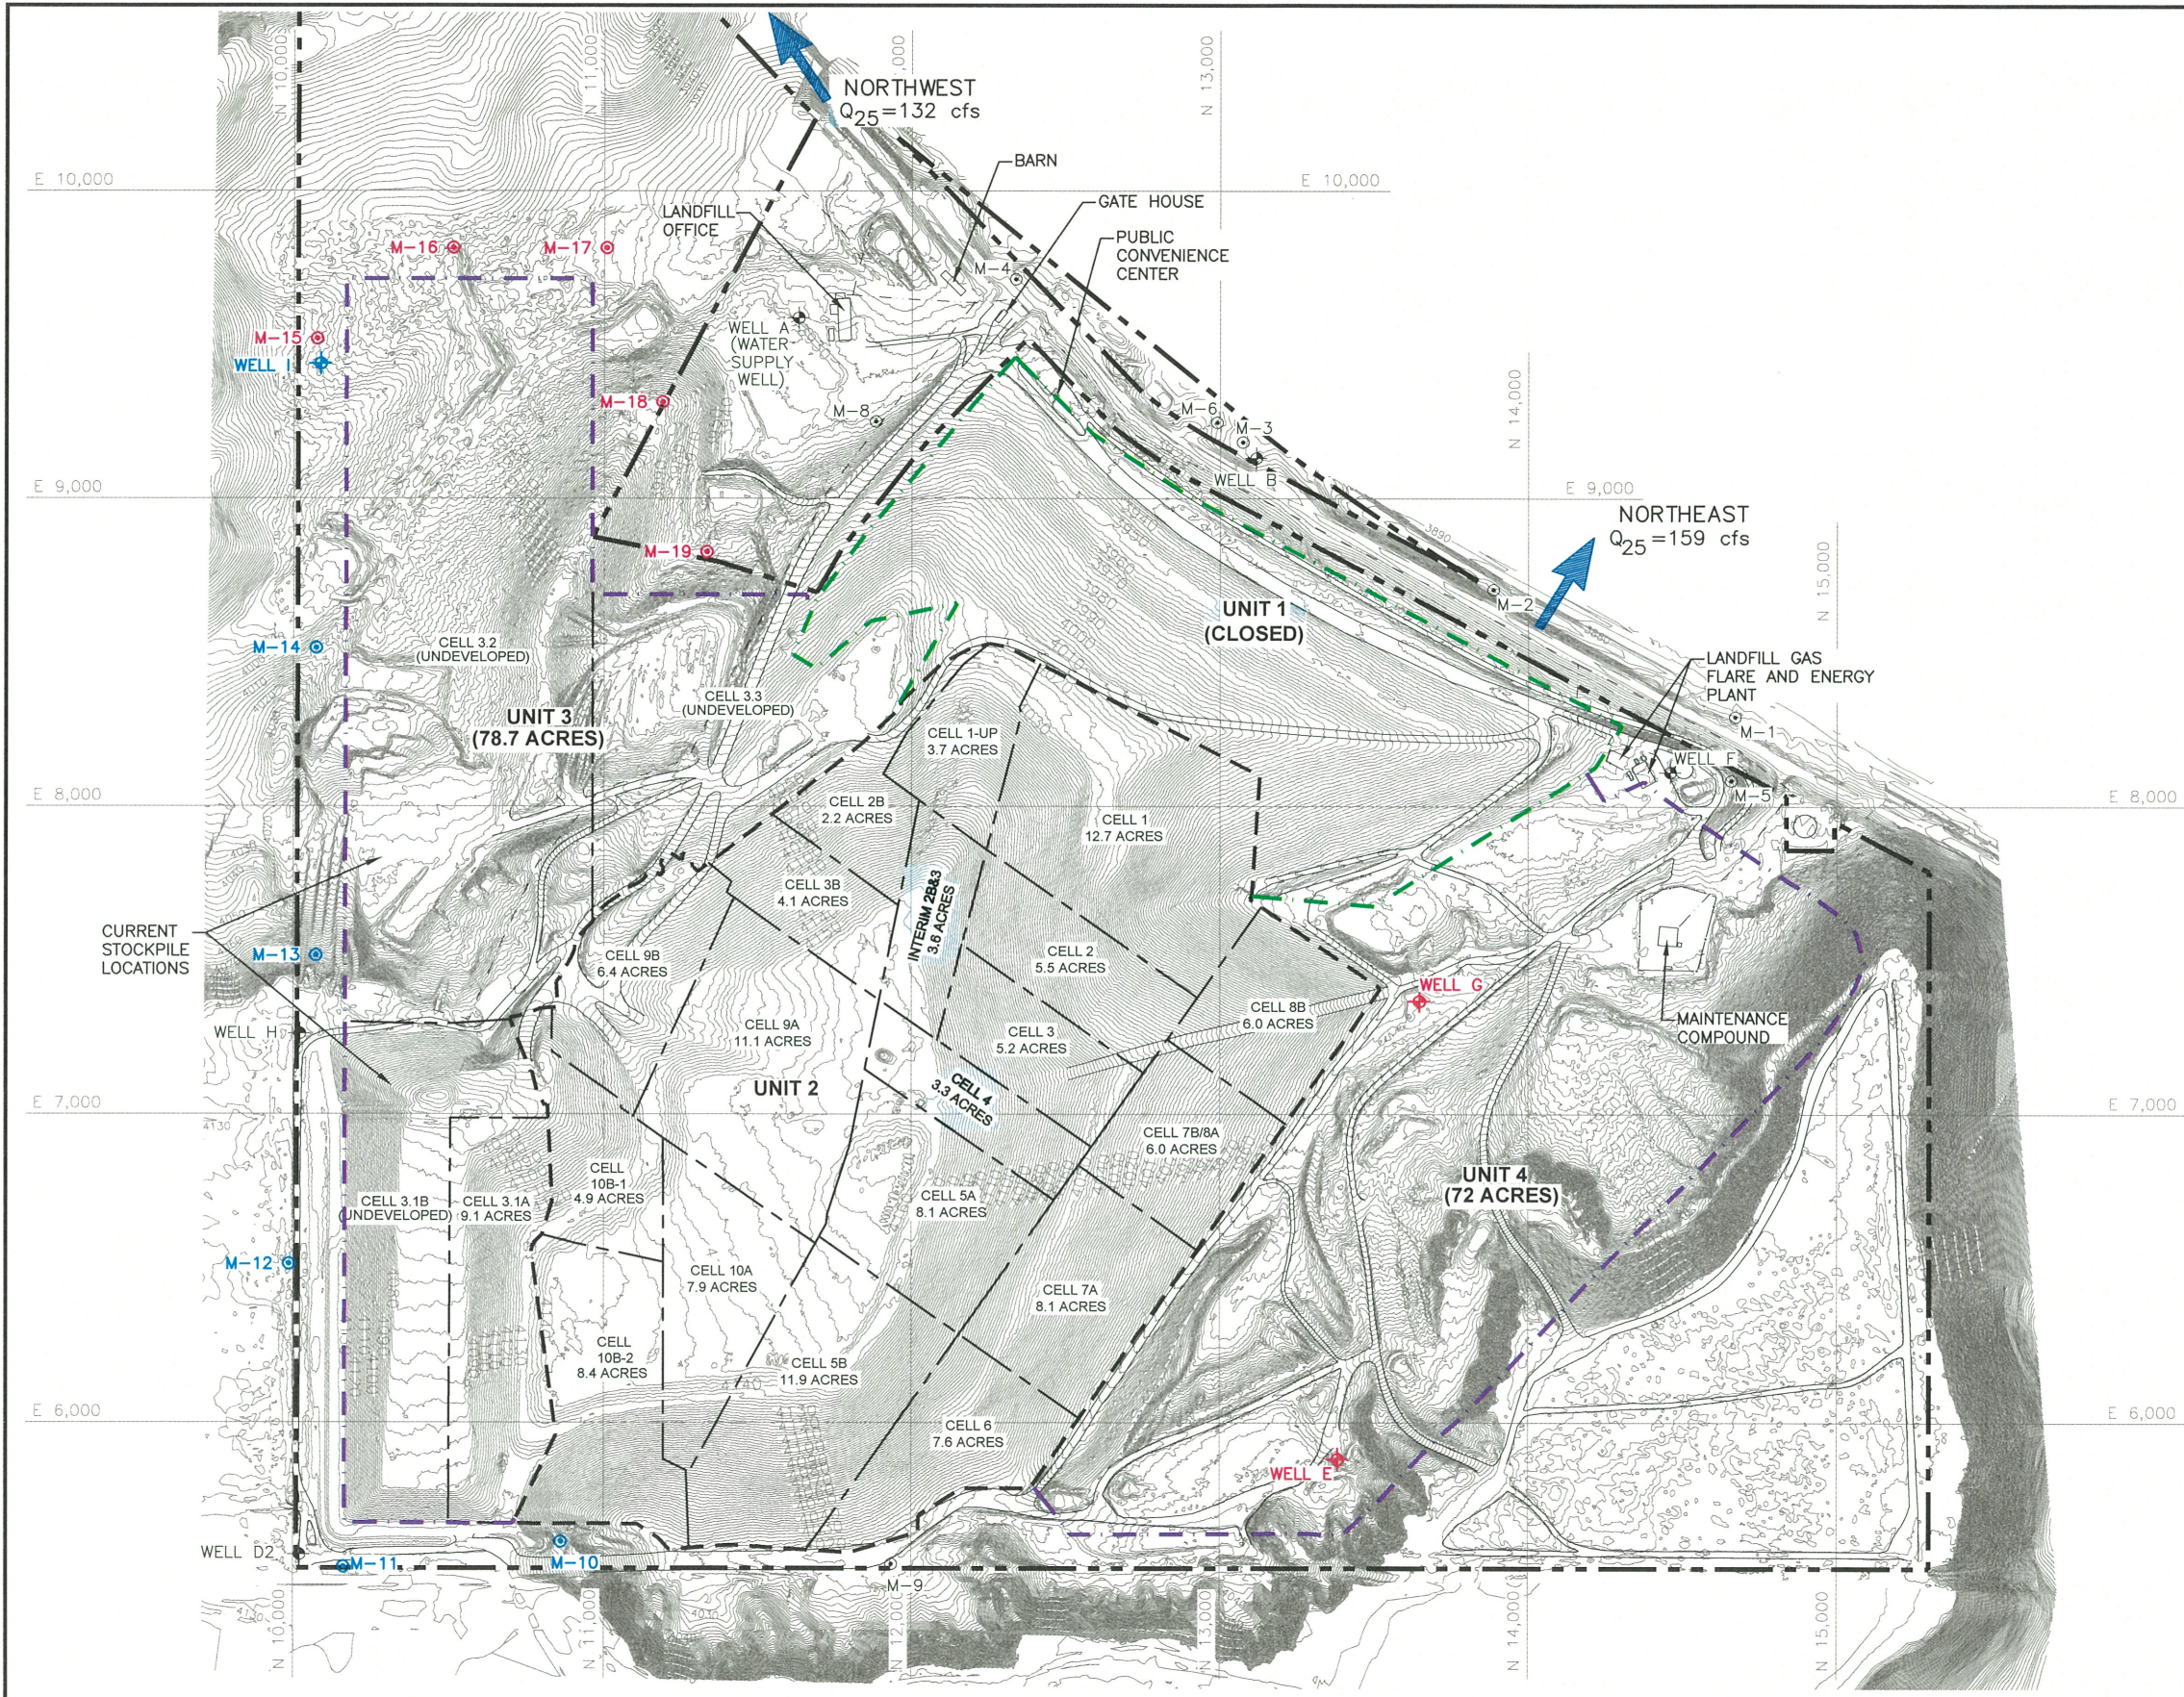
NORTHWEST
 $Q_{25}=132$ cfs
 $Q_{25}=11.22$ fps
 $VOL_{25}=30.6$ ac-ft
 DRAINAGE AREA=376.72 ac

NORTHEAST
 $Q_{25}=159$ cfs
 $Q_{25}=4.85$ fps
 $VOL_{25}=31.5$ ac-ft
 DRAINAGE AREA=323.88 ac

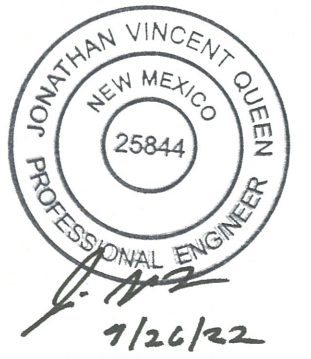
- LEGEND**
- PROPERTY BOUNDARY
 - - - PERMITTED LIMITS OF WASTE FOR UNIT 2
 - · - · - PERMITTED LIMITS OF WASTE FOR UNIT 1 (CLOSED)
 - - - - PERMITTED LIMITS OF WASTE FOR UNITS 3 AND 4
 - · - · - ADJUSTED LIMITS OF WASTE FOR UNITS 3 AND 4
 - CELL BOUNDARY
 - E 8,000 SITE GRID
 - 4120 COMPOSITE TOPOGRAPHY (SEE NOTE 1)
 - WELL B EXISTING GROUNDWATER MONITOR WELL
 - WELL I PERMITTED GROUNDWATER MONITOR WELL
 - WELL G PERMITTED GROUNDWATER MONITOR WELL (TO BE ABANDONED)
 - WELL G2 PROPOSED GROUNDWATER MONITOR WELL
 - M-4 EXISTING LANDFILL GAS PROBE
 - M-11 PERMITTED LANDFILL GAS PROBE
 - M-17 PERMITTED LANDFILL GAS PROBE (TO BE REPLACED WITH PROPOSED LOCATIONS)
 - M-27 PROPOSED LANDFILL GAS PROBE

<input type="checkbox"/> DRAFT <input checked="" type="checkbox"/> FOR PERMITTING PURPOSES ONLY <input type="checkbox"/> ISSUED FOR CONSTRUCTION		PREPARED FOR CAMINO REAL ENVIRONMENTAL CENTER, INC.		SITE PLAN CAMINO REAL LANDFILL SUNLAND PARK, NEW MEXICO										
DATE: 07/2022 FILE: 0601-667-11 CAD: II-5-2-SITE PLAN.DWG		DRAWN BY: JDW DESIGN BY: KRB REVIEWED BY: JVQ				REVISIONS

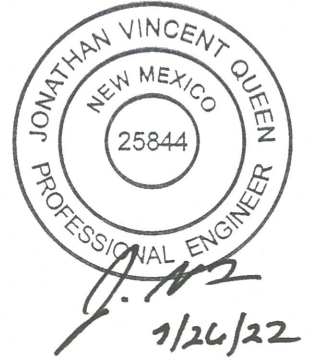
- LEGEND**
- PROPERTY BOUNDARY
 - PERMITTED LIMITS OF WASTE FOR UNIT 1 (CLOSED)
 - PERMITTED LIMITS OF WASTE FOR UNIT 2
 - PERMITTED LIMITS OF WASTE FOR UNITS 3 AND 4
 - ADJUSTED LIMITS OF WASTE FOR UNITS 3 AND 4
 - CELL BOUNDARY
 - SITE GRID
 - COMPOSITE TOPOGRAPHY (SEE NOTE 1)
 - ◆ WELL B EXISTING GROUNDWATER MONITOR WELL
 - ◆ WELL I PERMITTED GROUNDWATER MONITOR WELL
 - ◆ WELL G PERMITTED GROUNDWATER MONITOR WELL (TO BE ABANDONED)
 - ◆ WELL G2 PROPOSED GROUNDWATER MONITOR WELL
 - M-4 EXISTING LANDFILL GAS PROBE
 - M-11 PERMITTED LANDFILL GAS PROBE
 - M-17 PERMITTED LANDFILL GAS PROBE (TO BE REPLACED WITH PROPOSED LOCATIONS)
 - M-27 PROPOSED LANDFILL GAS PROBE

<input type="checkbox"/> DRAFT <input checked="" type="checkbox"/> FOR PERMITTING PURPOSES ONLY <input type="checkbox"/> ISSUED FOR CONSTRUCTION	PREPARED FOR CAMINO REAL ENVIRONMENTAL CENTER, INC.	ENVIRONMENTAL MONITORING NETWORK													
DATE: 07/2022 FILE: 0601-667-11 CAD: II-5-3 ENV MON PLAN.DWG	DRAWN BY: JOW DESIGN BY: JAE REVIEWED BY: JVV	REVISIONS

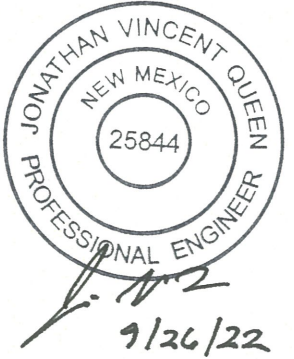
- LEGEND**
- PROPERTY BOUNDARY
 - - - PERMITTED LIMITS OF WASTE FOR UNIT 2
 - · - · - PERMITTED LIMITS OF WASTE FOR UNIT 1 (CLOSED)
 - - - PERMITTED LIMITS OF WASTE FOR UNIT 3 AND 4
 - · - · - ADJUSTED LIMITS OF WASTE FOR UNITS 3 AND 4
 - SITE GRID
 - 4120 --- COMPOSITE TOPOGRAPHY (SEE NOTE 1)
 - 4170 --- PROPOSED FINAL CONTOUR
 - PROPOSED SWALE (SEE NOTE 2)
 - PROPOSED DRAINAGE CHUTE (SEE NOTE 2)
 - ⊕ WELL B EXISTING GROUNDWATER MONITOR WELL
 - ⊕ WELL I PERMITTED GROUNDWATER MONITOR WELL
 - ⊕ WELL G2 PROPOSED GROUNDWATER MONITOR WELL
 - ⊙ M-4 EXISTING LANDFILL GAS PROBE
 - ⊙ M-11 PERMITTED LANDFILL GAS PROBE
 - ⊙ M-27 PROPOSED LANDFILL GAS PROBE
 - CLOSURE TURF AREA

<input type="checkbox"/> DRAFT <input checked="" type="checkbox"/> FOR PERMITTING PURPOSES ONLY <input type="checkbox"/> ISSUED FOR CONSTRUCTION	PREPARED FOR CAMINO REAL ENVIRONMENTAL CENTER, INC.	PROPOSED COMPLETION PLAN
DATE: 07/2022 FILE: 0601-667-11 CAD: 6-PROPOSED FINAL CONTOUR PLAN.DWG	DRAWN BY: JDW DESIGN BY: JAE REVIEWED BY: JVQ	CAMINO REAL LANDFILL SUNLAND PARK, NEW MEXICO
Weaver Consultants Group		WWW.WCGRP.COM DRAWING 6

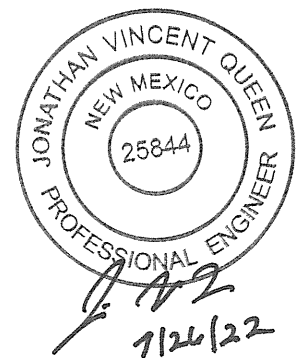
LANDFILL GAS MONITORING
PROBE PROFILE

1. ALL SIZES AND DIMENSIONS ARE APPROXIMATE.
2. ACTUAL LOCATION AND DESIGN OF LFG MONITORING PROBE WILL BE DETERMINED BASED ON FIELD CONDITIONS AT THE TIME OF INSTALLATION.

1. COMPOSITE TOPOGRAPHY IS A COMPOSITE FROM THE 2005 AND 2022 AERIAL SURVEYS.
2. PERMITTED LANDFILL GAS PROBE LOCATION BASED ON 2007 PERMIT APPLICATION.
3. LOCATIONS OF PROPOSED LANDFILL GAS MONITORING PROBES ARE APPROXIMATE. ACTUAL LOCATIONS MAY VARY BASED ON FIELD CONDITIONS AT THE TIME OF INSTALLATION.
4. FUTURE LANDFILL GAS MONITORING PROBES TO BE INSTALLED SIMILAR TO THE DETAIL SHOWN ON FIGURE II.6.2.

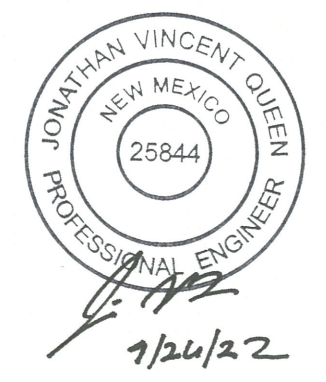
- SITE GRID
 - COMPOSITE TOPOGRAPHY (SEE NOTE 1)
 - EW-1 EXISTING LFG EXTRACTION WELL
 - EXISTING LFG COLLECTION PIPING
 - EXISTING LEACHATE FORCEMAIN
 - EXISTING REMOTE WELLHEAD
 - EXISTING LFG ISOLATION VALVE
 - EXISTING CLEANOUT RISER
 - EXISTING DRIPLEG
 - M-4 EXISTING LANDFILL GAS MONITORING PROBE

<input type="checkbox"/> DRAFT <input checked="" type="checkbox"/> FOR PERMITTING PURPOSES ONLY <input type="checkbox"/> ISSUED FOR CONSTRUCTION	PREPARED FOR CAMINO REAL ENVIRONMENTAL CENTER, INC.	LANDFILL GAS CONTROL PLAN
DATE: 07/2022 FILE: 0601-667-11 CAD: II.6.3 LFG CONTROL PLAN.DWG	DRAWN BY: JDW DESIGN BY: JAE REVIEWED BY: JVQ	CAMINO REAL LANDFILL SUNLAND PARK, NEW MEXICO
Weaver Consultants Group		WWW.WCGRP.COM FIGURE II.6.3

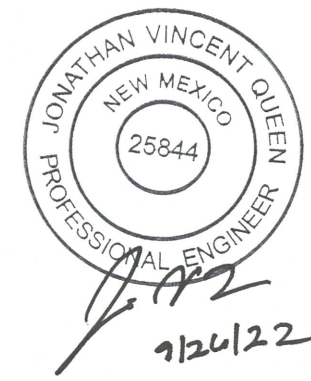
- LEGEND**
- PROPERTY BOUNDARY
 - PERMITTED LIMITS OF WASTE FOR UNIT 2
 - PERMITTED LIMITS OF WASTE FOR UNIT 1 (CLOSED)
 - PERMITTED LIMITS OF WASTE FOR UNITS 3 AND 4
 - ADJUSTED LIMITS OF WASTE FOR UNITS 3 AND 4
 - CELL BOUNDARY
 - SITE GRID
 - COMPOSITE TOPOGRAPHY (SEE NOTE 1)
 - 3980 PROPOSED SUBGRADE CONTOUR
 - 10-FOOT TALL ENGINEERED FENCE TO PROVIDE SCREENING TO EAST
 - LEACHATE COLLECTION PIPE
 - LEACHATE COLLECTION SUMP
 - UNIT 1 OVERLINER AREA
 - ⊕ WELL B EXISTING GROUNDWATER MONITOR WELL
 - ⊕ WELL I PERMITTED GROUNDWATER MONITOR WELL
 - ⊕ WELL G PERMITTED GROUNDWATER MONITOR WELL (TO BE ABANDONED)
 - ⊕ WELL G2 PROPOSED GROUNDWATER MONITOR WELL
 - ⊙ M-4 EXISTING LANDFILL GAS PROBE
 - ⊙ M-11 PERMITTED LANDFILL GAS PROBE
 - ⊙ M-17 PERMITTED LANDFILL GAS PROBE (TO BE REPLACED WITH PROPOSED LOCATIONS)
 - ⊙ M-27 PROPOSED LANDFILL GAS PROBE

- NOTES:**
1. COMPOSITE TOPOGRAPHY IS A COMPOSITE FROM THE 2005 AND 2018 AERIAL SURVEYS.
 2. THE UNIT 2 SUMP IS LOCATED NORTHEAST OF UNIT 2. DURING THE DEVELOPMENT OF UNIT 4, THIS SUMP WILL BE REMOVED AND REPLACED WITH A NEW SUMP IN UNIT 4. UNIT 2 WILL BE CONNECTED TO THE SUMP BY LEACHATE COLLECTION PIPES THAT WILL SLOPE A MINIMUM OF 2% FROM UNIT 2 TO THE UNIT 4 SUMP.
