# **GROUNDWATER MONITORING and WELL PLUGGING & ABANDONMENT REPORT**

**Fairview Station PST Site  
1626 North Riverside  
Española, New Mexico  
Facility #28779 RID #4657**

October 27, 2025

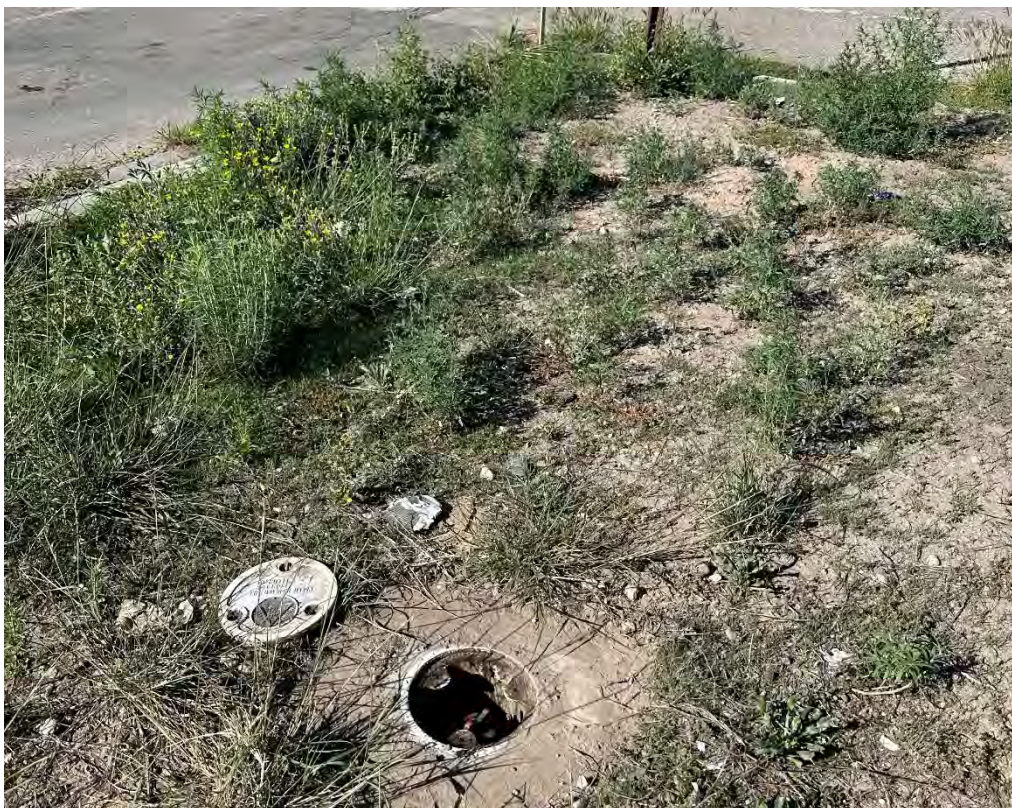
**Photo 1.** MW-23 prior P&A, looking southwest

Monitoring well abandonment was performed by filling each 2” PVC well with a neat Portland cement mixture delivered via a tremie hose starting near the total depth of each well and being slowly withdrawn as the wells were filled with the grout mixture. Following the placement of grout, concrete well pads were decommissioned using a jackhammer, all broken concrete debris was removed from the site. Following well pad removal, the tops of each well were removed to a depth approximately 1-2 feet below ground surface and clean surrounding backfill was used to fill the annulus flush with the existing ground surface. A copy of the abandonment field notes is included in Appendix 6.

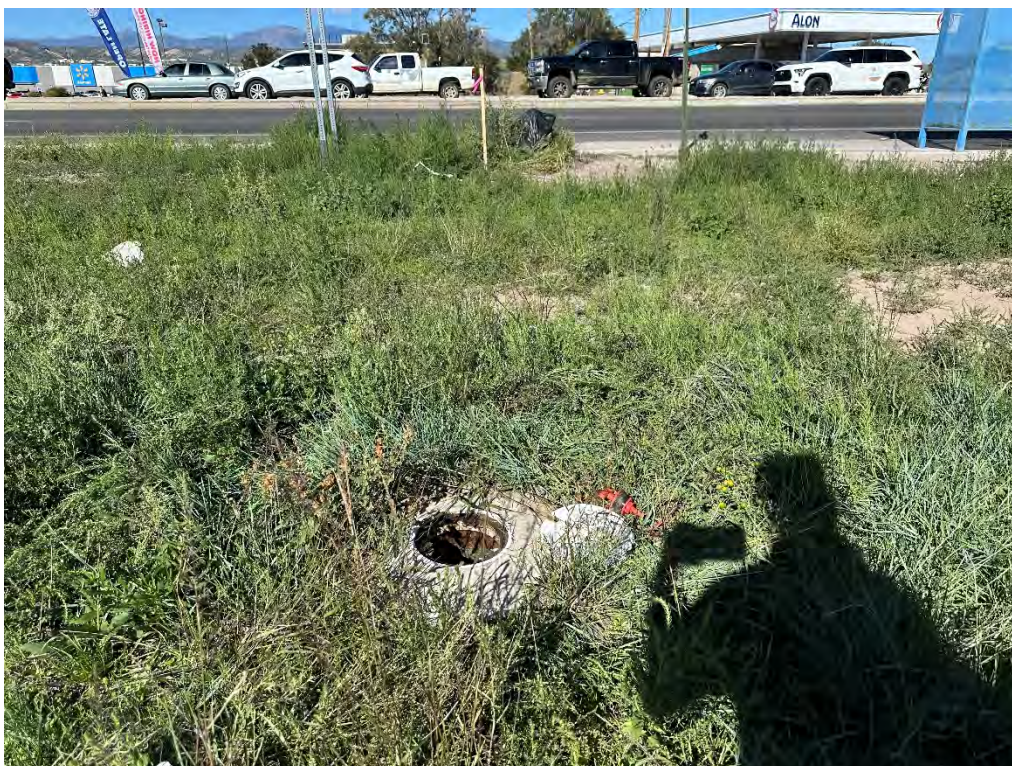
**Photo 2.** MW-13 prior to P&A, looking west

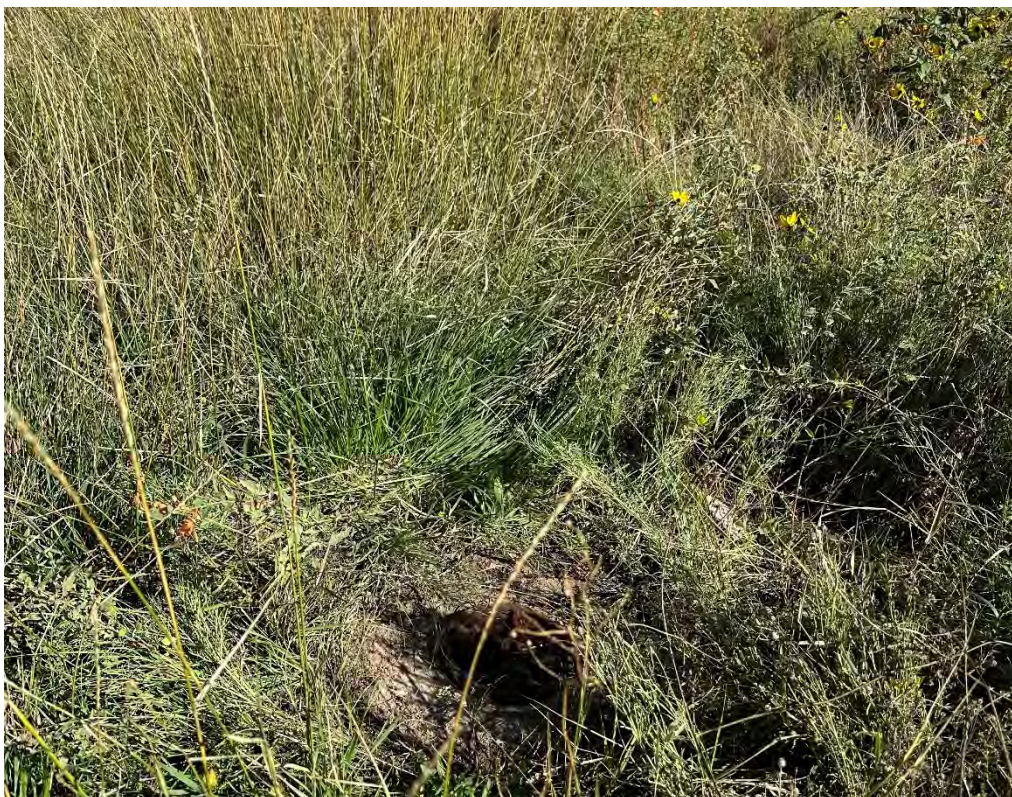
**Photo 3.** MW-22 prior to P&A, looking west

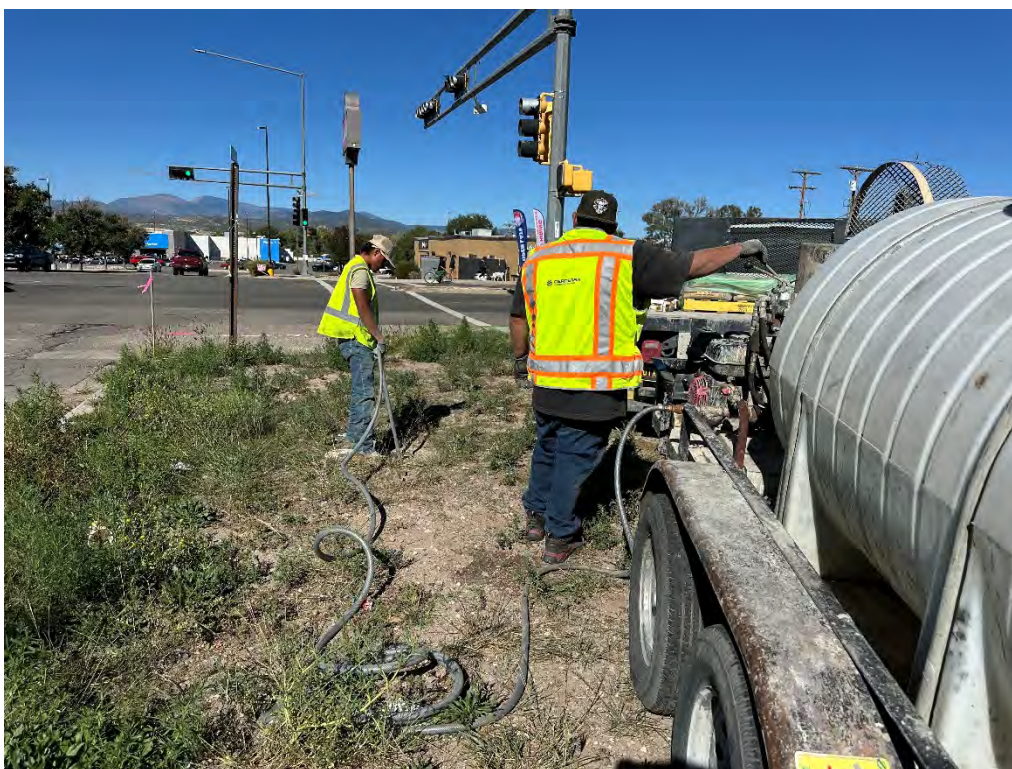
**Photo 4.** Enviro-Drill placing grout in MW-23, looking west

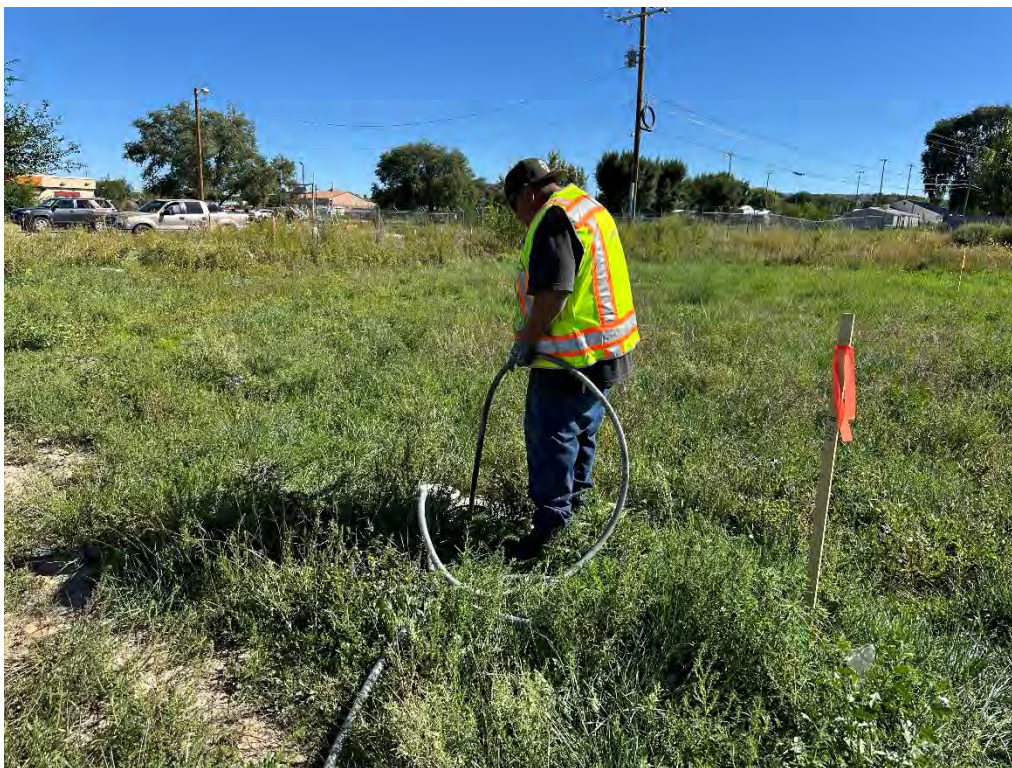
**Photo 5.** Enviro-Drill placing grout in MW-13, looking northeast

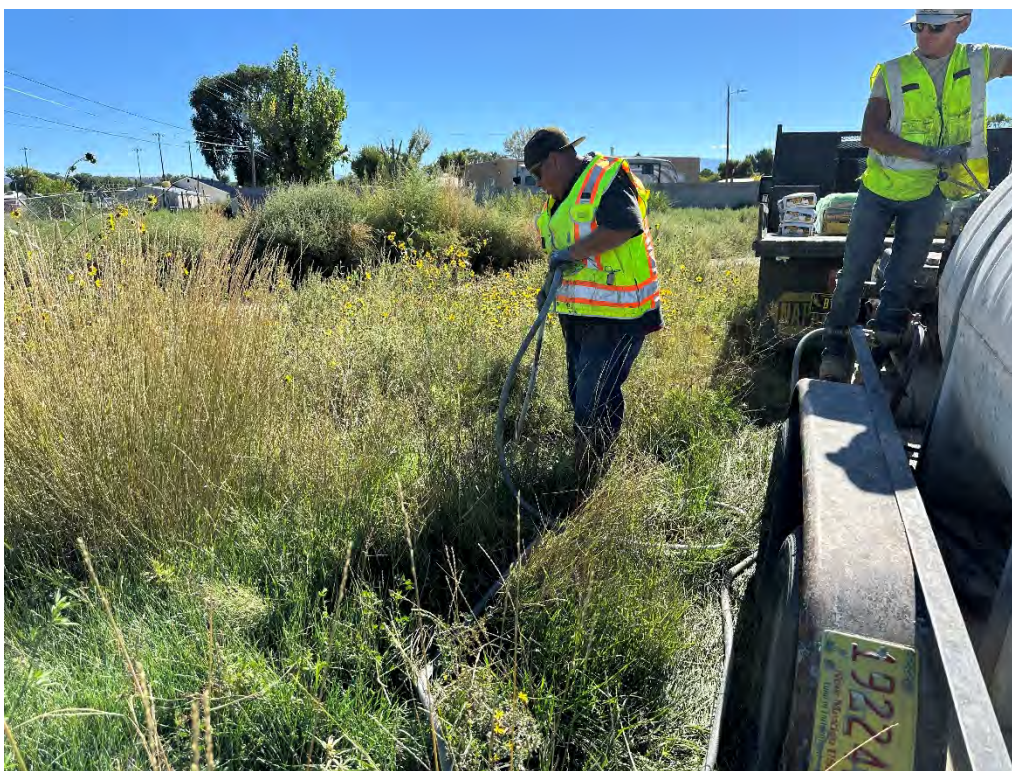
**Photo 6.** Enviro-Drill placing grout in MW-22, looking west

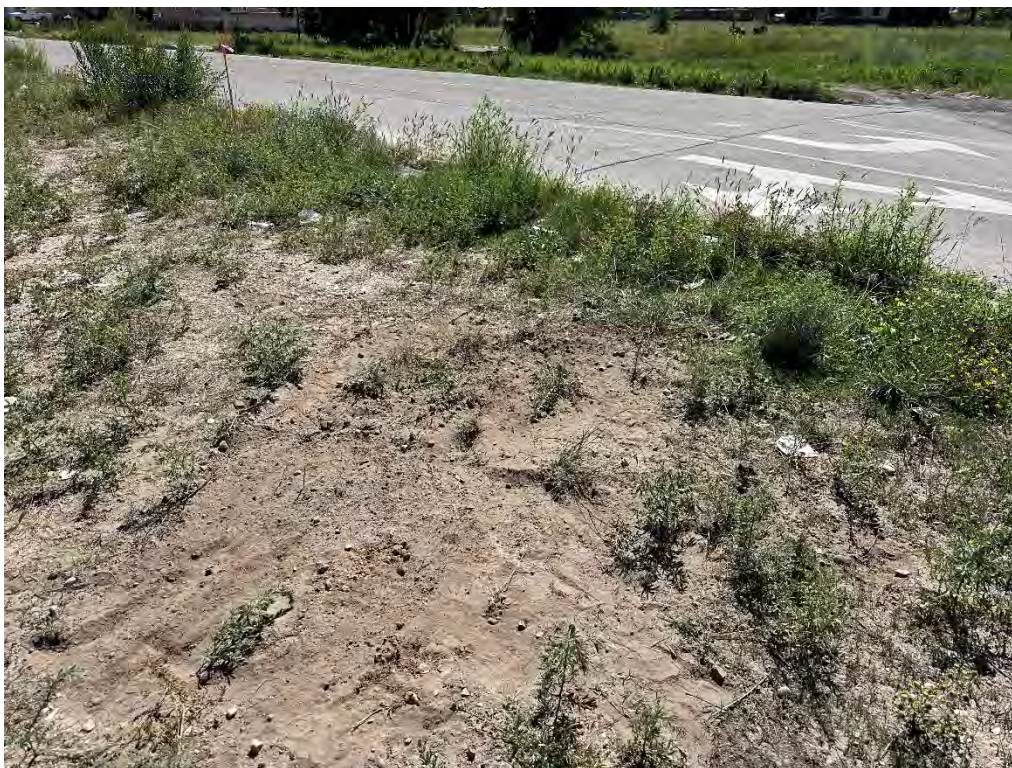
**Photo 7.** MW-23 location returned to grade, looking south

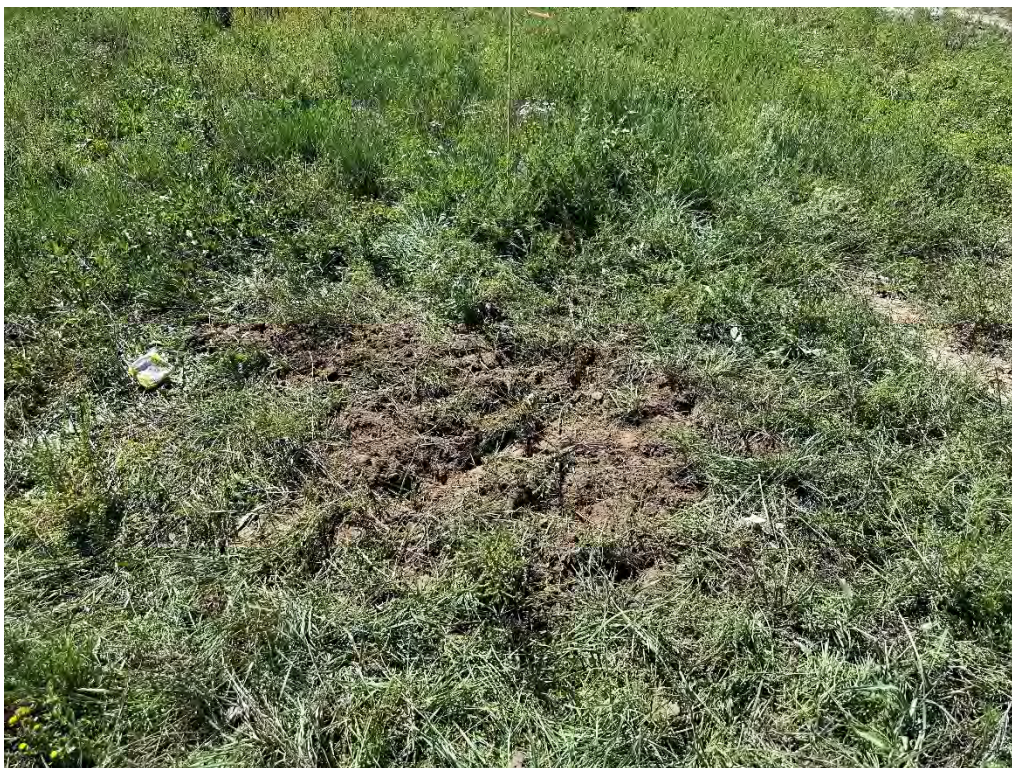
**Photo 8.** MW-13 location returned to grade, looking southwest

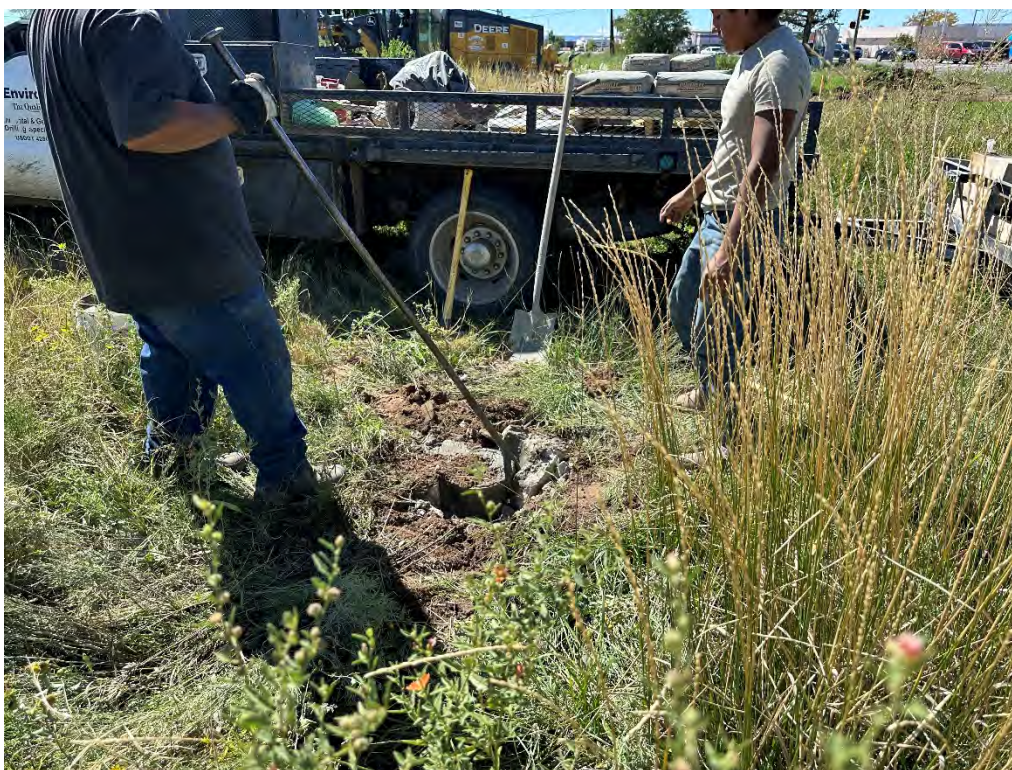
**Photo 9.** Enviro-Drill removing MW-22 surface completion, looking southwest

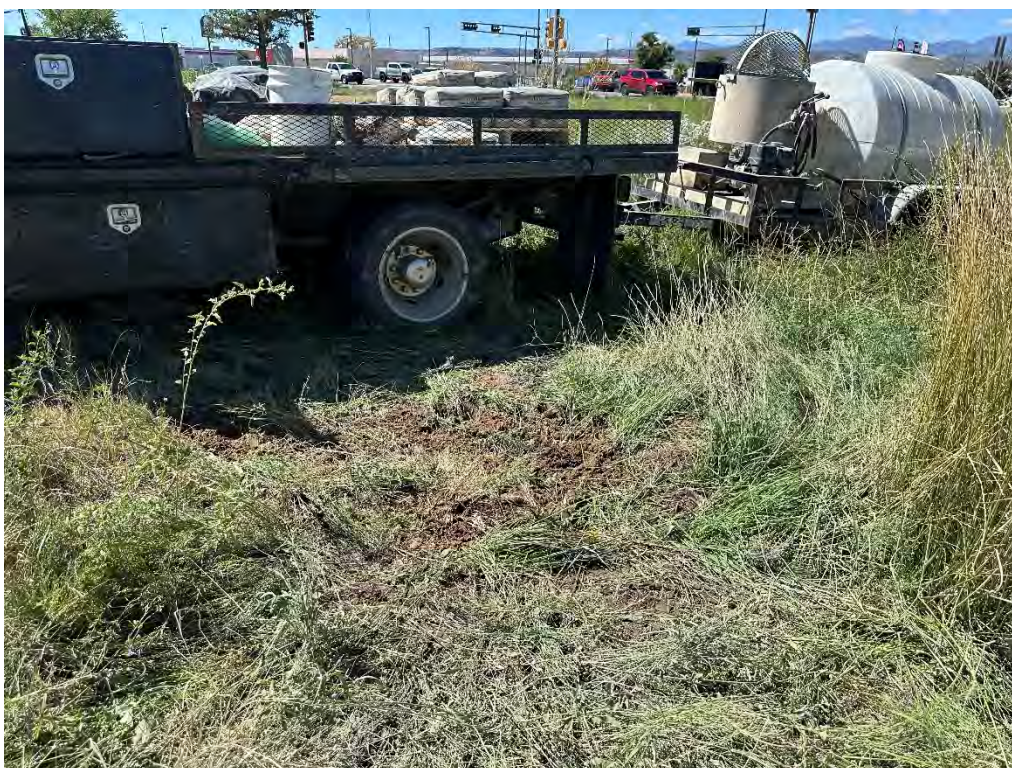
**Photo 10.** MW-22 location returned to grade, looking southwest
