# Abandoned Uranium Mine Assessment for the Marquez Site (NM0039)

## FINAL REPORT

NM0039

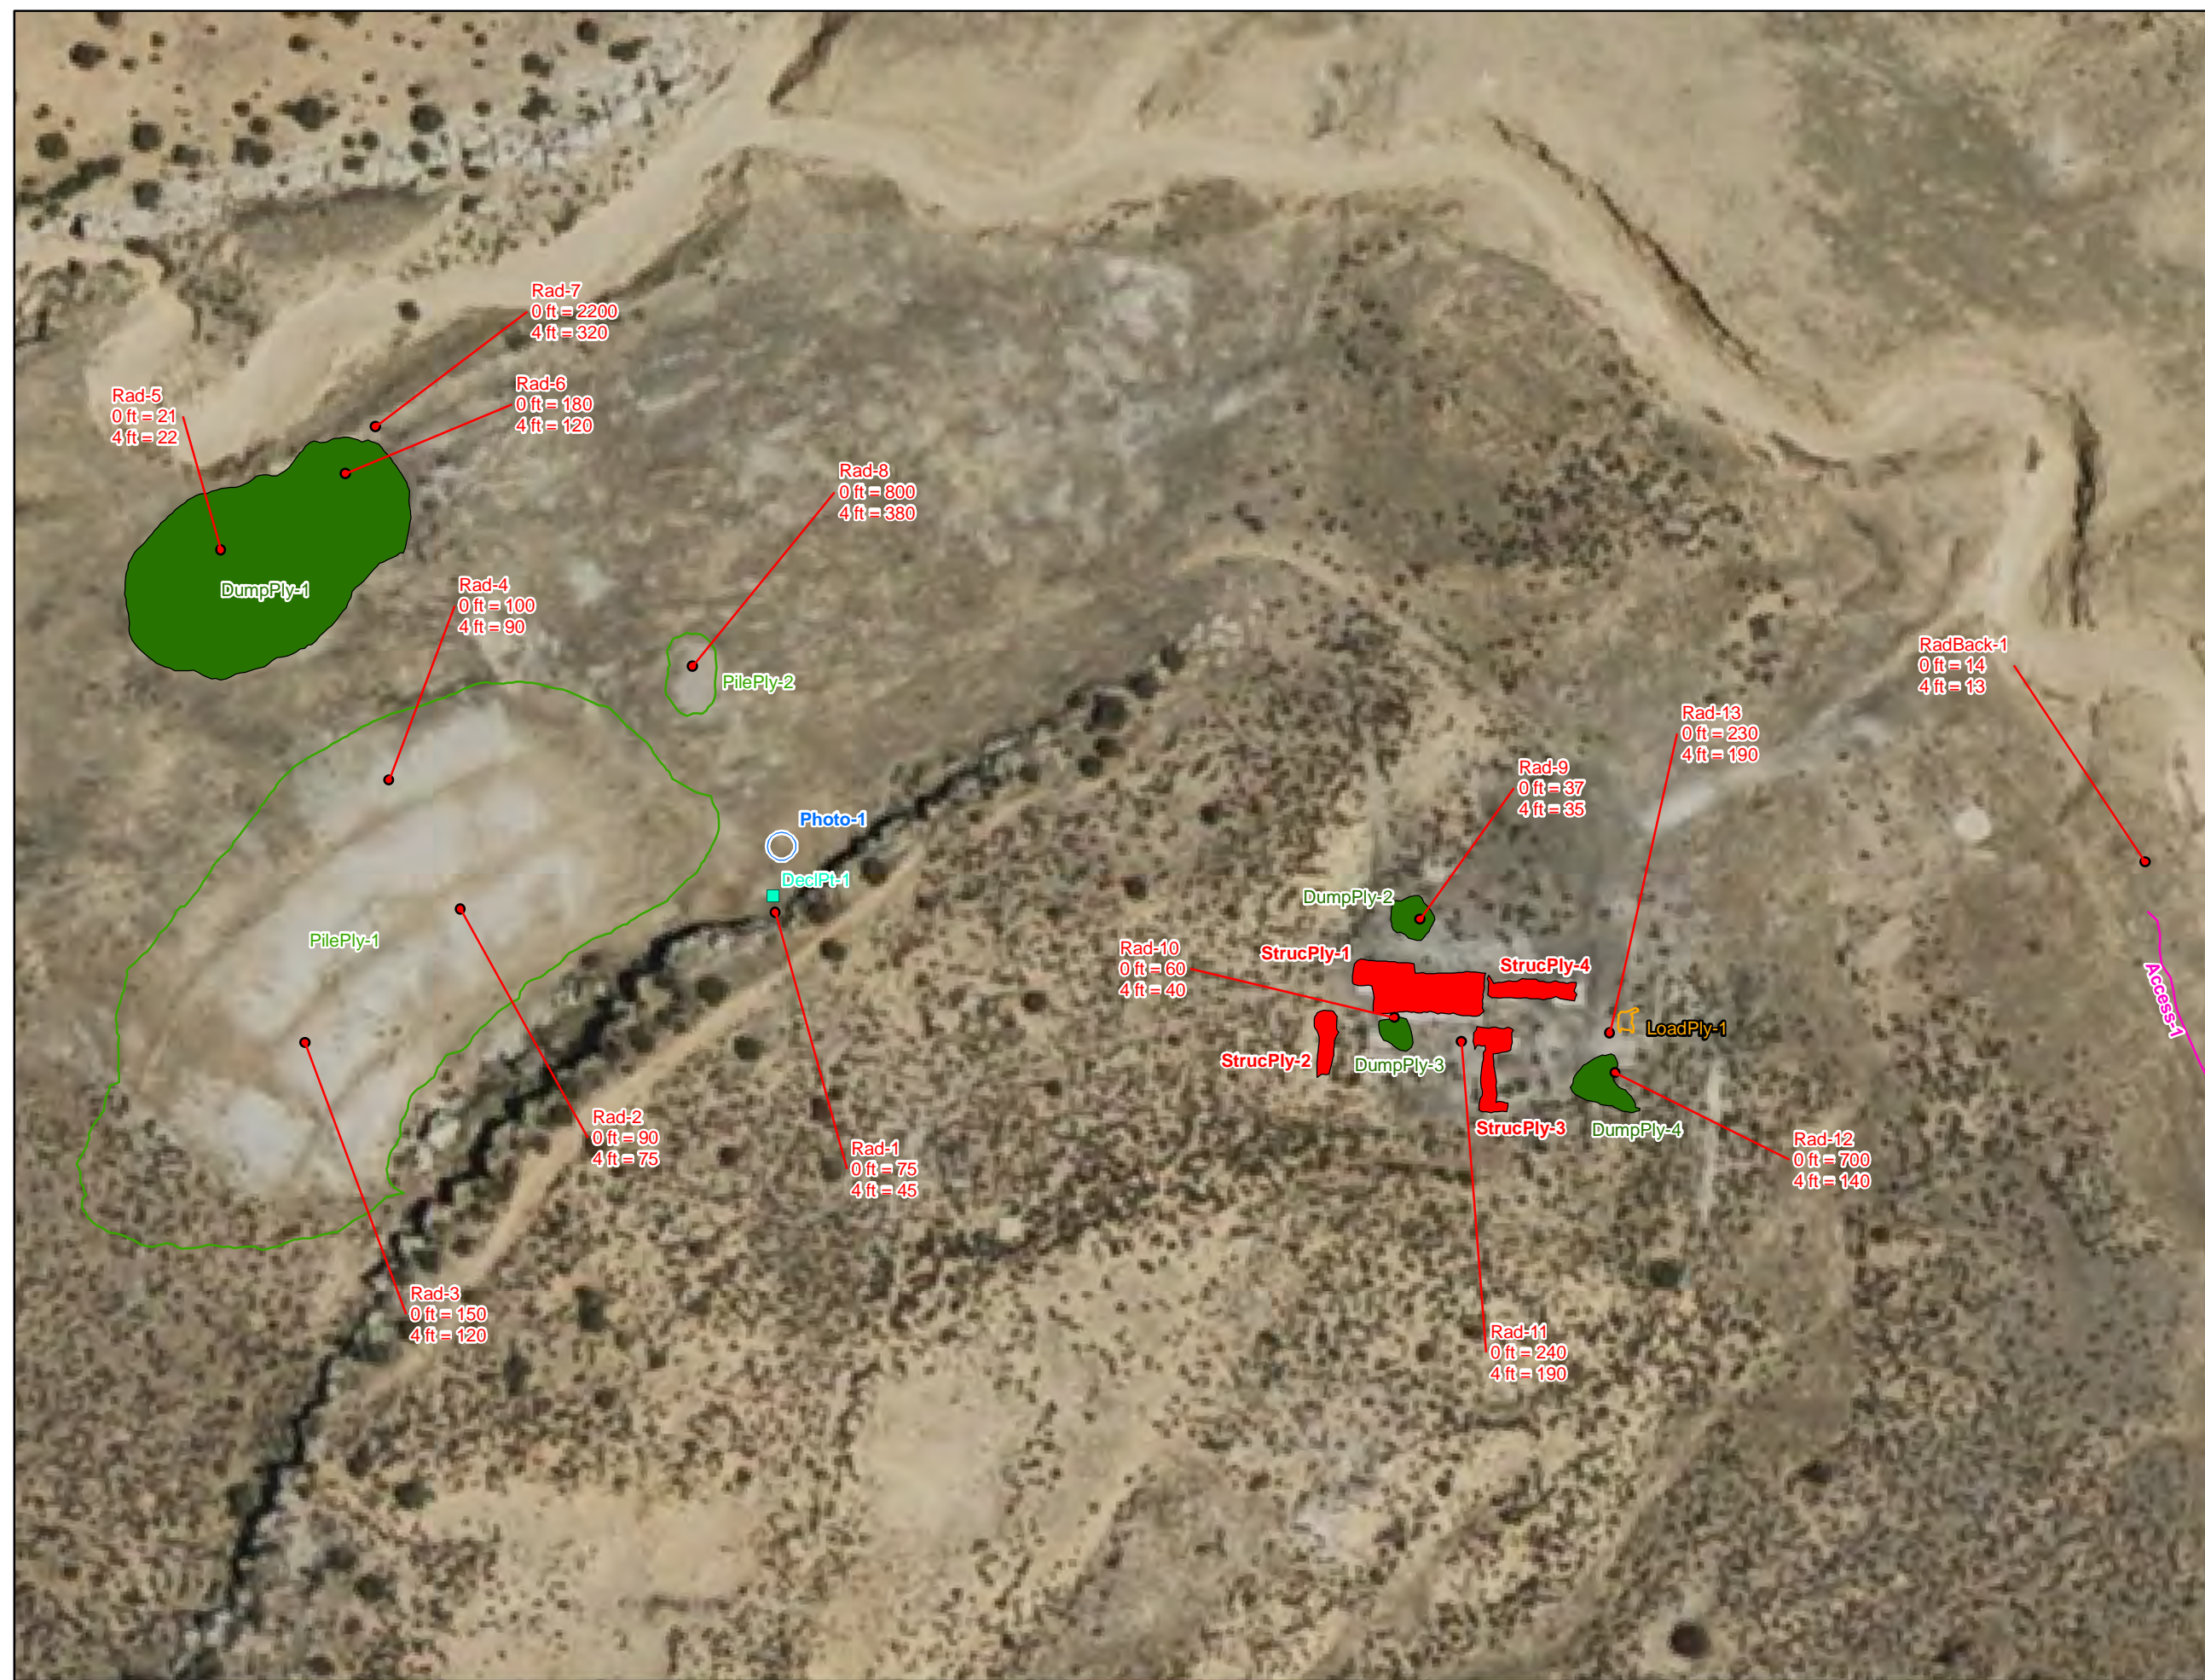
**Figure 4a**  
**Site Map on**  
**Aerial Photo**  
**NM0039-Marquez**  
 Abandoned Uranium  
 Mine Assessment

Two waste piles (PilePly-1 and -2) and four dumps (DumpPly-1, -2, -3, and -4) were found at the AUM Site. The waste piles and one of the dumps were found near the decline and the rest of the dumps were found near the buildings, approximately 600 ft east of DeclPt-1 (see Figures 4a and 4b). The piles consisted of sand and waste rock and were located northwest of the decline. PilePly-1 was the largest waste pile, measuring 20 ft high, 300 ft wide, and 400 ft long. The largest dump area was DumpPly-1, measuring 100 ft wide and 300 ft long and consisting of old timber and metal pipes. DumpPly-2, -3, and -4 consisted of timber, metal, and building materials. The maximum gamma radiation measurement for these features was 800  $\mu\text{R/hr}$  at 0 ft above ground at radiation survey point Rad-8 on PilePly-2 (see Table 2). Other notable gamma radiation measurements for these features was 700  $\mu\text{R/hr}$  at 0 ft above ground at radiation survey point Rad-12 on DumpPly-4 (see Table 2).

The background gamma radiation reading at the AUM Site was measured approximately 450 ft east from the AUM Site recording 14 ( $\mu\text{R/hr}$ ) at 0 ft above the ground surface and 13  $\mu\text{R/hr}$  at 4 ft above the ground surface (see Figures 4a and 4b). The gamma radiation readings taken at the AUM Site are provided in Table 2. Please see Table 2 for all the gamma radiation readings taken at the AUM Site and Figures 4a and 4b for the locations of the radiation readings.

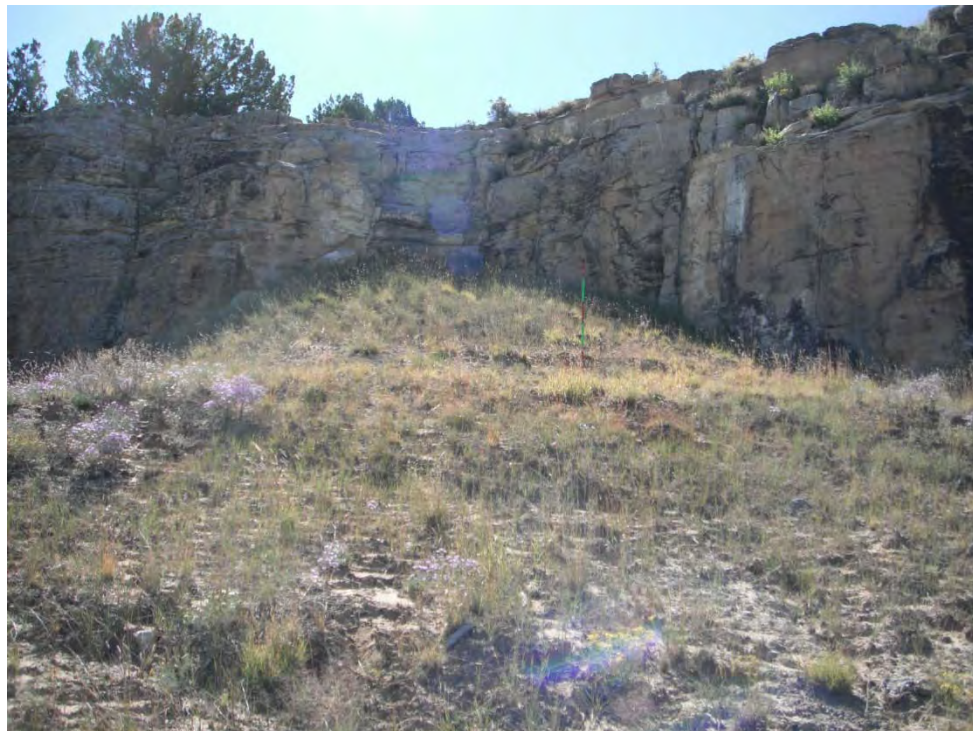
No mine shafts or adits were found at the AUM Site. One decline (DeclPt-1) was found at the location described in the Anderson Report (1980). Since 1980, the decline has been backfilled with soil, the backfill area measures 30 ft high, 30 ft wide, and 40 ft long (see Photo 2 in Appendix A). The maximum gamma radiation measurement for the decline was 75 microroentgens per hour ( $\mu\text{R/hr}$ ) at 0 ft above ground at radiation survey point Rad-1 (see Table 2).

Photo 2- Looking southeast at DeclinePt-1, replicating Anderson photos A and B.

Decline Pt-1 - Location of portal opening, now filled in - backfilled; southeast into Dakota sandstone; 30' tall, 30' wide, 40' long

Reclamation activities occurred at the AUM Site based on MMD files (email, 2010). In 1987 Santa Fe Pacific Gold completed reclamation work at the AUM Site (email, 2010). The decline has been backfilled with soil (see Photo 2 in Appendix A) and the waste pile (PilePly-1) to the west has been re-contoured (see Figures 4a and 4b and see Photos 3-6 in Appendix A). The buildings (StrucPly-1, -2, -3, and -4) mentioned in the Anderson Report are in similar condition as described in the Anderson Report (1980).

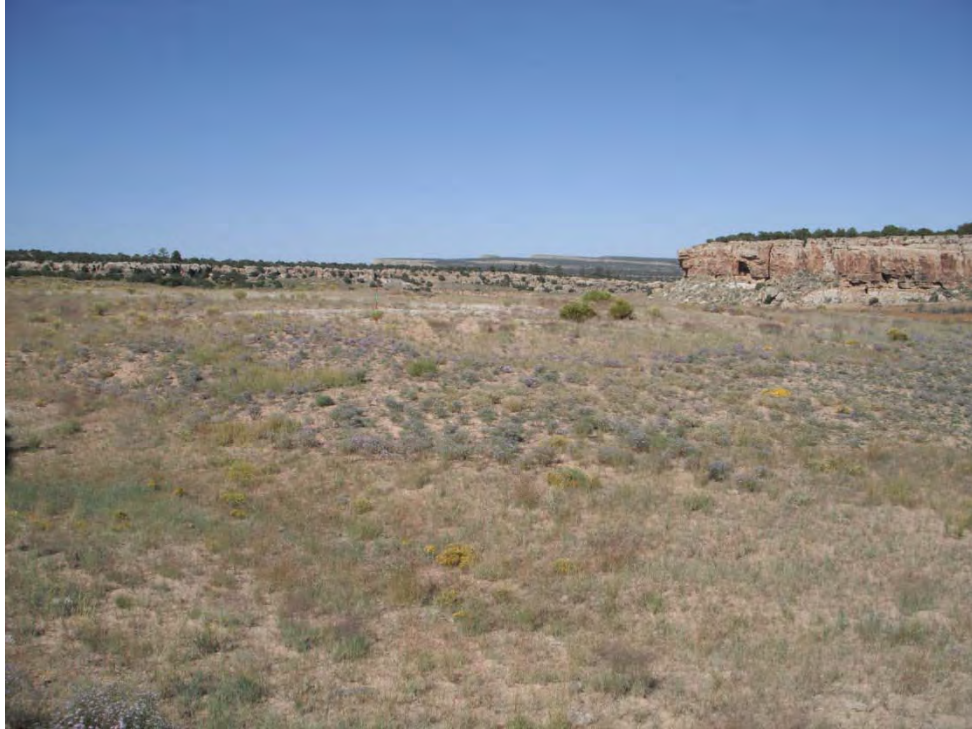
Photo 3- Looking west at PilePly-1, replicating Anderson photo C. Note that the pile has been recontoured.

Pile Ply-1 - 20' high; 300' wide; 400' long 10° slope; sand and waste rock

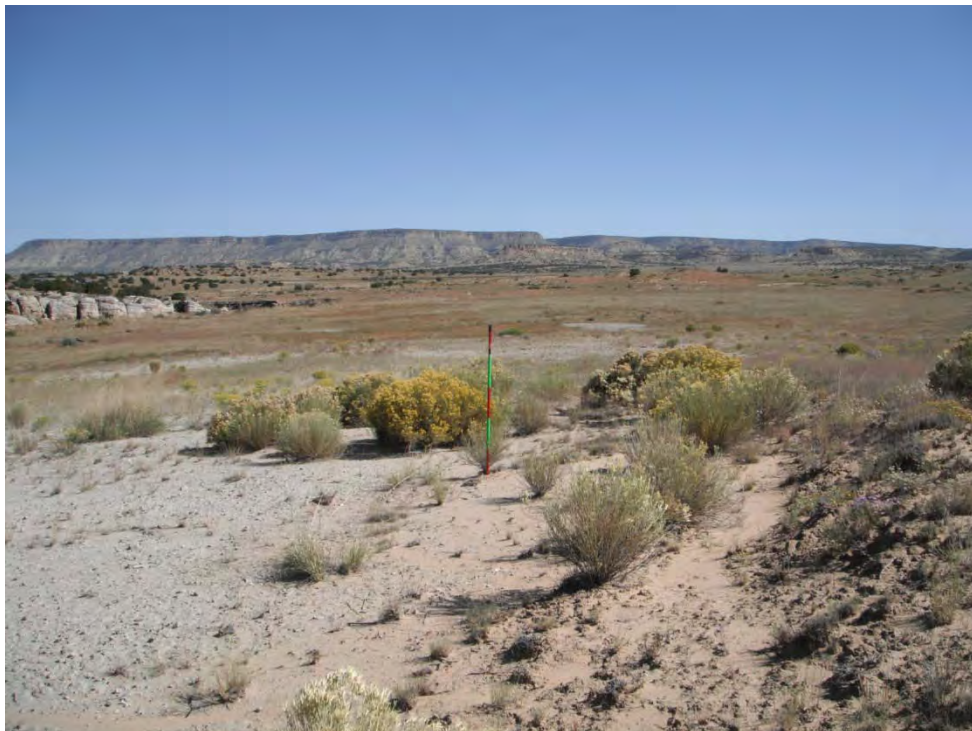
Photo 4-Looking northeast at PilePly-1, replicating Anderson photo D. Note that the pile has been recontoured.

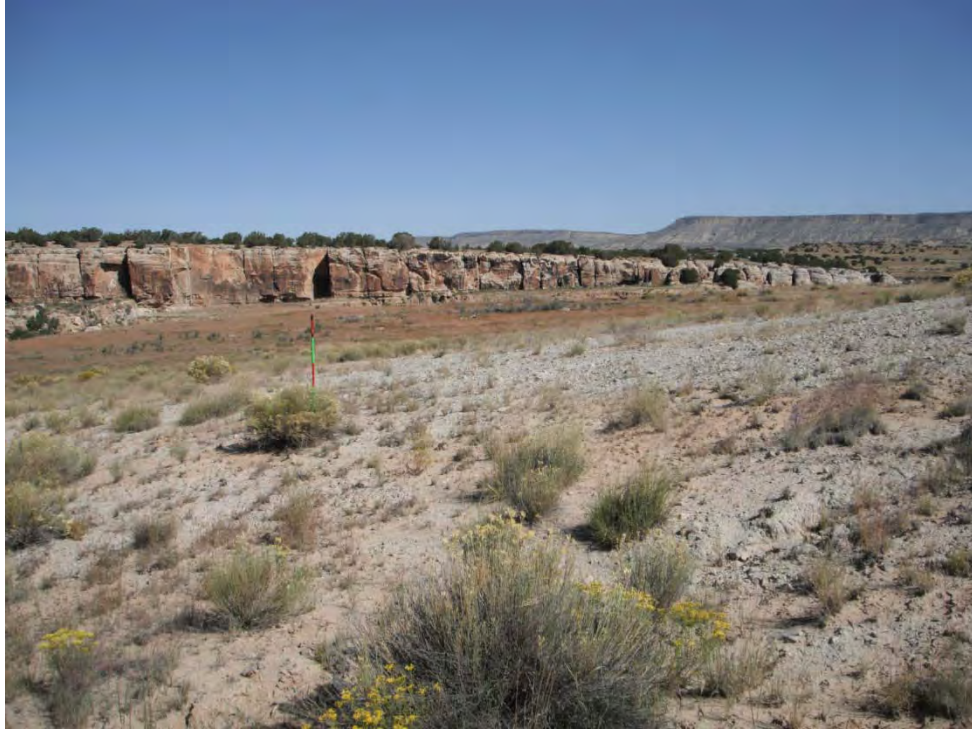
Photo 5-Looking north at west end of PilePly-1, replicating Anderson photo E. Note that the pile has been recontoured.

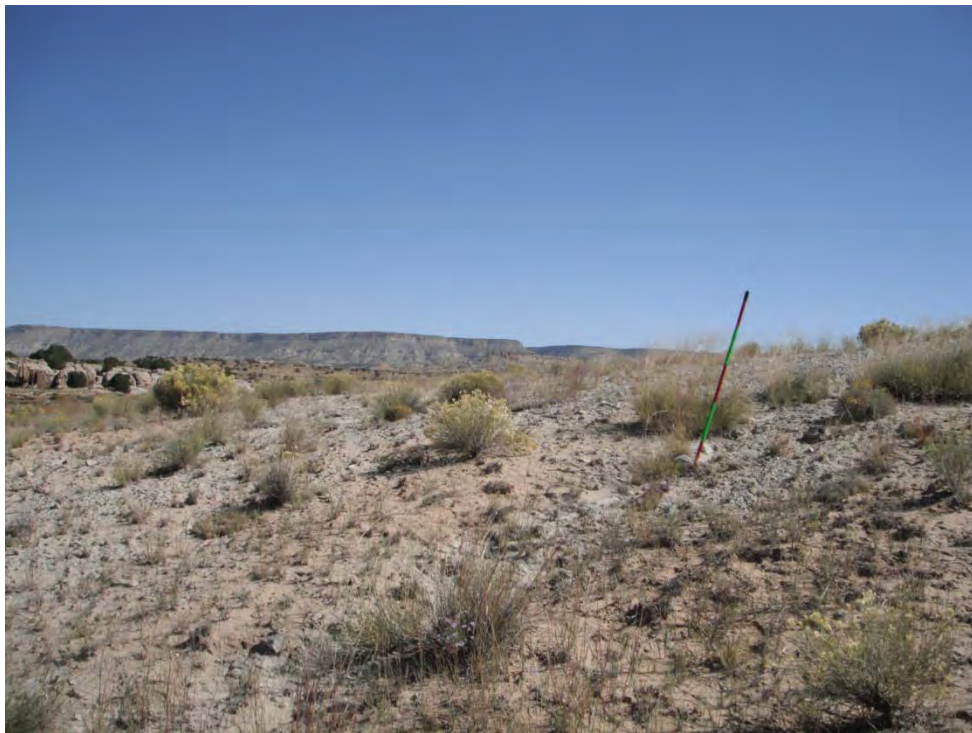
Photo 6-Looking east at PilePly-1, replicating Anderson photo F. Note that the pile has been recontoured.

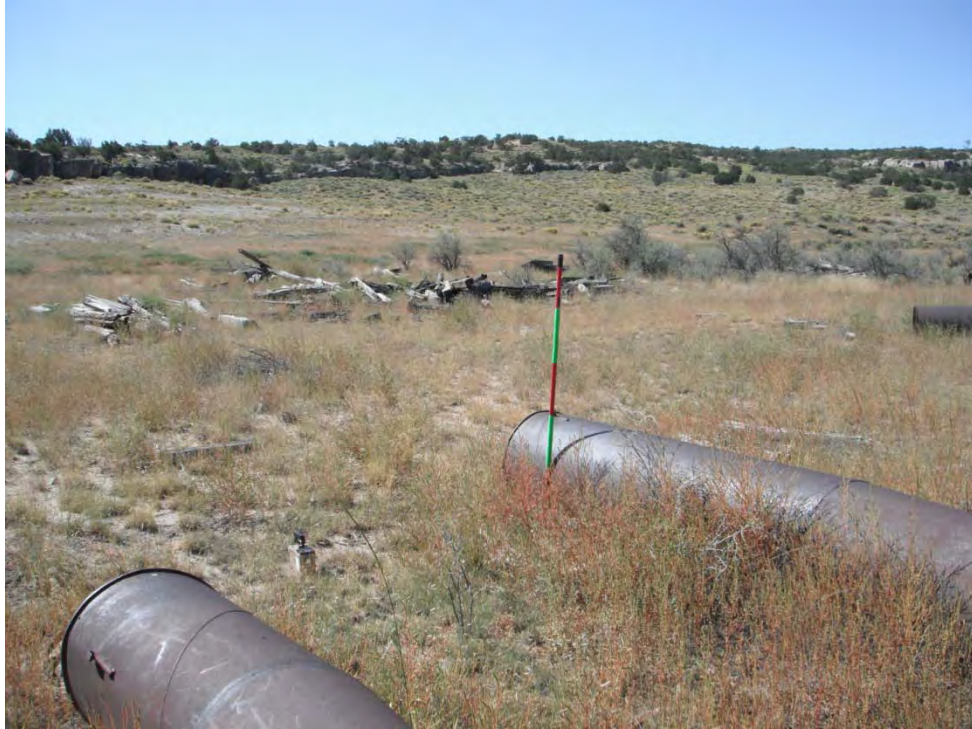
Photo 7-Looking south from DumpPly-1.

DumpPly-1 - wood timbers, metal pipes and tubes; 100' x 300'

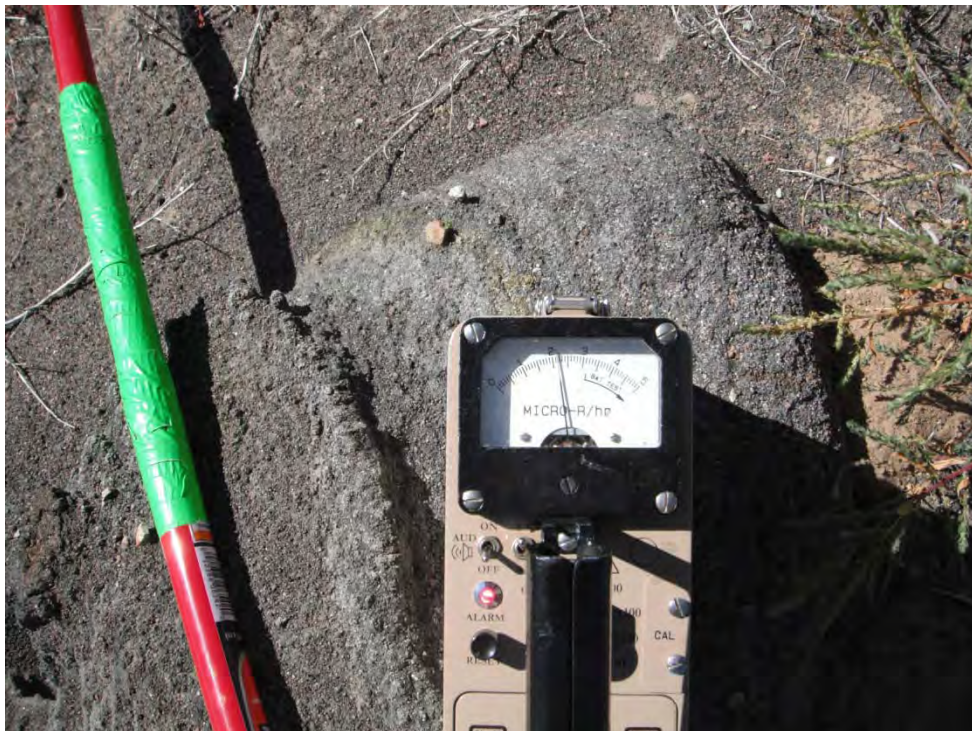
The gamma radiation readings throughout the AUM Site varied significantly (see Table 2). The maximum readings were recorded on isolated ore material, black rock with yellow banding, and were measured at 2200  $\mu\text{R/hr}$  at 0 ft above ground surface and 320  $\mu\text{R/hr}$  at 4 feet above ground surface at radiation survey point Rad-7 (see Photos 8 and 9 in Appendix A and Table 2). A gamma radiation reading taken at PilePly-2 (radiation survey point Rad-8) recorded 800  $\mu\text{R/hr}$  at 0 ft above ground and a gamma radiation measurement taken at DumpPly-4 (radiation survey point Rad-12) recorded 700  $\mu\text{R/hr}$  at 0 ft above ground.

Photo 8-Looking south at Rad-7. High radiation levels were concentrated near the yellowish band in this black ore material.

Rad 7 - near DumpPly-1; 0m - 2200 uR/h; 1m - 320 uR/h

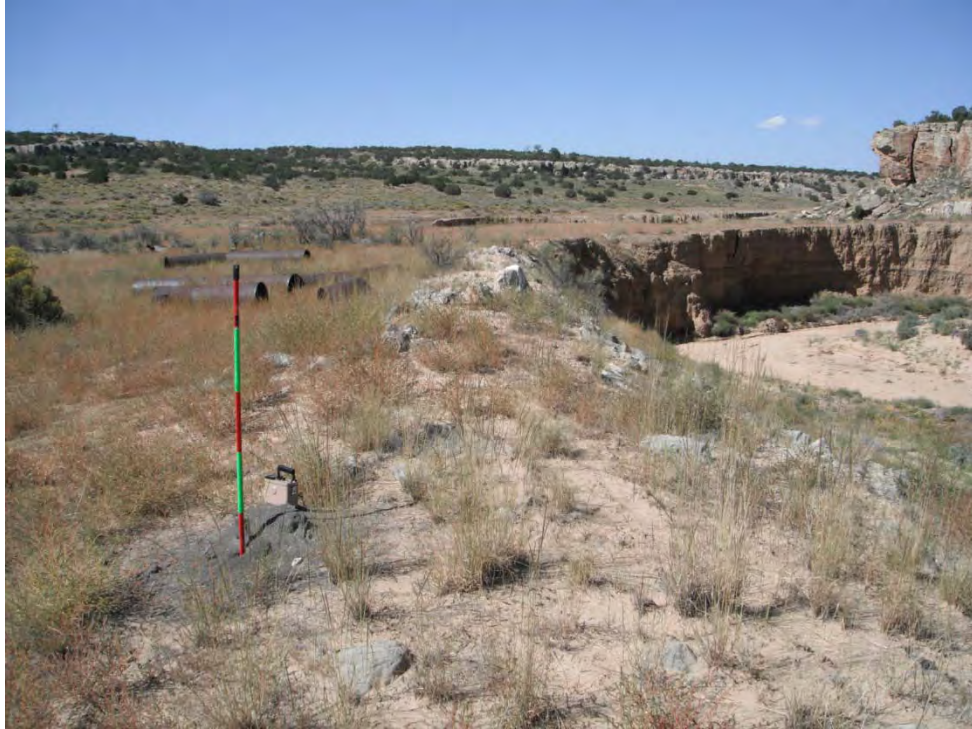
Photo 9-Looking west at Rad-7, replicating Anderson photo H, San Mateo Creek to the north.

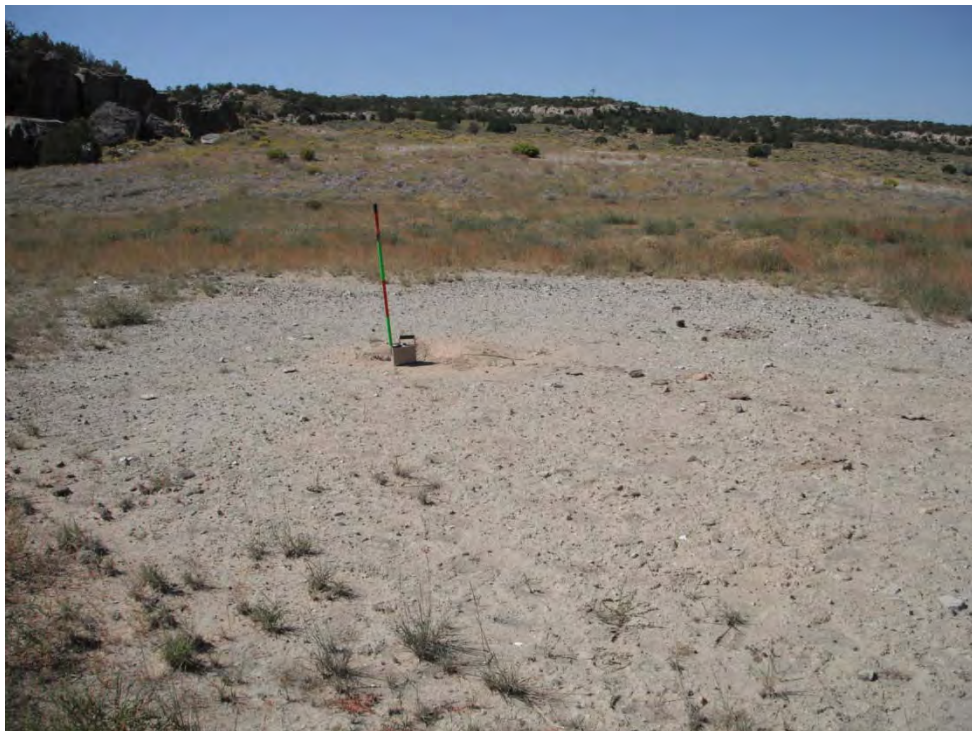
Photo 10-Looking west at PilePly-2.

PilePly-2 - small pile east of PilePly-1; 1' tall, 25' wide, 50' long  
5° slope

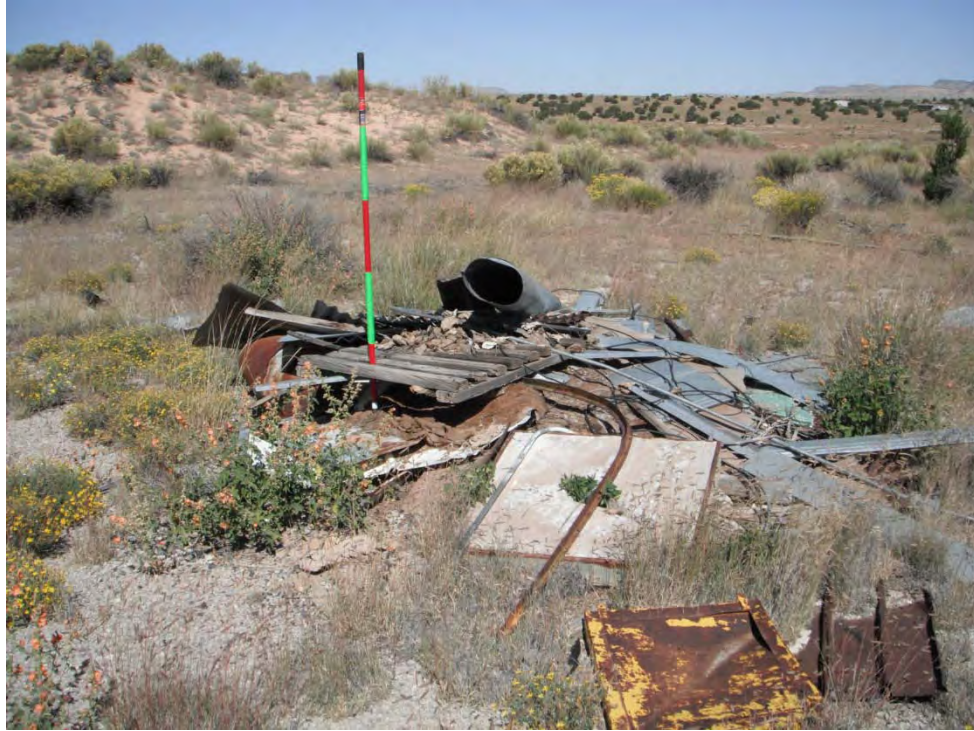
Photo 11-Looking north at DumpPly-2.

DumpPly-2 - wood, metal; appears recent; 1' tall; 15' wide, 20' long  
construction debris

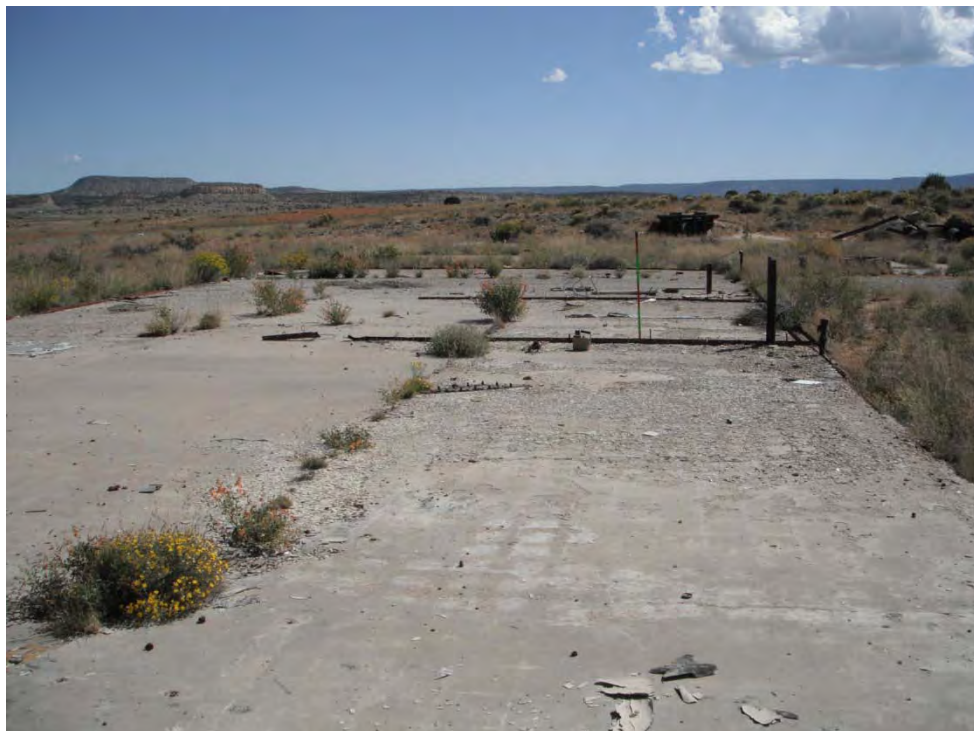
Four mine-related concrete foundations and one load out were found at the AUM Site. StrucPly-1 was the largest of the concrete foundations measuring 30 ft wide by 80 ft long (see Photo 12 in Appendix A). StrucPly-2 consisted a concrete foundation and a raised wooden deck, measuring 15 ft wide by 40 ft long (see Photo 14 in Appendix A). StrucPly-4 is a concrete foundation located in the east corner of the other foundations. Metal equipment and pipes are located on the east end of StrucPly-4 (see Photo 16 in Appendix A). The maximum gamma radiation measurement taken near these features was 240  $\mu\text{R/hr}$  at 0 ft above ground at radiation survey point Rad-11 near StructPly-3 (see Figures 4a and 4b).

Photo 12-Looking east at StructPly-1.

StructPly-1 - foundation, cement; 0' tall, 30' wide, 80' long

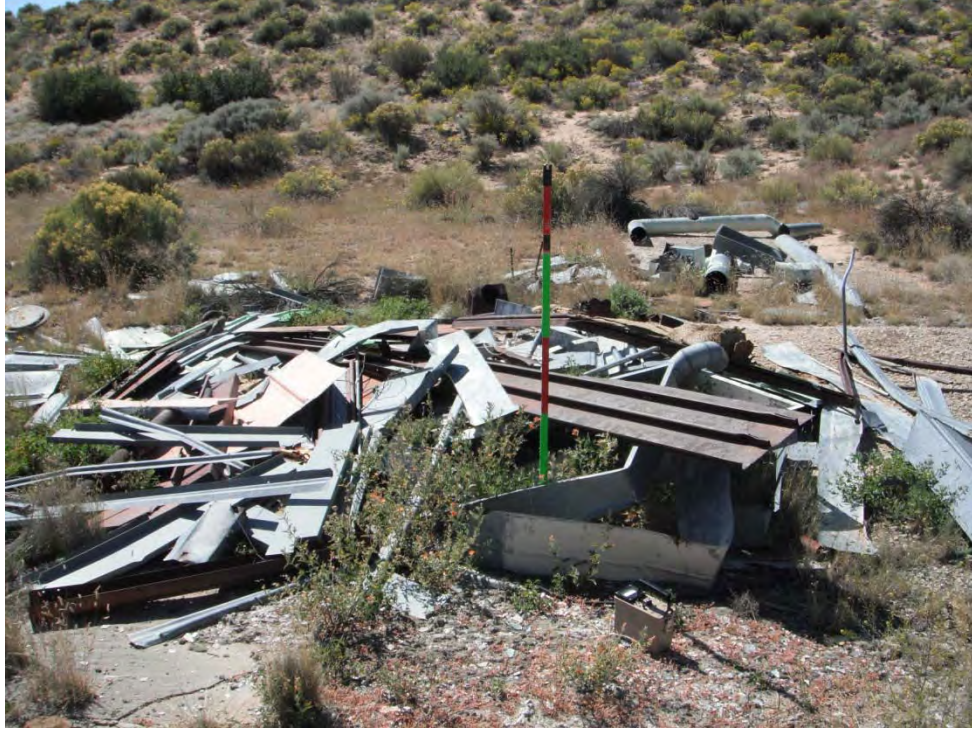
Photo 13-Looking south at DumpPly-3.

DumpPly-3 - construction debris, wood, metal, plastic  
2' tall, 10' wide, 15' long

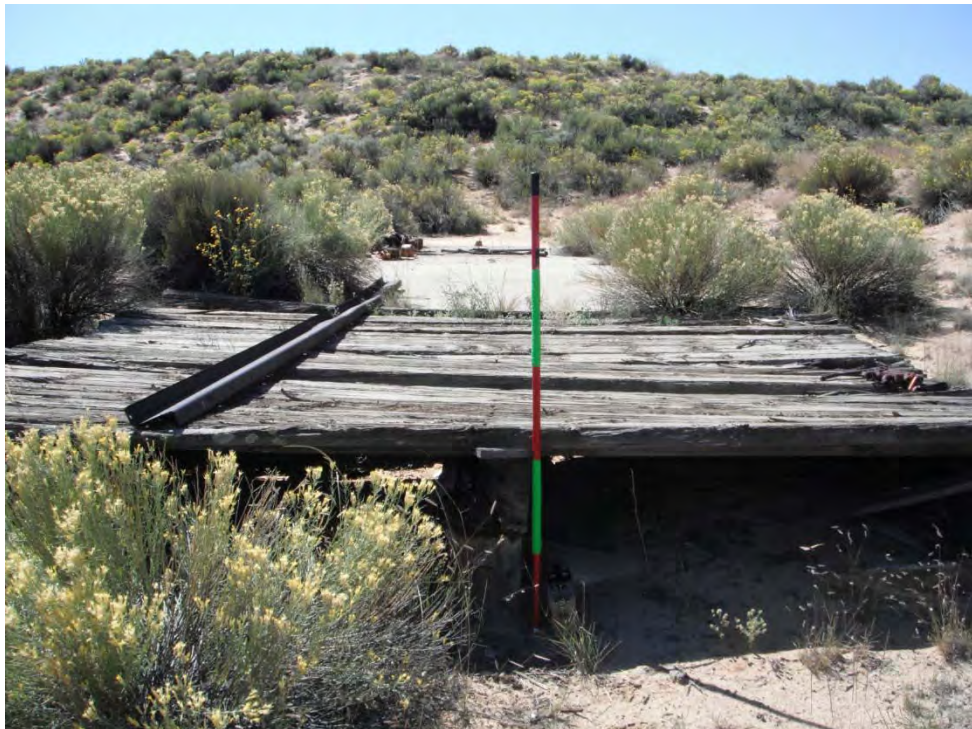
Photo 14-Looking south at StructPly-2.

StructPly-2 - cement foundation and wood ~~load~~  
2' high, 15' wide, 40' long

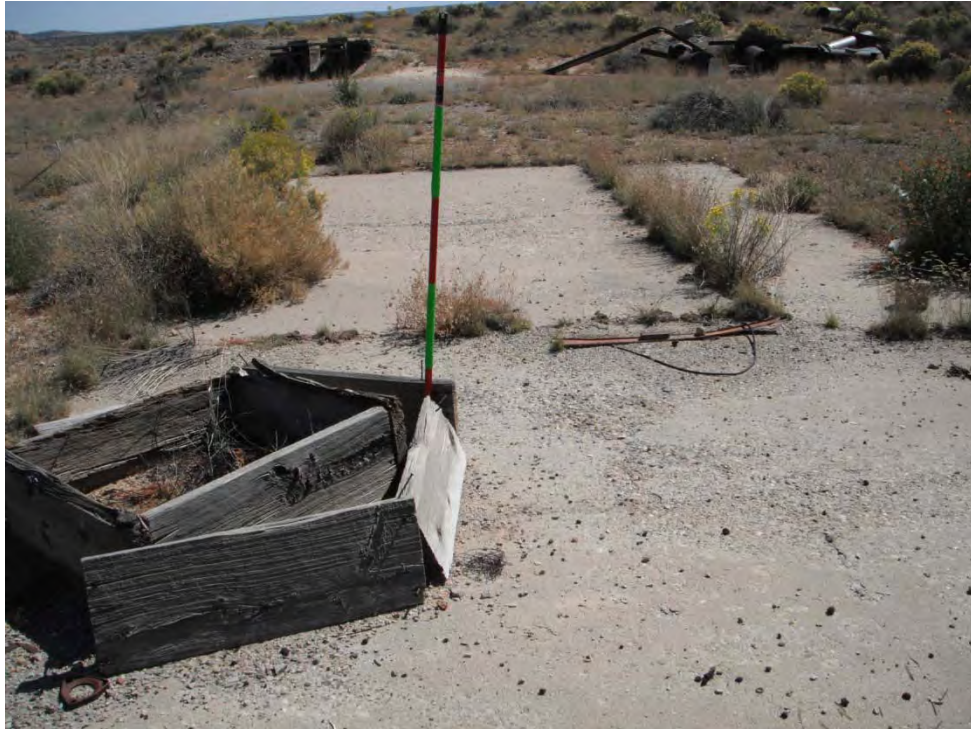
Photo 15-Looking east at StructPly-3.

StructPly-3 - cement foundation; 0' tall, ~~20~~ 20' wide, 80' long

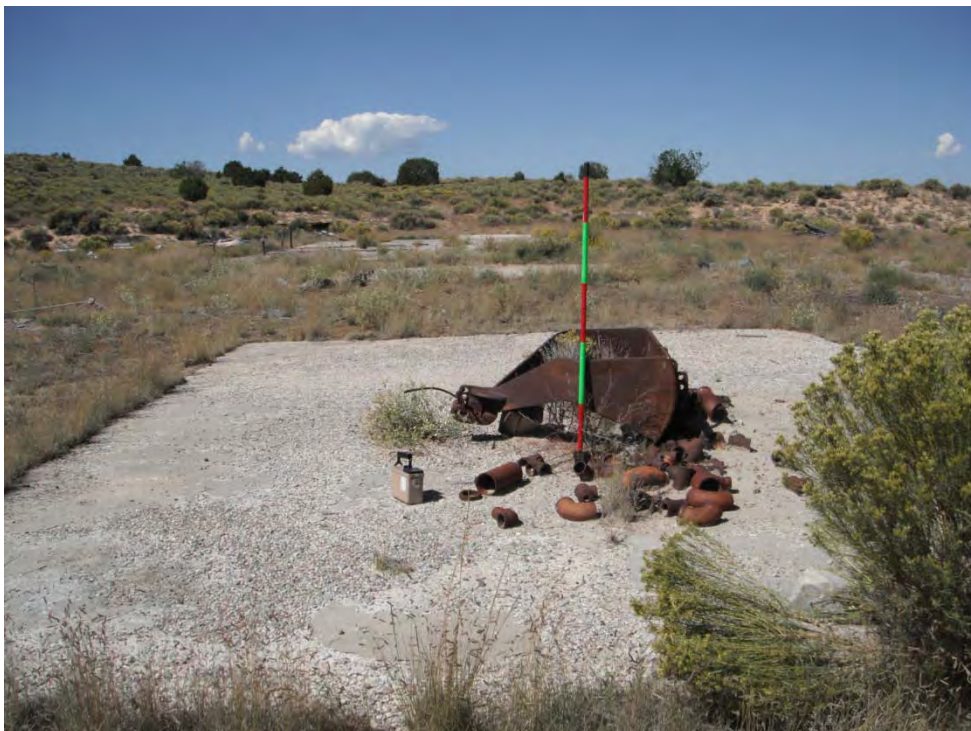
Photo 16-Looking west at StructPly-4.

StructPly-4 - cement foundation; 0' tall; 20' wide, 80' long

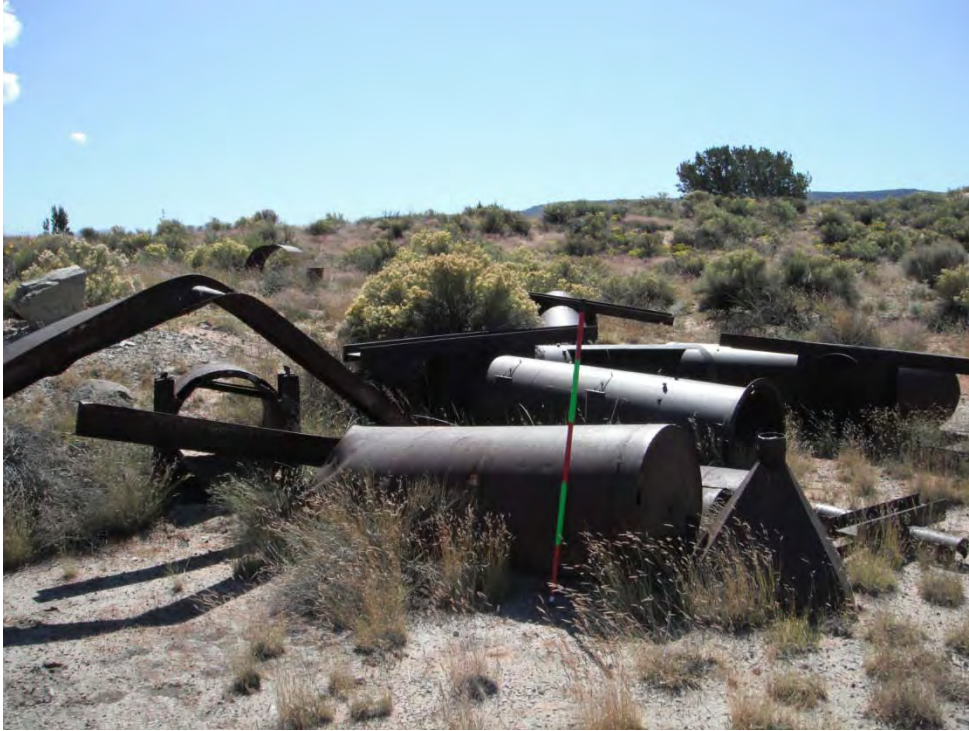
Photo 17-Looking south at DumpPly-4.

DumpPly-4 - metal; 26' wide, 50' long, 3' tall

Rad 12 - DumpPly-4, black rock; 0m - 700 uR/h; 1m - 140 uR/h

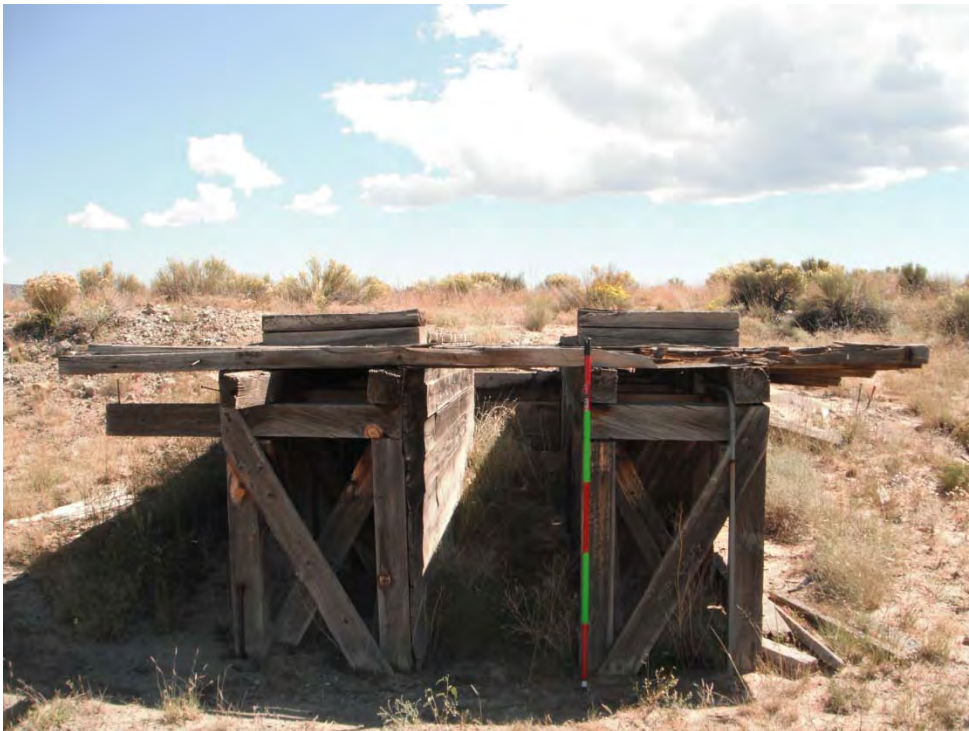
One loadout (LoadPly-1) was found at the AUM Site. LoadPly-1 was located approximately 50 ft east of the concrete foundations (see Figures 4a and 4b). LoadPly-1 was constructed of wood and measured 5 ft tall, 10 ft wide, and 20 ft long (see Photo 19 in Appendix A). The maximum gamma radiation measurement for this feature was 230  $\mu\text{R/hr}$  at 0 ft above ground at radiation survey point Rad-13 (see Table 2).

Photo 18-Looking east at LoadPly-1.

Loadout-1 - wood, 5' tall, 10' wide, 20' long
