# Abandoned Uranium Mine Assessment for the J.O.L. Site (NM0178)

**FINAL REPORT**

INTERA Incorporated (INTERA) has prepared this Abandoned Uranium Mine (AUM) Site Assessment Report for the Mining and Minerals Division (MMD) of the New Mexico Energy, Minerals and Natural Resources Department (EMNRD) in compliance with the Professional Service Agreement dated November 2, 2009. INTERA visited the J.O.L. Site (AUM Site), MMD ID: NM0178 on September 01, 2010.

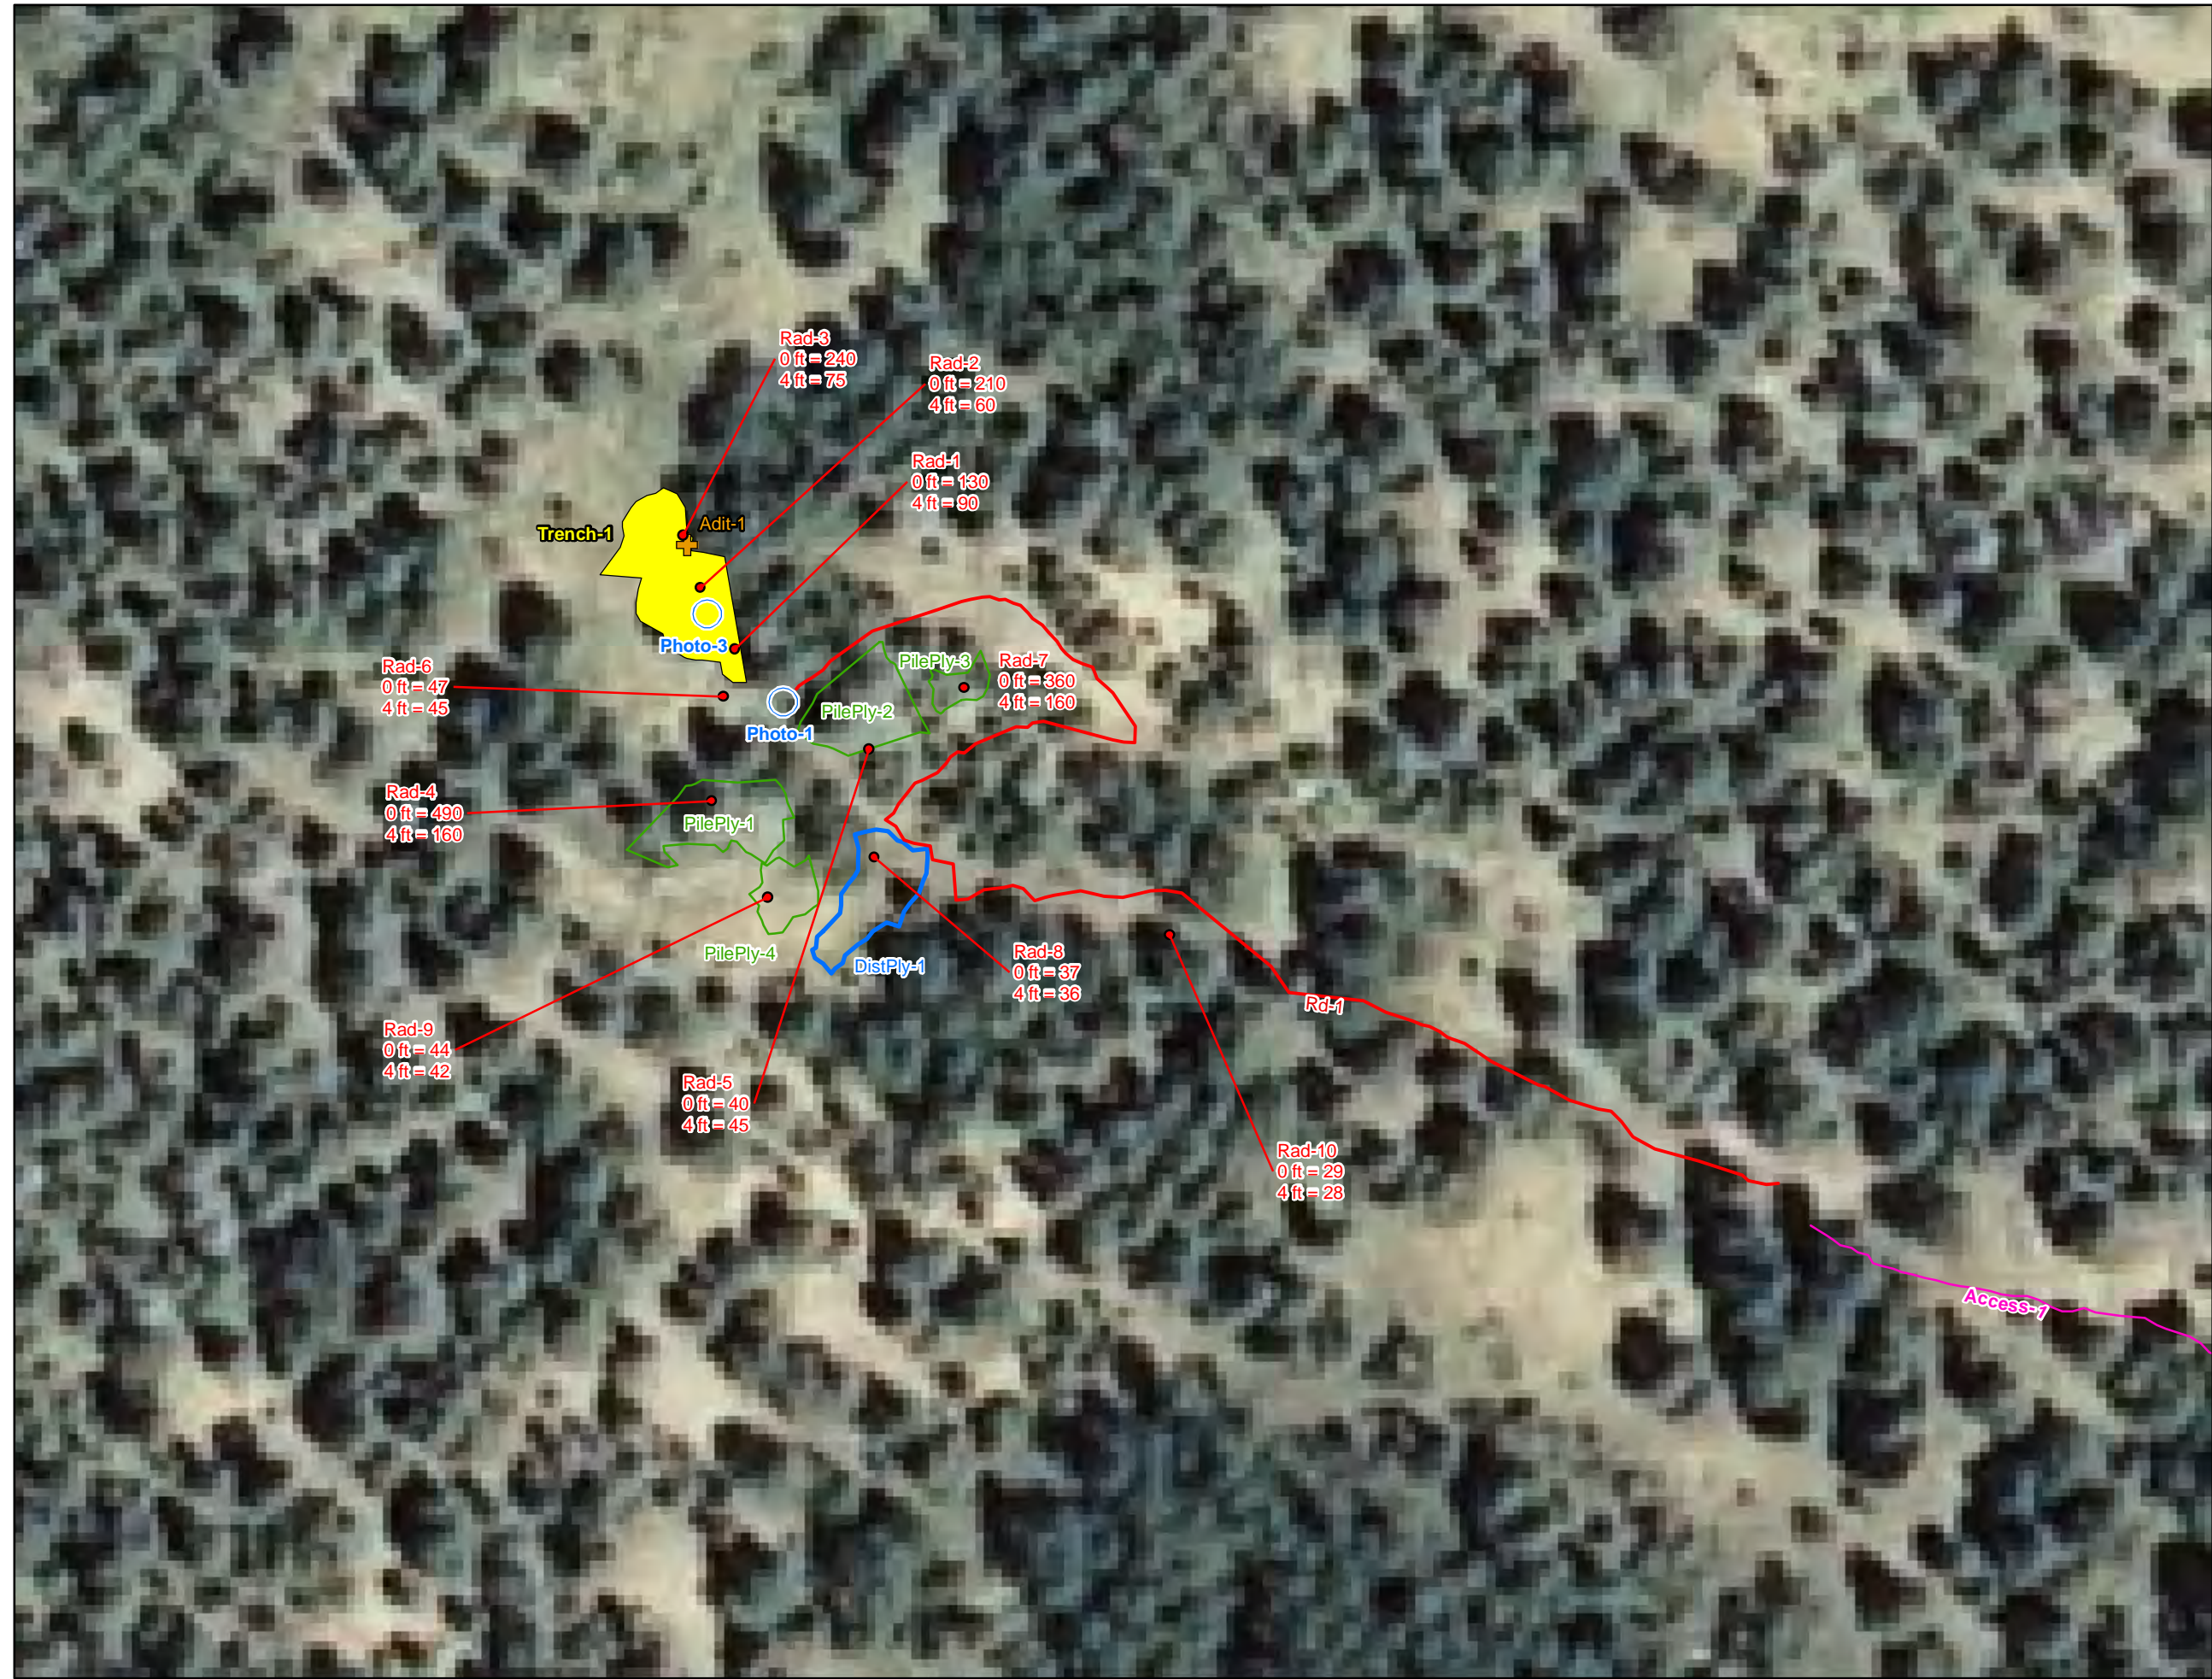
**Figure 4a**  
**Site Map on**  
**Aerial Photo**  
**NM0178-J.O.L.**  
 Abandoned Uranium  
 Mine Assessment

The mine features described below are based on the features provided to INTERA by MMD in the GIS Data Dictionary (MMD, 2009). INTERA marked the locations of the AUM Site features using a Trimble Global Positioning System (GPS), and entered details about the features into the GPS using the MMD data dictionary. One adit, four waste piles, one trench and one disturbed area were found onsite. Please see the Photo Log in Appendix A for photos of the AUM Site features, Table 1 for a list of the AUM Site features, and Figures 4a and 4b for the locations of the AUM Site features.

A mine road (Rd-1) exists at the AUM Site. This road extends from Adit-1 and Trench-1 at its northern end and connects to Access-1 approximately 500 feet to the southeast. PilePly-2 and -3 and DistPly-1 are located along this road (see Figures 4a and 4b).

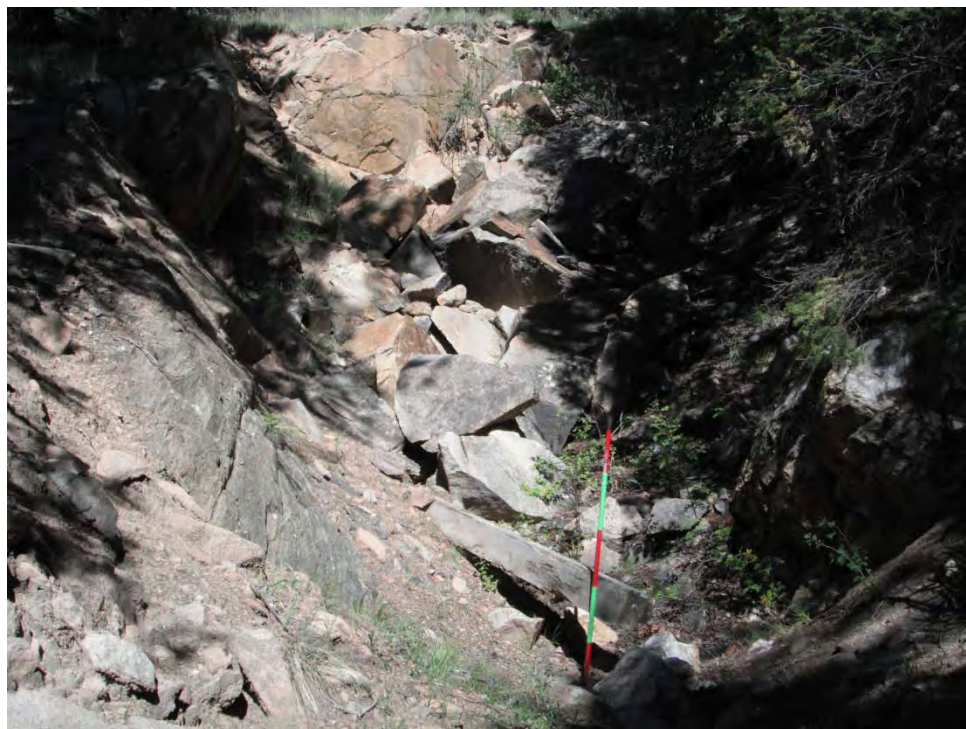
One trench (Trench-1) was found at the AUM Site. The adit (Adit-1) was found at the back of Trench-1. The trench is filled with large boulders of igneous and metamorphic rock (See photos 2 and 4 in Appendix A). The maximum gamma radiation measurement for this feature was 210  $\mu\text{R/hr}$  at 0 ft above ground at radiation survey point Rad-2 (see Table 2).

Photo 2-Looking north at Trench-1.

Trench 1 - 20' deep, 50' long, 20' wide; collapsed adit in northern end.

Photo 2 - Trench 1 looking north

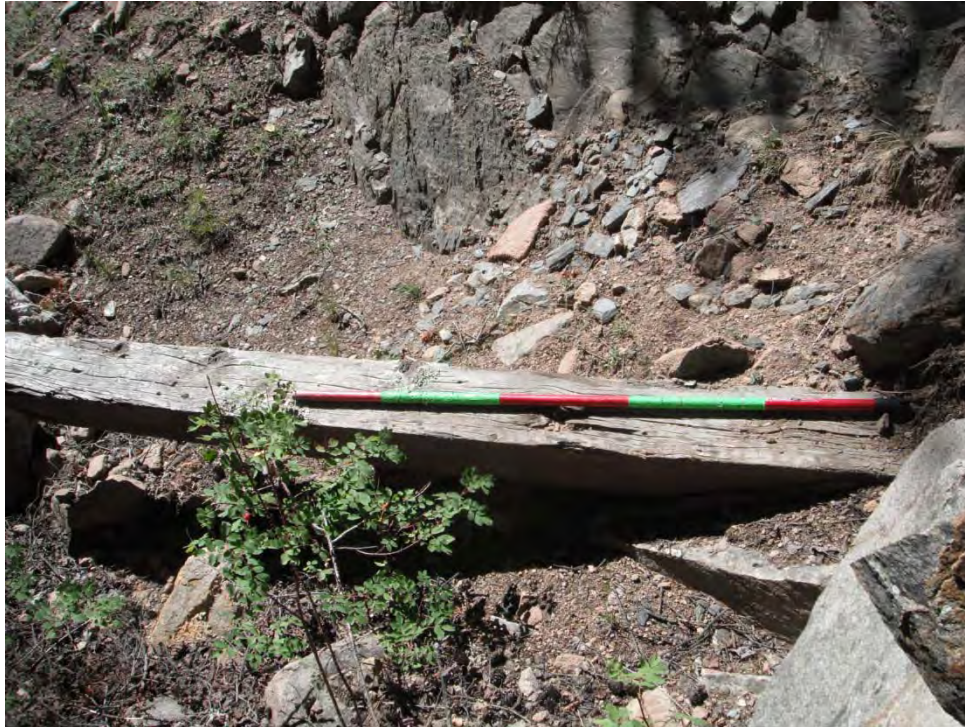
One collapsed adit (Adit-1) was found on site. Gamma radiation at the adit was measured to be 240  $\mu\text{R/hr}$  (microroentgens per hour) at 0 ft above ground and 75  $\mu\text{R/hr}$  at 4 ft above ground at radiation survey point Rad-3 (see Table 2). Timber that may have been associated with the adit was found nearby (See Photo 3 and 4 in Appendix A).

Photo 3-Timber in Trench-1.

Photo 3 - timber in trench 1, possible headframe for Adit 1

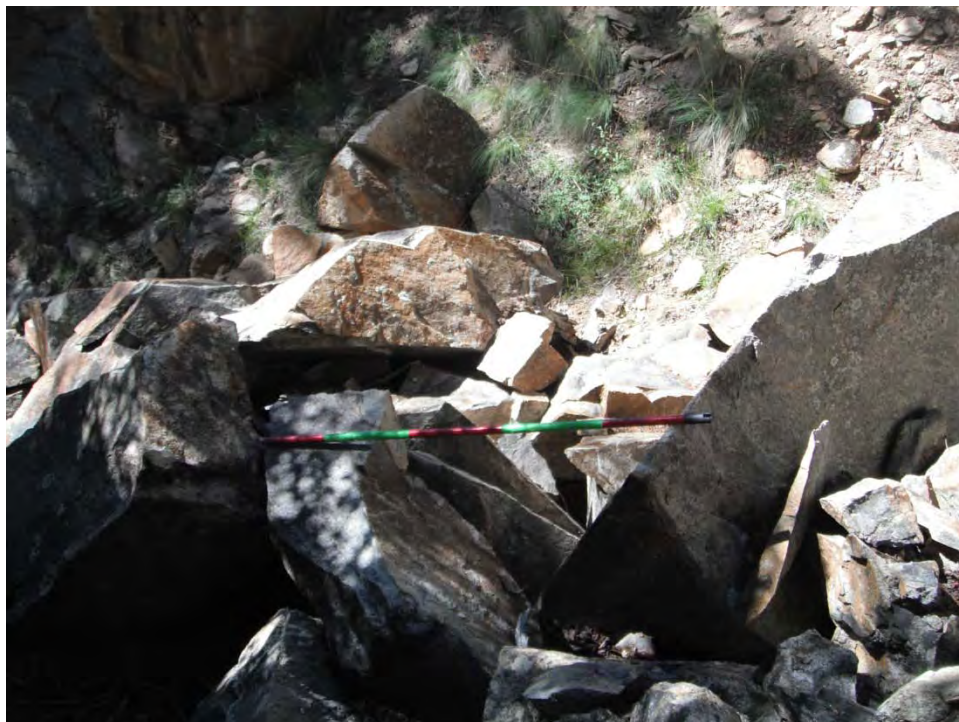
Photo 4-Looking southwest at Adit-1.

Adit 1, north end of Trench 1; collapsed

Photo 4 - collapsed Adit 1, looking southwest

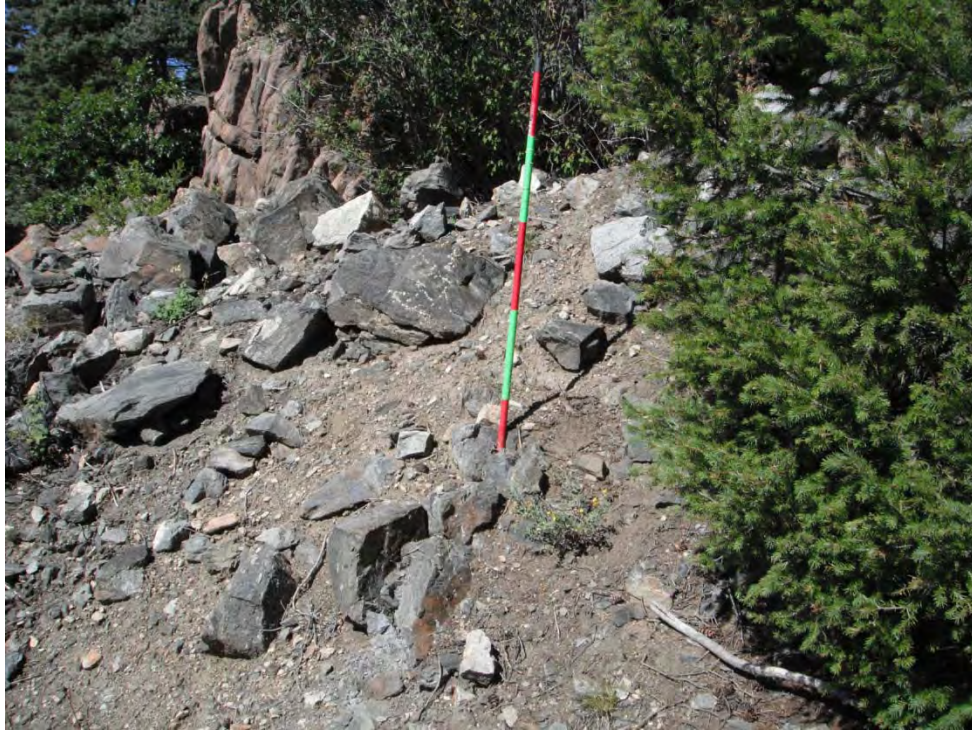
Four waste piles (PilePly-1, -2, -3, and -4) and one disturbed area (DistPly-1) were found onsite. PilePly-1, -2, and -3 consisted of excavated waste rock. The largest of these was PilePly-1, located down slope from Adit-1. It is approximately 3 ft tall and 30 ft by 30 ft. PilePly-4, located down slope from the other features, appeared to consist mainly of topsoil bulldozed from the adjacent DistPly-1. DistPly is approximately 40 ft wide by 50 ft long. The maximum gamma radiation measurement for these features was 490  $\mu\text{R/hr}$  at 0 ft above ground at radiation survey point Rad-4 on PilePly-1 (see Table 2).

Photo 5-Looking west at PilePly-1.

Pile Ply 1; 3' tall, 30' x 30', 45° slope, waste rock falling down hill slope

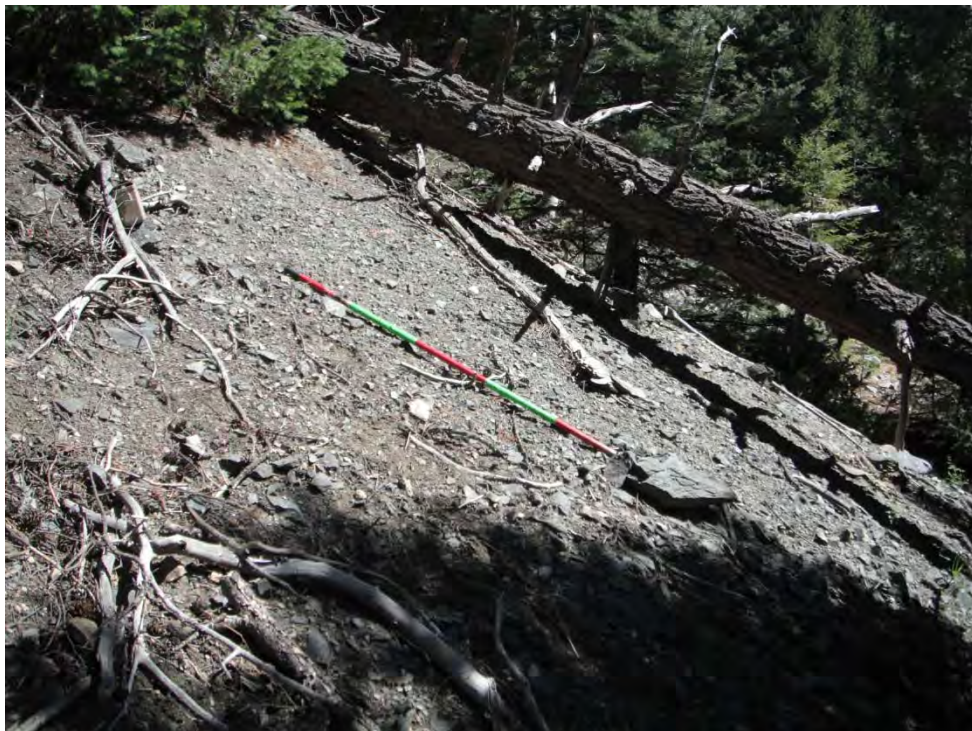
Photo 6-Looking east at PilePly-2.

Pile Ply 2 - 1' tall, 20' wide, 25' long, 45° slope, waste rock spreading down hill slope

Photo 6 - Pile Ply 2 looking east

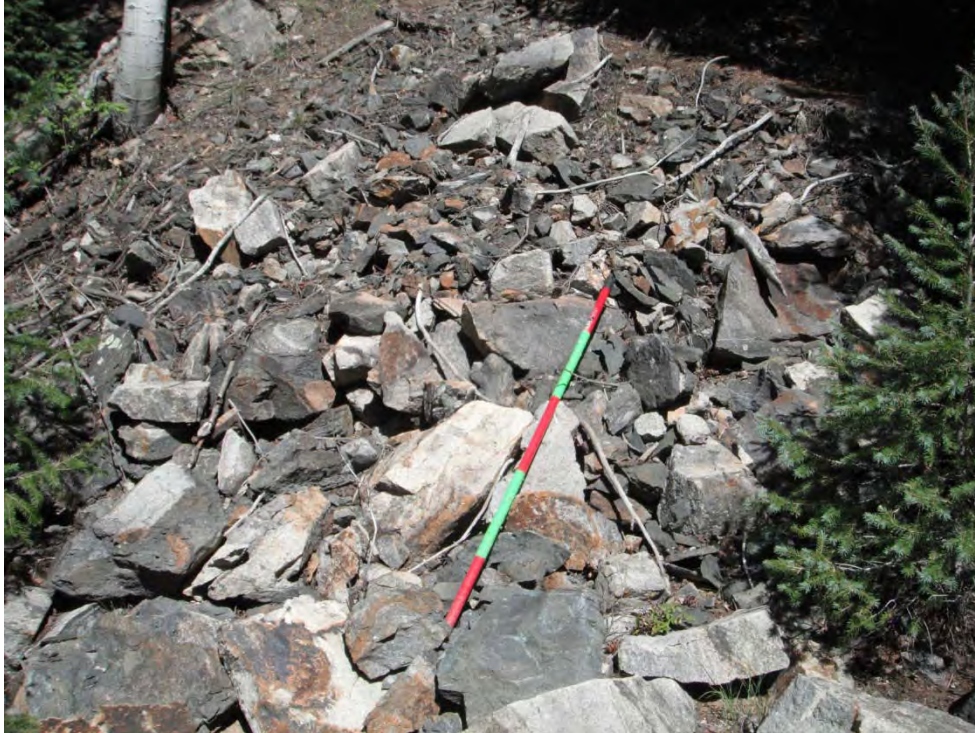
Photo 7-Looking north at PilePly-3.

Pile Ply 3 - 1' tall, 10' wide, 15' long, 35°

Photo 7 - Pile Ply 3 looking north

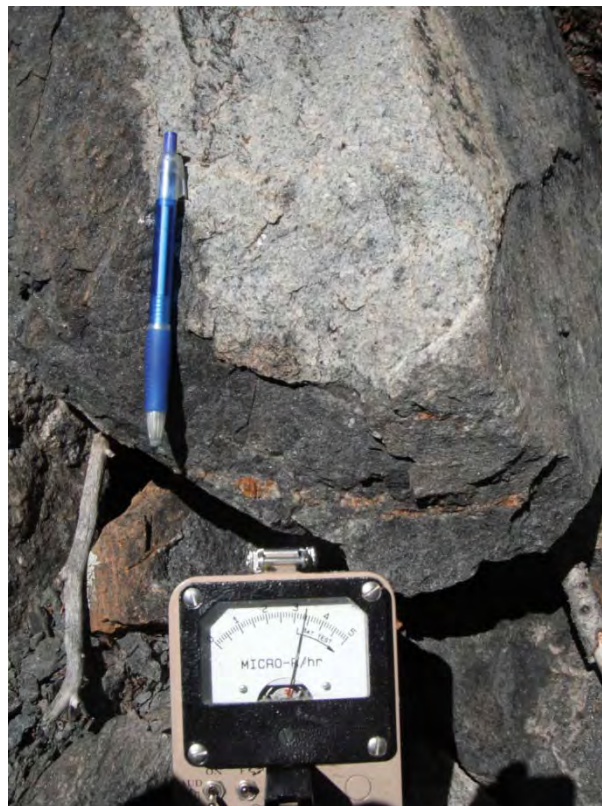
The maximum gamma radiation measured on site was 490  $\mu\text{R/hr}$  at 0 ft above ground and 160  $\mu\text{R/hr}$  at 4 ft above ground at radiation survey point Rad-4 at PilePly-1. A gamma radiation measurement taken at PilePly-3 (radiation survey point Rad-7, see Photo 8 in Appendix A) recorded 360  $\mu\text{R/hr}$  at 0 ft above ground and a gamma radiation measurement taken at Adit-1 (radiation survey point Rad-3) recorded 240  $\mu\text{R/hr}$  at 0 ft above ground.

Photo 8-At Rad-7 looking west.

Rad 7 - Pile Ply 3; 0m - 360 uR/h; 1m - 160 uR/h

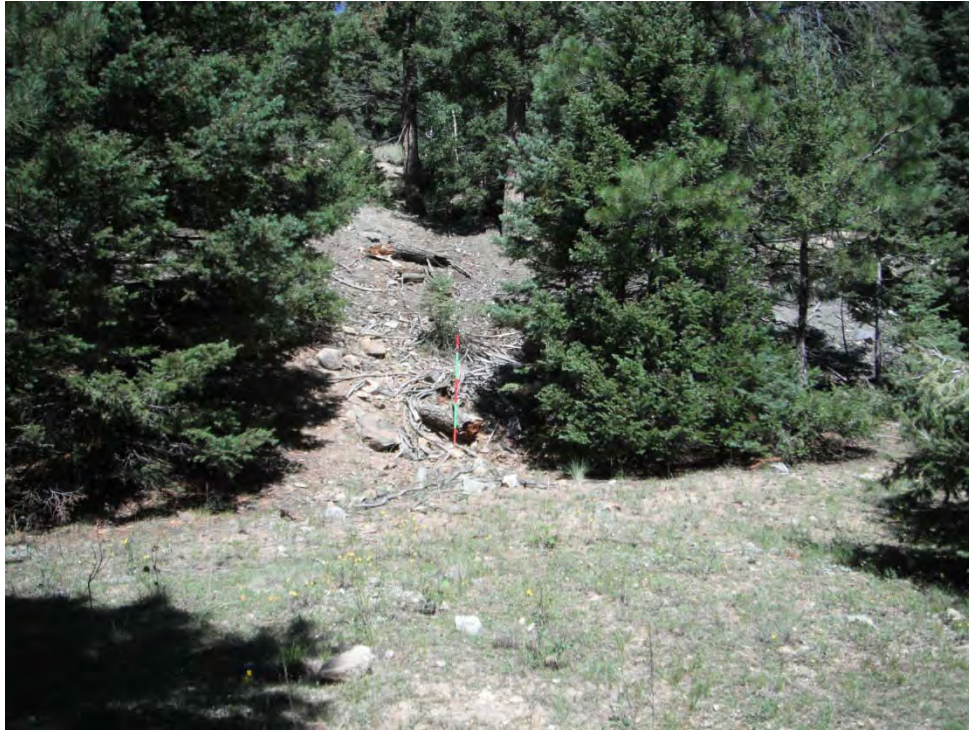
Photo 9-Looking north at DistPly-1, replicating Anderson photo A.

Dist Ply 1 - 40' wide, 50' long

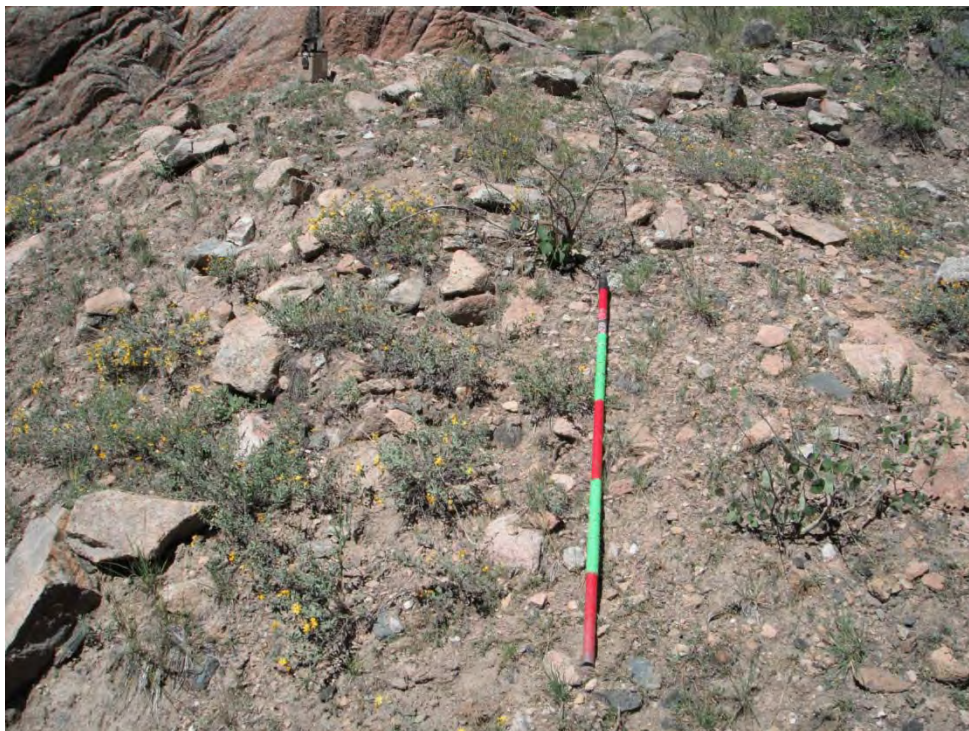
Photo 10-Looking north at PilePly-4.

Pile Ply 4 - 5' tall, 10' wide, 15' long, 45°
