# **Wetlands Action Plan for the Lordsburg Playa Watershed**

## **Hidalgo County, New Mexico**

Surface Water Quality Bureau  
Project ID CD #02F04101  
Agreement #24-667-2060-42734

**May 2025**

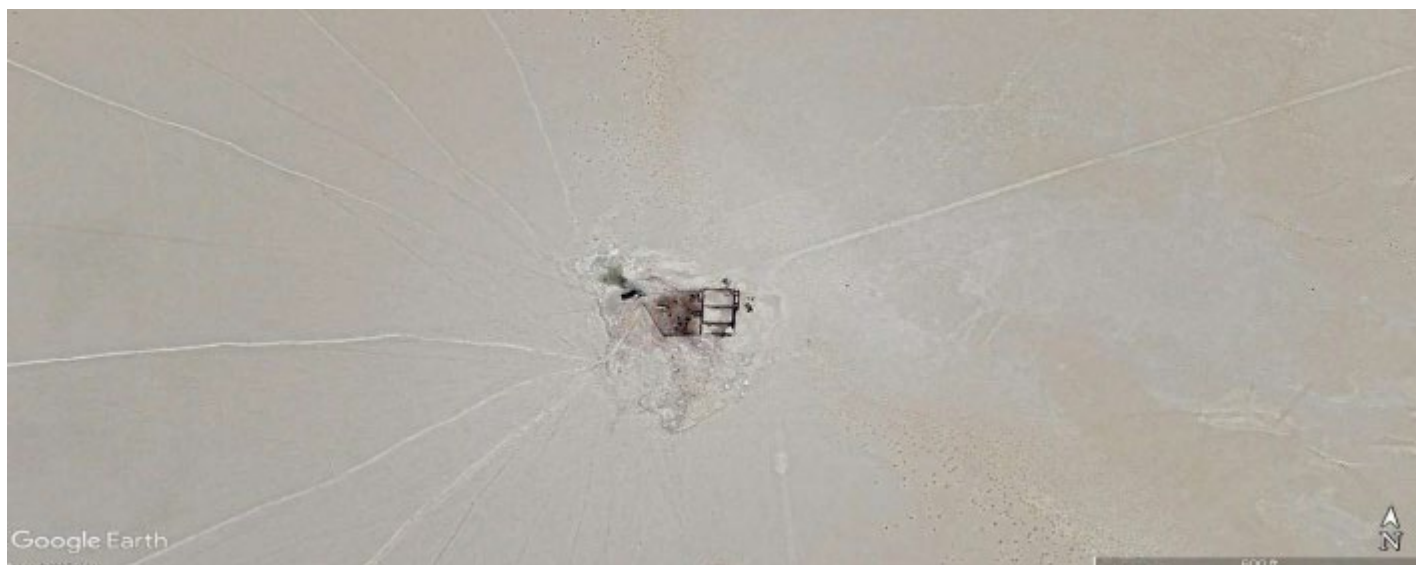
**Figure 4. Many established cow trails lead out from livestock watering facilities and corrals**

In reference to the Baddock et al (2011) study on Jornada Experimental Range, Figure 4 shows cow trails in the center of Lordsburg Playa leading to and from a livestock watering source. Cows are creatures of habit and will use the same trail many times.

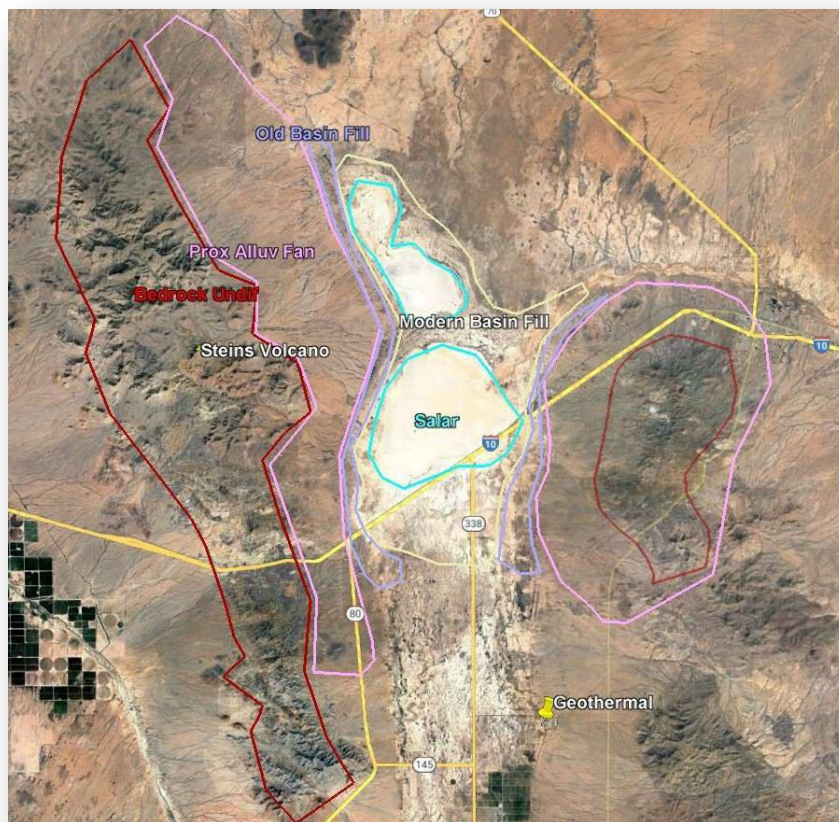
**Figure 8. Potential sources of lithium are shown around and within Lordsburg Iaya.**

Mechanisms for concentrating lithium in brines include evaporation and hydrothermal fluids reacting with an aquifer and liberating lithium. Mechanisms for removing lithium from a brine pool include: brine spills out of the basin; brine leaks out from the bottom of a basin; Li minerals crystallize from saturated brine; Li clays crystallize from hydrothermal fluids; Li brines are trapped in fluid inclusions in halite. Potential lithium sources within and around Lordsburg Playa are shown in Figure 8 (adapted from Bradley et al 2013).

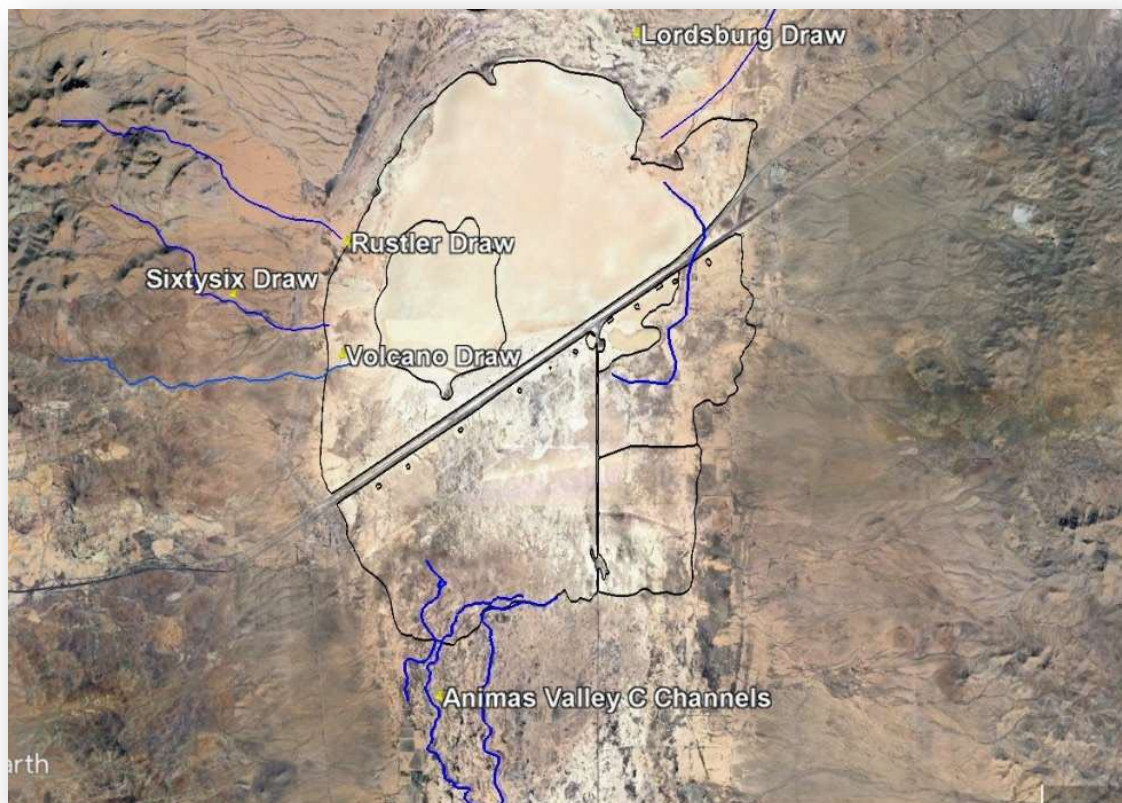
**Figure 9. Tributaries contribute sediment to the playa.**

Sediments between the shoreline ridges and the floor of the playa were deposited as Lake Animas dried, and includes Holocene-age shorelines, lagoon sediments, sand bars, as well as eolian deposition of deflation-derived playa sediments. Surface water coming into the playa crosses this zone via the Lordsburg Draw on the eastern side of the playa and through Rustler Draw (Volcano Draw and Sixty-Six Draw) area on the western side of the playa. These sediments are composed primarily of silt and clay with minor beds of medium- to fine-grained sand (Figure 9). These processes were also described by Schwennesen and Hare (1918, page 26): "When flooded the playas perform some of the function of ordinary lakes. Along their edges, shore features may be reproduced in miniature, such as pebbly beaches, beach ridges, sand bars, spits extending out from the shore, and sand dunes on the sides opposite the prevailing winds.

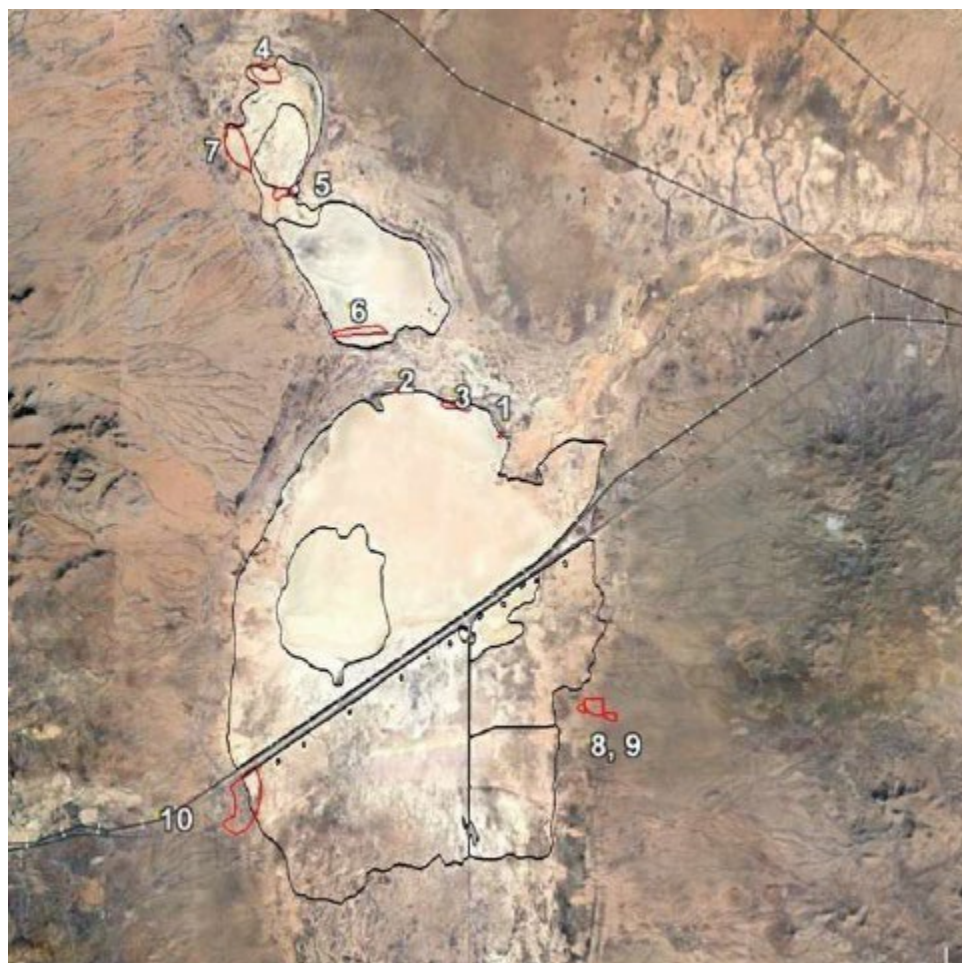
Figure 18. Surface erosion polygons.

About 715 acres of surface disturbances were identified around the shore perimeter. This does not include on-going habitat restoration work being conducted north of Steins for the NMDOT dust mitigation project, representing another 3000 acres. Ten parcels were identified that display accelerated erosion. A full description and location of each parcel is provided in the Table 13. Figure 18 shows the locations of the surface eroded areas around the edge of the Playa.

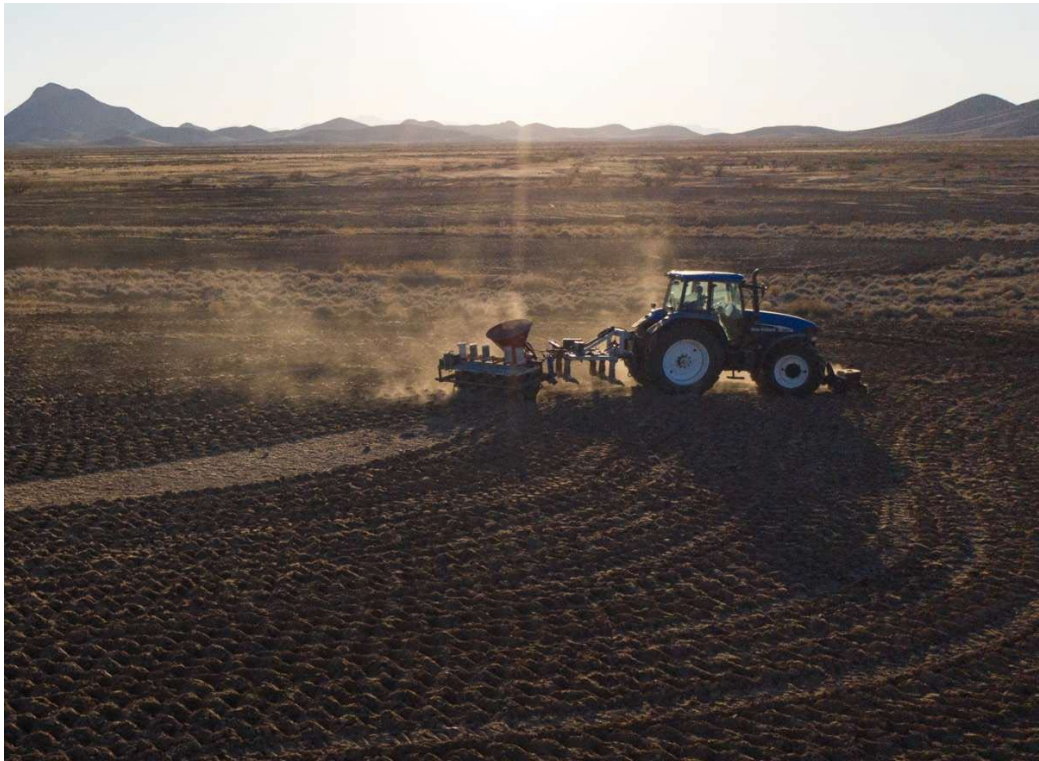
Figure 20. Agricultural tractor with keyline plow, imprinter and seeder. Treatment results in a loosened soil surface with waffle-like texture that captures seed, litter, and rainwater. Photo by Esha Chiochio.

| Figure 20. Agricultural tractor with keyline plow, imprinter and seeder. Treatment results in a loosened soil surface with waffle-like texture that captures seed, litter, and rainwater. Photo by Esha Chiocchio. .... | 58 |

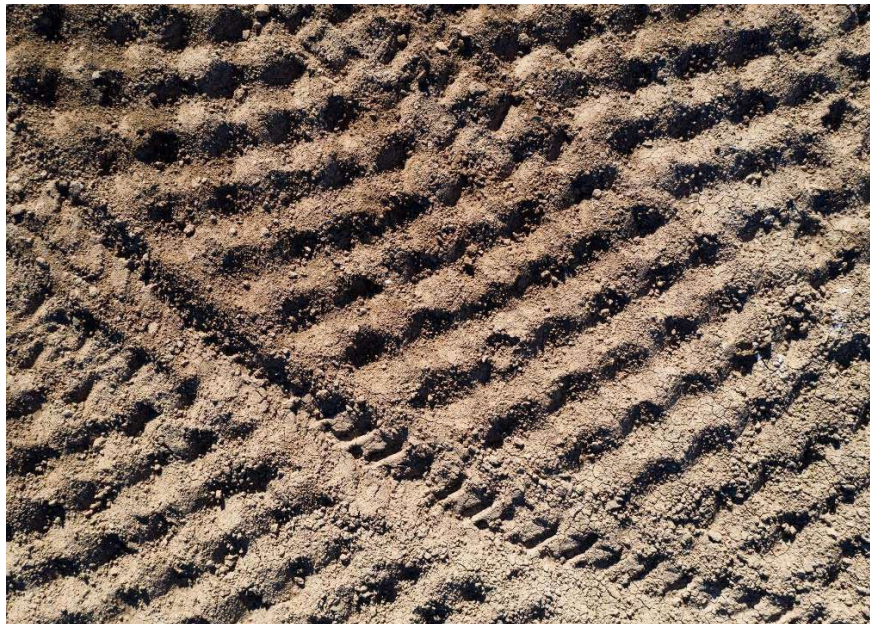
Figure 21. Plan view of soil surface treated with keyline plow and imprinter. Each imprint is approximately 1 square foot, and holds about one gallon of water where it lands on the soil surface, enough to allow  $\frac{1}{4}$  to  $\frac{1}{2}$  inch of rain to infiltrate. Photo by Esha Chiochio.

| Figure 21. Plan view of soil surface treated with keyline plow and imprinter. Each imprint is approximately 1 square foot, and holds about one gallon of water where it lands on the soil surface, enough to allow ¼ to ½ inch of rain to infiltrate. Photo by Esha Chiocchio..... | 58 |

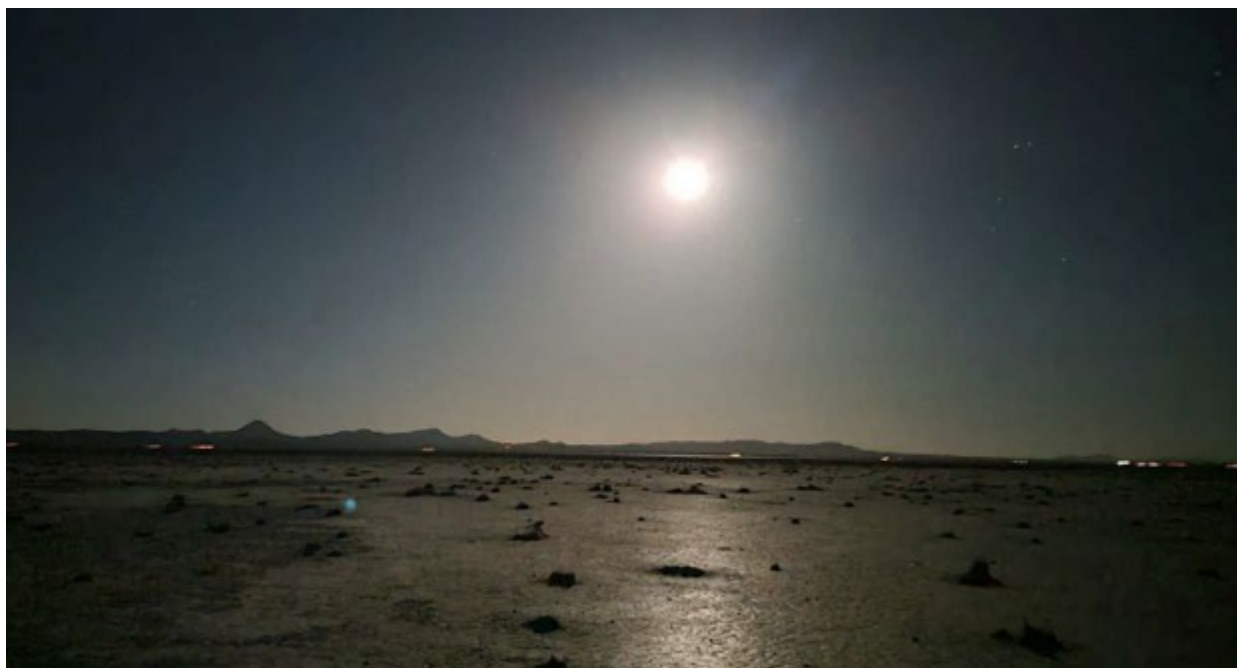
**Figure 29. Playa patina shines under moonlight. Photo by J.S. Cockman**

- Playa patina is created by fresh sediment from flood events (Figure 29). Patina gets ripped out during storm events. How well does patina stand up to storm events? Phenocam documentation

- would help us better understand the process and the patina role in armoring the playa.

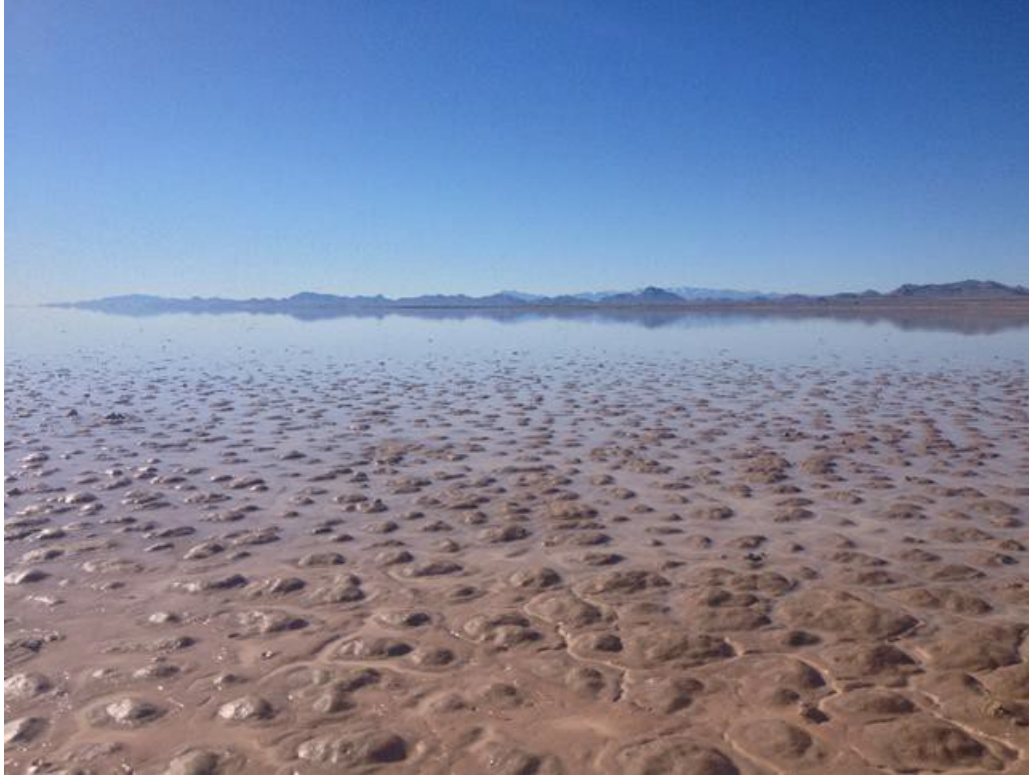
*Figure 5 The Saline/Sodic Dry Playa ES is located at the lowest position of the playa (Garcia 2025a).*

This ES occurs at the lowest position of the closed basin system. Some basins may have a series of playas separated by elevated eolian (lunette dune) or alluvial deposit. Topographically, the lowest most frequently ponded portion is relatively flat to slightly concave with slopes < 0.10%. The less frequently ponded edges can be slightly elevated and undulating due to recent soil deposits (Figure 5).

Fine textured saline soil of the playa seals when ponded. Deep soils are clayey and silty; these saline soils disperse, collapse and seal. This reduces infiltration rates and causes water to pond.

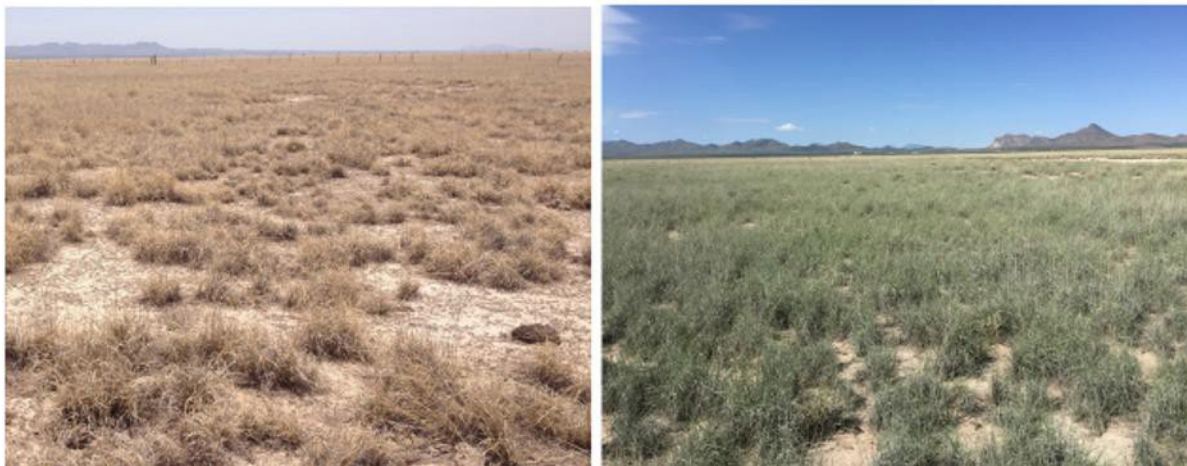
Figure 9 Alkali sacaton grassland is shown during the wet monsoon season and during the dry season (Garcia 2025b).

The Sodic (Alkaline) Flat ES is created by unique circumstances. Sediments transported to the basin floor are overlaid onto a saline playa, creating an alluvial flat which is elevated from the playa floor. Due to increased elevation, the site does not pond, does not become hard packed and surface soils are non-saline. The spreading overland flow provides the additional irrigation required to support the dense stands of Alkali sacaton (*Sporobolus airoides*) (Figure 9).

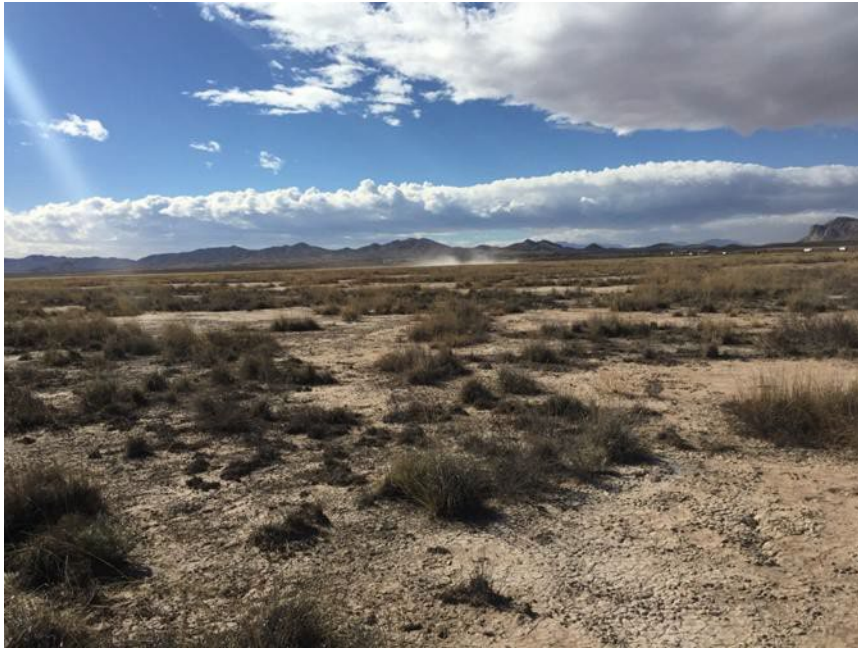
Figure 10. The deteriorated state of the Sodic Alkali Flat grassland has interconnected patches of bare ground.

When reference-state surface soils are lost, exposing subsurface soils erosion will cause plant pedestals and interconnected patches of bare ground. There is a corresponding loss of plant vigor, a reduction of Alkali sacaton and an increase in halophytes (Figure 10). As conditions deteriorate the process may become irreversible (Garcia 2025b).

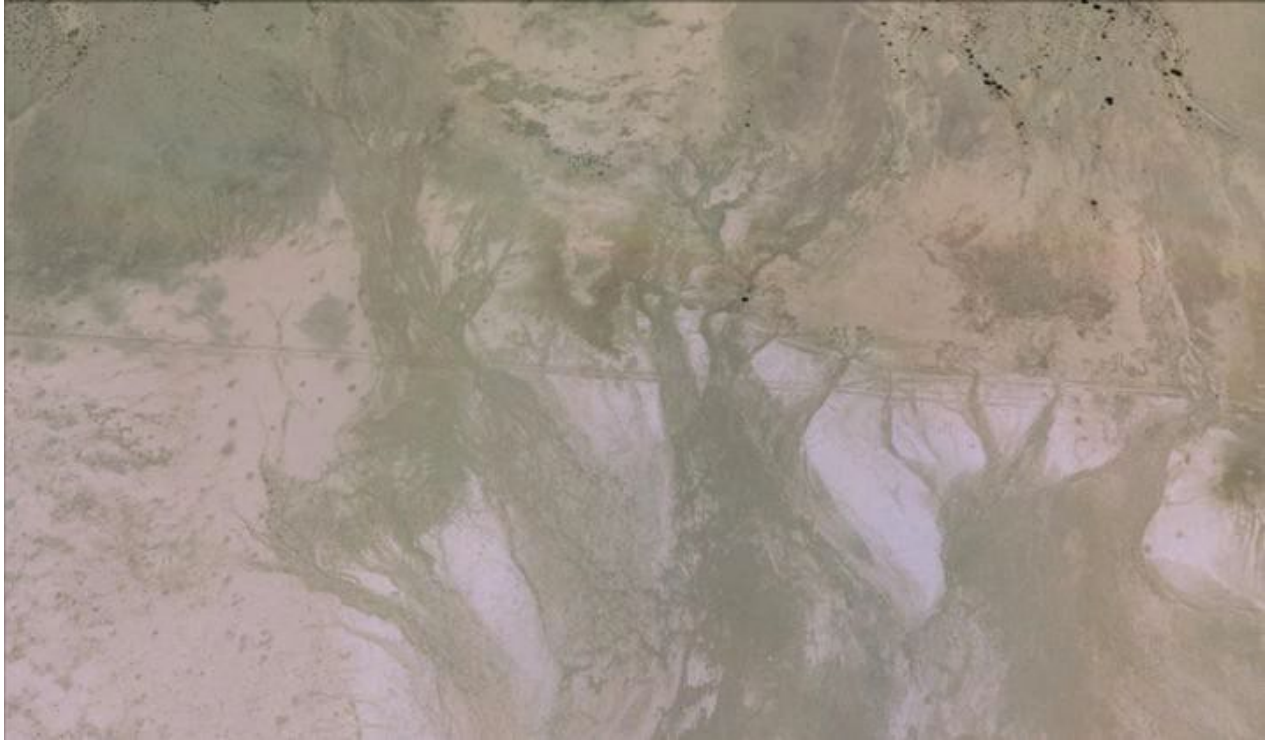
*Figure 11 The Saline Playa Rim Slope ES is characterized by shallow, braided drainages and is situated just above the ponding zone of the playa.*

In Figure 11 dendritic vegetated drainageways emanate from the upper watershed at three breach points. Also depicted is the barren phase of this ES that was previously scoured and is now slightly elevated from the drainageways and remains dry. This location is highly saline and is relatively void of vegetation (Figure 12). The soil is easily eroded with a Rupture Resistance Class of 1 on bare ground. Because there is no ponding the site does not become water packed, and there are no soil crack features on this ES. Due to the high salinity levels, soils remain “soft”. When soil crust is compromised by physical impact this site becomes highly susceptible to wind erosion. Maintenance of the soil crust is necessary to protect these sites.

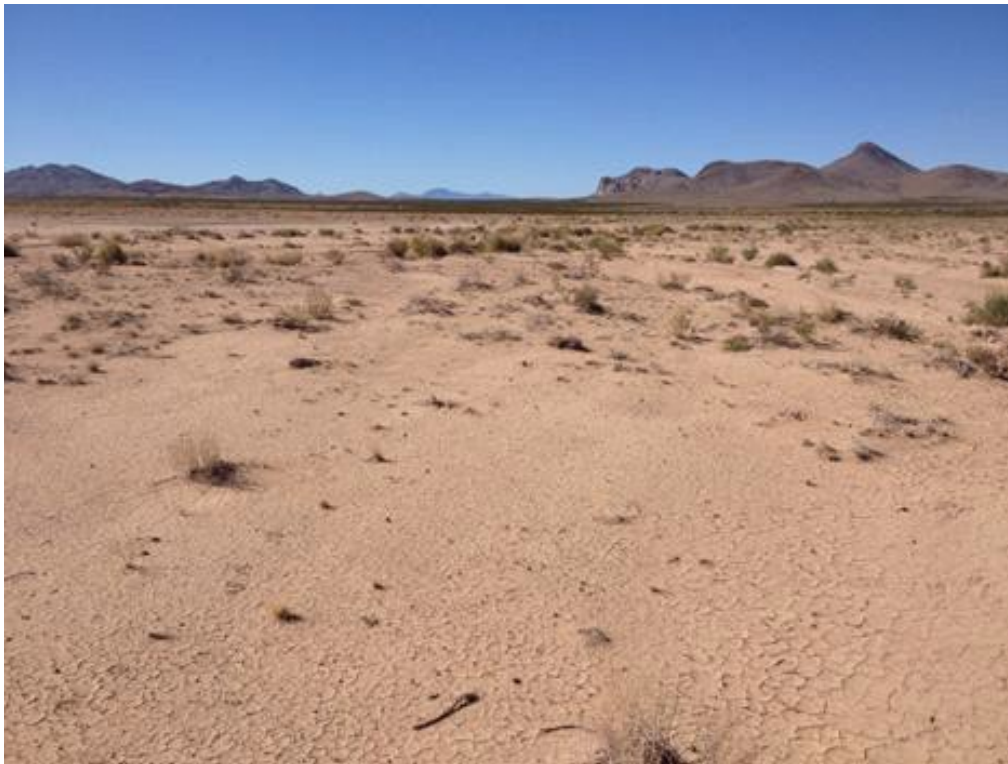
*Figure 122. Reference condition ES shows Tubercled saltbush occupying slightly elevated positions.*

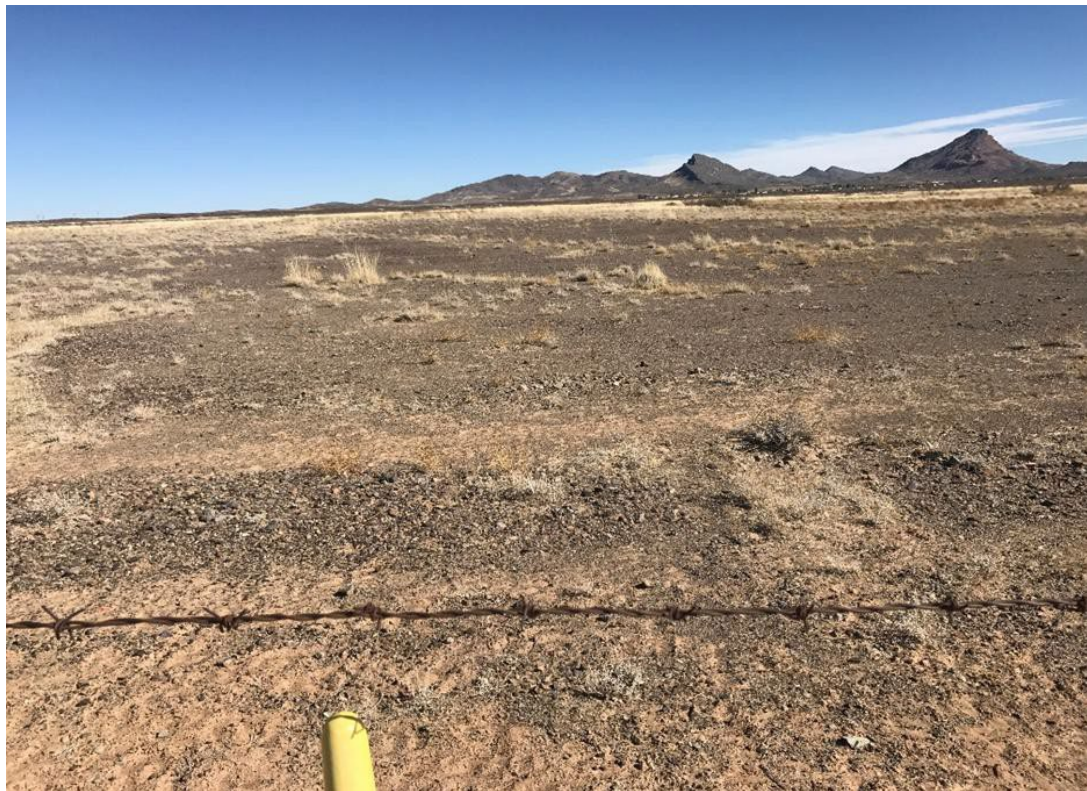
Figure 133 Alkali sacaton occupies shallow drainages while the elevated interspaces remain bare on the Sodic Piedmont ES.

Figures 13 and 14 show reference states photographed at a playa south of Lordsburg near the village of Playas. The Pyramid Mountains are shown in the background. Both photos show the ES located on piedmont fan with < 2% Slope. The site is gravelly throughout the profile. Figure 13 shows Alkali sacaton on the broader drainageways where the elevated drier sites are relatively void of vegetation but do produce sparse Mound saltbush (*Atriplex obovata*). Figure 14 shows a flush of annual vegetation; the site is relatively void of perennial vegetation. Perennial vegetation is at 13% foliar coverage.

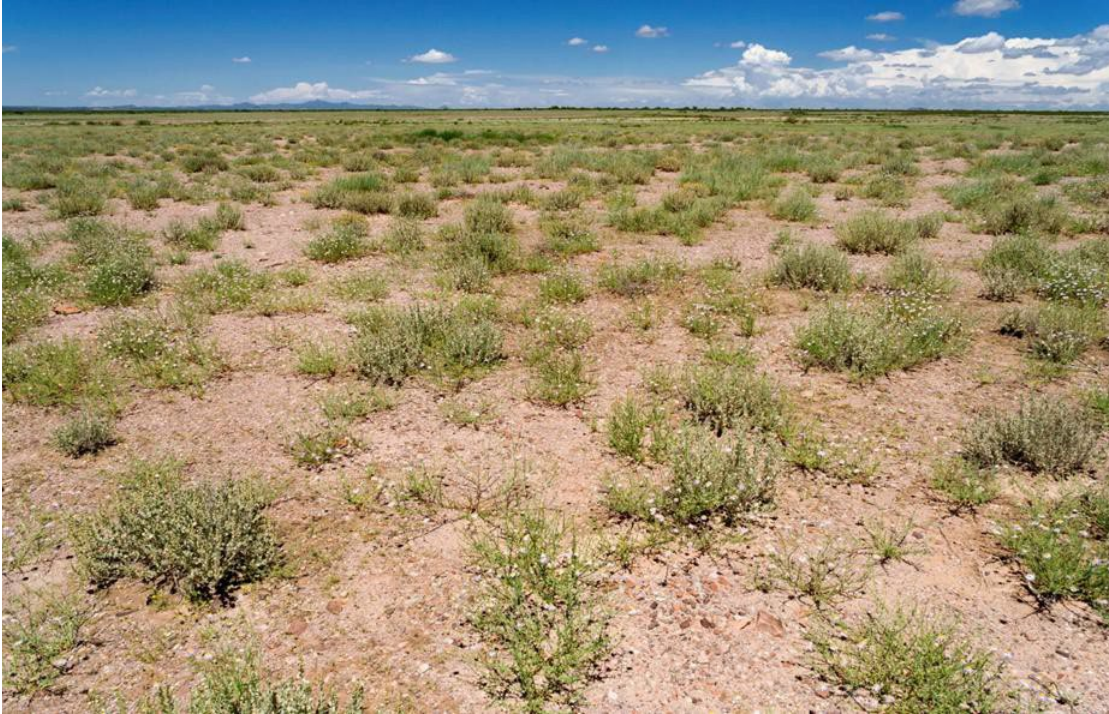
*Figure 144 During wet years a flush of annual plant species may occupy the otherwise bare elevated areas of the Sodic Piedmont ES.*

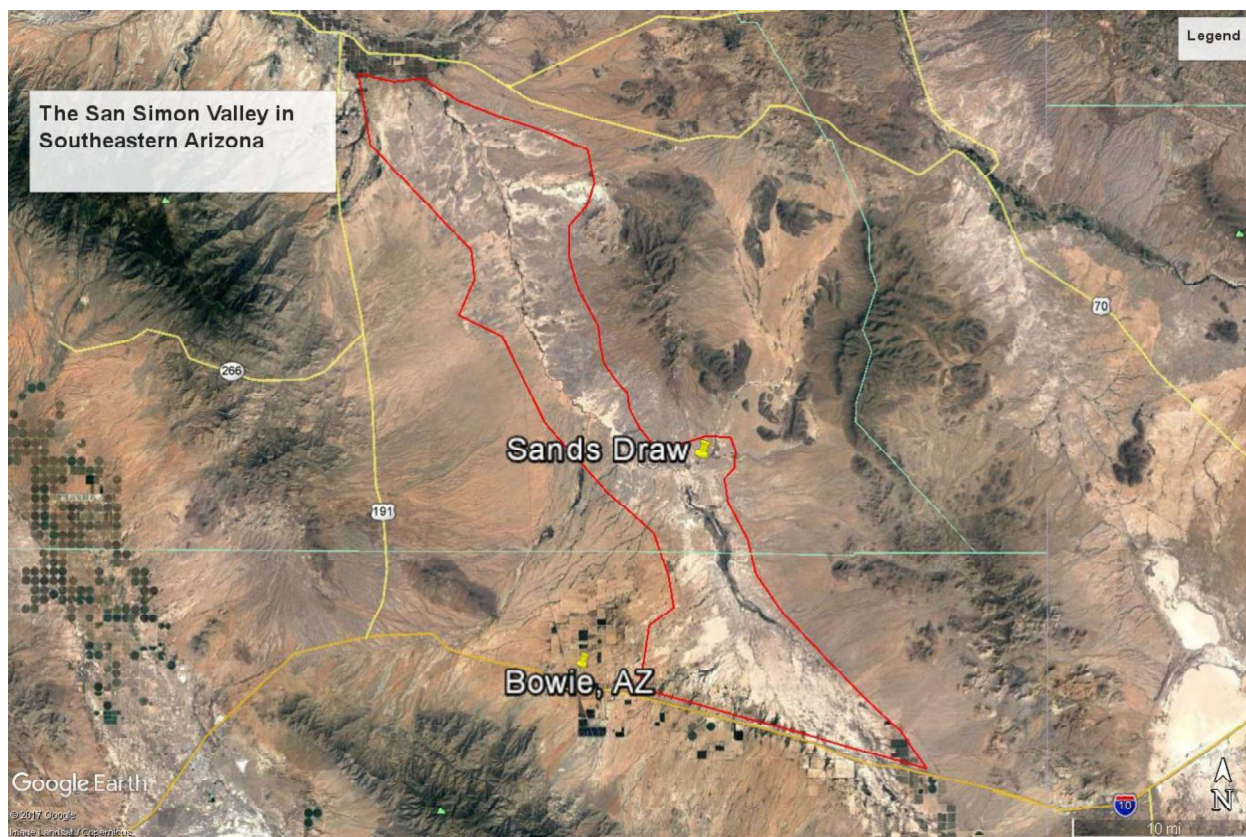
*Figure 1. The heart of the San Simon Valley is outlined in red. It occupies an area of about 253 square miles north of Interstate 10.*

The study area is located in the San Simon Valley of southeastern Arizona approximately 8 miles north of the town of Bowie (Figure 1). The project area in the Sands Draw wildlife exclosure is situated on a landscape characterized by abundant seasonal overland flow of surface water (Figure 2). The research plots are situated on ground that was scraped to mine soil for surface water catchments and dam construction. One of the surface water flow catchments can be seen in Figure 3 just below the research plots.

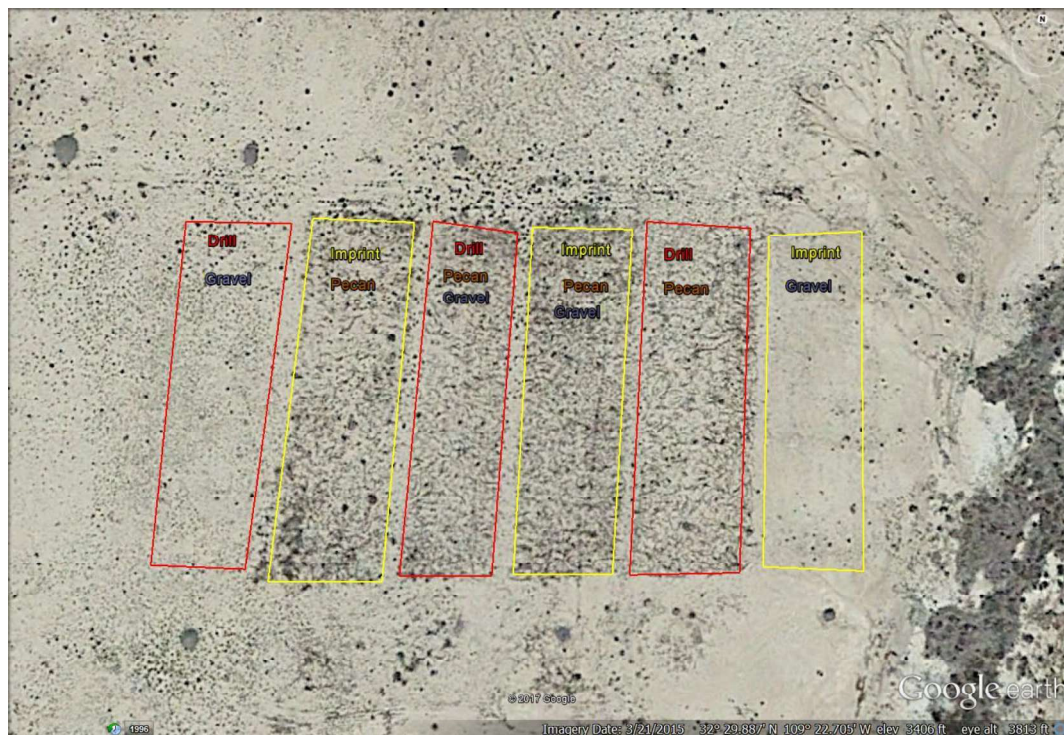
Figure 6. Grass seed plots are 15 m x 50 m in size. From left to right the treatments include: drill/gravel, imprint/pecan, drill/pecan and gravel, imprint/pecan and gravel, drill/pecan and imprint/gravel.

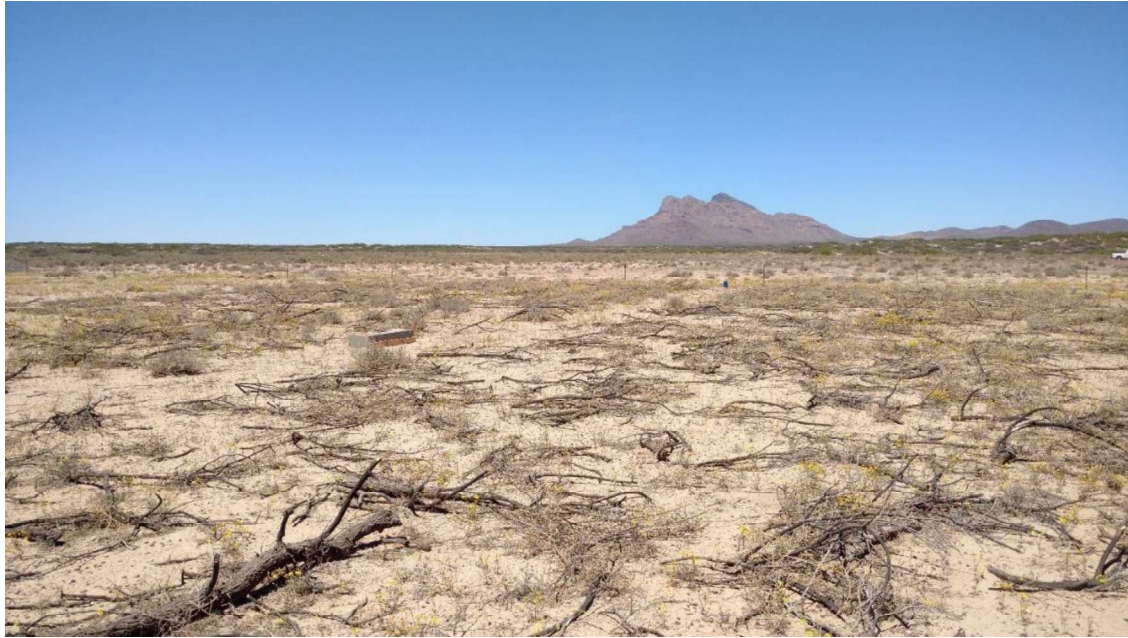
*Figure 7. Pecan branch and gravel mulch were applied to a native grass seed plot. The view looks north toward a fence line. The bare control plots are located on the north side of the fence. Sediment traps were staged to capture surface water flow coming from north to south and from west to east. Note: the sediment trap at left center in the photo is sitting just outside of the plot. It was relocated to within plot.*

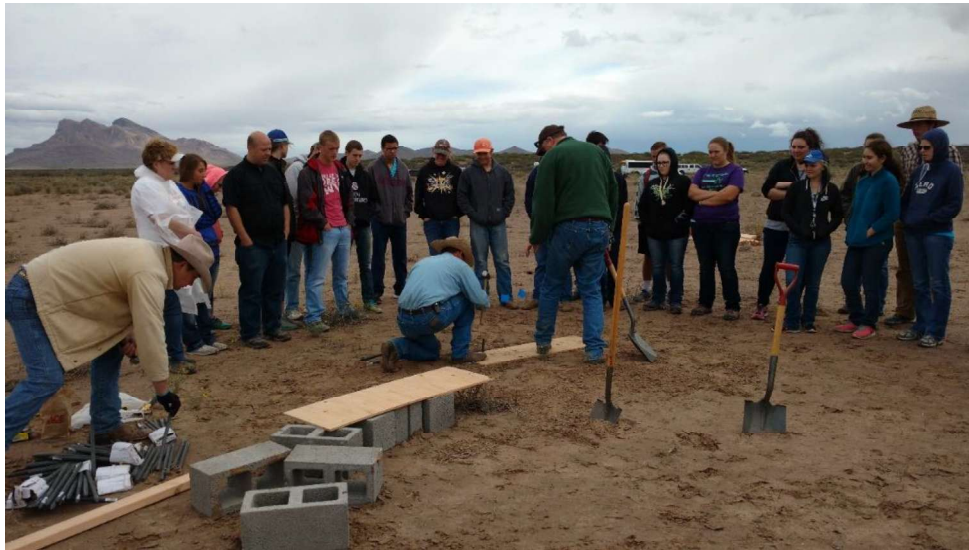
*Figure 9. Students gather at a STEM Partnership youth day event to learn about sediment traps and construct two traps in each of the grass seed plot treatments and in an untreated control plot.*

Sediment traps were installed within each treatment plot in a configuration to capture overland flow from two different directions perpendicular to one another. Sediment traps were designed by Dave Henson, biology chairman at Eastern Arizona College (Henson 2017). The sediment traps are constructed of inexpensive materials and are easy to install. Description of the trap design is provided in Appendix A. Installation of sediment traps was incorporated into one of several youth day events co-hosted by the Safford Field Office and Eastern Arizona College through their STEM Partnership (Figures 9, 10, 11, 12).

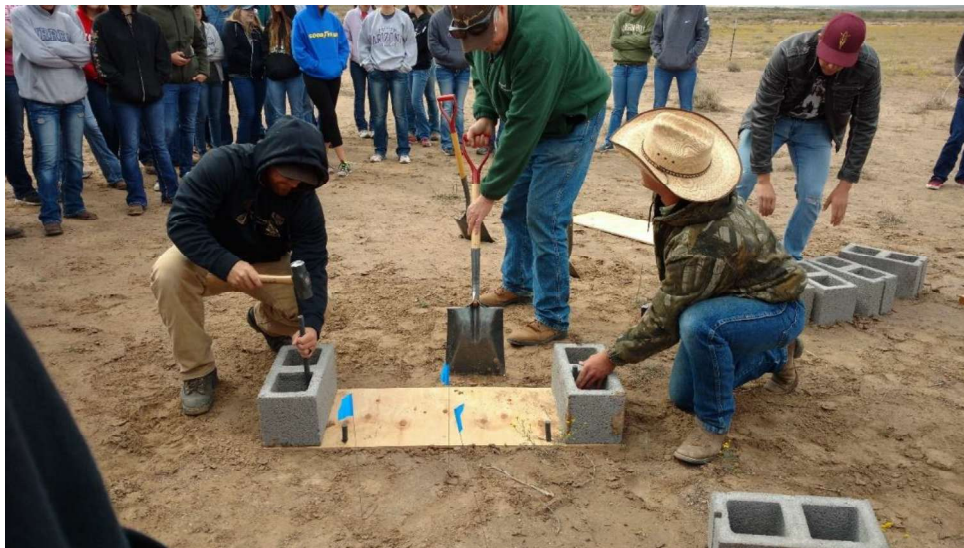
*Figure 10. STEM Partnership interns took the lead in construction of sediment traps (Jeremy Gillette (left) and Dillon Hancock (right)). The base is plyboard anchored by rebar pegs. Three sides are built around the plyboard out of anchored cinder blocks.*

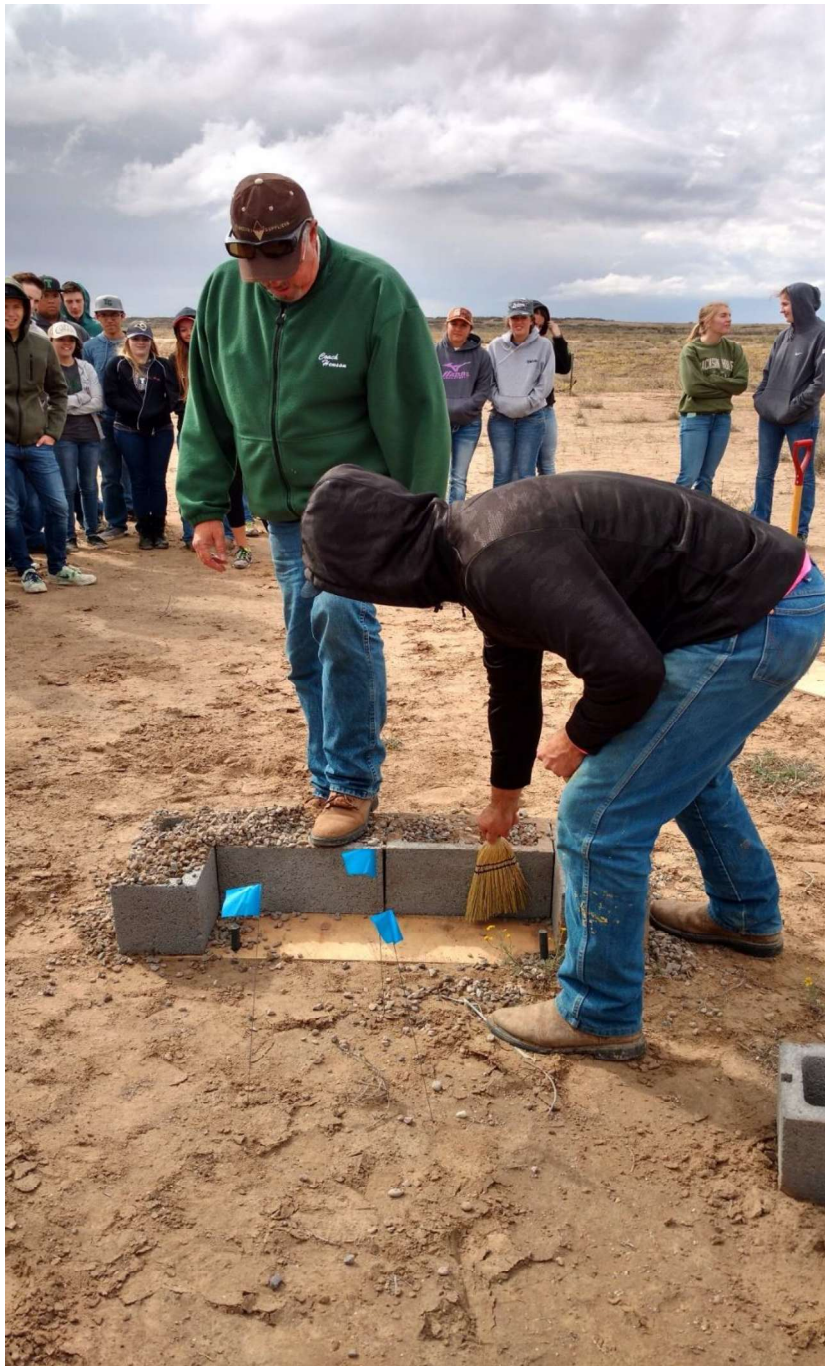
*Figure 11. The anchored cinder blocks are filled with pea gravel to further secure the contraption. During monitoring the plywood floor is swept clean of debris with a whisk broom and dust pan. This debris is the sample which is taken back to the lab for weighing and laboratory analyses. The designer of the sediment trap, Dave Henson, is shown in the green sweatshirt.*

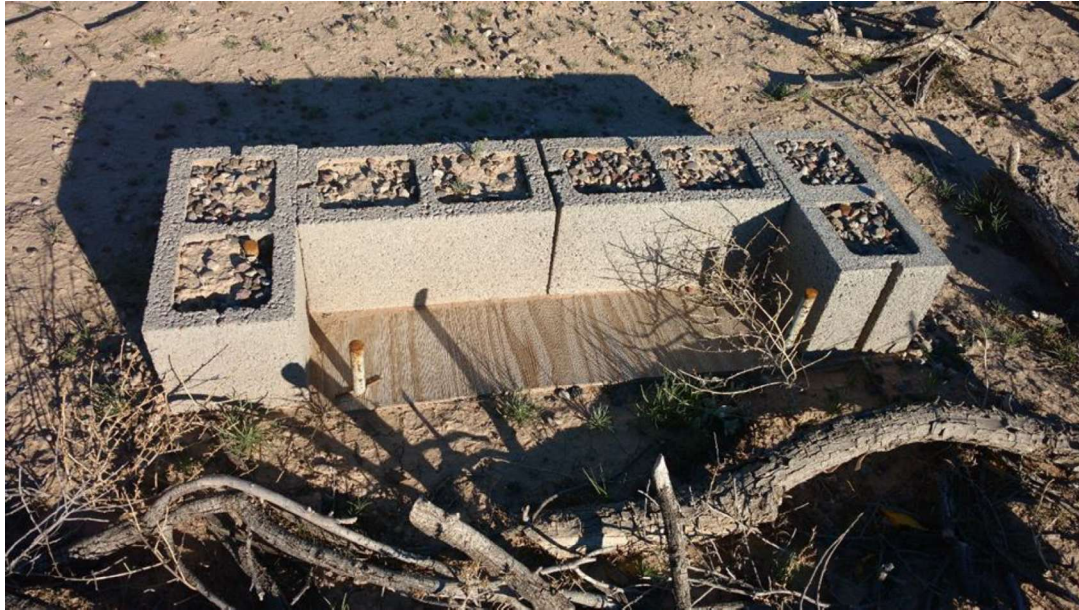
*Figure 12. A sediment trap installed on a treatment with pecan branch mulch shows no accumulation of sediment.*

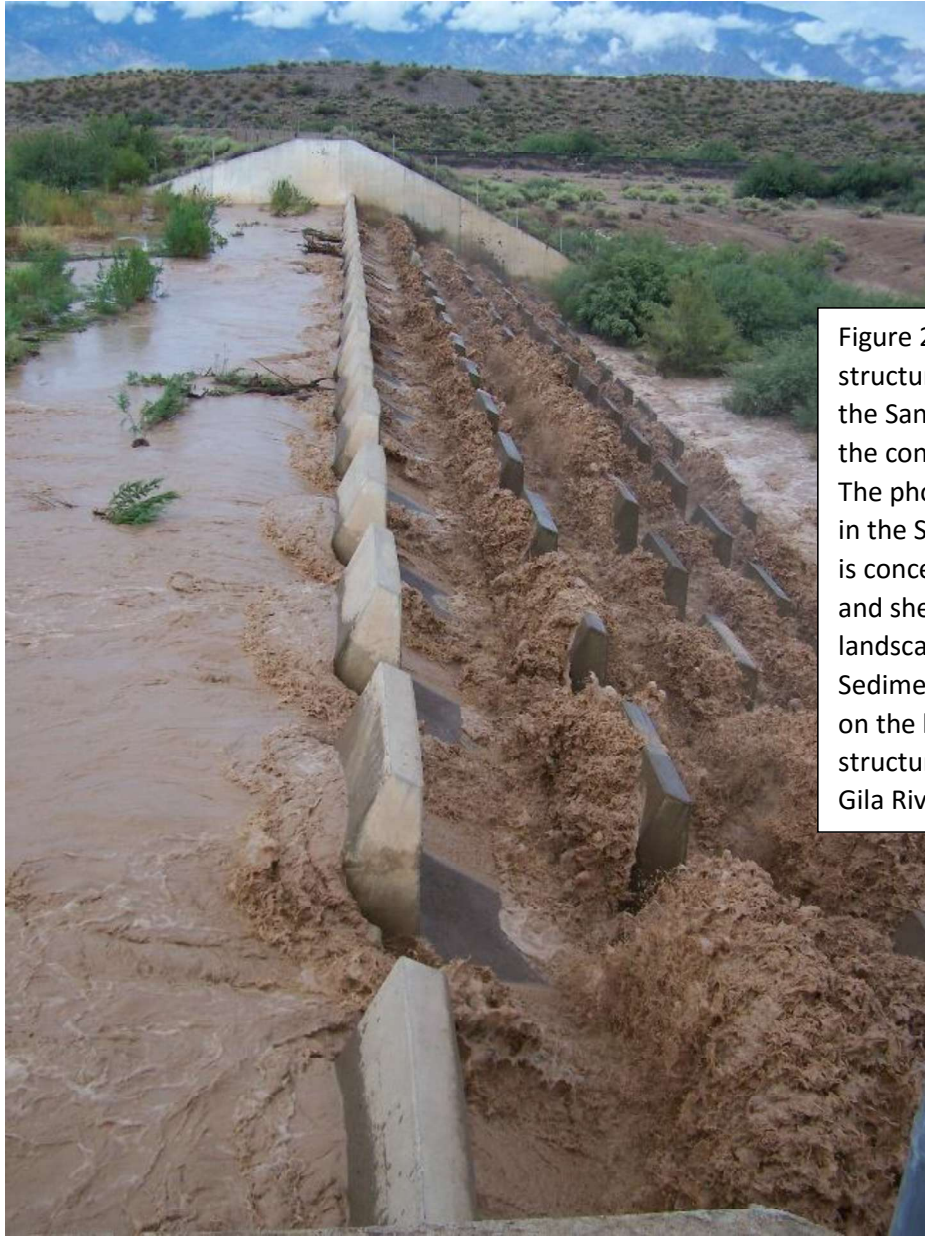
Figure 23. This water control structure sits at the lower end of the San Simon Valley just above the confluence with the Gila River. The photo shows ephemeral flow in the San Simon River. This flow is concentrated from surface flow and sheet erosion from across the landscape in the San Simon Valley. Sediments that are not captured on the land or by upstream structures, are deposited into the Gila River.
