ABANDONED OR INACTIVE URANIUM
MINES IN NEW MEXICO

A report of investigation carried out
between August 1979 and May 1980 under
contract with the New Mexico Energy and
Minerals Department.

New Mexico Bureau of Mines and
Mineral Resources
Open-File Report 148

Mine name(s) Faith (Westvaco) (Sec. 29) County McKinley

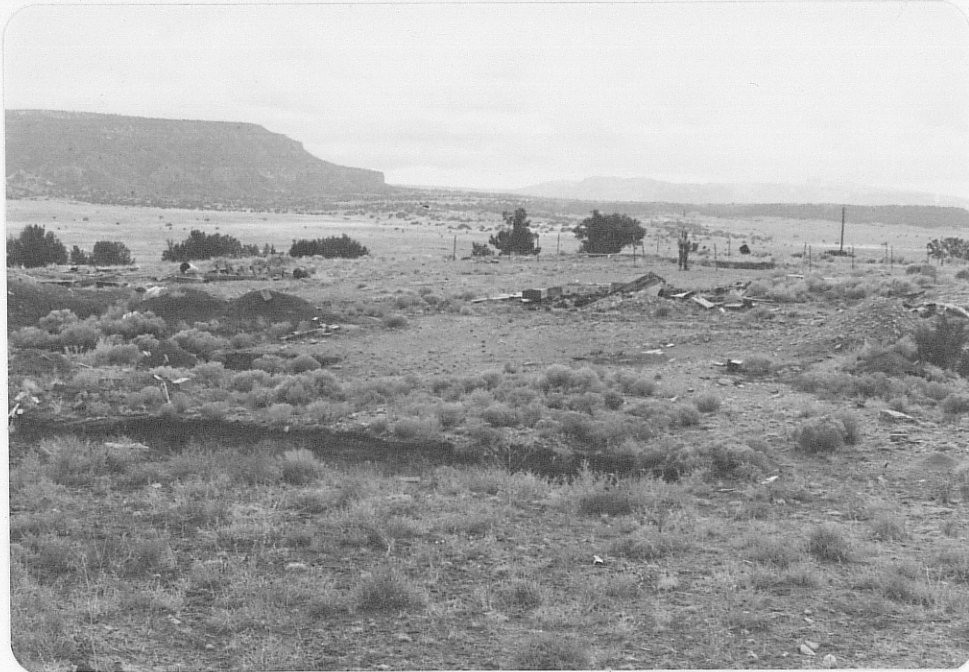
The mine consists of the main shaft on the south bank of a small drainage (photos a through c), and a hoisting shaft about 1,000' to the south (photos d through f).

Photo A Looking SE into main shaft area; shaft is enclosed by fence immediately behind person to right of center; gully along south bank of drainage may be seen at left. Close-ups of shaft and drainage shown on following photos.

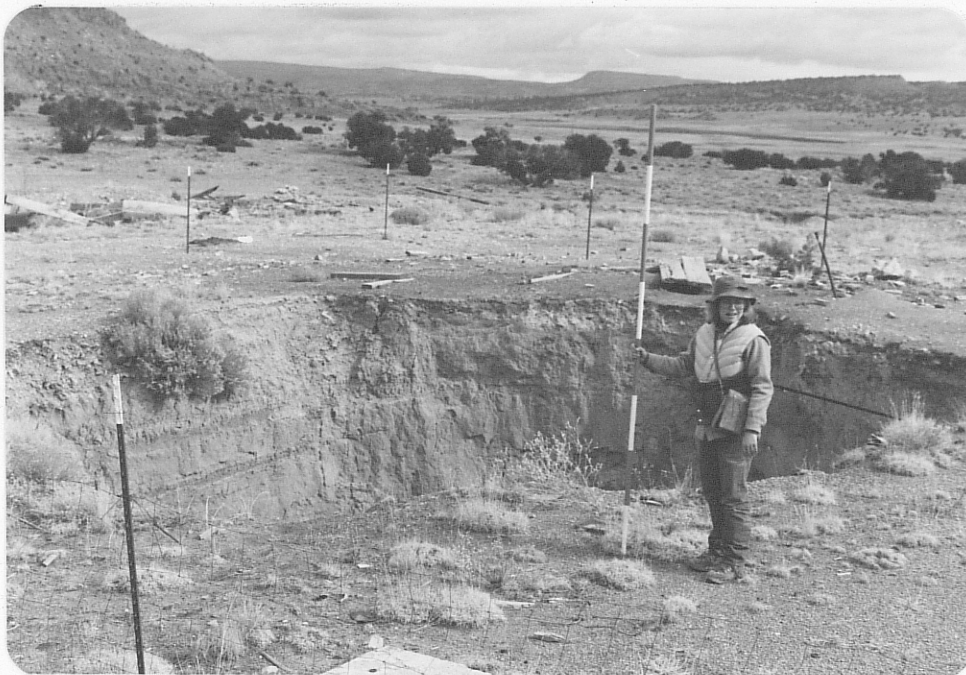
The main shaft has caved leaving a 25' diam. hole 24'-26' deep (photo b); scintillometer readings at shaft site range up to 500 cps (background = 50-60 cps). Mine dumps are scattered about the site, with small piles to west and southwest of shaft, and on stream bank to north of shaft (photo c) where scintillometer readings of 500 cps (10 x background) were recorded. The small conical piles immediately northwest of the shaft read up to 1,400 cps, but they are 100' back from the stream bank.

Photo B Look NE at caved shaft; enclosing fence is effective for livestock, not for people.

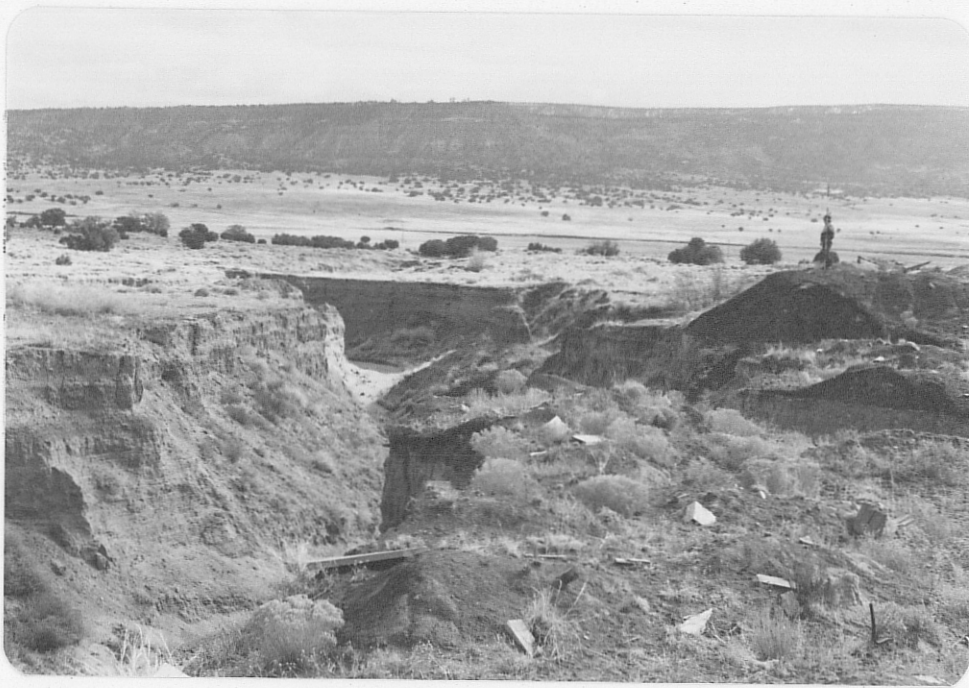
Photo C Looking southeastward down drainage that skirts main shaft area; mine waste perched on edge of bank has gamma valves of 10X background.

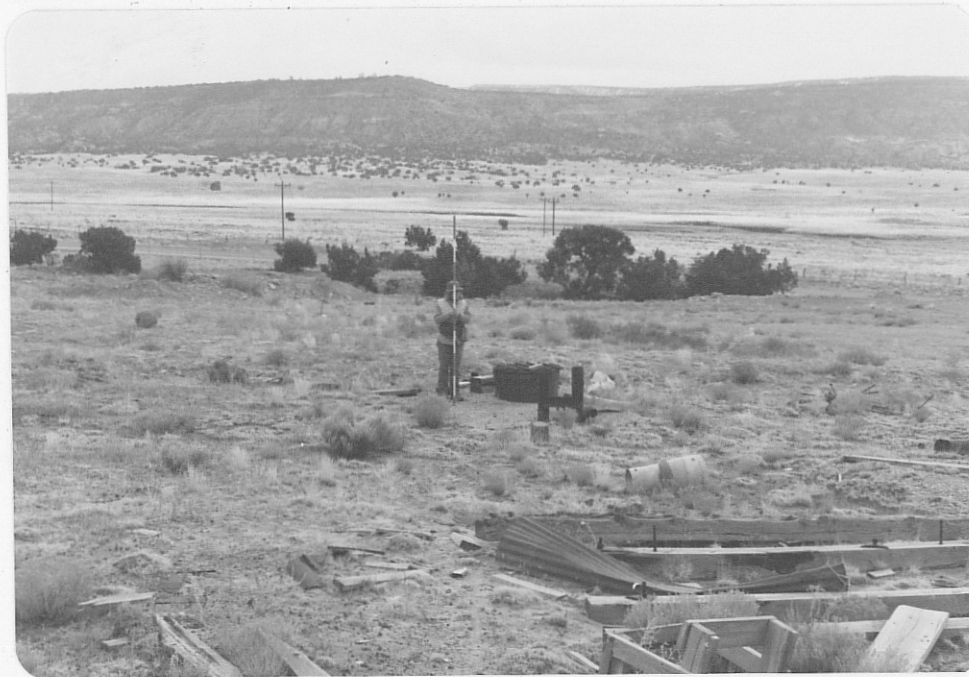
The hoisting shaft, about 1,000' south of the main shaft, is covered with a concrete slab with a metal vent at the center (photo d). The shaft is probably about 6' x 8'. Radiation levels are not unusually high at small opening in vent. The dumps associated with the hoisting shaft are (1) an area of low piles and ridges (photo e) extending northwest of the shaft with scintillometer readings of up to 850 cps, and (2) the main dump to the east of the shaft, and visible from the highway that appears large, but in reality is composed of a thin layer of waste forming a veneer on a rock-cored natural topographic feature (photo f). It covers an area of 200' x 300' and scintillometer readings on it range from 300 to 2,600 cps.

Photo D Looking east at hoisting shaft site, 1000' south of main shaft; a raised cylindrical metal lined vent protrudes about 1' above the concrete cover on shaft (arrow).

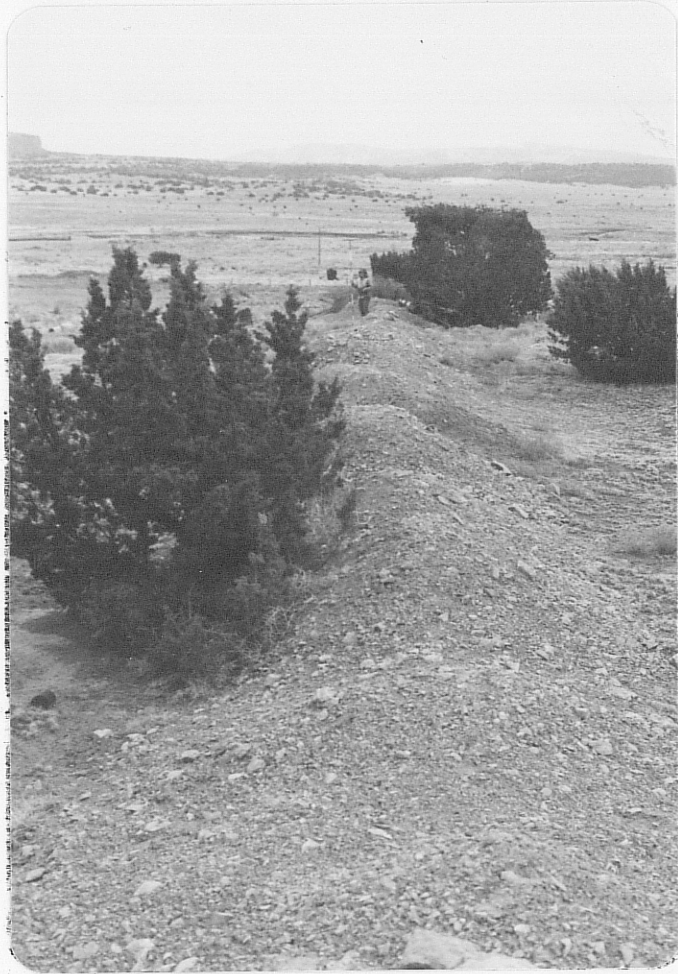
Photo E Looking SE at 4' high 200' long mine dump or low grade ore; dump extends NW of hoisting shaft.

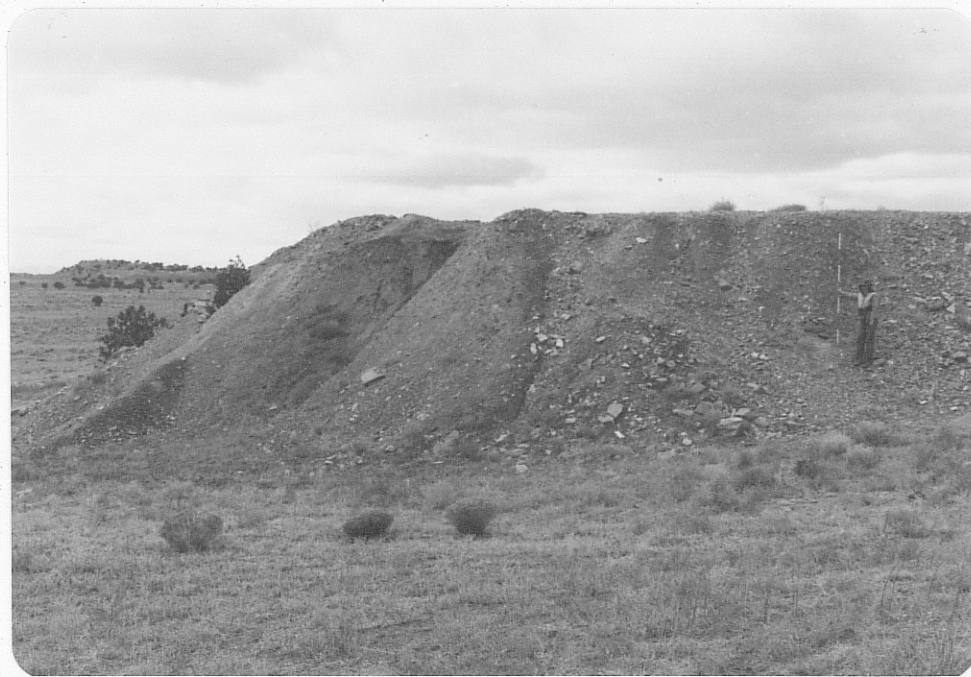
Photo F Main dumping area for hoisting shaft; waste forms only veneer on rock cored natural feature.
