ABANDONED OR INACTIVE URANIUM  
MINES IN NEW MEXICO

A report of investigation carried out  
between August 1979 and May 1980 under  
contract with the New Mexico Energy and  
Minerals Department.

New Mexico Bureau of Mines and  
Mineral Resources  
Open-File Report 148

Mine name(s) Mary No. 1 (Dysart No. 3) County McKinley

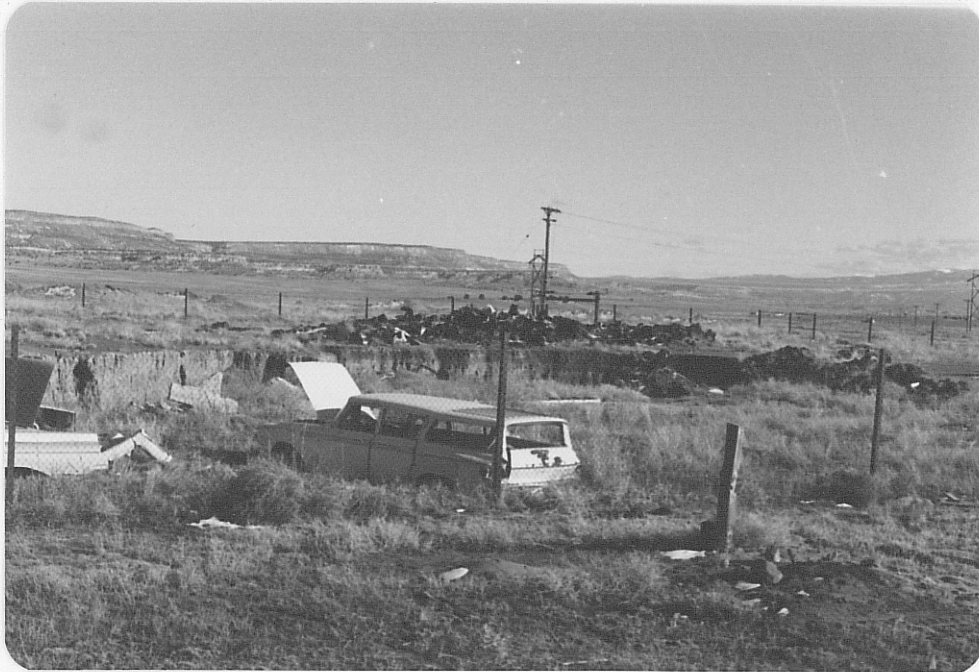
Photo (a) Looking eastward at caved shaft site showing fence and general debris.

The shaft has subsequently caved leaving a 75' diameter funnel shaped hole perhaps 75' deep or deeper (see photos a & b). A close up of the lower portion of the hole is shown in photo (c). The shaft site is enclosed with a 6' high wire mesh fence that is nearly 250' long on each side; however, a section along the south side has been damaged and this allows access to the mine shaft. Scintillometer readings around the shaft site range from 400-600 cps; one area along the north fence line up to 1,200 cps. The mine dump extends mainly eastward from the shaft; it is composed of very low, 3'-4' high, scattered conical piles and ridges that extend 600' east of the shaft. Scintillometer readings were in the 600-1500 cps. range in the dump area (see photos d & e). A small powder magazine remains about 700' west of the shaft.

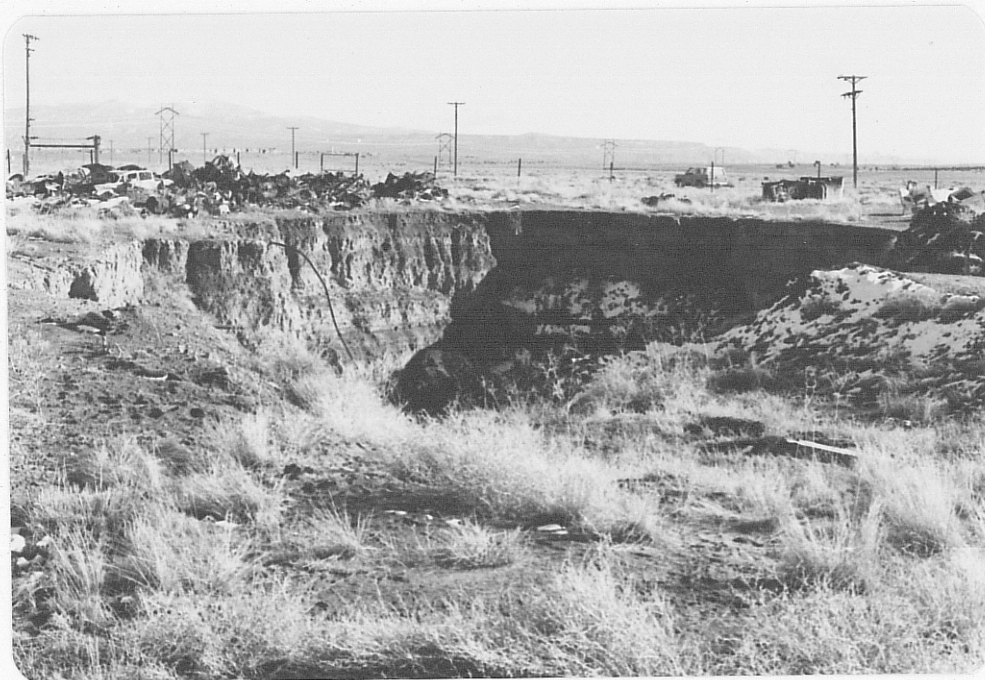
Photo (b) Looking southeastward into caved shaft.

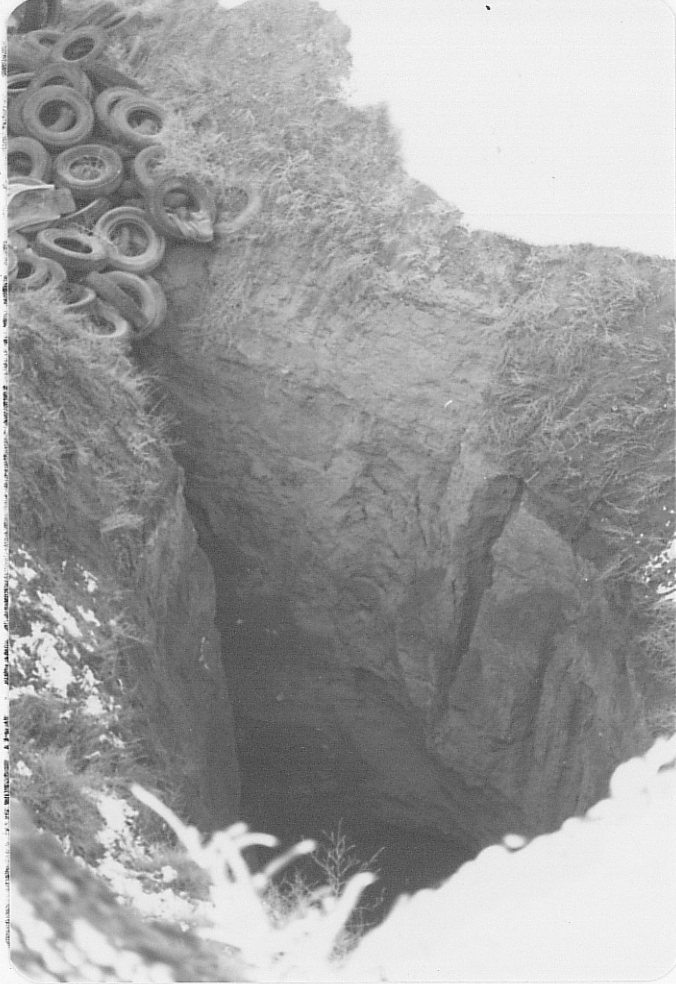
Photo (c) Close-up of lower portion of caved depression where it funnels into the old shaft.

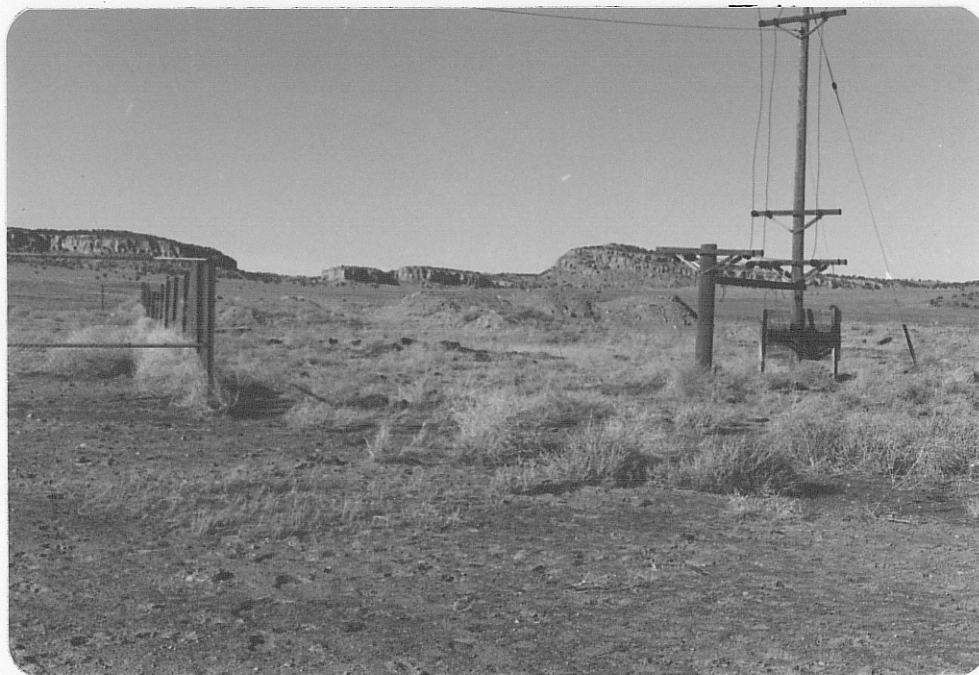
Photo (d) View northward at east fence line of the mine shaft; note small dump at center and right and electric utility line.

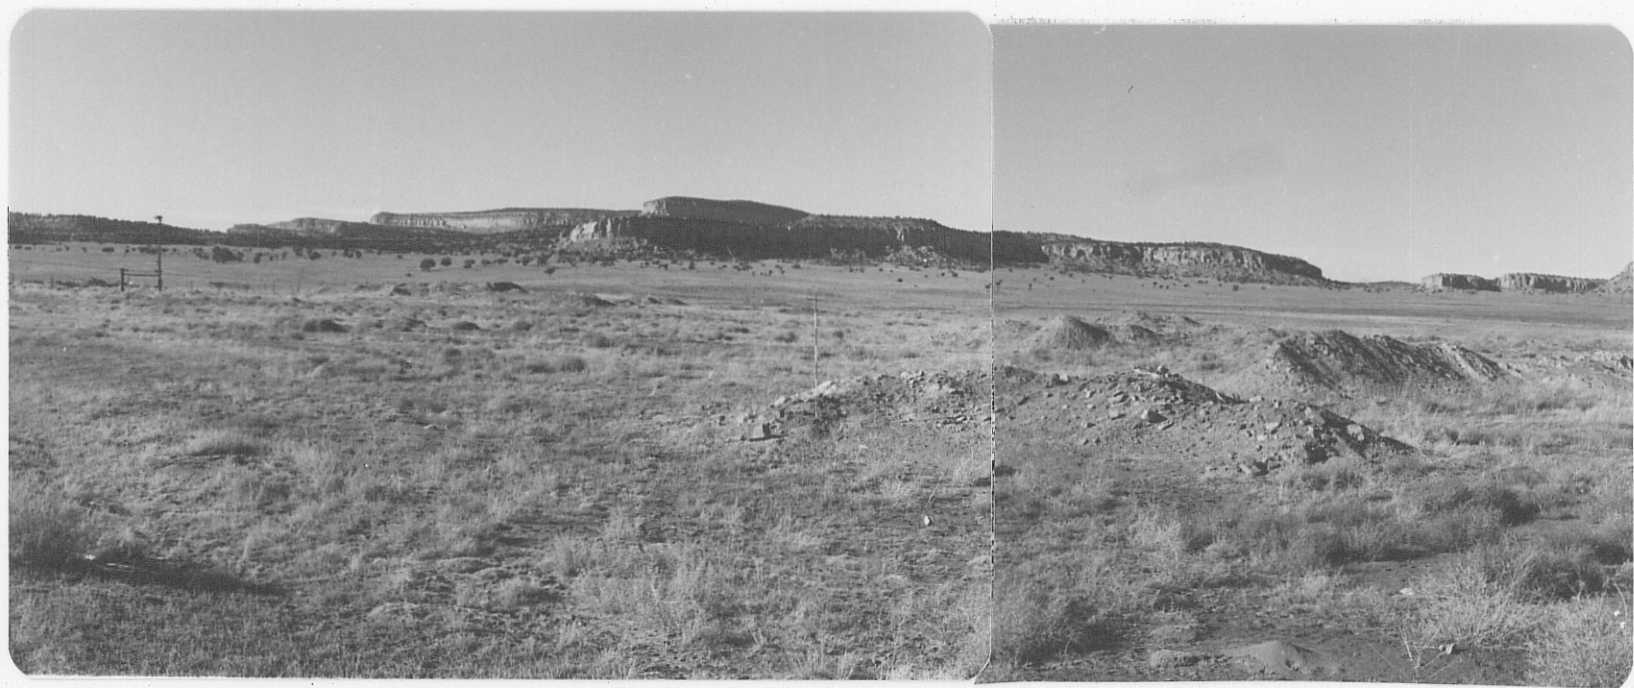
4-210 Mc-4  
Photo (e) Looking northwest at dump (ore stockpile are?) 600' east of the mine shaft which is indicated by arrow at left. Note range pole at center for scale.
