ABANDONED OR INACTIVE URANIUM

MINES IN NEW MEXICO

A report of investigation carried out between August 1979 and May 1980 under contract with the New Mexico Energy and Minerals Department.

New Mexico Bureau of Mines and  
Mineral Resources  
Open-File Report 148

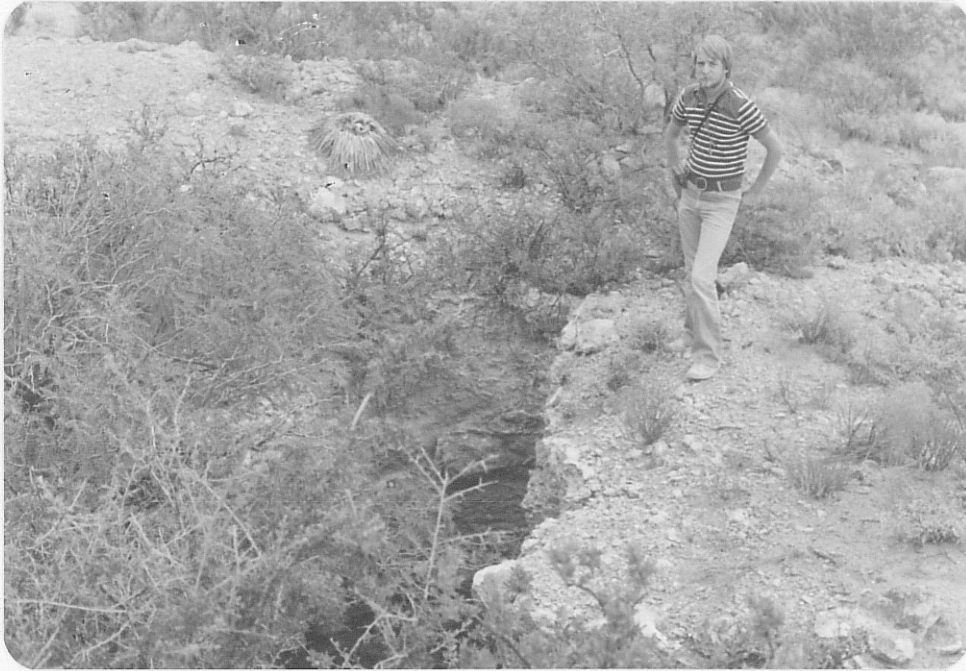
Photo (a) Looking northward at incline shaft 250' to west of access road in SE $\frac{1}{4}$  sec. 25 as mining district is approached; site is nearby an abandoned trailer house. Sign on approach advertises the Cruz Blanca Mining Co.

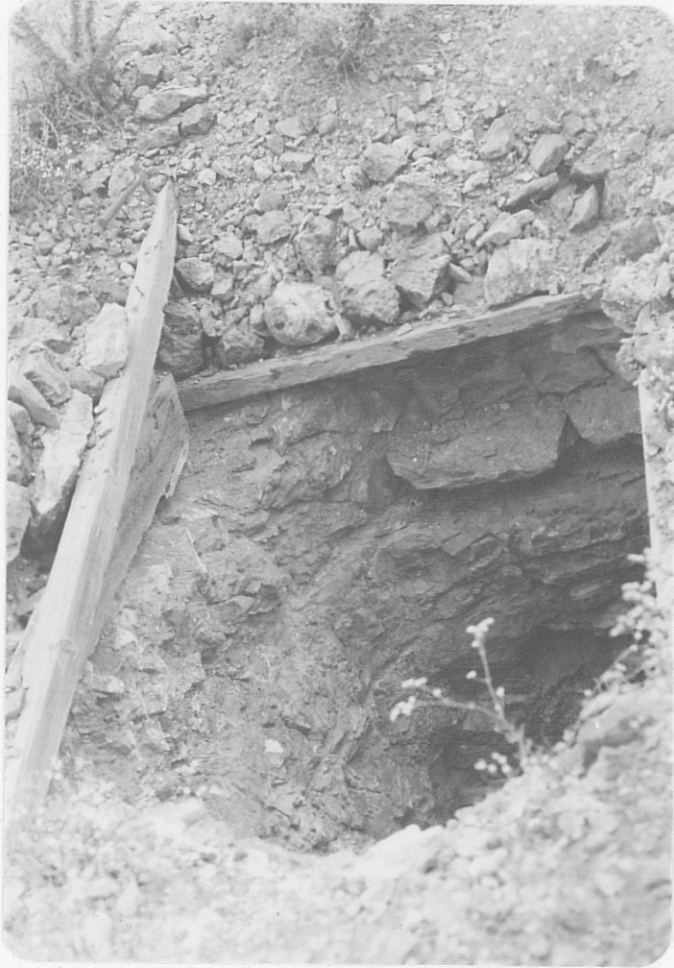
Photo (b) Vertical shaft, 4' x 6', 50' deep; in cluster of workings east of abandoned trailer house near the International Boundary, in SE $\frac{1}{4}$  sec. 25.

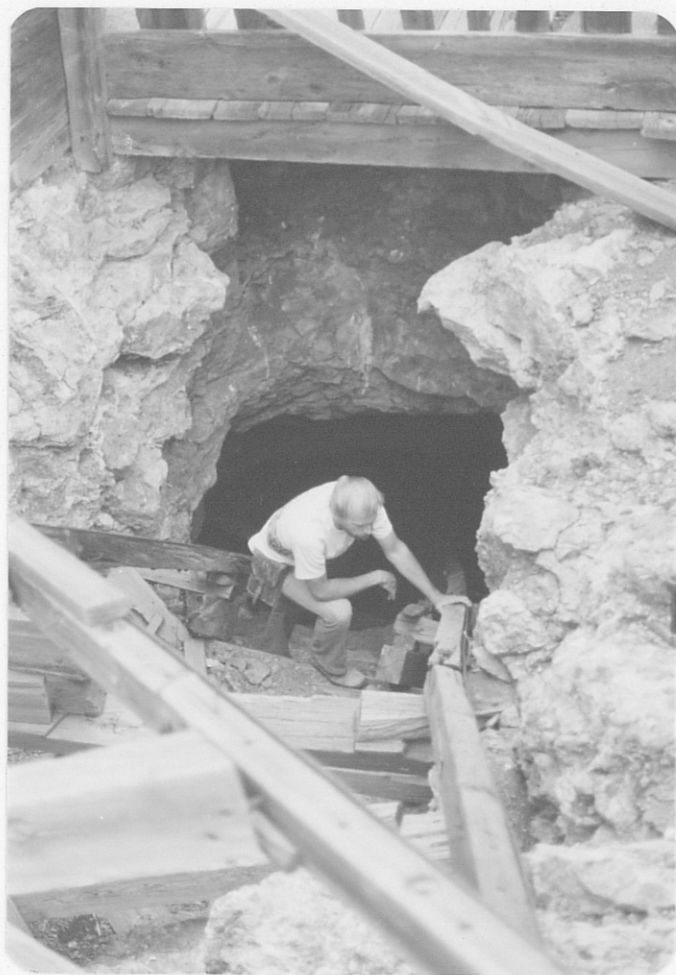
Photo (c) Entrance to 30° decline with a due east heading; workings are 100' west of shaft shown in photo (b).

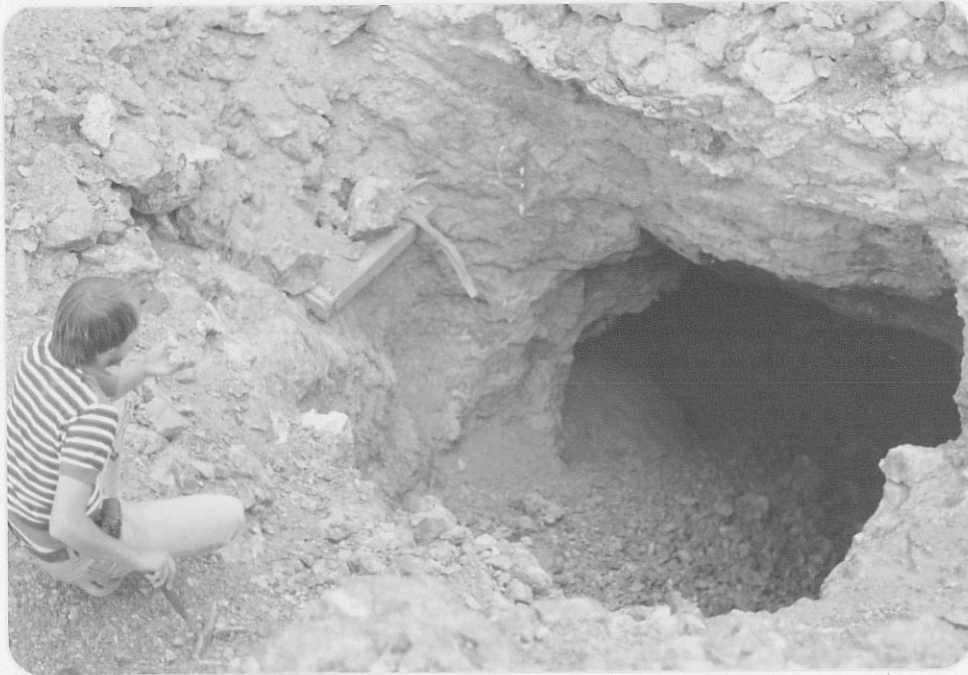
Photo (d) In 8' x 12' open pit with small decline at east face; underground workings only 10' - 12' long. Area is immediately south of decline shown in photo.

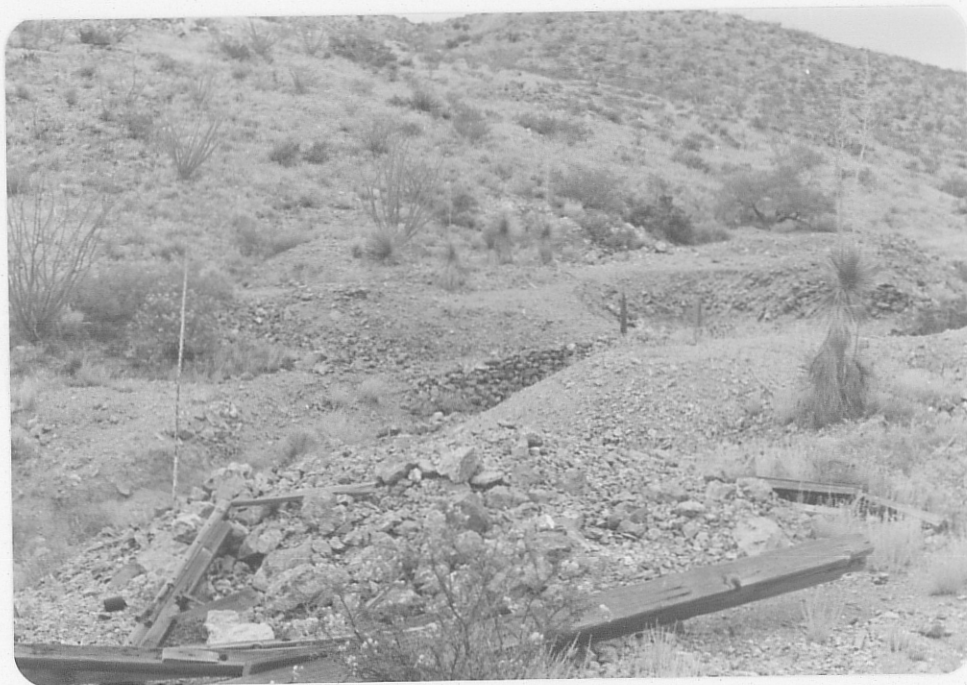
Photo (e) Tailings dump from workings shown in photos (c) and (d).

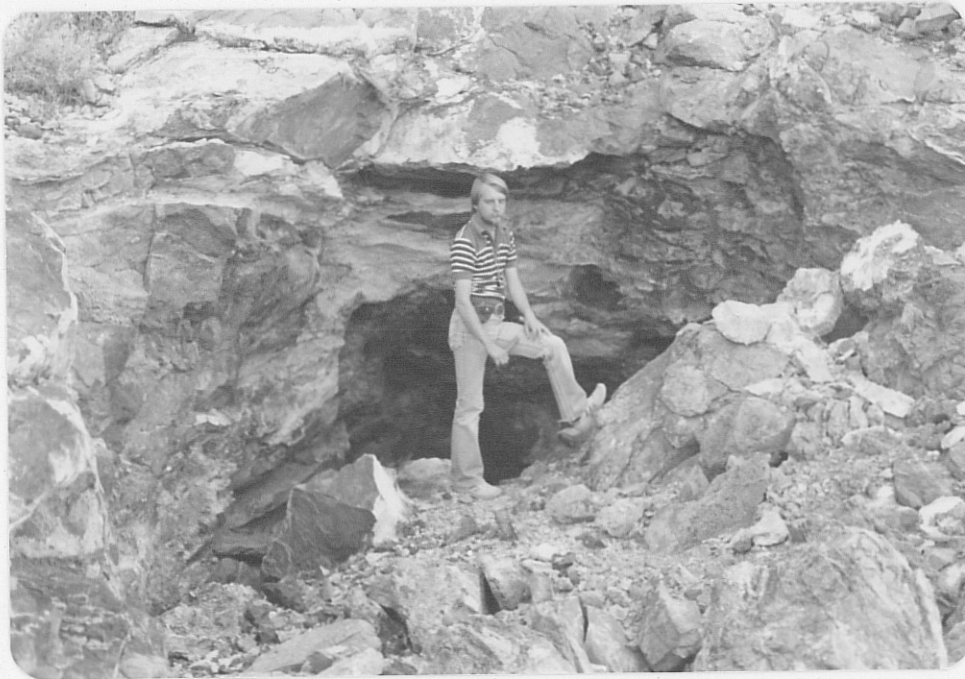
Photo (f) Small inclined shaft, 5' x 6', in E $\frac{1}{2}$  SE $\frac{1}{4}$ , sec. 25.

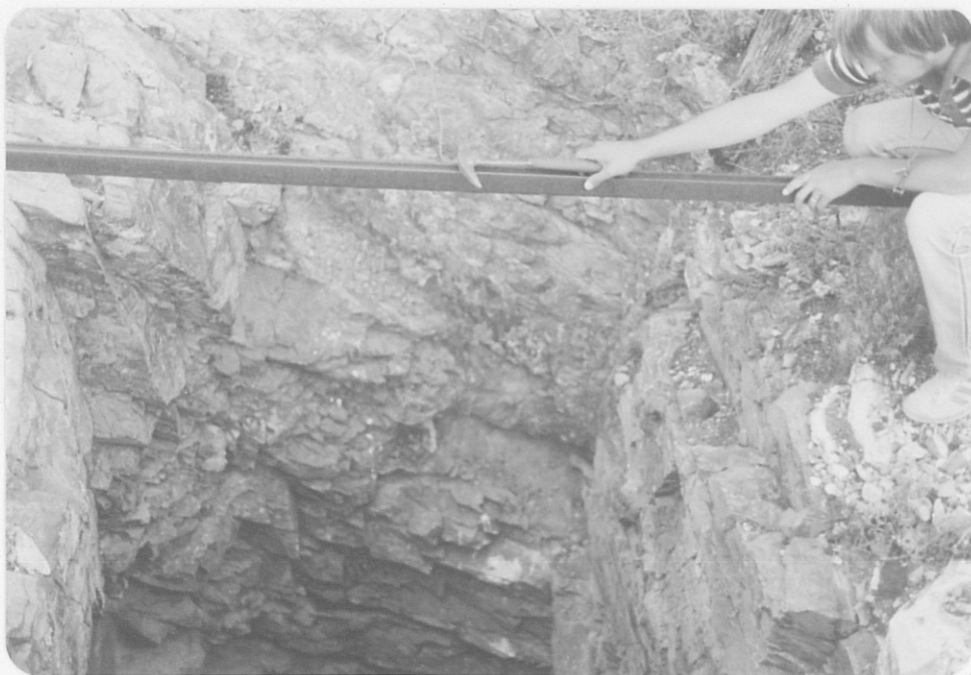
Photo (i) Vertical shaft, 6' x 6', at least 50' deep, in E $\frac{1}{2}$  SW $\frac{1}{4}$ , sec. 25.

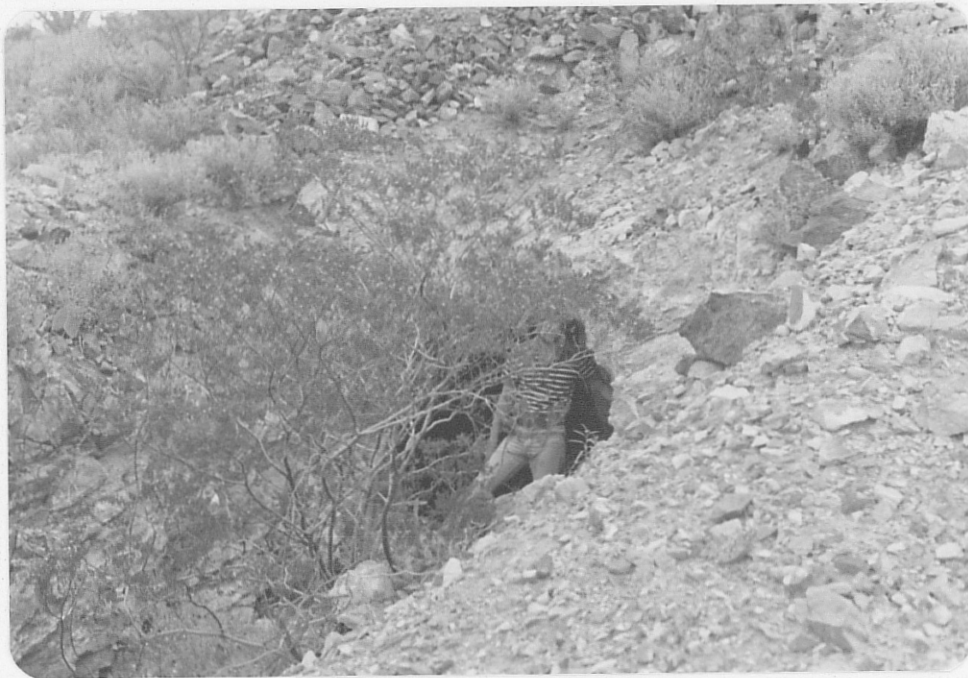
Photo (j) Small adit with a heading of  $335^{\circ}$ , portal 5' high, 6' wide, in  $E\frac{1}{2}$   $SW\frac{1}{4}$ , sec. 25. Ore in tailings pile is iron rich.
