Abandoned Uranium Mine Assessment for the F33 Site (NM0057)

FINAL REPORT

NM0057

October 5, 2010

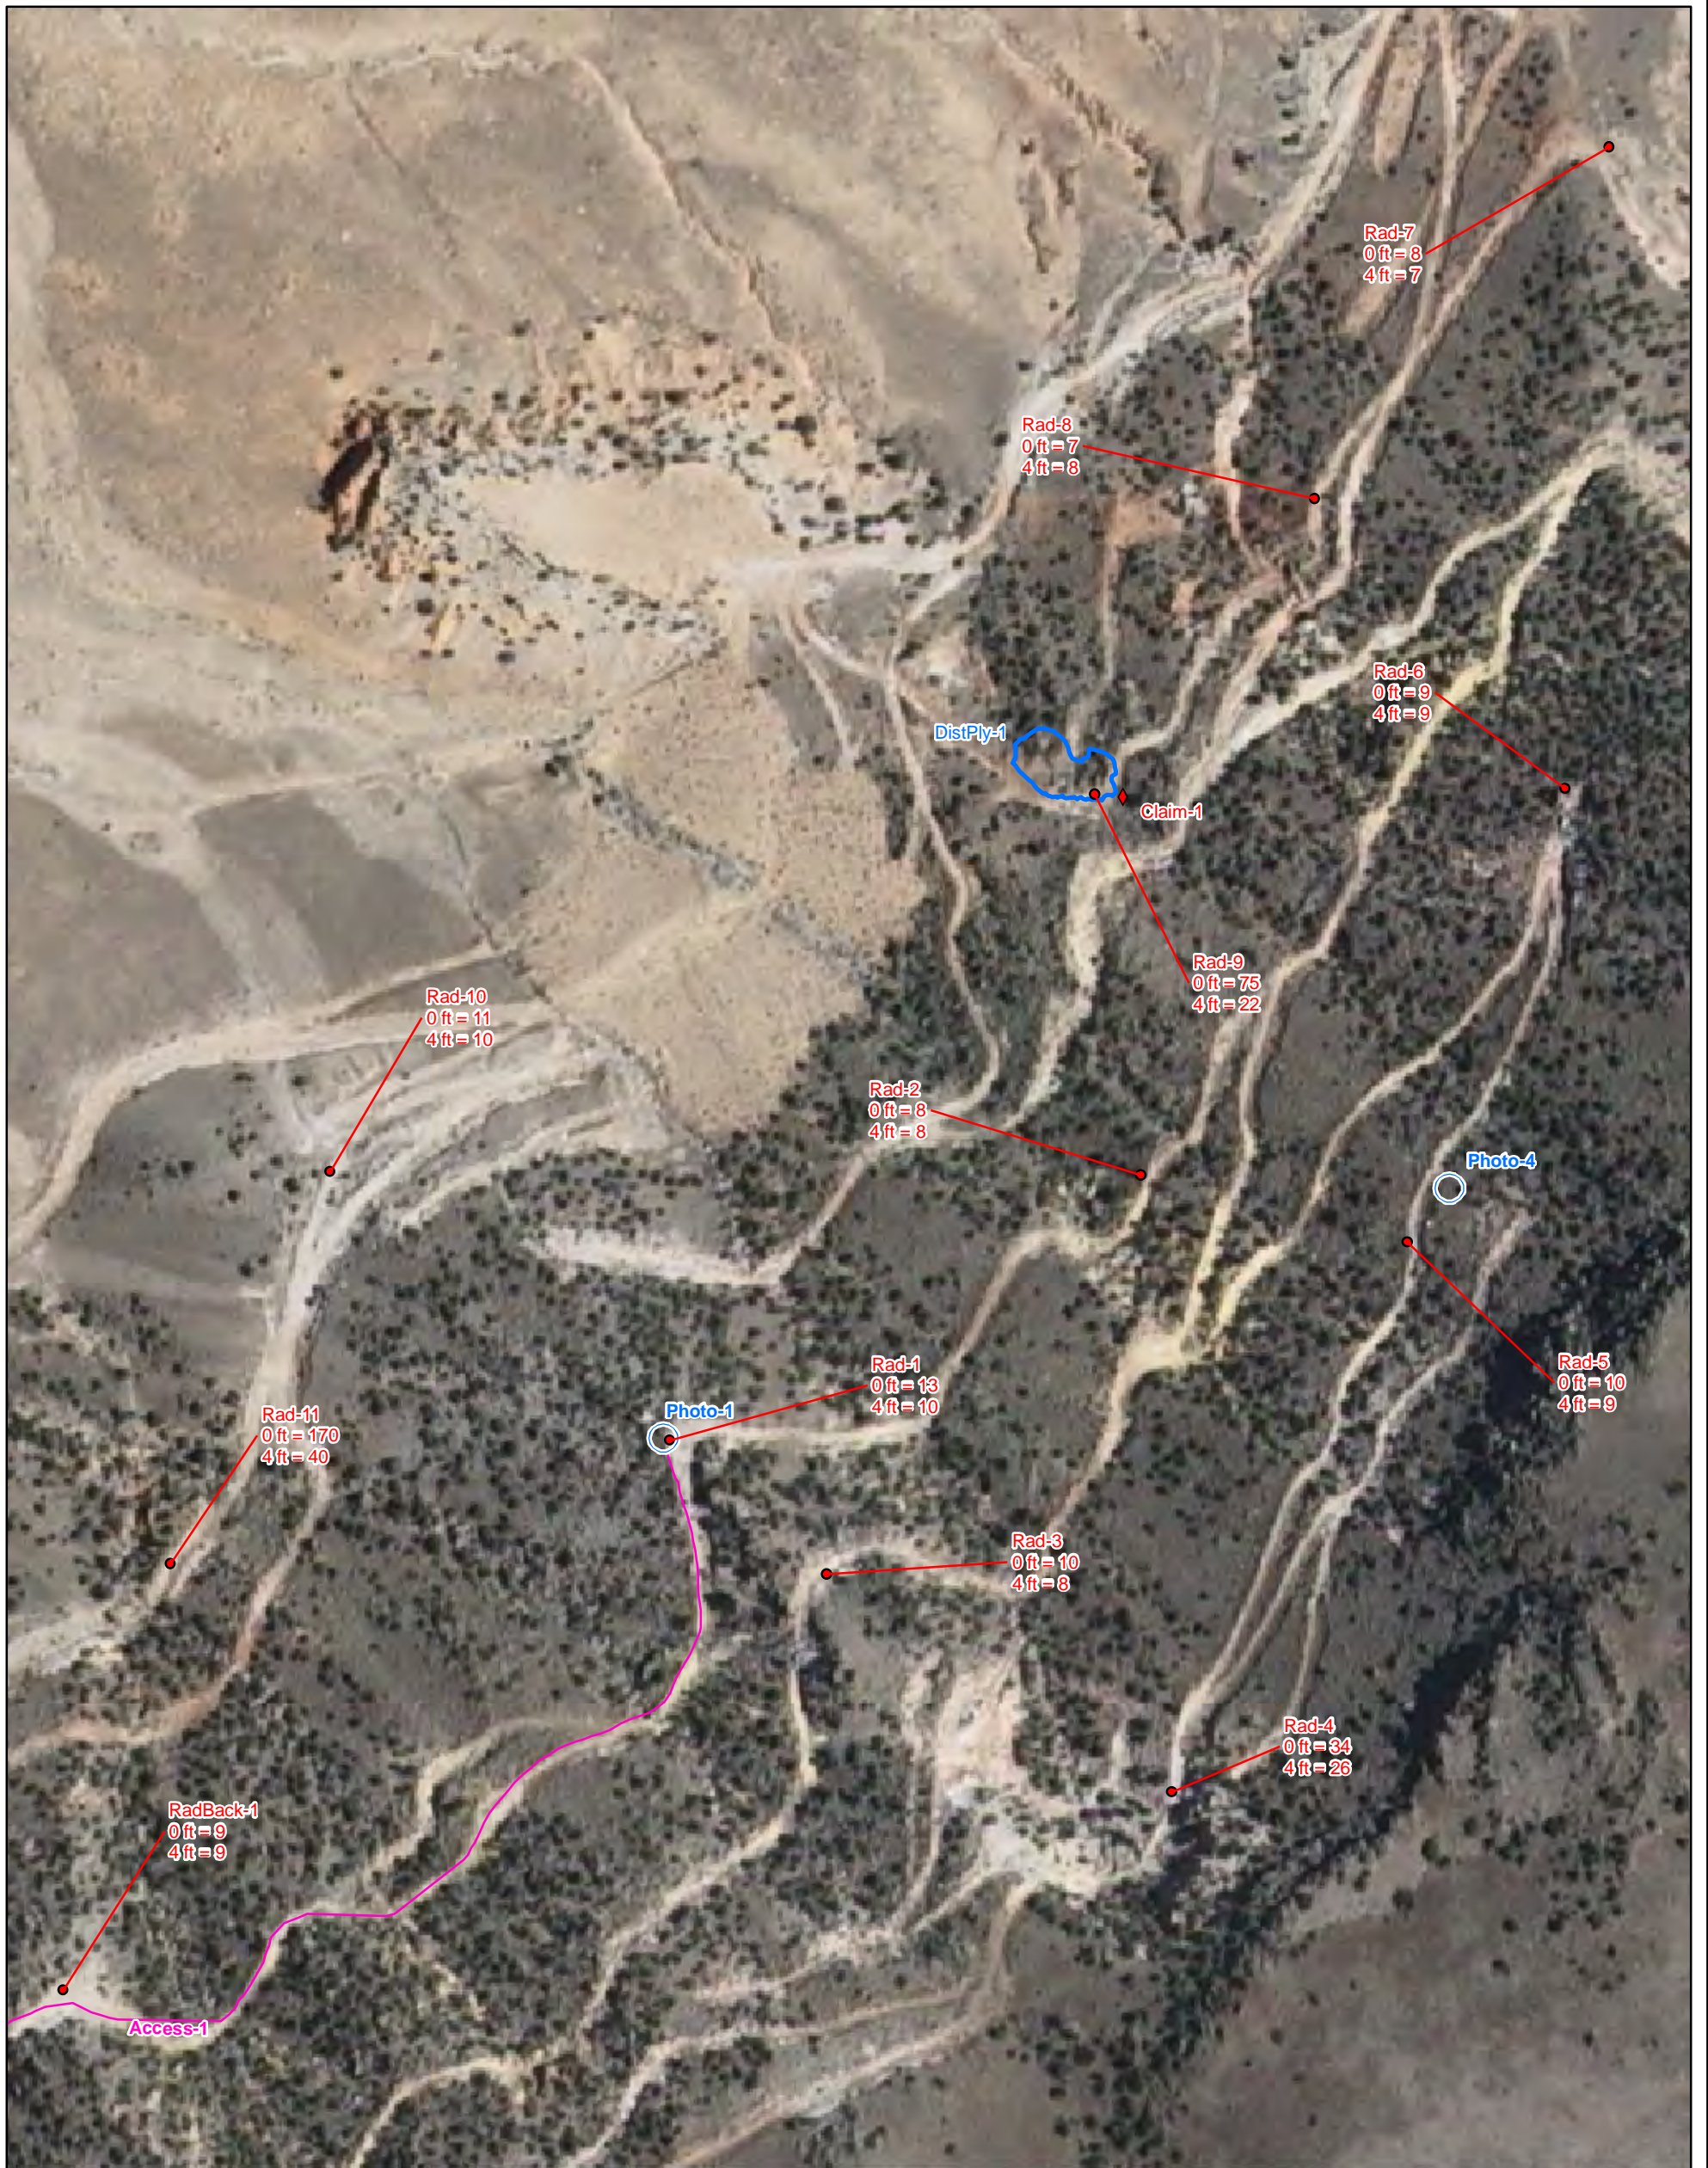
Figure 4a
Site Map on
Aerial Photo
NM0057-F33
 Abandoned Uranium
 Mine Assessment

The mine features described below are based on the features provided to INTERA by MMD in the GIS Data Dictionary (MMD, 2009). INTERA marked the locations of the AUM Site features using a Trimble Global Positioning System (GPS), and entered details about the features into the GPS using the MMD data dictionary. One claim and one disturbed area were found onsite. Please see the Photo Log in Appendix A for photos of the AUM Site features, Table 1 for a list of the AUM Site features, and Figures 4a and 4b for the locations of the AUM Site features.

One background gamma radiation reading was taken approximately 0.2 miles southwest of the AUM Site, recording 9 $\mu\text{R/hr}$ at 0 ft above ground and 9 $\mu\text{R/hr}$ at 4 ft above ground. Please see Table 2 for all of the gamma radiation readings taken at the AUM Site and Figures 4a and 4b for the locations of the radiation readings.

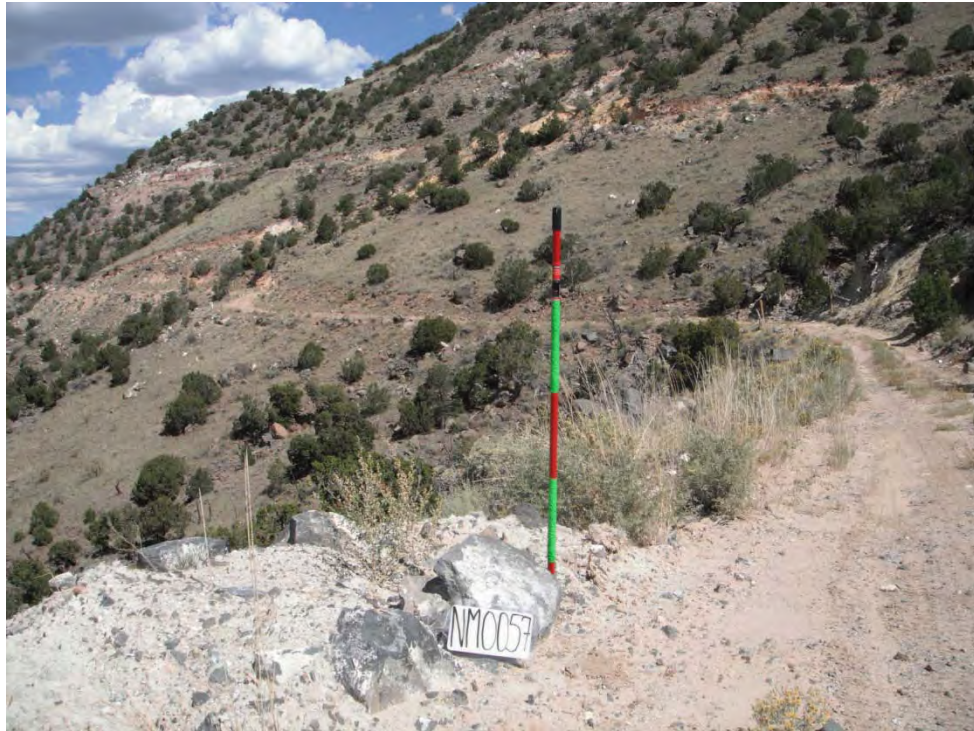
Photo 1- Looking east at AUM Site identification.

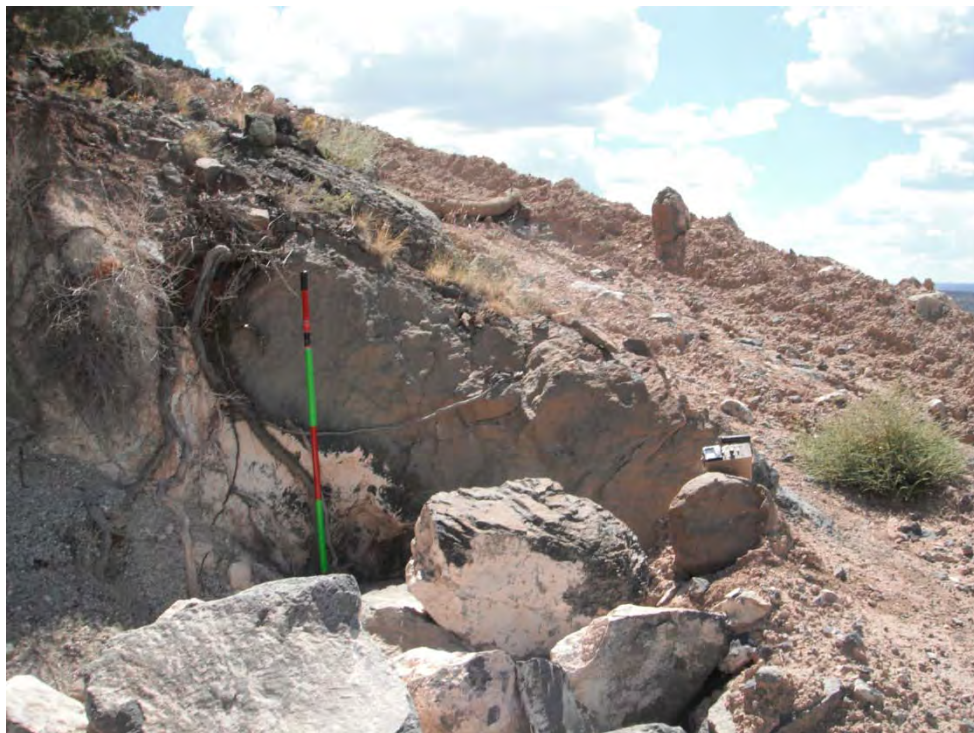
Photo 2-Looking west at radiation survey point Rad-3 (10 μ R/hr at 0 ft above ground).

Rad-3 - 0m - 10 nR/h; 1m - 8 nR/h; Photo 2; no apparent mine features

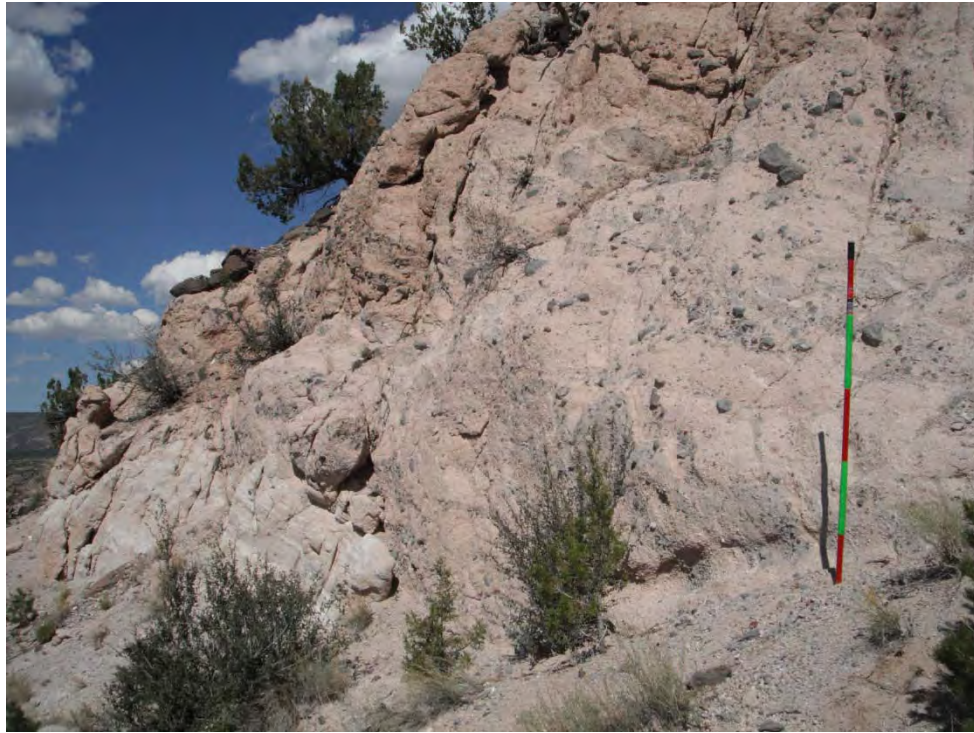
Photo 3- Looking south at radiation survey point Rad-4 (34 μ R/hr at 0 ft above ground).

Rad-4 - 0m - 34 nR/h; 1m - 26 nR/h; Photo 3

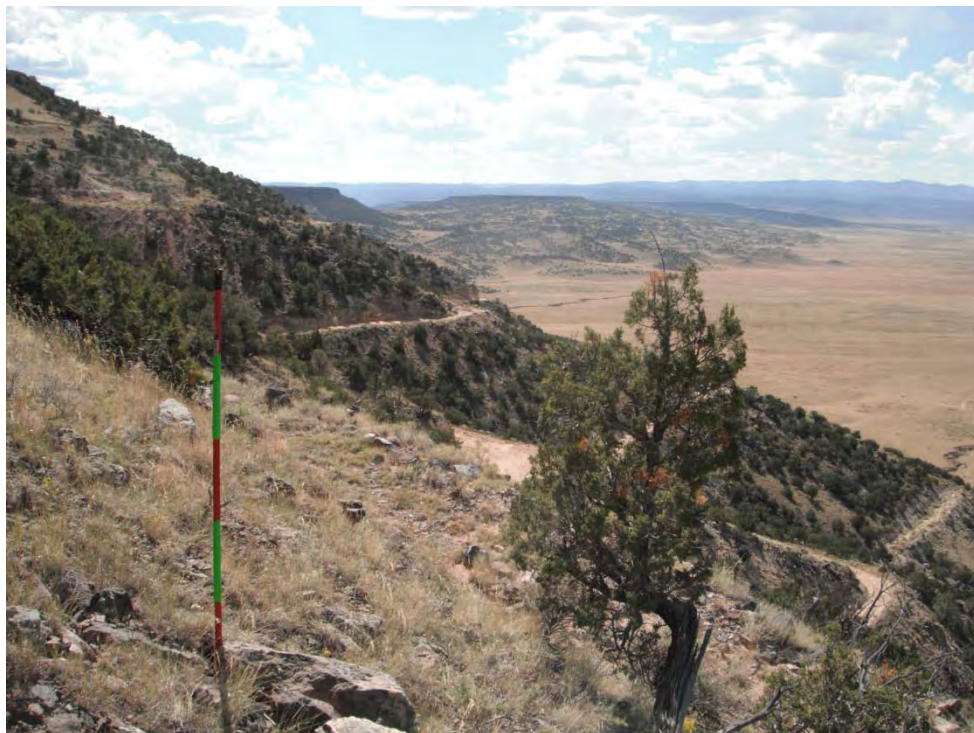
Photo 4-Looking west at MMD provided polygon area.

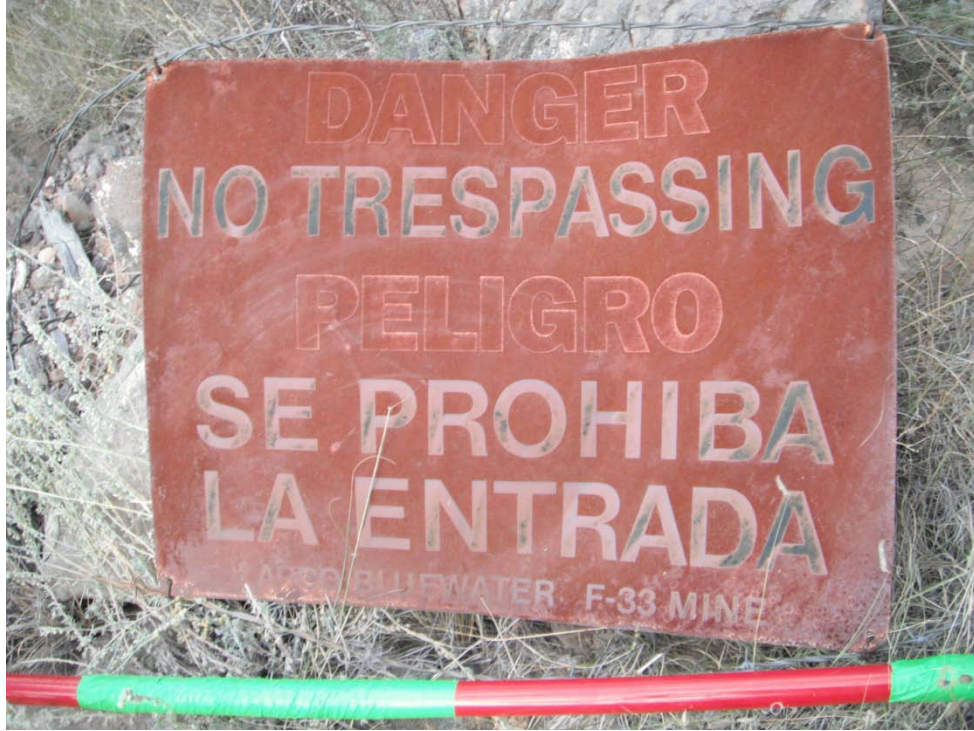
Photo 5-Looking east at Claim-1.

59 9/16/10 NT Abandoned Uranium Mines
Claim-1 - Metal sign "Danger No Trespassing, Peligro Se
Prohíbe La Entrada, Arco Bluewater F-33 Mine"
1' tall, 2" wide, 0' long; attached to barbed wire
fence.

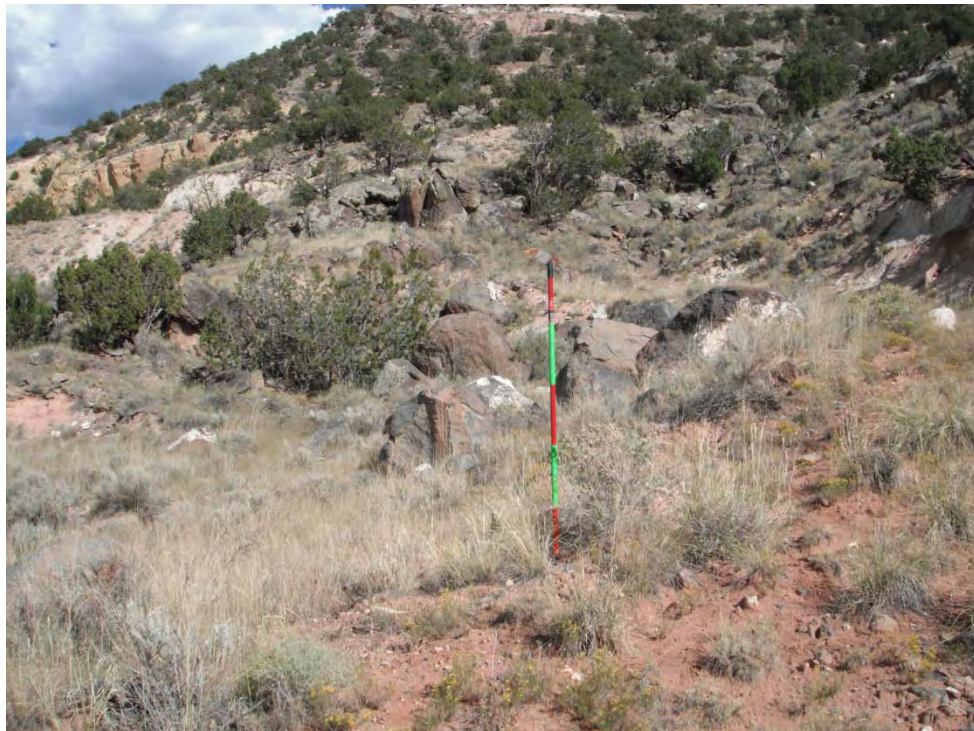
One disturbed area (DistPly-1) was found at the AUM Site. DistPly-1 appears to be a bulldozed area that consists of piles of soil and rock and graded areas. DistPly-1 is approximately 200 ft wide, 300 ft long. The maximum gamma radiation measurement for this feature was 75 μ R/hr at

0 ft above ground at radiation survey point Rad-9 (see Table 2). No ore piles or waste piles were evident at the AUM site.

Photo 6-Looking south at DistPly-1.

DistPly-1 - Possible area of mine site, near sign "Claim-1"
20" tall, 200" wide, 300" long

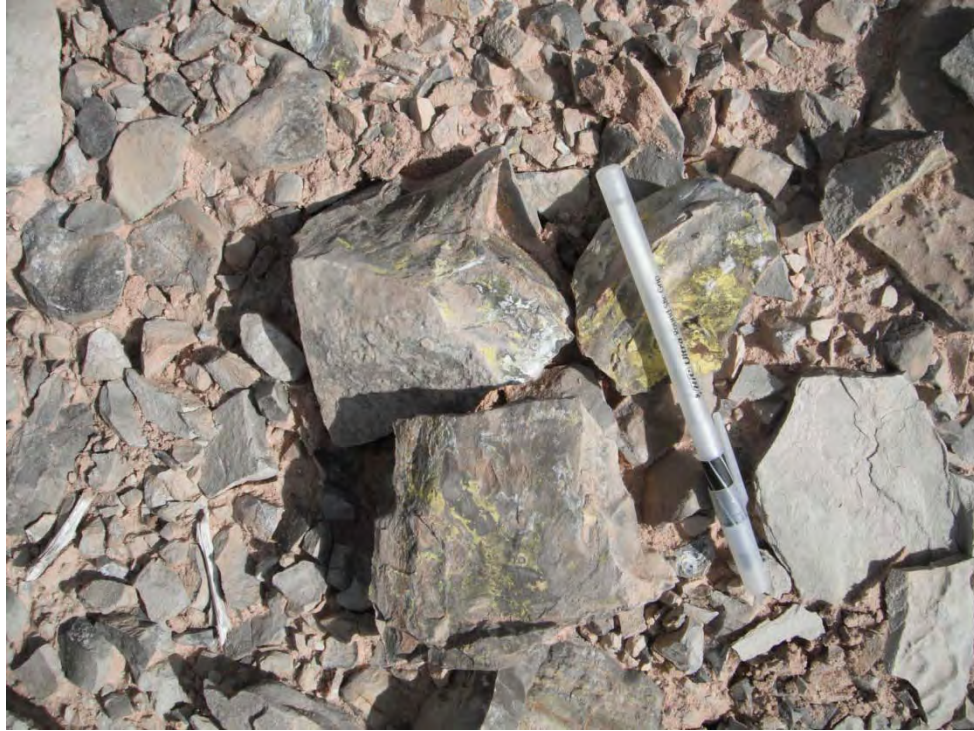
The maximum gamma radiation measured onsite was 170 $\mu\text{R/hr}$ at 0 ft above ground at radiation survey point Rad-11. Another notable radiation reading was 75 $\mu\text{R/hr}$ at 0 ft above ground at radiation survey point Rad-9, associated with DistPly-1.

Photo 7-Looking at radiation survey point Rad-11 (170 μ R/hr at 0 ft above ground).

Rad 11 - 0m - 170 mR/h; 1m - 40 mR/h - Photo 7

Photo 7 - Rad 11, ore deposit
