Abandoned Uranium Mine Site Assessment for the Osmer-Silver Site (NM0134)

FINAL REPORT

April 14, 2010

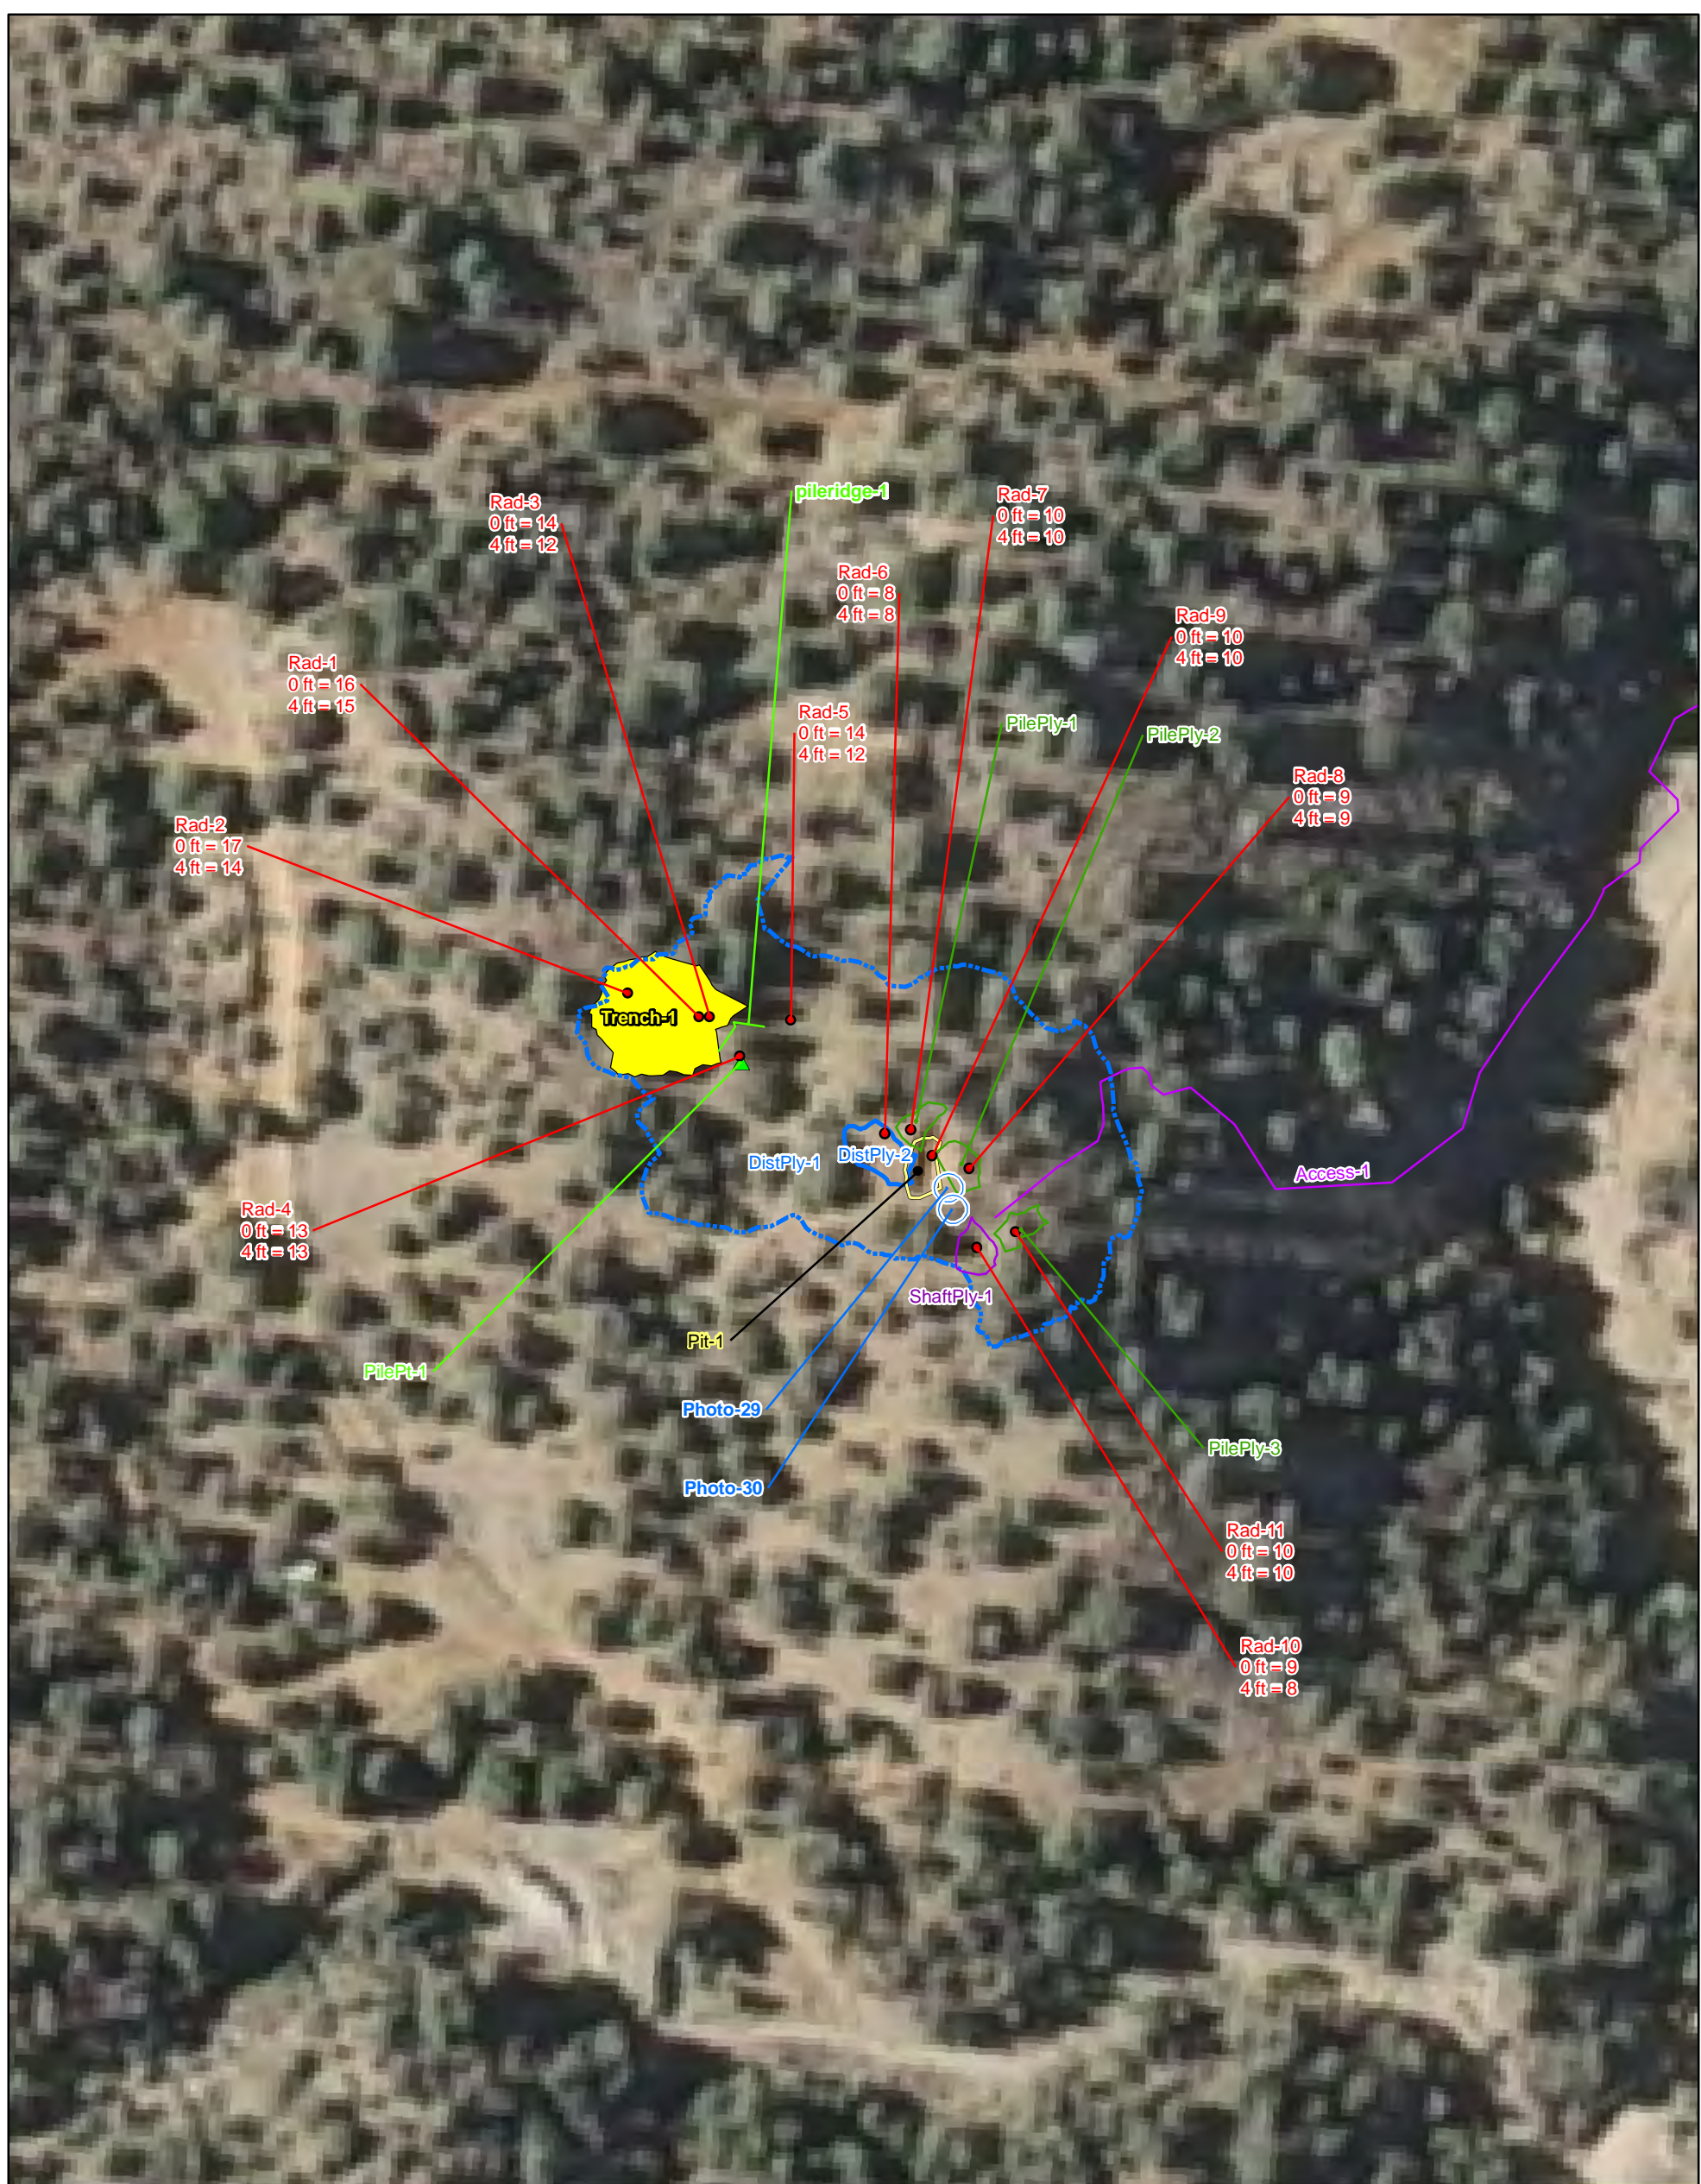
Figure 4a
Site Map on
Aerial Photo
NM0134-Osmer Silver
 Abandoned Uranium
 Mine Assessment

The mine features described below are based on the features provided to INTERA by MMD in the GIS Data Dictionary (MMD, 2009). INTERA marked the locations of the AUM Site features using a Trimble Global Positioning System (GPS) and entered details about the features into the GPS using the MMD data dictionary. The AUM Site consists of one shaft, one pit, one trench, and five piles. Please see the Photo Log in Appendix A for photos, Table 1 for a list of all AUM Site features, and Figures 4 for the locations of the AUM Site features. Note that the scale differs between Figure 4a (aerial photo) and 4b (ownership map) due to resolution on aerial photographs.

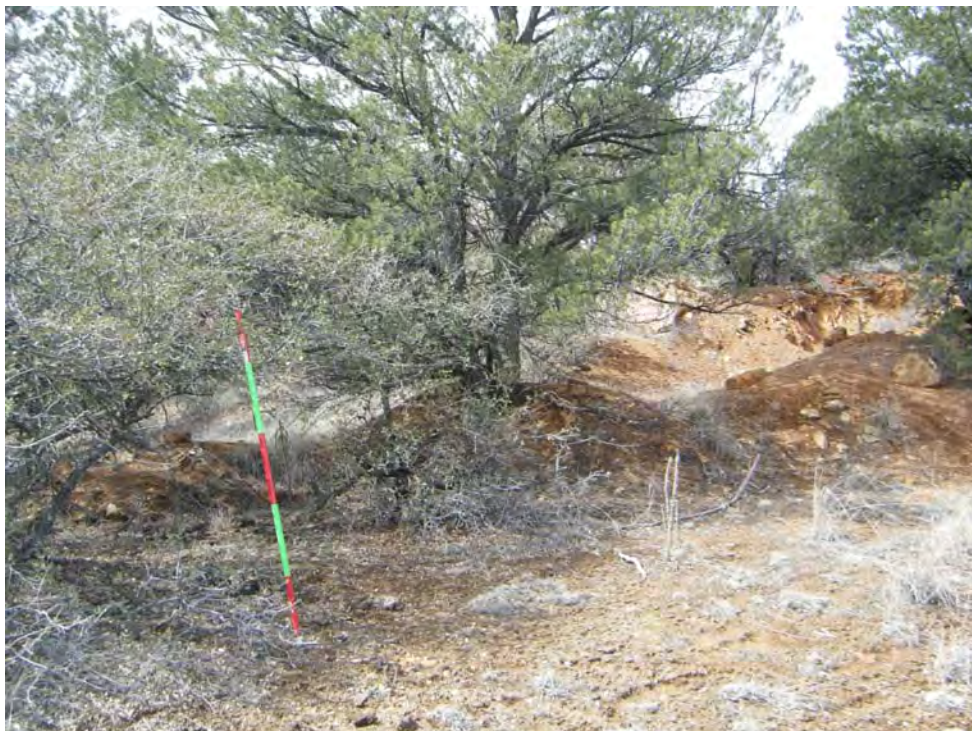
Photo 3-Looking north at the site with the trench in the background (Trench-1).

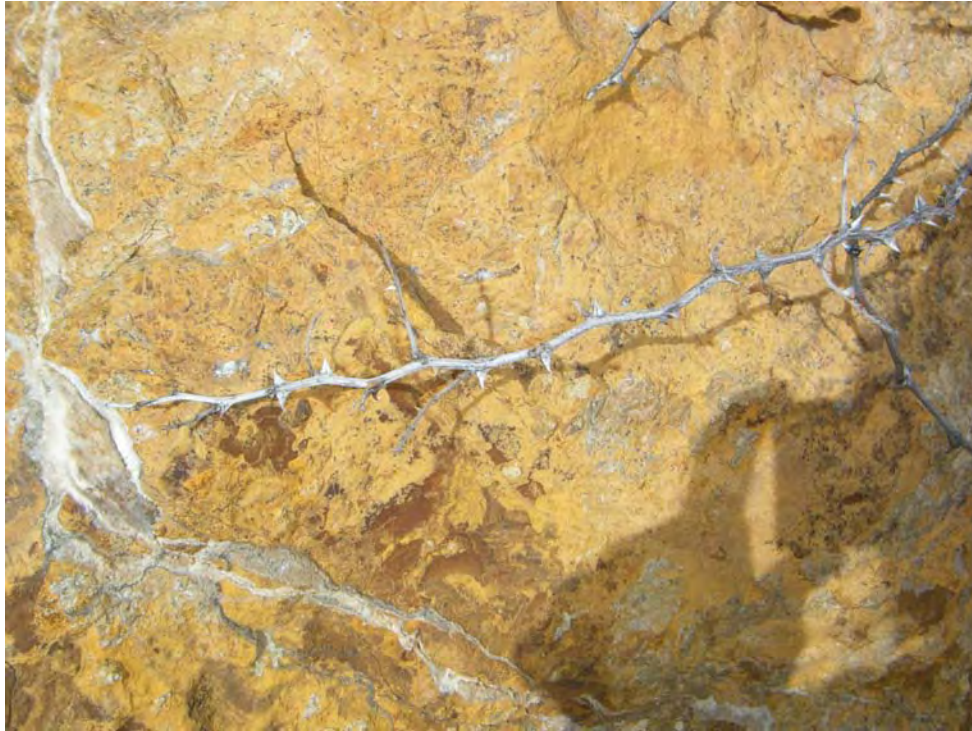
Photo 10-Vegetation at the AUM Site, the rock is similar to material in Trench-1.

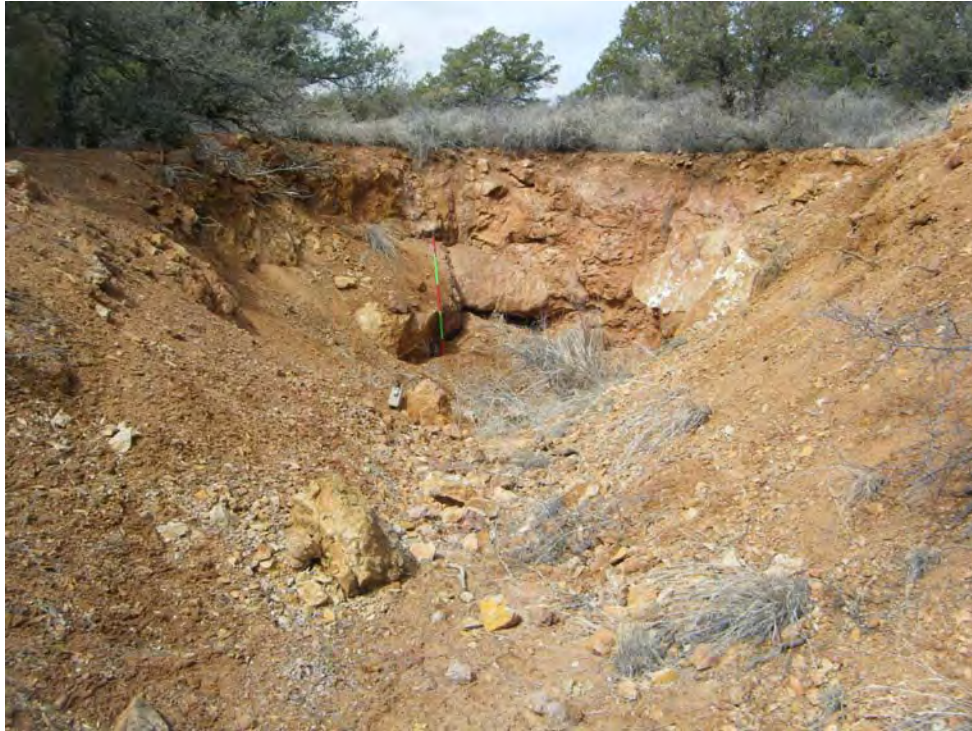
One open cut (Trench-1) was identified at the AUM Site. The cut was approximately 40 feet long, 15 feet wide, and 10 feet high. One exploration pit (PitPly-1) was also identified, near the shaft. The pit was approximately 20 feet long, 10 feet wide, and 5 feet deep.

Photo 14-Looking northwest at Trench-1.

Photo 14 - looking NW at Trench-1

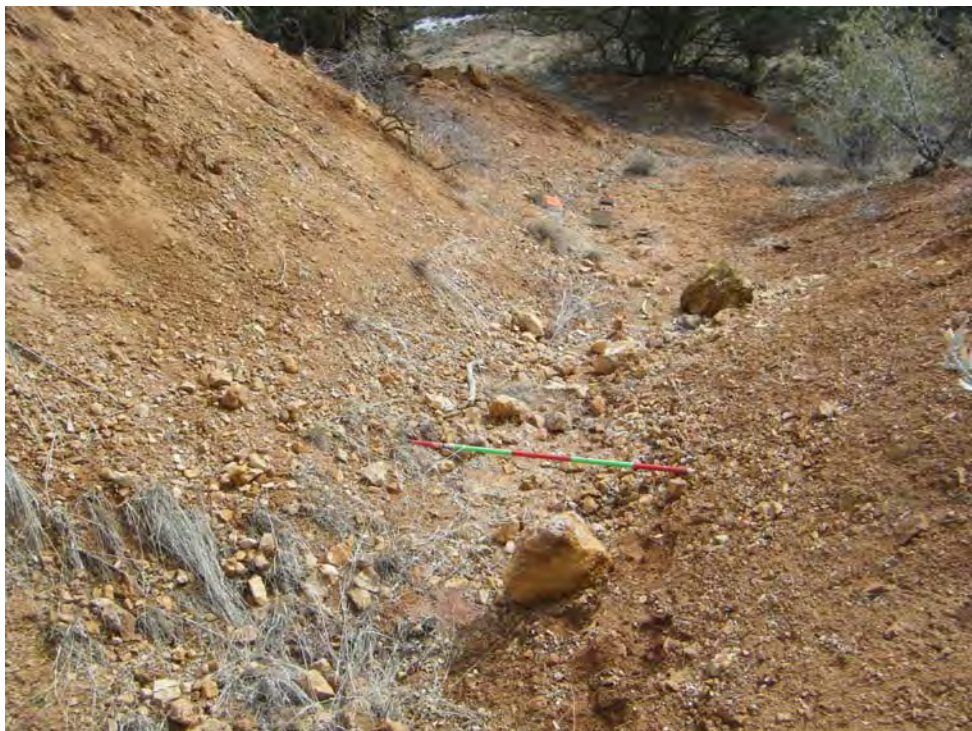
The gamma radiation readings at the AUM Site did not vary significantly above background levels. The highest gamma radiation readings were in the open cut (Trench1) and were measured at 17 $\mu\text{R/hr}$ at the ground surface and 14 $\mu\text{R/hr}$ at 4 feet above the ground surface. Please see Table 2 for details.

Photo 15-Looking southeast at Trench-1.

Photo 15 - looking southeast at Trench-1

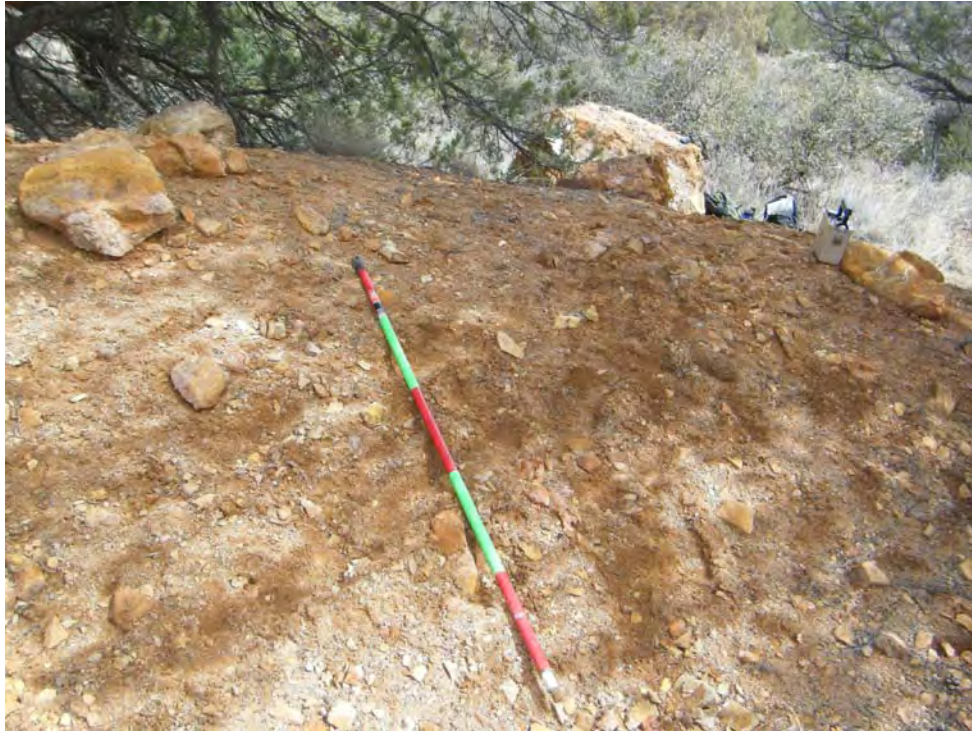
Photo 16-Looking northeast at Pileridge-1.

Pile Ridge-1 - At entrance to Trench-1
4' high, 20' long,

Photo 16 - looking ne at piled ridge-1

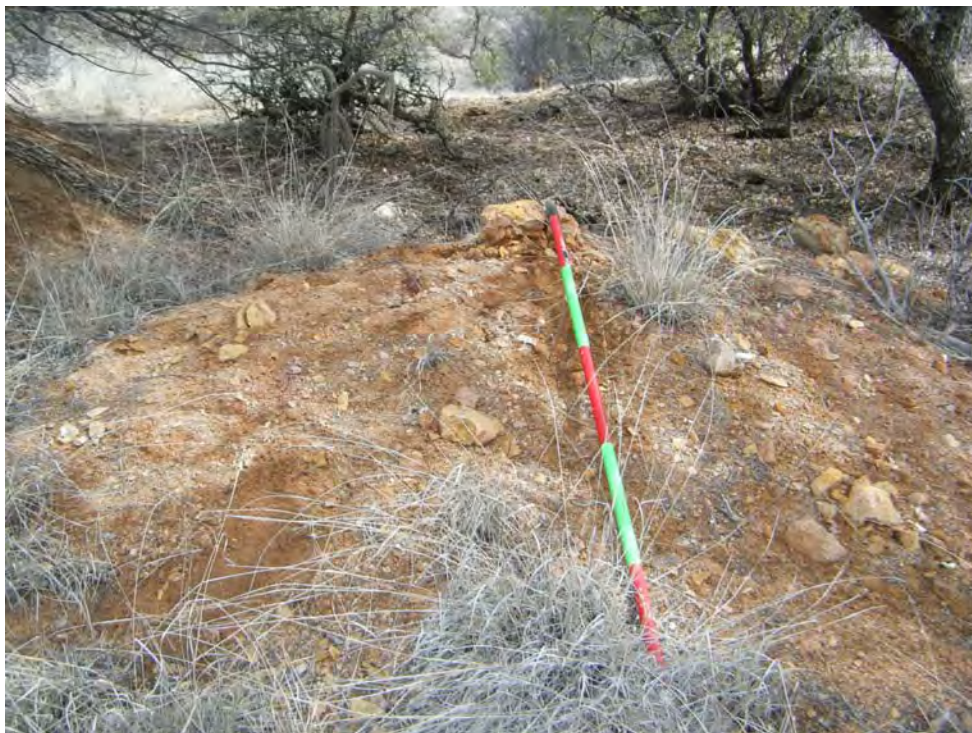
Photo 17-Looking east at Pileridge-1.

Photo 17 - looking east at pile ridge-1

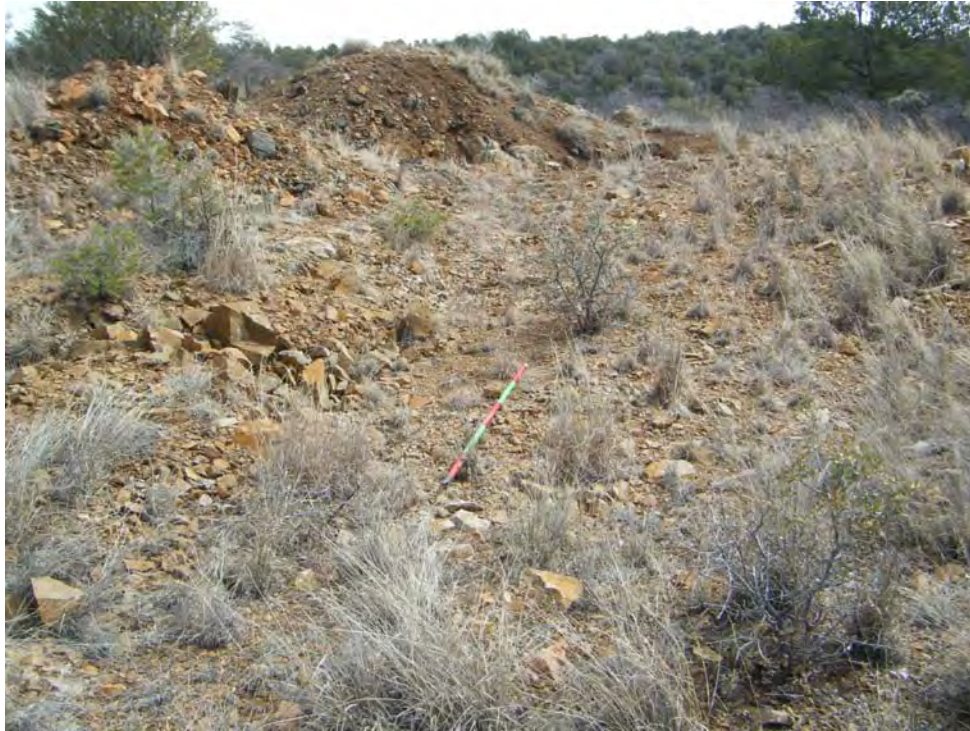
Photo 18-Looking east at DistPly-2, PilePly-1 and PilePly-2 are in the background on the left.

Dist Ply 2 - Bulldozed area, west of Pit-1

35' long, 20' width

Photo 18 - looking ^{NE} east at Dist Ply 2

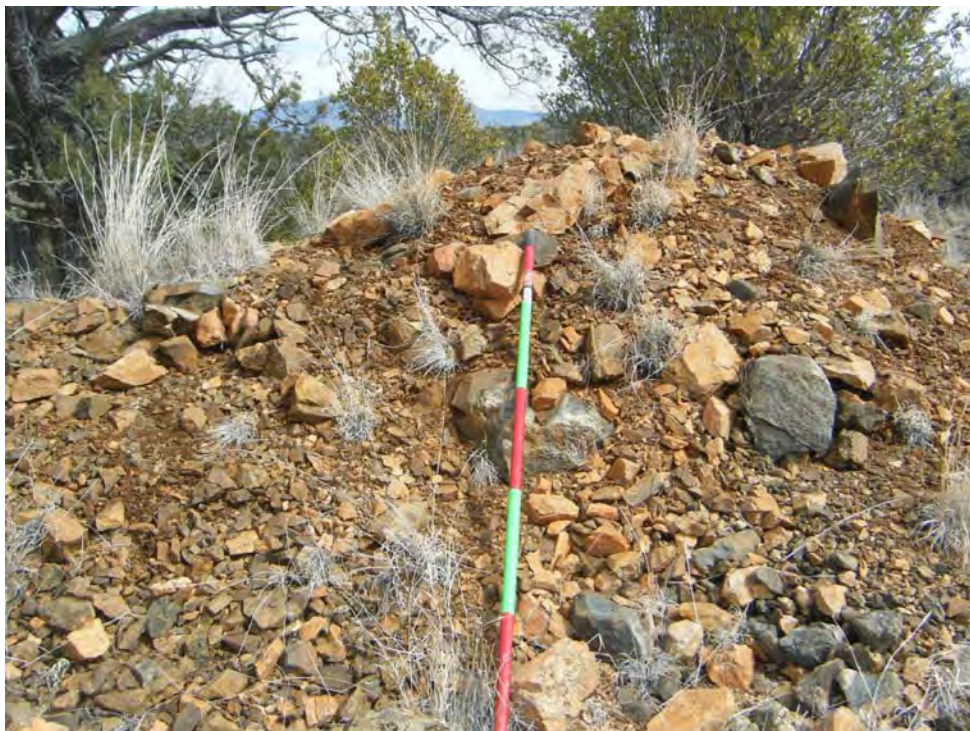
Photo 19-Looking north at PilePly-1.

Pile Ply 1 - 4' high, 15' long, 20' wide

Photo 19 - looking north at pile ply 1

Rad 7 - on Pile Ply 1 - Om - 10 MR/hr; 1m - 10 MR/hr

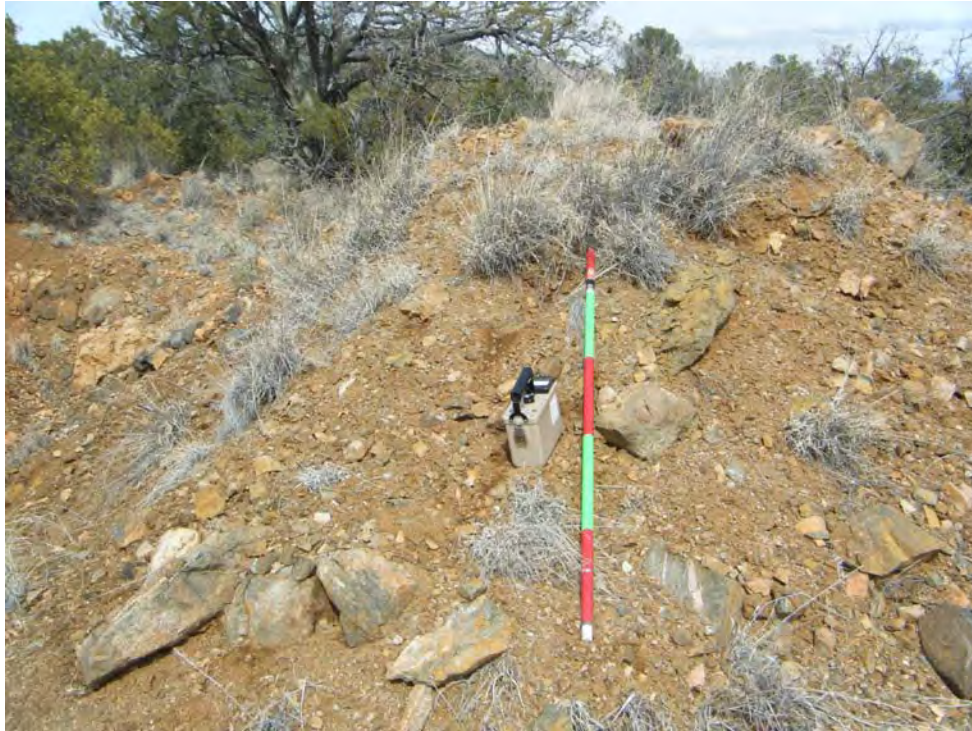
Photo 20-Looking north at PilePly-2.

Pile Ply-2 - east of Pit-1; 5' high; 18' long, 16' wide

Photo 20 - looking ^{north to alt} south at Pile Ply-2

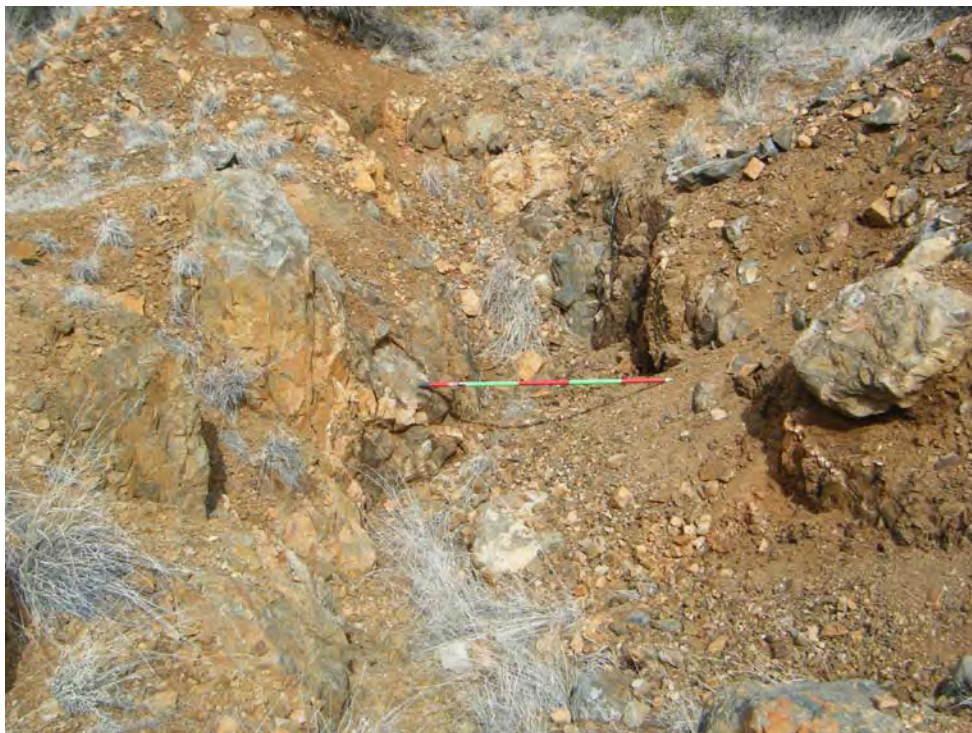
Photo 21-Looking north at Pit-1.

Pit Ply 1 - 5' high; 20' long, 10' wide

Photo 21 - looking north at Pit Ply 1

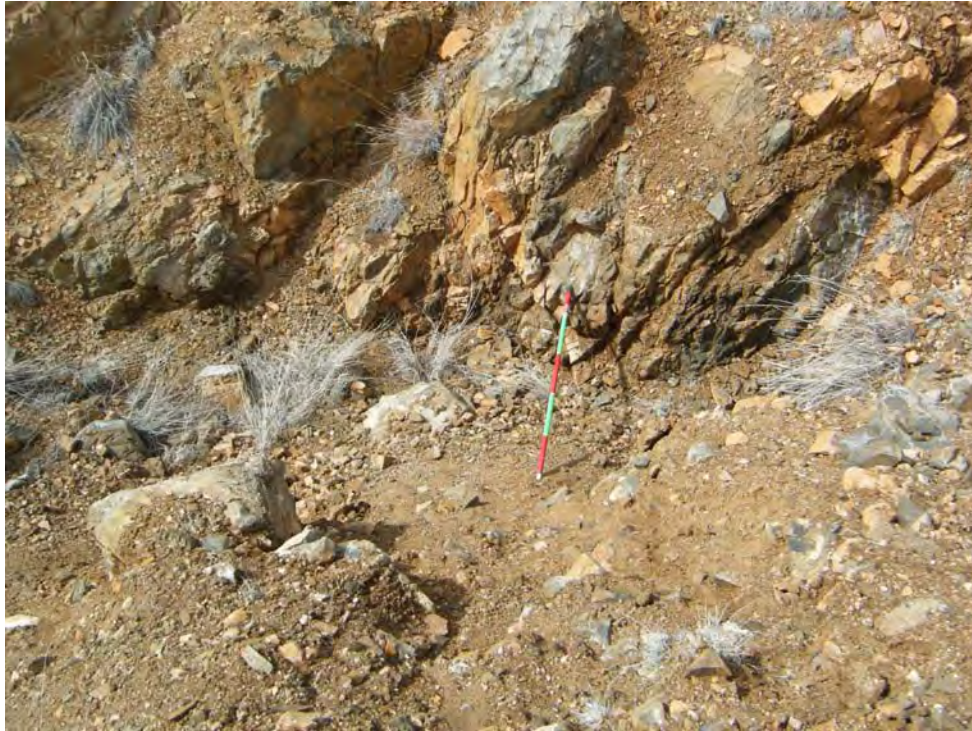
Photo 22-Looking west and down at Pit-1.

Photo 22 - looking west at pit Ply 1

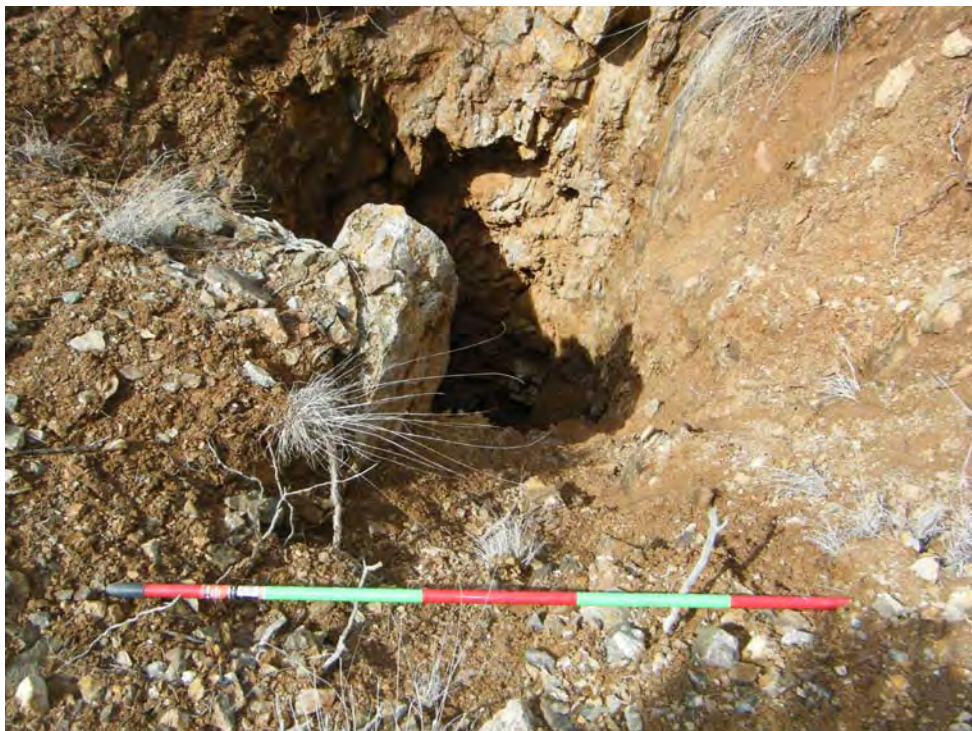
One shaft was found on the AUM Site, it was estimated to be approximately 50 feet deep (Shaft-1) and had a 5 foot diameter. McLemore reports that the shaft is approximately 40 feet deep (McLemore, 1983). A few pieces of old timber were near the shaft opening. The shaft is open at the ground surface.

Photo 23-Looking north at ShaftPly-1.

Shaft Ply-1 - 5' diameter shaft, more than 50' deep
(unknown depth), a few old pieces of timber
are near by

Photo 23 - looking north at shaft Ply-1

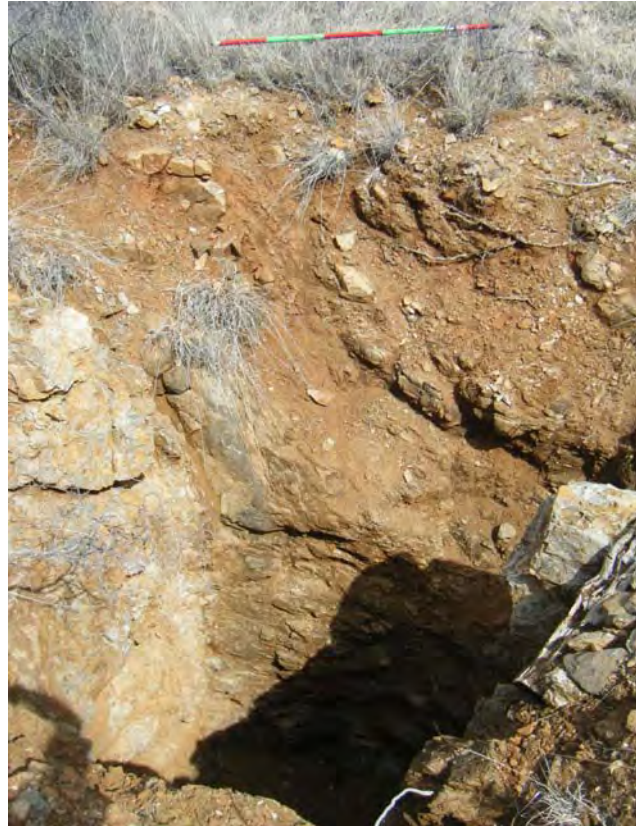
Photo 24-Looking north at ShaftPly-1.

Photo 24 - looking north at shaft Ply-1

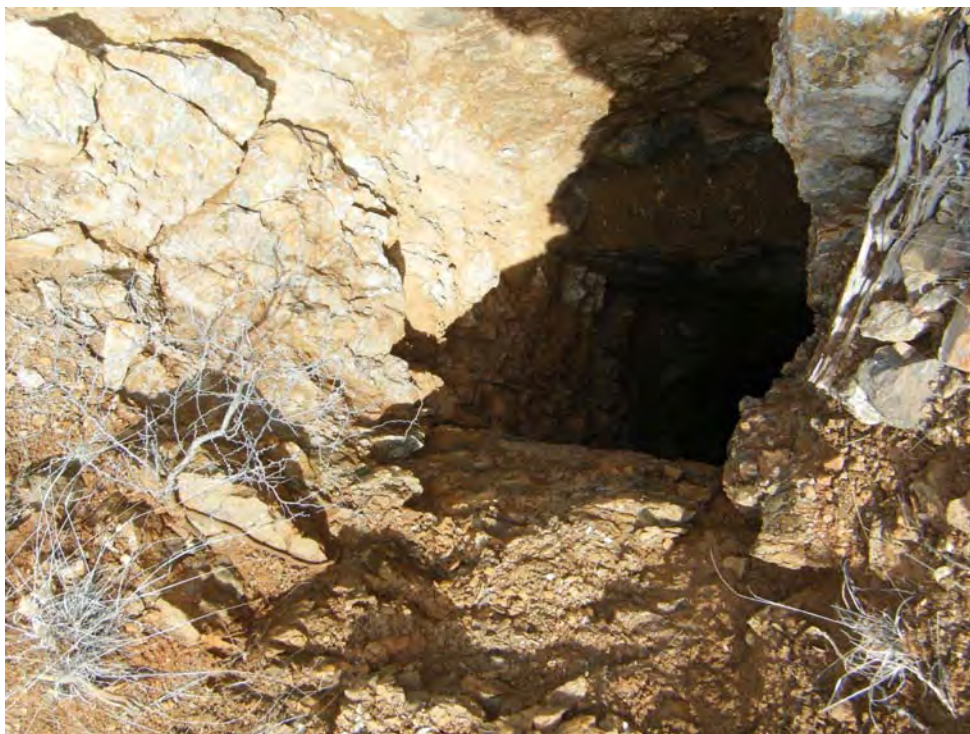
Photo 25-Looking down into ShaftPly-1.

Photo 25 - looking down into shaft Ply-1

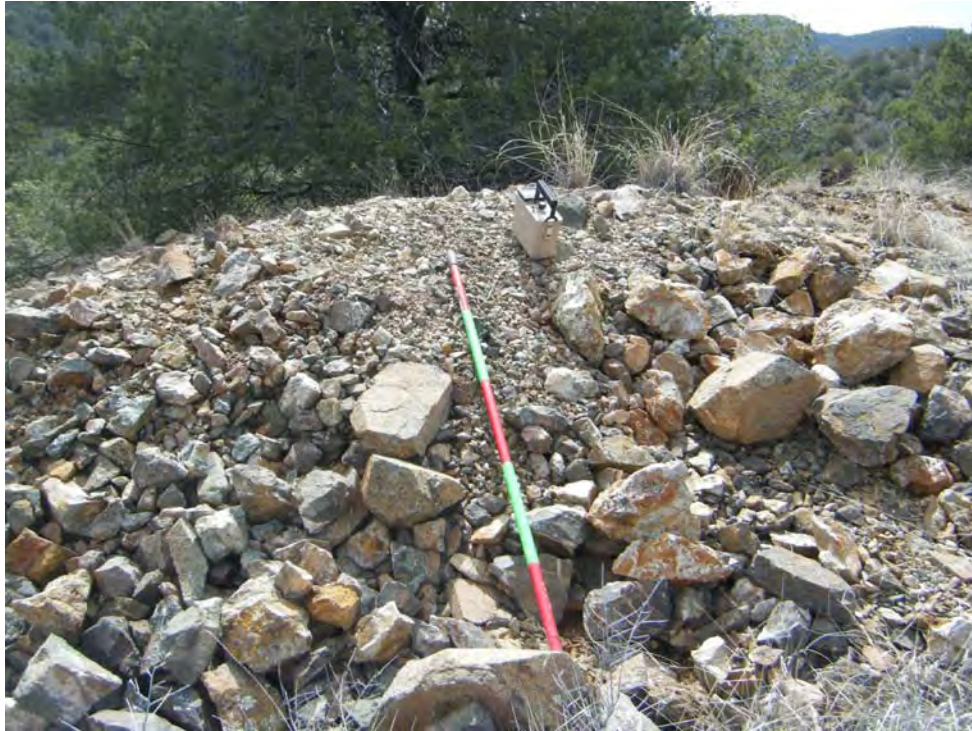
Photo 26-Looking southwest at PilePly-3 and Rad-11.

^{ALT} Pile Ply 3
~~Pile Pt-2~~ - east of shaft Ply-1

4' high, 7' wide, 15' length

Photo 26 - looking south west at Pile Ply 3

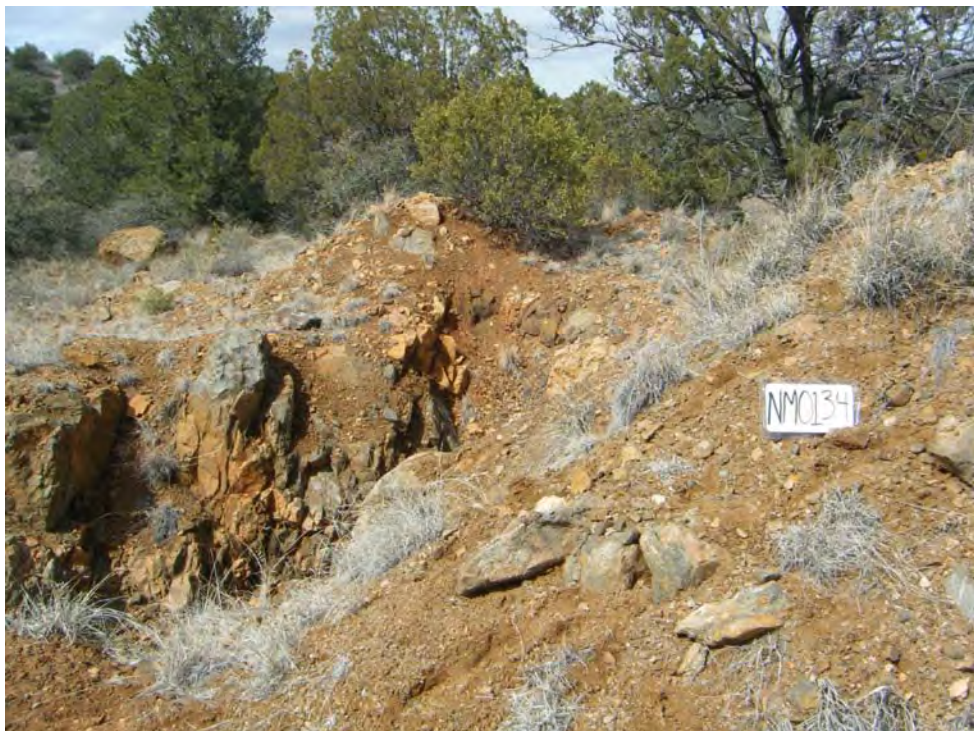
Photo 29-Looking northwest at the site location, Pit-1 in on the left.

Photo 29 - looking northwest at site location

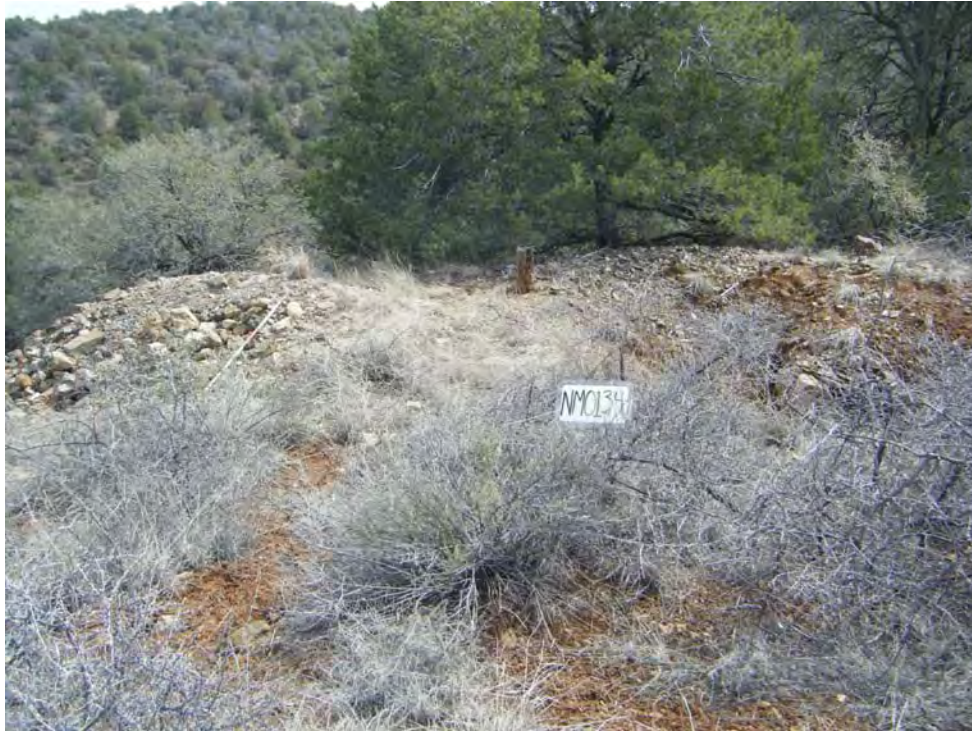
Photo 30-Looking southeast at the site location, ShaftPly-1 is on the right and PilePly-3 is on the left.

Photo 30 - looking south east at site location

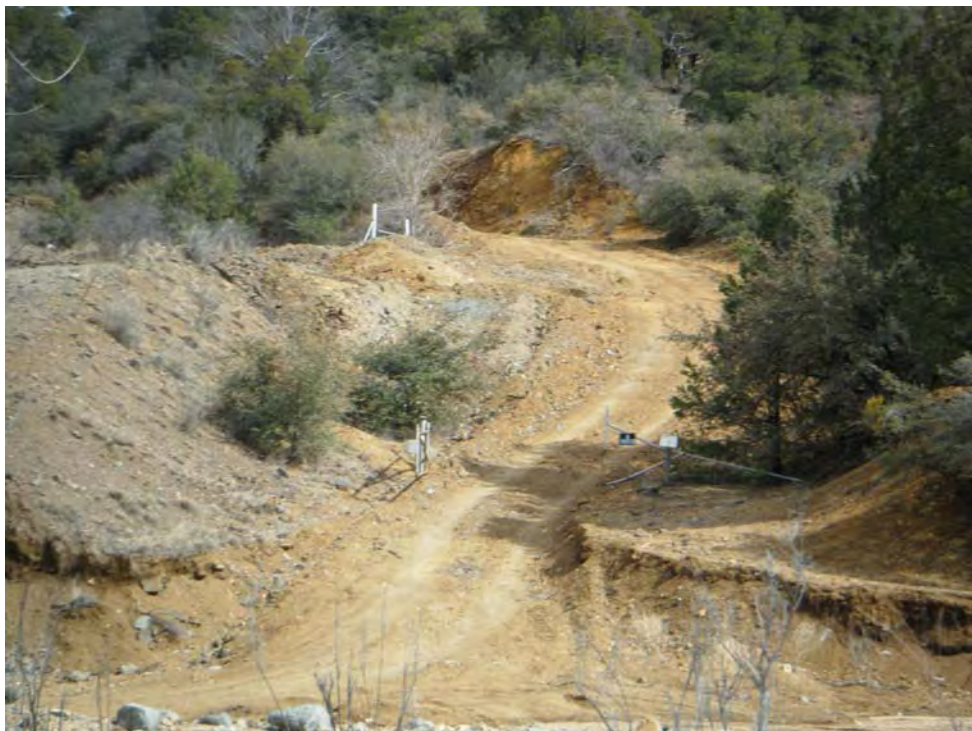
Photo 31-Looking south-southeast at road with private/no trespassing signs.

Photo 31 - looking S-SE at road (assumed access
road) with private/no trespassing sign
