NEW MEXICO
ENVIRONMENT DEPARTMENT

Subject: Pre-CERCLIS Screening Assessment of Flea Mine, McKinley
County, New Mexico: Further action under CERCLA
recommended

Site name	Flea Mine				
City	not applicable	State	New Mexico	Zip code	not applicable
County	McKinley				
Latitude	35° 20' 27.51"	Longitude	107° 48' 20.64"

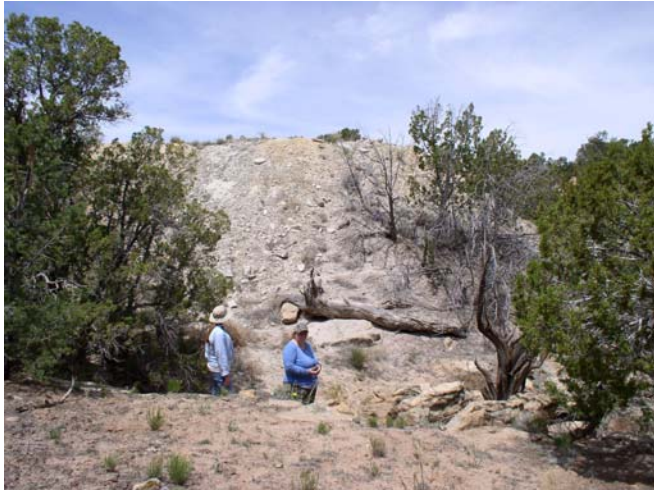
P1: Flea Mine waste pile at end of mine disturbance, eroding into arroyo.

1. Remove waste with elevated radioactivity.
2. Plug open shaft.

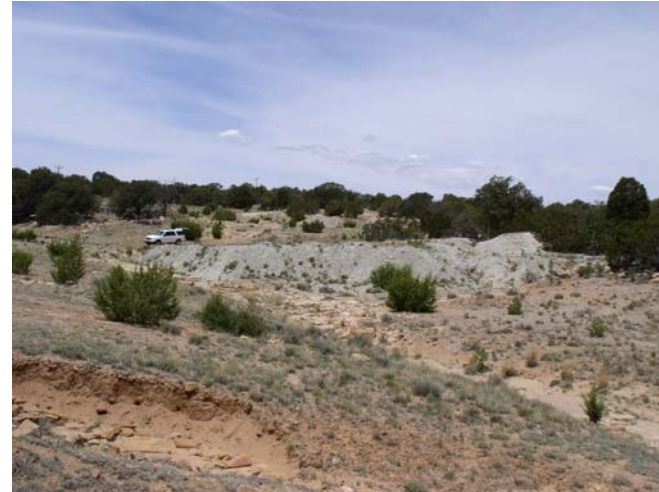
P2: Flea Mine waste pile bordering arroyo

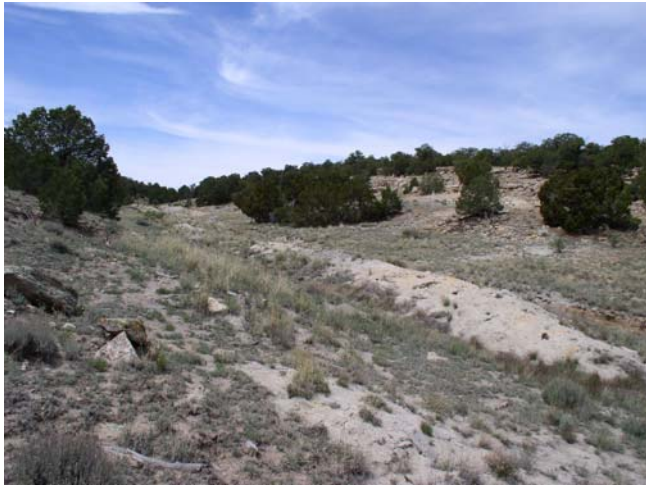
P3: Flea Mine waste pile bordering arroyo
