Ponil Creek Restoration Project Final Report

(With Final Financial Numbers)

RFP: FY08-SWQB/NPS-001

Date: May 10, 2013

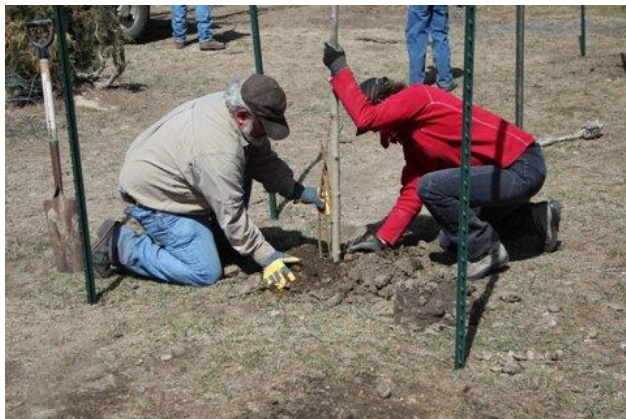
2013 Cottonwood Planting 1 – Alan Huerta and Julia Stafford

Also, 21 cottonwood poles were planted with mini-exclosures around each one. This does not include cottonwood plantings that were part of restoration treatments at the Low Water Crossings, Cut Banks, or the Head-Cut. The cottonwood pole plantings are doing better than expected, given the severe drought conditions in the area since they were planted. Many of them did not survive, most likely due to the record drought, but the survival rate was about 25%, which is better than we expected. In the spring of 2013, the CWA replanted fifteen of these cottonwoods that did not survive due to the drought

and rebuilt the mini-exclosures around the plantings.

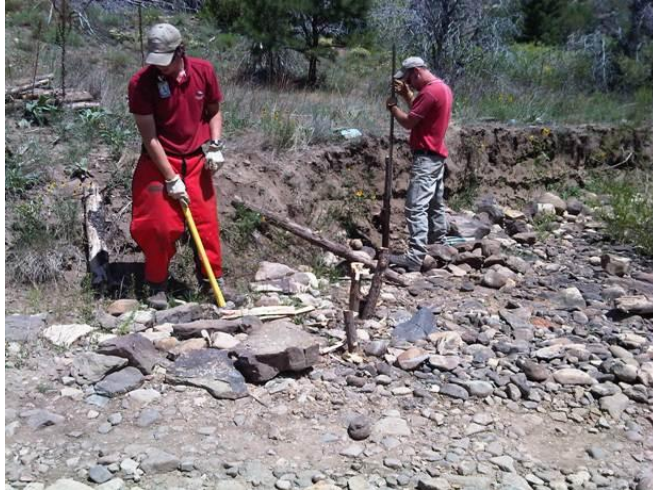
2011 – Philmont Conservation Crew installing post vanes Low-Water Crossing #3

Low Water Crossing #3 is 0.2 miles upstream from the Elliot Barker Wildlife Area on Vermejo Park Ranch. The instability at Low Water Crossing #3 consisted of an overly wide crossing and an actively eroding cut bank on river left. To reduce the width to depth ratio and relieve some of the near bank stress, in 2012 a series of post vanes were installed along the river left cut bank above and below the crossing, and this area was planted with willows. In 2013, a bankfull bench was excavated behind the post vanes to further reduce the near bank stress. Rolling water bars were constructed on the uphill approach to the crossing to reduce sedimentation from the road. Refer to Appendix A for photo documentation of the low-water crossings.

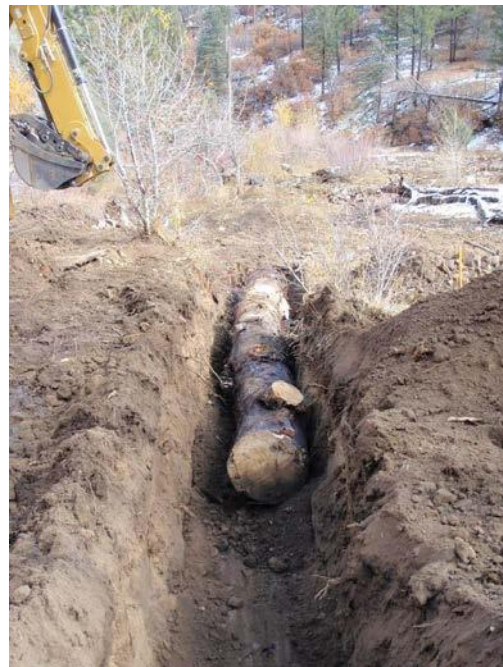
2009 – Rangeland Hands, Inc. Installing Log Vane

Restoration of the Head-Cut was completed in 2009. Restoration consisted of placing a large boulder baffle to deflect water back into the original channel and away from the Head-Cut that threatened to cause a cut-off meander. A series of log vanes were placed in the original channel to assist with stability of the original channel. A second cross section was established in 2011 just downstream from the Head-Cut and boulder baffle in a location that appears to be down cutting slightly. No down cutting was apparent from the re-survey of the cross section in 2012. This cross section will continue to be monitored annually to assess stability of the channel. Please refer to Appendix A for pictures of the Head-Cut restoration (Photo Point 3a) and Appendix A for a schematic of the Head-Cut restoration showing the two cross section locations and cross section data.

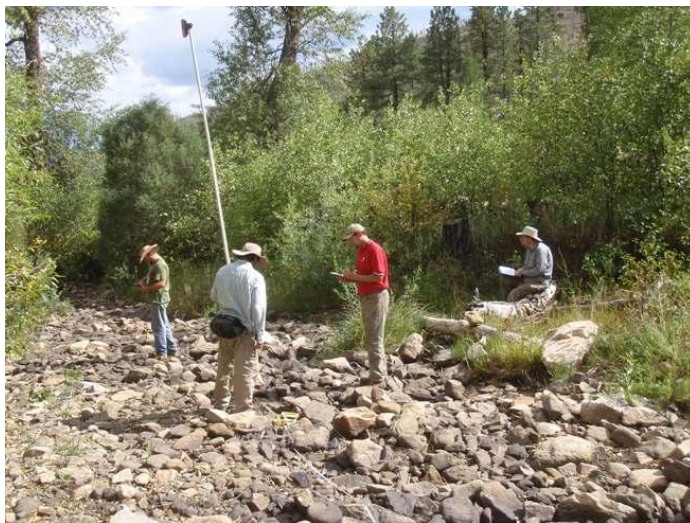
2011 Ponil Workshop – Surveying Cross Section

Ponil Monitoring Workshop – The CWA hosted the Ponil Monitoring Workshop on August 24-26, 2011. The Workshop focused on proper monitoring techniques for a riparian restoration project including proper techniques for photo points and Rosgen Level II Morphological Description. A Rosgen Level II Morphological Description includes establishing a cross section, longitudinal profile, pebble count, and meander geometry to determine stream classification and velocity / discharge estimates. Eighteen people attended the Workshop and conducted field work on three reaches of the Middle Ponil. A

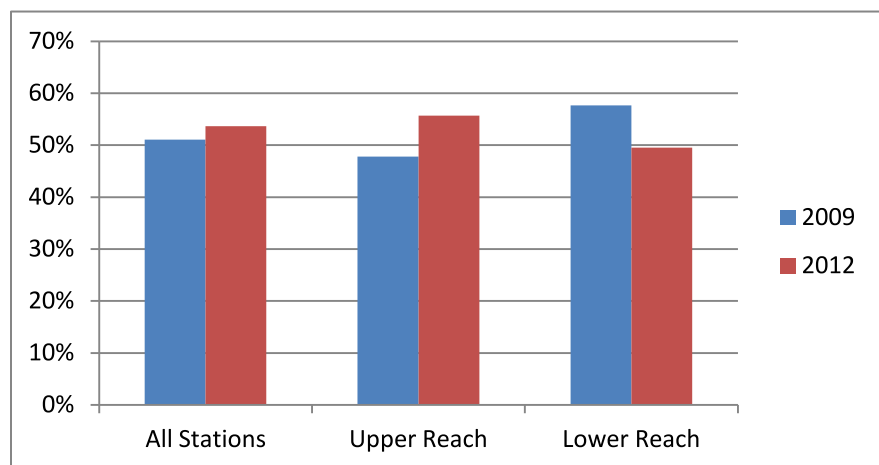
Riparian Canopy Density – Canopy measurements were taken at 30 randomly selected locations along Middle Ponil Creek. Overall the monitoring shows an increase in canopy from 51% to 54%.

However on the lower reach, the canopy density decreased from 58% to 50%. Based on field observations, most people that have worked on the project reported seeing an increase in canopy. The drop in the lower reach

measurements could be attributable to the drought conditions that have persisted in the project area since 2010.

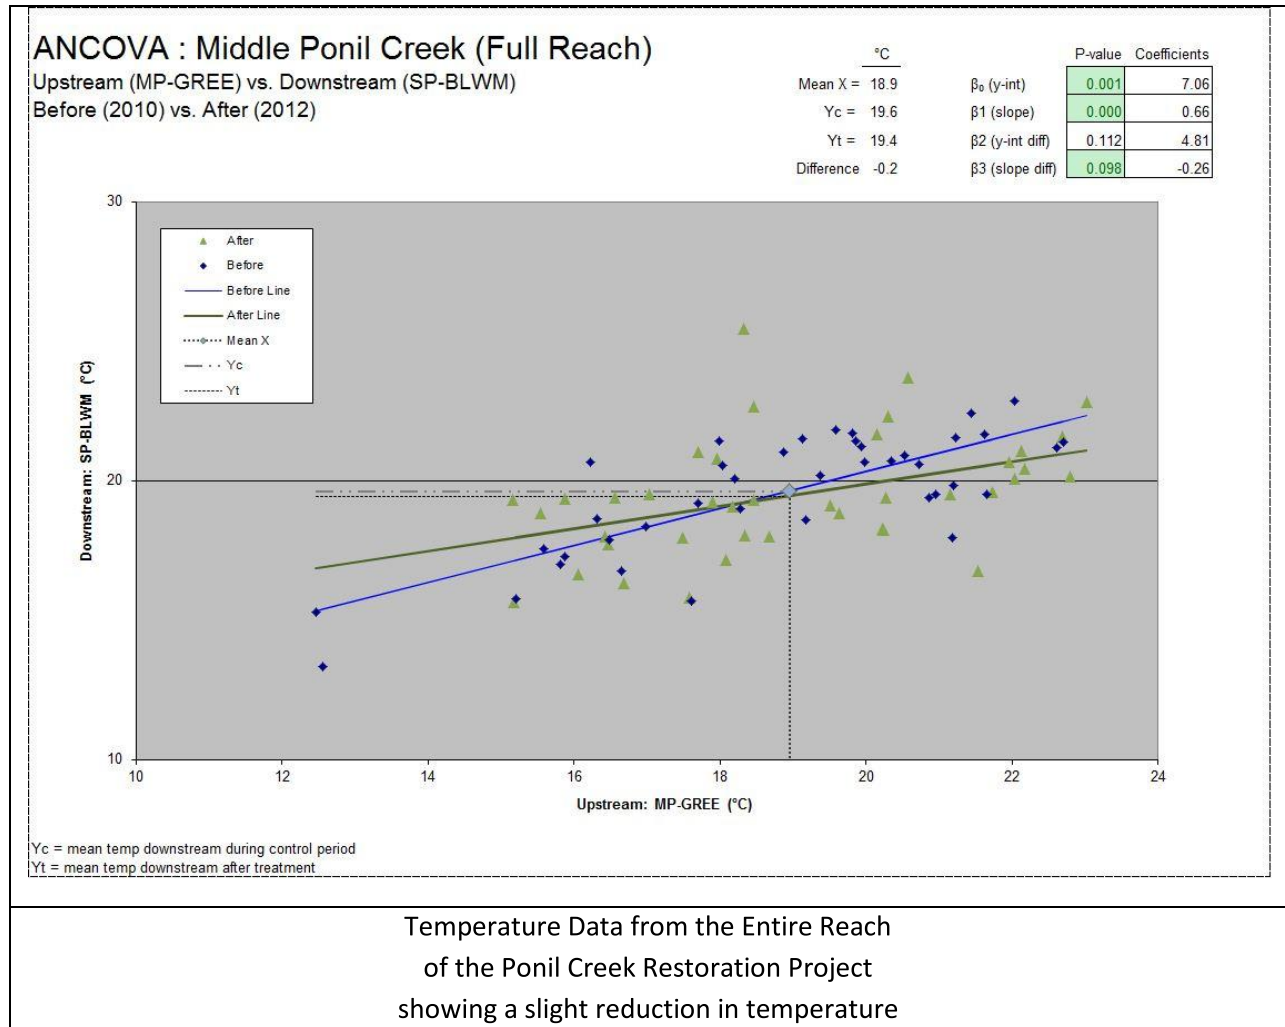
The results of an analysis of covariance (ANCOVA) using the Upstream/Downstream Before/After study design (UDBA) indicate that there has been a slight reduction in daily maximum temperature in the full project reach after treatment (reference chart for full reach). The full reach extends from above Greenwood Creek downstream to Ponil Camp. The regression analysis indicates that a statistically significant difference in slope between the before and after lines exists at a 90% confidence level. The negative value of coefficient Beta3 indicates a decrease in slope, which means greater reductions at the higher temperature range. The mean difference over the entire range of temperatures is a reduction of 0.2°C.

The same analysis for the upper reach (above Greenwood to Rich Cabins) resulted in a slightly lower mean temperature after treatment; however the difference was not statistically significant between before and after regression lines (upper reach chart). The Lower Reach (Rich Cabins to Ponil Camp) showed a slight increase in temperatures,

and it was statistically significant at the 95% confidence level. These results are likely due to the drought conditions during the 2012 post-treatment period. Further monitoring is recommended to better determine the effects of the project (Refer to Appendix A – Temperature).

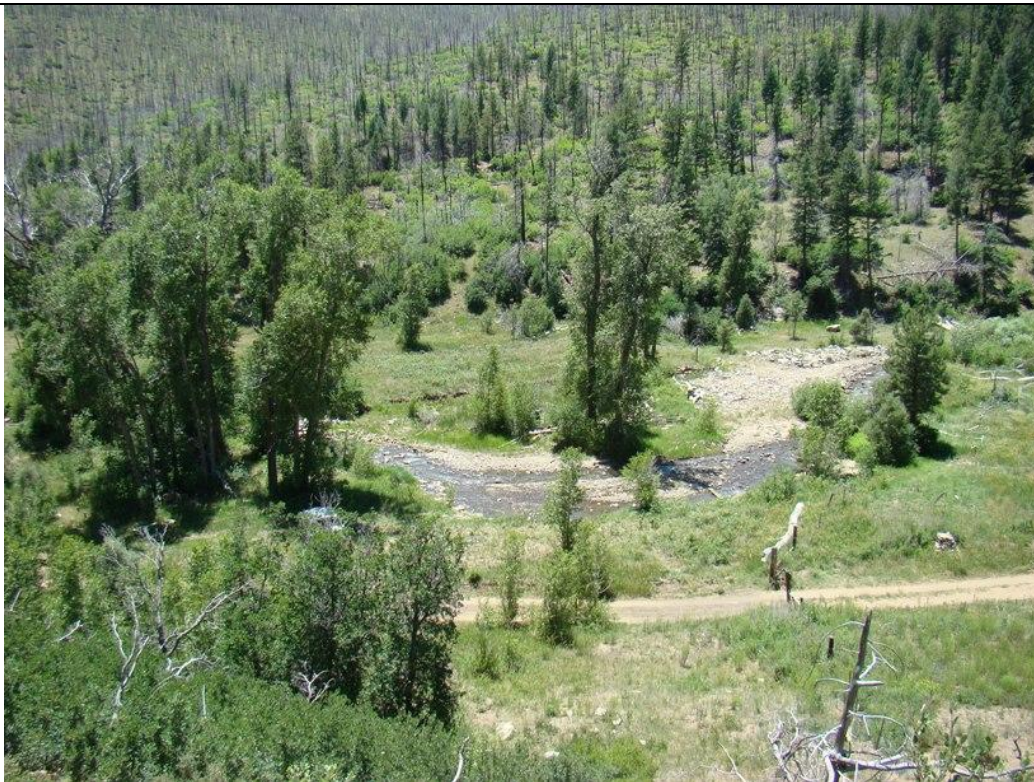
Photo Point 3a - Head Cut, June 30, 2010 after restoration with
Ponil Creek returned to its original channel.
