SAN MATEO - EXHIBIT V

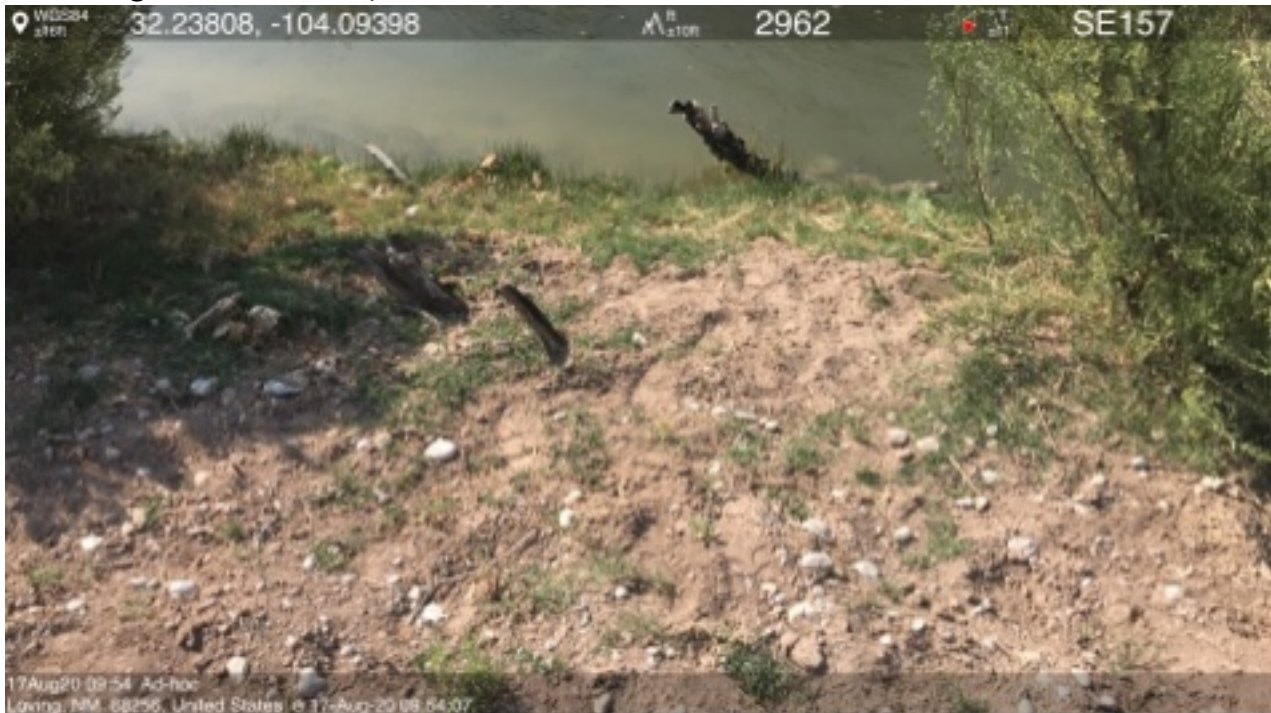
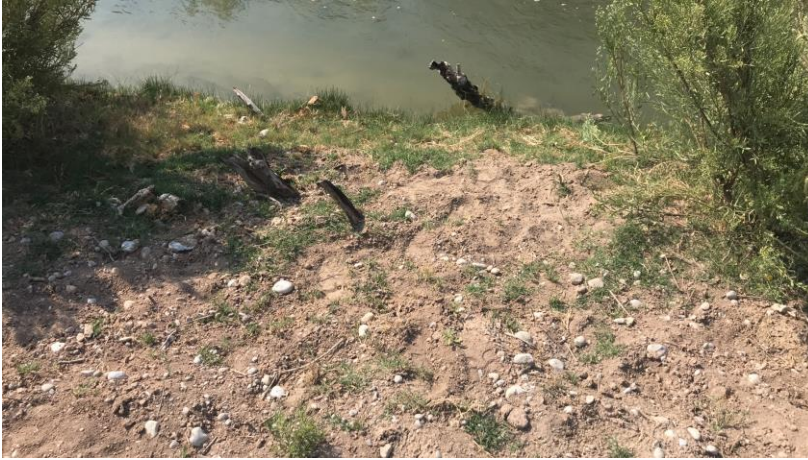
Point 1. Title: 17Aug20 09:54

The images to the left correspond in sequence to the preceding data-tagged images, which were reproduced in lower resolution. These photos depict an area upstream from the alleged release location and downslope from a large caliche pit or quarry. Caliche appears to erode from this area into the river during rain events. Sediment of the same color and texture identified in Exhibit U is visible within this upstream portion of the river and along the riverbank.
