ABANDONED OR INACTIVE URANIUM  
MINES IN NEW MEXICO

A report of investigation carried out  
between August 1979 and May 1980 under  
contract with the New Mexico Energy and  
Minerals Department.

New Mexico Bureau of Mines and  
Mineral Resources  
Open-File Report 148

Mine name(s) San Mateo County ValenciaSection NE $\frac{1}{4}$  Sec. 30 Twنش. 13 N R. 8 WQuadrangle sheet San Mateo 7 $\frac{1}{2}$ 'Mining district Mt. TaylorElevation 7,020'Nearest city and/or dwellings San Mateo, 4 $\frac{1}{2}$  mi. east

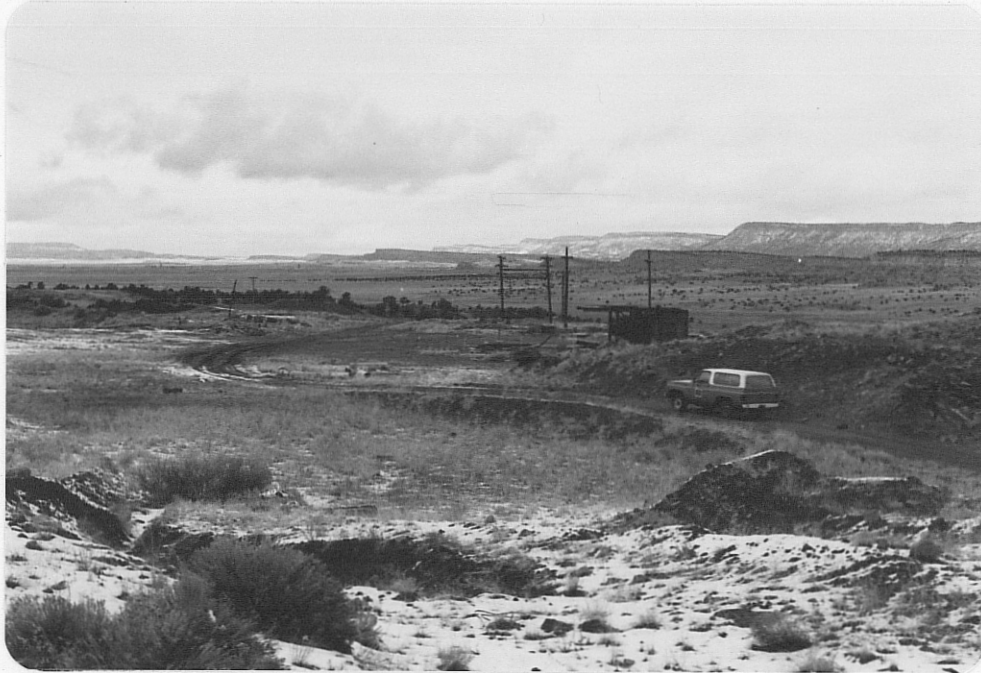
A view of the mine site is shown in photo (a). A close-up of the shaft site, photo (b), shows a re-inforced concrete slab covering the shaft, caving around the slab, a danger sign, and a toppled over ore bin. Photos (c) & (d) are close-ups showing the extent of the caving around the west side of the concrete slab that has exposed a portion of the upper shaft. Dimensions of the shaft are not known; some timbering exposed at about 20' down. Scintillometer readings at the shaft edge ranged up to 700 cps.

Photo (a) View northwestward of San Mateo Mine site.

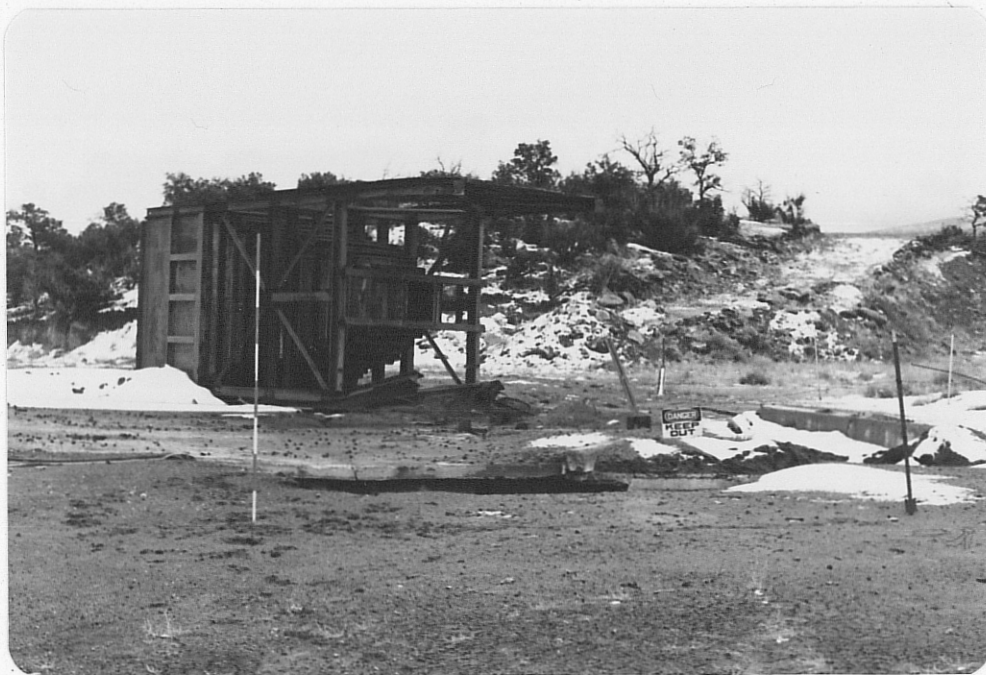
Photo (b) Looking northeast at shaft site showing caving which has begun around perimeter of concrete slab, and toppled ore bin; note range pole for scale.

Recommendations: (1) The shaft site should be fenced to keep man and beast away from the area of active caving. Present fence is in poor condition and is ineffective.  
(2) United Nuclear Corporation officials should be contacted for details on how the upper shaft area was sealed before the surface slab was poured. A description of how the heap leaching site was sealed is also needed.

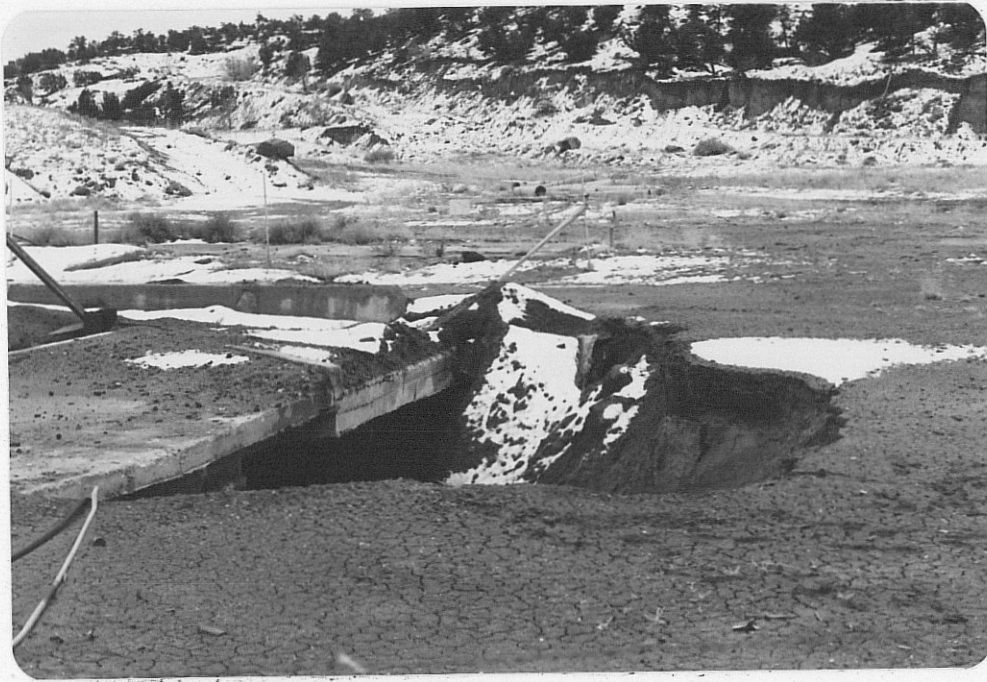
Photo (c) Close-up of shaft site showing extent of caving; concrete slab is 8" thick at far left.

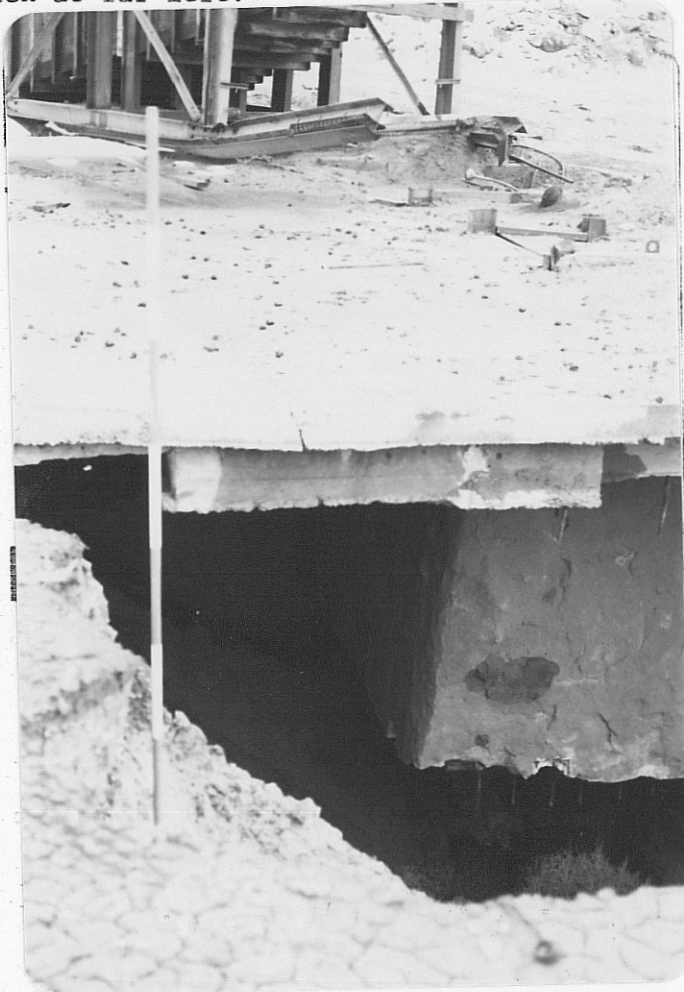
Photo (d) Close up of concrete slab over mine shaft showing void beneath; note range pole in foreground and again the ore bin.

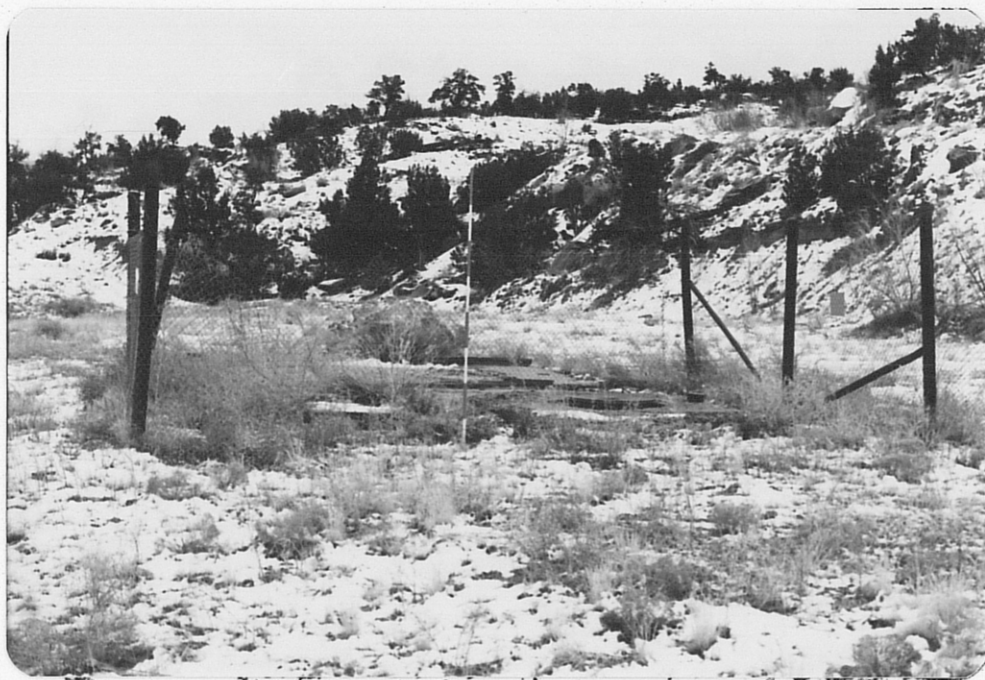
Approximately 250' east of the shaft is a 30" diam. ventilation shaft covered with  $\frac{1}{4}$ " plate metal. A concrete pad for the blower motor remains; site is enclosed by a wire mesh fence that has been partially broken down (see photo e). Immediately north of the mine shaft is the concrete slab and foundation for the hoist and drum and a machine shop. The slab measures 38' x 115' (see photo f). 175' west of the shaft is another concrete slab, 40' x 110' with a considerable amount of general debris strewn about (see photo g).

Photo (e) Looking eastward at 30" diam. ventillation shaft and foundation for blower motor. Wire mesh fence surrounding site has been partially destroyed.

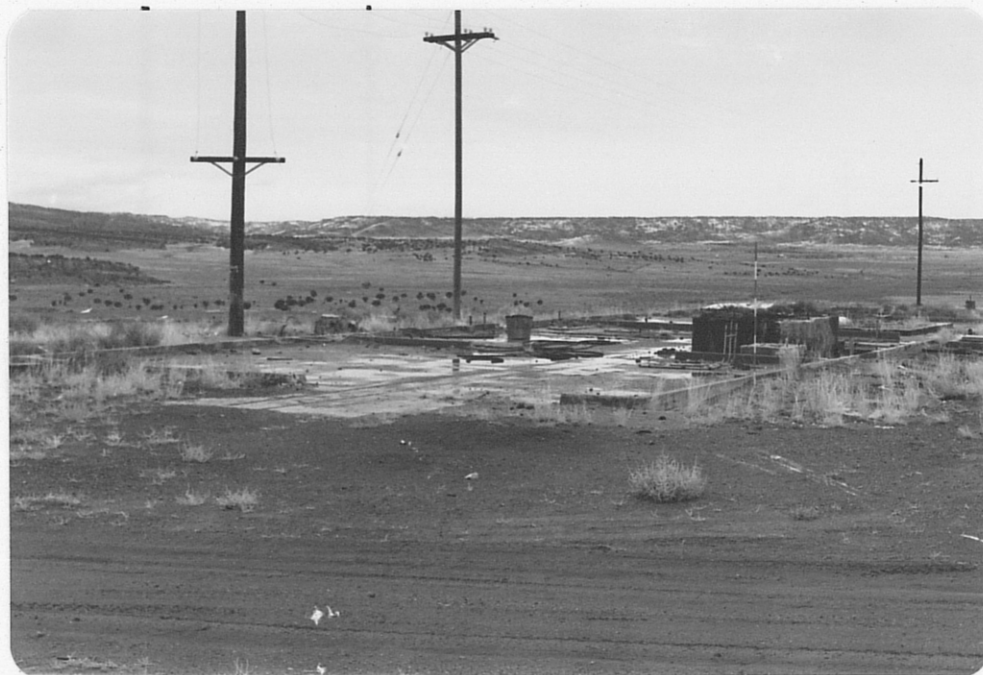
Photo (f) Looking northeastward at concrete slab and hoist and drum foundation. Slab measures 38' x 115'; note range pole for scale.

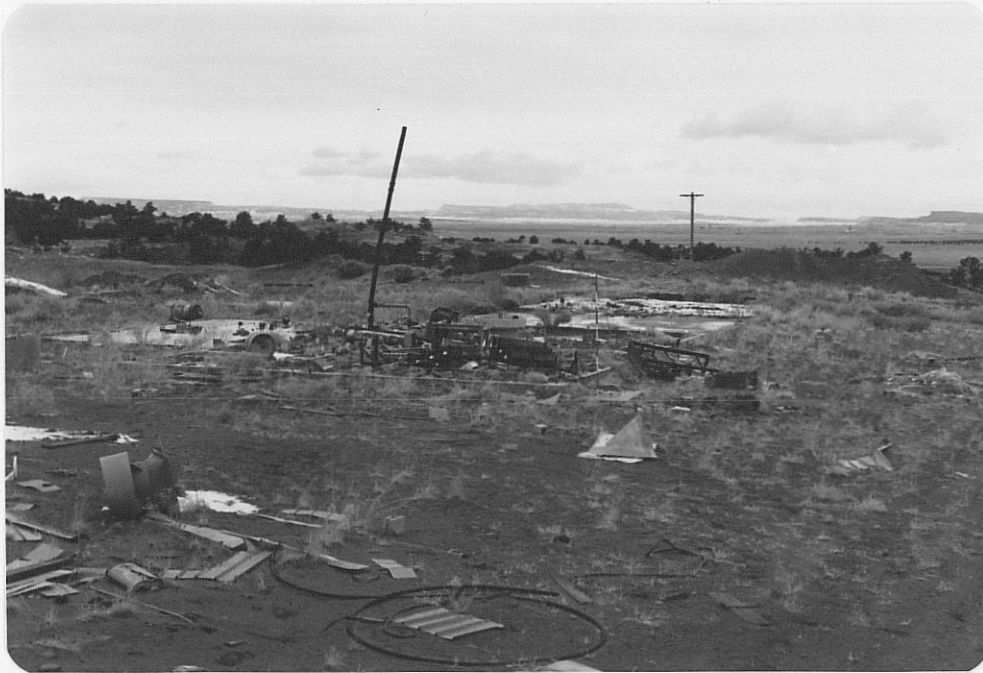
Photo (g) Looking westward at concrete slab and general debris west of shaft site: Slab measures 40' x 110' and was probably used as office space; note range pole just right of center.

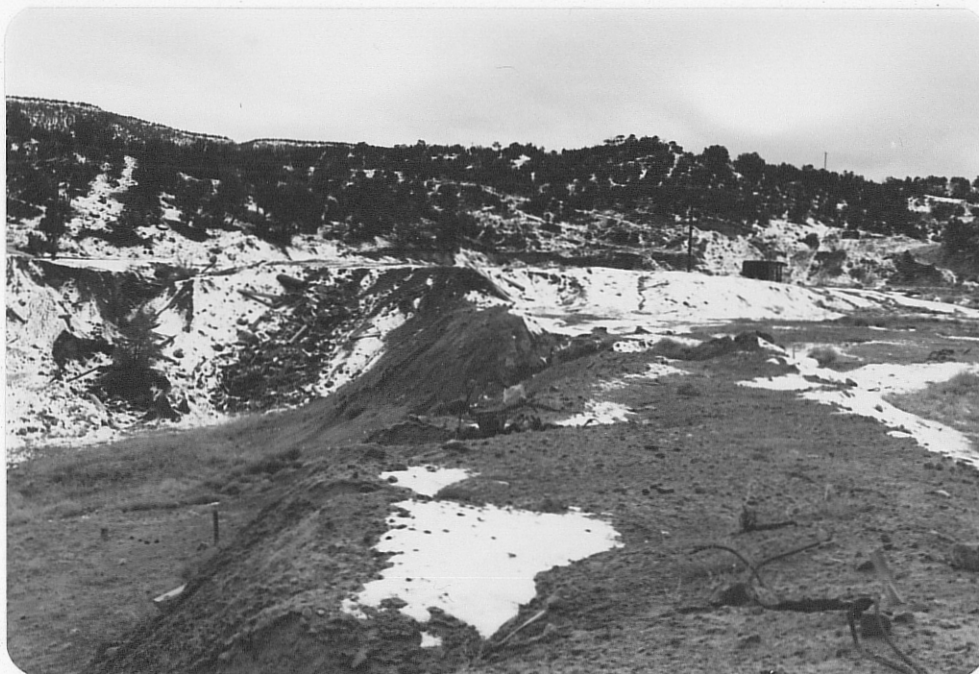
The mine waste dump area extends northward from the mine shaft at a level 15'-20' lower than that at the mine. It measures approximately 450' long (E-W) and up to 300' in width. Photo (h) is a view southward from near the NE corner of the dump toward the mine shaft. Height of the dump at the toe ranges up to 30'. Maximum scintillometer reading on a traverse of the dump area was 3000 cps. Erosion and gulying on the east edge of the dump is illustrated in photo (i). Deep gulying to this extent is not, however, characteristic of the entire margin of the waste dump. The abrupt slope that separates the bench at mine level from the broad, flat surface of the

Photo (h) Looking southward from near northeast corner of mine dump area toward the mine shaft on bench at higher level.

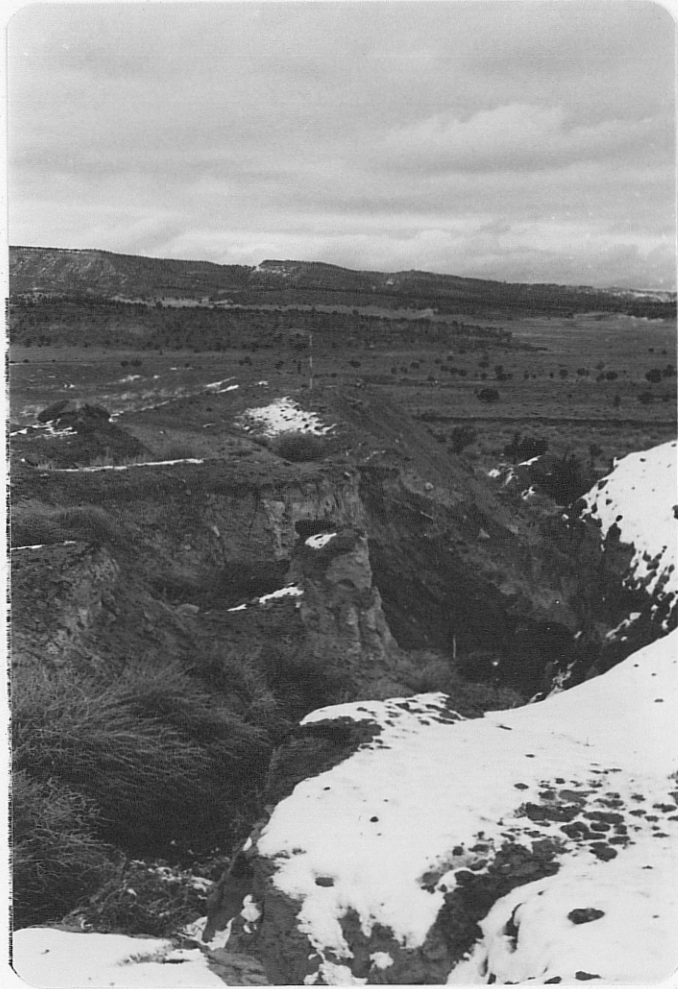
Photo (i) View northward at east edge of dump showing gullying; note range pole for scale and tributary in background visible through the gully notch.

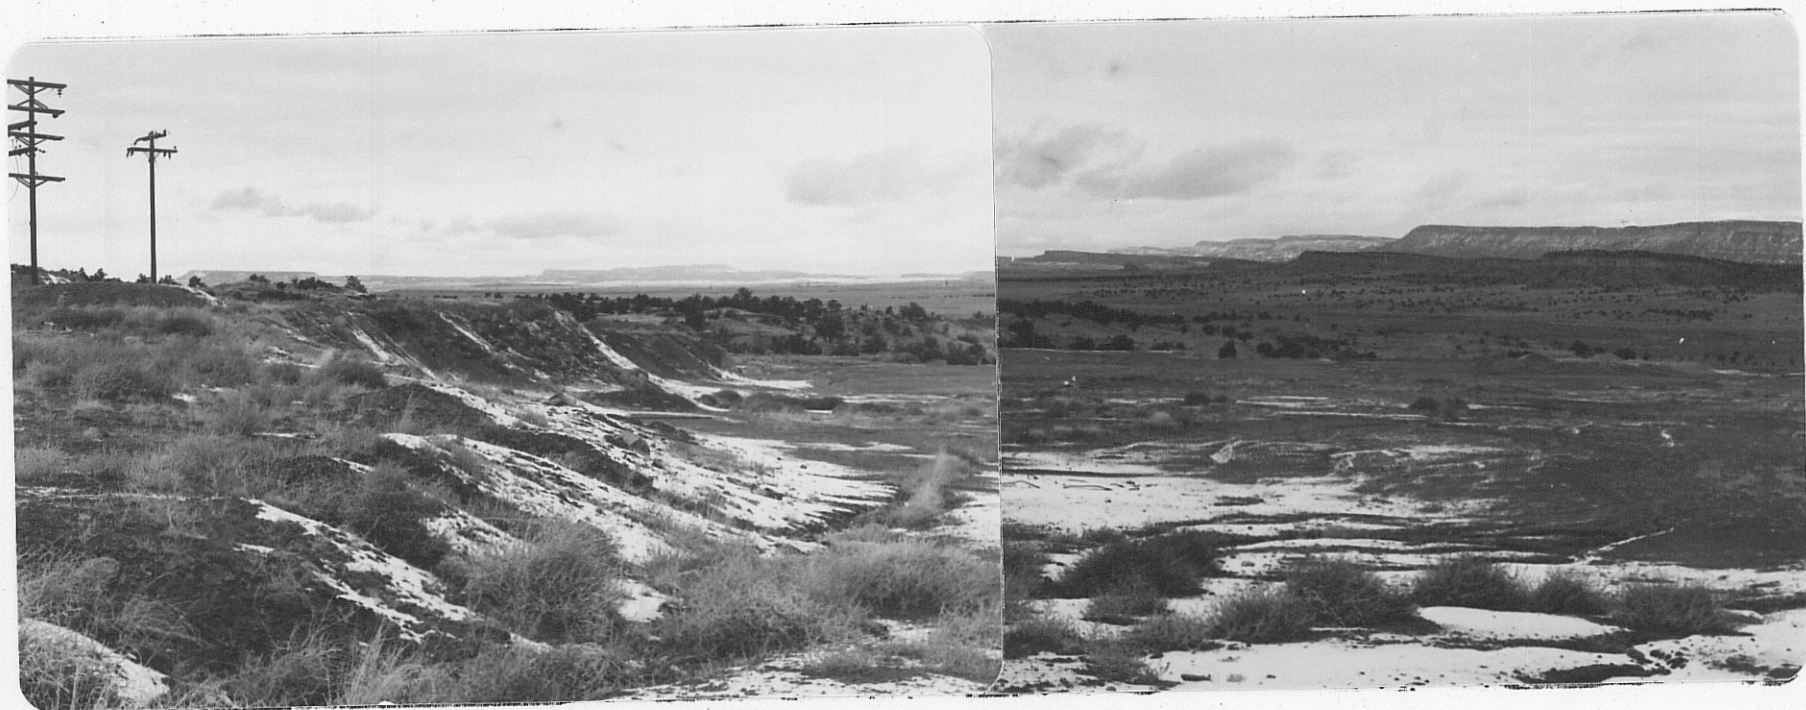
dump area is shown in photo (j). Part of the dump area shown may have been used to stockpile ore as local "hotspots" were found.

Photo (j) View northwestward from eastern edge of dump showing mine level at far left, upper surface of dump area at center foreground and right, and level of San Mateo Creek at right in the middle distance.

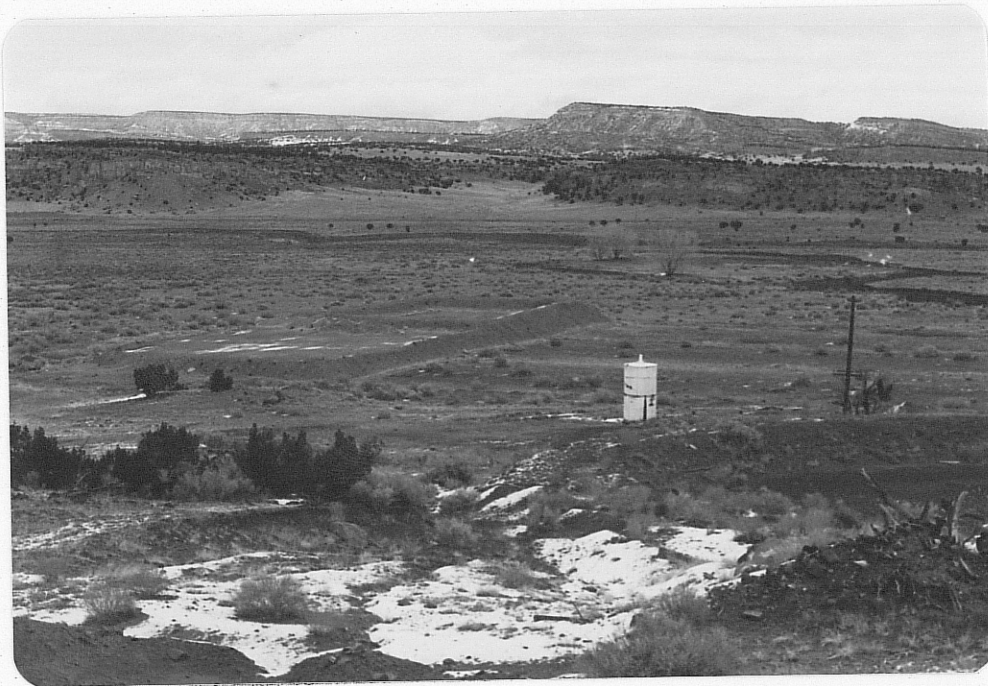
A view northward from the toe of the dump toward San Mateo Creek (photo k) shows the rectangular shaped earthen embankment where the company carried on some heap leaching experiments. The embankment measures about 100' x 200'; the 20' high cylindrical metal tank remaining near the site was perhaps used to store chemicals. Distance from the toe of the dump to San Mateo Creek is perhaps 1500', however, a tributary passes much closer than this at the eastern edge.

Photo (k) View northward from toe of dump showing rectangular earthen embankment used for heap leaching experiments; note metal tank perhaps used for chemical storage. San Mateo Creek in middle distance flows from right to left. A tributary entering from south (arrow) passes within several hundred feet of eastern edge of dump.
