Corrective Action Report

**Cimarron River Spill
Near Horseshoe Mine,
Cimarron Canyon State Park
New Mexico**

Date of Spill: December 27, 2016

Re: Corrective Action Report for the Cimarron River Spill on State Highway 64
Near the Horseshoe Mine, Cimarron Canyon State Park, New Mexico

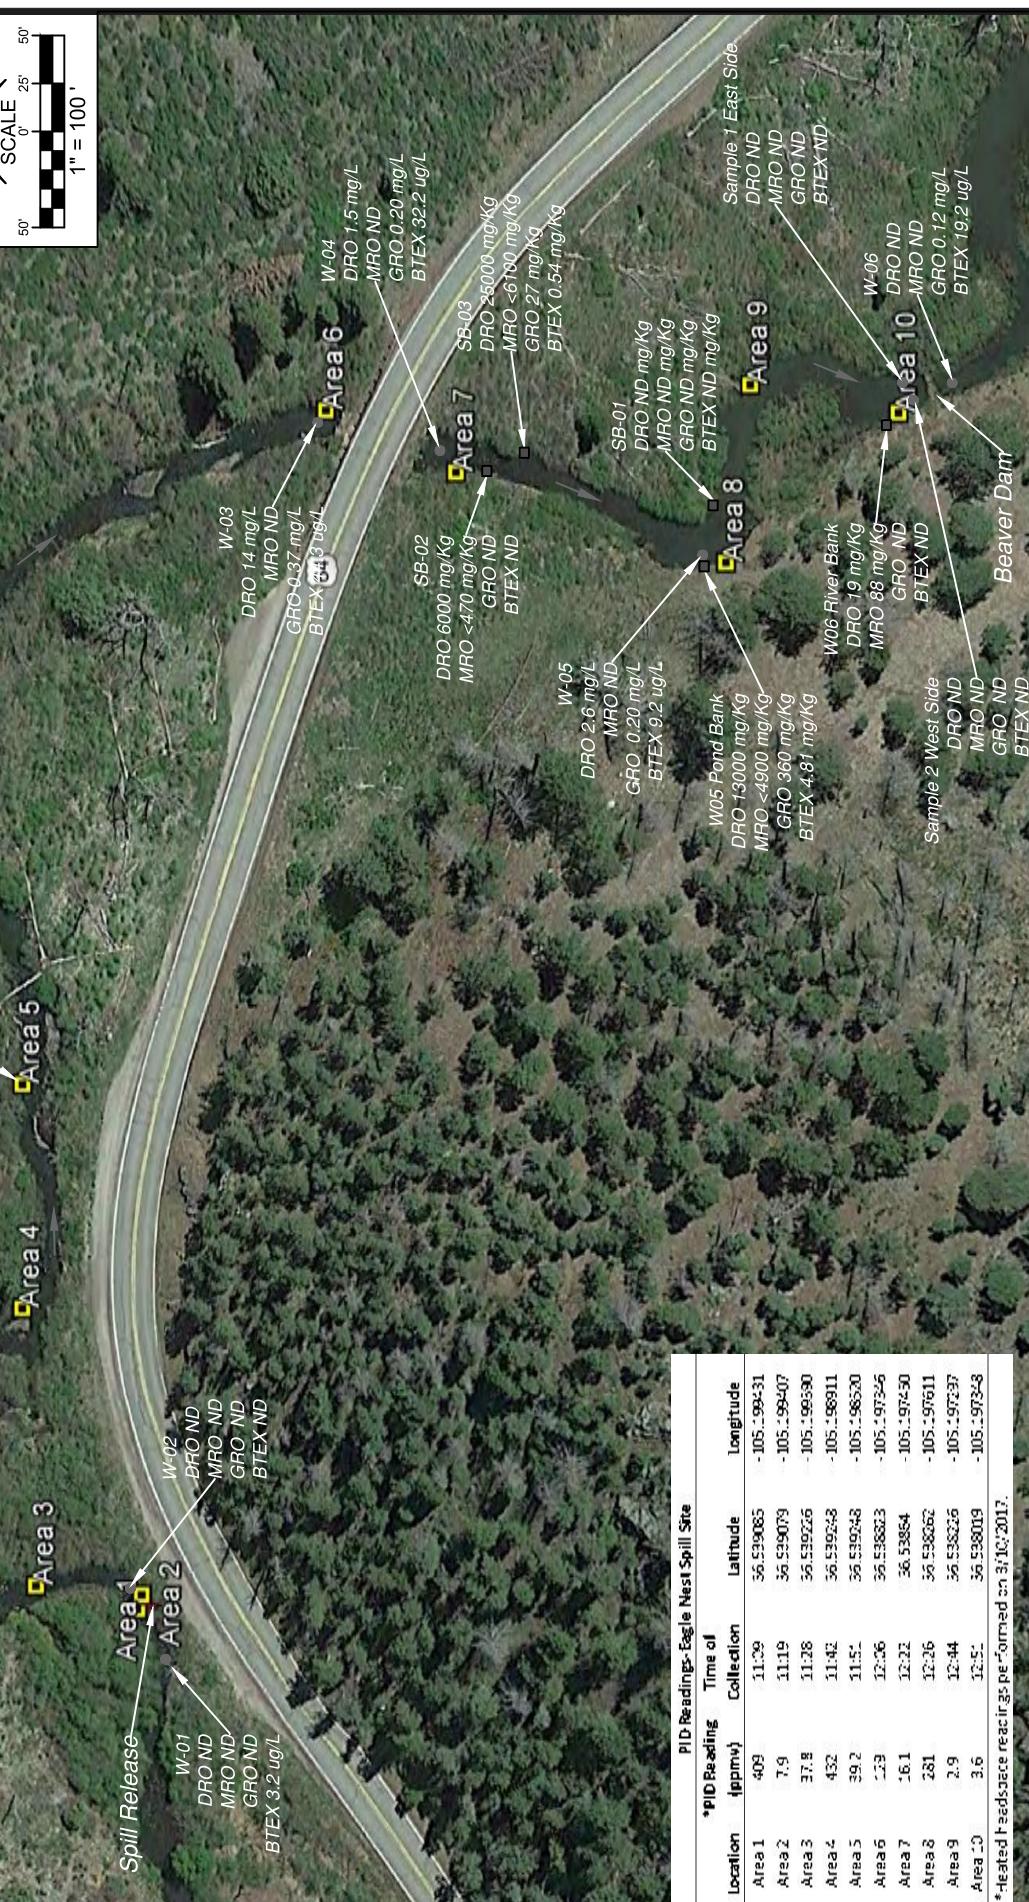
Locations of PID Readings

Location	*PID Reading (ppmv)	Time of Collection	Latitude	Longitude
Area 1	409	11:29	36.539085	-105.99431
Area 2	7.9	11:19	36.539079	-105.99407
Area 3	37.8	11:28	36.539266	-105.99390
Area 4	432	11:42	36.539248	-105.98911
Area 5	39.2	11:51	36.539248	-105.98520
Area 6	1.3	12:06	36.538823	-105.97246
Area 7	16.1	12:22	36.53854	-105.97430
Area 8	281	12:26	36.538262	-105.97511
Area 9	2.9	12:44	36.538246	-105.97237
Area 10	3.6	12:51	36.538019	-105.97248

*Heated headspace readings performed on 3/10/2017.

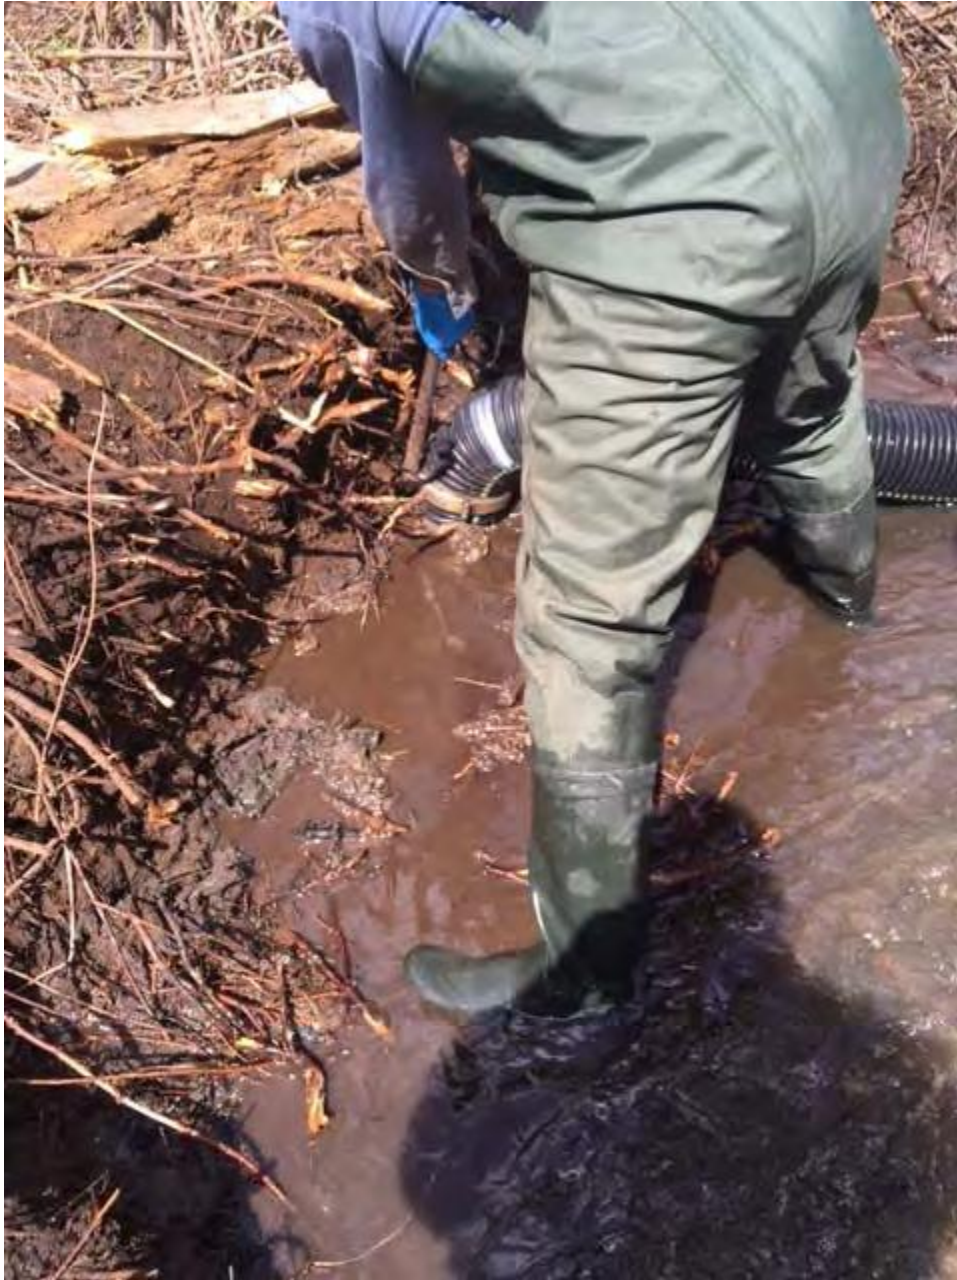
Photo 1 Removal of soil by Dry Vac truck at Area #1.

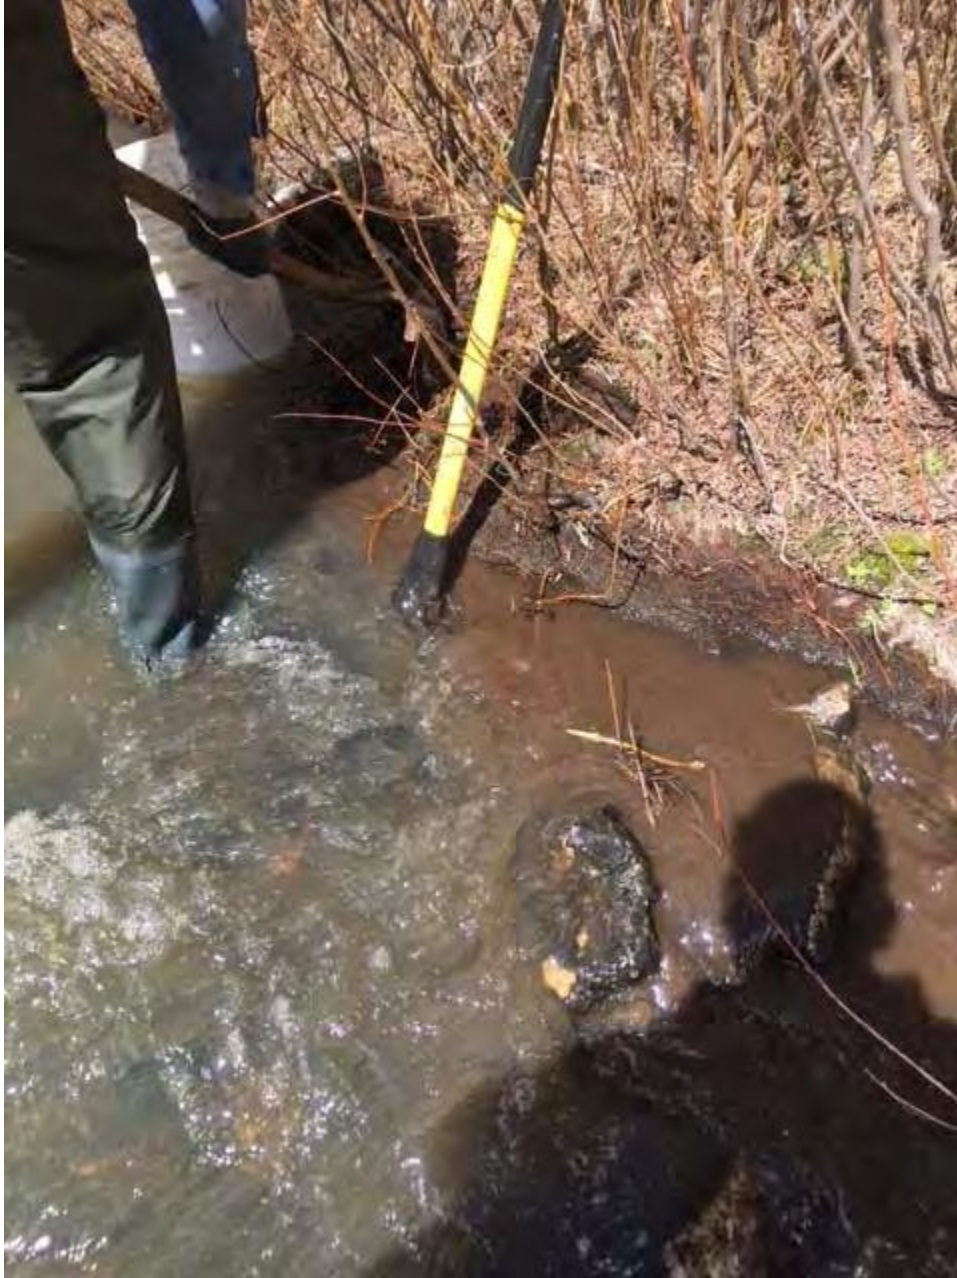
Photo 2 Removal of soil at Area #2 using hand tools.

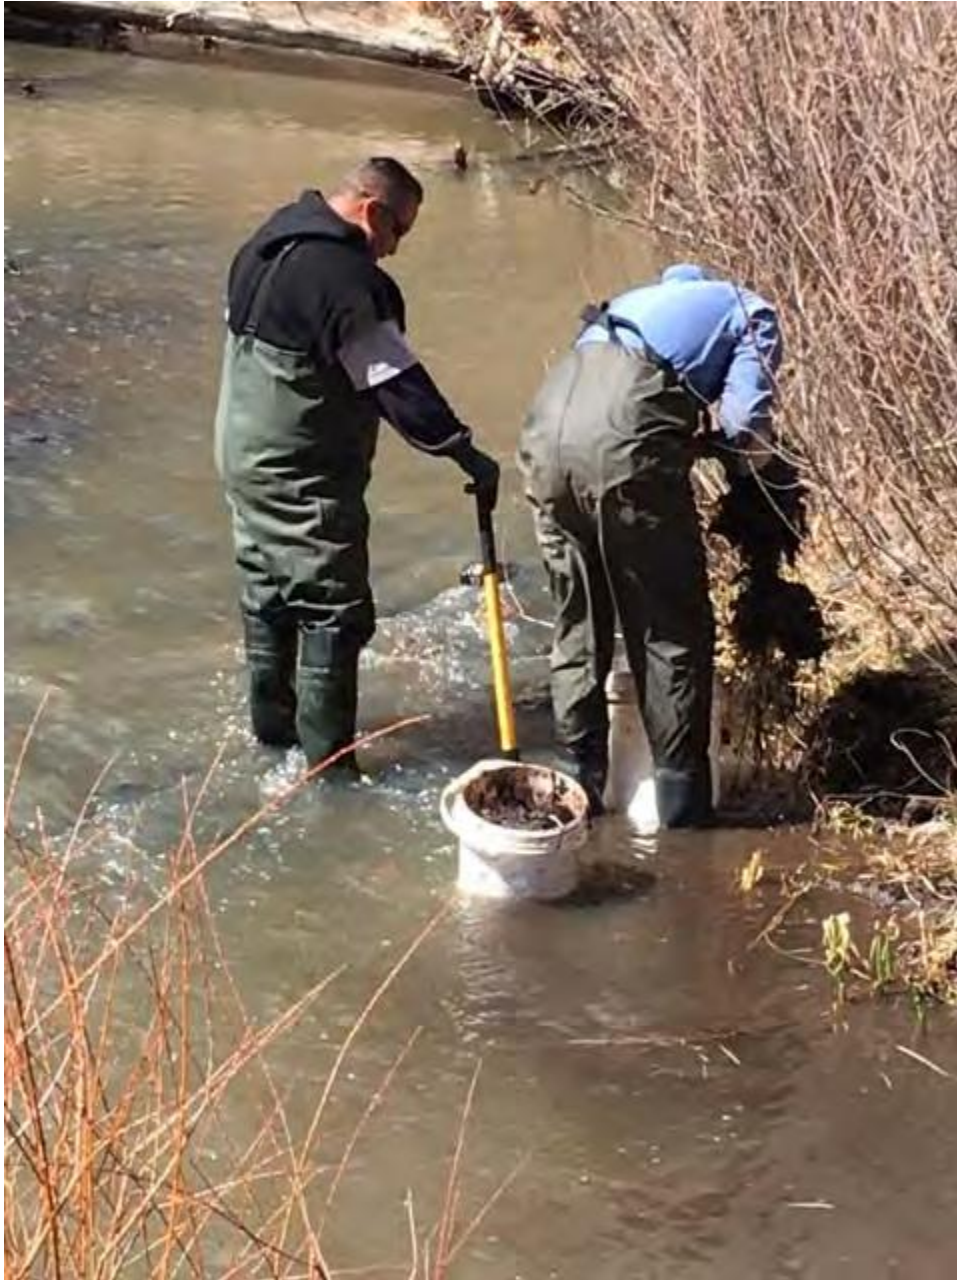
Photo 3 Use of buckets to transfer removed soils from the river bank at Area 2.

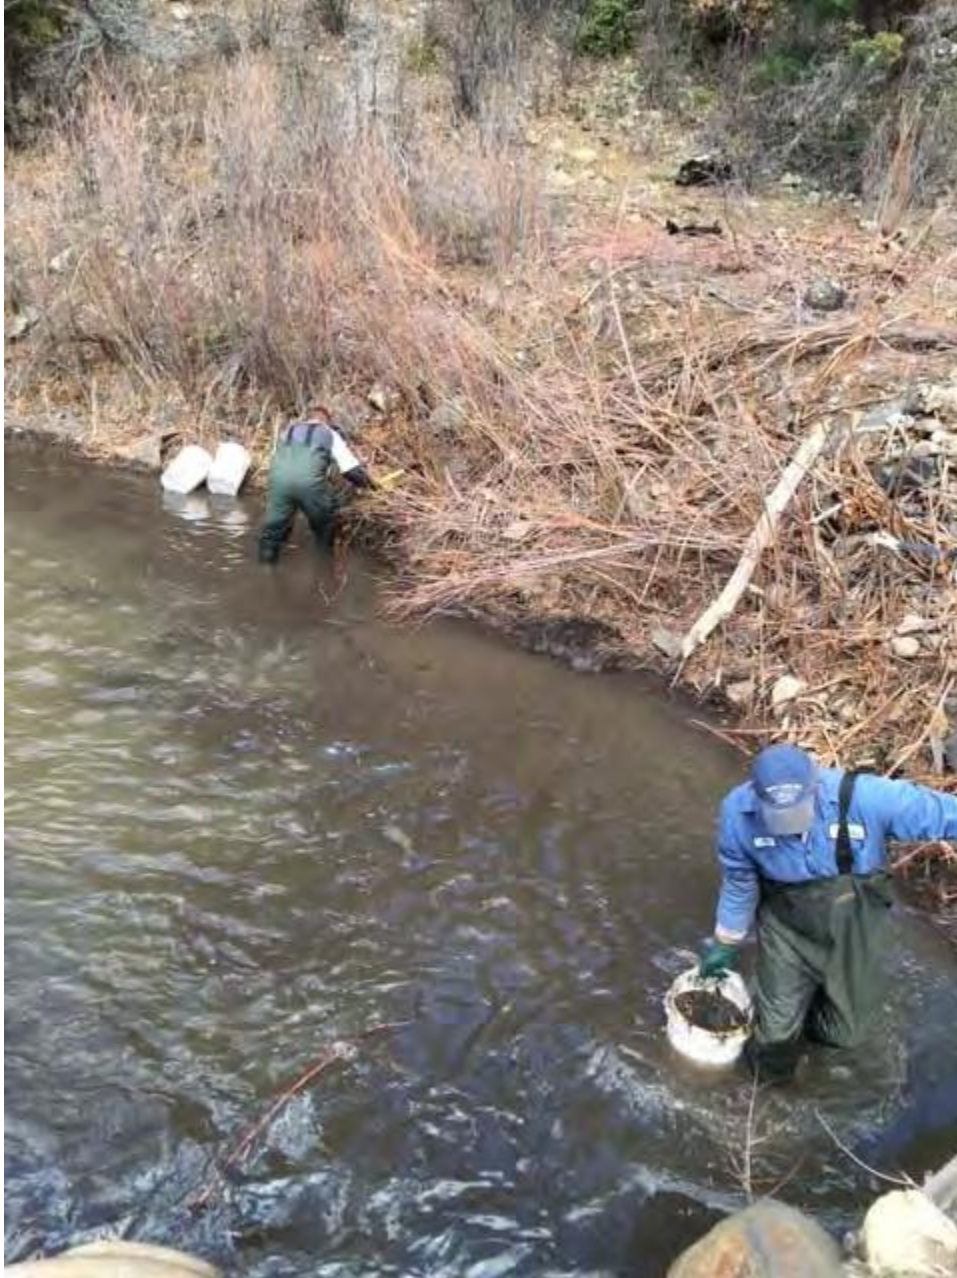
Photo 4 Use of hand tools and buckets to remove and transfer soils from the river bank at Area #3.

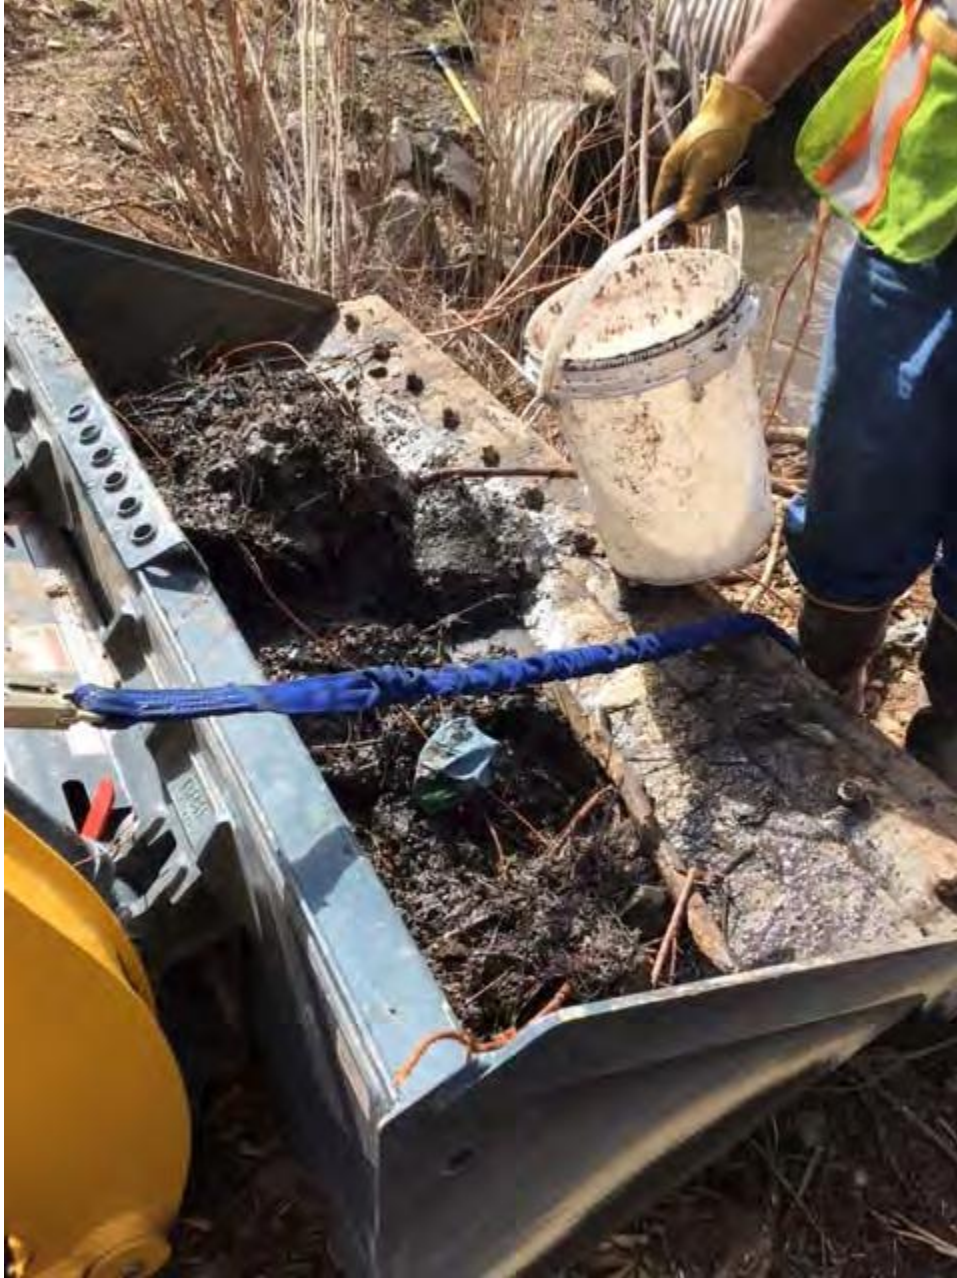
Photo 5 Use of bobcat to transfer soils to rolloff boxes.

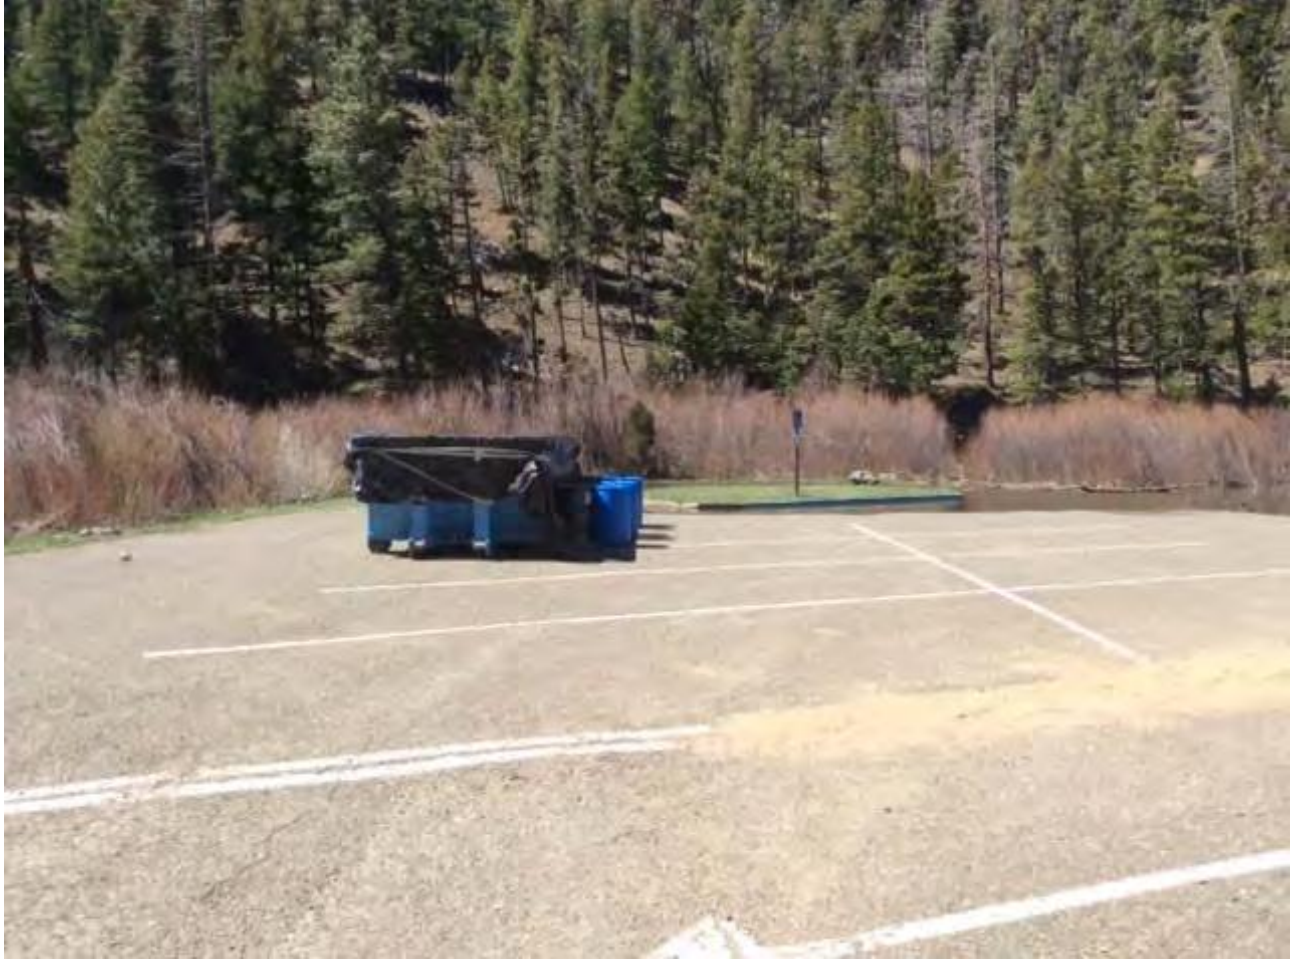
Photo 6 Staging area of rolloff box and drums.

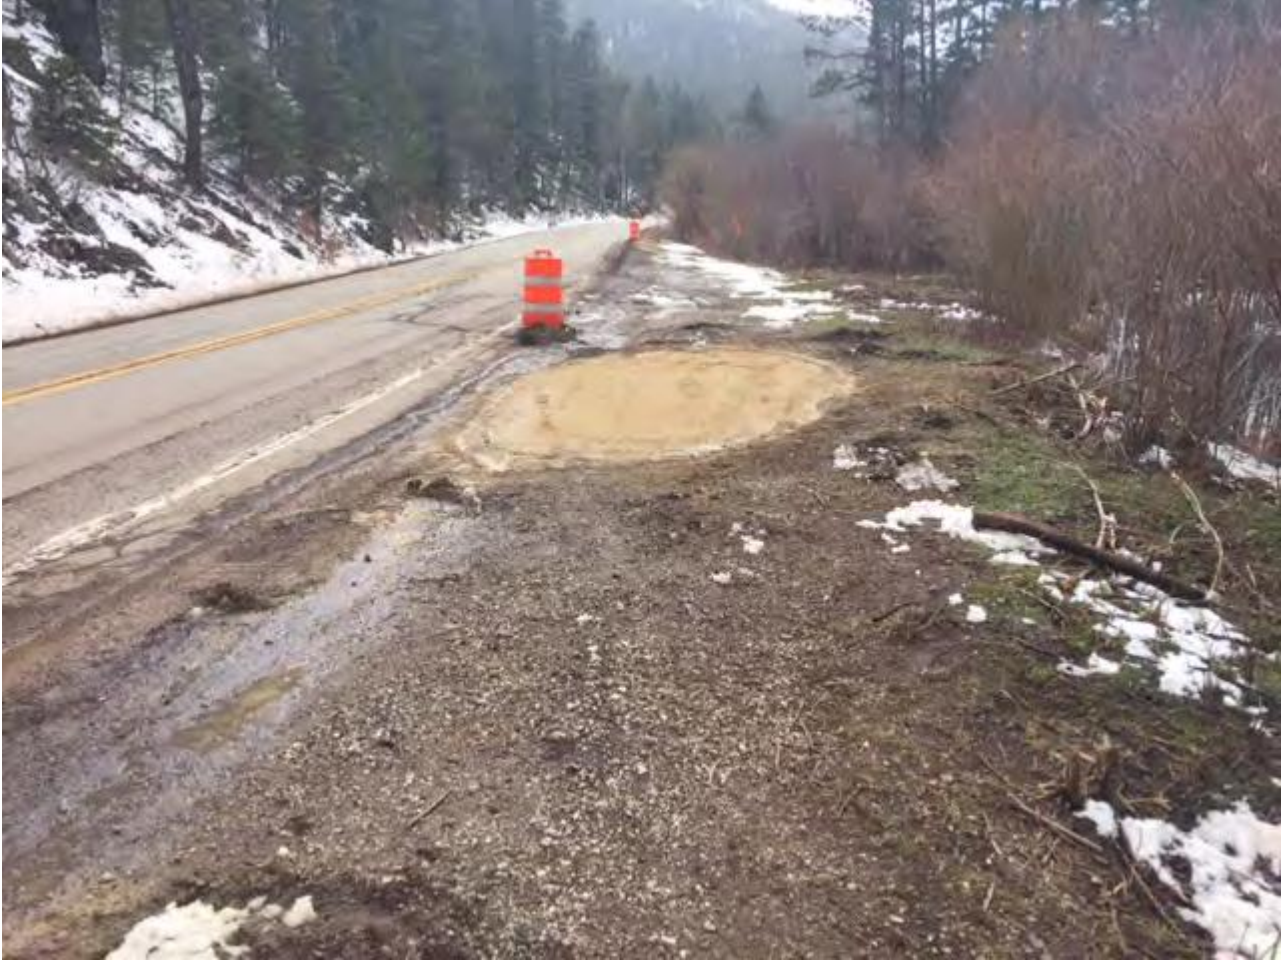
Photo 7 Backfill of area between edge of road shoulder and river south of Area #1.

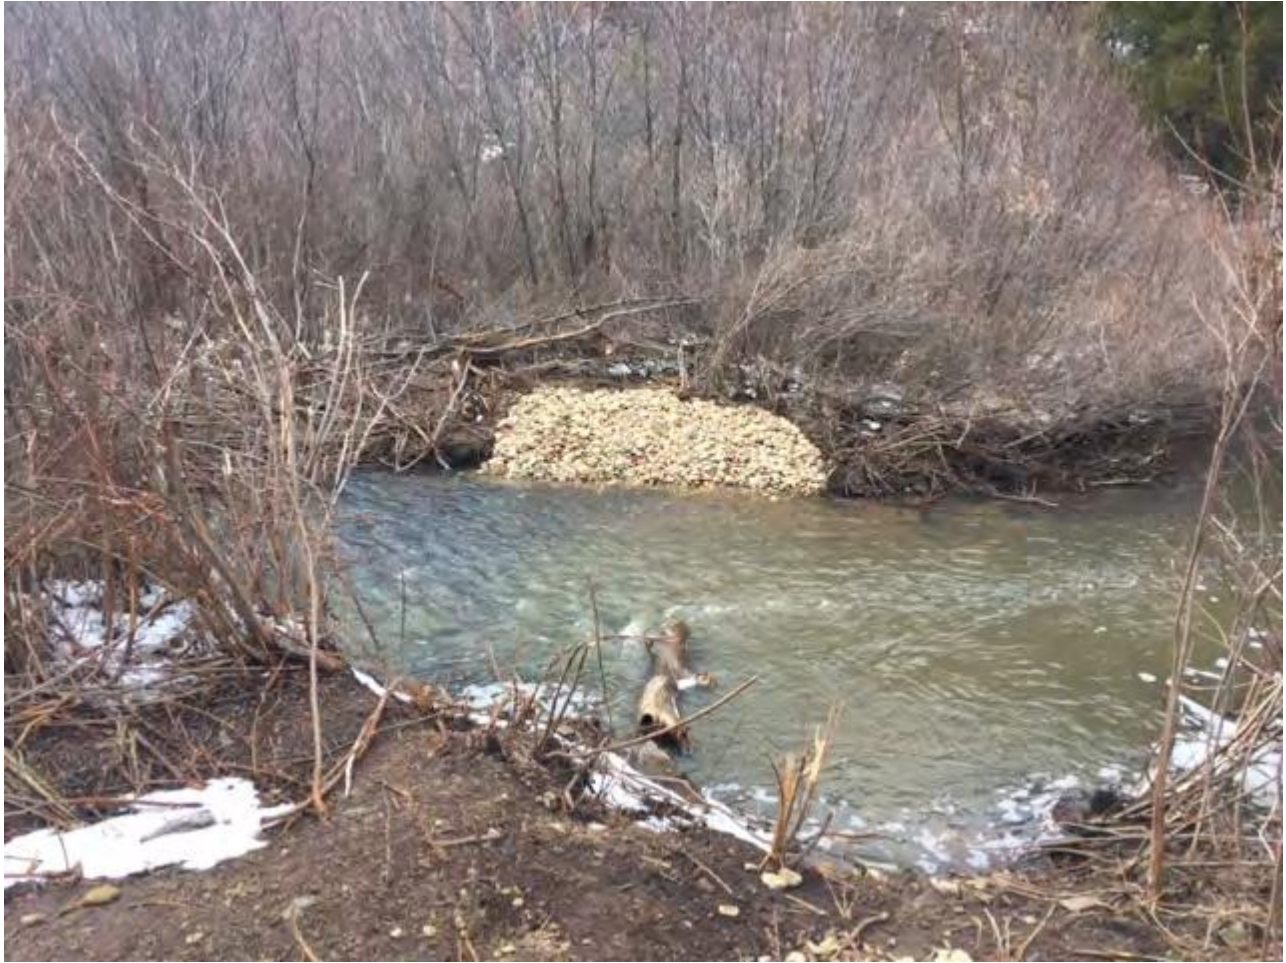
Photo 8 Backfill of Area #1 with river rock.

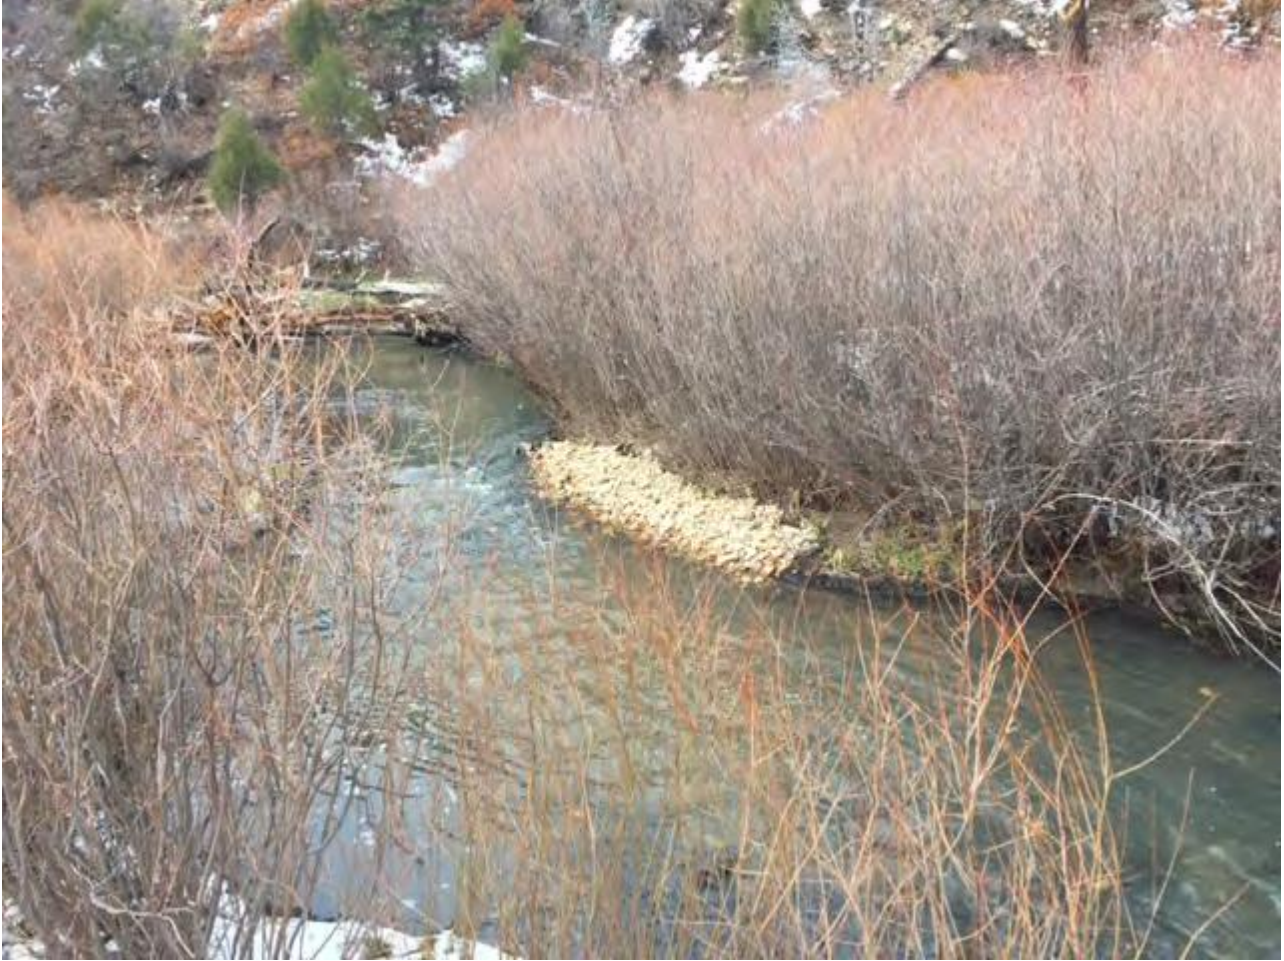
Photo 9 Backfill of Area #2 with river rock.

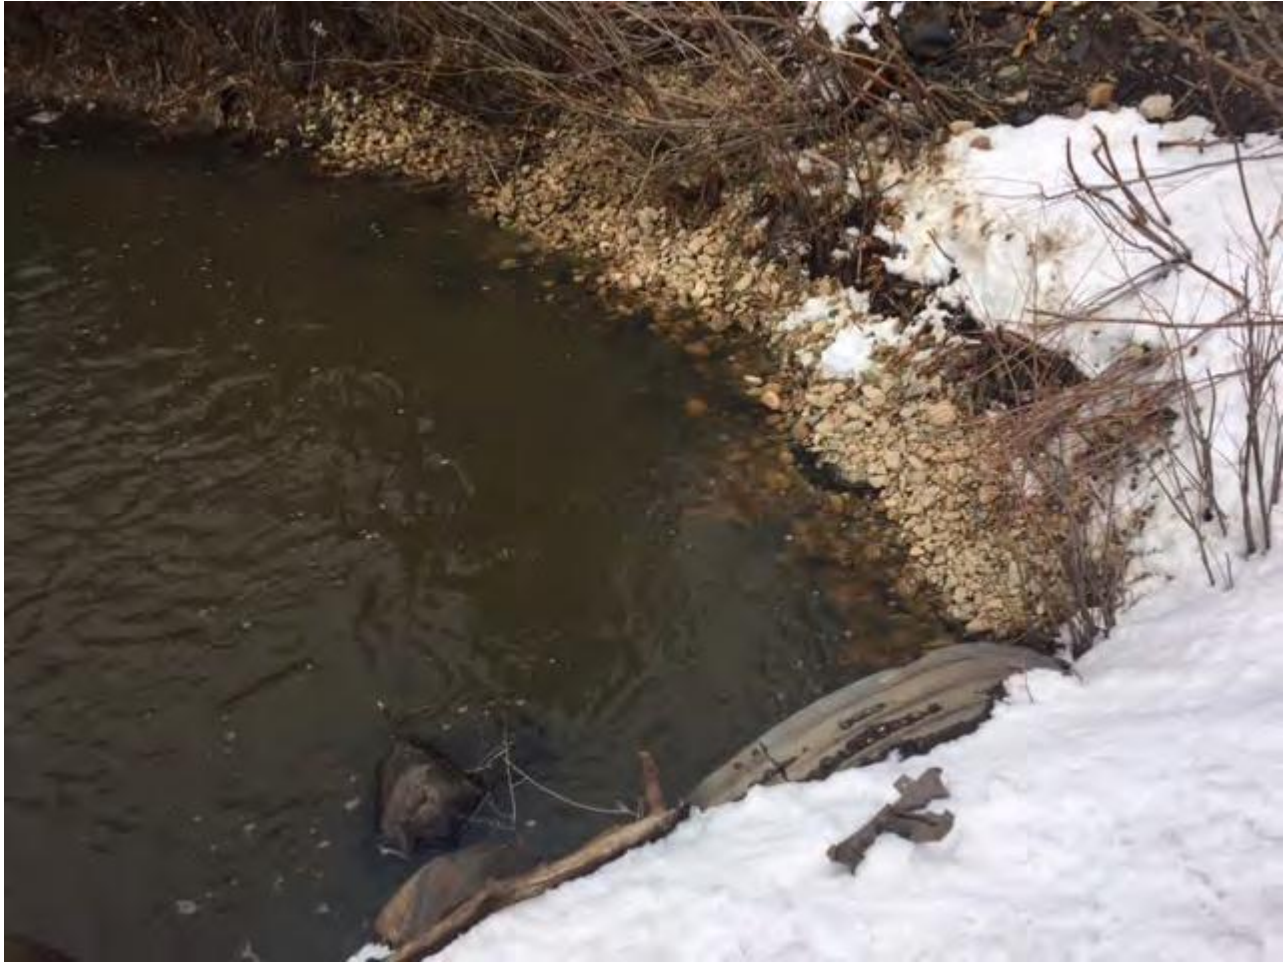
Photo 10 Backfill of Area #3 with river rock.

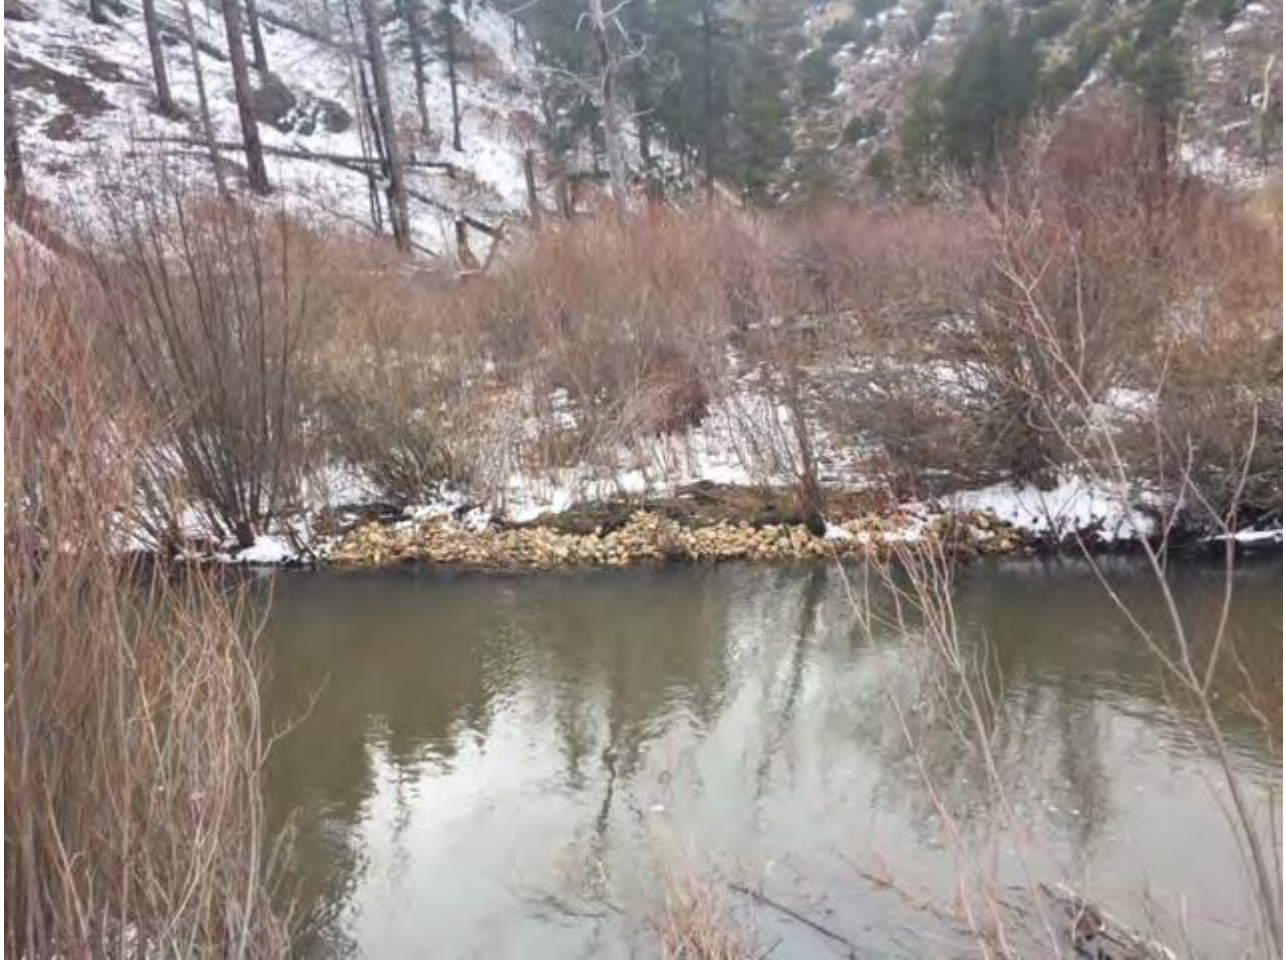
Photo 11 Backfill of Area #4 with river rock.

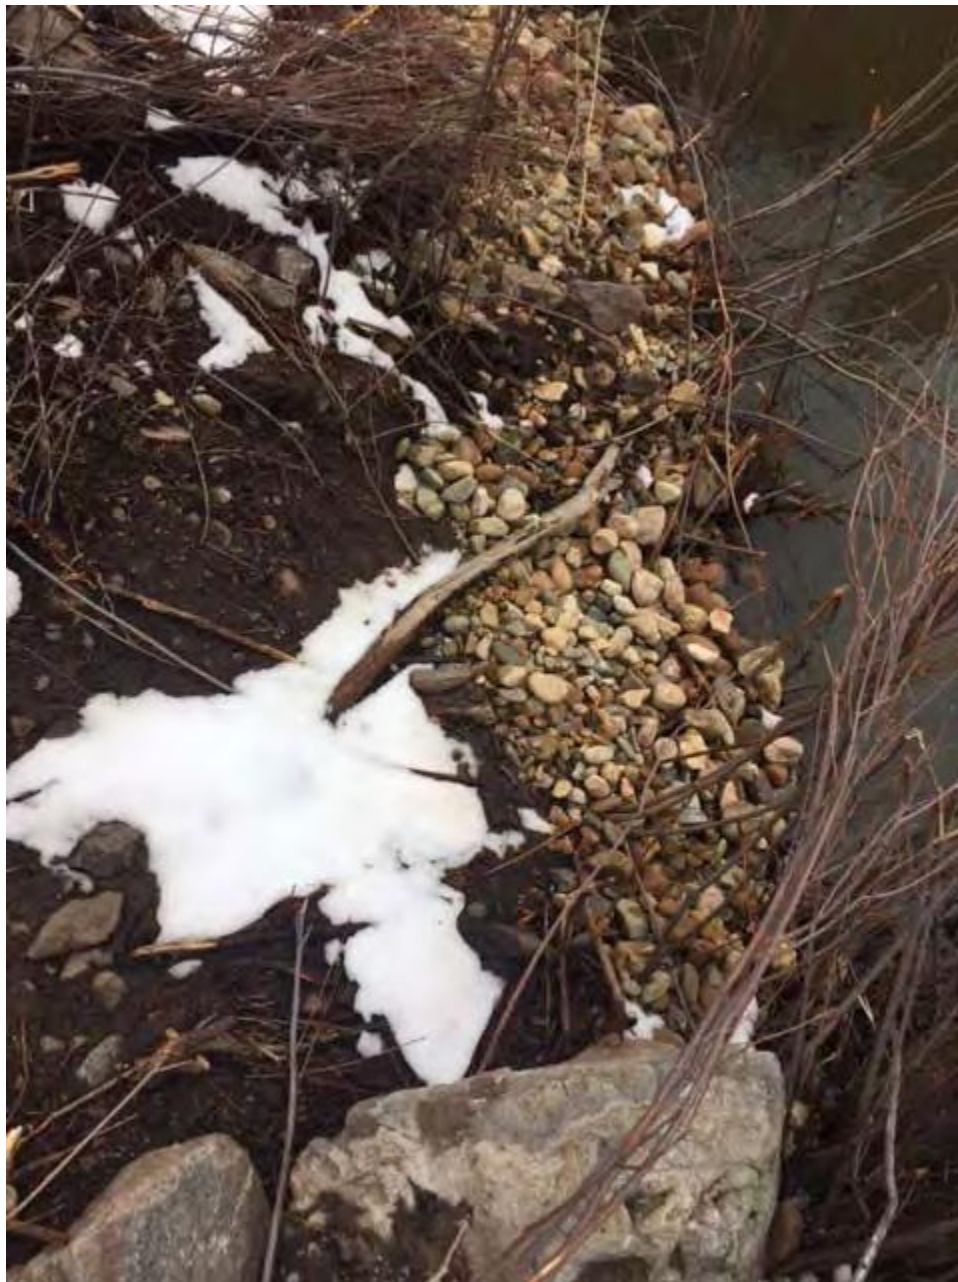
Photo 12 Backfill of Area #5 with river rock.

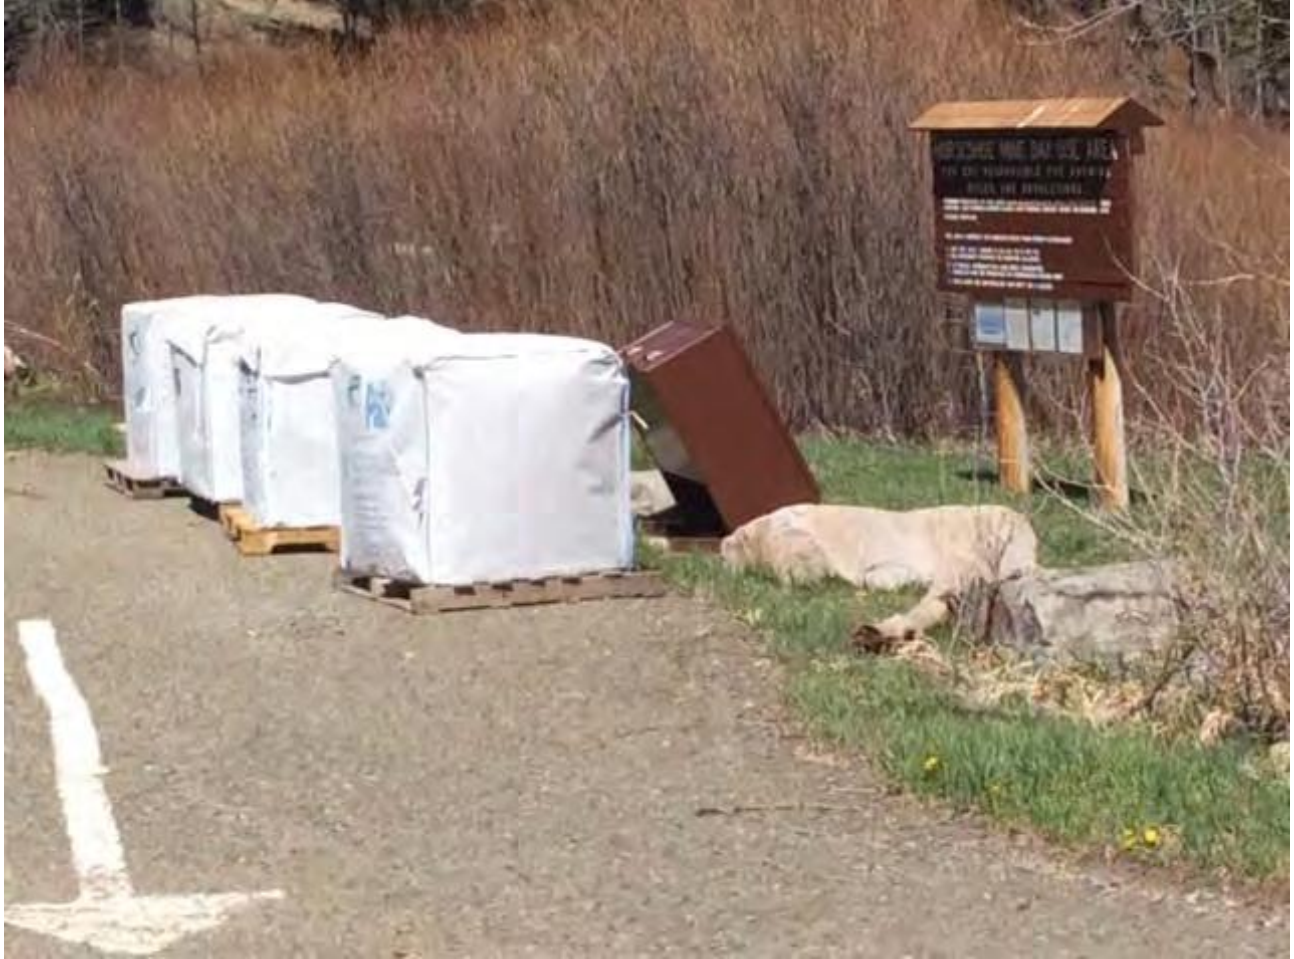
Photo 13 Staging area of cubic yard boxes.

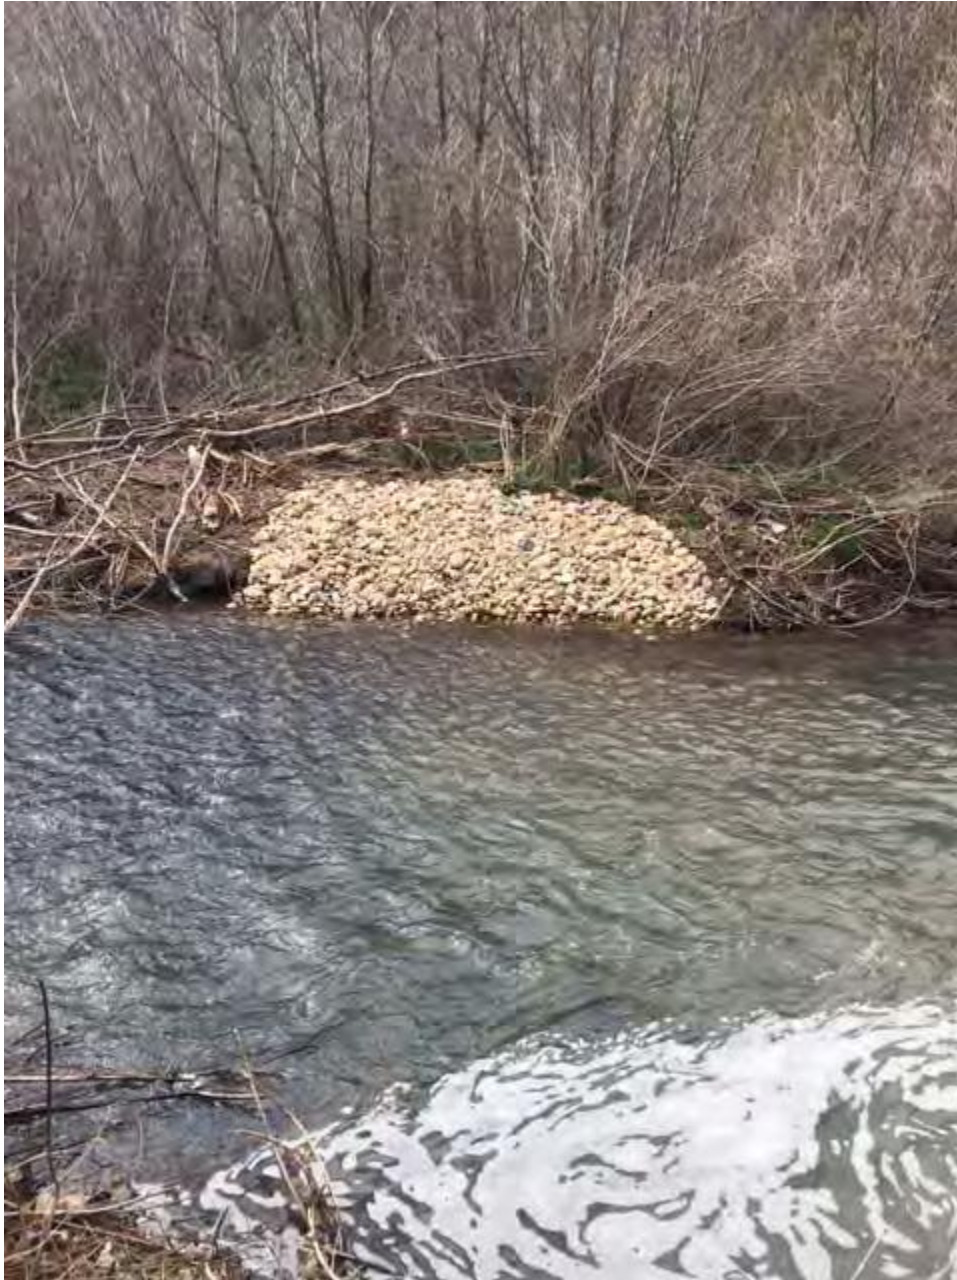
Photo 1 View of Area #1 taken on May 1, 2017 from the south bank facing north.

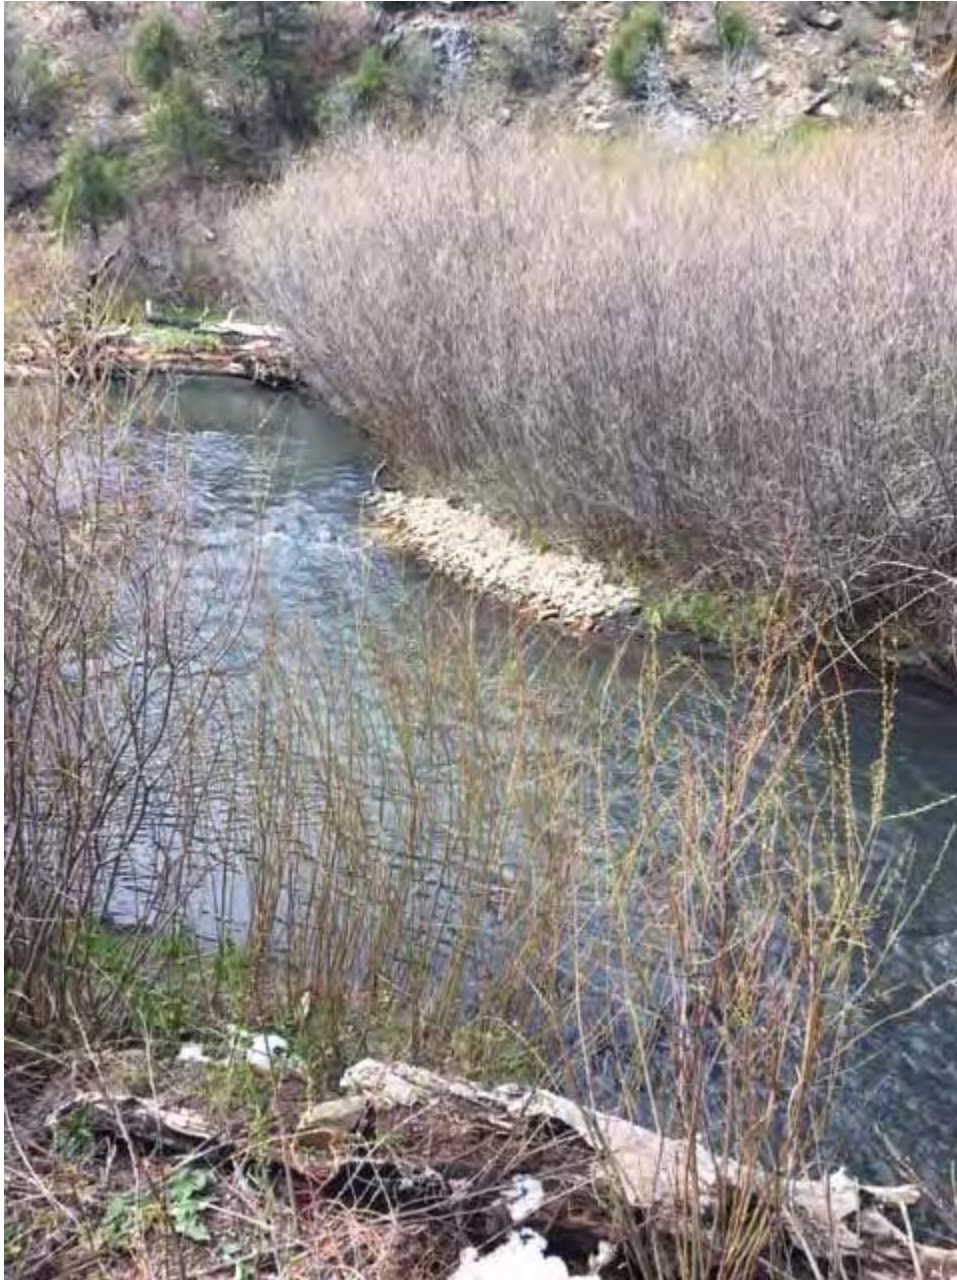
Photo 2 View of Area #2 taken on May 1, 2017 from the south bank facing northwest.

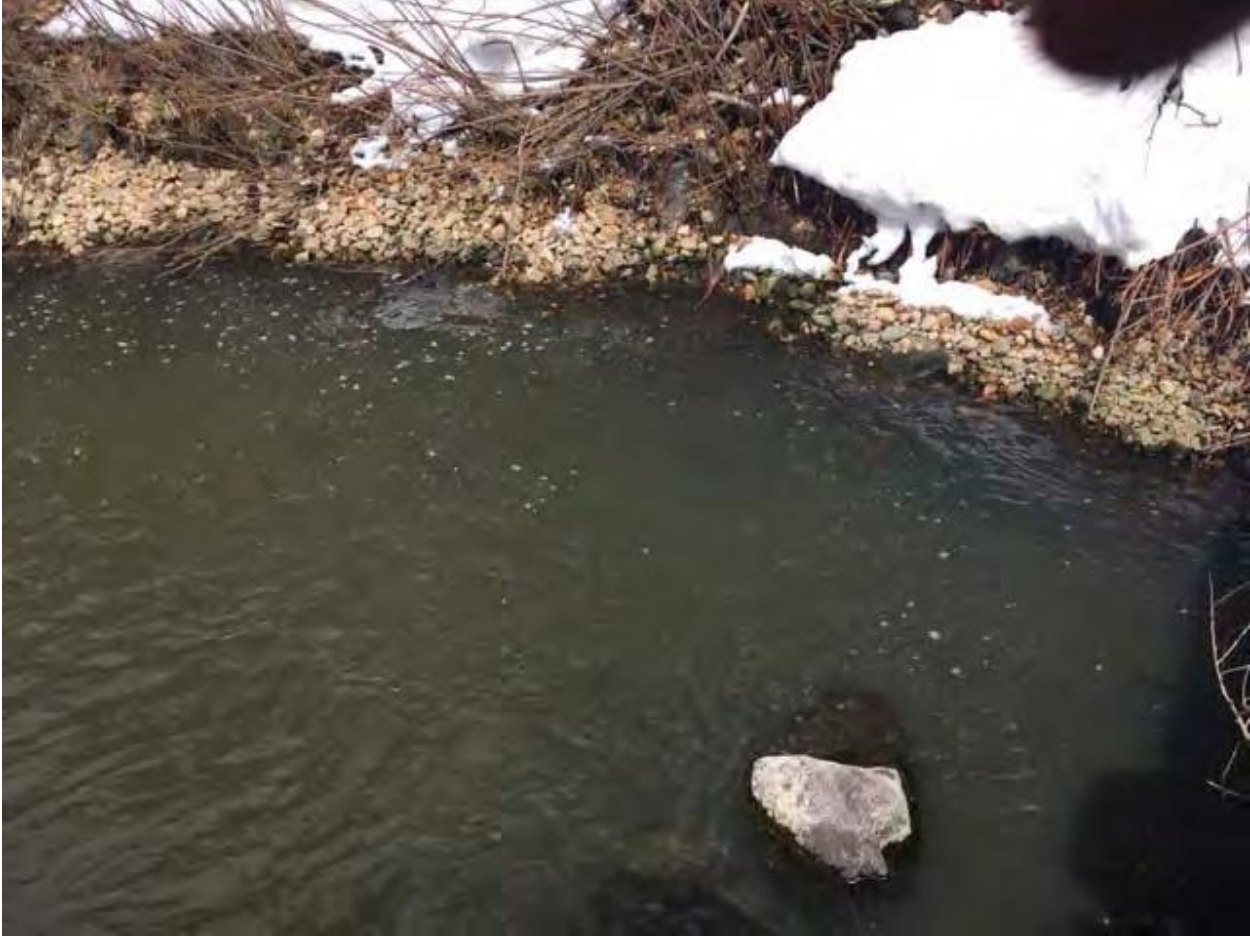
Photo 3 View of Area #3 taken on May 1, 2017 from the west bank facing east.

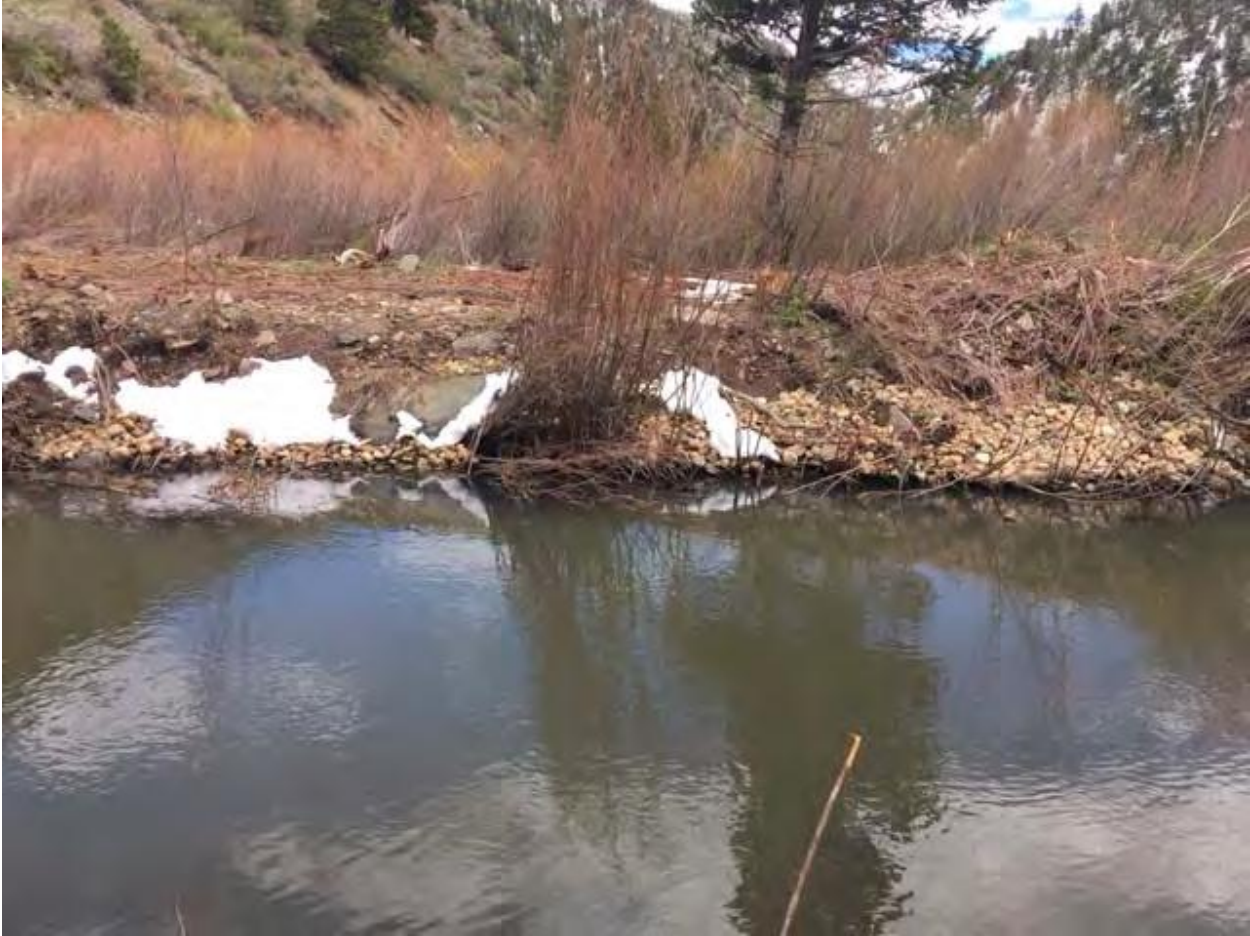
Photo 4 View of Area 4-1 taken on May 1, 2017 from the east bank facing west.
