Corrective Action Report

**Cimarron River Spill
Near Horseshoe Mine,
Cimarron Canyon State Park
New Mexico**

Date of Spill: December 27, 2016

Re: Corrective Action Report for the Cimarron River Spill on State Highway 64
Near the Horseshoe Mine, Cimarron Canyon State Park, New Mexico

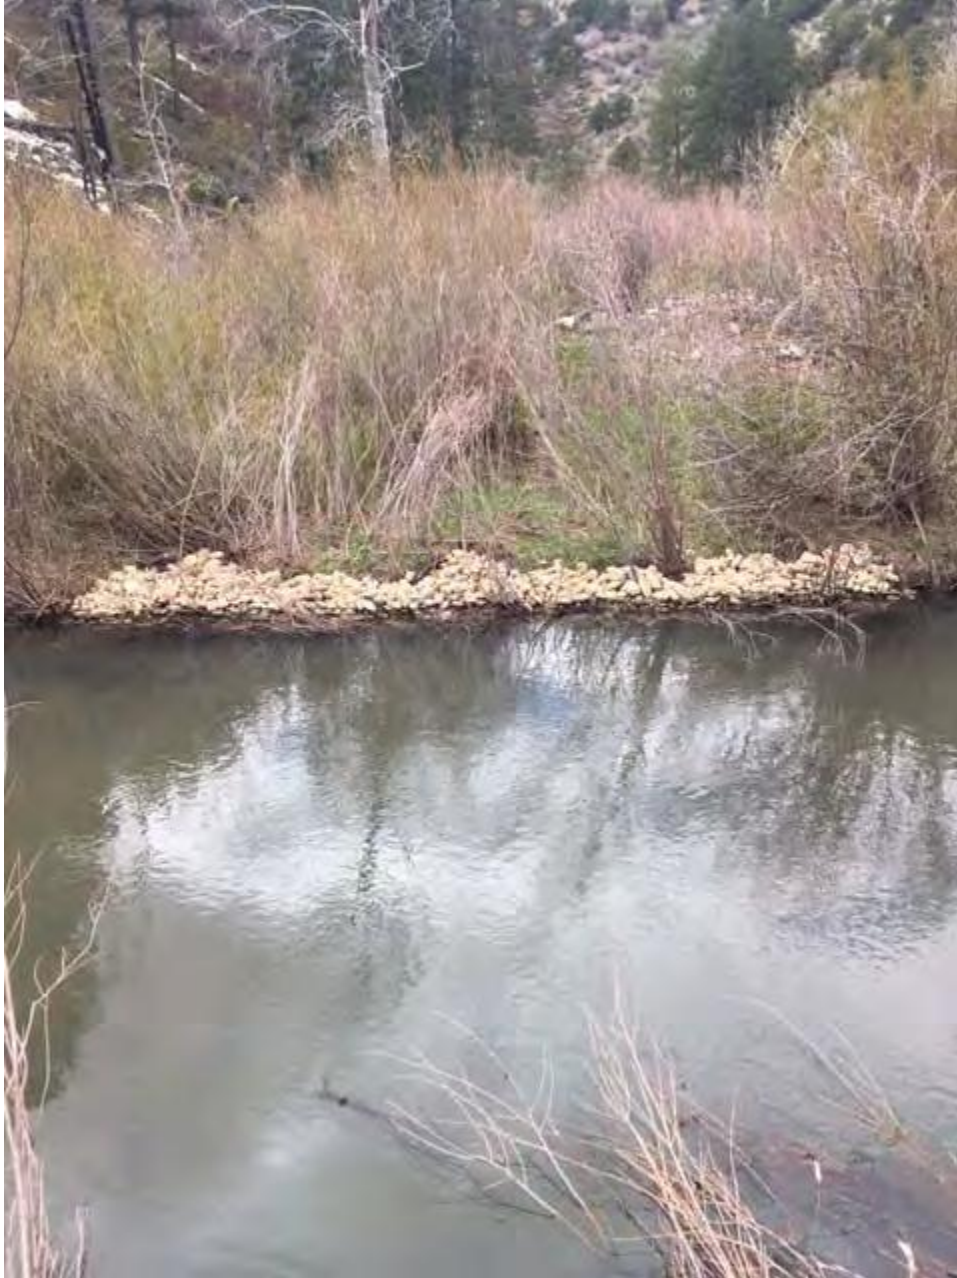
Photo 5 View of Area 4-2 taken on May 1, 2017 from the west bank facing east.

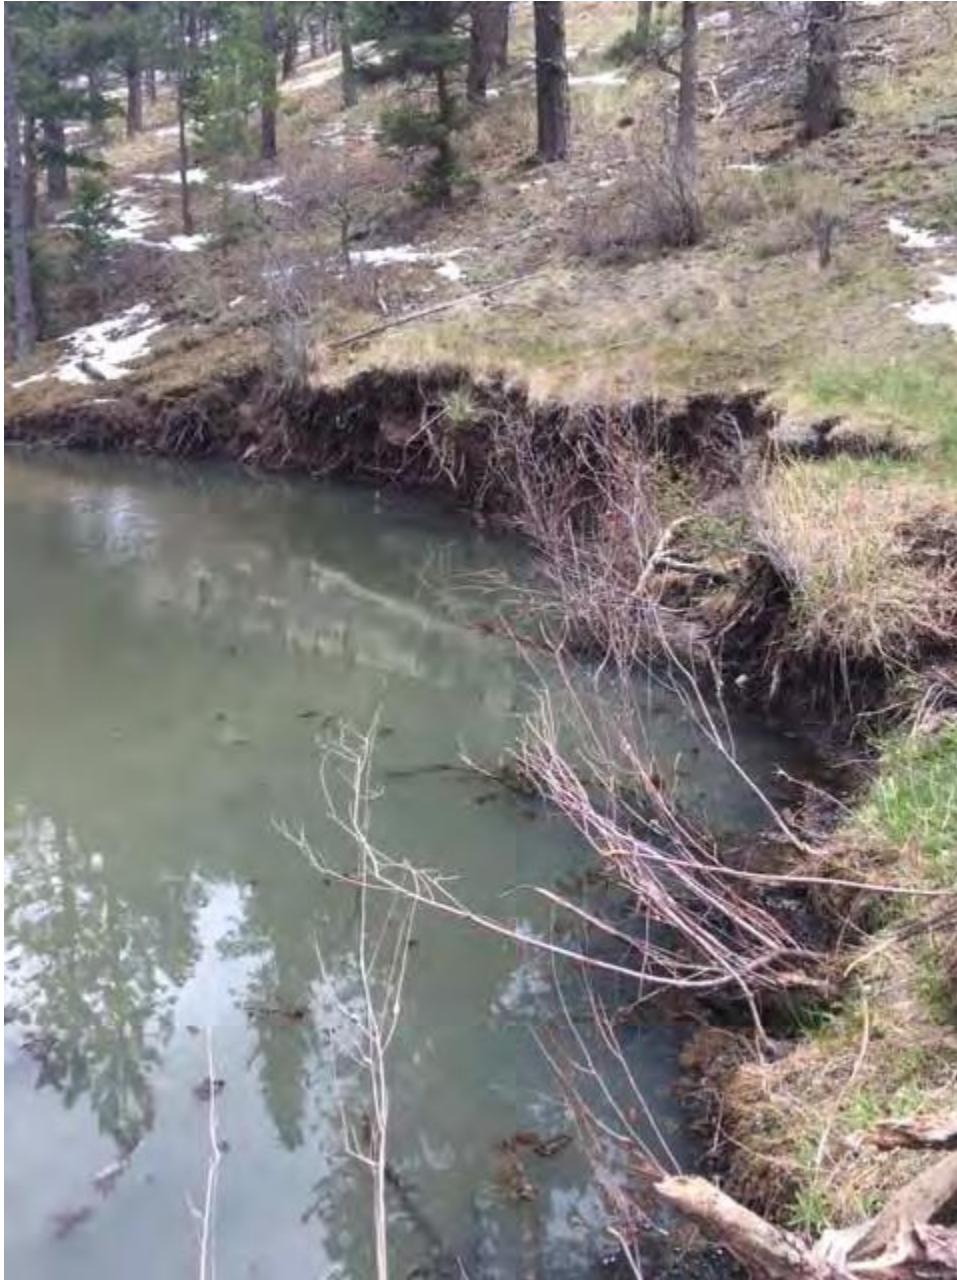
Photo 6 View of Area #5 taken on May 1, 2017 from the west bank facing towards the south.

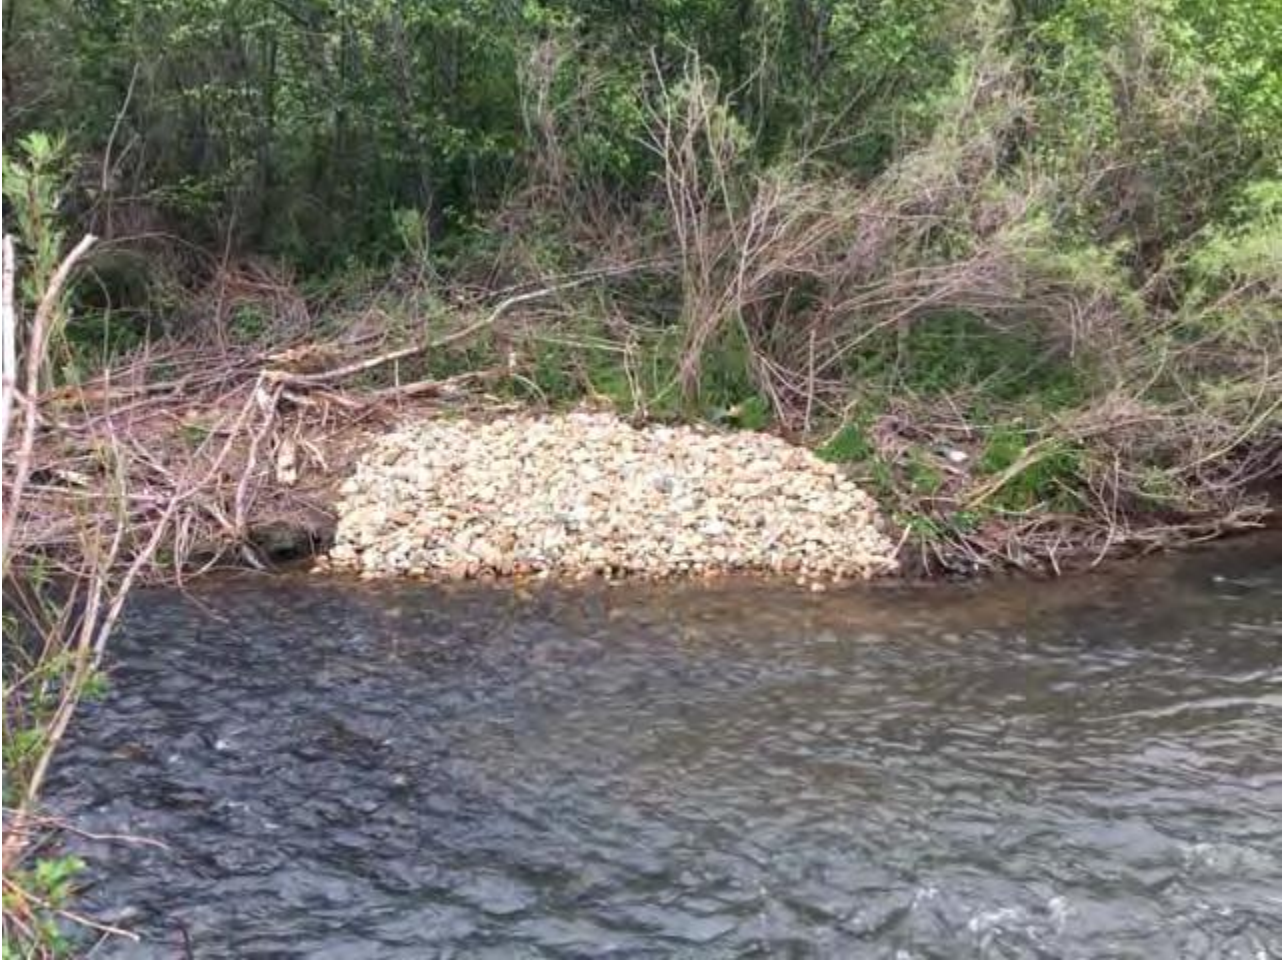
Photo 1 View of Area #1 taken on June 1, 2017 from the south bank facing north.

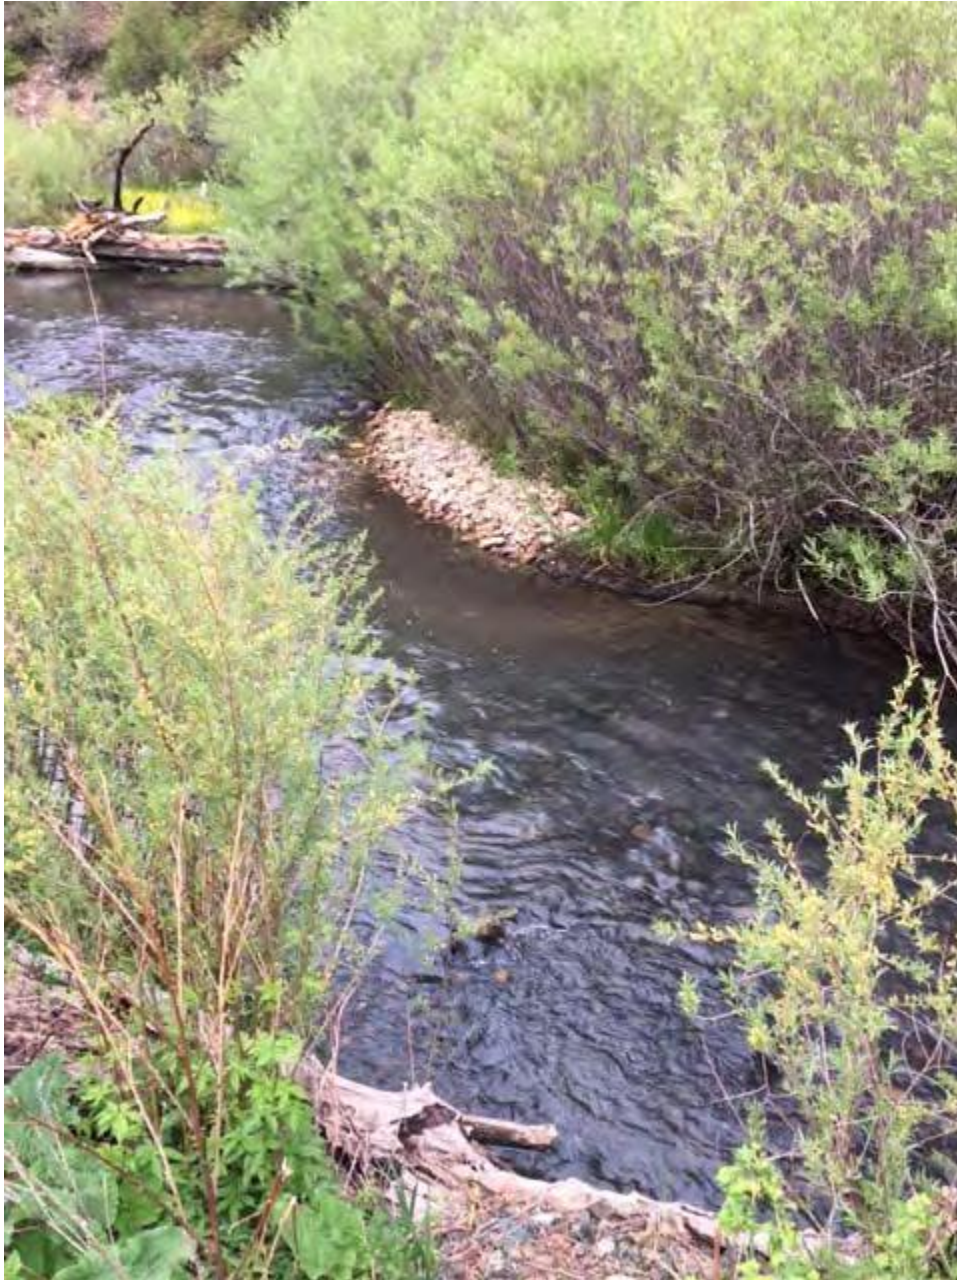
Photo 2 View of Area #2 taken on June 1, 2017 from the south bank facing northwest.

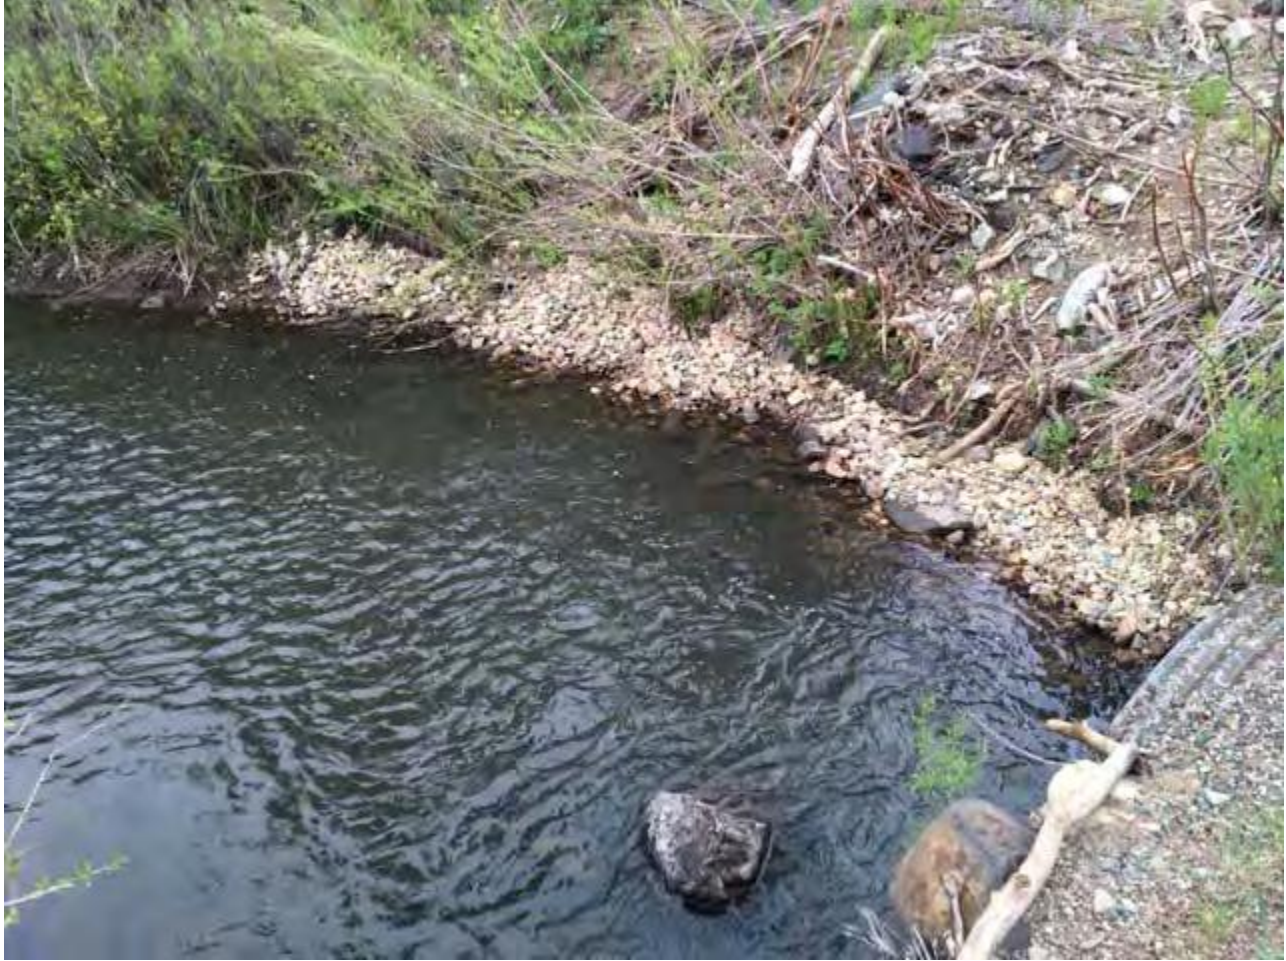
Photo 3 View of Area #3 taken on June 1, 2017 from the west bank facing east.

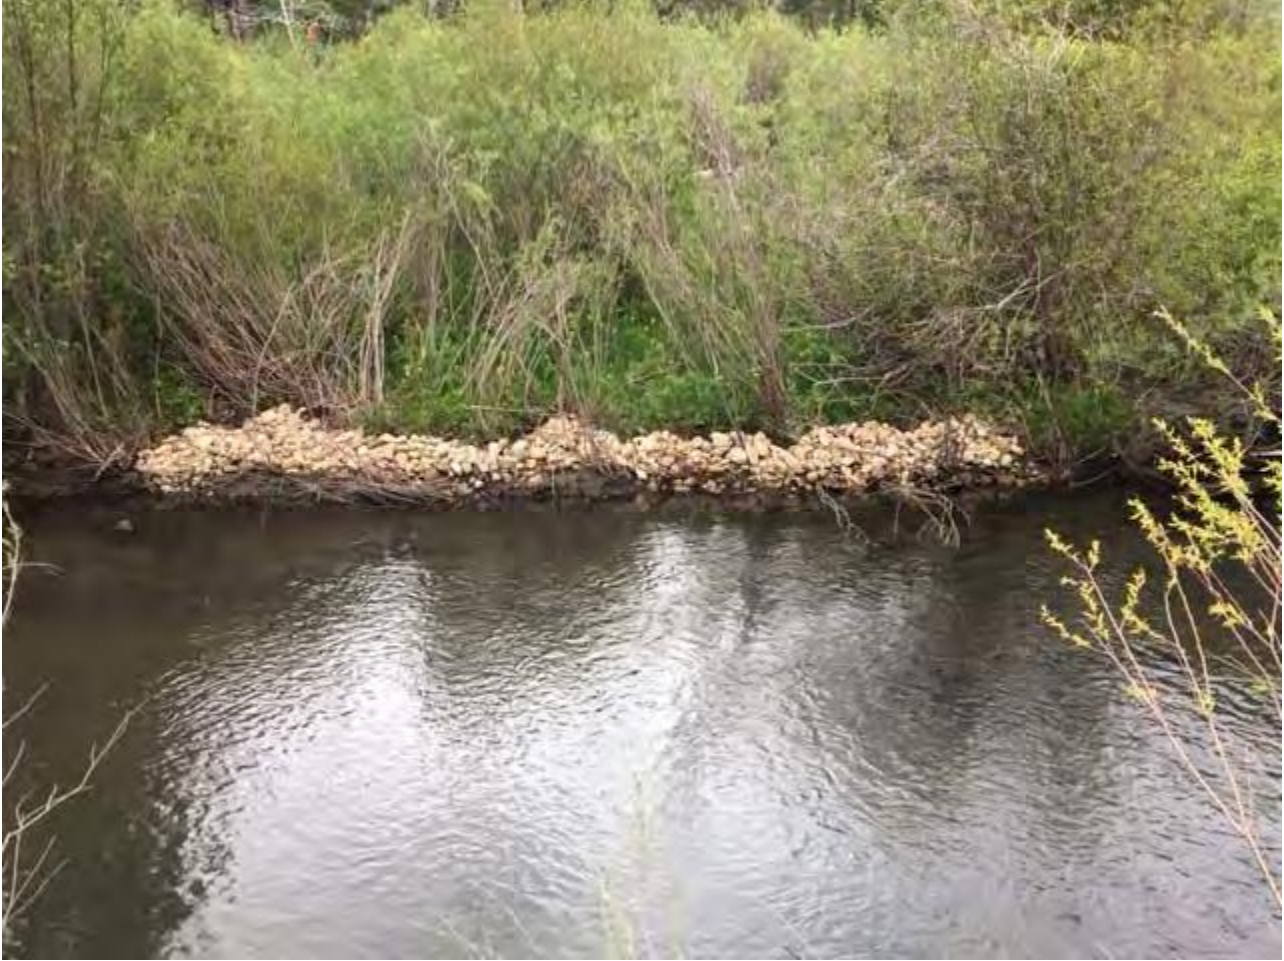
Photo 4 View of Area 4-1 taken on June 1, 2017 from the east bank facing west.

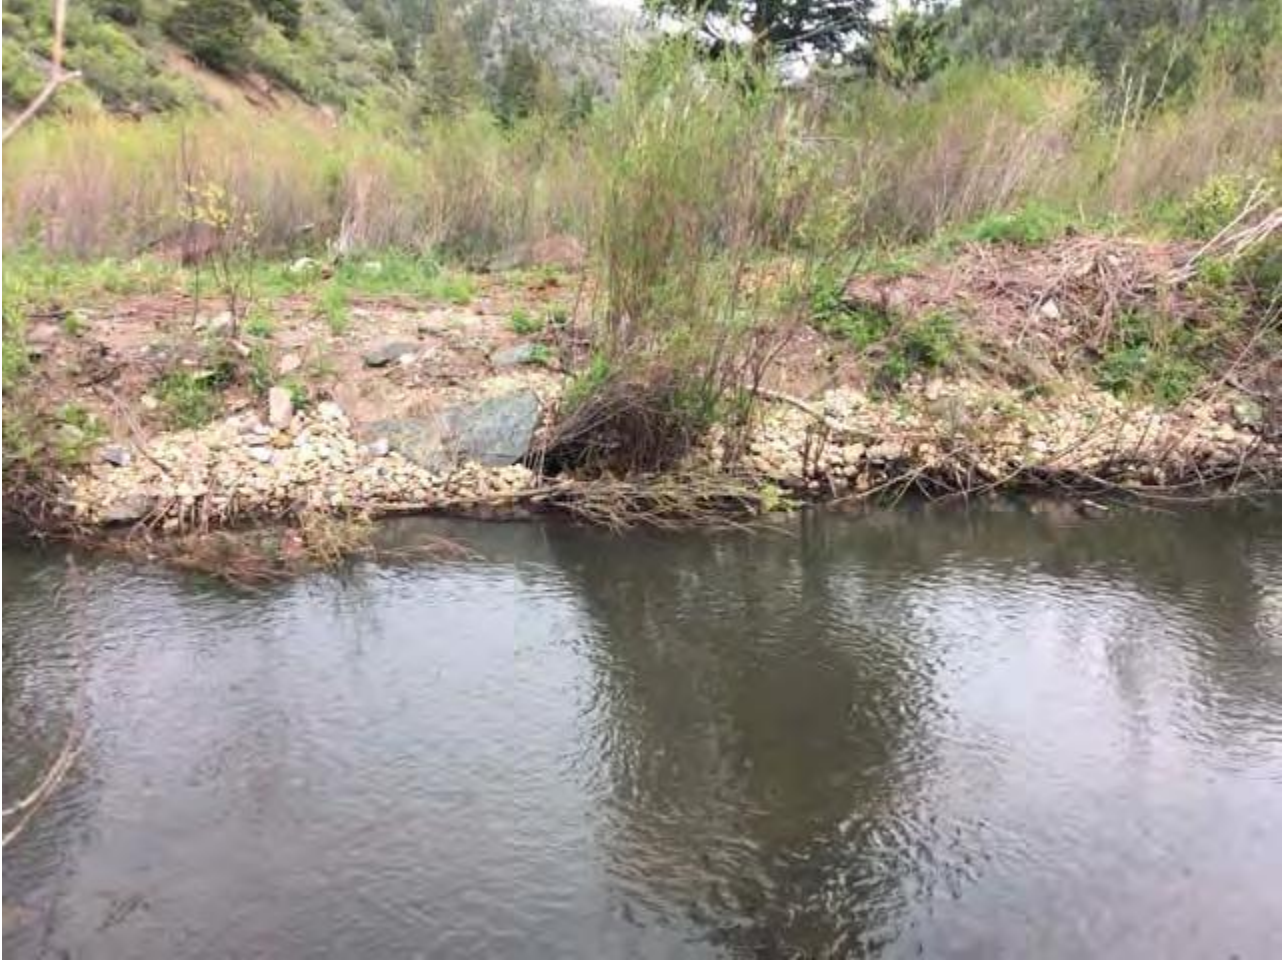
Photo 5 View of Area 4-2 taken on June 1, 2017 from the west bank facing east.

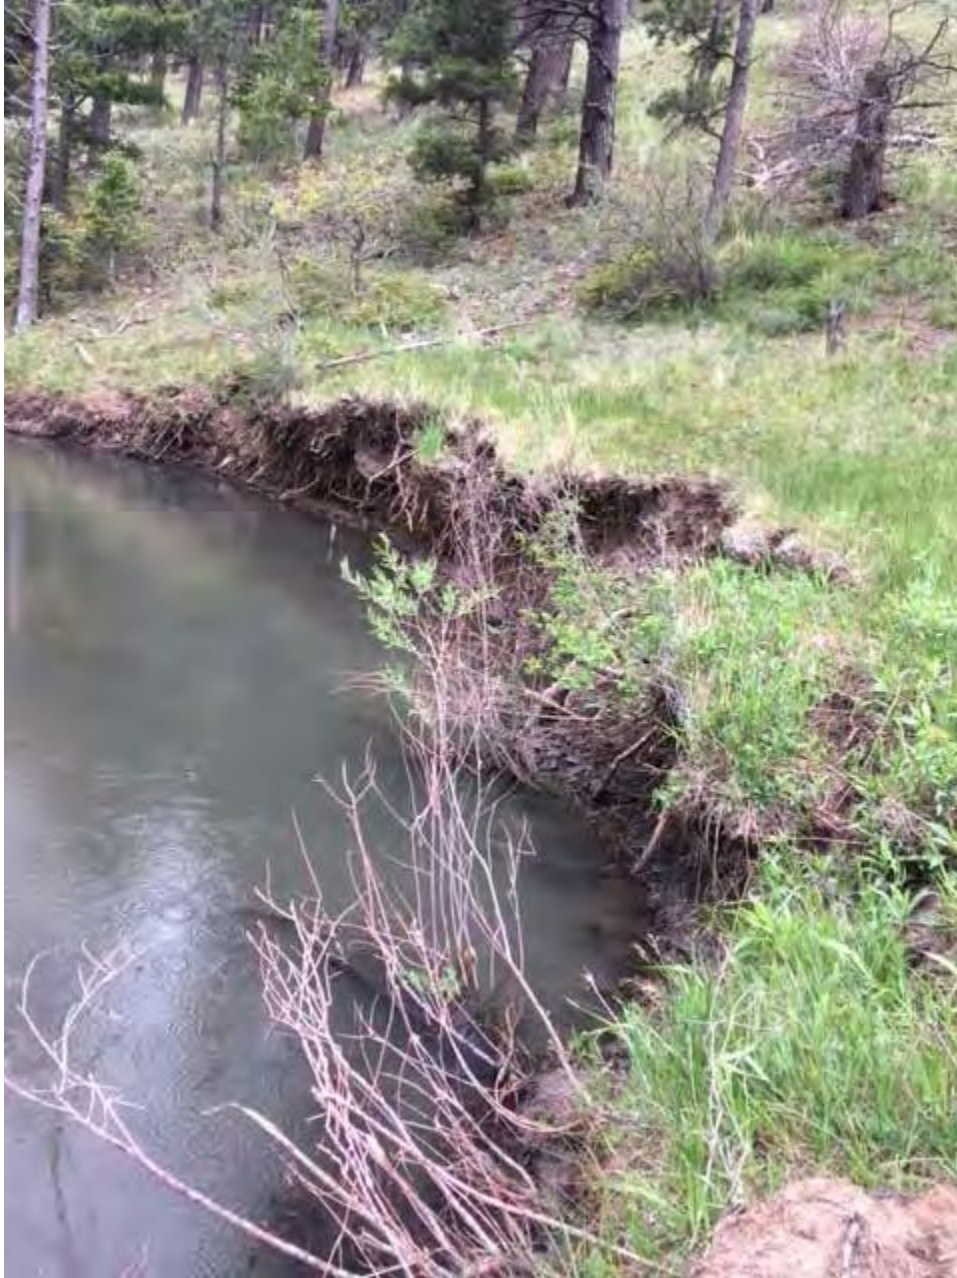
Photo 6 View of Area #5 taken on June 1, 2017 from the west bank facing towards the south.

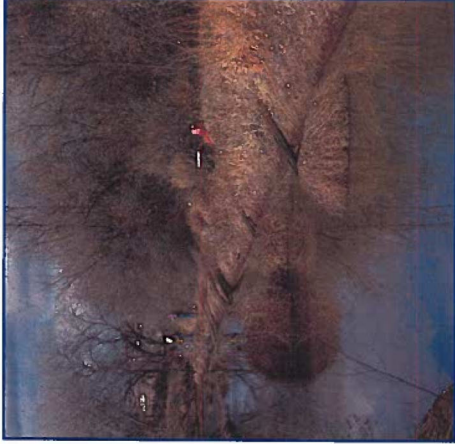
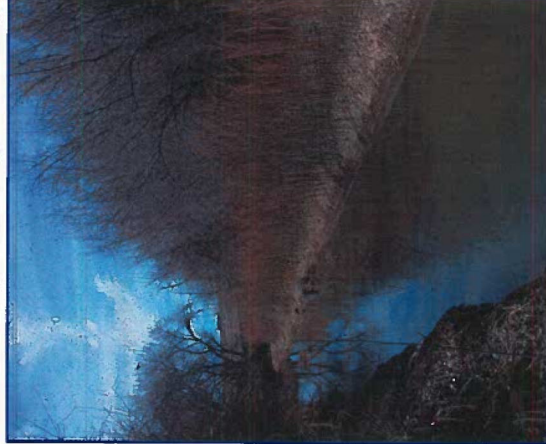
Before and after: Coyote willows "deep planted" along drainage ditch

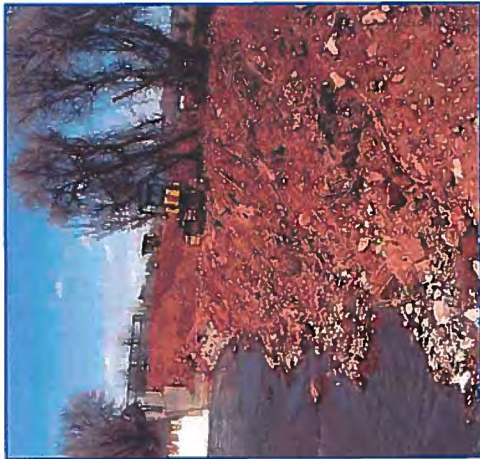
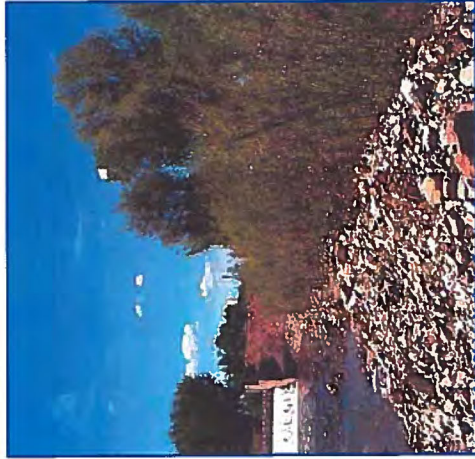
Before and after: Streambank stabilization is achieved by "deep planting" coyote willow whips; planting holes were augered in the rocky soil by using rotary hammers.
