ABANDONED OR INACTIVE URANIUM

MINES IN NEW MEXICO

New Mexico Bureau of Mines and  
Mineral Resources  
Open-File Report 148

Mine name(s) Cedar 1 (Yucca) (Falcon?) County Valencia

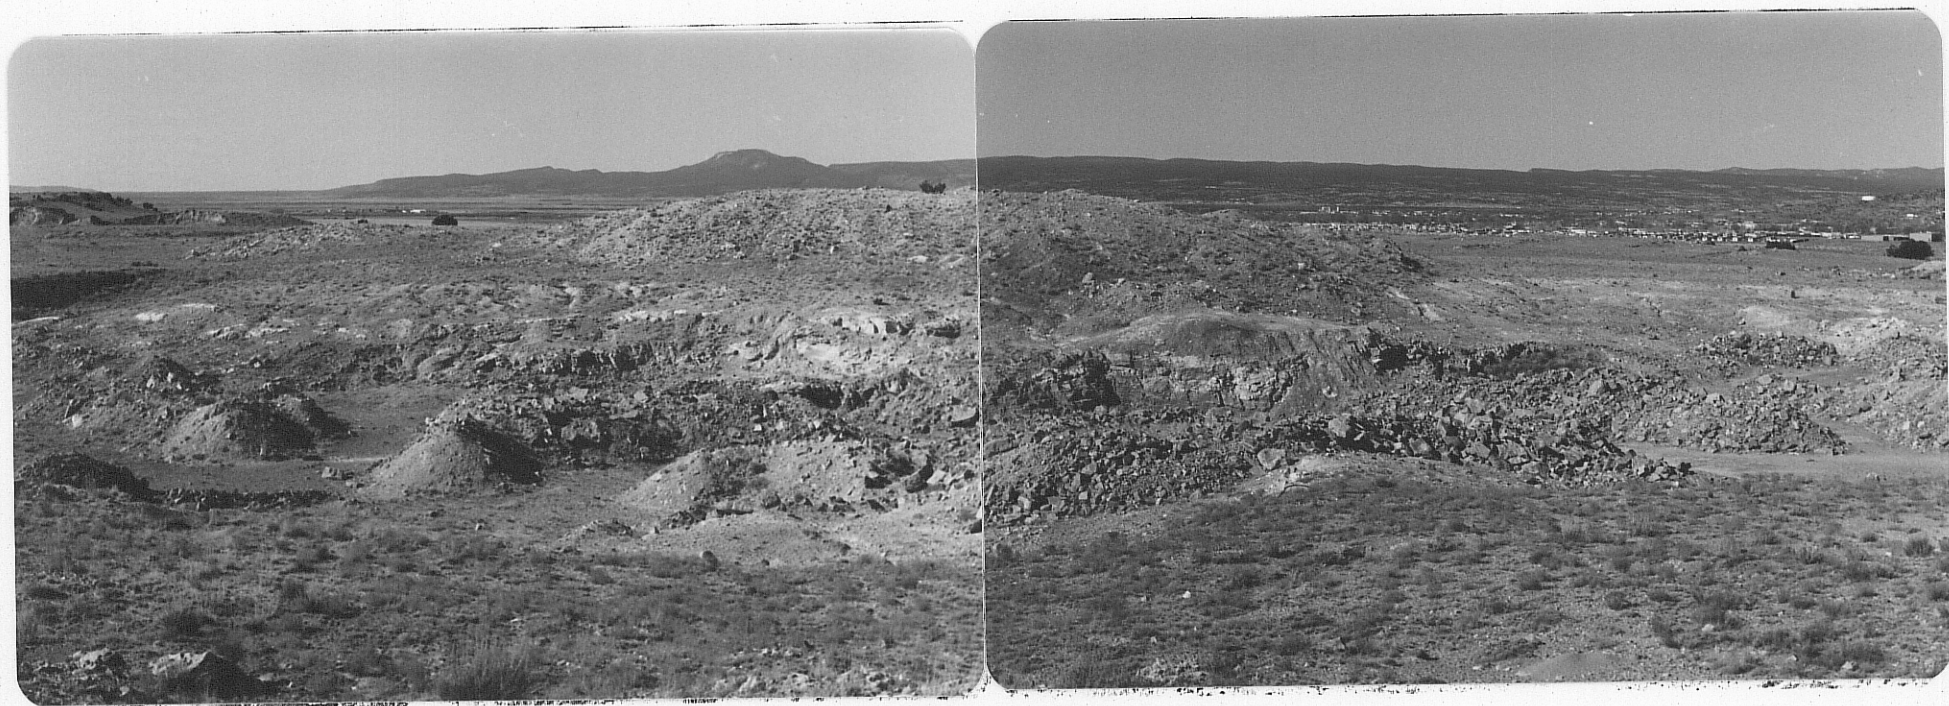
The open pit measures 300' N-S, by 200' E-W, and is 25' deep at maximum (see photo a); pit entrances are located at the northwest and south ends. The deposit is associated with a series of east trending intraformational folds in Todilto limestone (see photos b & c). Scintillometer response in the areas of the exposed folds was 700 cps, or 10 x background. Yellow uranium vanadates are present, but sparingly.

The main waste pile lies immediately west of the main pit (photo a), however, mine waste piles lie to the north and east as well; some ore may have been stockpiled in the north and east areas as scintillometer responses were stronger there.

Photo (a) Looking generally southwest at open pit mine on Cedar 1 Claims; overburden pile at center behind the pit, Grants at right in background. At upper left is the remnants of an abandoned aggregate pit operation.

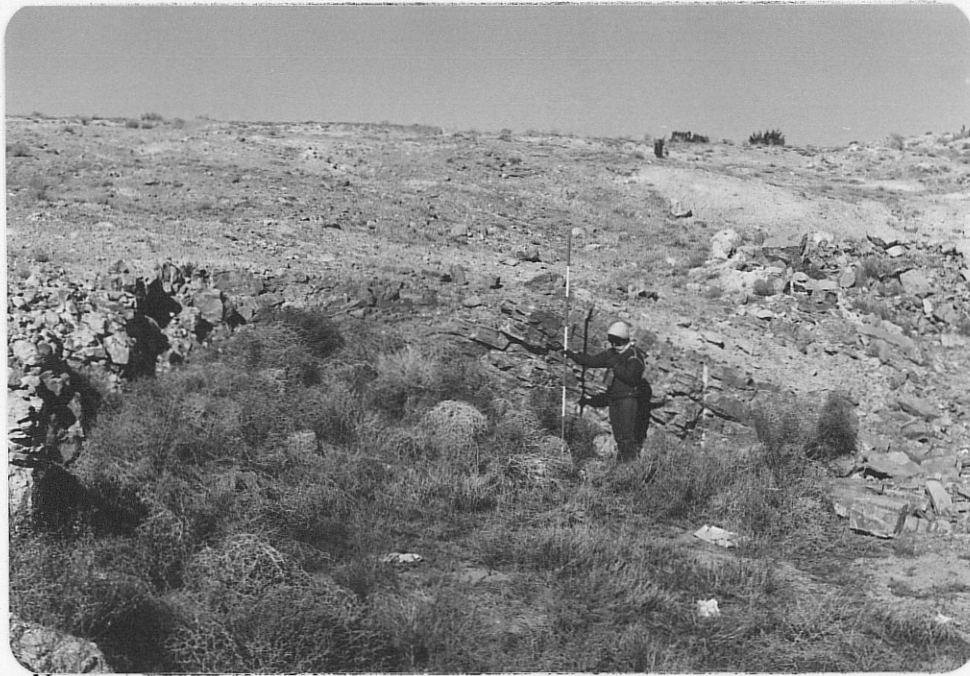
Photo (b) Looking westward into intraformational fold exposed in north end of open pit.

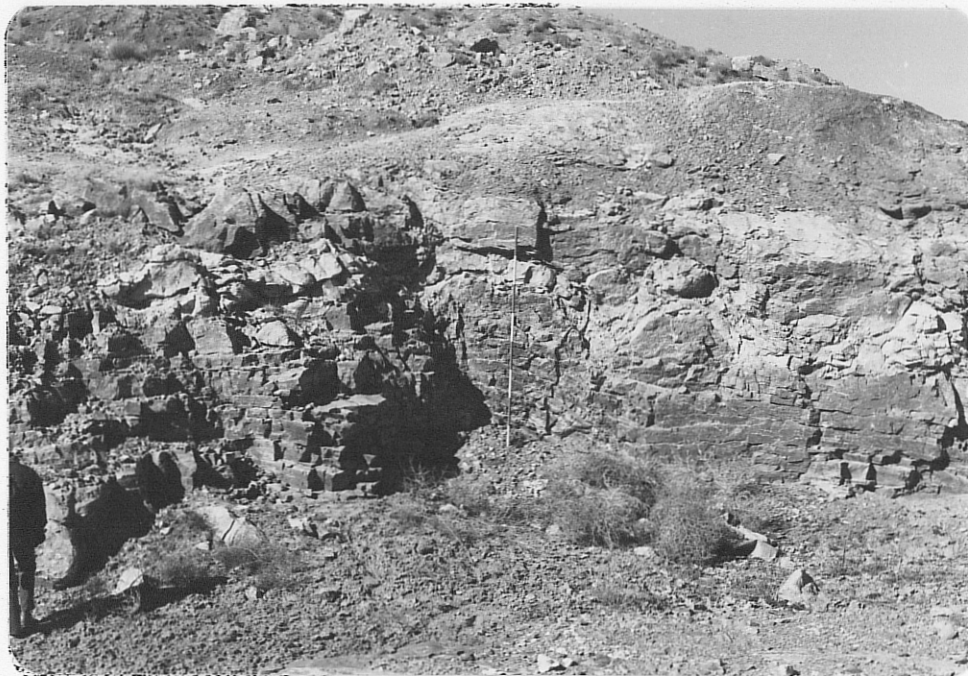
Photo (c) Looking westward into intraformational fold parallel to and 50' south of the fold in Photo (b). Scintillometer response was moderate, but visible mineralization scant.

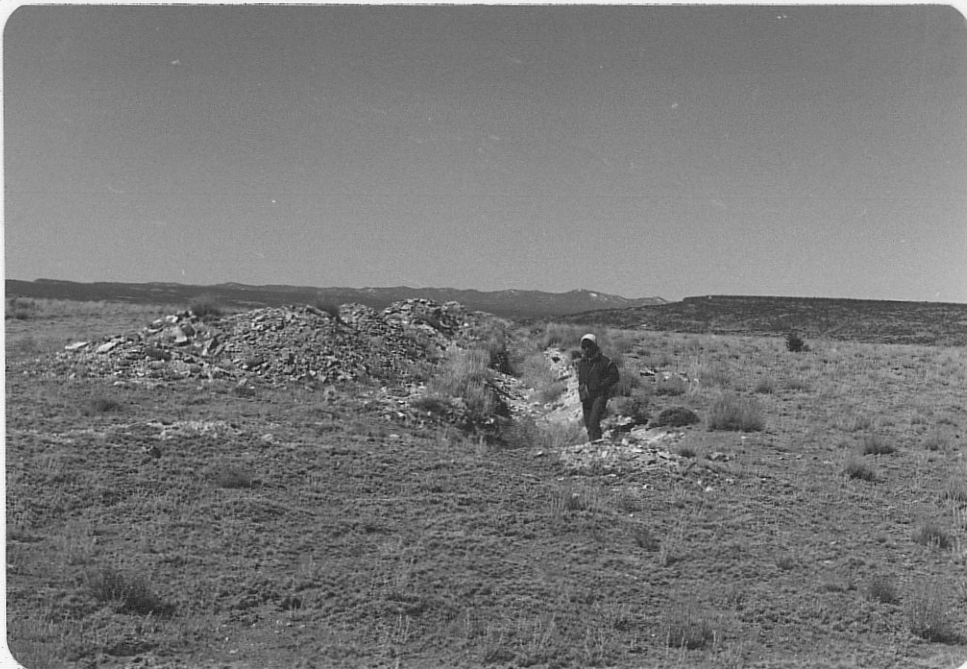
Linear prospecting trenches extend eastward toward the sec. 21 line (see photos d & e), but no prospecting or mine workings were recognized in sec. 21; an AEC mine listing noted the Falcon 1 and 2 claims in sec. 21. The name "Falcon" was mentioned as an alternate to the Cedar at the top of this page because the State Mine Inspector's Office has used "Falcon" for this mine on the Cedar claims; they however, also listed the location as being 4 miles southeast of Grants.

Photo (e) Looking westward at linear prospecting trench near southeast corner of sec. 20.
