Memorandum

Subject: Pre-CERCLIS Screening Assessment of Blue Peak Mine, McKinley
County, New Mexico: Further action under CERCLA recommended

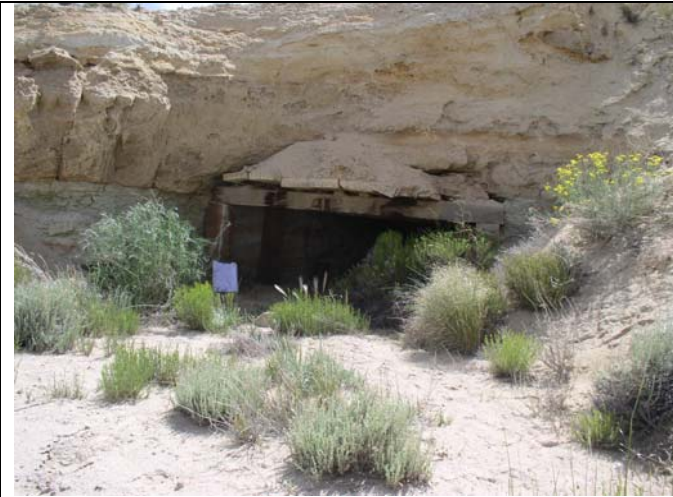
Site summary: Observations made during NMED's Site reconnaissance are shown on the accompanying figures. One open adit and partially-open adit with radioactivity elevated above background are visible along the upper bench cut road. Most remaining waste rock has only slightly elevated radioactivity (maximum=679 cps; background=14-45 cps). Most waste appears to have been contoured to minimize erosion. An open vent shaft on the mesa top that is not well-

P1: Blue Peak mine open adit

1. Remove waste with elevated radioactivity.
2. Seal open adits and vent hole.

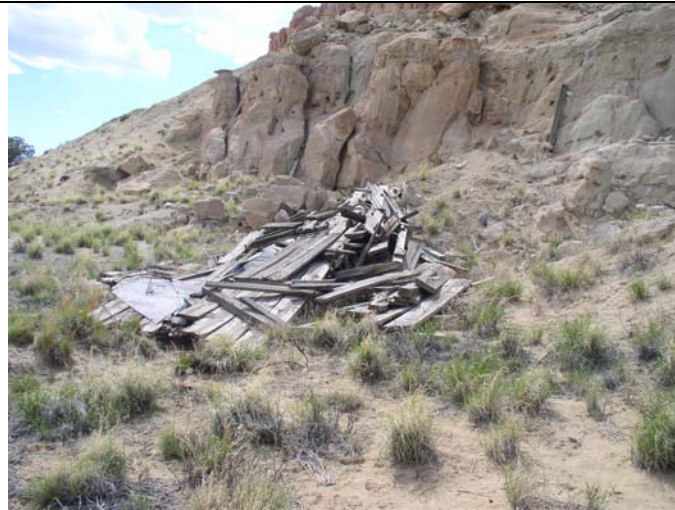
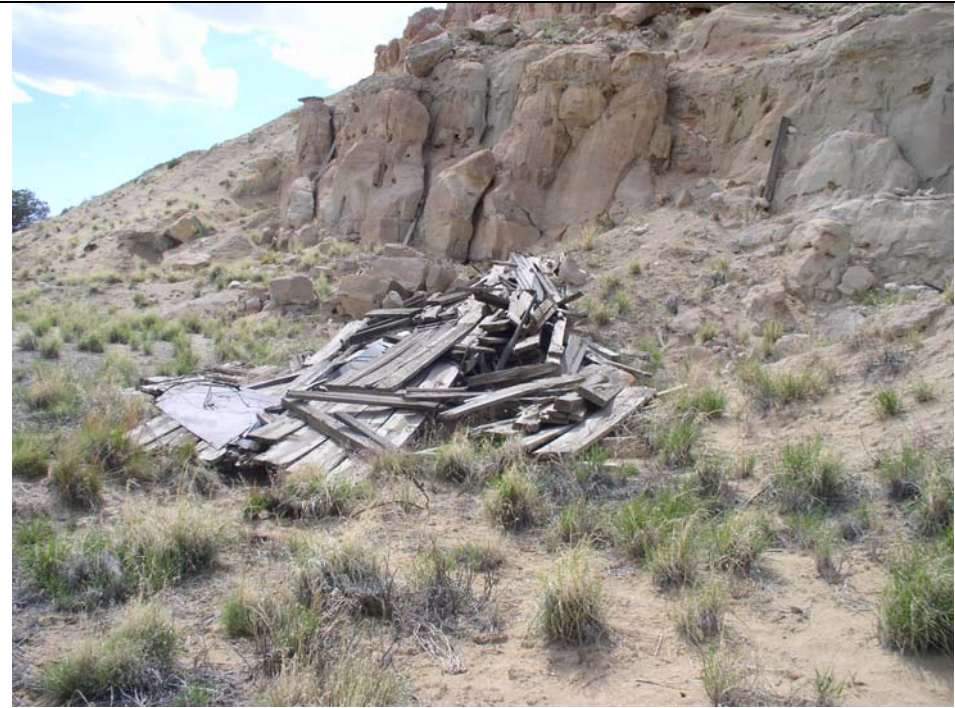
P2: Blue Peak mine load-out facility remains

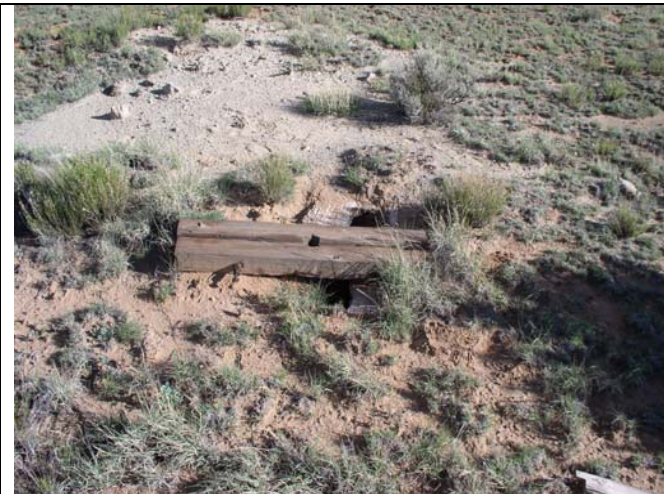
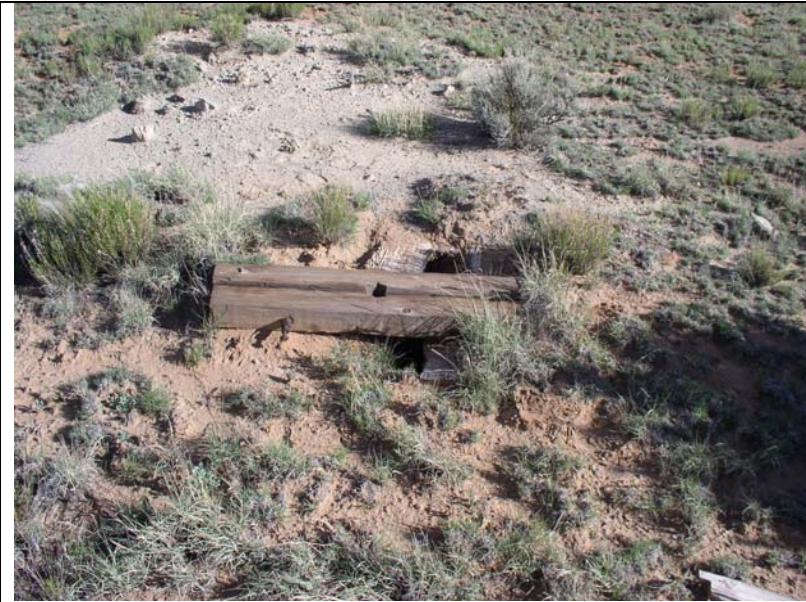
marked could be hazardous to humans, livestock, and wildlife, and could provide an avenue for aquifer cross-contamination.

P3: Blue Peak mine open vent shaft on mesa top.

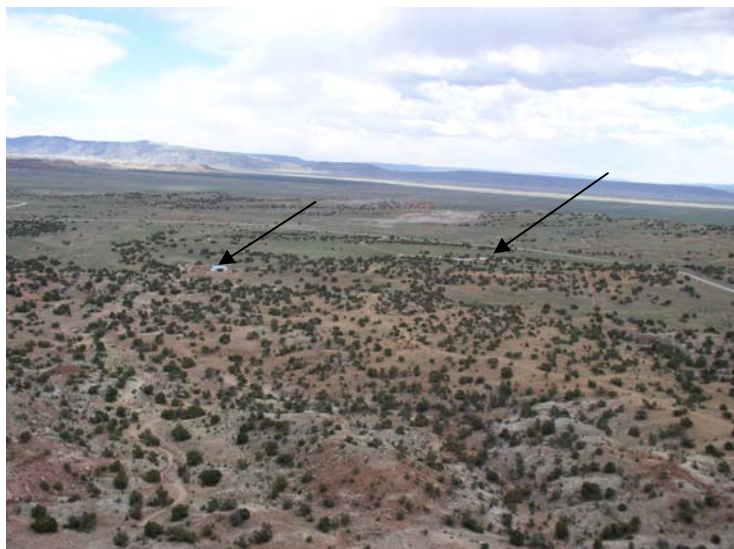
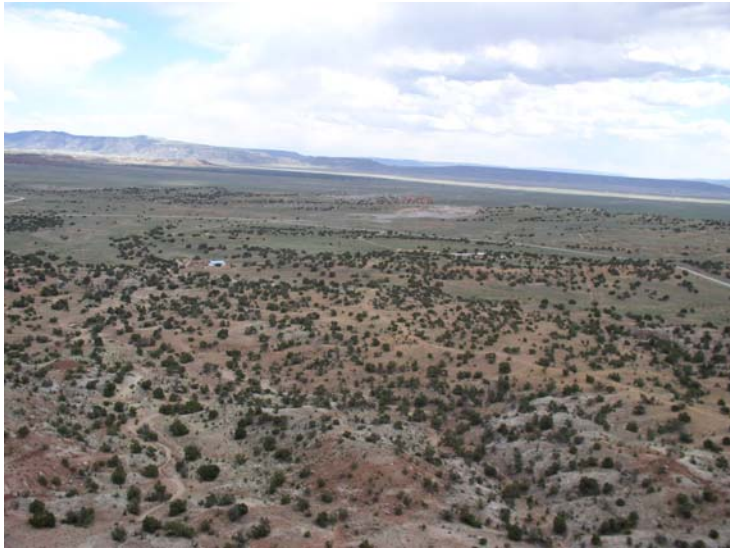
Targets: Residences are located near the junction of State Hwy. 605 and 509, approximately 3.65 air-miles east-northeast of the Site. Another residence is located along Haystack Road approximately 0.7 air-miles south of the Site, from which another residence is visible further to the west. Other potential targets may include cattle and wildlife.

Blue Peak mine view towards southwest showing residences (arrows)

Blue Peak mine view towards southwest showing residences
