Abandoned Uranium Mine Field Survey Project

prepared for
New Mexico Energy, Minerals and Natural Resources Department
Mining and Minerals Division

July 18, 2008

Cedar Mine

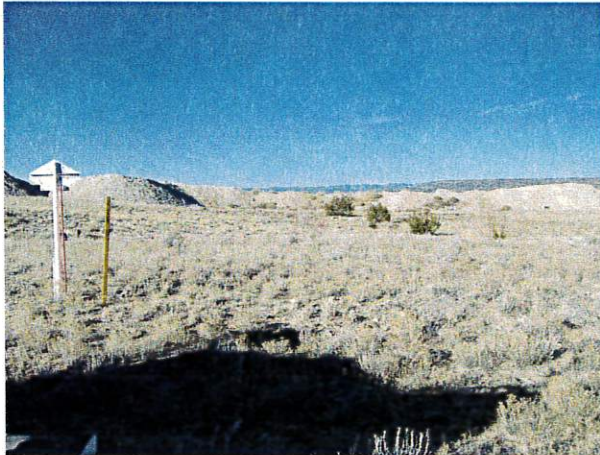
View west, pipeline marker, gravel pit in distance

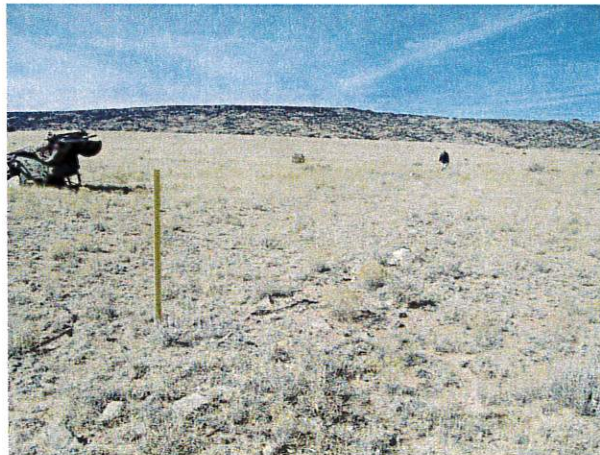
Equipment remaining on-site includes an old truck, an engine, and what appears to be a powder box.

View north, pipeline, old truck

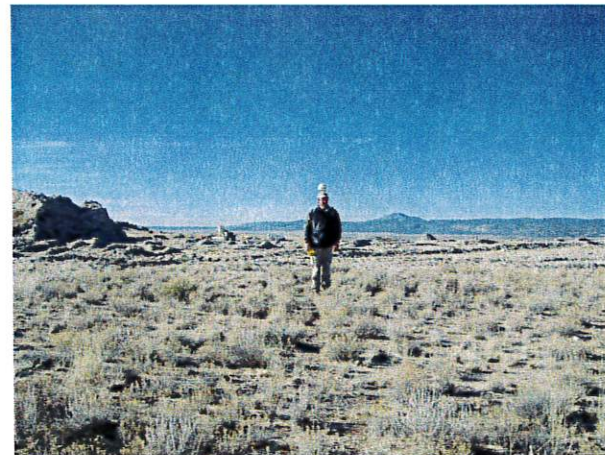
2. Human Activity: The Cedar Mine is directly adjacent to an active sand and gravel mining operation operated by B-b Concrete. Trash (heavy equipment, air filters, etc.) has been discarded on-site. A buried gas pipeline crosses the site in a north-south direction. The nearest residence is approximately 1,000 feet to the east of the site.

View southwest to sand and gravel op.

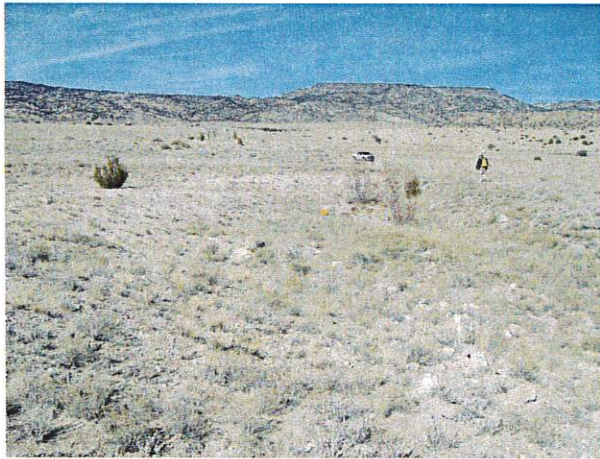
4. Mine Disturbance: The mine consists of seven lateral exploratory cuts extending east-west an average of 1,200 feet. To the west of these cuts are two shallow pits (one approximately 180 ft. in diameter by 10 ft. deep maximum, noted as large pit in photo, the other approximately 75 ft. by 25 ft., 3 ft depth), as well as two rock piles associated with the east-west cuts on the east margin of the site. These piles are 340 and 460 feet long respectively, approximately 4 feet wide and approximately two feet thick. A pile approximately 35 feet in diameter and three feet thick exists on the east margin of the site, and a pile approximately 15 feet in diameter and 2 ft. thick is present in the center of the site.

View of large pit

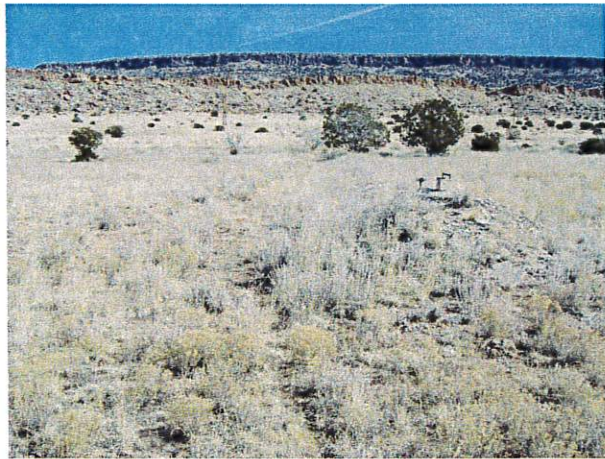
E-W rock pile
