Abandoned Uranium Mine Assessment for the Lucky Strike Site (NM0181)

FINAL REPORT

NM0181

October 19, 2010

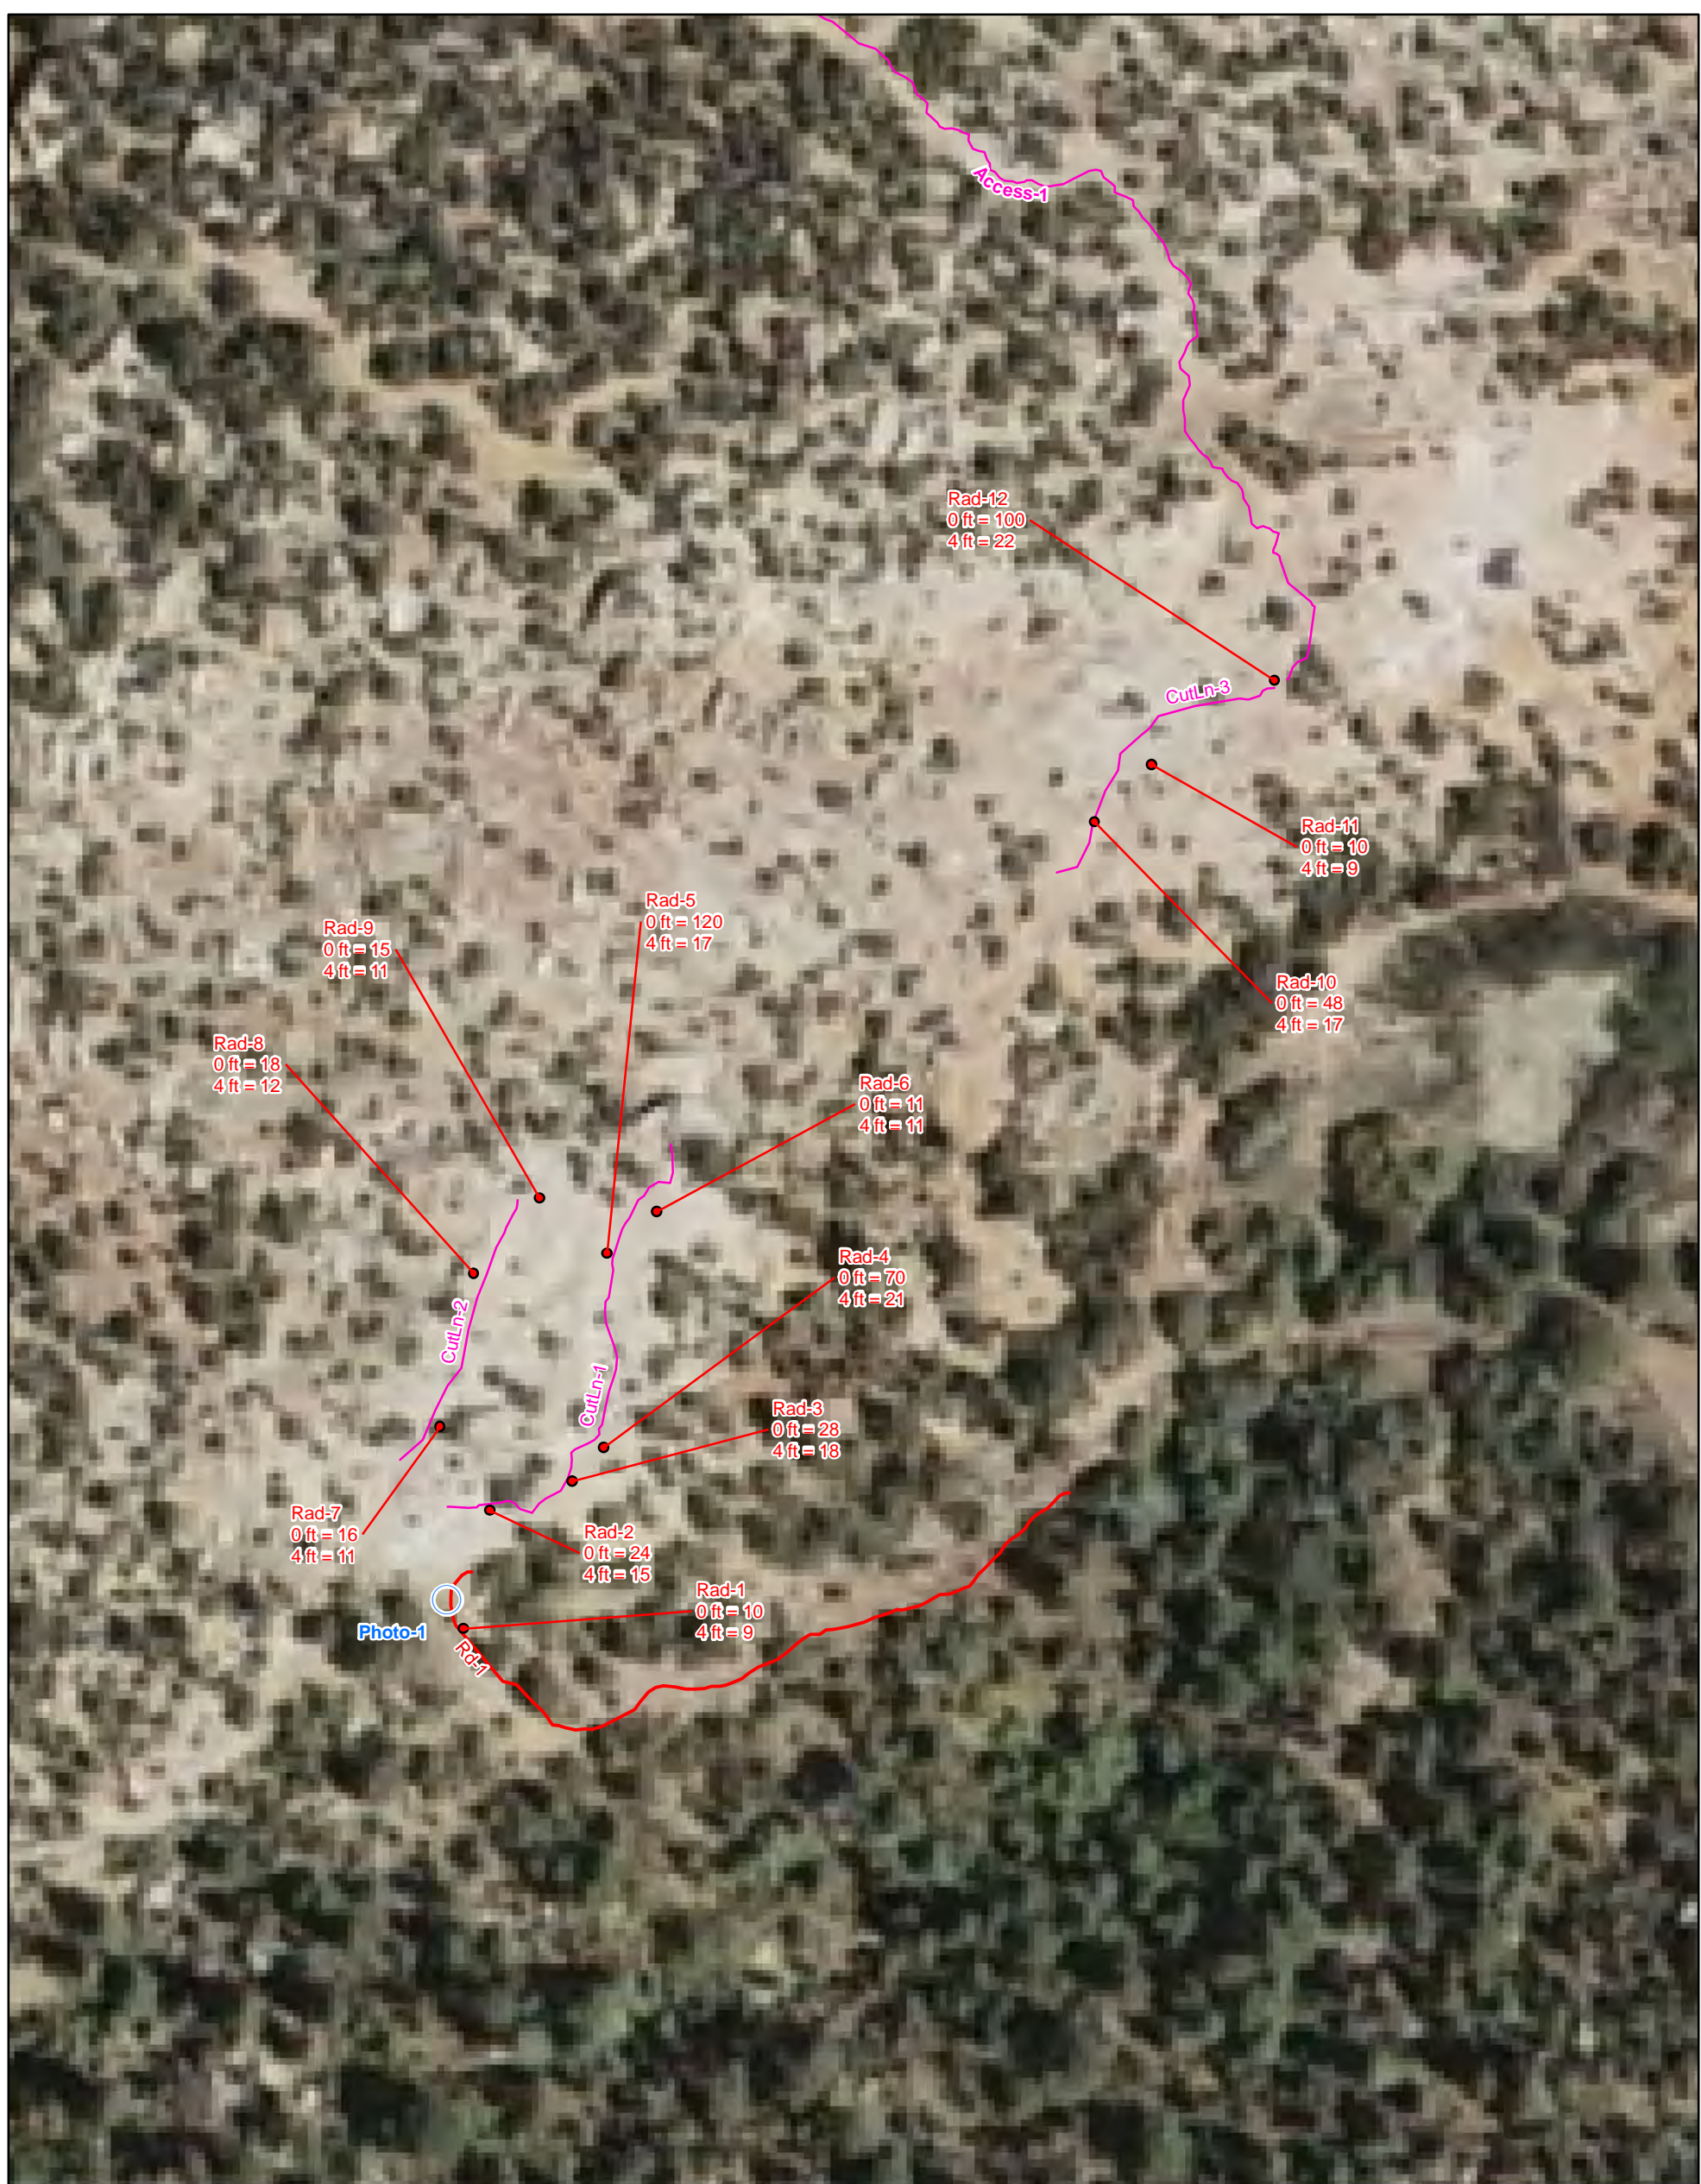
Figure 4a
Site Map on
Aerial Photo
NM0181-Lucky Strike
 Abandoned Uranium
 Mine Assessment

The mine features described below are based on the features provided to INTERA by MMD in the GIS Data Dictionary (MMD, 2009). INTERA marked the locations of the AUM Site features using a Trimble Global Positioning System (GPS) and entered details about the features into the GPS using the MMD data dictionary. Three open cuts and a mine road were found onsite. Please see the Photo Log in Appendix A for photos of the AUM Site features, Table 1 for a list of the AUM Site features, and Figures 4a and 4b for the locations of the AUM Site features.

One mine road (Rd-1) was found onsite. This road extends southeast from the southern workings several hundred feet into the canyon below (see Figures 4a and 4b).

One background gamma radiation reading was taken near the AUM Site, recording 9 $\mu\text{R/hr}$ at 0 ft above ground and 9 $\mu\text{R/hr}$ at 4 ft above ground. Please see Table 2 for all of the gamma radiation readings taken at the AUM Site and Figures 4a and 4b for the locations of the radiation readings.

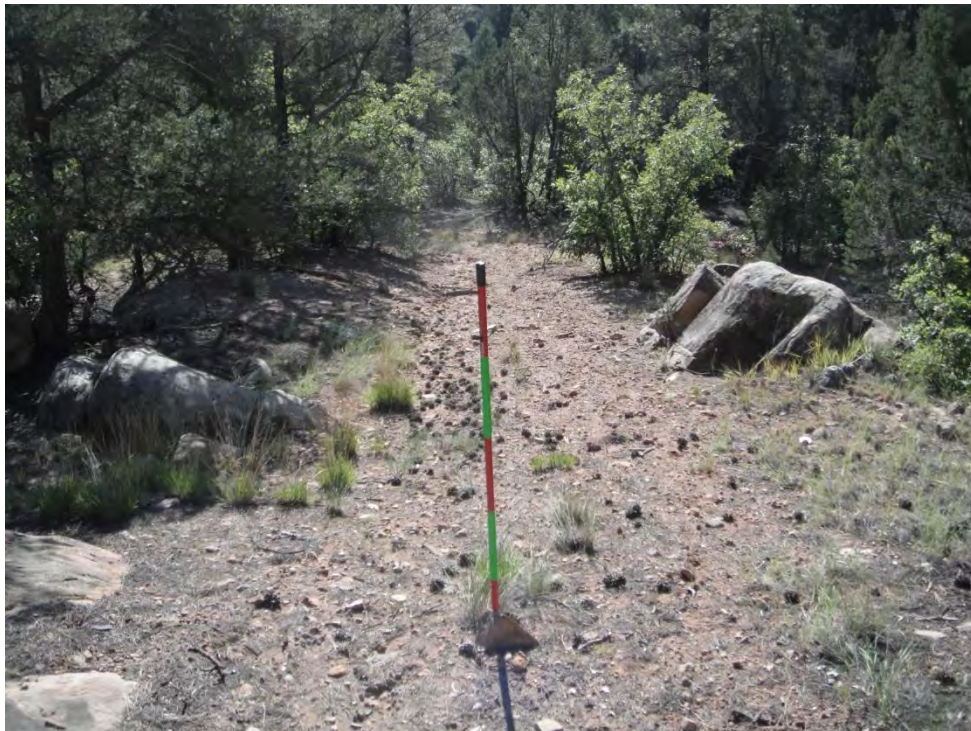
Photo 2-Looking east at Rd-1.

Photo 2 - mine Rd - 1 looking east

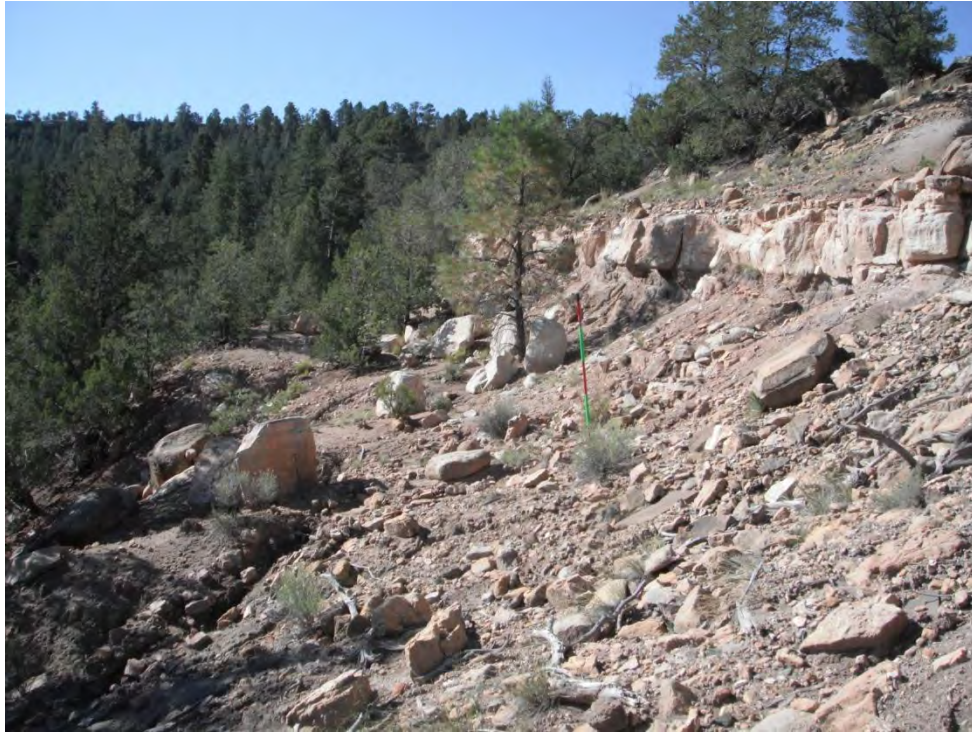
Three open cuts (CutLn-1, CutLn-2, and CutLn-3) were identified onsite. CutLn-1 represents the southern rim cut referred to in Anderson (1980). This cut, approximately 10 ft high and 200 ft long, is cut into the Triassic sedimentary deposits that form the hillside. Approximately 50 ft above CutLn-1 is a smaller bench cut, CutLn-2. CutLn-2 is approximately 15 ft high and 150 ft long. CutLn-3 is a bench cut found approximately 200 north of CutLn-1 and CutLn-2 (see Figures 4a and 4b). CutLn-3 is approximately 20 ft high and 200 ft long, exposing the same deposits as CutLn-1. The maximum gamma radiation measurement for these features was 120 $\mu\text{R/hr}$ (microroentgens per hour) at 0 ft above ground at radiation survey point Rad-5 along CutLn-1 (see Table 2).

Photo 3-Looking southwest at CutLn-1, replicating Anderson photo C.

Cutln - 1 - 10' high, 15' wide, 200' long - bench cut, southern cut

Photo 3 - Cutln - 1 looking southwest replicating Anderson c

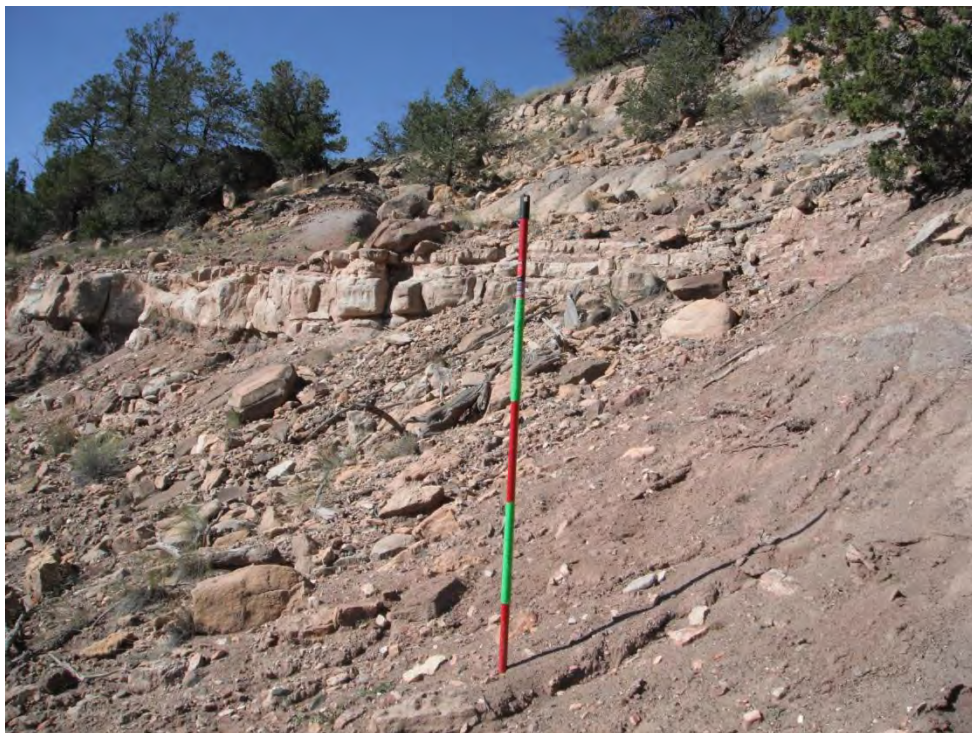
Photo 4-Looking southwest at CutLn-1, replicating Anderson photo B.

Photo 4 - Cutln - 1 looking southwest replicating Anderson b

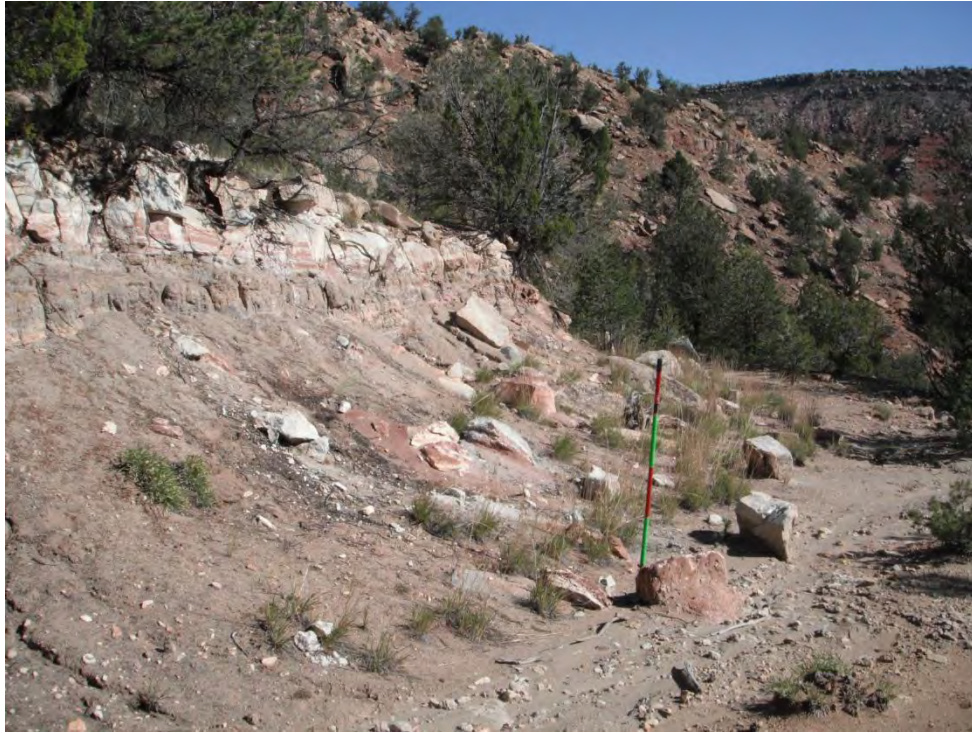
Photo 5-Looking north at CutLn-1.

Photo 5 - Cutln - 1 looking north

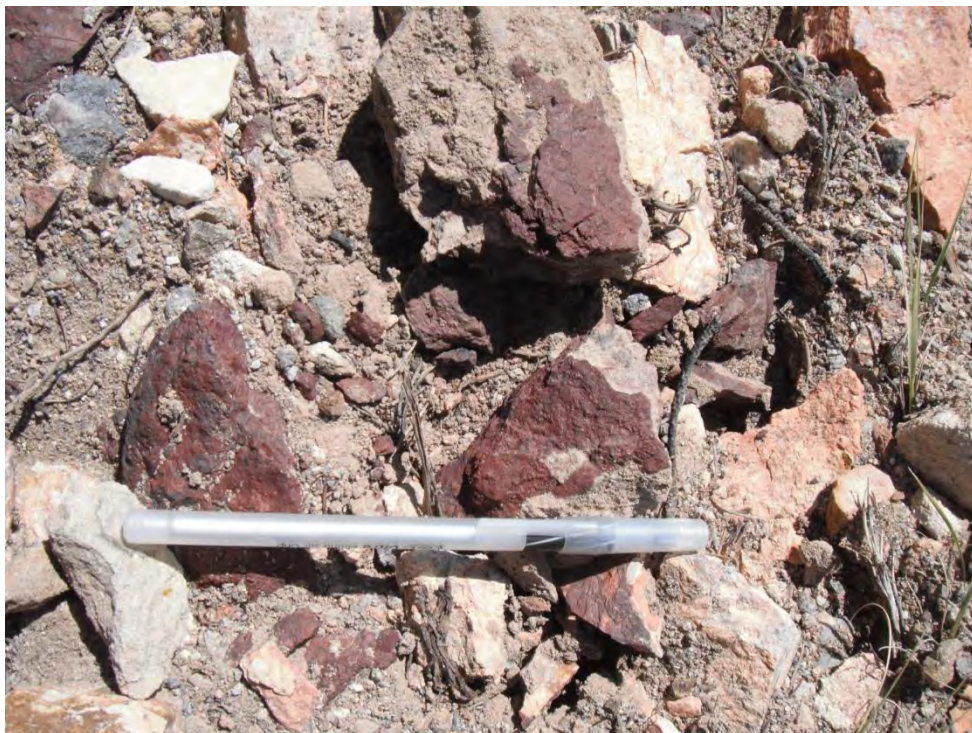
Photo 6-Closeup of red, ore-bearing rock at Rad-4.

Rad 4 - Cutln - 1; Om - 70 ^{ALT} uR/h; 1m - 21 uR/h

Photo 6 - Rad - 4 closeup reddish-black rock

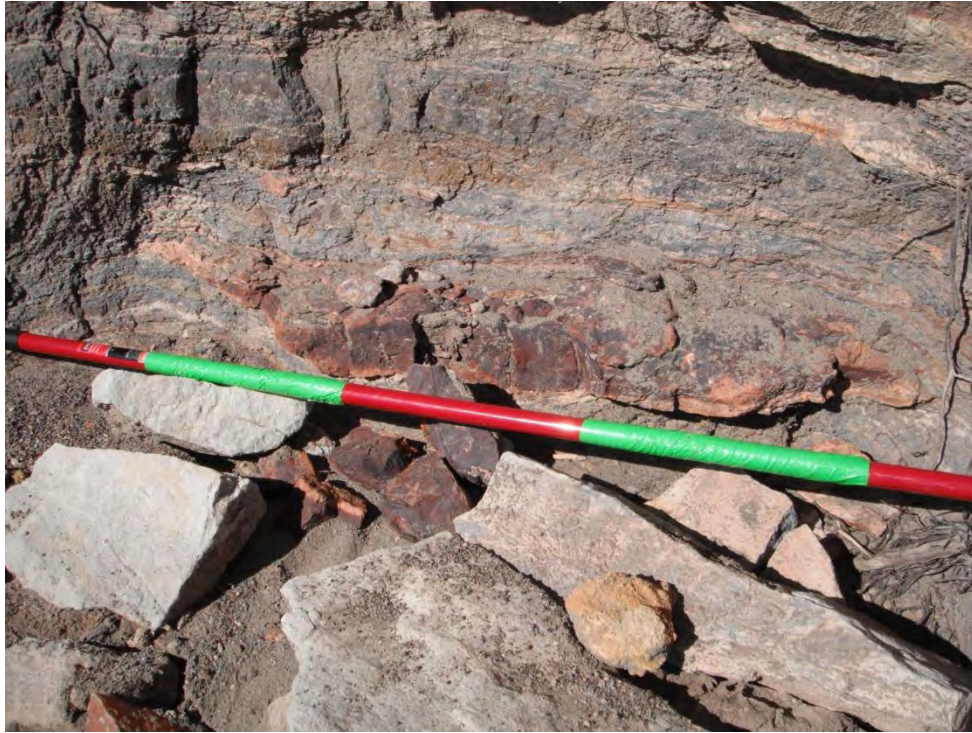
The maximum gamma radiation measured onsite was 120 $\mu\text{R/hr}$ at 0 ft above ground at radiation survey point Rad-5 on CutLn-1. A gamma radiation measurement taken at CutLn-3 (radiation survey point Rad-12) recorded 100 $\mu\text{R/hr}$ at 0 ft above ground.

Photo 7-Closeup of dark red lens in outcrop at Rad-5.

Rad 5 - Cutln - 1; Om - 75 ¹²⁰ uR/h; 1m - 17 uR/h

Photo 7 - Rad 5 - reddish-black lens

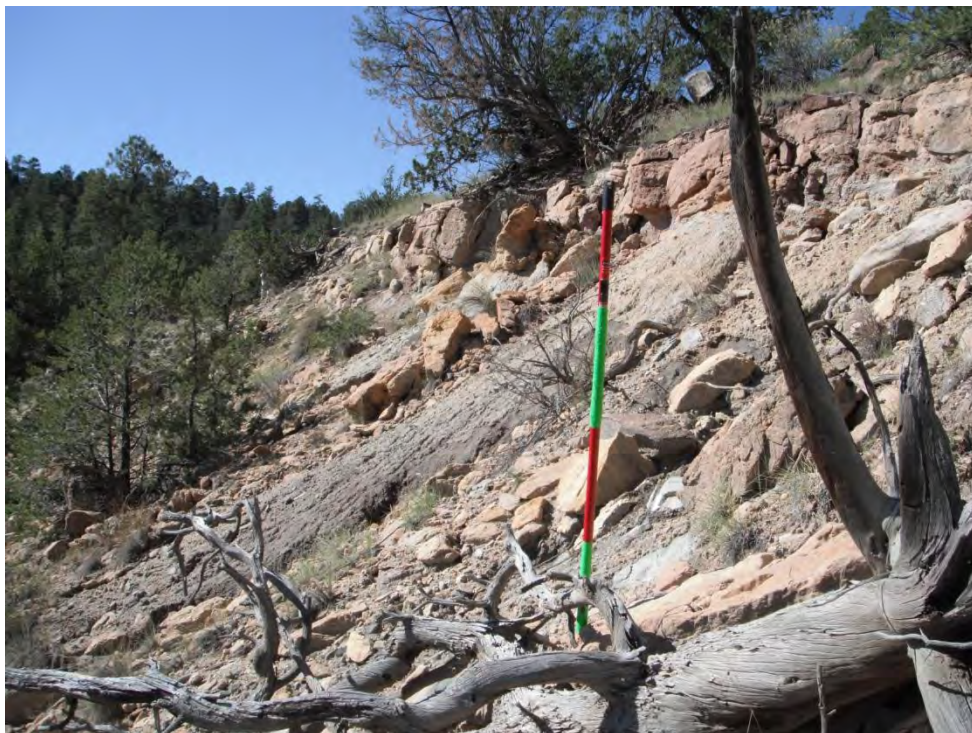
Photo 8-Looking southwest at CutLn-2.

Cutln - 2 - 15' tall, 150' long, 10' wide

Photo 8 - looking southwest at Cutln - 2

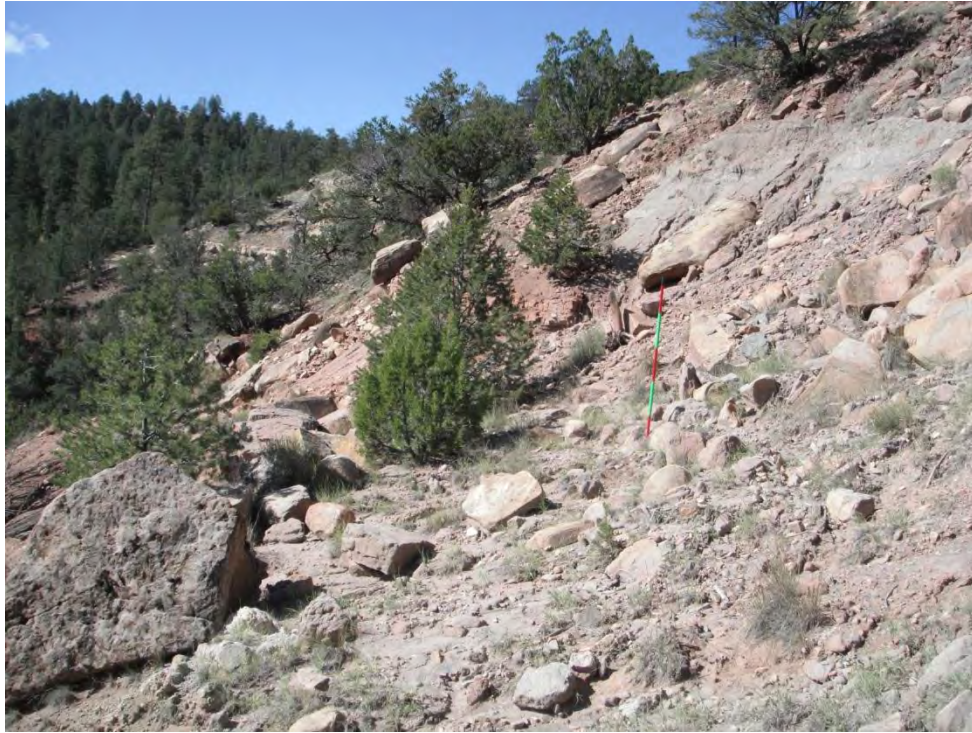
Photo 9-Looking southwest at CutLn-3, replicating Anderson photo A.

Cutln - 3 - 20' tall, 25' wide, 200' long; northern cut

Photo 9 - looking southwest at Cutln - 3, replicating Anderson a
