# Kirtland Air Force Base Bulk Fuels Facility Leak Cleanup

Kate Lynnes, Air Force Senior Advisor Diane Agnew, NMED Hydrologist

New Mexico Tech Engineering April 13, 2016

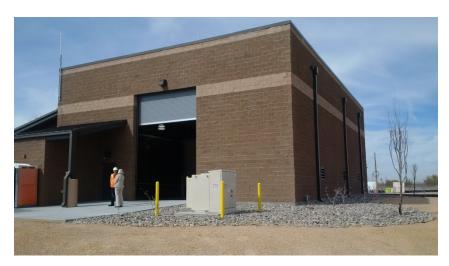
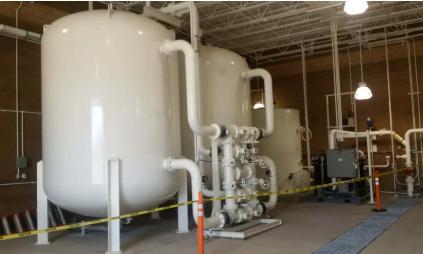
## **GWTS** Operation

- The full-scale GWTS came online, with three extraction wells, in December 2015
- Current extraction rates average at 400 gallons per minute
- Treated water is discharged at the KAFB Golf Course main pond or KAFB-7

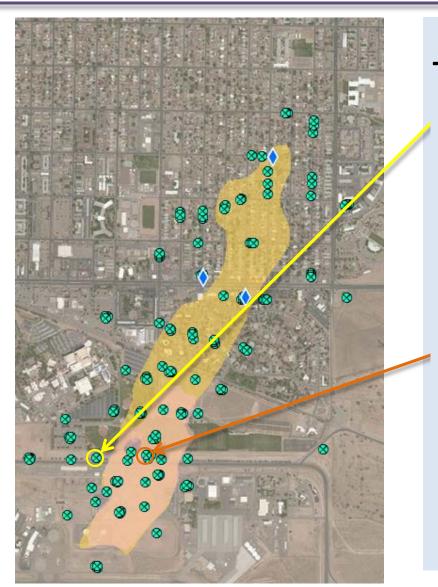
## **Laboratory Microcosm Testing**

**Two Areas of Plume Studied**

## **Microcosm Summary**
