**FINAL REMEDIATION PLAN. REVISION 1
MOBERG'S GARAGE AND TEXACO STATION
NEW MEXICO HIGHWAY 161
WATROUS, NEW MEXICO**

PSTB FACILITY #'s: 29439/1869

June 2020

EA Project No. 6350901

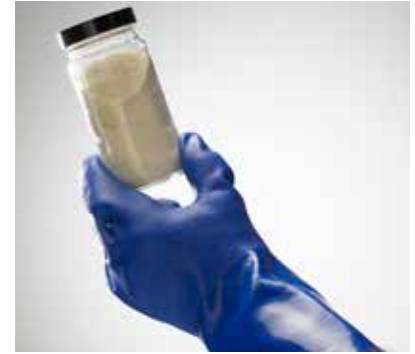
ORC Advanced® is an engineered, oxygen release compound designed specifically for enhanced, *in situ* aerobic bioremediation of petroleum hydrocarbons in groundwater and saturated soils. Upon contact with groundwater, this calcium oxyhydroxide-based material becomes hydrated producing a controlled release of molecular oxygen (17% by weight) for periods of up to 12 months on a single application.

Example of ORC Advanced

ORC-A[®] is a slow oxygen release compound designed specifically for enhanced, in situ aerobic bioremediation of petroleum hydrocarbons in groundwater. Once injected into groundwater, the ORC-A[®] becomes hydrated providing a controlled release of 17% by weight molecular oxygen. The ORC-A[®] is active for periods of up to 12 months. ORC-A[®] facilitates significantly faster and highly effective degradation of petroleum-contaminated sites. Manufacturer's specification sheets are included in Appendix D.

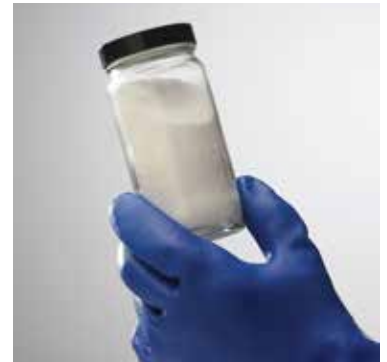
RegenOx is an advanced chemical oxidation technology that destroys contaminants through powerful, yet controlled chemical reactions. This product maximizes *in situ* chemical oxidation (ISCO) performance through use of a two-part product system; a sodium percarbonate oxidizer complex activated by a patented surface catalyst system. The technology degrades pollutants through direct oxidation, as well as through the generation of a suite of free radical compounds which in turn oxidize recalcitrant contaminants. RegenOX rapidly and effectively destroys a range of target contaminants including petroleum hydrocarbons and chlorinated compounds.

Close up of RegenOx

RegenOx[®] Part-A is an advanced chemical oxidant that destroys contaminants through controlled chemical oxidation consisting of a sodium percarbonate oxidizer complex. It will be used to pre-condition the aquifer at Moberg's Garage hot spot. Manufacturer's specification sheets are included in Appendix D.

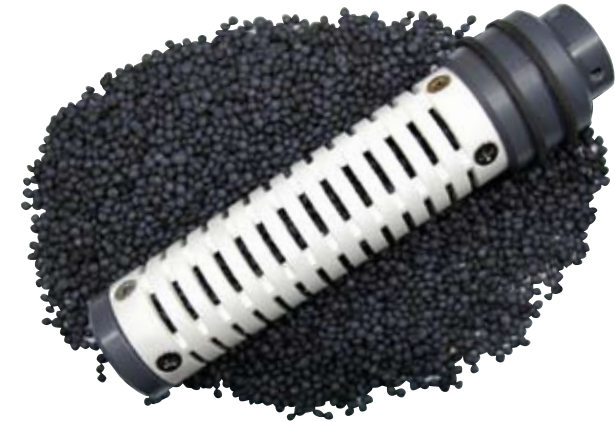
A modern approach to microbial sampling

Bio-Trap samplers utilize a passive sampling approach allowing the results to be integrated over time rather than from a single sampling event

Multiple Bio-Trap samplers can be isolated from one another using a double seal cap assembly

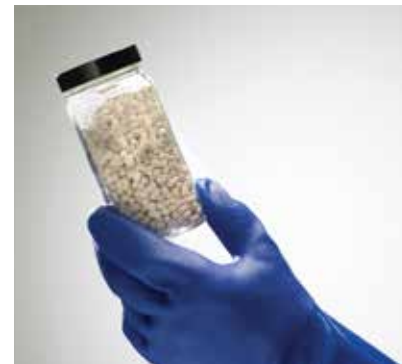
They are designed specifically for the treatment of dissolved-phase petroleum hydrocarbons through direct application into excavations, petroleum storage tank pits, trenches and backfill.

Oxygen is released from ORC Advanced for a period of 9 to 12 months *in situ*.

Example of ORC Advanced Pellets
