*East Fork of the Jemez River
Wetlands Action Plan*

New Mexico Environment Department,
Surface Water Quality Bureau,
Santa Fe, New Mexico
2023

CITATION: McGraw, M. and Johnson, B. 2023. *East Fork of the Jemez Watershed Wetlands Action Plan*. New Mexico Environment Department, Surface Water Quality Bureau, Santa Fe, New Mexico.

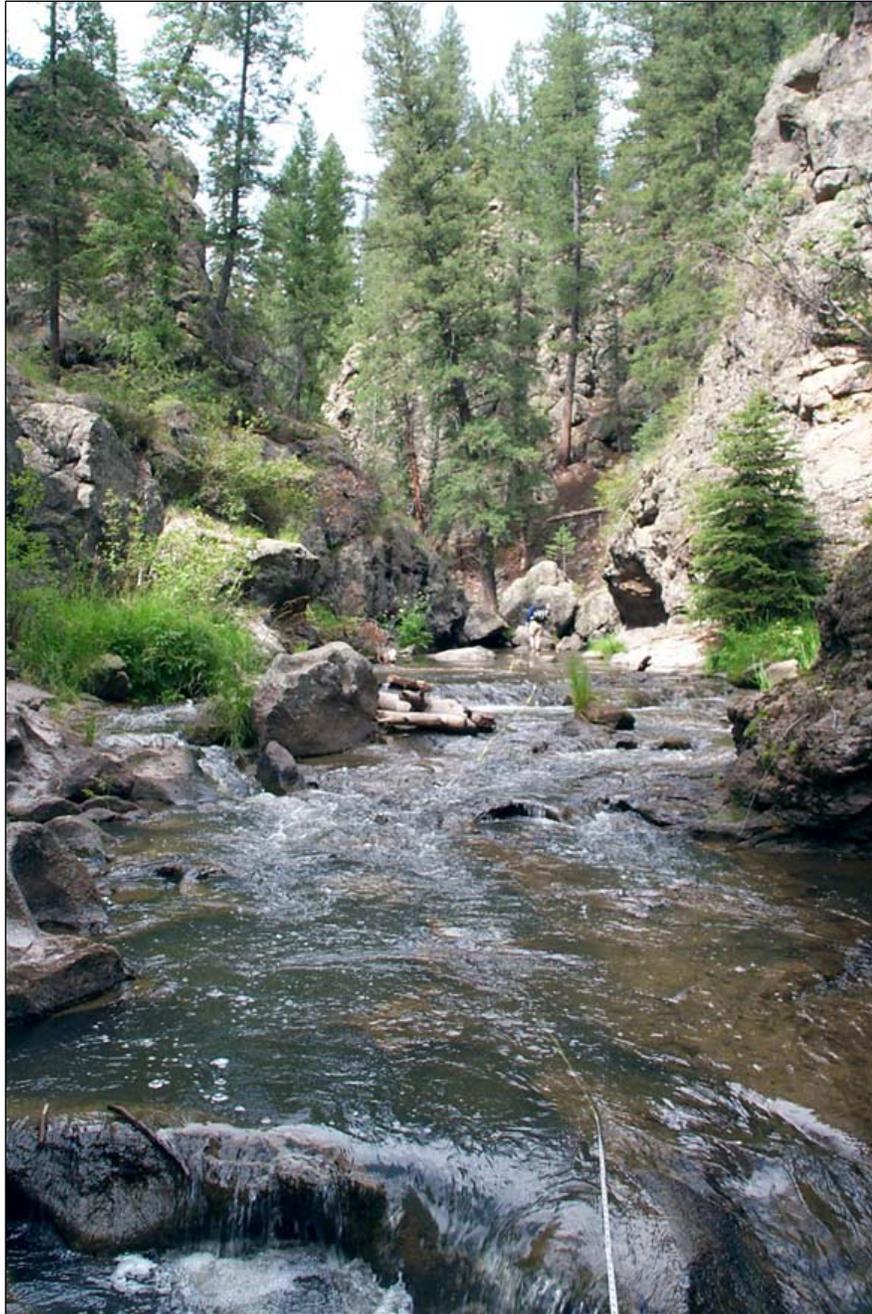
*Figure 3.
Typical riffle
from the reach
from Jemez
Falls to NM
HWY4
Crossing.
Notice the
bedrock
substrate,
riparian
grasses, and
deep eroded
potholes in the
bedrock.
(Photo
courtesy of the
Santa Fe
Fisheries
Crew, 2001.)*

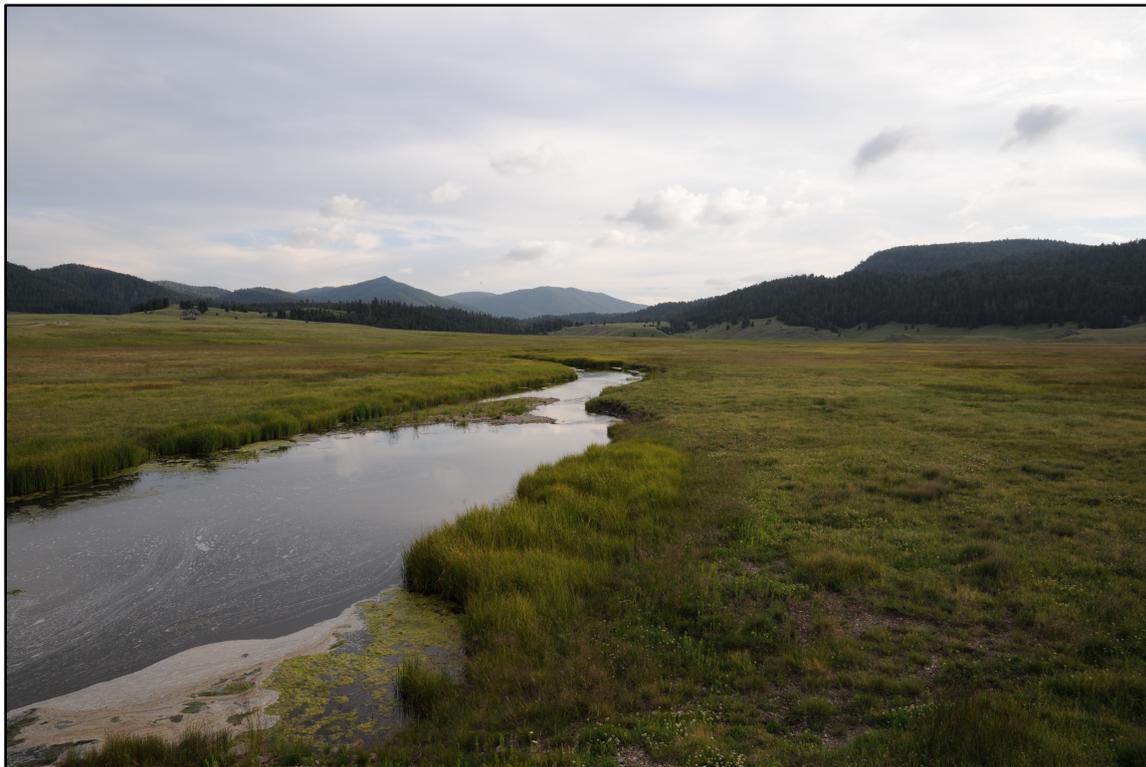
Figure 9. East Fork flowing in the Valle Grande. (Photo courtesy of Valles Caldera Trust.)

In the Valle Grande, there is an overall lack of quality in-stream habitat where the typical riffle-pool sequence expected in the area has been replaced by near continuous riffle sections that persist for the majority of the stream length across the Valle Grande. These long riffles are broken at features such as side channels or tributaries. The riffles throughout the entire river are dominated by a fine substrate. The amount of fine substrate is largely due to the delivery of fines from the surrounding Valles Caldera. Lack of pools means limited overwintering habitat for fish, decreased thermal protection, and poor fish habitat overall.

Streams associated with meadow systems, like the Valle Grande, are typically comprised of sinuous meandering riffle systems dominated by gravels and interspersed with long deep pools. Within these pools, the banks are deeply undercut providing habitat for fish, and shading the water from the sun. Due to the extensive sinuosity of streams associated with the E-channel type, deeper pools are found with deep undercut banks at meander bends. However, in the Valle Grande, the system has been significantly altered by past grazing. The undercut banks have begun to slough off into the stream, and the stream has become wider and shallower and unstable. This bank erosion is removing the undercut bank habitat and adding fine sediments to the stream. Typical E channels are unstable, relying on the dense root structure of wetland vegetation for bank stabilization. See photo on page 27. The large amounts of livestock and wildlife grazing over the years has had significant impact on that bank stability.

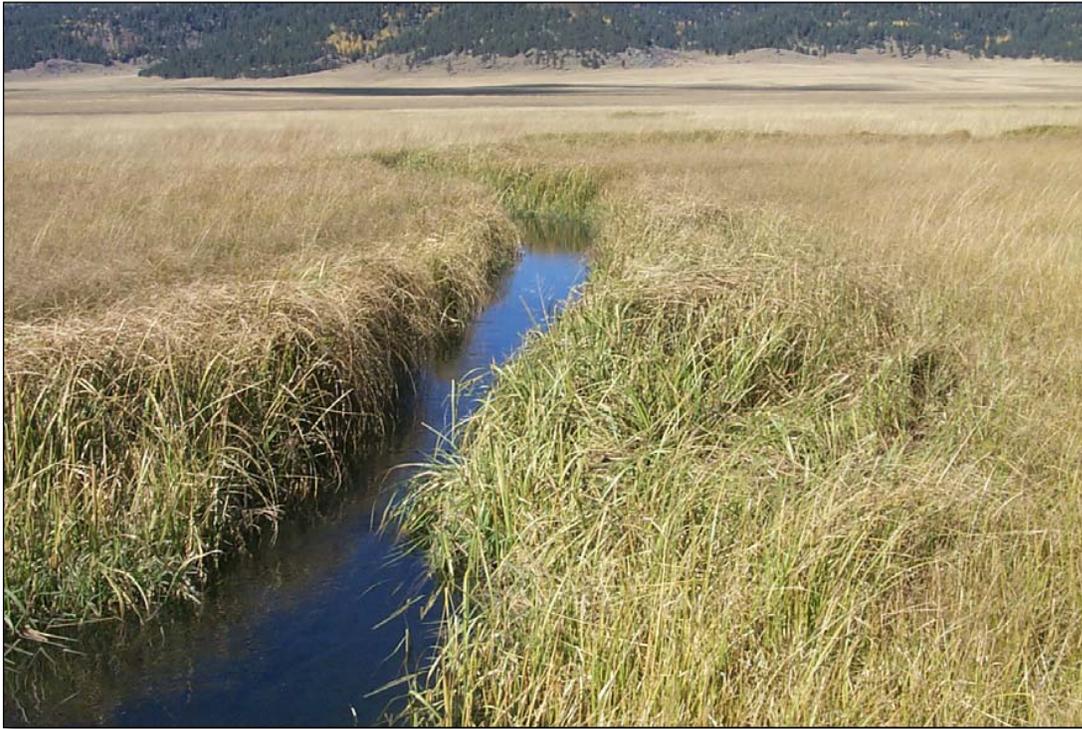
Figure 10. Example of a Properly Functioning Condition hydric meadow on the upper Jemez River. This area could be used as a baseline sampling area for comparing condition of other hydric sections of the Preserve.

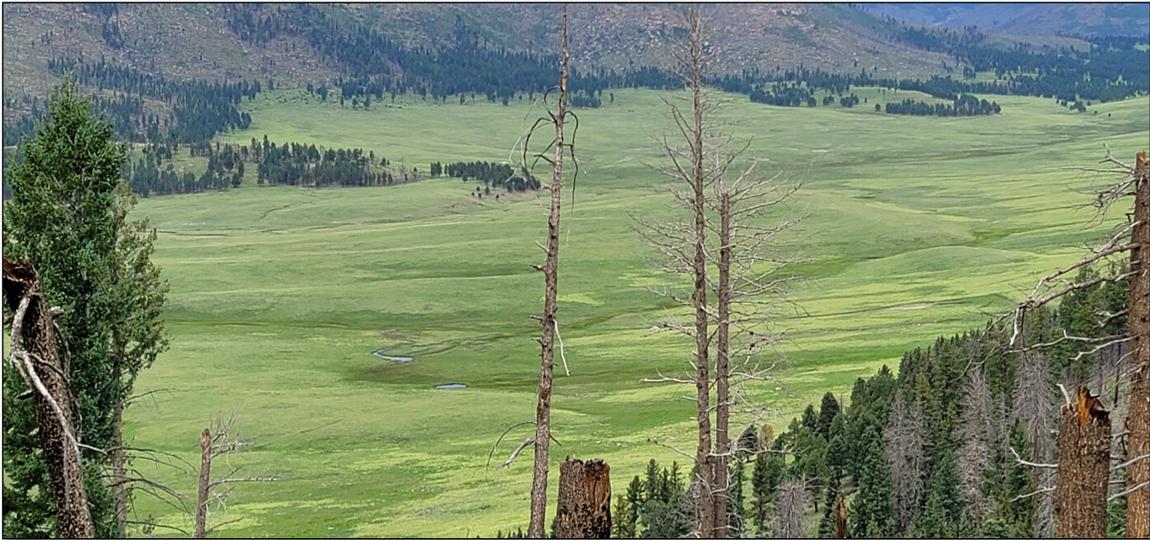
Figure 15. Looking Northeast from Hwy 4 at EFJR slope wetland restoration project implemented in 2019. A series of plug in ponds, contour swales and sod berms slowly releases monsoonal rainfall to the wetland area. (Photo courtesy of Steve Vrooman.)

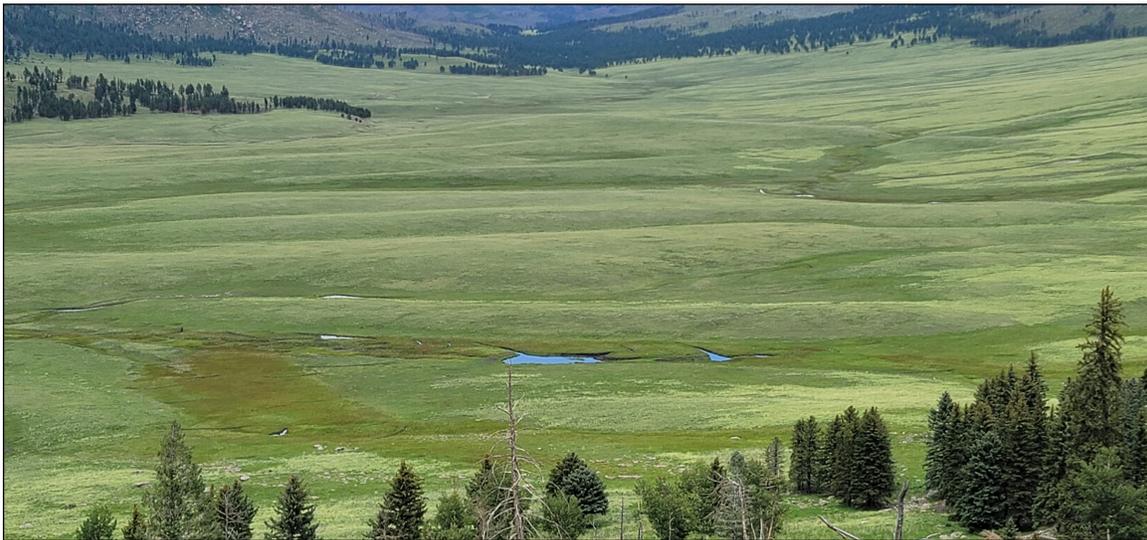
Figure 16. Looking North from Hwy 4 a series of plug and pond structures treats gully cutting through EFJR tributary slope wetland. (Photo courtesy of Steve Vrooman.)

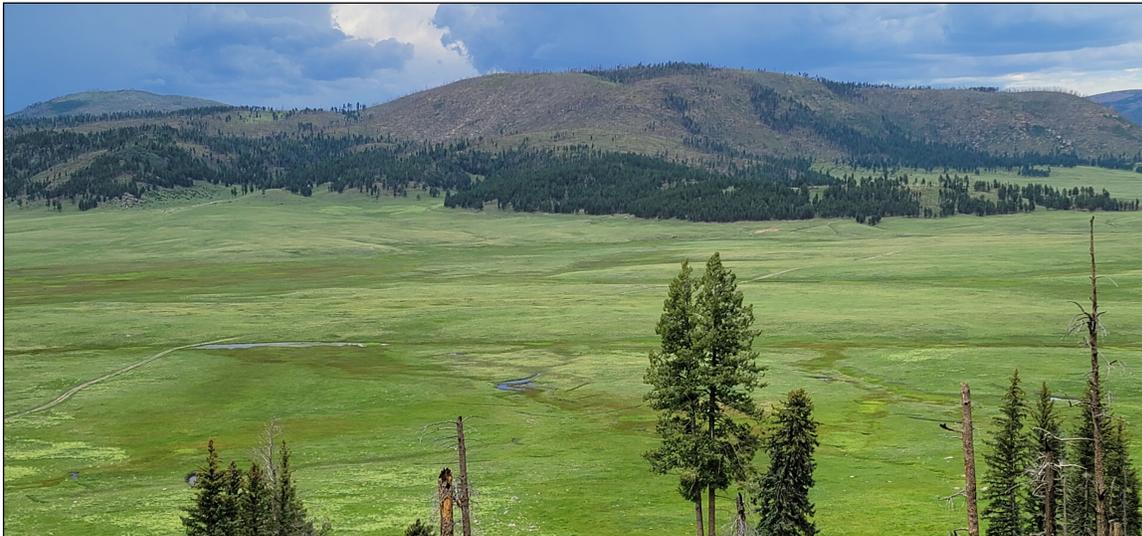
Figure 17. Westernmost tributary slope wetland treated in the EFJR restoration project with plug and pond, swales and one-rock dams. Large pond in left of picture created by road, which bisects the tributary before flow reaches the EFJR channel. (Photo courtesy of Steve Vrooman.)

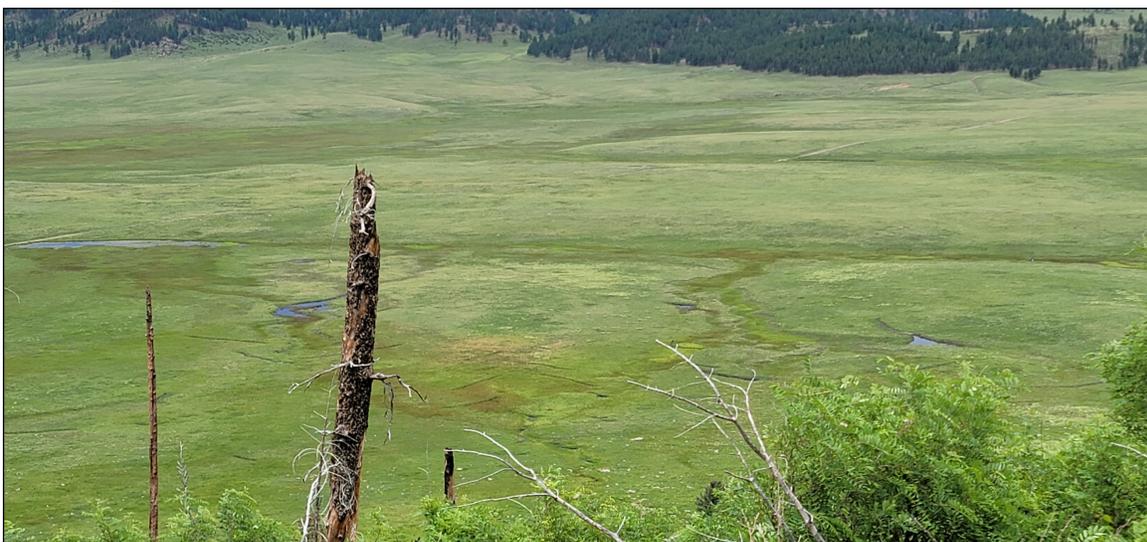
Figure 19. A close-up of the plug and pond restoration structures as seen from Hwy 4. (Photo courtesy of Steve Vrooman.)

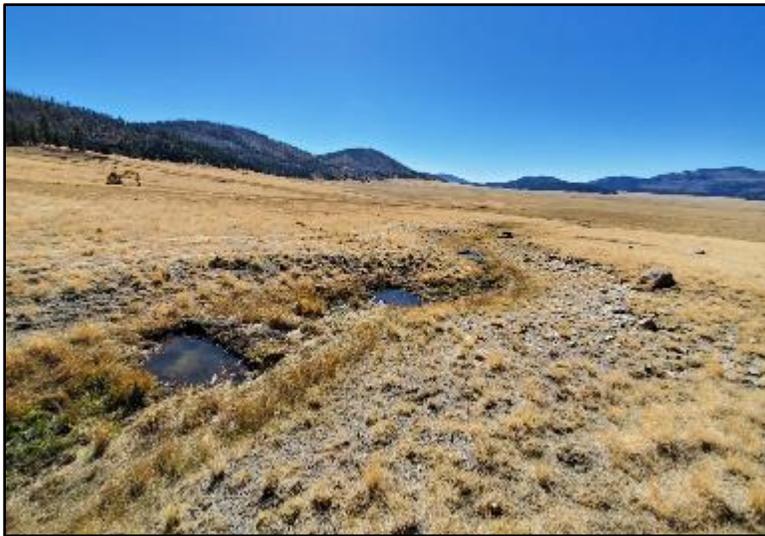
Figure 20. Sod Bowl. (Photos courtesy of Steve Vrooman.)

Sod bowls will be installed as soft, absorbent treatment structures that fill a headcut. Sod containing wetland sedges will be stacked and layered from the base to the top of the headcut, forming the overall shape of a bowl. The sod bowl will fill the former headcut and the sedge roots will bind the sod in place. The layers of sod will create small terraces for the water to descend, each terrace dropping only a couple of inches along the soft, permeable, live sod. The sod bowls will work in concert with the contour swales installed upstream that will route some of the flow away from the gully, reducing the erosive energy of water within the channel.

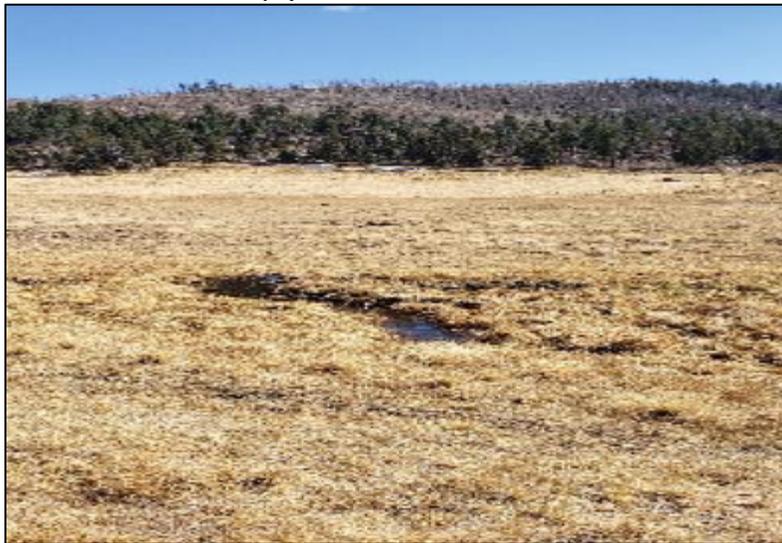
Figure 21. Sod Berm.

Sod berms will be installed in series in the gullies downstream of the headcuts. The bottoms of V-shaped gullies will be flattened and smoothed with machinery and sod will be laid across the channel as low-height berms (approximately 3-6 inches high) oriented perpendicular to flow direction. Blocks of wetland sod will be harvested from wet meadows adjacent to the gullies as well as from the contour swales. The sod berms will create small rises at intervals as water moves down slope. The sod berms will provide grade control that slows and infiltrates water, and propagules for local native wetland vegetation to spread. Installation

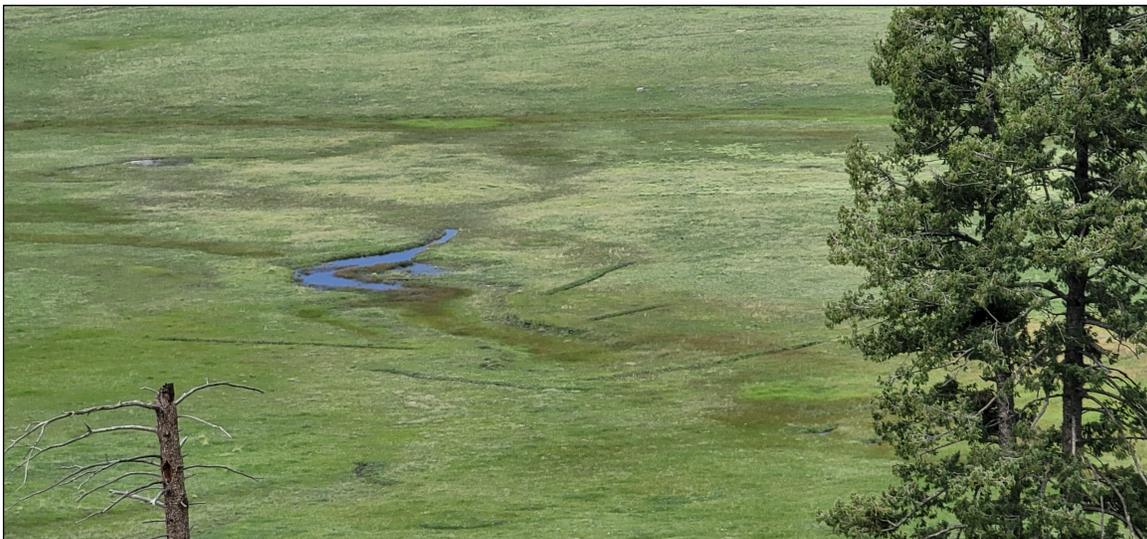
Figure 22. Same plug and pond structure from pg 44. The very top of the gully formation can be seen here. Darker lines are contour swales diverting water flow away from the headcut and spreading water to surrounding areas, sub-irrigating vegetation and reducing erosional forces. (Photo courtesy of Steve Vrooman.)
