Keyline Design for Restoration of Headwater Slope Wetlands in the Holman Creek Wetlands Complex Assistance Agreement CD# 01F109-01-0C

**New Mexico Environment
Department Surface Water Quality
Bureau Wetlands Program**

**Final Report
December
2021**

**Keyline Design for Restoration of Headwater Slope Wetlands
in the Holman Creek Wetlands Complex,
December 2021**

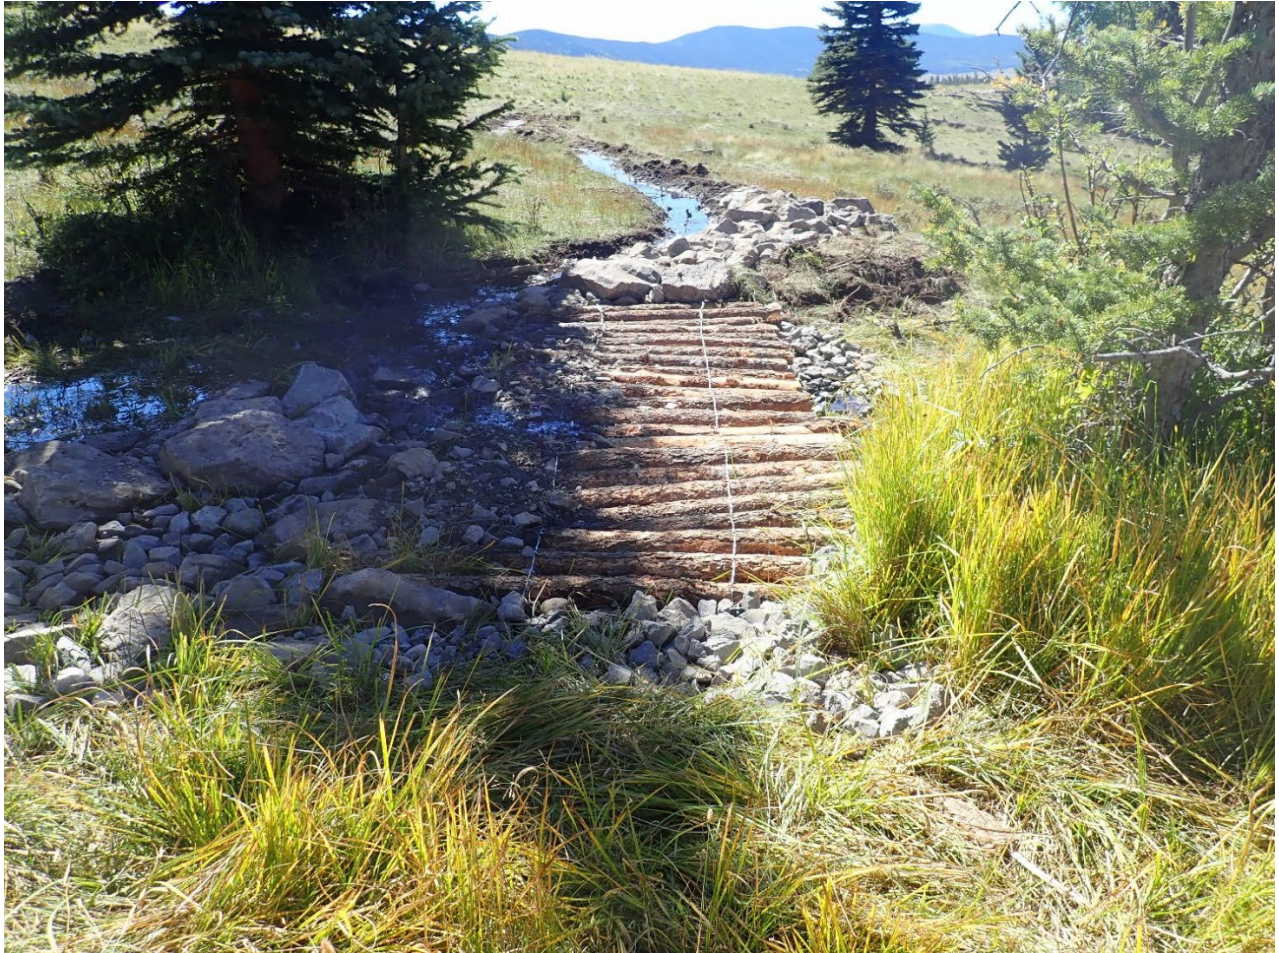
Log Split, Log Mat and Log Reinforced Contour Berm spreads water across a previous wetland surface, West Drainage, Holman Creek Watershed Complex. September 13, 2018. Photo by Emile Sawyer

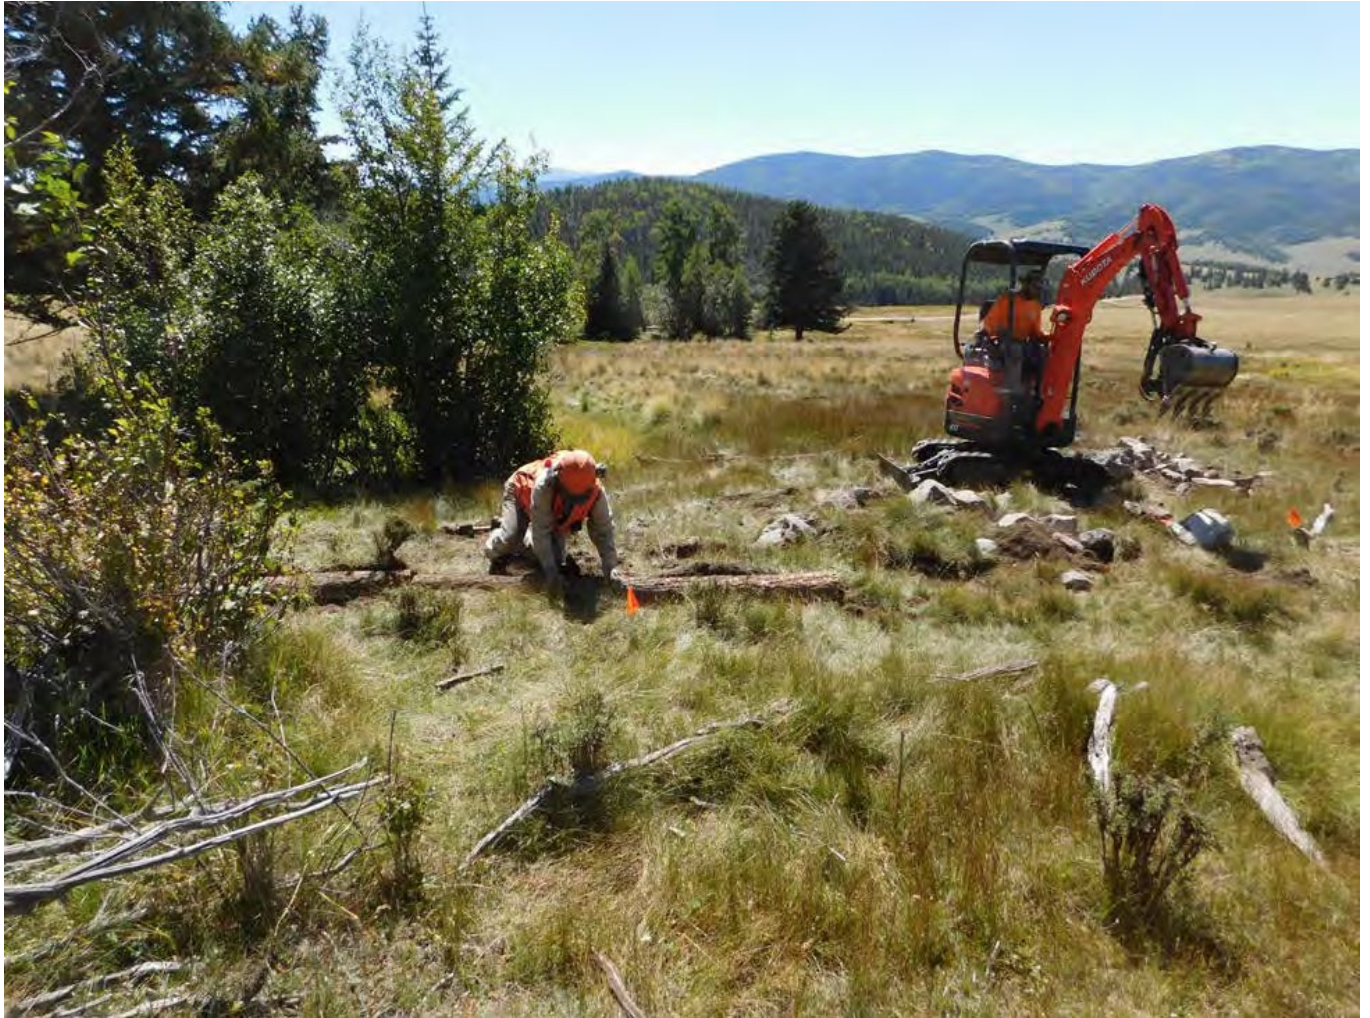
Figure 4. The mini-excavator is used to dig and place anchor rocks, while manual labor, shown here by Margie Tatro, is used to set and chink log berm structure. Photo by Mollie Walton.

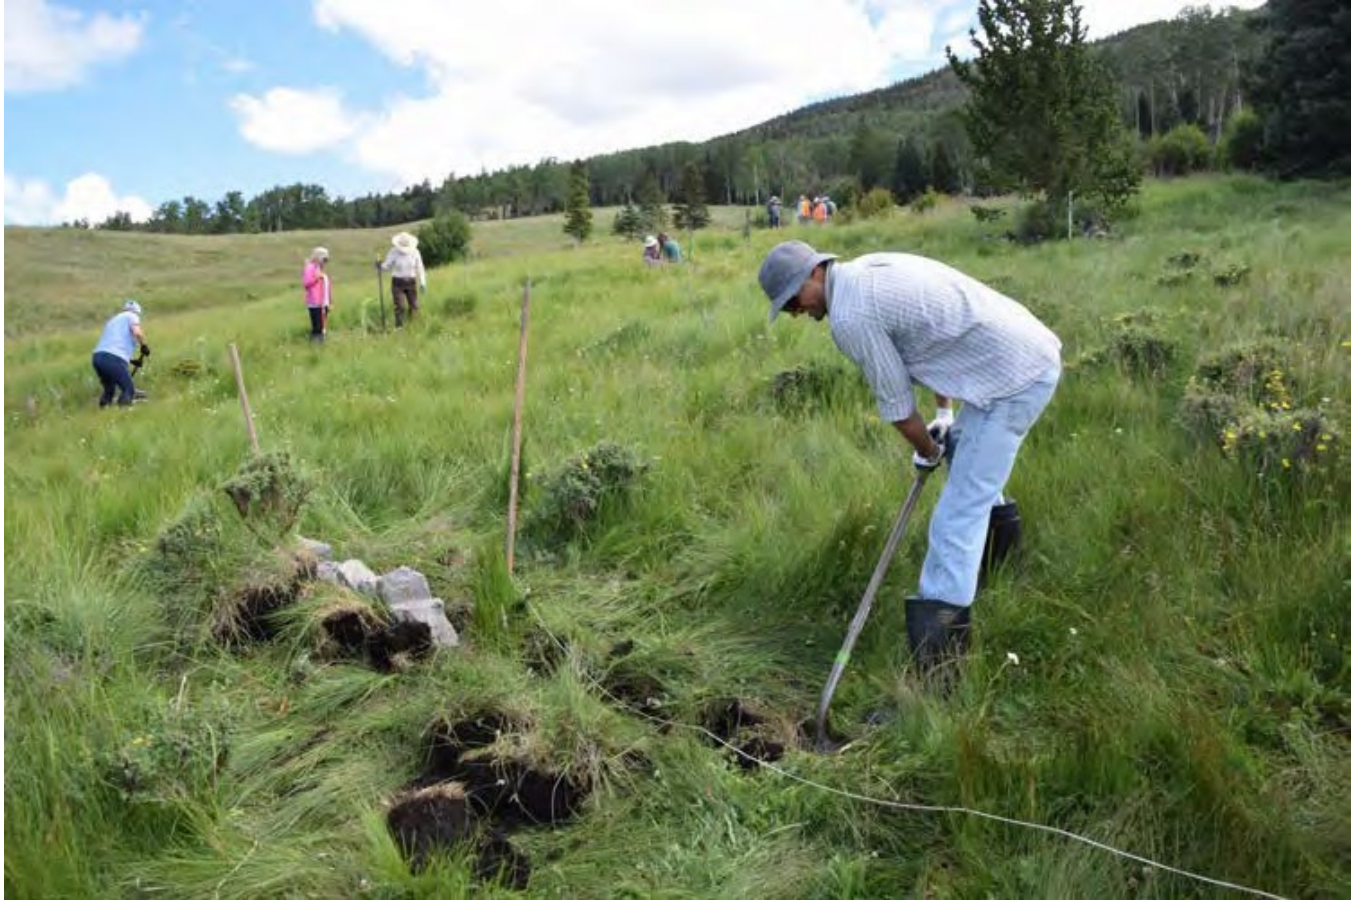
Figure 5.

In 2018 at the volunteer work weekend, volunteers added structures for adaptive maintenance and to increase impact of existing design features (Figures 5 & 6 below). Figure 5 shows a volunteer digging a footer trench for a media luna while volunteers in the background install a series of sod plugs in an incised channel. The completed structure is shown a week later capturing and spreading water, Figure 6.

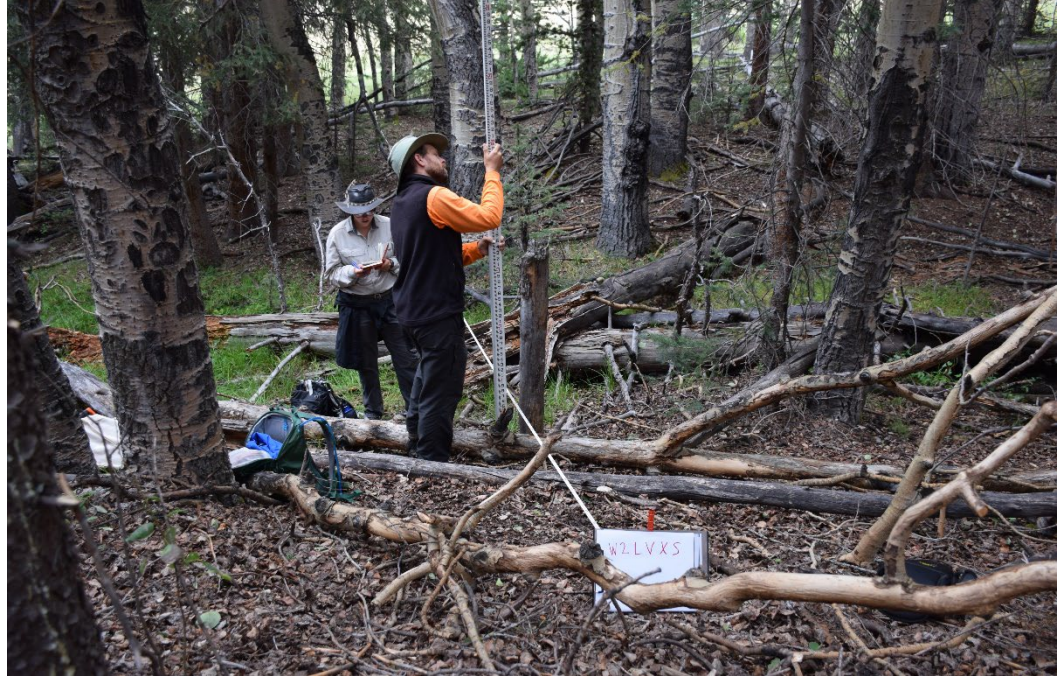
Figure 10.
Volunteers - Chris Micheal reads an elevation rod, while Mori Hensley writes down elevation and vegetation information along the W2LVXS (See Figure 8 map above) vegetation monitoring cross-section in the upper west drainage of the Holman Creek Subwatershed – August 23, 2018. Photo by Emile Sawyer.

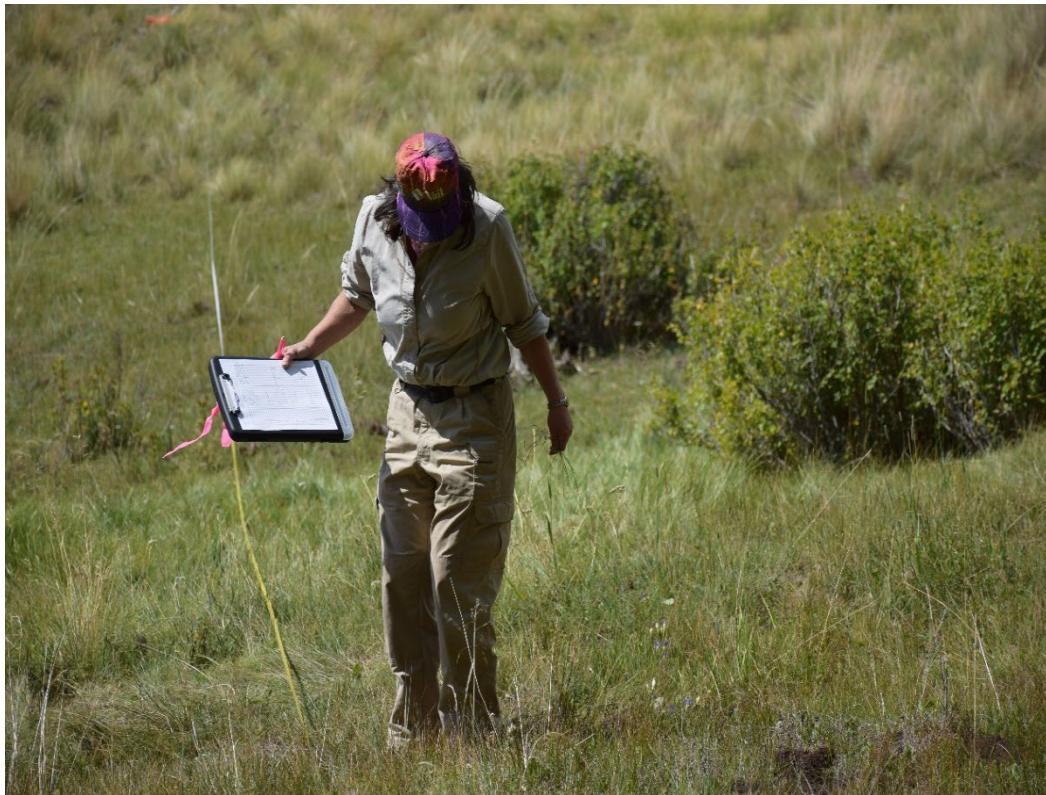
Figure 11.
Rachel Jankowitz observes vegetation along the W2LVXS (See Figure 8 map above) vegetation monitoring cross-section in the upper west drainage of the Holman Creek sub-watershed – September 1, 2020. Photo by Emile Sawyer.

The Vegetation Monitoring Team was composed of volunteers, contractors and NMED staff that measured cross-section and long profiles of the area before and after construction in order to compare data and use a modified version of Greenline Survey (citation? 2000) to evaluate field observations for changes in vegetation. A pre-construction survey was conducted in 2018. A post-construction survey was conducted in 2020. Unfortunately, overall, no major vegetation changes were observed within the short term of two years between surveys.

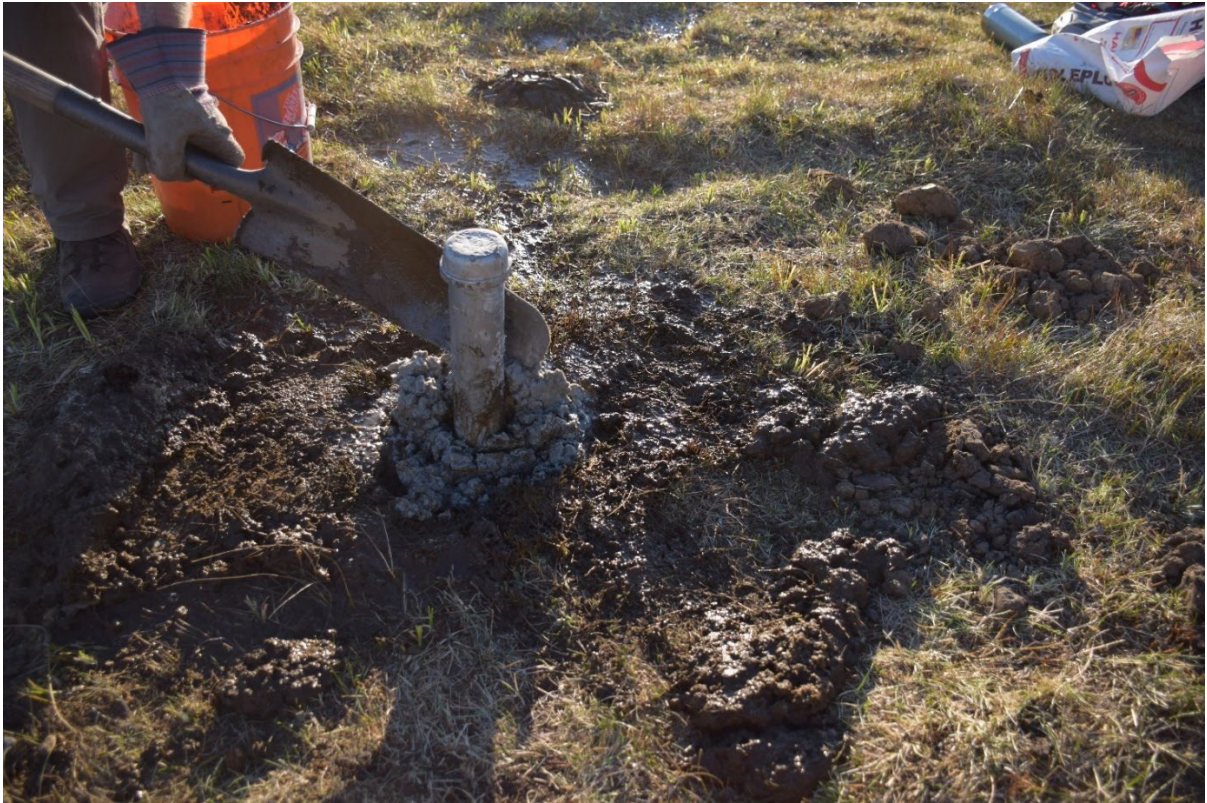
Figure 14. Gunner Johnson fills borehole with bentonite mixture to complete P6E2DS piezometer.

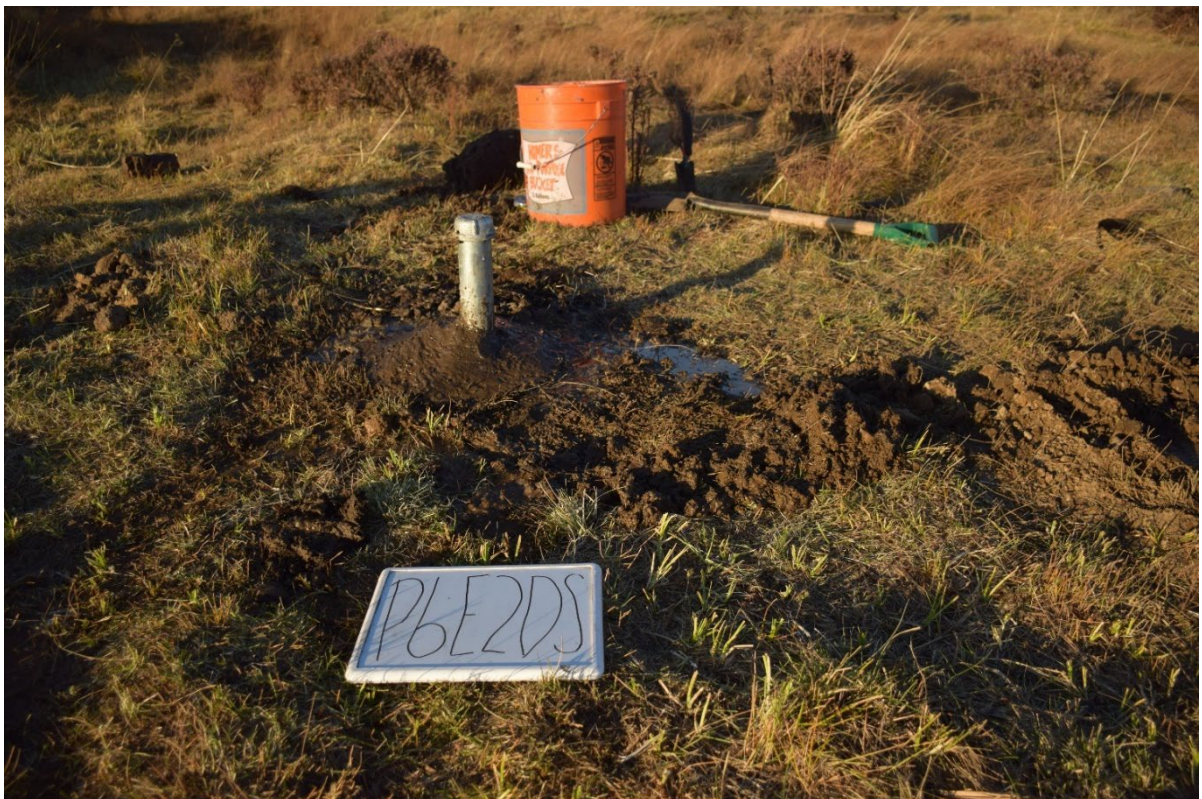
Figure 15. Completed piezometer P6E2DS in the East Drainage just up hill of FS 1910. Photo Emile Sawyer.

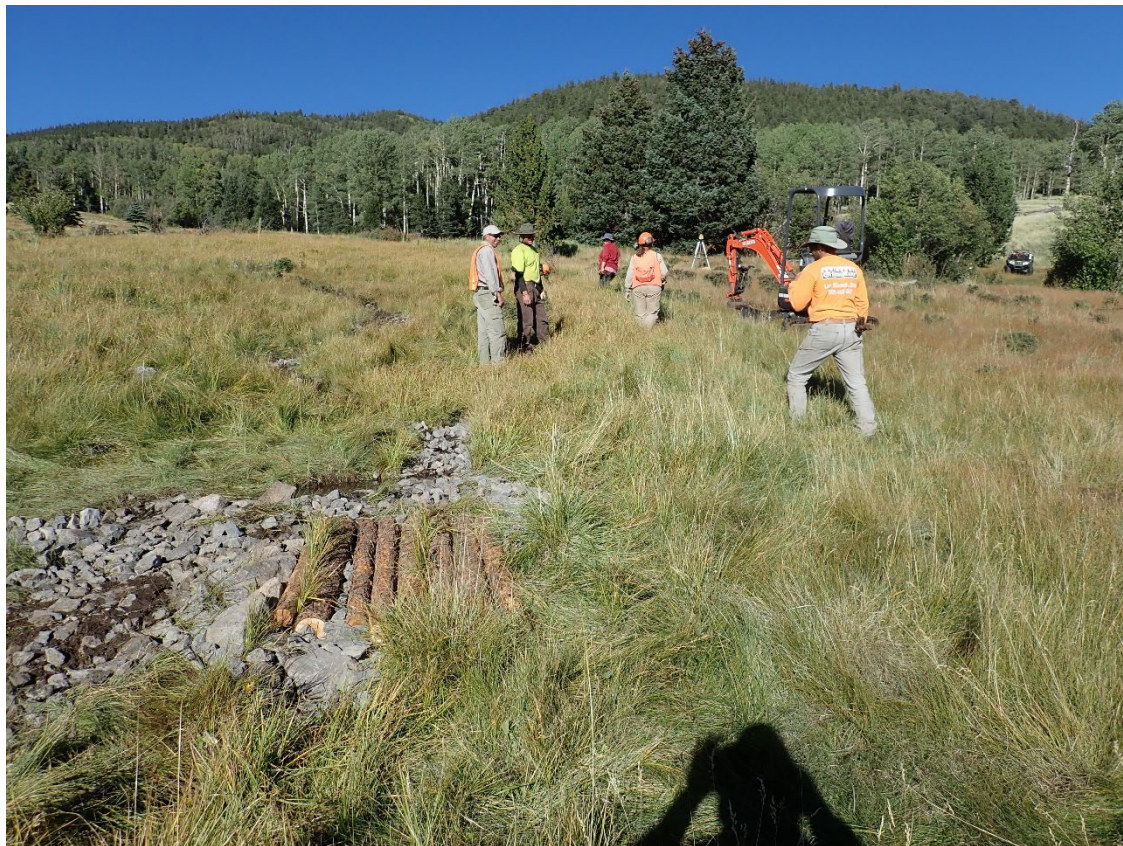
Figure 16.
Contractors
installing log
structures in
the HCWC
East Drainage
in 2018.
Photo by
Emile Sawyer.
