Lower Animas River Watershed Based Plan

Accepted by EPA August 9, 2016
Updated December 30, 2021

Mountain Studies Institute
SAN JUAN MOUNTAINS, COLORADO

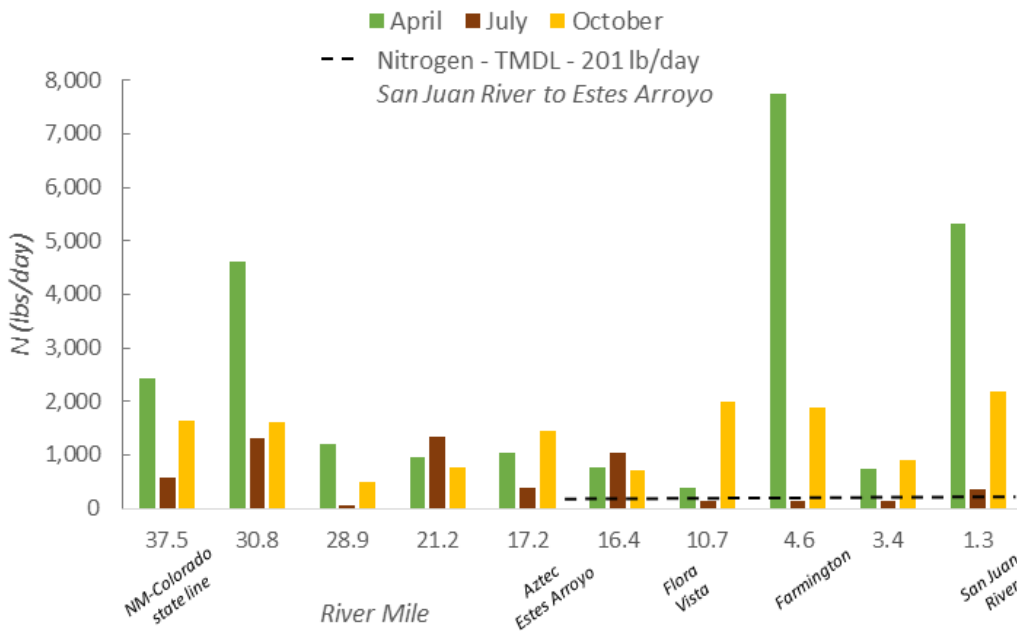
Figure 3. Total nitrogen load measured in the Animas River in 2014

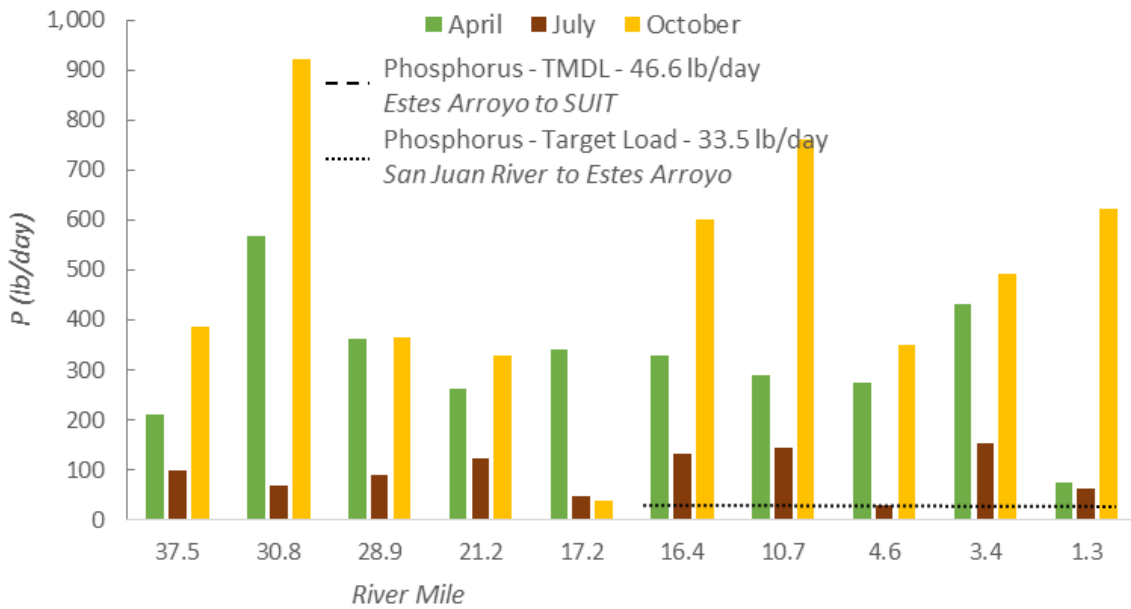
Figure 5. Total phosphorus load measured in the Animas River in 2014

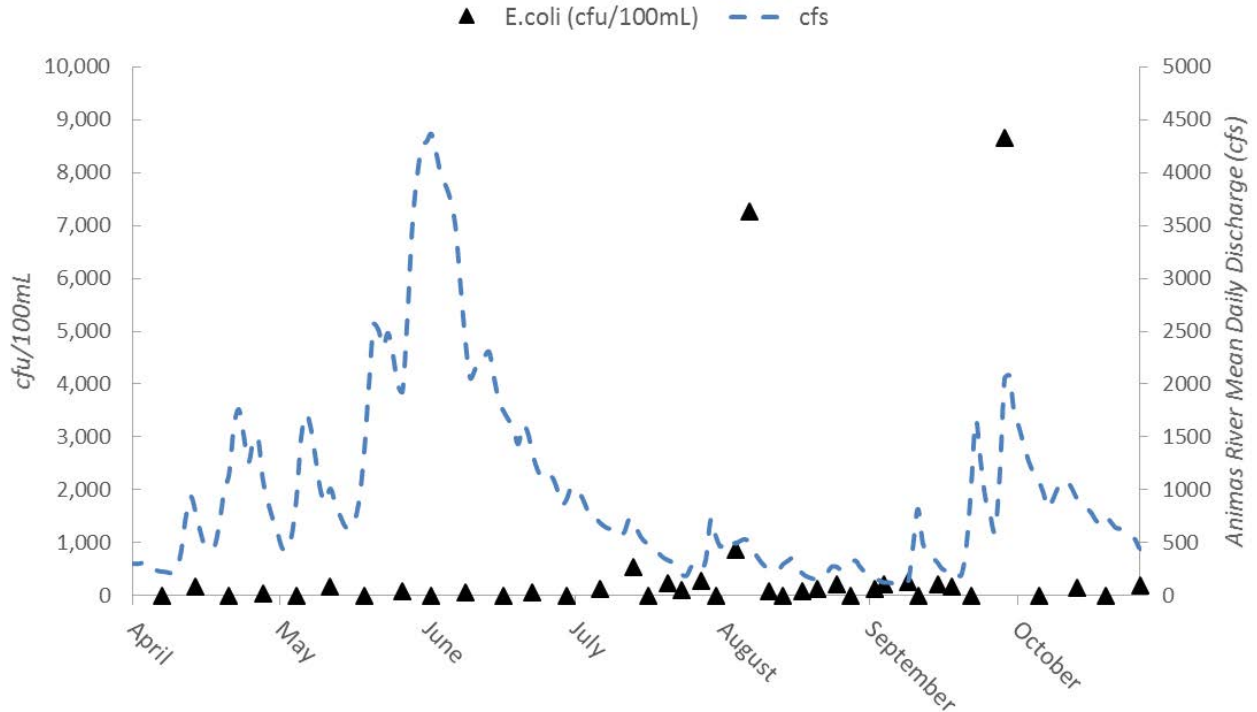
Figure 9. *E. coli* concentration and mean daily discharge on the Animas River at Boyd Park in Farmington in 2014

The majority of the bacteria exceedances occurred in the months of July through October (Table 8), which corresponds to monsoon season (Figure 9), but also overlaps with a heavy recreation season during the heat of the summer. The data indicate that significant quantities of fecal material are reaching the river during these periods, and care should be taken by all swimmers not to ingest river water. (SJSWCD 2015).

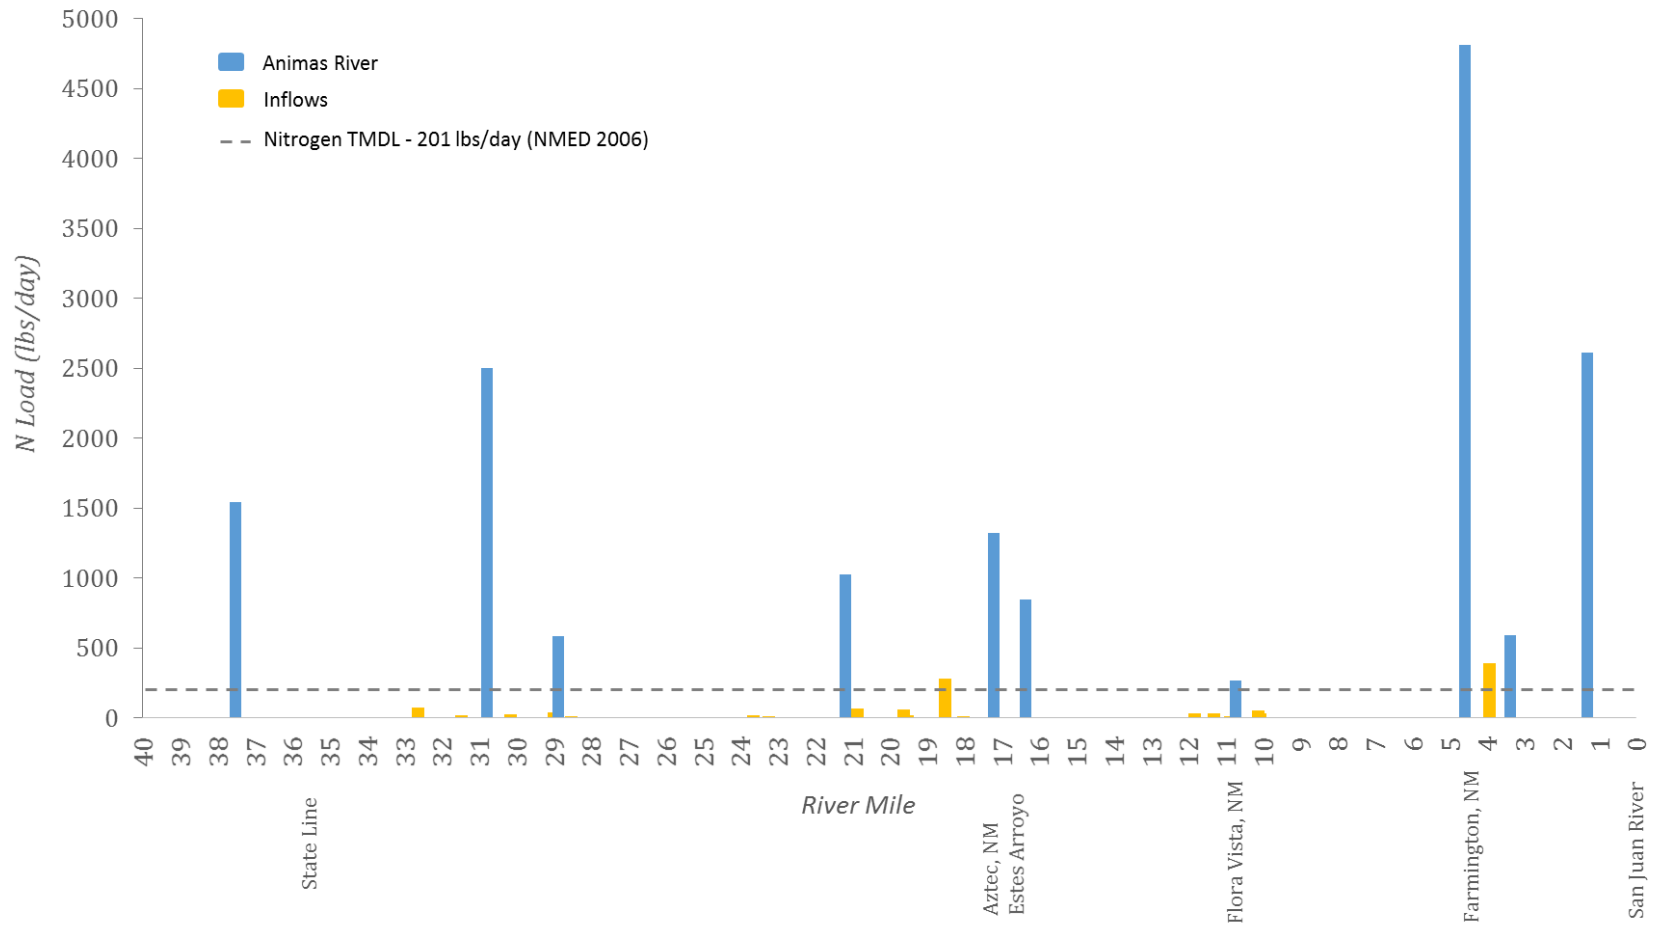
Figure 10. Average total nitrogen load in 2014

Average of three sample events (April, July, and October of 2014) for the Animas River and inflows to the Animas River. River miles start at the confluence with the San Juan River (River Mile 0).

The nutrient and *E. coli* loads measured in the Animas River mainstem at low flow in 2014 were observed to be much higher than the loads entering the river from sampled inflows (e.g., arroyos, tailwater ditches, field drains, return flow from irrigation ditches). Figures 10, 11, and 12 show the loads from these sampled inflows, as compared to the mainstem loads. These data suggest that the primary sources of nutrient and *E. coli* loads in the Animas River at low flow cannot be solely explained by “hotspot” inflows. This finding is consistent with previous studies of inflows to the Animas River (e.g., BUGS 2011). If the loads in the Animas at low flow were driven primarily by inputs from specific inflows, we would expect to see jumps in the mainstem load following inputs from these “hotspots,” with an overall trend of increasing mainstem loads from up to downstream. As shown in Figures 10-12, this was not the case.

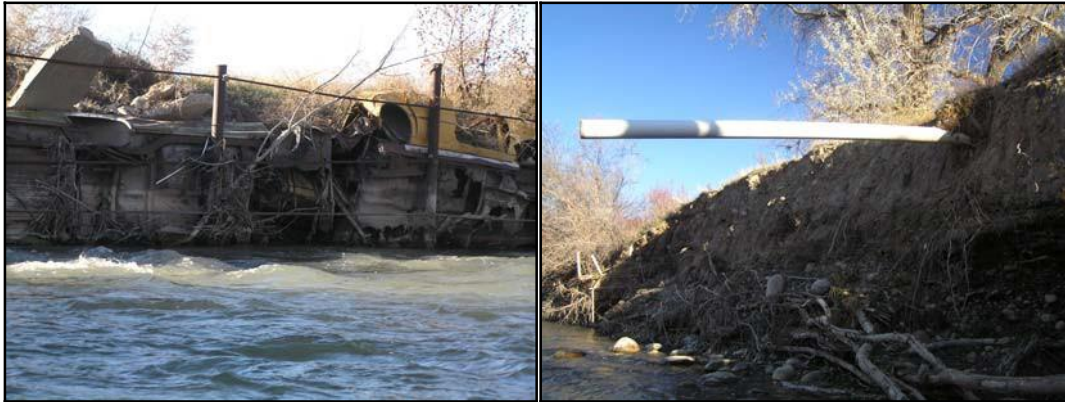
Figure 17. Picture of inappropriate bank stabilization (L) and actively eroding bank (R)

Results of this mapping showed that at least 8% of the 38.7 mile length of the study reach is in poor condition, with over 1 mile of actively incising channel and over 2 miles of rip-rapped bank with materials such as boulders, automobiles, scrap concrete, gabions, scrap metal, and other refuse (BUGS 2008).

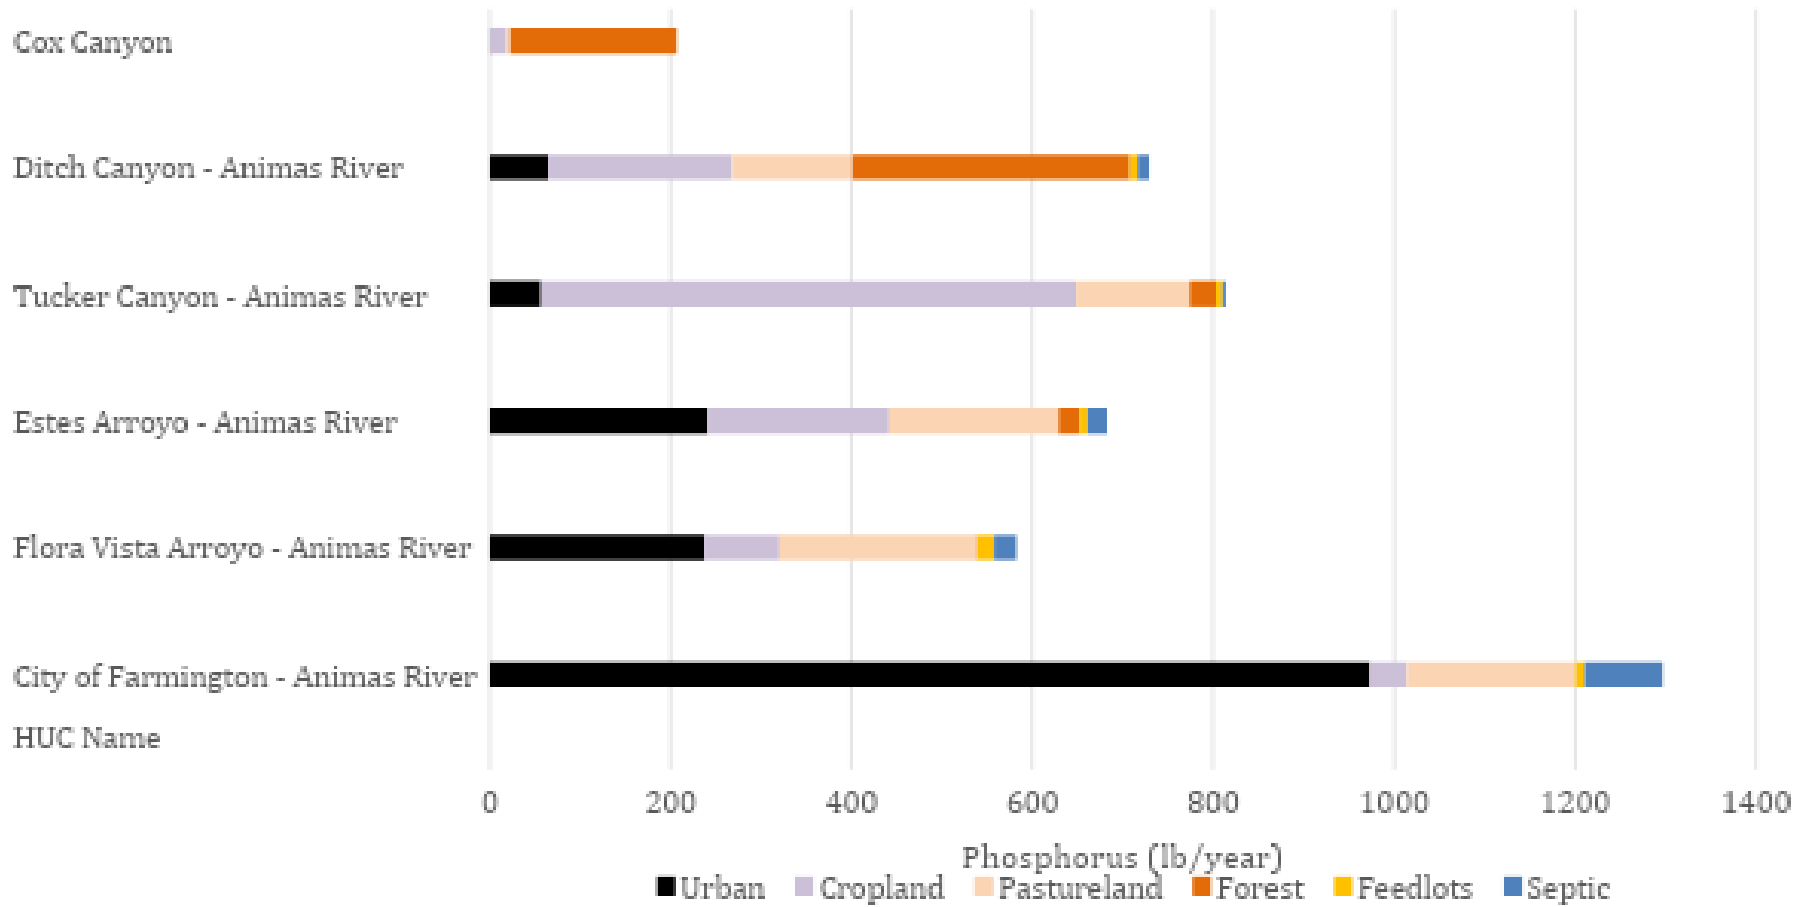
Figure 20. STEPL – Modeled total phosphorus load (lb/year) by land use for each HUC12 subwatershed

The land uses used in the STEPL model are shown in [Map 20](#), and their estimated nutrient loading contributions by subwatershed are shown in [Figures 19 and 20](#).
