**Rio Costilla**  
**Watershed Restoration Action Strategy**  
(WRAS)

**October 2005**

**Prepared by**  
**Bionomics Southwest**  
**under a 319 Grant administered by The Quivira Coalition**

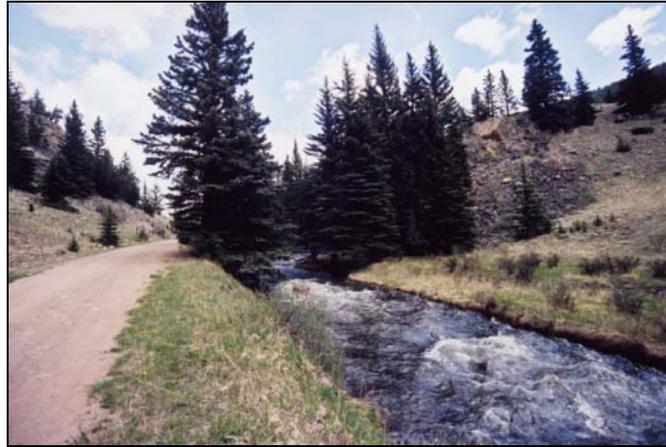
*Figure 1 Rio Costilla along NM 196*

While the temperature exceedances in the Rio Costilla appear to originate in Comanche Creek, they are amplified by the condition of the stream channel below the confluence.

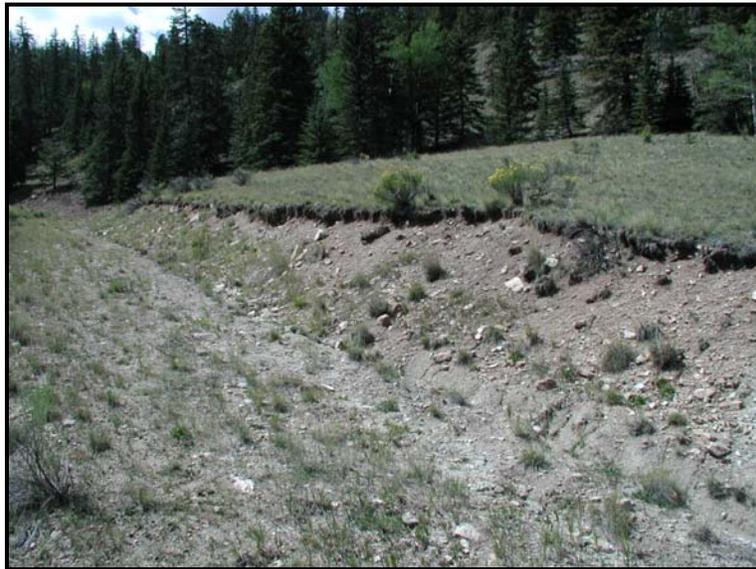
*Figure 2. Road Cut Beginning to Revegetate*

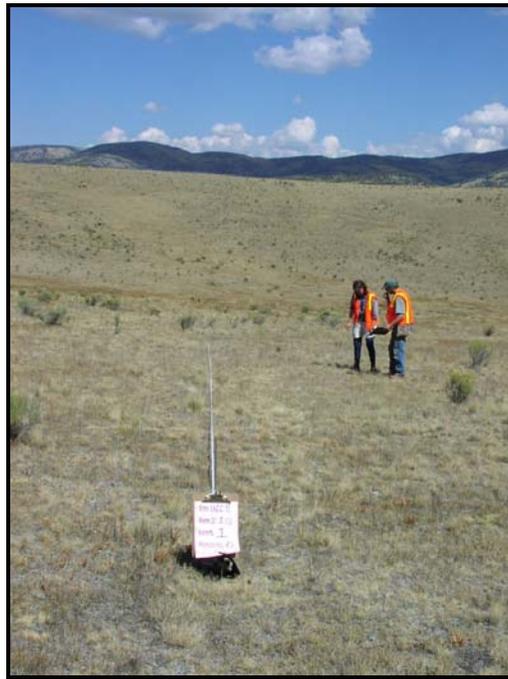
Figure 4. Upland Monitoring Photo Point in Upper Comanche Creek Watershed

1. Photo points – permanent photo points allow qualitative monitoring of vegetation and landscape changes through time.
2. Line-point intercept for vegetative cover and composition – this is a rapid, objective way of assessing ground cover consisting of vegetation, litter, rocks, and biotic crusts, and involves recording the types of cover encountered at regular points along each monitoring transect.
3. Gap intercept or substitution of measurement to nearest perennial plant – gap intercept measures the proportion of a monitoring transect covered by plant canopy. Spaces greater than 20 centimeters are considered gaps.

The results of this monitoring are included in the Baseline Monitoring Report included here as Appendix 2. These monitoring sites will be re-recorded in September or October of 2004 and revisited at least every three years. Reference photos will be taken annually at each monitoring site (Figure 13).

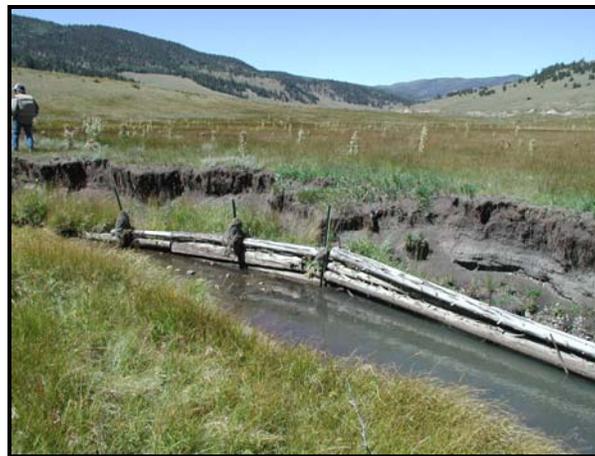
*Figure 5 Revetment Structure in Comanche Creek built in the late 1980s*

There have been a variety of efforts to stabilize and improve habitat along Comanche Creek and they have resulted in mixed levels of success. Revetment structures and small wood and rock in-stream habitat structures installed in the mid to late 1980s (see Figure 5) failed rapidly. Failure most likely was due to improper design, placement, and construction relative to channel characteristics, so they could not withstand heavy stream flows during spring and summer rain events.

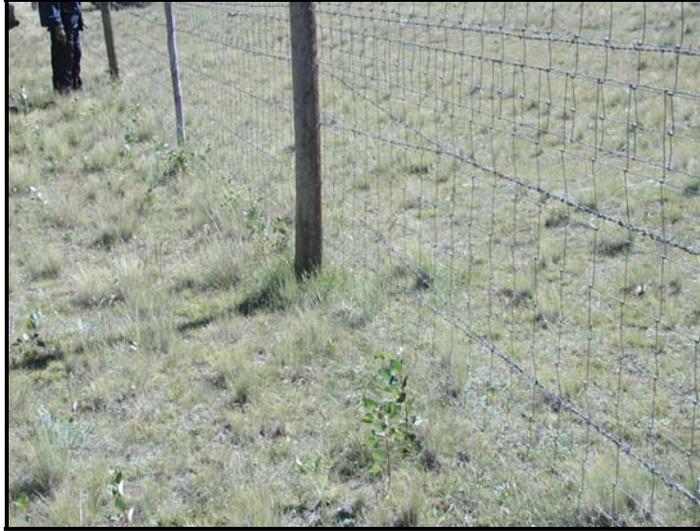
*Figure 6 Young aspen growing within large elk enclosure.*

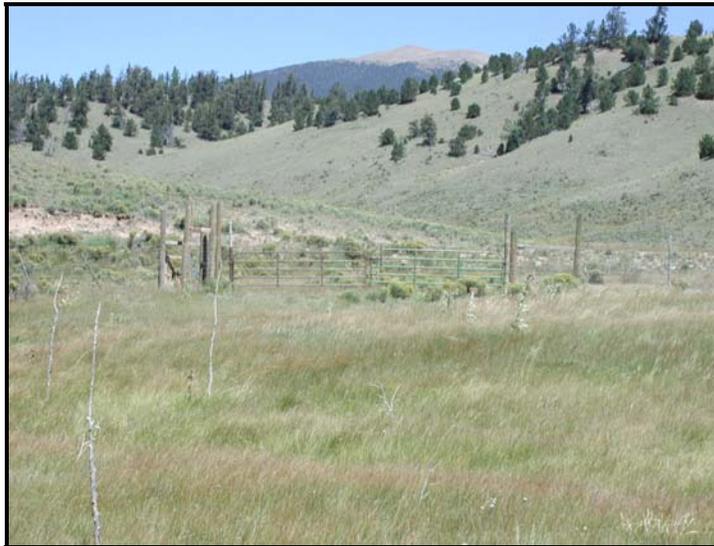
*Figure 7 Pipe gate on large enclosure – this gate is too low to effectively exclude elk*

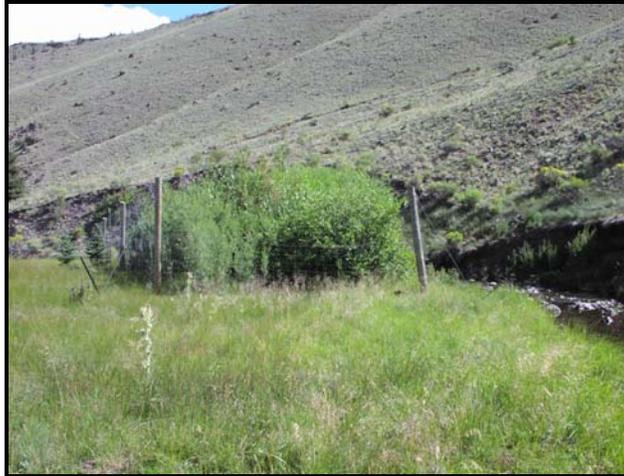
*Figure 8 Woody riparian vegetation growing within a cattle/elk exclosure built in the 1990s*

*(photo taken August 2002)*

While limited in scope, the exclosures have demonstrated the potential effectiveness of these structures in restoring riparian vegetation - primarily willows – to the banks of Comanche Creek.

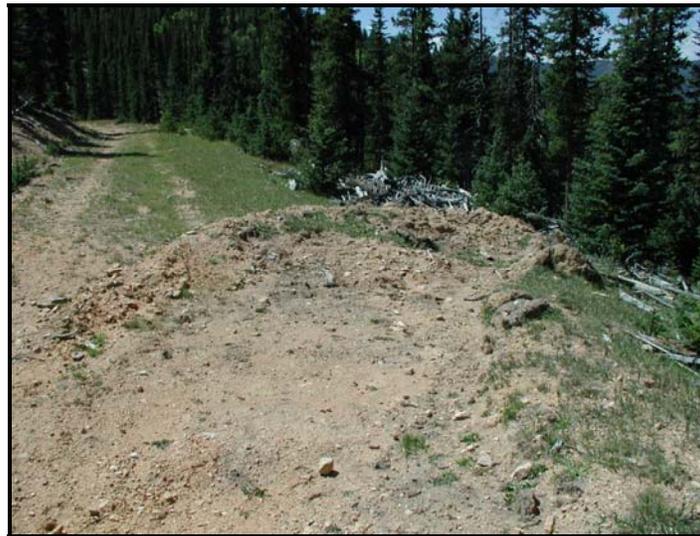
*Figure 10 Water bar on old road in Comanche Creek Watershed*

Water-barring or obliteration of roads has been done in the past 3 years, though it is still not known which roads contribute the most sediment (Figure 10).

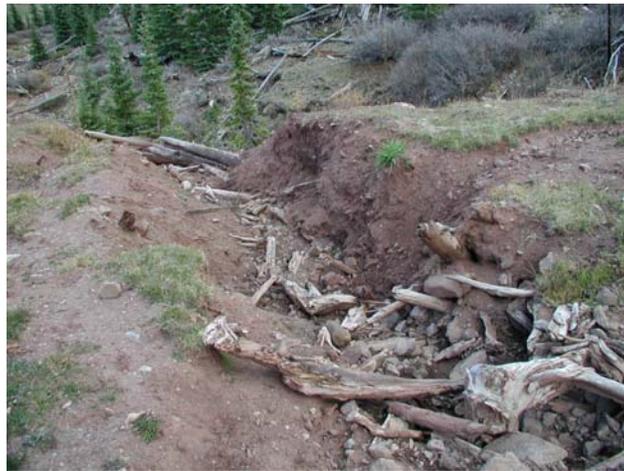
*Figure 11 Erosion Along Ski Run On Ski Rio*

Slopes have been contoured and cleared for ski runs, and along much of its length, Cordova Creek has been modified from its original position to make room for ski runs. Vegetation has been inadequately reestablished to prevent rills and gullies from forming on ski slopes. Up to a million gallons of water from snowmaking can be applied to the slopes in the form of snow in one application. The normal channel capacity of Cordova Creek is not adequate to carry the additional runoff from snowmaking, resulting in accelerated stream bank and bed erosion. Riparian vegetation has been

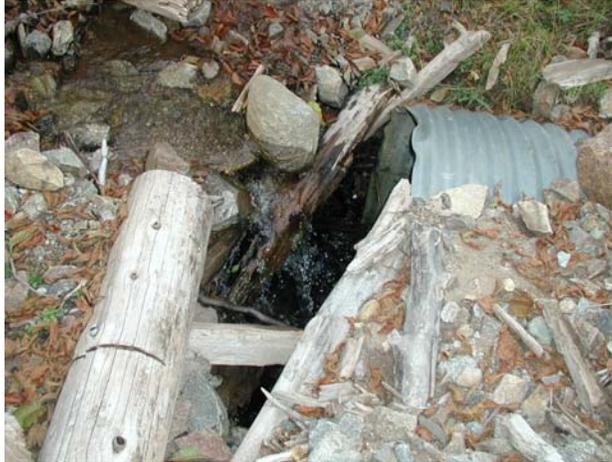
*Figure 12 Culvert Opening Almost Plugged*

removed or has been lost through severe erosion of Cordova Creek banks. The remaining riparian vegetation is in jeopardy because of down cutting of the stream and loss of floodplain function. Logs and wood debris left over from slope clearing remain within Cordova Creek channel and in some places is exacerbating the erosion problem. Because of increased slope runoff, culverts have become undersized and are creating severe headcuts and gullies.

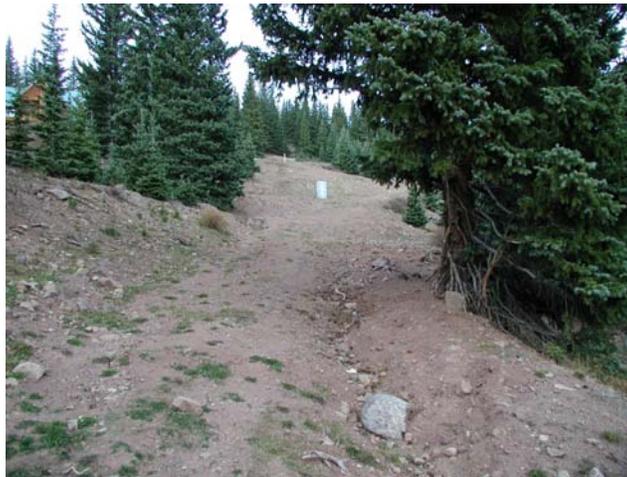
*Figure 13 Roads and Ski Runs Have Altered Drainage*

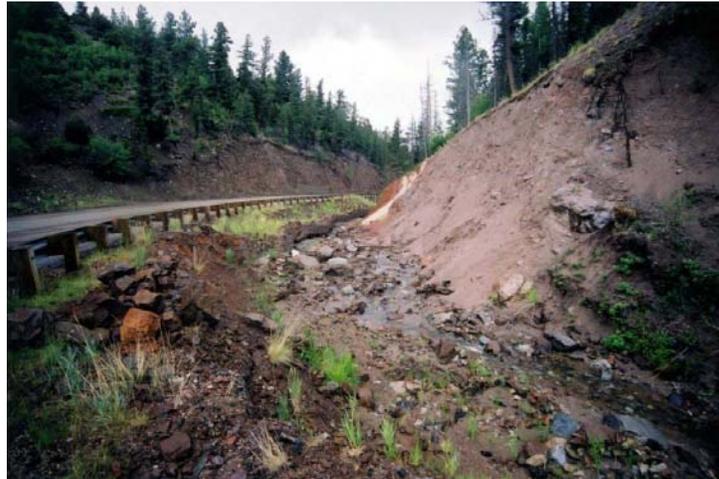
*Figure 14 Bank Erosion Along NM 196*

The New Mexico State Department of Transportation (NMDOT) has initiated a study to evaluate possible new locations for the road and to provide for at least an interim solution to the drainage issues along NM 196. A geomorphological survey was completed by the NMDOT in August of 2005. This survey will provide the data necessary to design and construct slope stabilization, energy dissipation structures within the creek channel alongside the roadway and to improve flows at road crossings.

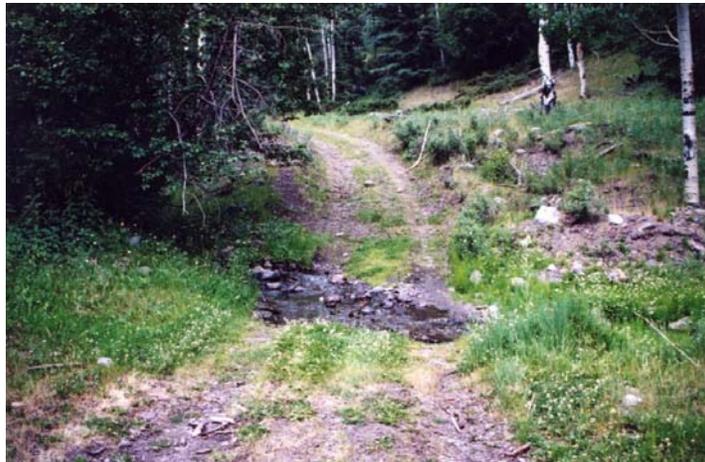
Figure 15 Road Crossing on Sanchez Creek
