Abandoned Uranium Mine
Field Survey Project

New Mexico Energy, Minerals and Natural Resources Department
Mining and Minerals Division

July 18, 2008

Taffy Mine

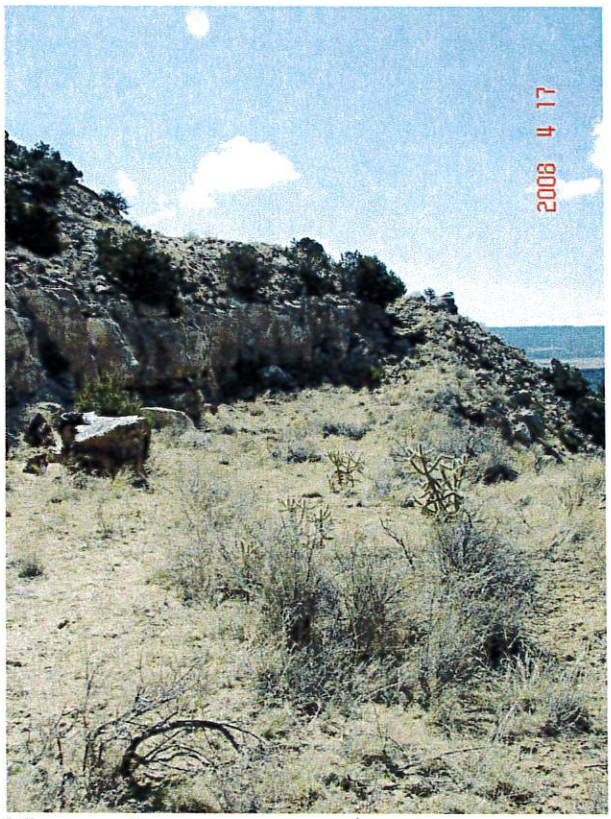
4. Mine Disturbance: The mine consists of two lateral cuts into the side of the mesa. There is little evidence of the mine remaining as most of the site and the road leading to the site has been extensively eroded. The mine site is marked by several horizontal borings into green sediments, remains of an unknown iron structure, and a single 55 gallon drum.

View east

Former structure (?)

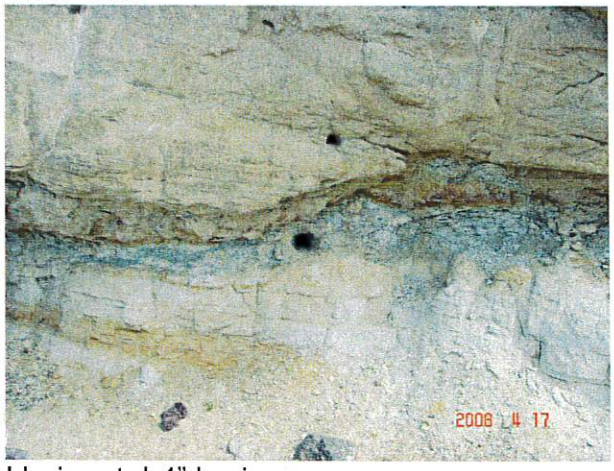
Horizontal 4" borings

Trash
