ABANDONED OR INACTIVE URANIUM MINES IN NEW MEXICO

A report of investigation carried out between August 1979 and May 1980 under contract with the New Mexico Energy and Minerals Department.

New Mexico Bureau of Mines and
Mineral Resources
Open-File Report 148

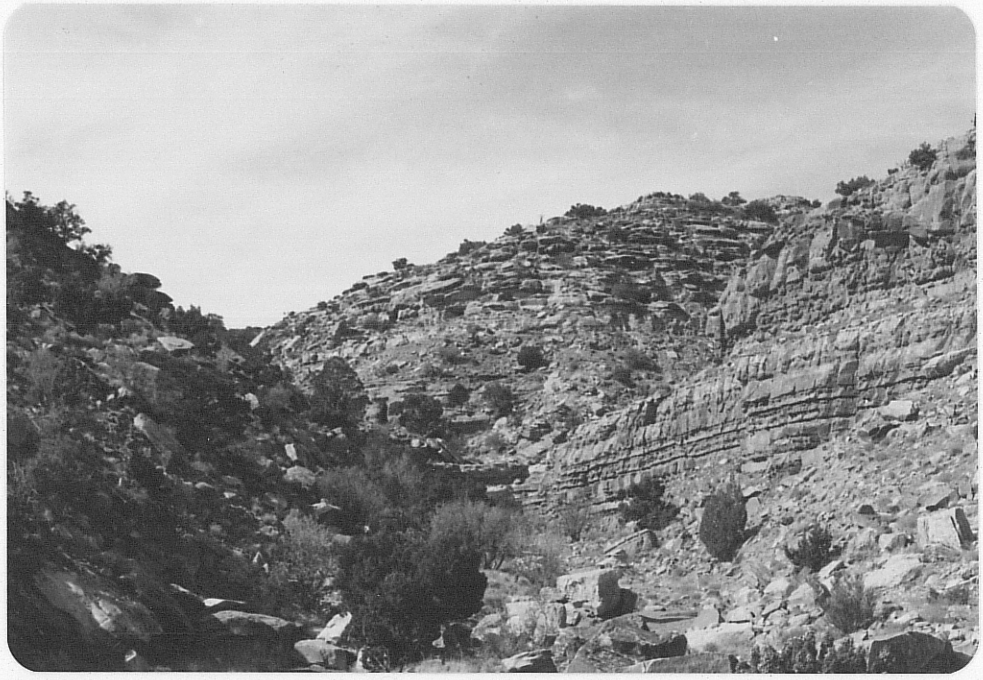
Photo (a) Looking west at Jimmy King #6 workings, south adit at left arrow, north adit at right.

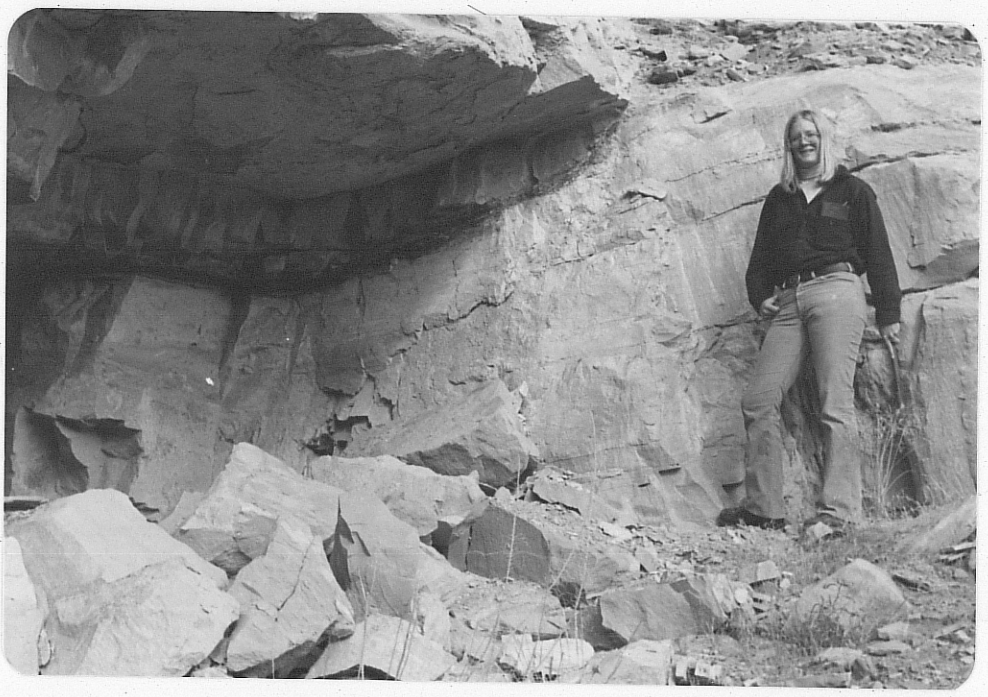
Photo (b) Looking W NW into southern adit.

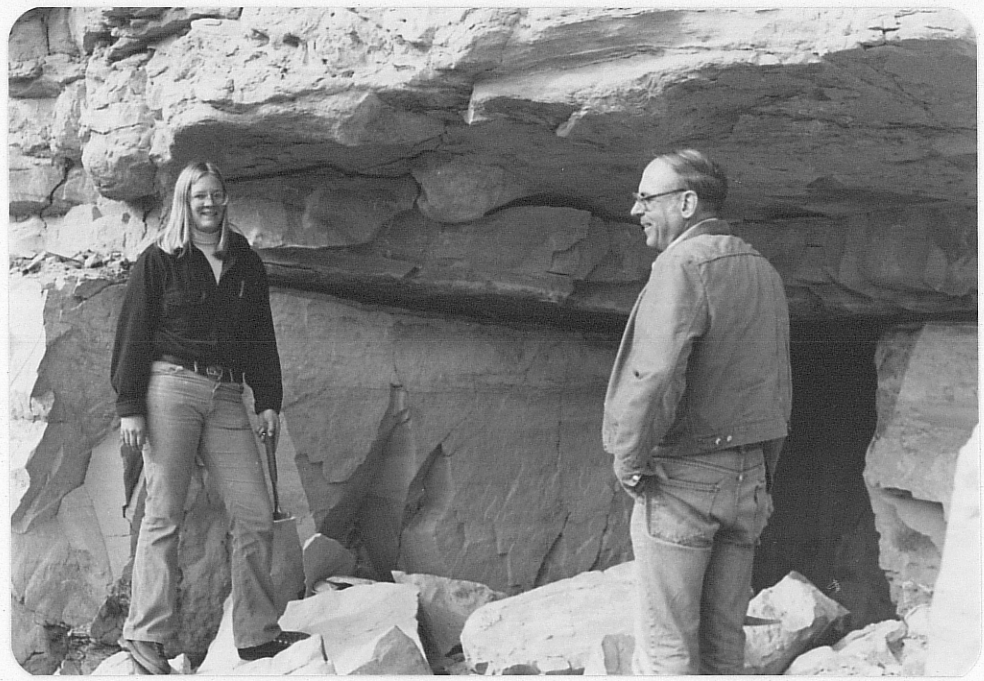
Photo (c) Looking at south wall of southern adit.

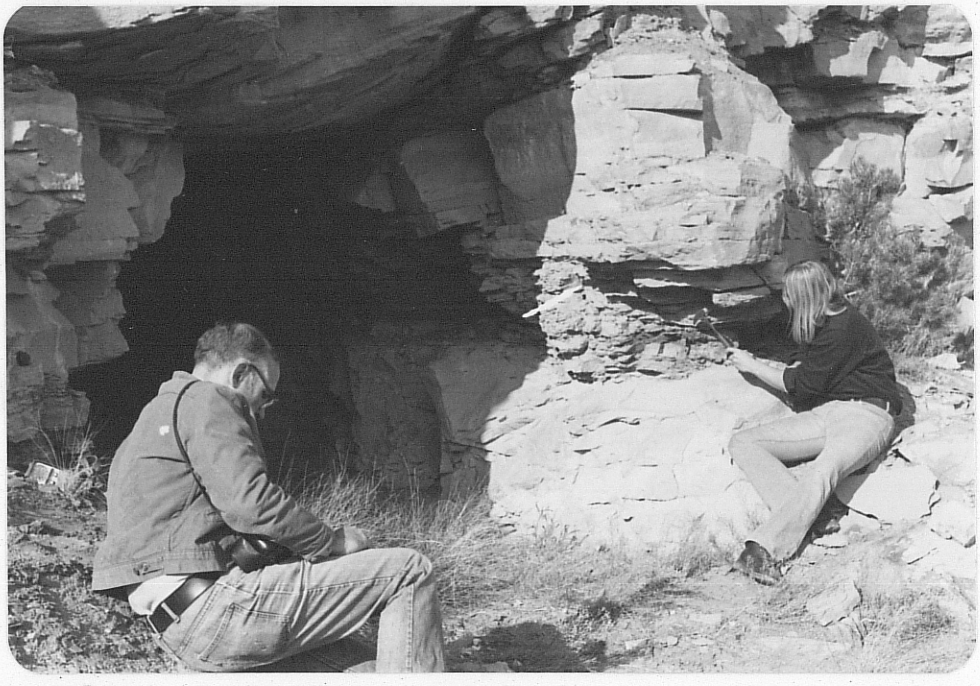
Photo (d) Looking into northern adit showing mudstone lens on north wall.

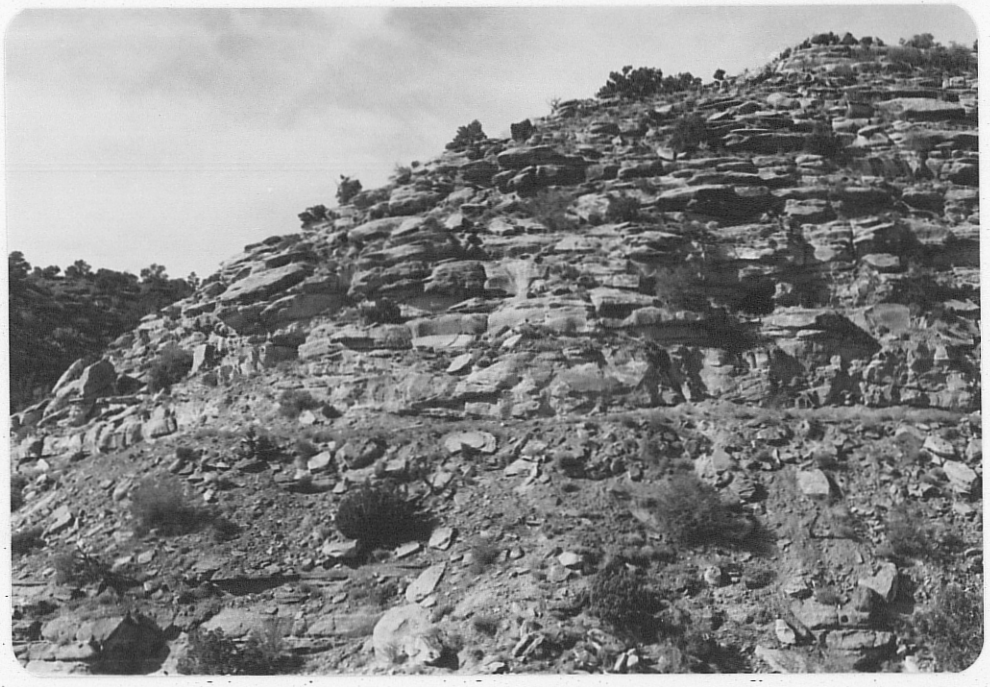
Access to the mine is from the east via a short road leading off the Oak Springs road. The mine road is now in a badly deteriorated condition and walking in the approximately 1/3 mi. distance from the Oak Springs road is the recommended way. The area is actively grazed by Navajo goat & sheep herds. Host rock for the uranium deposits is the Salt Wash sandstone member of the Morrison fm. The uranium occurs in association with vanadium; u:v ratio in the vicinity is 1:5, but mine run ore averaged a slightly higher ratio. Mine was operated from 1955 to 1957 by the Troy Rose Mining Co. A total of 54 tons of ore was produced containing 114 lbs. of U_3O_8 for an average grade of .11%. V_2O_5 content was 773 lbs. or .72%. The mine dumps are correspondingly small, as seen in photo e where the arrows point to each adit.

Photo (e) Looking W at both adits; note small size of mine dumps.

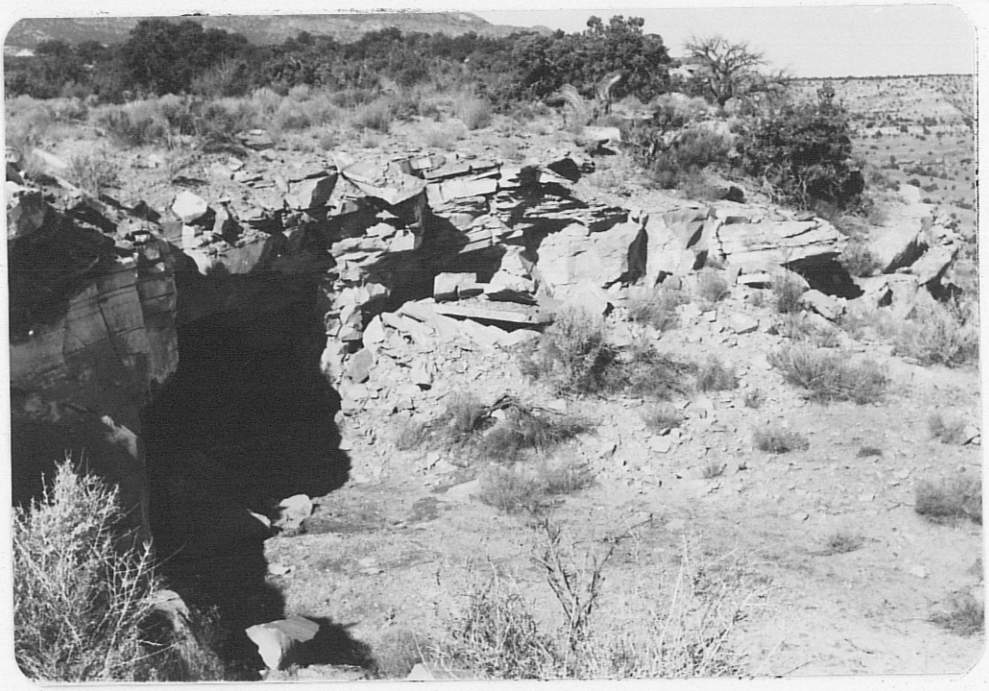
Photo (a) Barton & Begay workings; looking west.

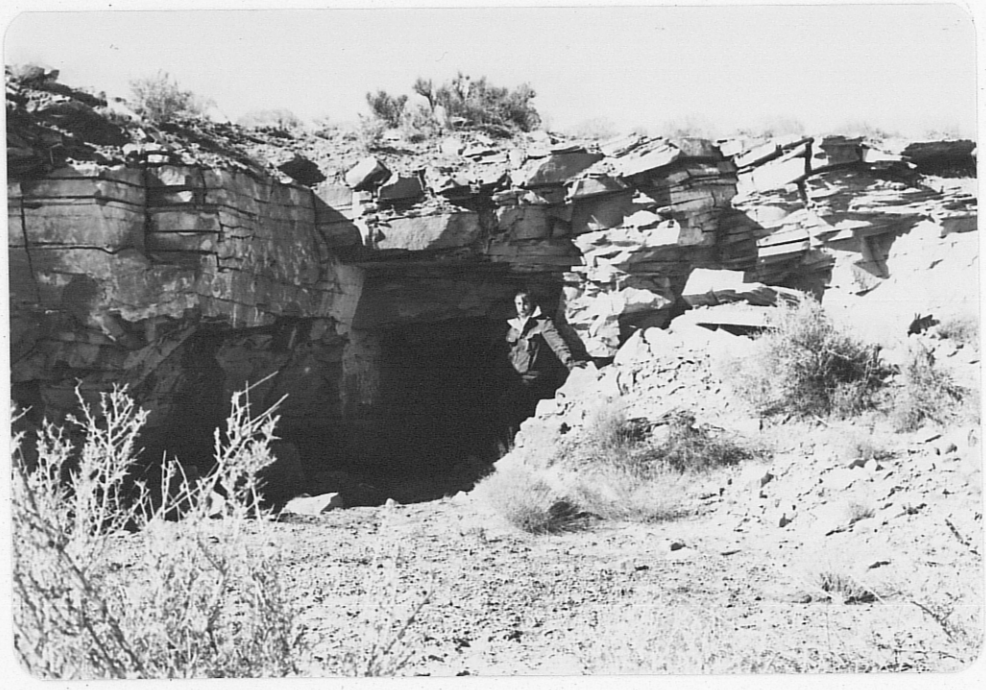
Photo (b) Adit in workings shown in photo a; looking SW.

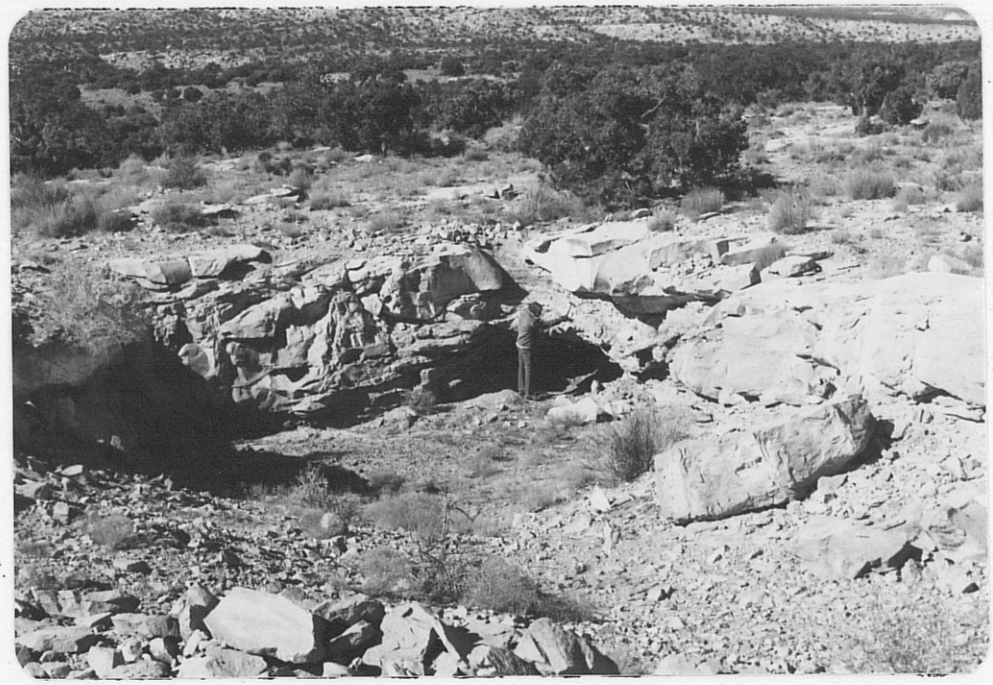
Photo (c) Barton & Begay workings; looking SW into pit.

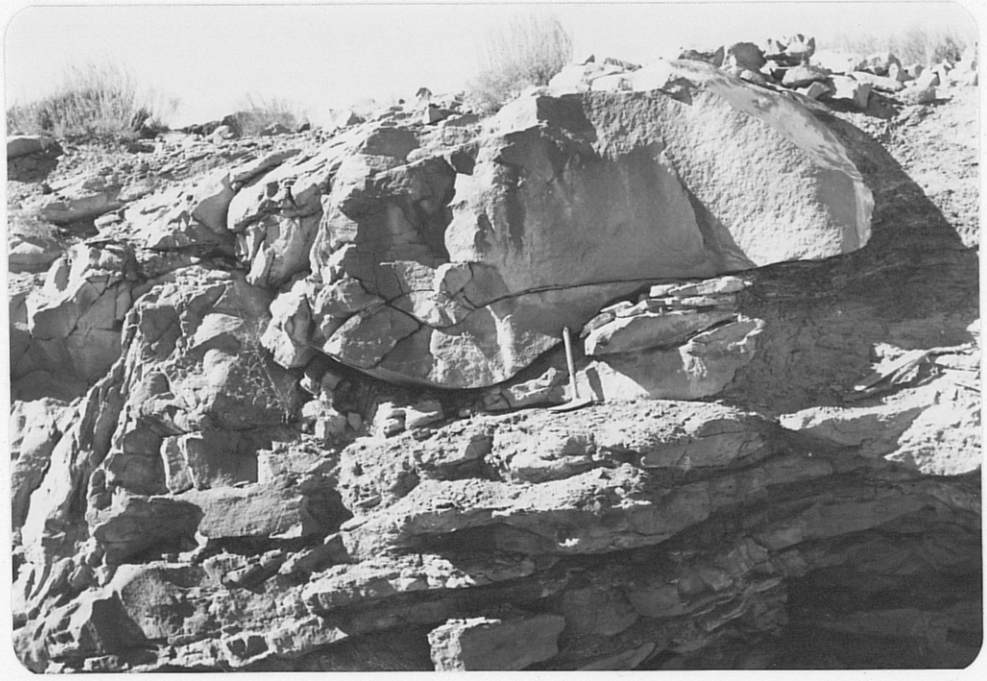
Photo (d) Scour & fill feature exposed on south wall of pit shown in photo c.

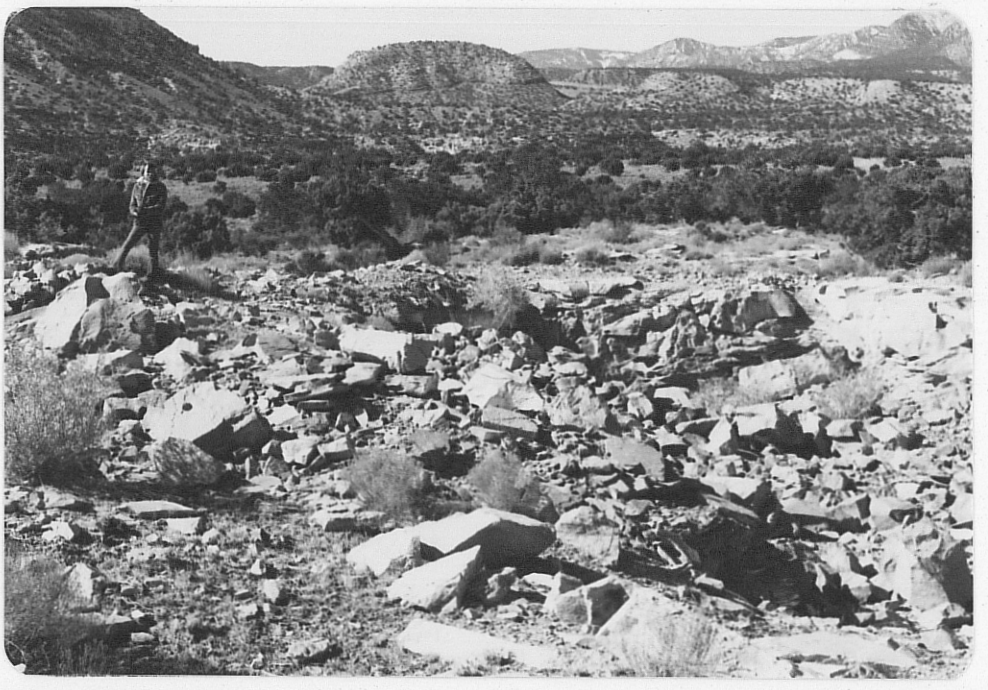
Photo (e) Barton & Begay eastern workings; looking SW. Carrizo Mountains at right in the distance.

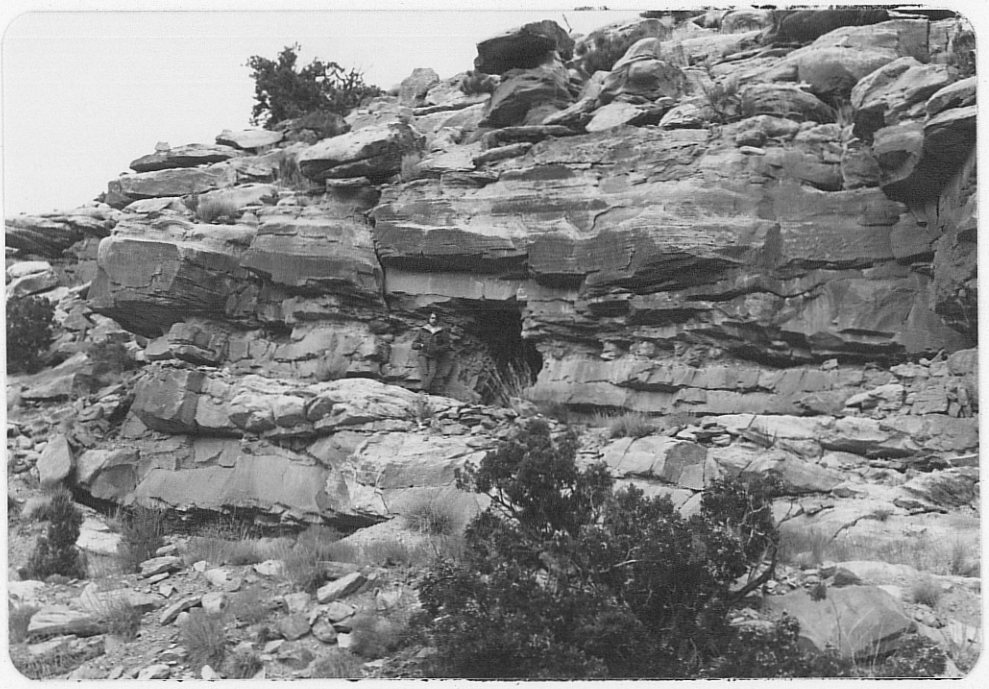
The John John #1 consists of a small adit on the north wall of the small canyon that follows the north side of Cottonwood Butte. The adit, about 6' high, 5' wide, and 20' long, was driven on a north 5° east heading into the Sandstone Cliffs, (see photos a & b); a very minor amount of mine tailings are present below the adit entrance. A 2 inch thick fine grained vanadium stained sandstone lens can be traced along the adit wall and may have been the primary ore bearing zone.

Photo (a) John John #1; looking NW.

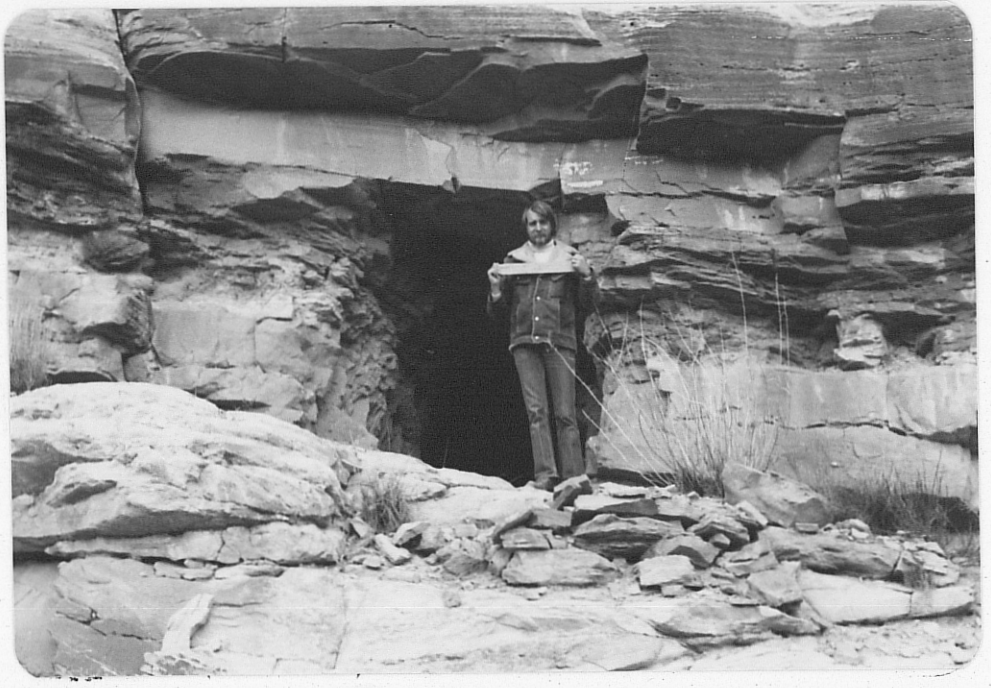
Photo (b) John John #1; looking N.

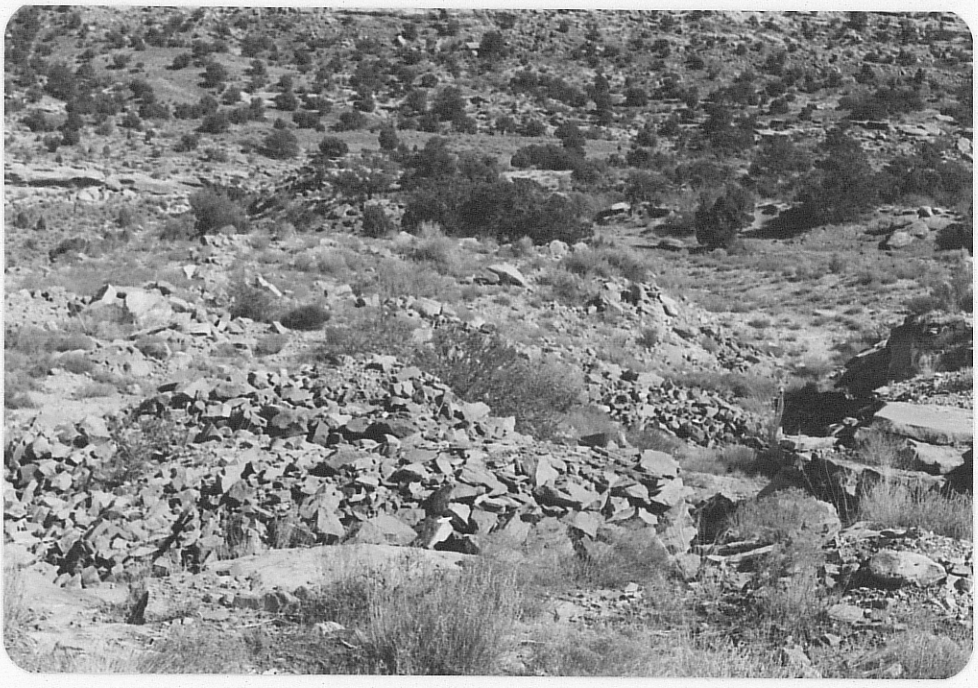
Photo (a) Looking E SE into open cut of King #2. Note access.

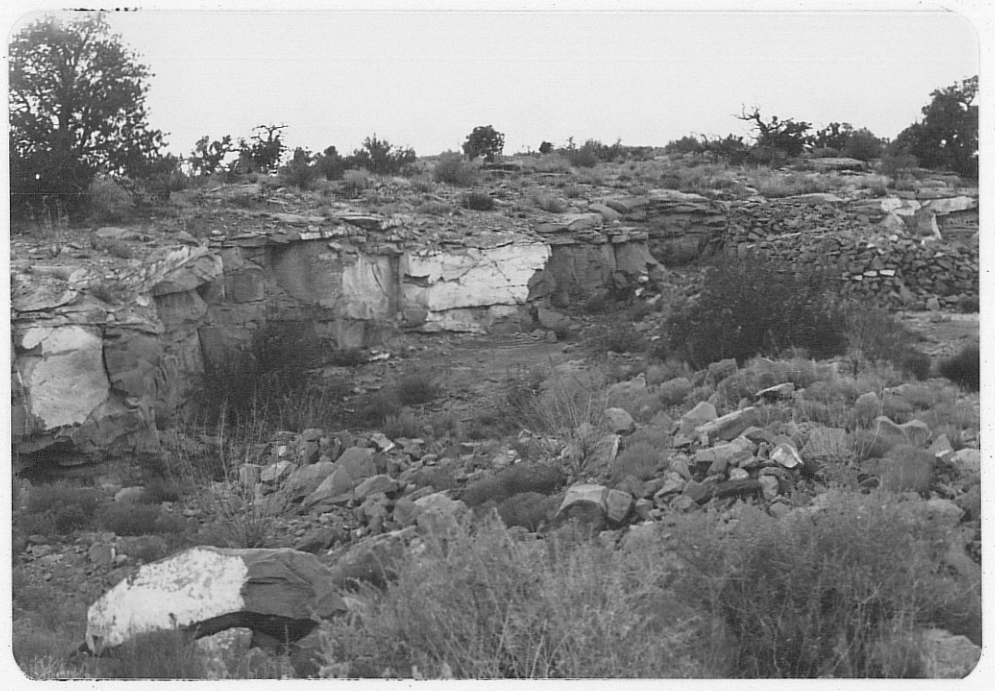
Photo (c) Jimmy King #2; looking west into open cut from access road. Area shown in photo b appears in center of photo c.

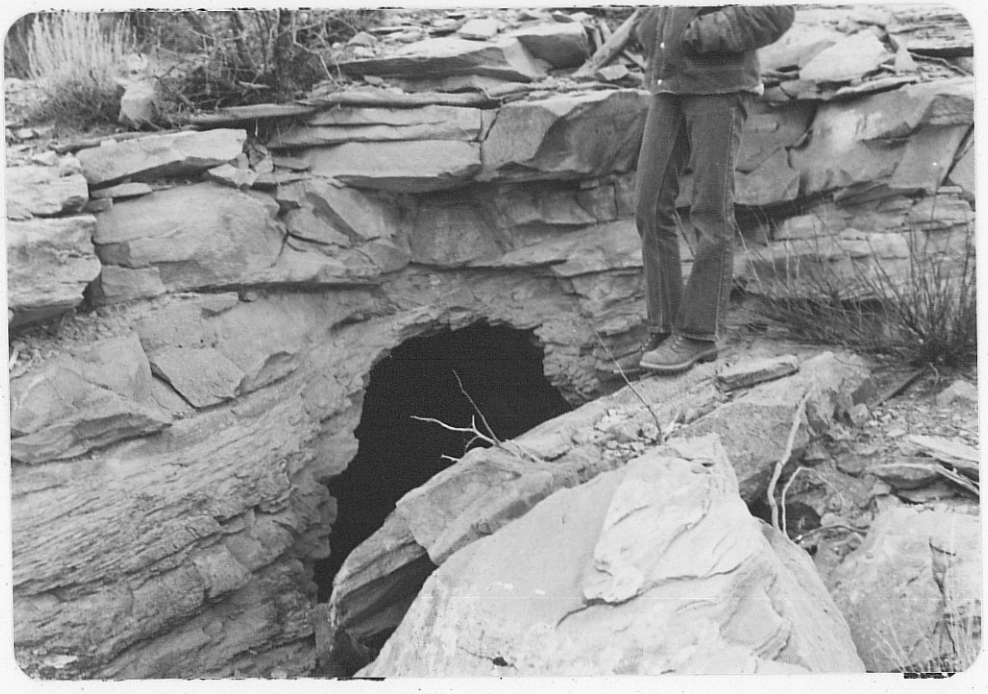
This very small working is on the east edge of the Jimmy King #2 mine dump. The 12' long stub adit with a 5' x 5' opening shown in photos a & b is untimbered and was not entered during the visit. Mineralization at the portal was scant. Some carnotite/tyuamunite was coloration noted on dump rocks above, but it is believed this dump material is largely from the Jimmy King #2 cut; see photo c with arrow pointing to Ricky Flats adit with dump beyond. Adit heading is nearly due south.

Photo (b) Rocky Flats #2; close-up of adit; looking south.

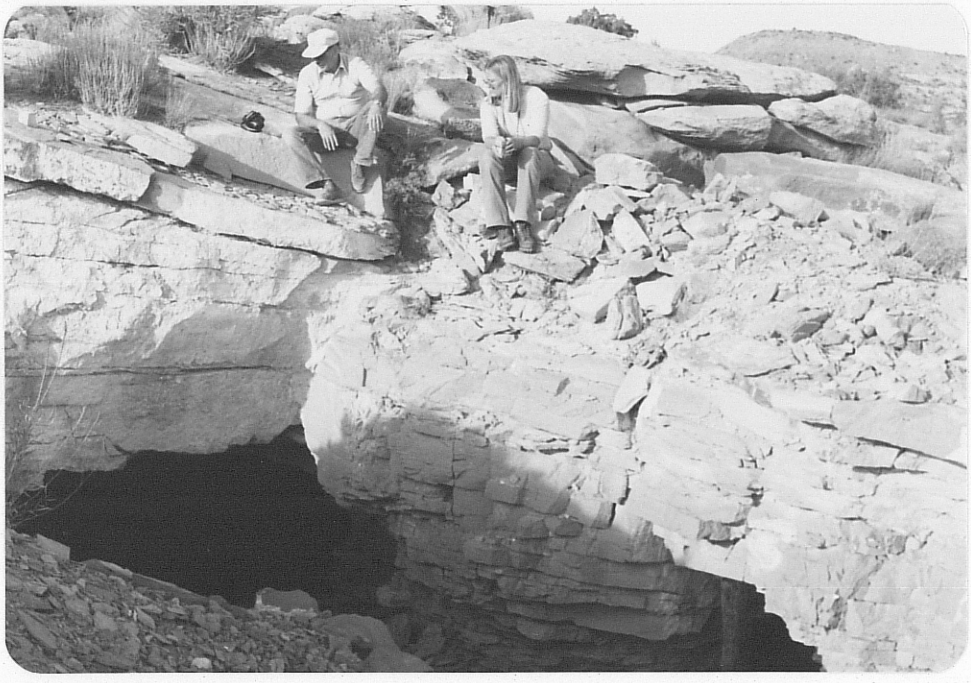
Photo (b) Cottonwood Butte adit; looking NE.

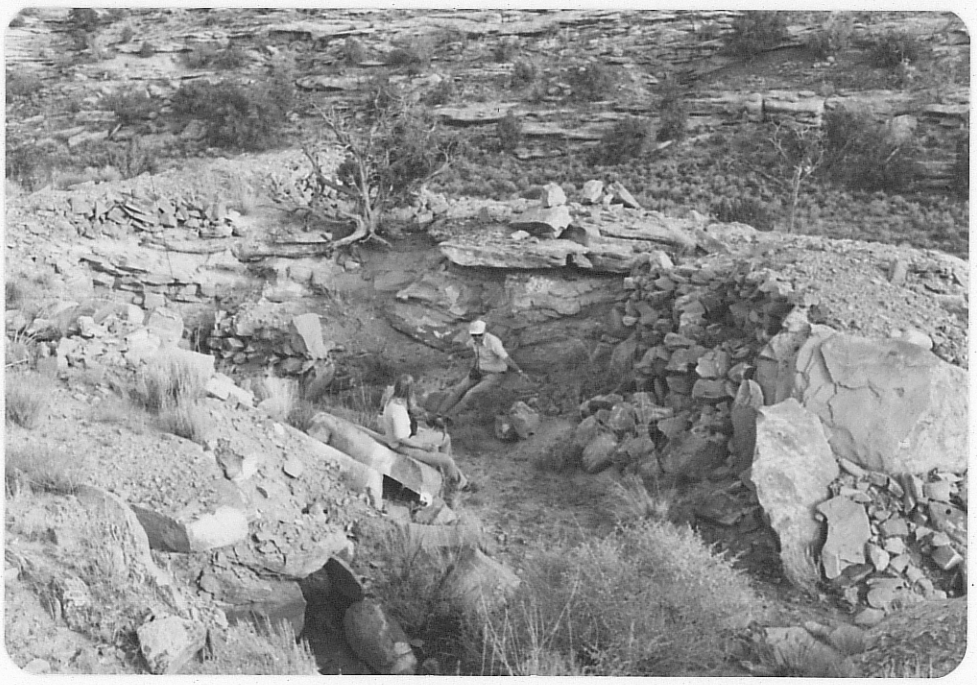
Photo (d) Open cut, part of Cottonwood Butte workings.

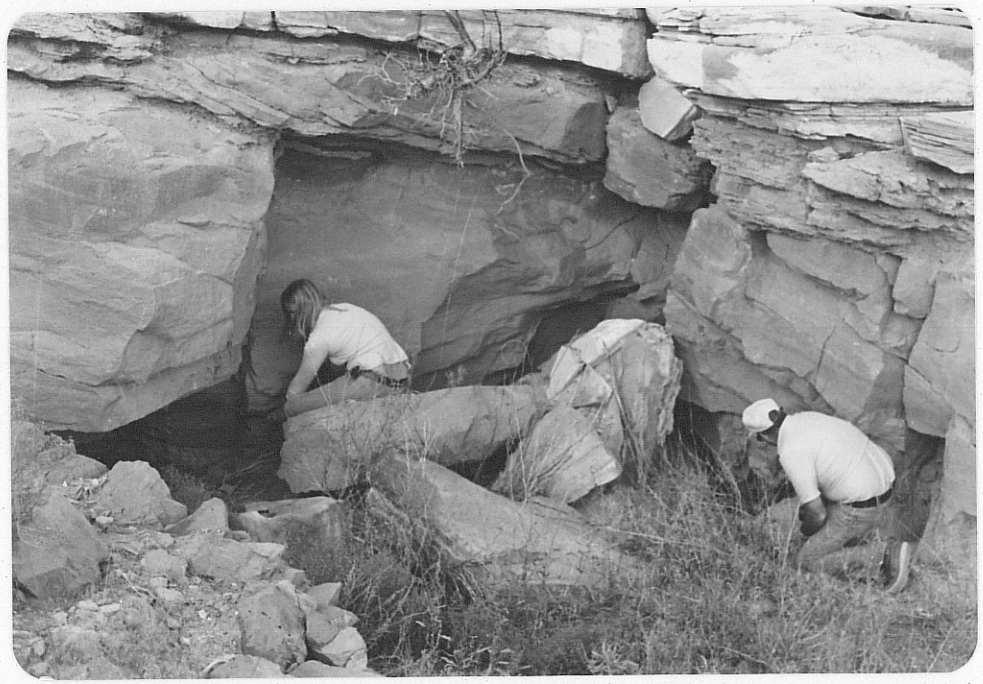
Part (f) Close-up of open cut shown in e; note dark staining being traced at left.

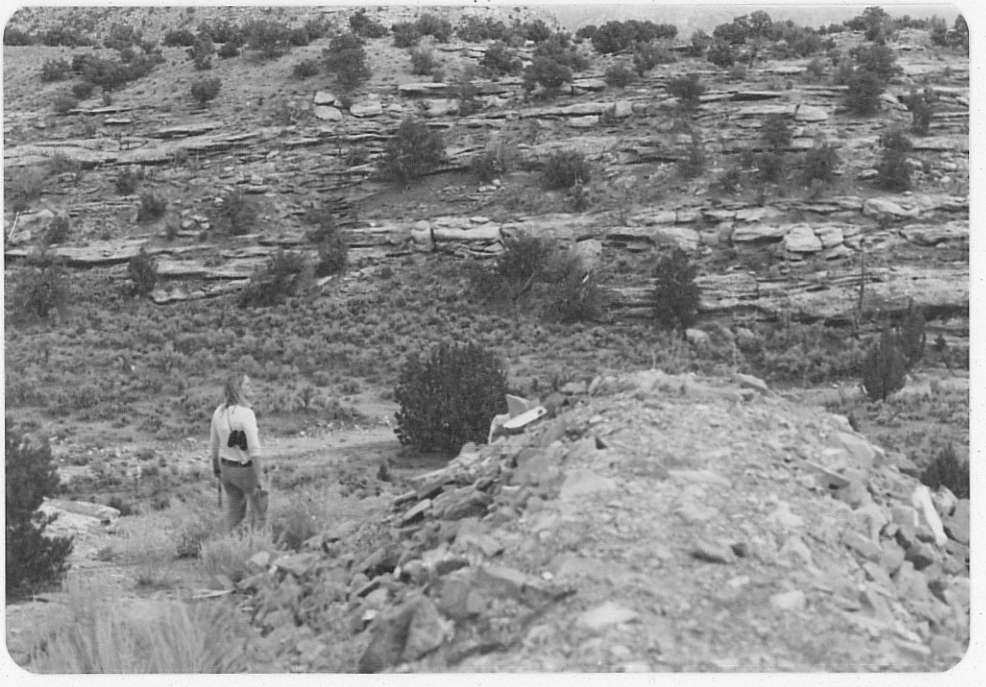
Photo (h) Nose of dump showing drainage line below.

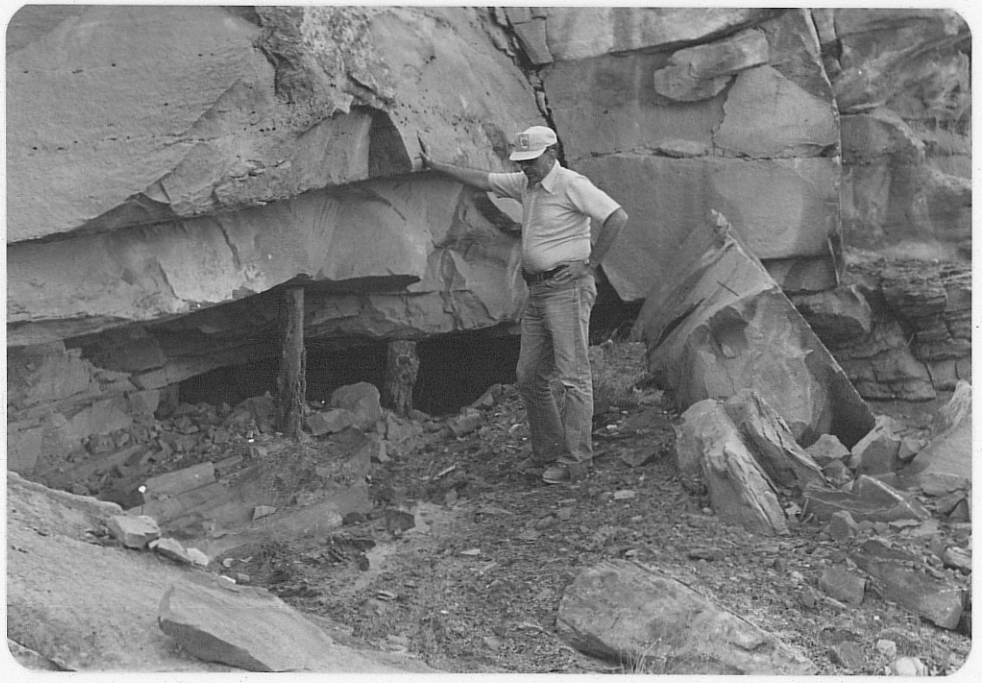
Photo (b) Lone Star adit, looking S SW.

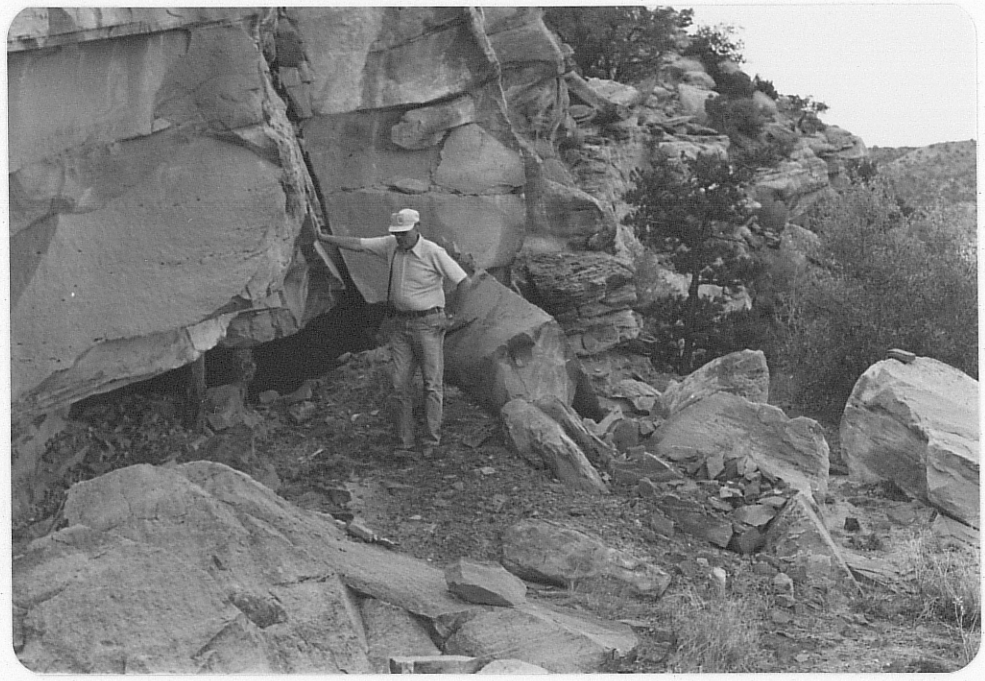
Photo (c) Lone Star adit, looking SW.

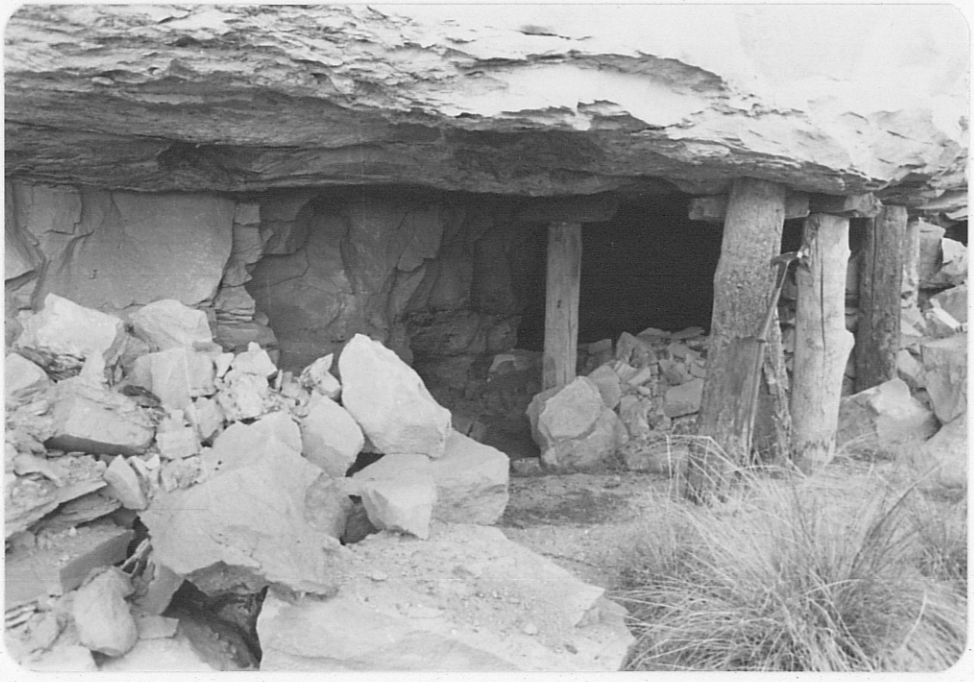
Photo (d) Looking west at small adit in lower left hand corner of photo (c) Rock pick in post for scale. Near the SE corner of VCA Plot #7.

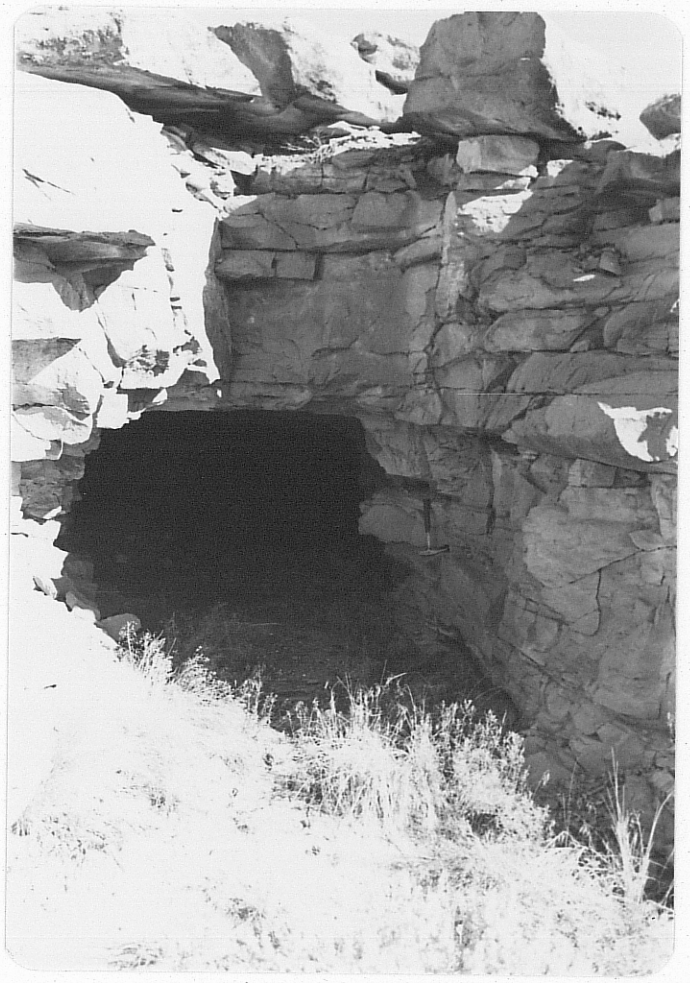
Photo (e) Looking east at small adit in right center of photo (c) near the SE corner of VCA Plot #7. Hammer on right wall for scale.

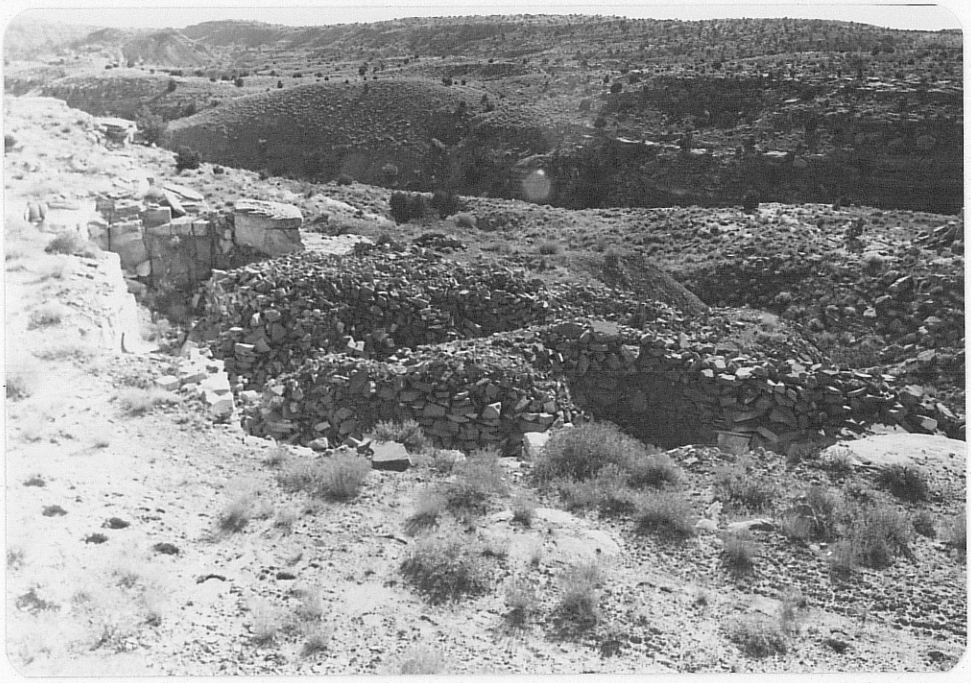
Photo (f) Looking SW at pit to the west of the workings in photo (c). Location is still in the S-SE corner of the VCA Plot #7. Note stacking of waste rock. Depth of trenching is 5' on left side of photo.

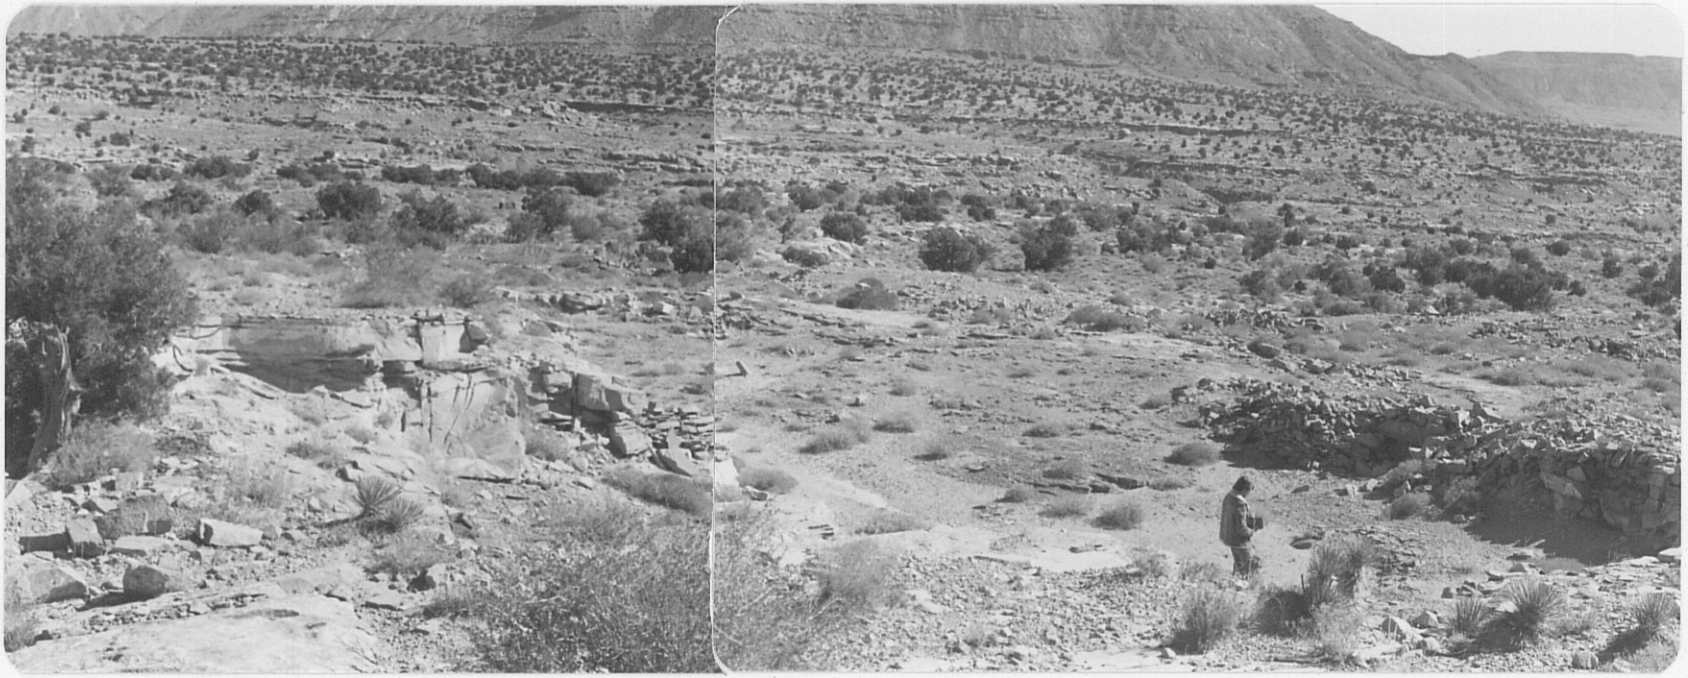
Photo (a) Looking generally east at Franks Point Mine; Oak Spring Wash in background.

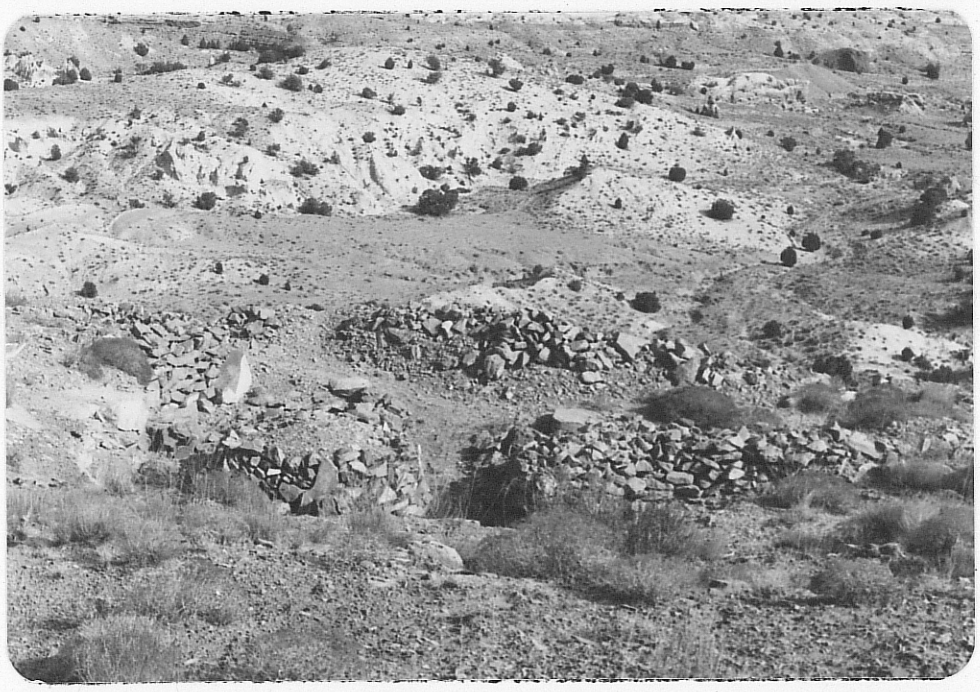
Photo (b) Williams Point mine; looking east; small trench in foreground up to 6' deep.

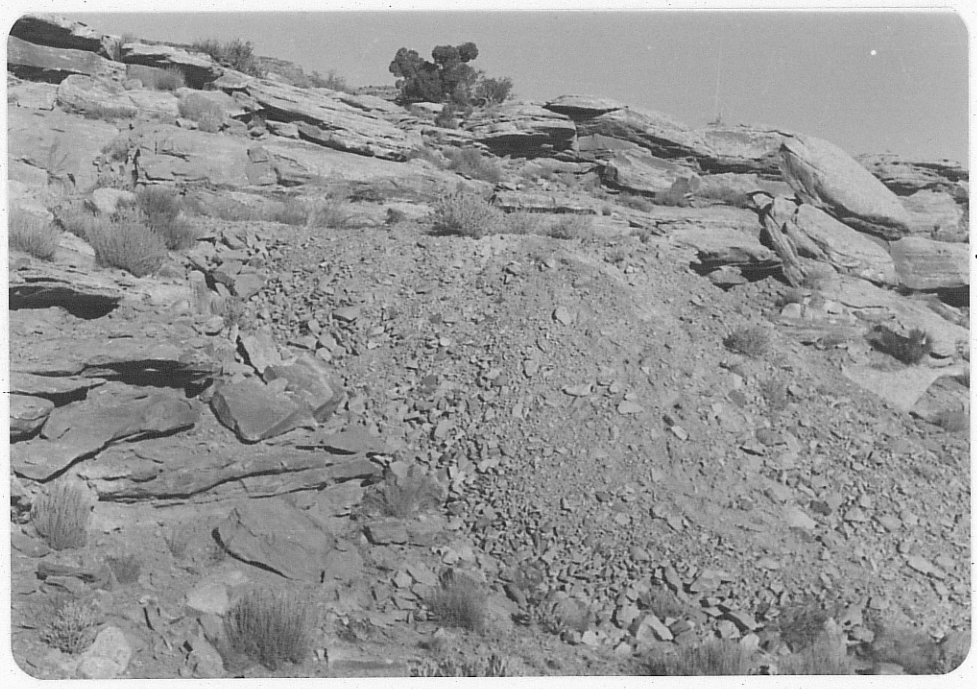
Photo (b) Close-up of dump shown on left in photo a.

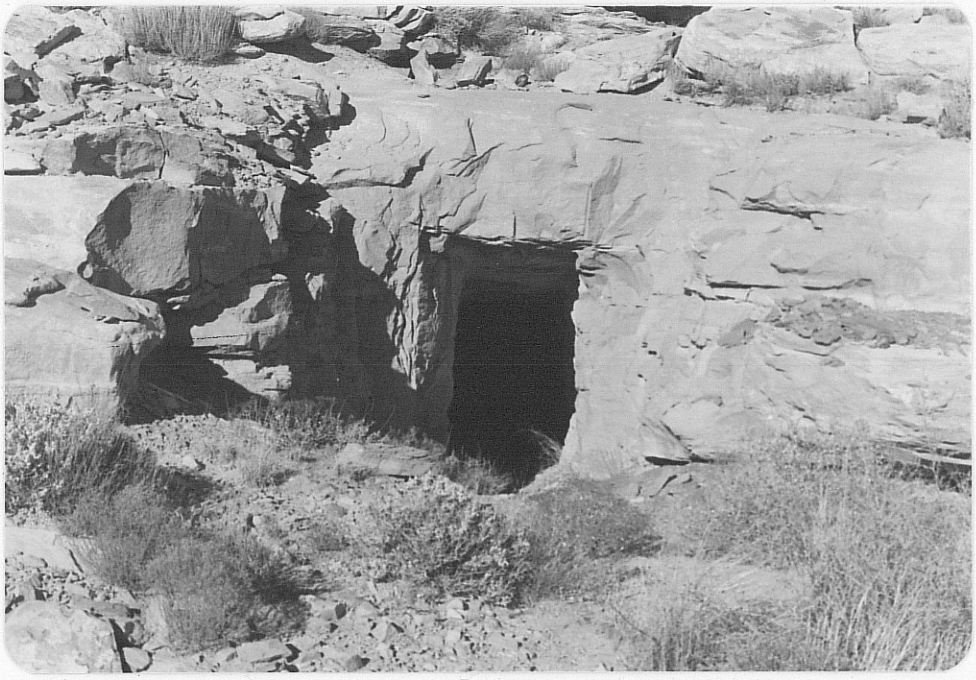
Photo (c) Close-up of north trending adit from which waste dump shown in photo b was produced; portal is approx. 6'x 3', adit is at least 50 long. Scintillometer readings averaged 100 cps (or 2x background).

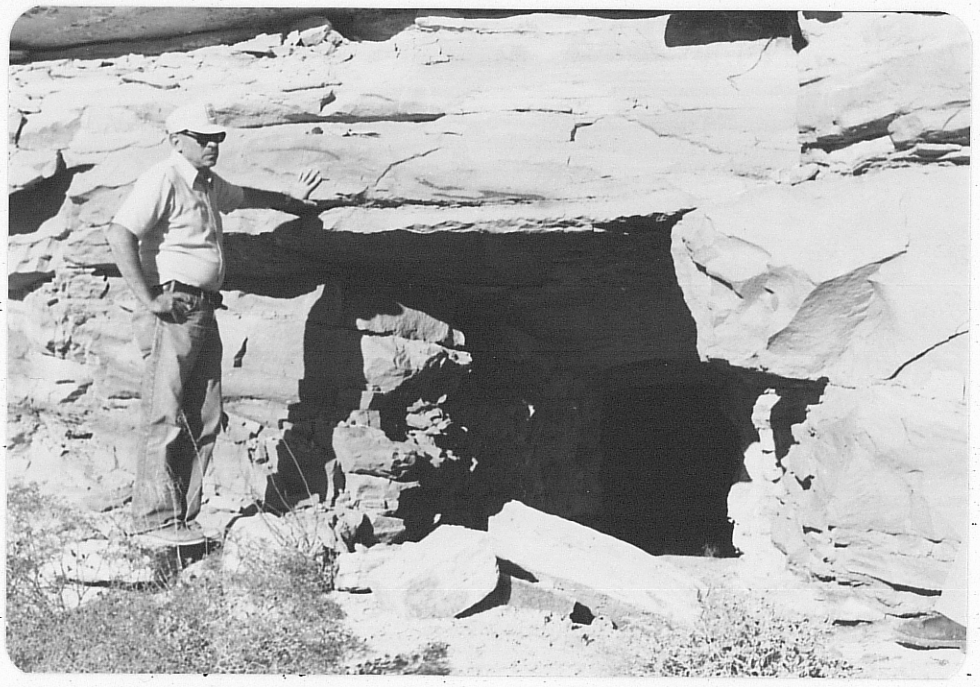
Photo (d) Northeastward trending adit several hundred feet east of adit in (c). Portal is 5'x 5' and workings extend back at least 40'. Maximum scintillometer reading in adit = 1000 cps.

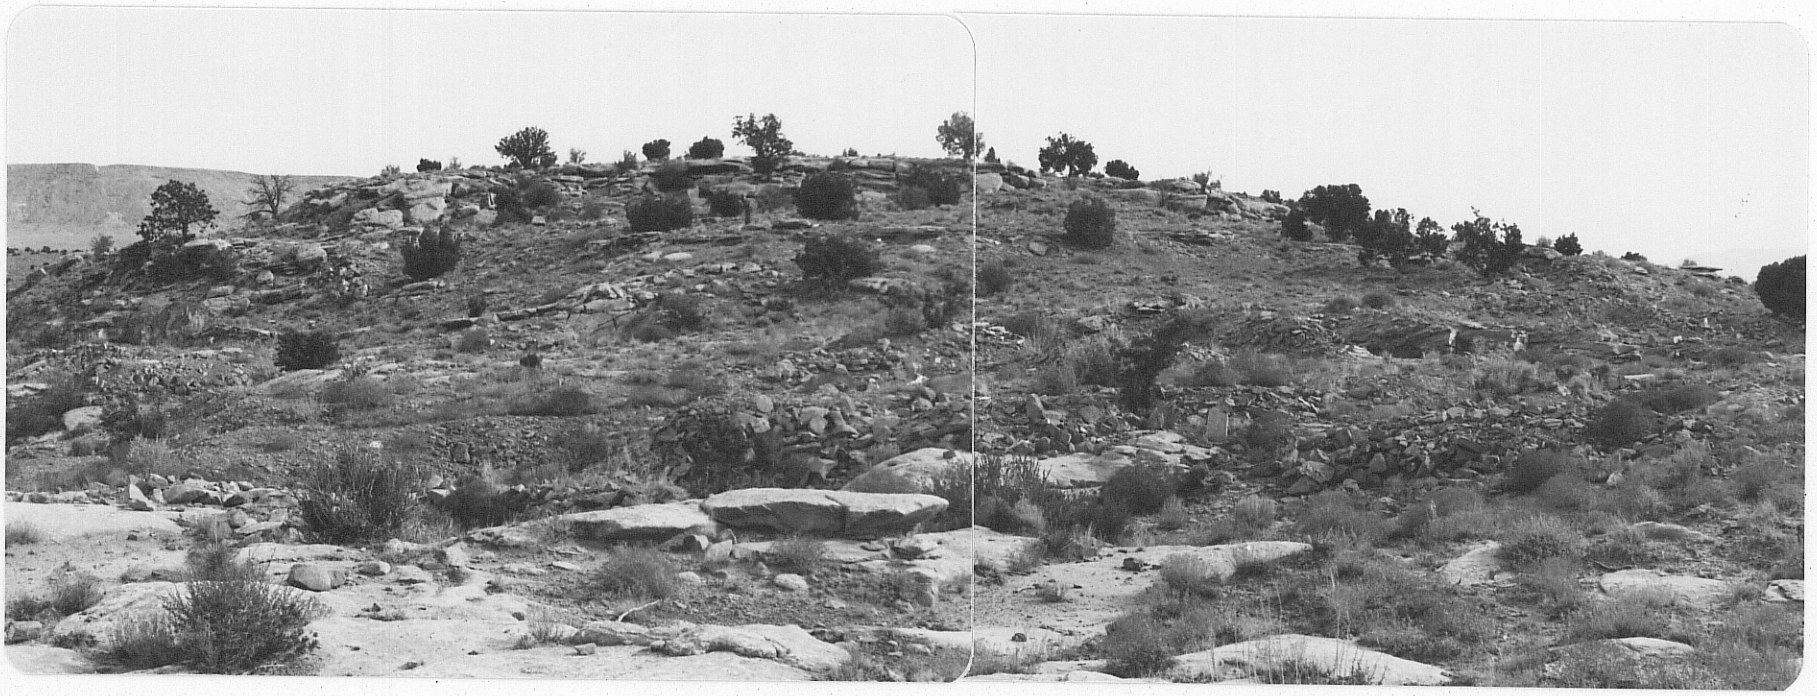
Photo (a) Lookout Point, viewed from NW side. Note numerous small disturbances indicated by circles. Small open pits generally 10' to 20' in length. Close ups offered in the following photographs.

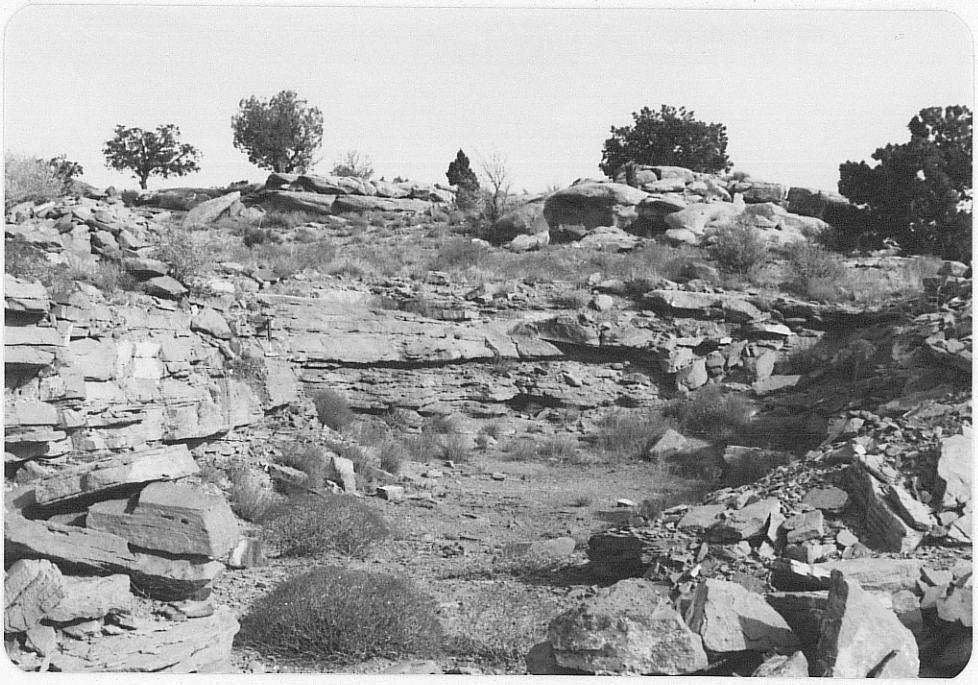
Photo (f) Lookout Point workings; looking east into one of few cuts longer than 20'; note hammer for scale (circled).
