ABANDONED OR INACTIVE URANIUM MINES IN NEW MEXICO

A report of investigation carried out between August 1979 and May 1980 under contract with the New Mexico Energy and Minerals Department.

New Mexico Bureau of Mines and
Mineral Resources
Open-File Report 148

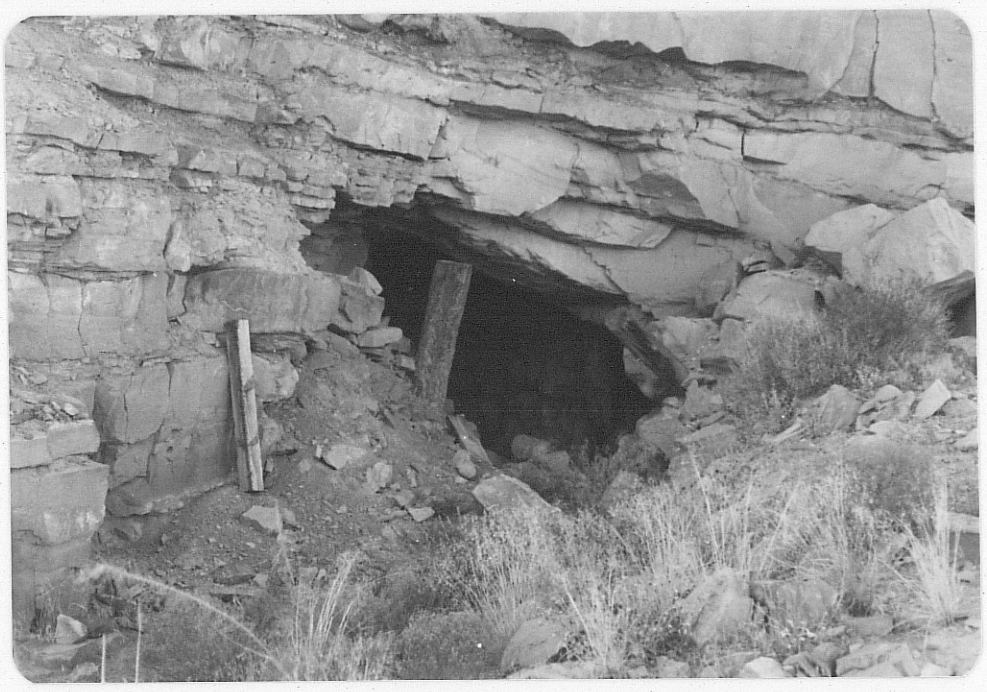
Photo (h) Sunnyside adit, looking west. Portal is 6' x 10', timber is 3' long. Workings split 8' into mine; yellow to greenish yellow uranium minerals very apparent as encrustation on adit walls. Note thin mudstone lenses.

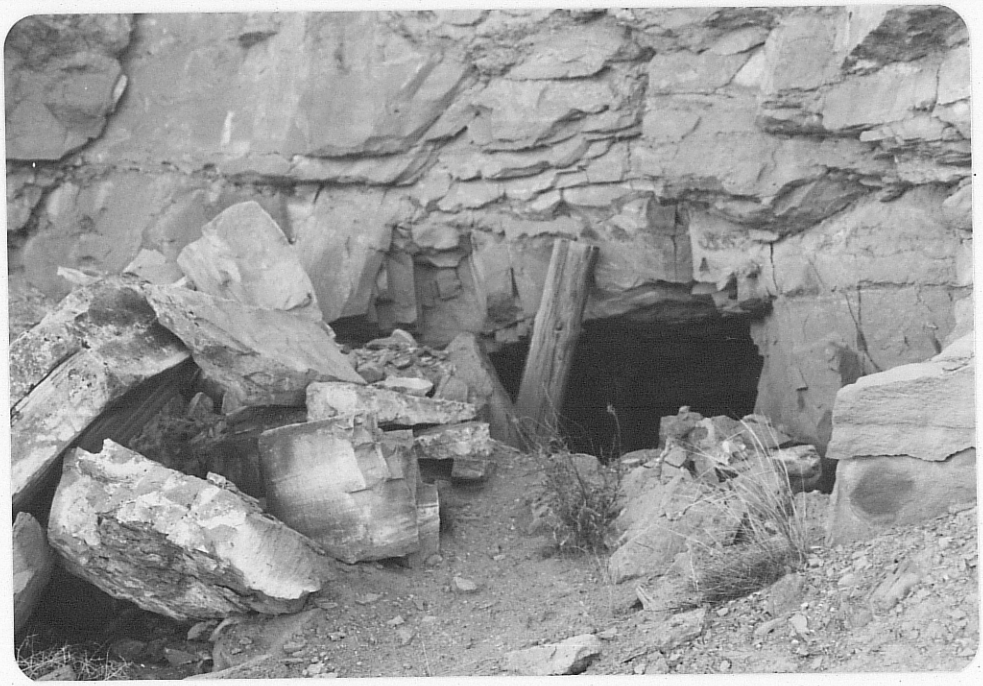
Photo (i) Sunnyside adit, approx. 100' south of photo (h). Portal 5' high, 6' wide, is partially caved; timber is 10" in diameter. Uranium minerals are apparent as encrustation on adit walls, but to lesser extent than others in area.

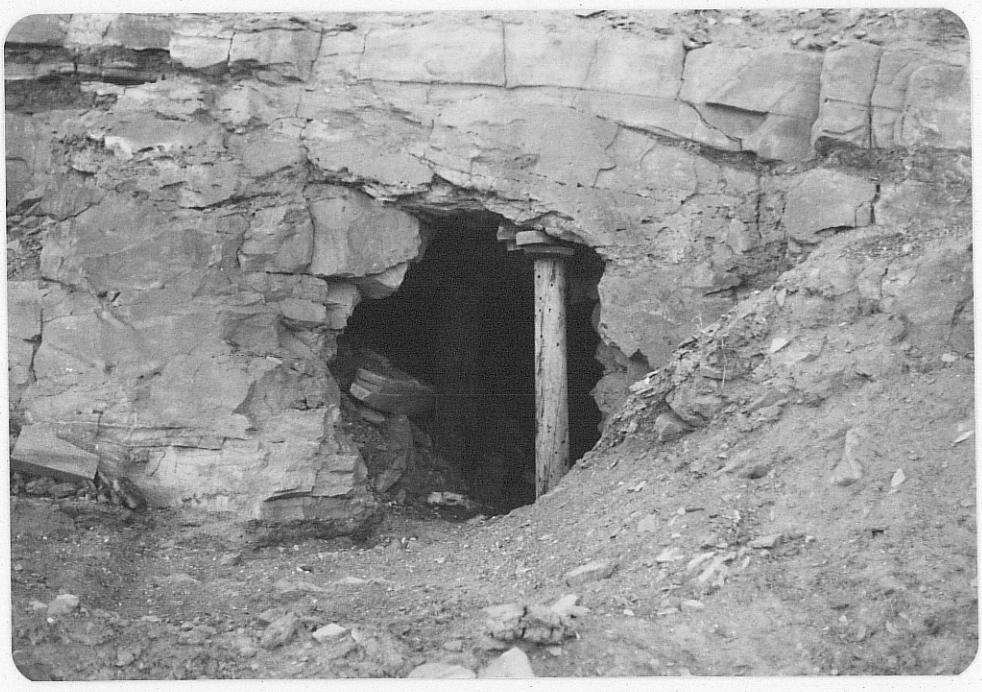
Photo (j) Sunnyside adit about 50' south of photo (i), looking west; portal is 6' high, 5' wide, adit about 60' long. Is crudely timbered and is used occassionally for picnics and cookouts. Uranium mineralization is very apparent as yellow encrustation on adits walls. Scintillometer readings up to and in excess of 6000 cps were recorded in the mine, face counts range somewhat higher.

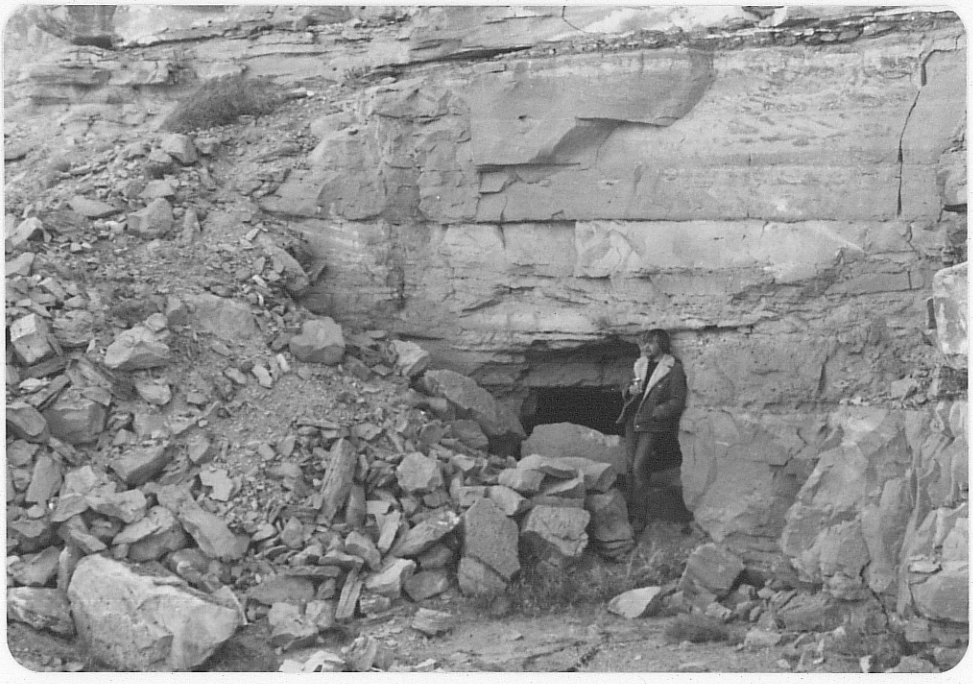
Photo (k) Last (or southernmost) in the Sunnyside adit series, about 100' south of photo (j); looking west. Portal, partially blocked by rock slide, is about 5½' high, 7' wide, adit is at least 40' long. Uranium mineralization is apparent as patchy, yellow encrustation on adit walls. Scintillometer readings up to 2,500 cps were recorded.

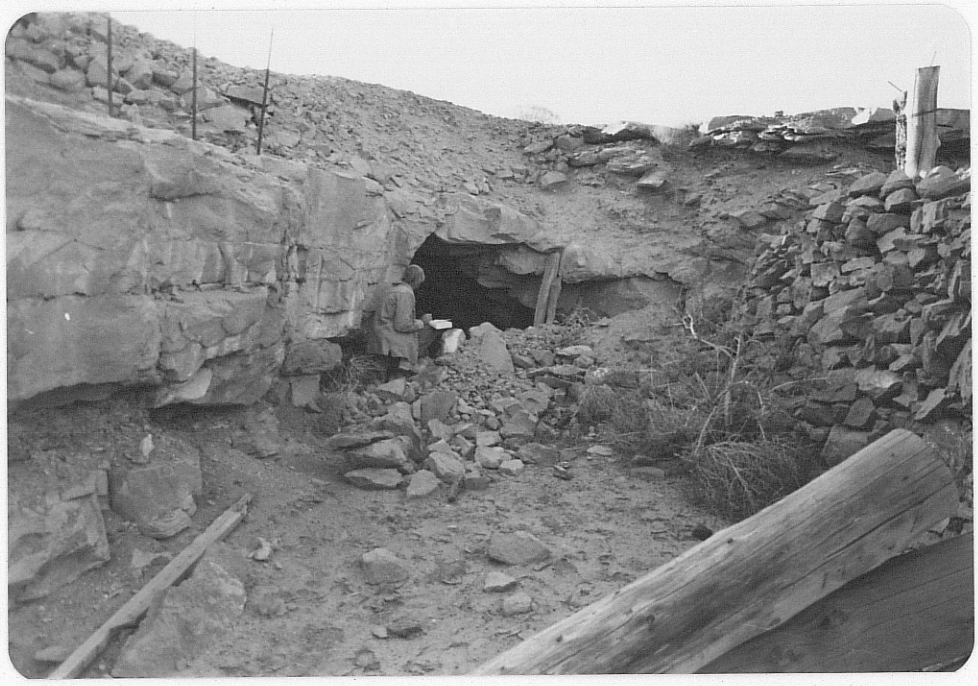
Photo (r) Looking NE at small incline on the southern portion of the VCA Plot #3 workings.

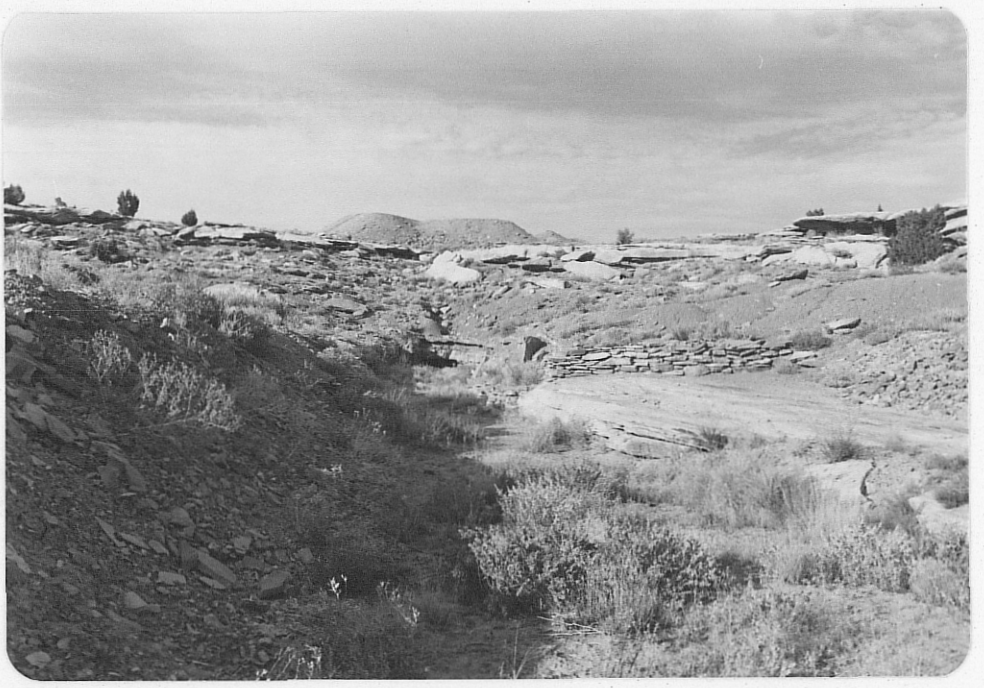
Photo (a) Tent Mine, looking N along 12' wide, 120' long, entrance cut.

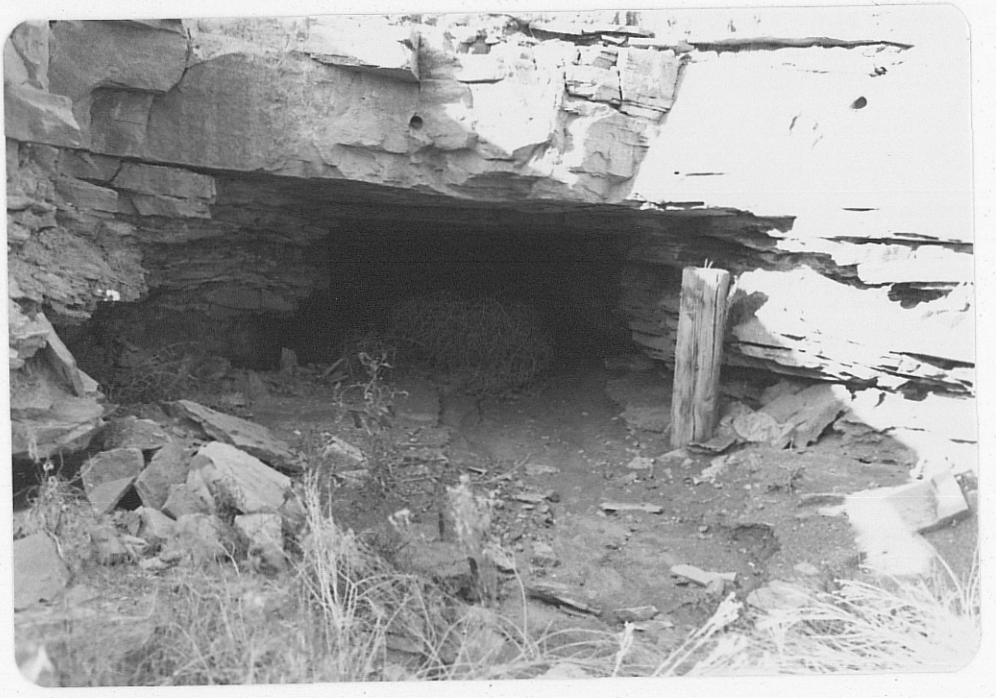
Photo (b) Tent Mine; portal is presently only 3' high by 7' wide.

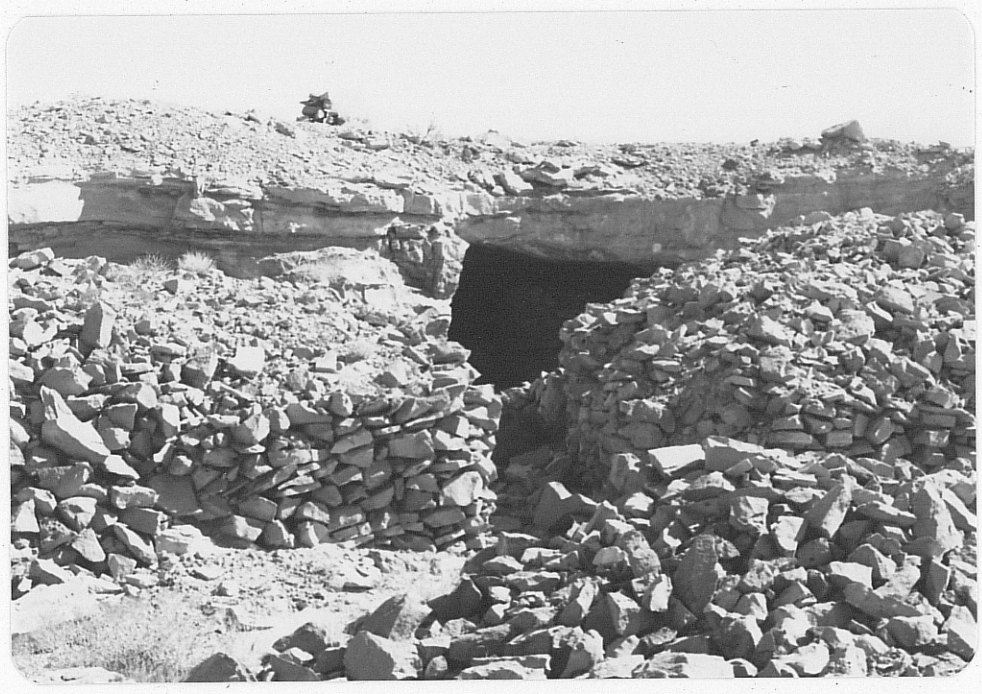
Photo B - King Tutt Point, looking east; note hand stacking of coarse waste rock just outside adit.

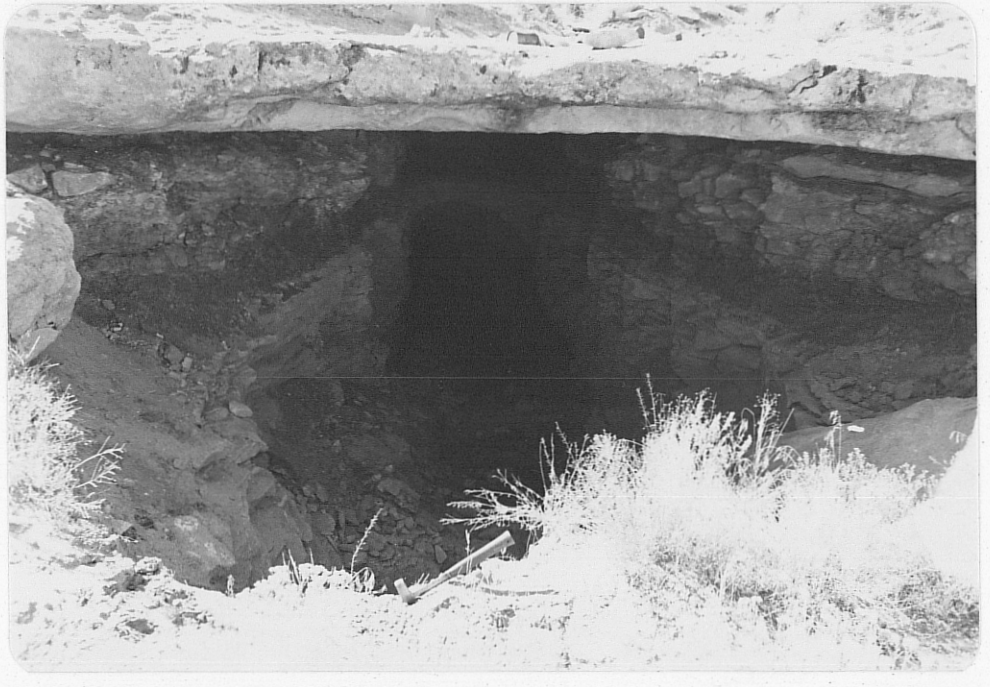
Photo B - Portal to southern decline. Hammer in foreground for scale. Photo looking SW.

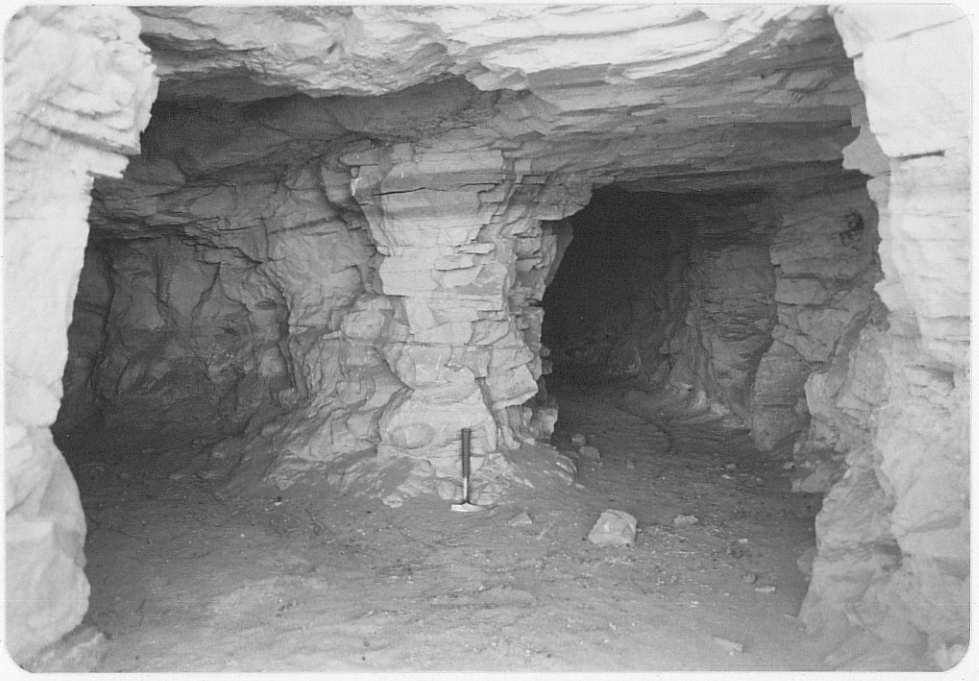
Photo B - Looking east inside adit. Note drift on left side of photo. Hammer in foreground for scale.

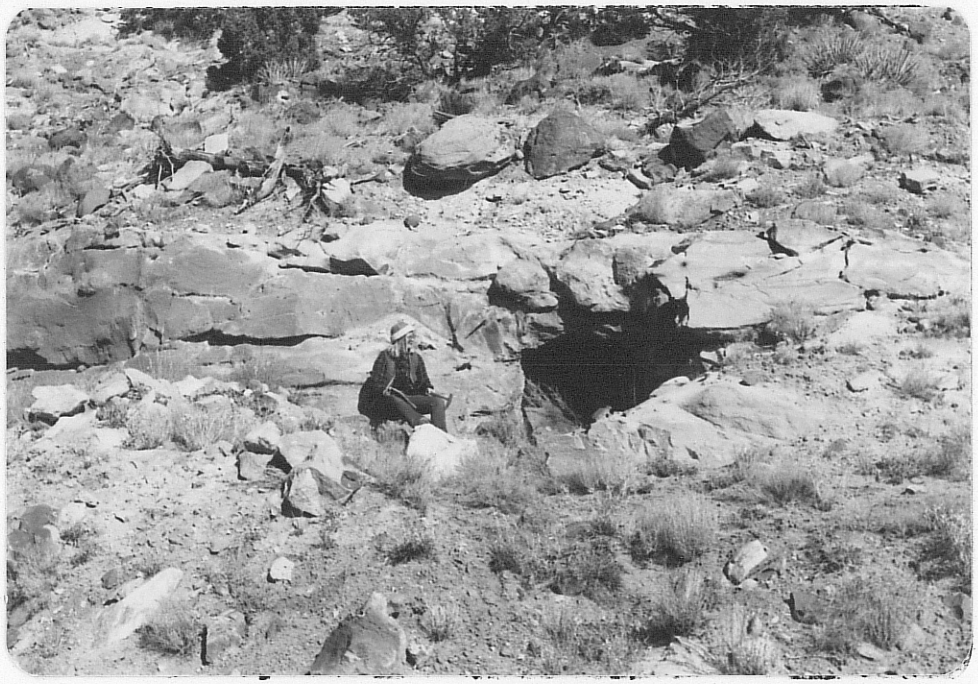
Photo (a) Dennet Nezz claim; looking east at small adit.

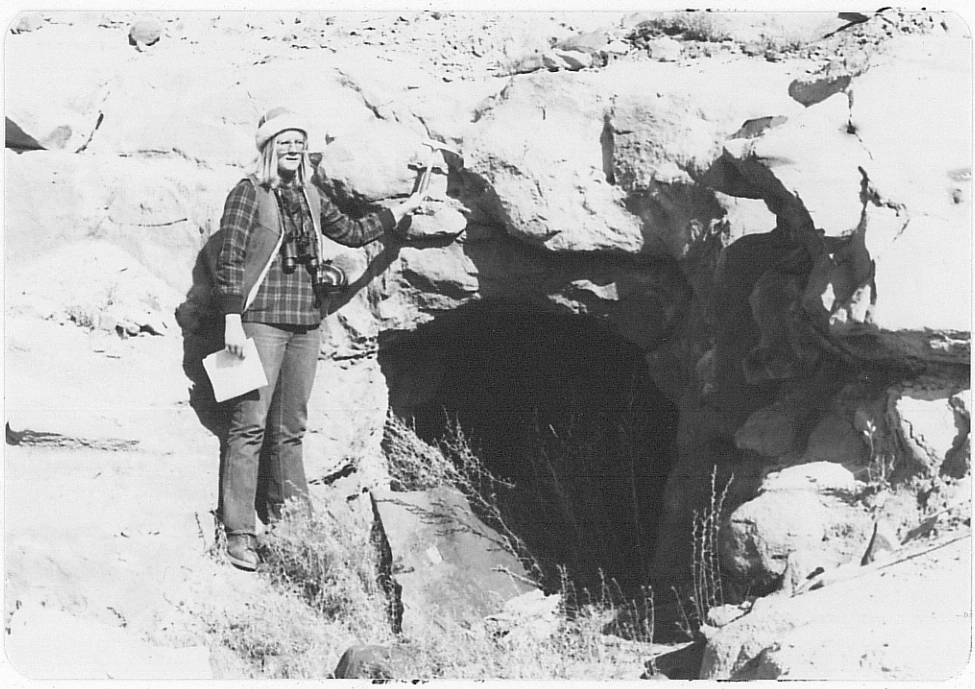
Photo (b) Dennet Nezz claims, looking east; close up of small adit shown in (a).

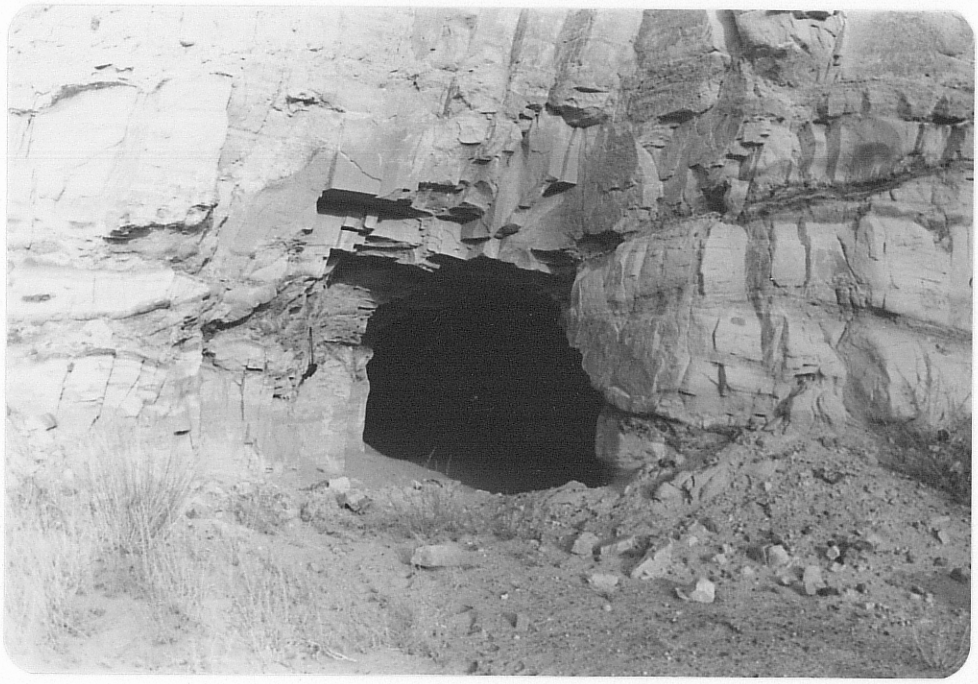
Photo (c) Looking eastward into 7'x 9' portal of Sec. 8 adit; note field glasses hanging at left of portal for scale.

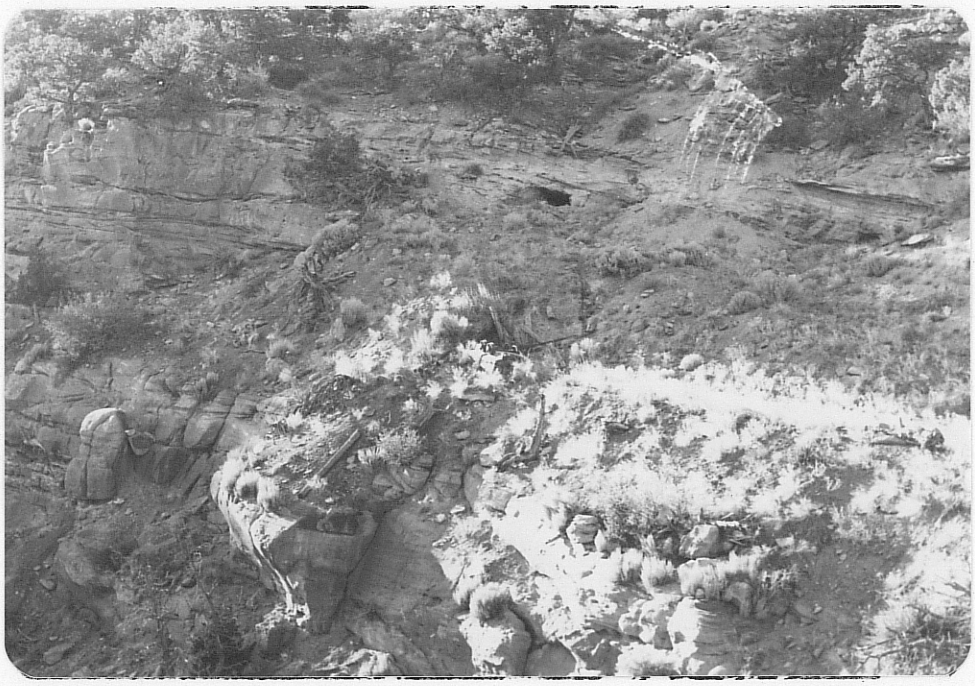
Photo (a) Key and Tohe Mine, looking N NW at the adit (arrow) blocked from view by tailings dump; flanking it are a powder magazine, left, and a short adit, right.

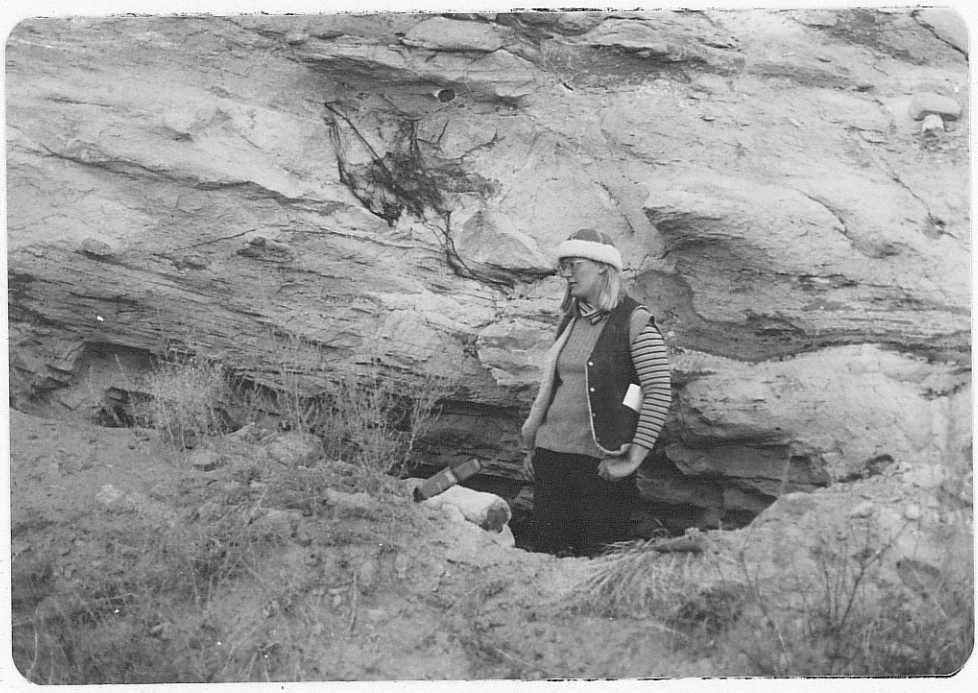
Photo (b) Key and Tohe adit, close up; face caving has nearly blocked adit entrance.

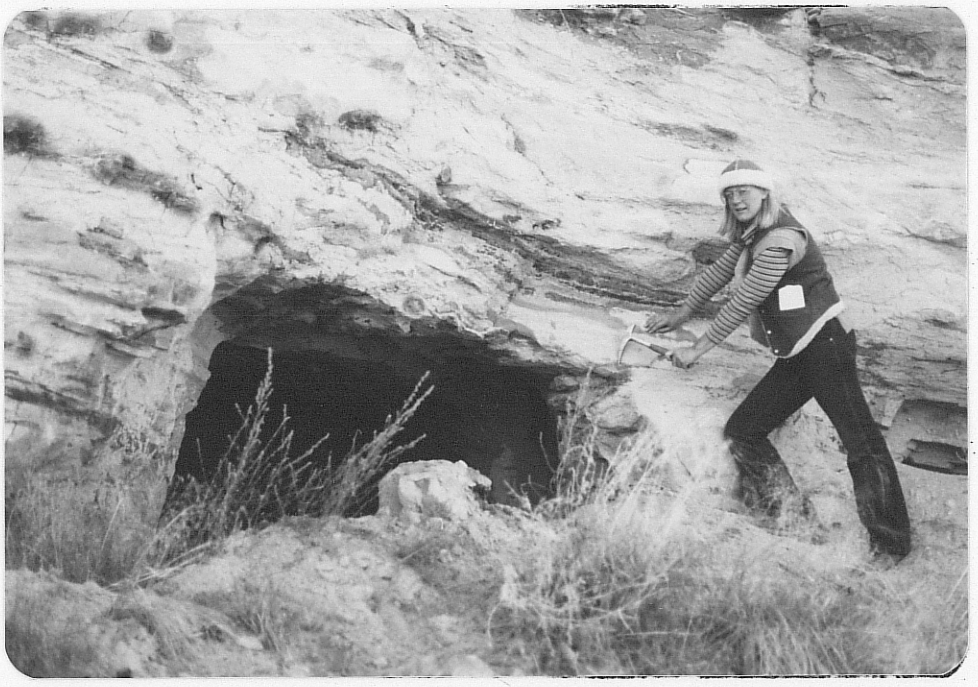
Photo (c) Key and Tohe workings; powder magazine to left of main adit.

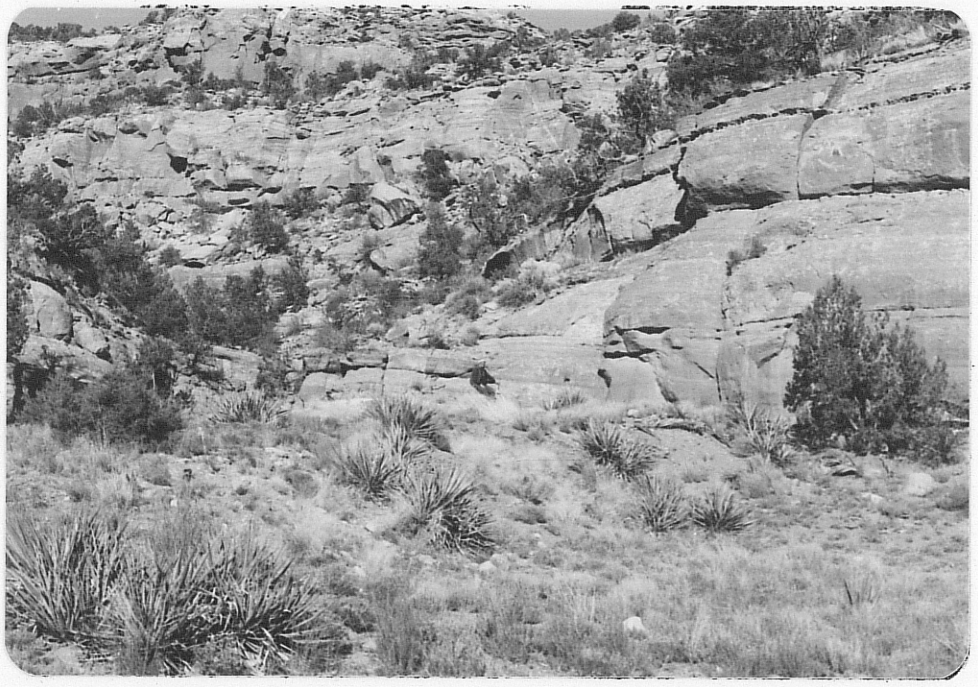
Photo (a) Looking E, at the Joe Ben #1 prospect on south side of small canyon.

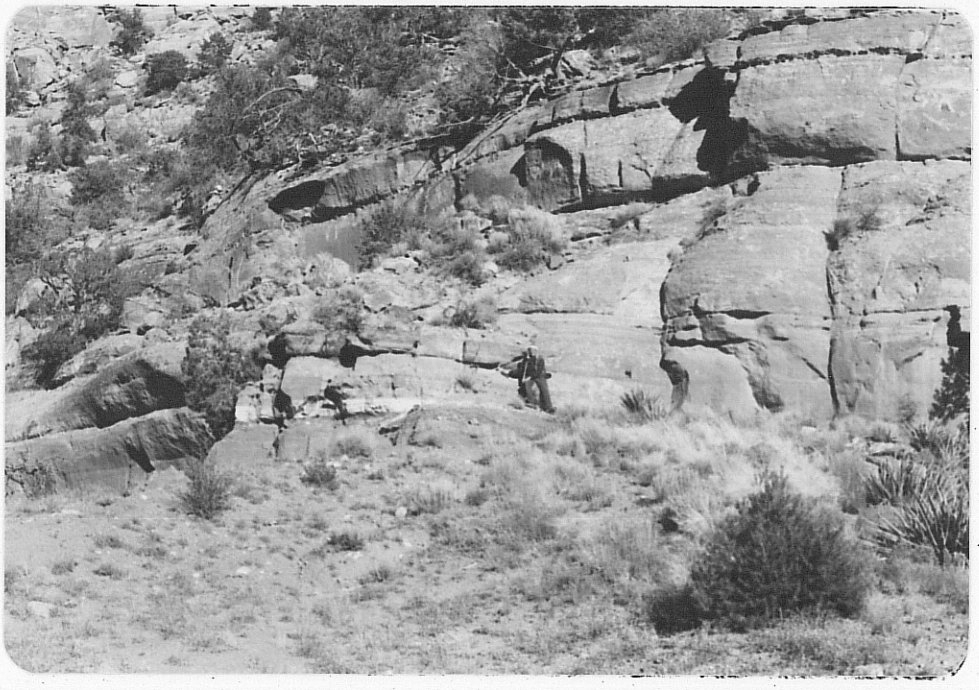
The anomalous readings of up to 230 cps (or 4 x background)were found just below a pronounced bedding plane in massive, medium to fine grained, red to brownish red sandstone (see again photo b). No uranium mineralization was noted.

Photo (b) Close up of view shown in photo (a); person in photo is pointing to parting having radiometric anomaly.

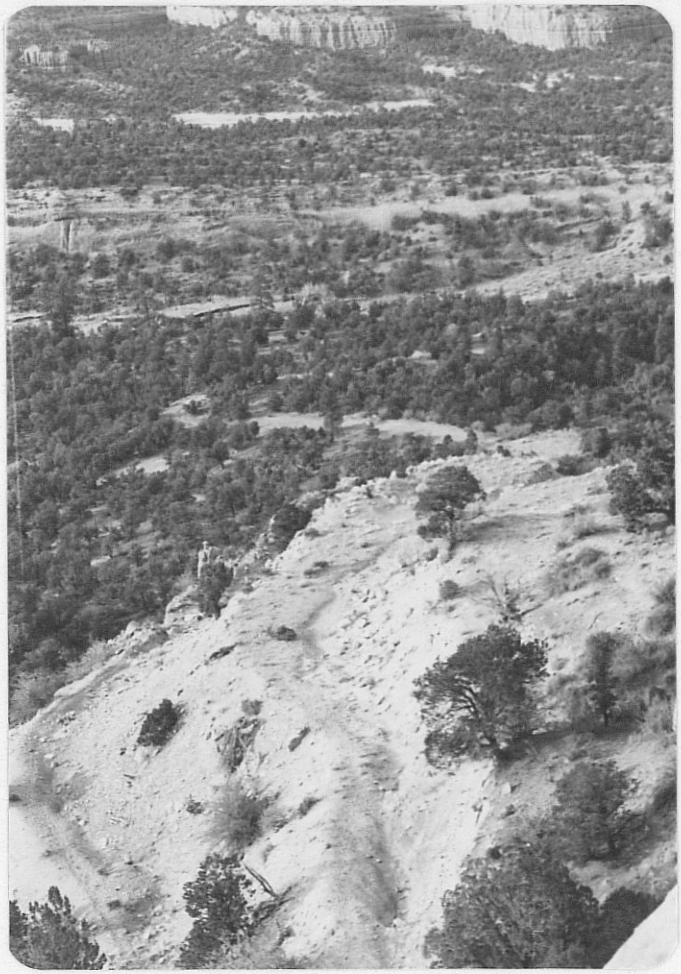
Photo (a) Joe Ben #3 rim cut; looking N from cliff top.

Photo (b) Joe Ben #3 rim cut; looking S. Note numerous shale (mudstone) beds at this locality.

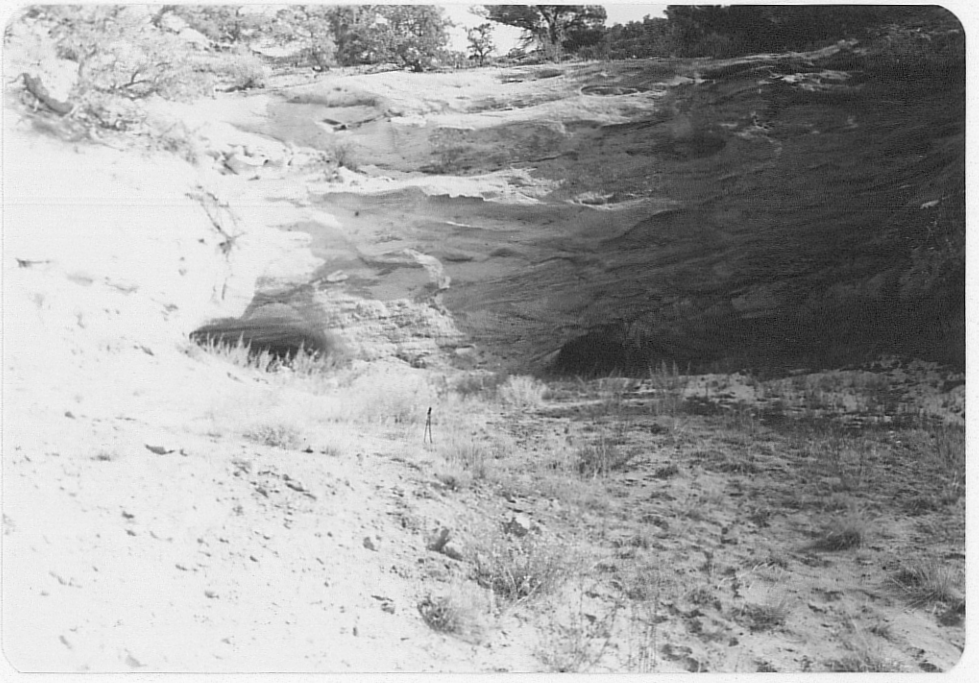
Photo (a) Carl Yazzie #1; looking SE. Note person in front of right adit for scale. Small tailings dump lies off to the right.

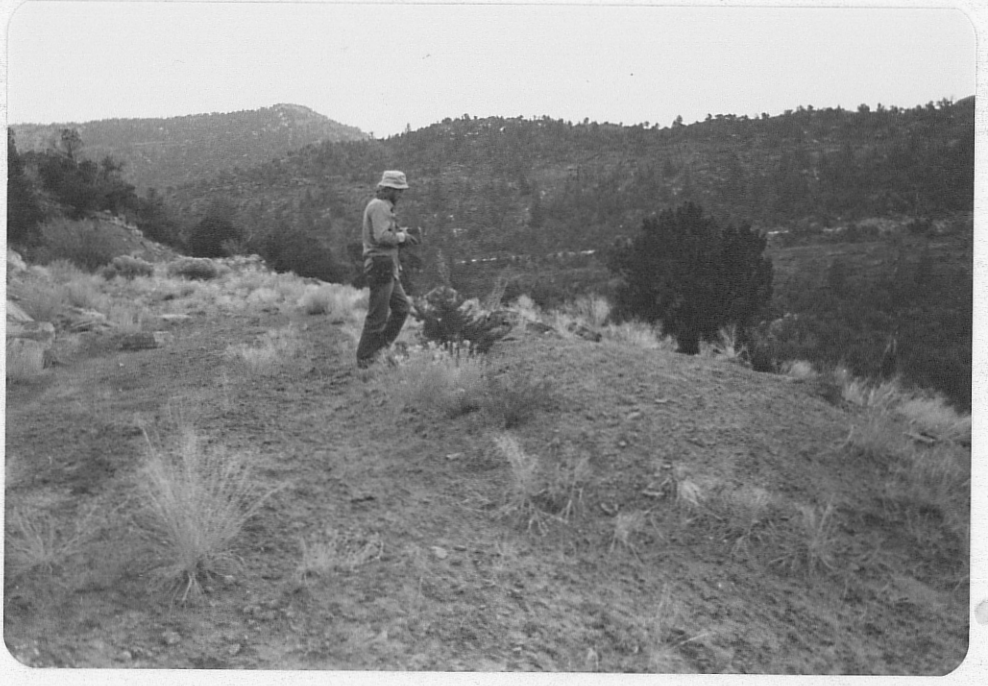
Photo (b) H.B. Roy #2, looking SW at ore stockpile/dump area.

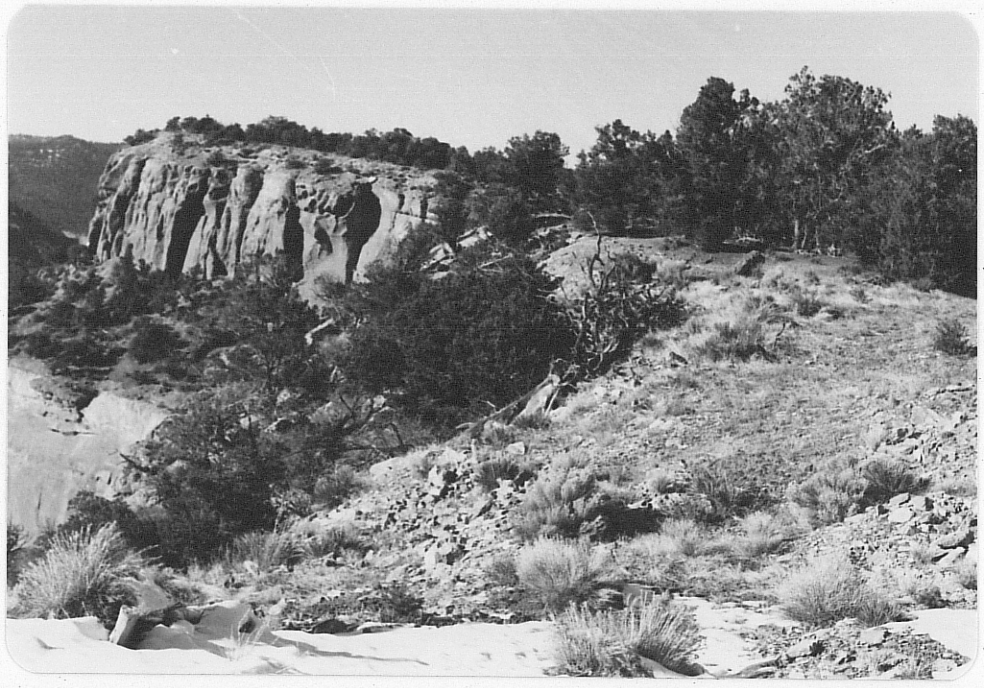
Photo (a) Looking N, at Reed Henderson claim workings; disturbed area in foreground measures about 70' in length, up to 30' wide. Site has largely revegetated itself.

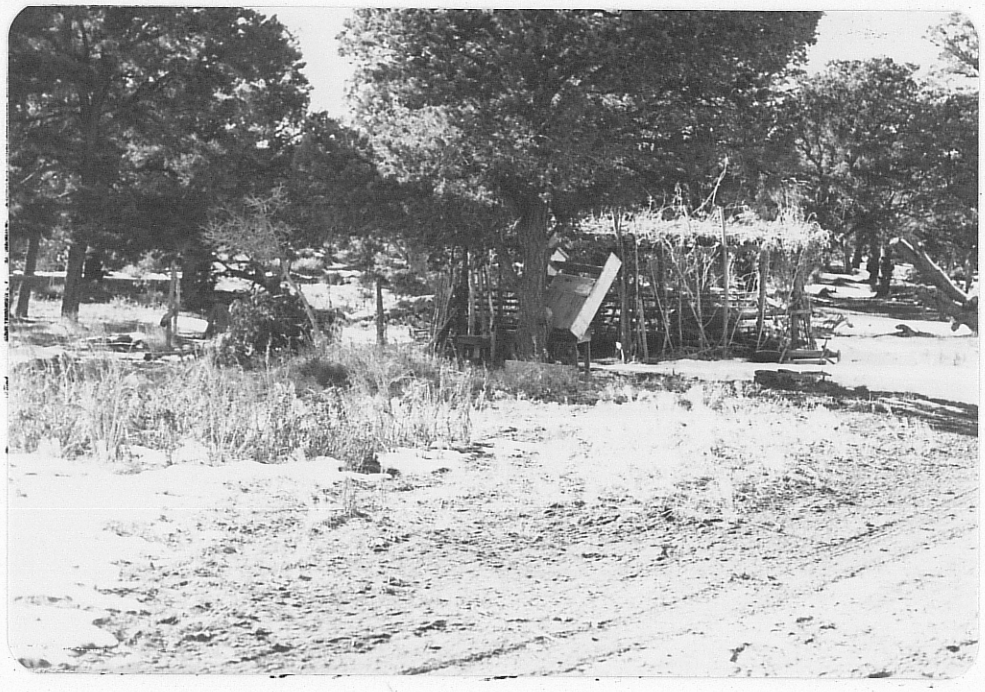
Photo (d) Navajo pinon nut collecting camp several hundred feet from Reed Henderson workings.

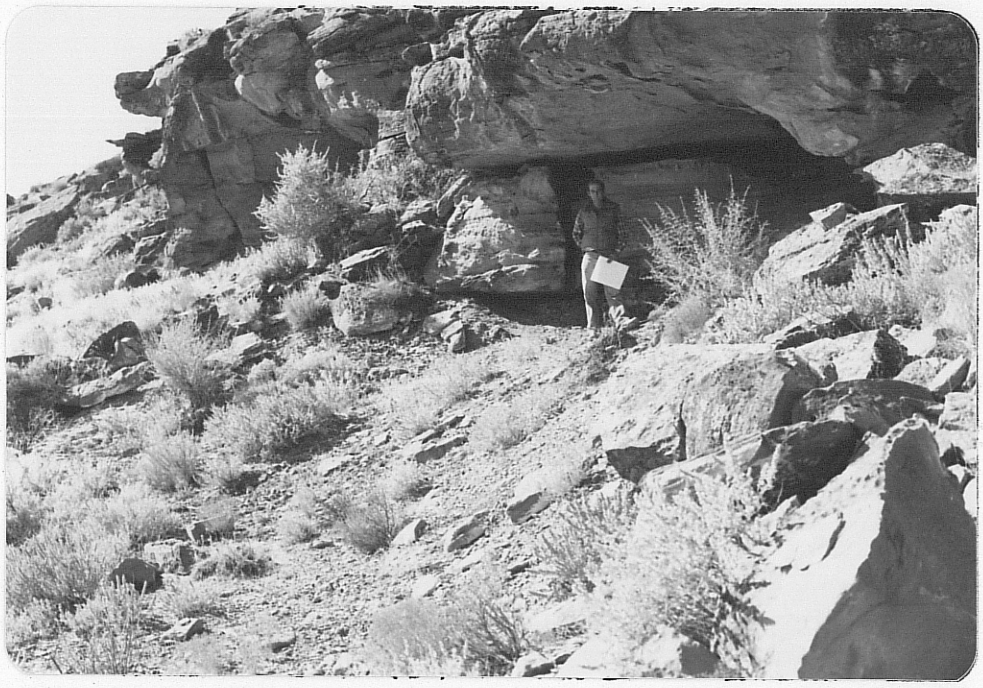
Photo (a) Looking SW at prospect pit, east end of claim no. 10 of Boyd Claims. Person in photo is standing near base of ore zone.

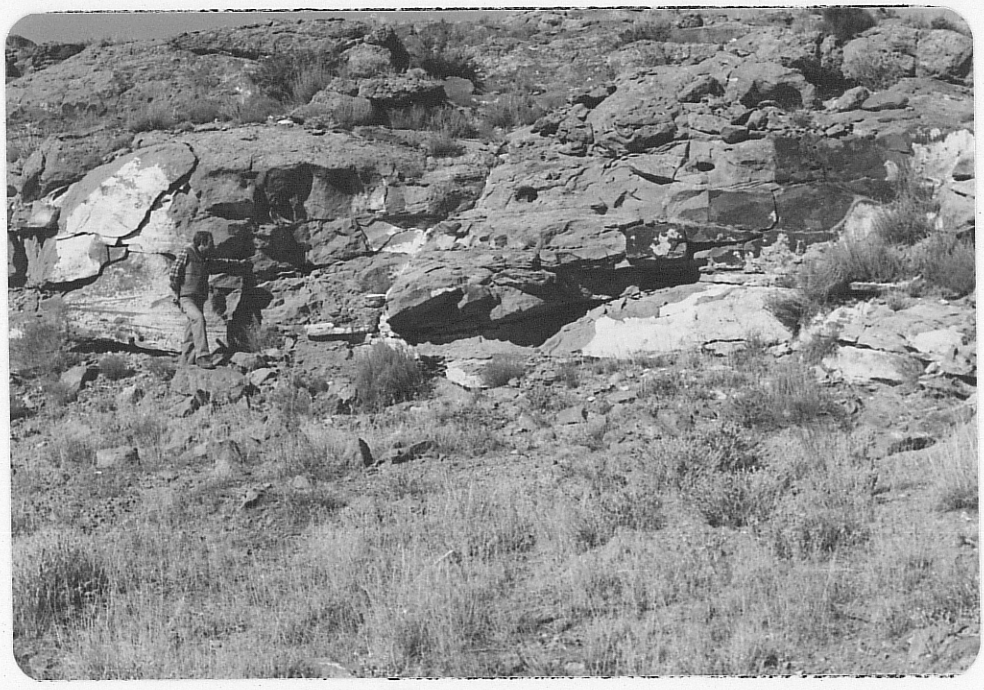
Photo (d) Small prospect pit in southern portion claim no. 5, showing evidence of blasting.
