2020 4th Quarter Groundwater Monitoring Report
Chevron Isleta Site
3401 Isleta Boulevard
Albuquerque, New Mexico
Bernalillo County

NMED PSTB Facility No. 30681
NMED PSTB RID No. 314
NMED PSTB Deliverable ID No. 4135-3

January 21, 2021

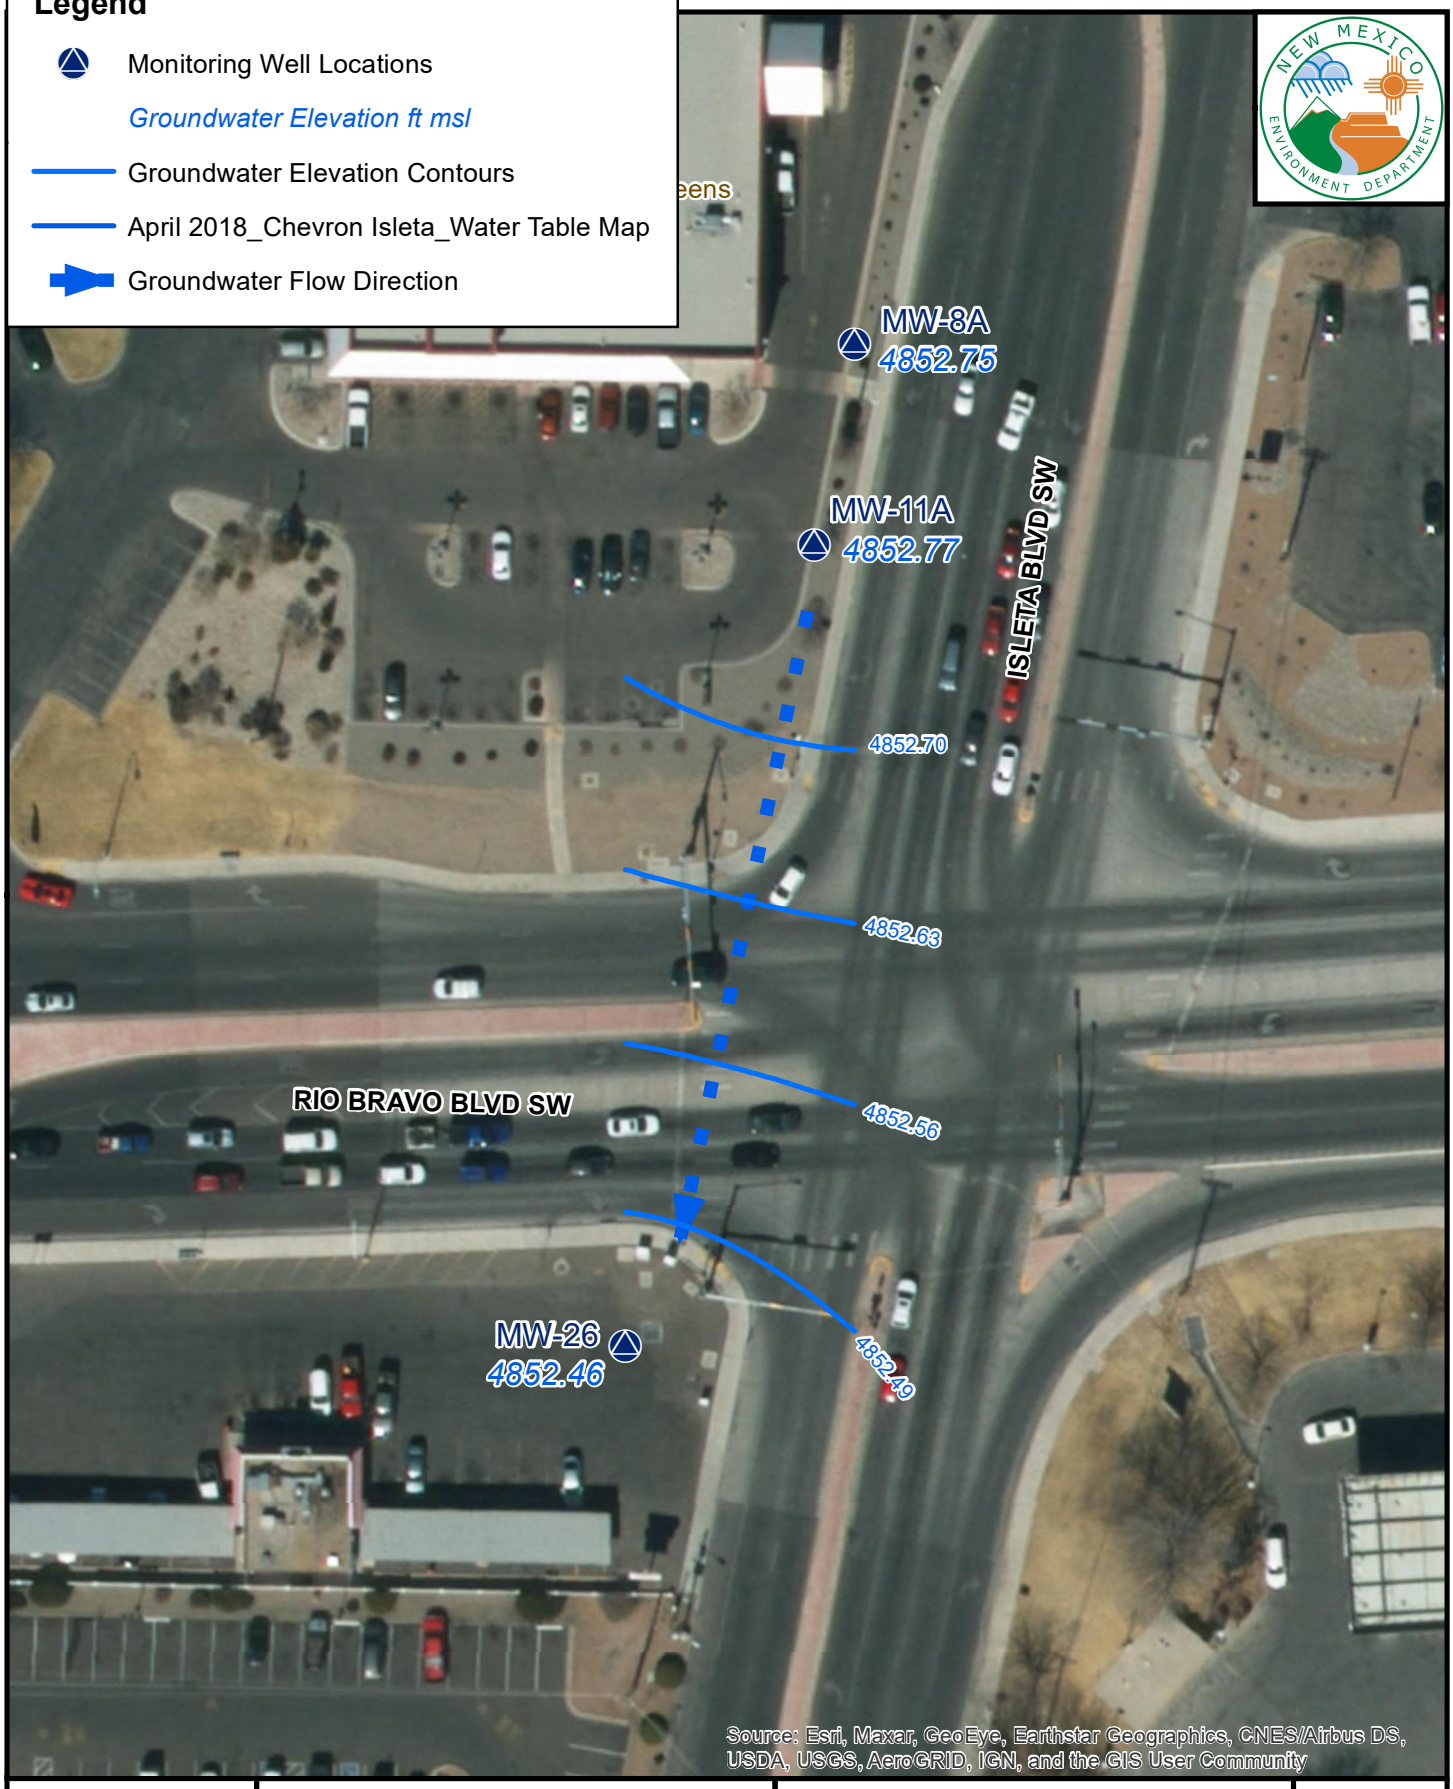
FIGURE 3

On December 28, 2020, prior to monitor well purging and sampling, fluid levels and total depths were measured in each monitor well with an electronic oil/water interface probe. Monitor wells were gauged in order of increasing contamination (MW-26, MW-11A, and MW-8A) to minimize the potential of cross contamination and the interface probe was decontaminated prior to each use. During this event, groundwater elevations declined by an average of 0.16 ft and were within their historic fluctuation range. Groundwater flowed at an approximate gradient of 0.0009 feet per foot (ft/ft) (see calculation below) to the south (Figure 3), relatively consistent with historic conditions. Historic fluid level data are summarized in Table 1.

On December 28, 2020 water levels were within their historic fluctuation range.

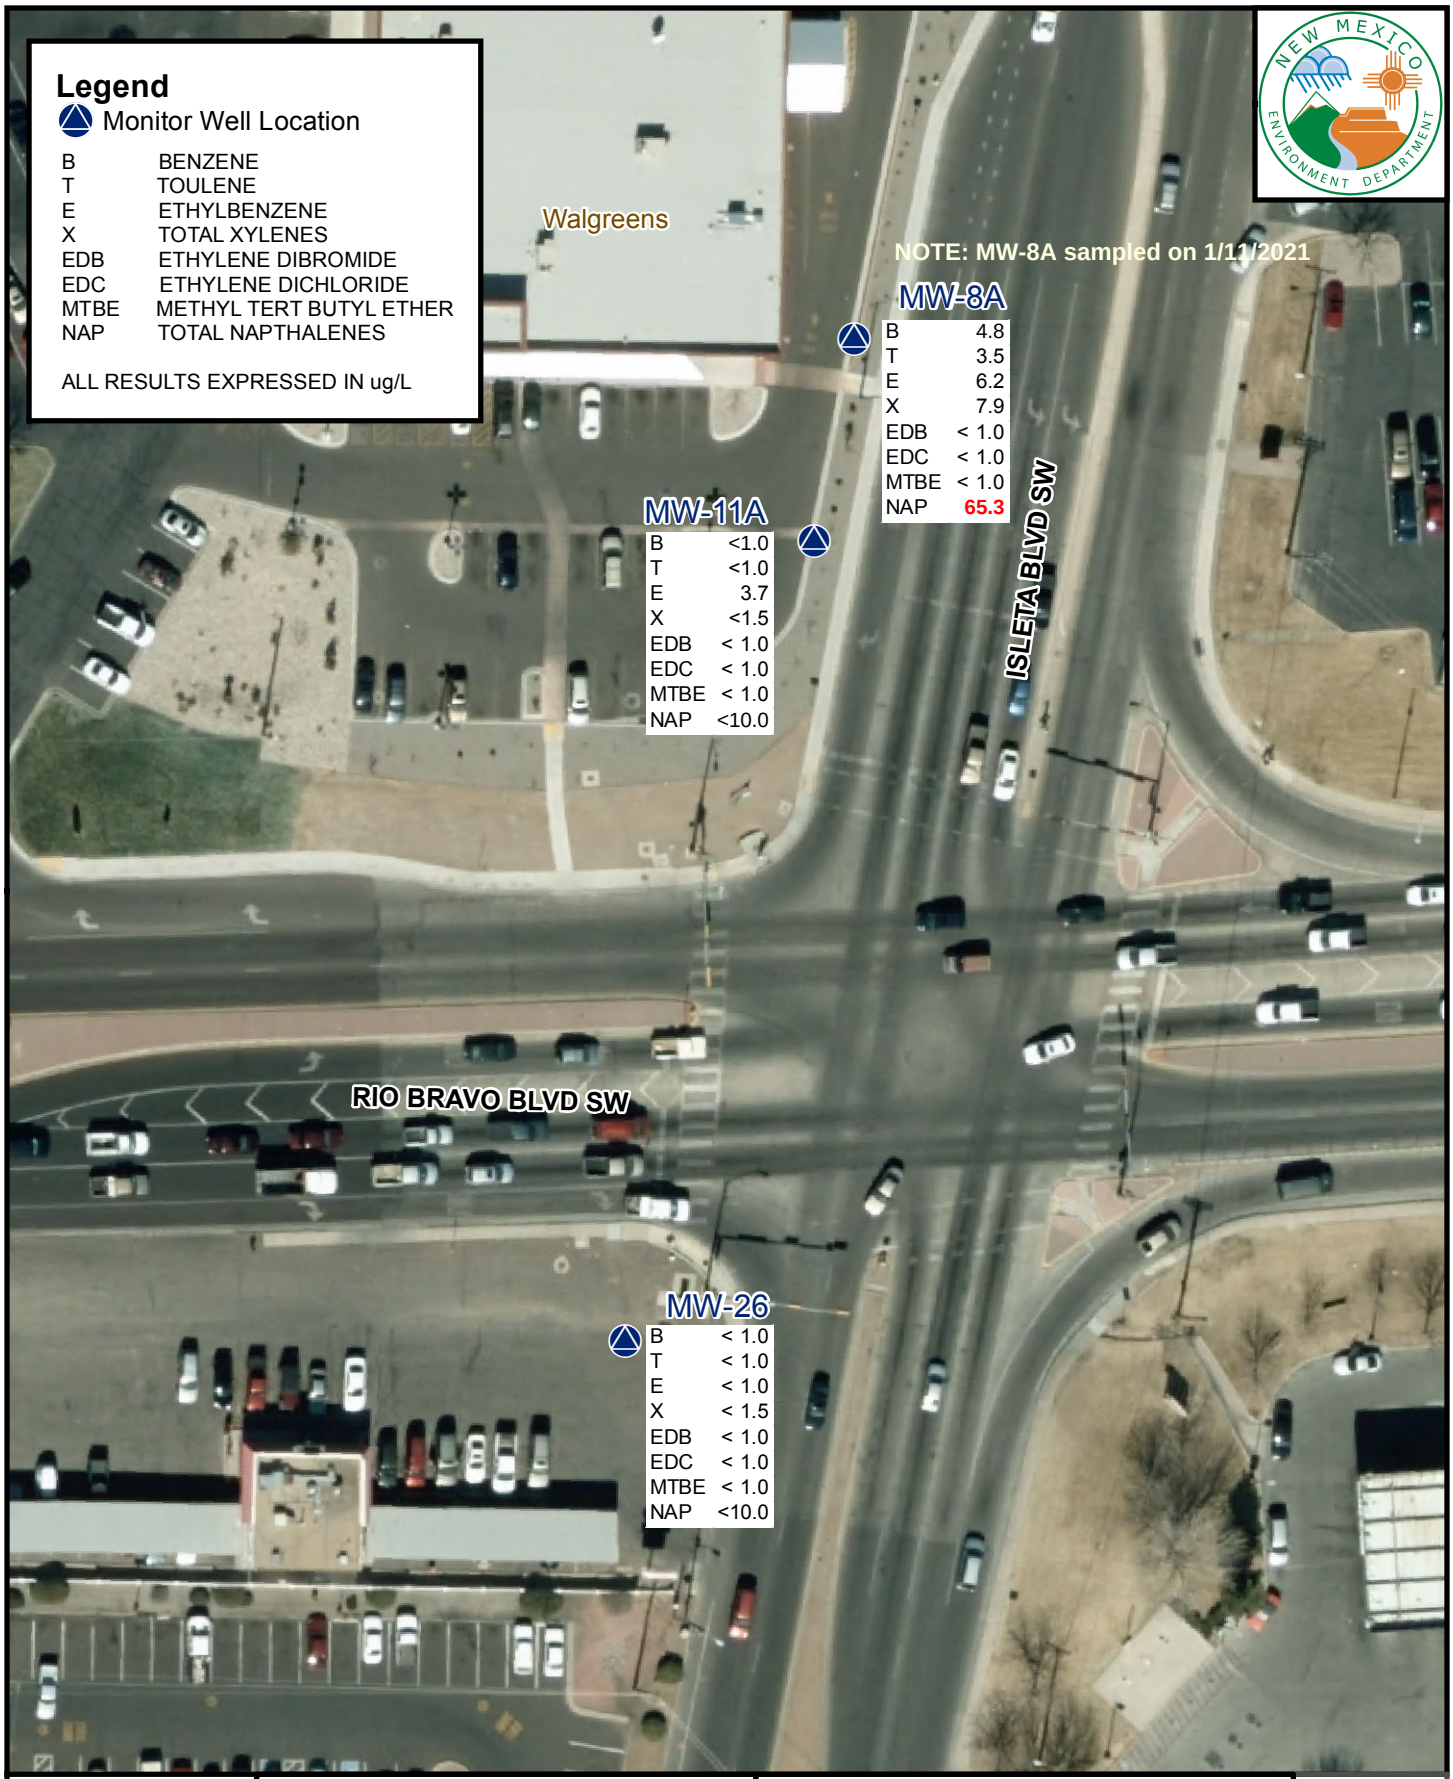
FIGURE 4
Sample Date 12/28/2020

MW-8A – Dissolved benzene was not detected above the NMWQCC groundwater standard (5 µg/L) at a concentration of 4.8 µg/L during the resampling event performed on January 11, 2021. The dissolved benzene concentration was greater than the previous sampling event (October 2020) of 1.2 µg/L. Total naphthalenes were detected above the NMWQCC groundwater standard (30 µg/L) at a concentration of 65.3 µg/L. The total naphthalenes concentration was greater than the previous sampling event (October 2020) of <10.0 µg/L. Dissolved toluene, ethylbenzene, and xylenes (BTEX) constituents in monitor well MW-8A were all below their respective NMWQCC standards.

MW-11A – Dissolved BTEX constituents in monitor well in MW-11A were all below their respective NMWQCC groundwater standards. Total naphthalenes were not detected during the December 28, 2020 event.

MW-26 – Dissolved organic contaminants were not detected at monitor well MW-26 and have not been detected at MW-26 since at least October 1999 (Table 2).

Injection of BTEX BOS 200® in March 2019 was effective at lowering petroleum constituents in groundwater below to below their respective NMWQCC groundwater standards. Dissolved total naphthalene concentrations in monitor wells MW-8A and MW-11 have declined and remained below the NMWQCC Standard for three quarters of sampling, however, dissolved benzene and total naphthalenes have rebounded during this event and now exceed the NMWQCC standard once again. A summary of results for the groundwater samples collected from monitor wells MW-8A and MW-11A are shown on Figure 4.

Groundwater elevations in December 2020 have declined by an average of approximately 0.22 ft since the October 6, 2020 sampling event and are within their historical fluctuation range (Table 1). Total naphthalenes in MW-8A rebounded to above the NMWQCC groundwater standard with a concentration of 65.3 µg/L. Total naphthalenes concentrations in monitor well MW-8A had been below the NMWQCC groundwater standard of 30 µg/L for two consecutive quarters but rebounded during the January 2020 sampling event to above the NMWQCC standard (Table 2 and Graphs 1 and 2). No other petroleum constituents exceeded NMWQCC groundwater standards in any of three montioirng wells during the October 6, 2020 quarterly sampling event. Continued future quarterly groundwater sampling is recommended at the Site to verify that petroleum concentrations remain below groundwater standards. Should the groundwater concentrations remain below NMWQCC groundwater standards, No Further Action in accordance with Petroleum Storage Tank Regulations 20.5.119.1930 should be recommended for the Site.
