August 2015

2015 3rd Quarter Groundwater Monitoring Report:

Chevron Isleta Site
3401 Isleta Boulevard
Albuquerque, New Mexico
Bernalillo County

NMED PSTB Facility No. 30681

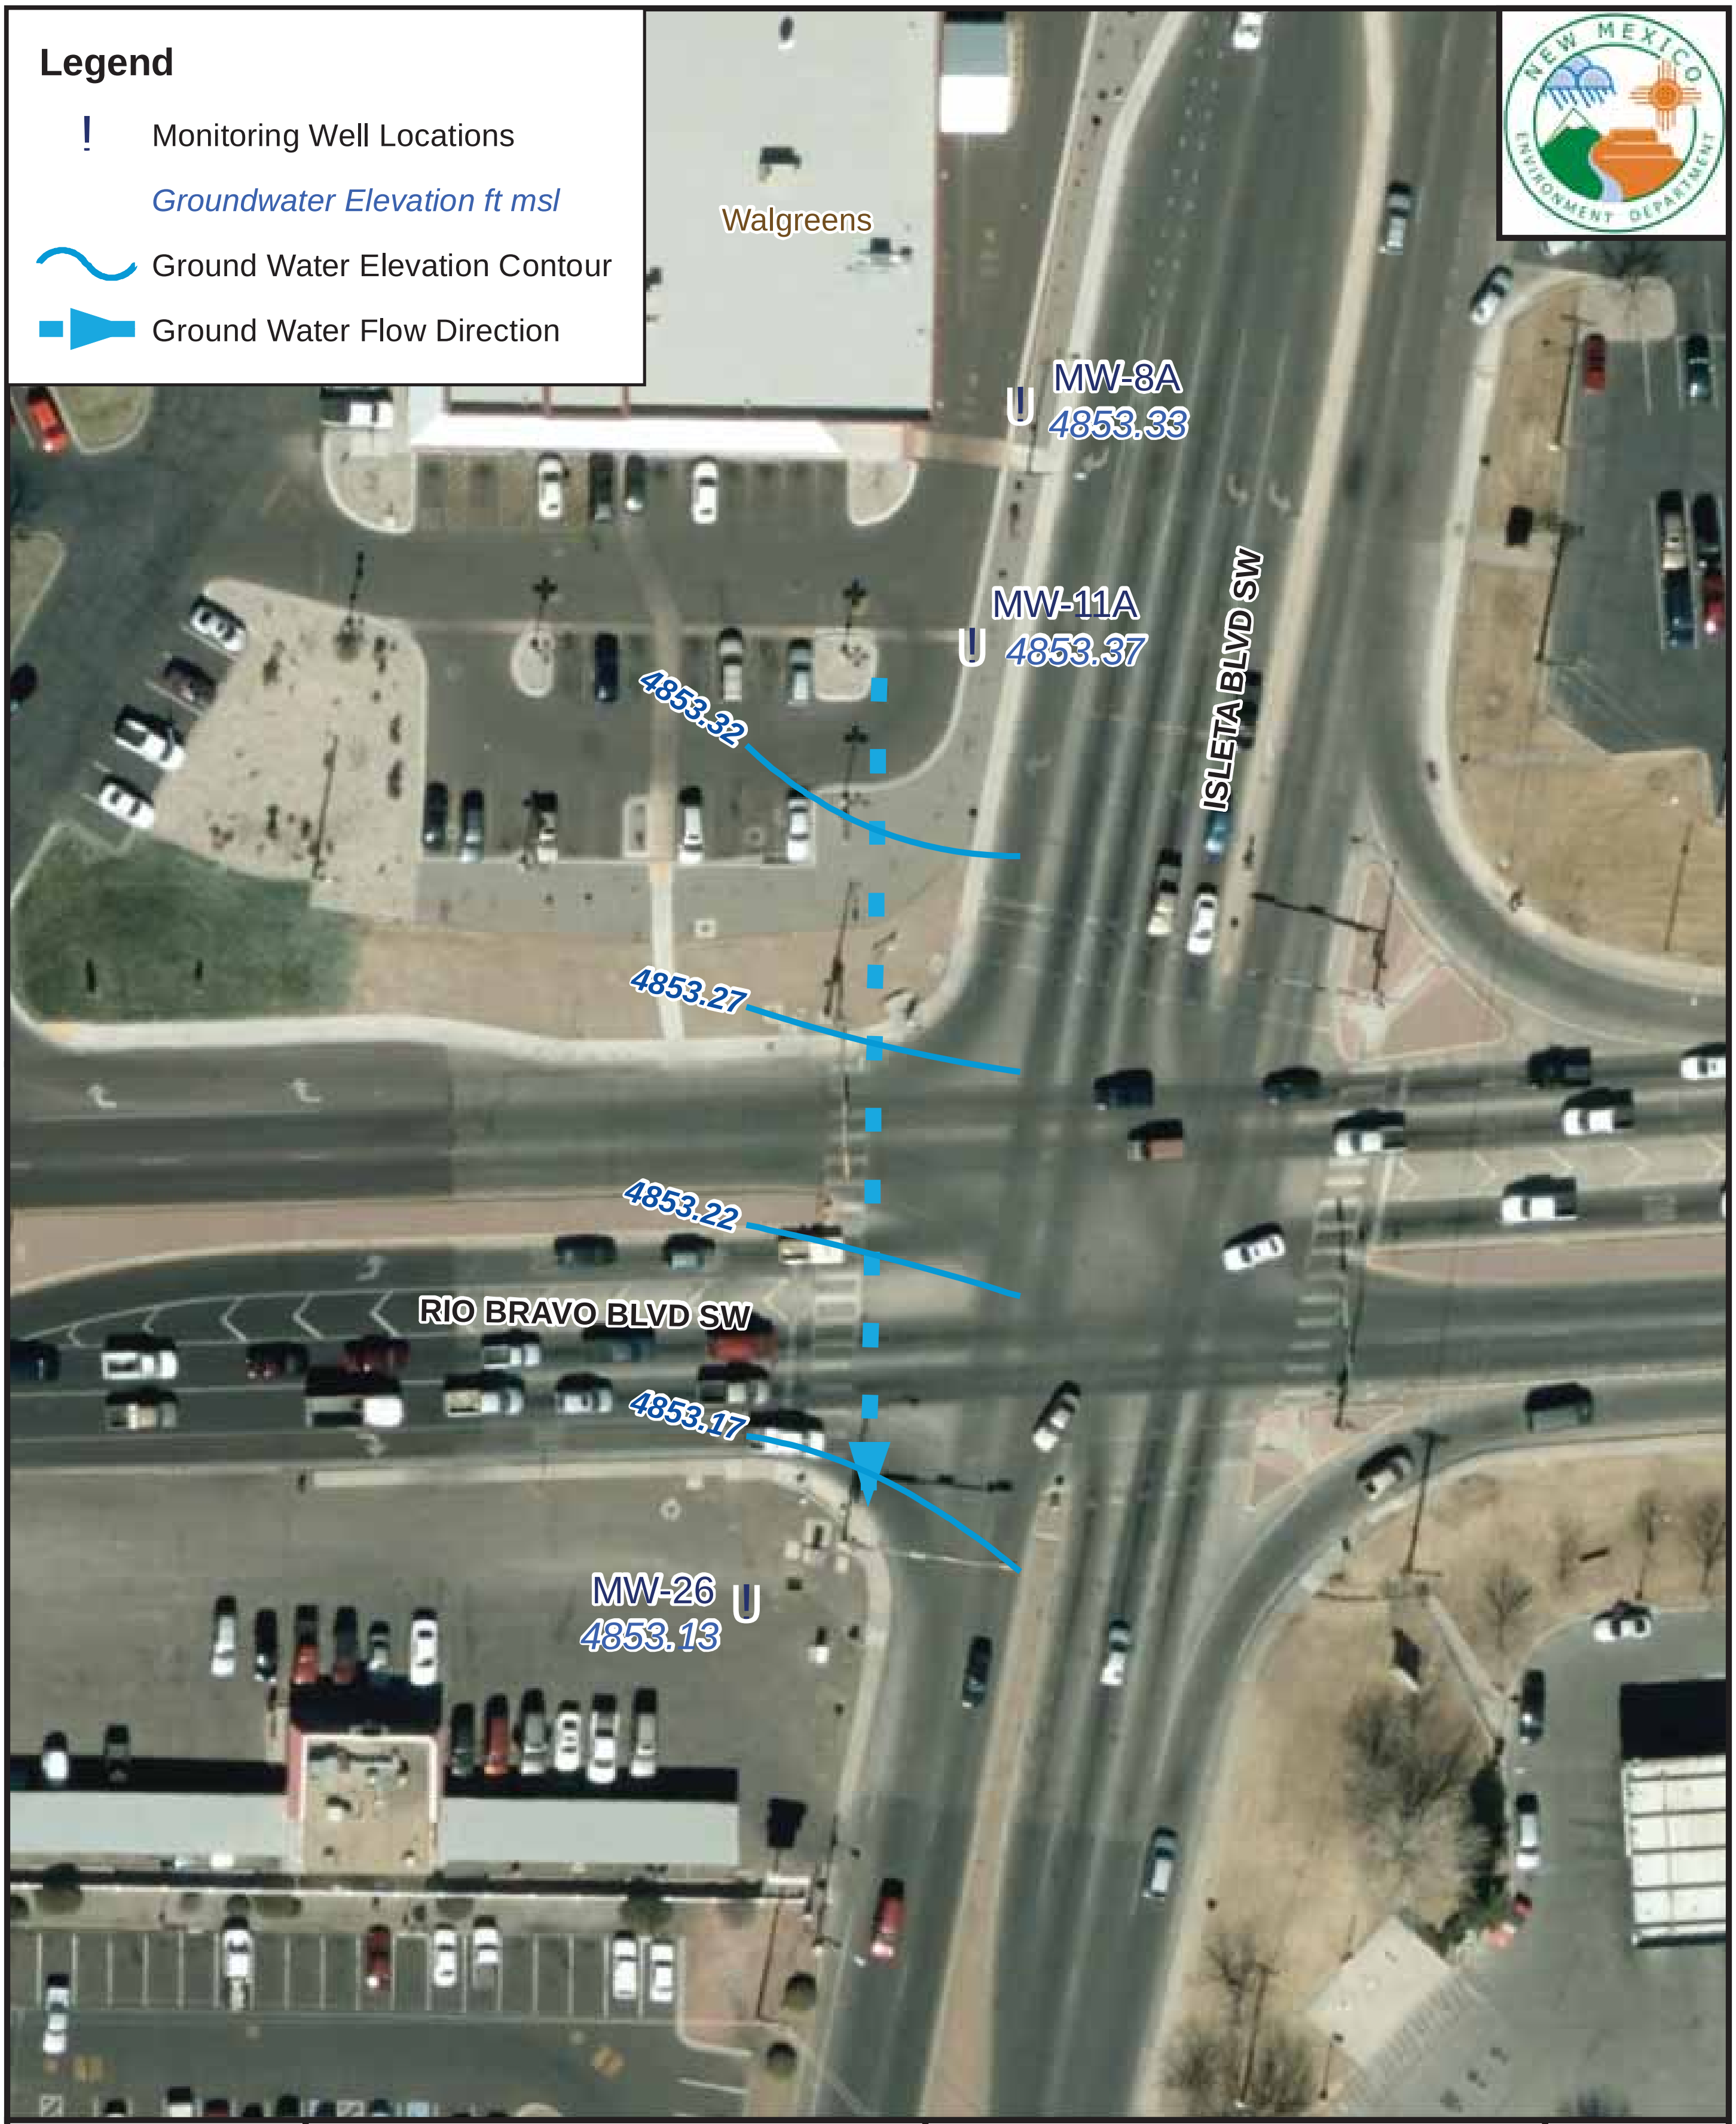
FIGURE 3
8/13/2015

On July 20, 2015, prior to monitor well purging and sampling, fluid levels and total depths were measured in each well with an electronic oil/water interface probe. Monitor wells were gauged in order of increasing contamination to minimize cross contamination and the interface probe was decontaminated prior to each use. During this event, groundwater elevations rose by an average of 0.13 foot and groundwater flowed at an approximate gradient of 0.001 ft/ft to the south (Figure 3), consistent with historic conditions. Historic fluid level data are summarized in Table 1.

WATER TABLE MAP

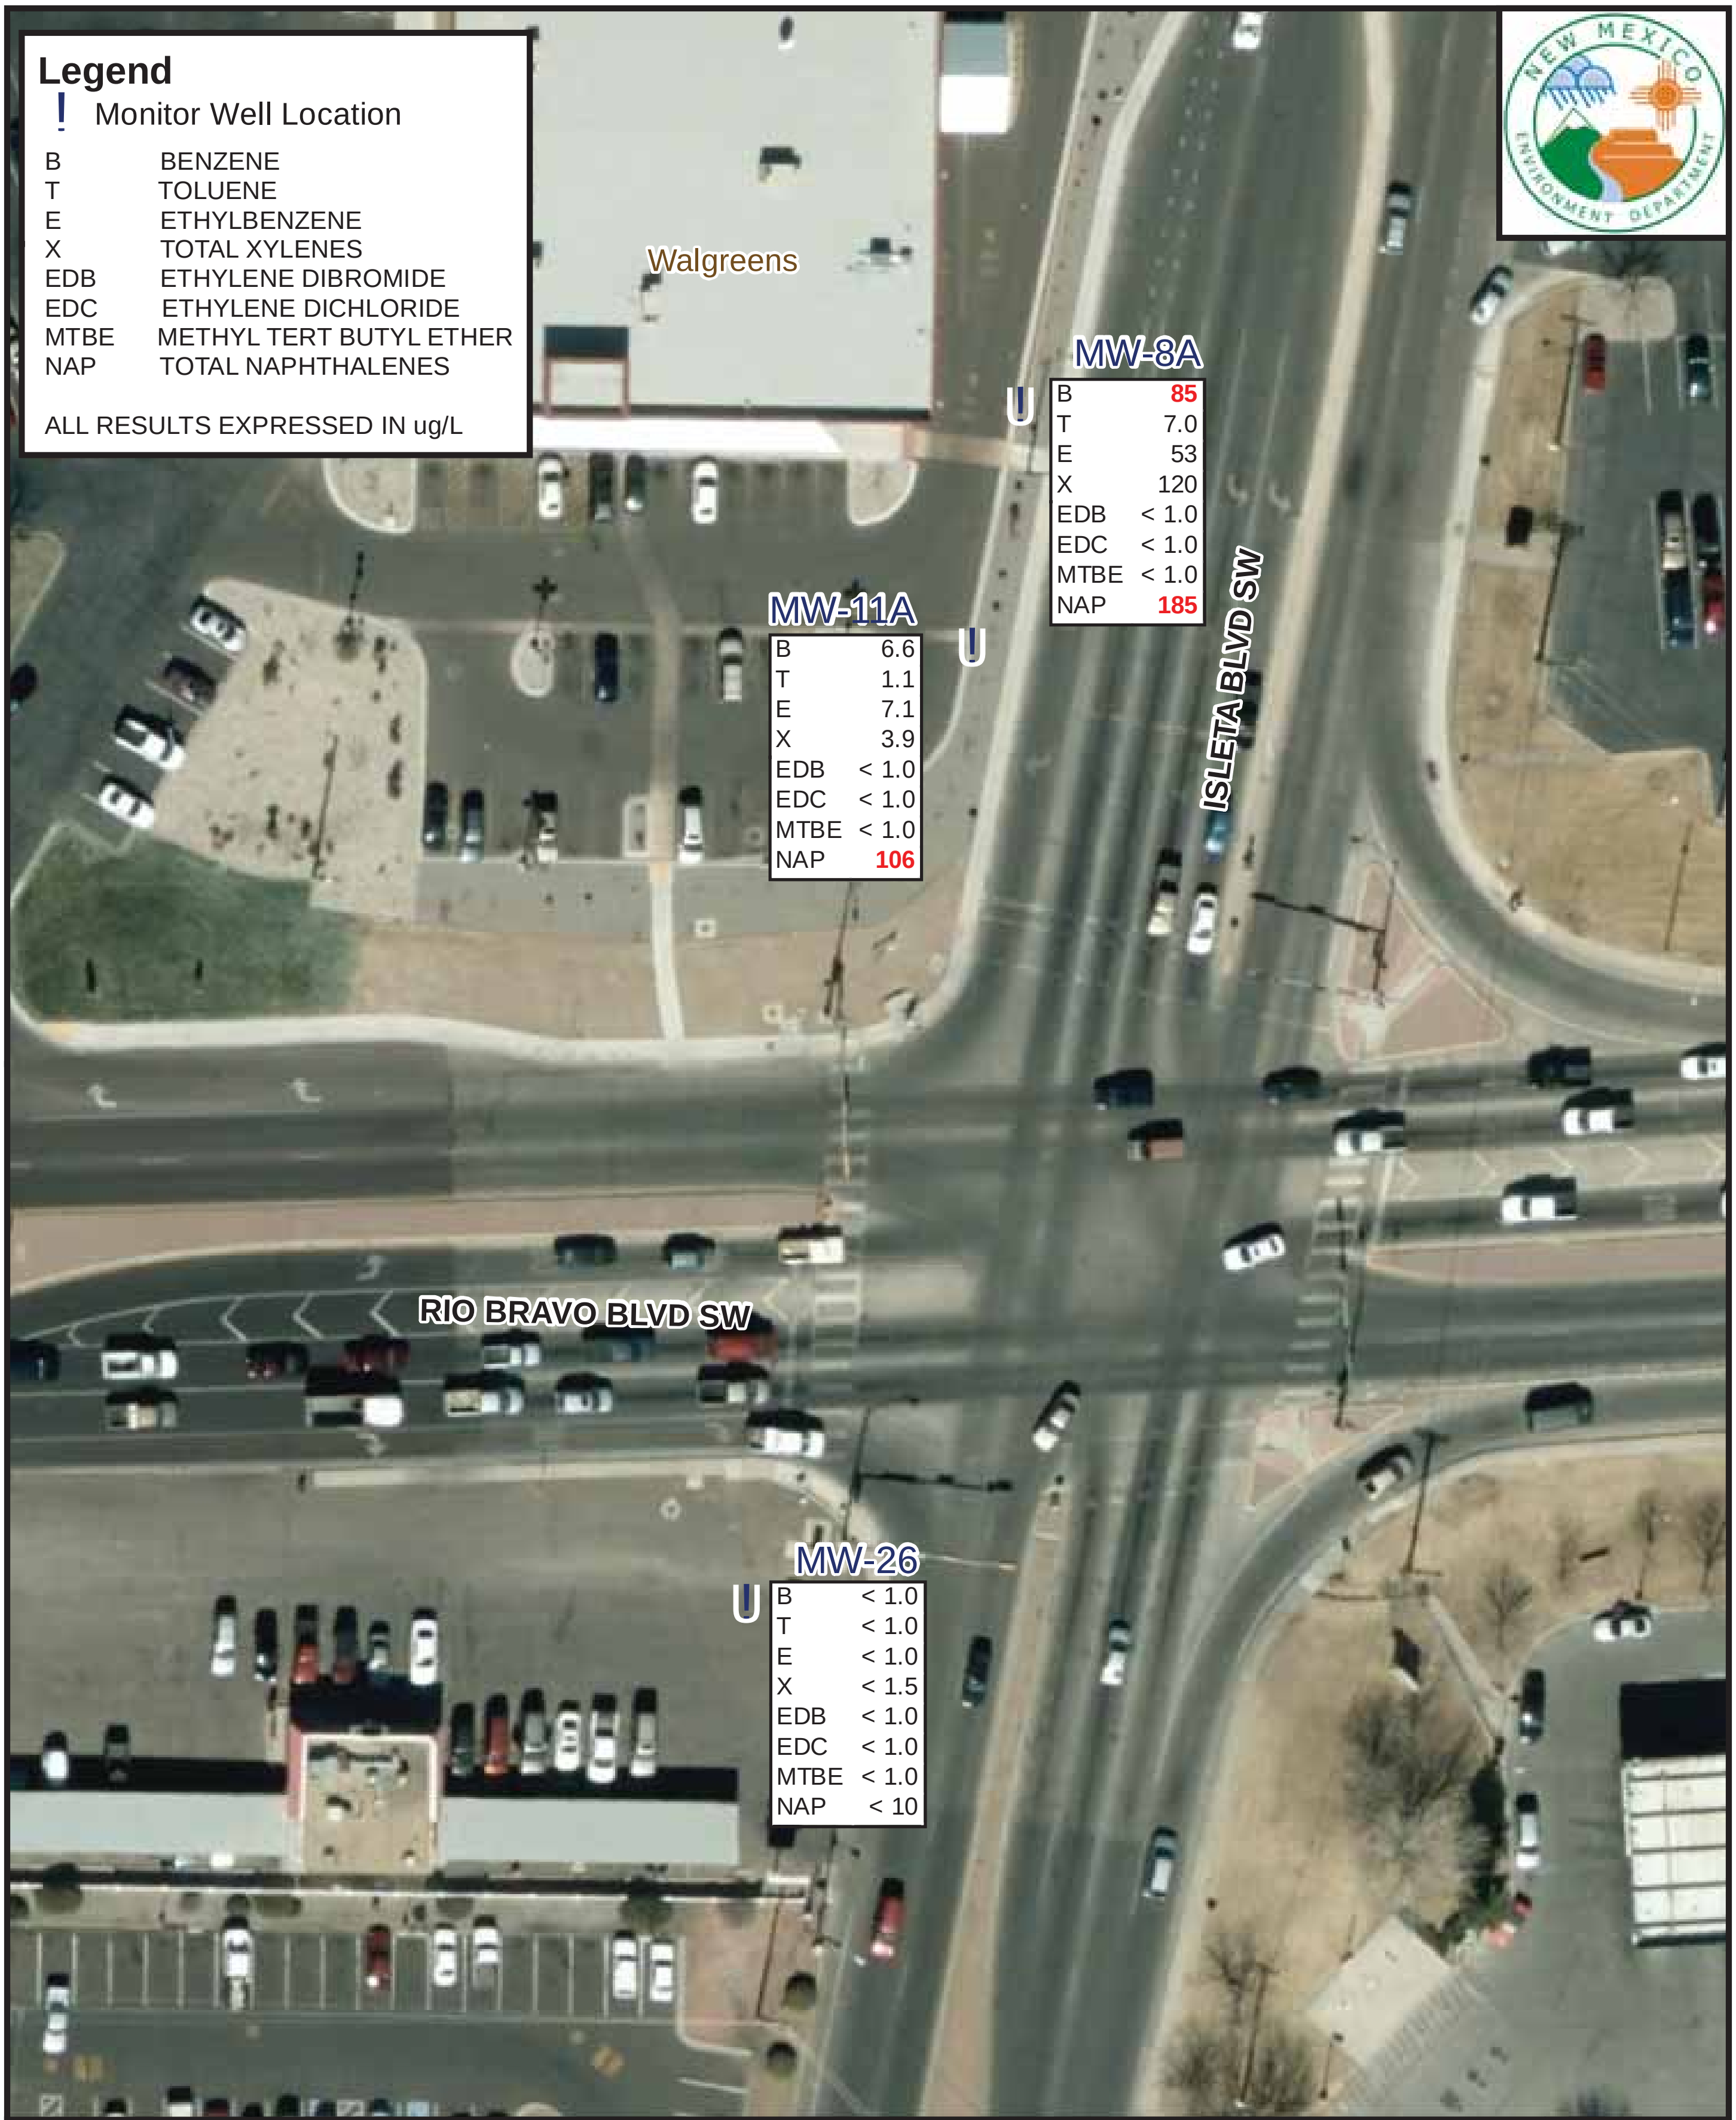
FIGURE 4
8/13/2015

On July 20, 2015, water levels were near their historic highs. Since April 2015, water levels have risen by an average of 0.50 foot (Table 1). Dissolved benzene and/or naphthalenes at monitor wells MW-8A and MW-11A continue to be the primary contaminants of concern at the site (Figure 4).

Ethylbenzene (53 µg/L), toluene (7.0 µg/L) and total xylenes (120 µg/L) were also detected, but at concentrations below their respective NMWQCC standards (Figure 4). All three contaminants of concern at MW-8A have exhibited a generally decreasing trend over time with intermittent periods of rebound, as observed during this sampling event.

DISSOLVED ORGANIC RESULTS
CHEVRON ISLETA
3401 ISLETA BOULEVARD SW
ALBUQUERQUE, NM

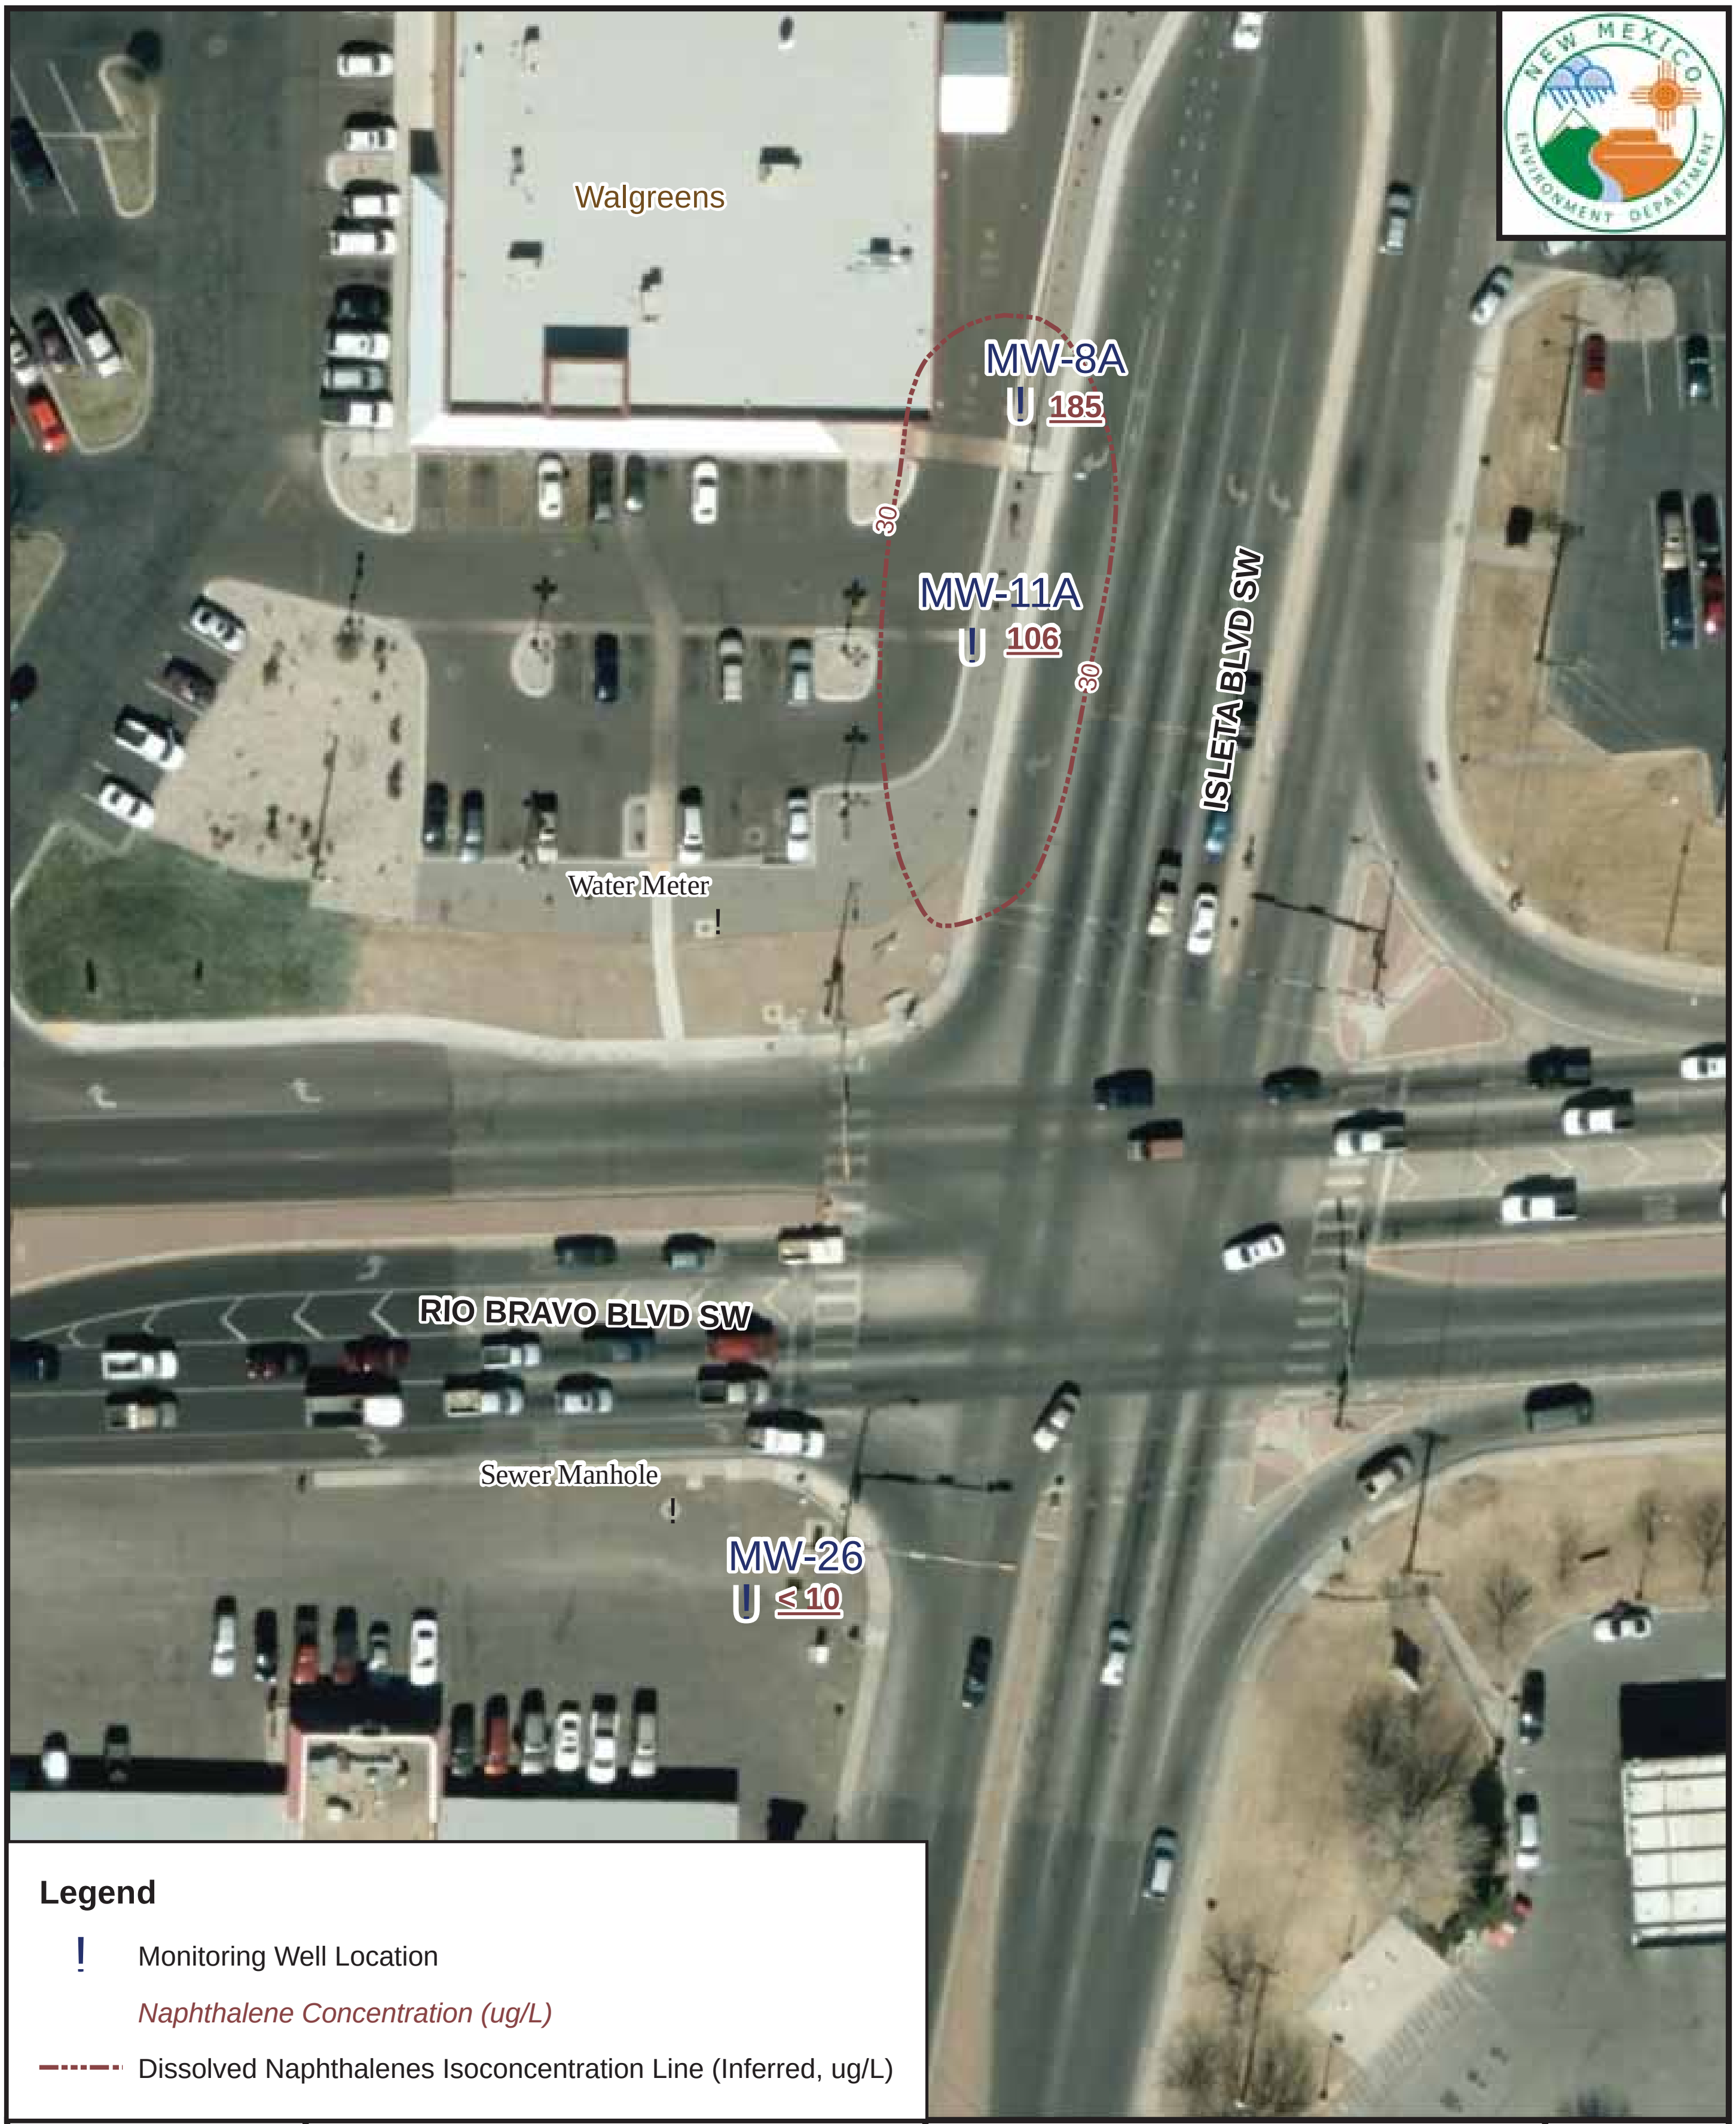
FIGURE 6
8/13/2015

Based on groundwater flow direction and laboratory data, the dissolved phase hydrocarbon plume of contamination appears to have migrated off-site underneath the southbound turn lane of Isleta Boulevard. Historical data, as well as data from this monitoring event, indicate that the plume is generally shrinking over time (Figures 5 and 6).

DISSOLVED NAPHTHALENES MAP
CHEVRON ISLETA
3401 ISLETA BOULEVARD SW
ALBUQUERQUE, NM

Therefore, based on the data and observations found in this report and correspondence with NMED-PSTB personnel, AECOM recommends continued quarterly monitoring of natural attenuation at the site. Remedial action is not recommended.

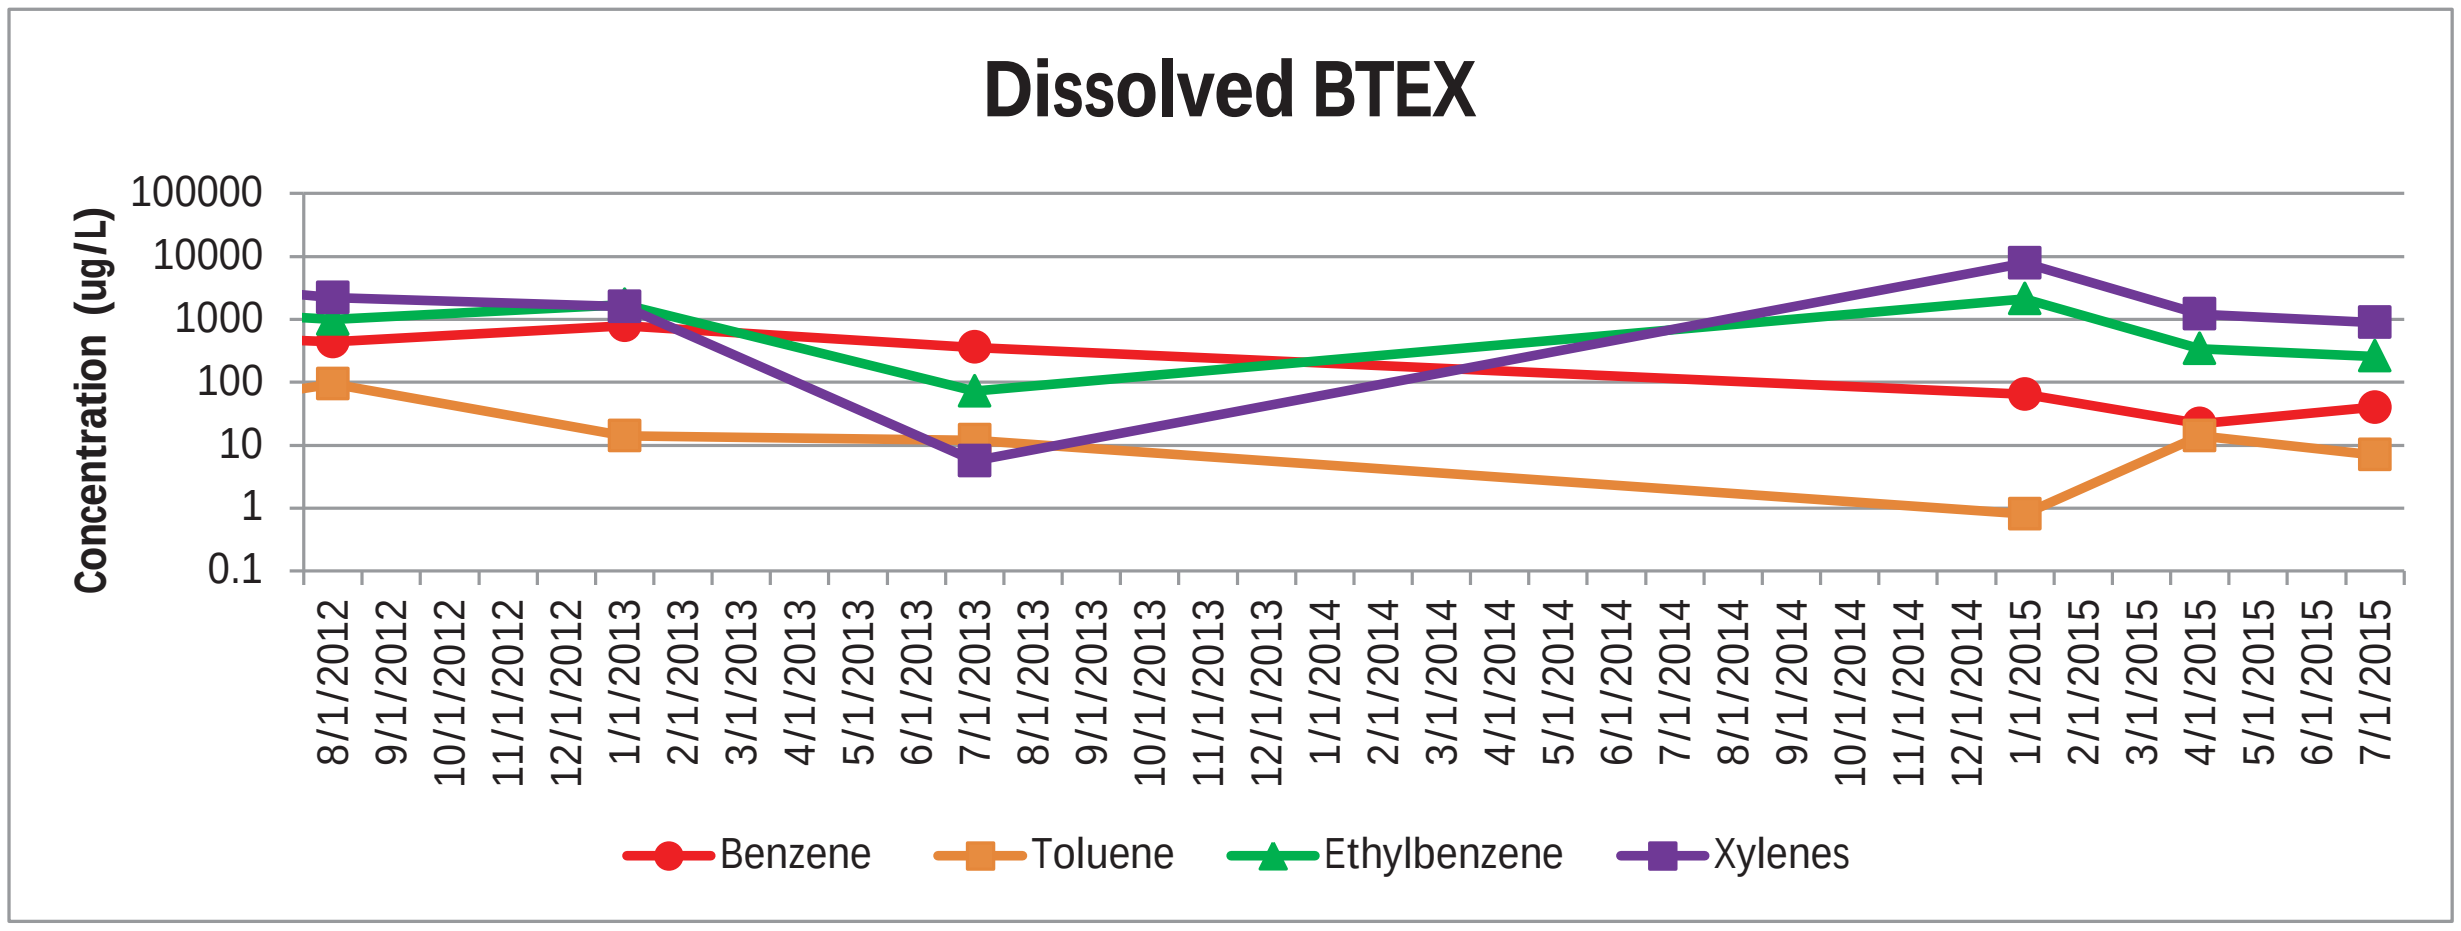
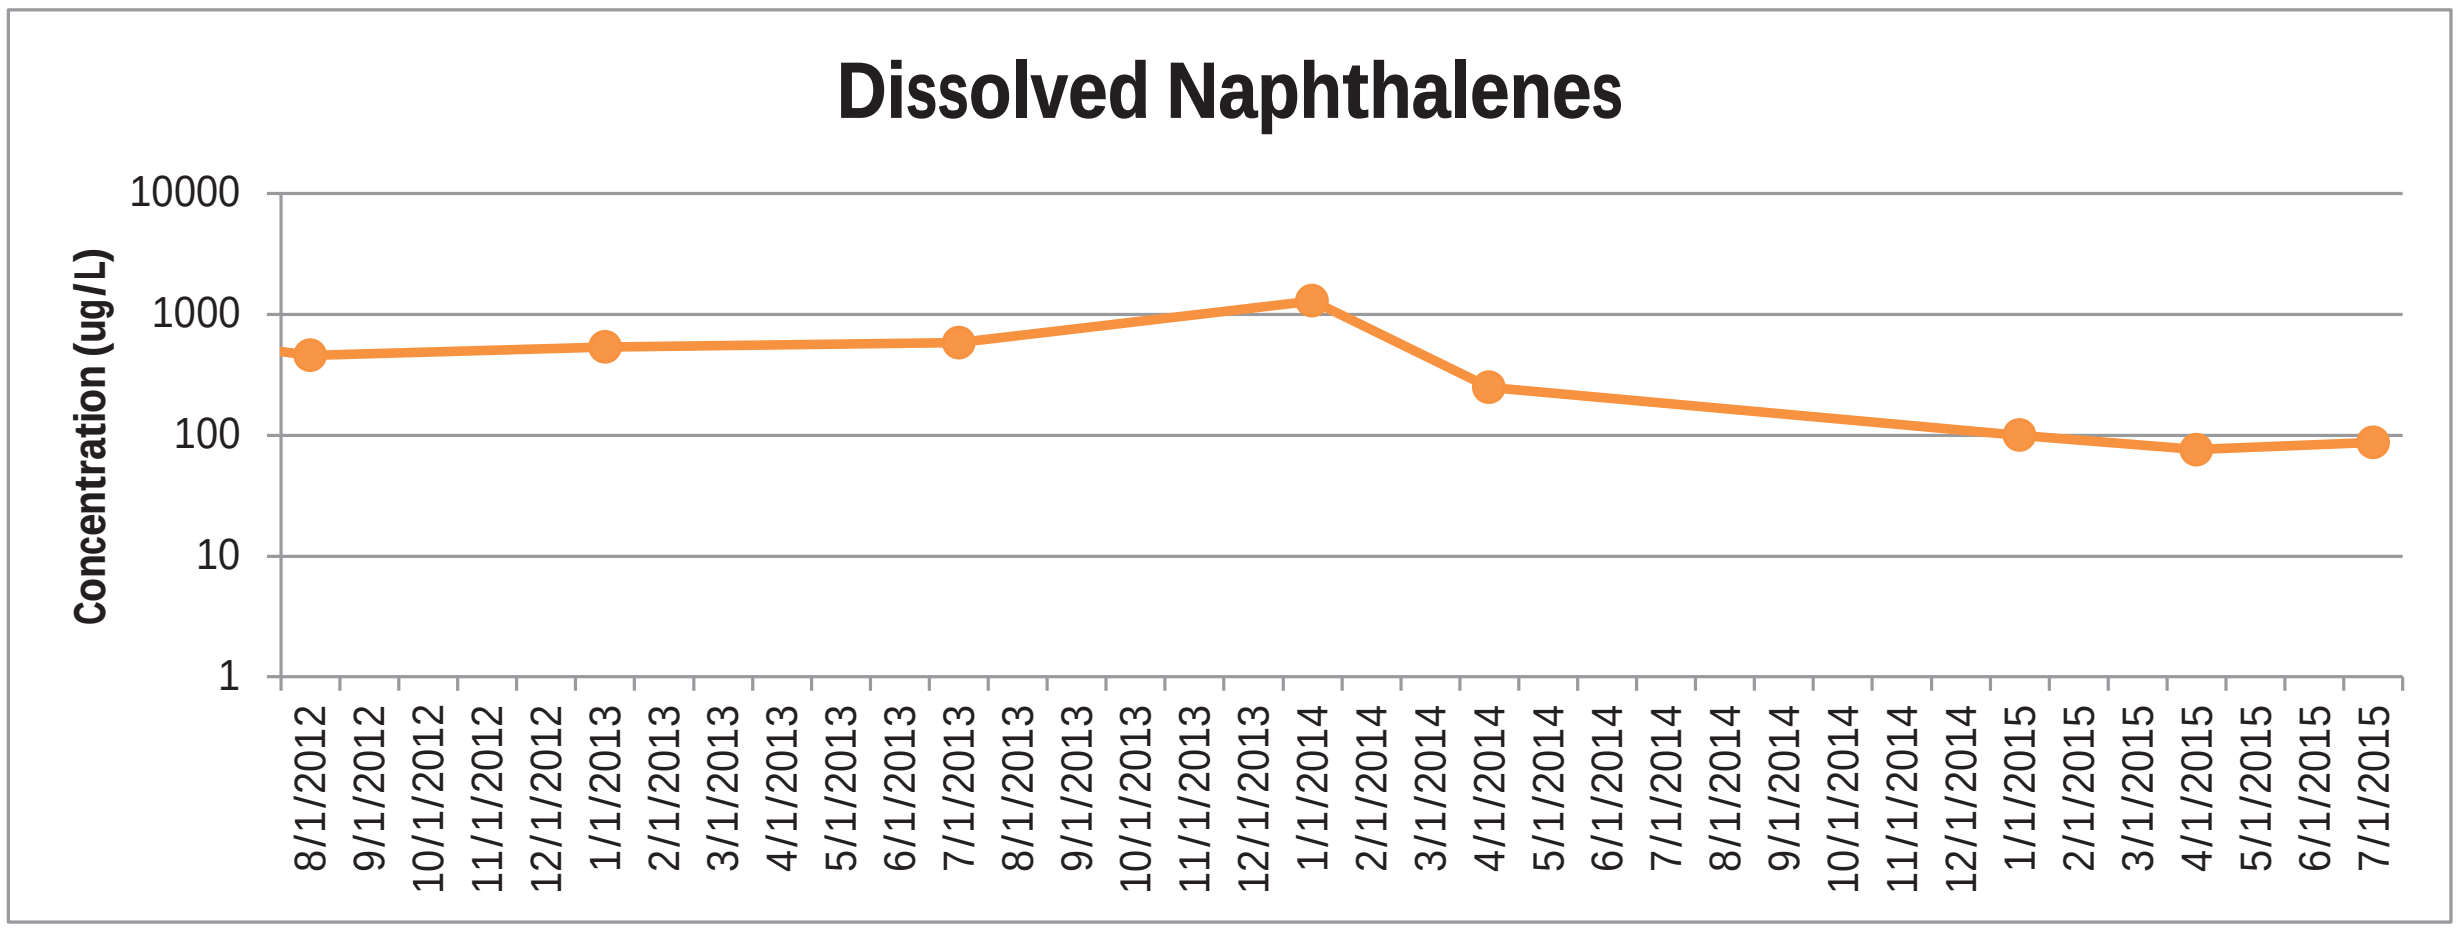
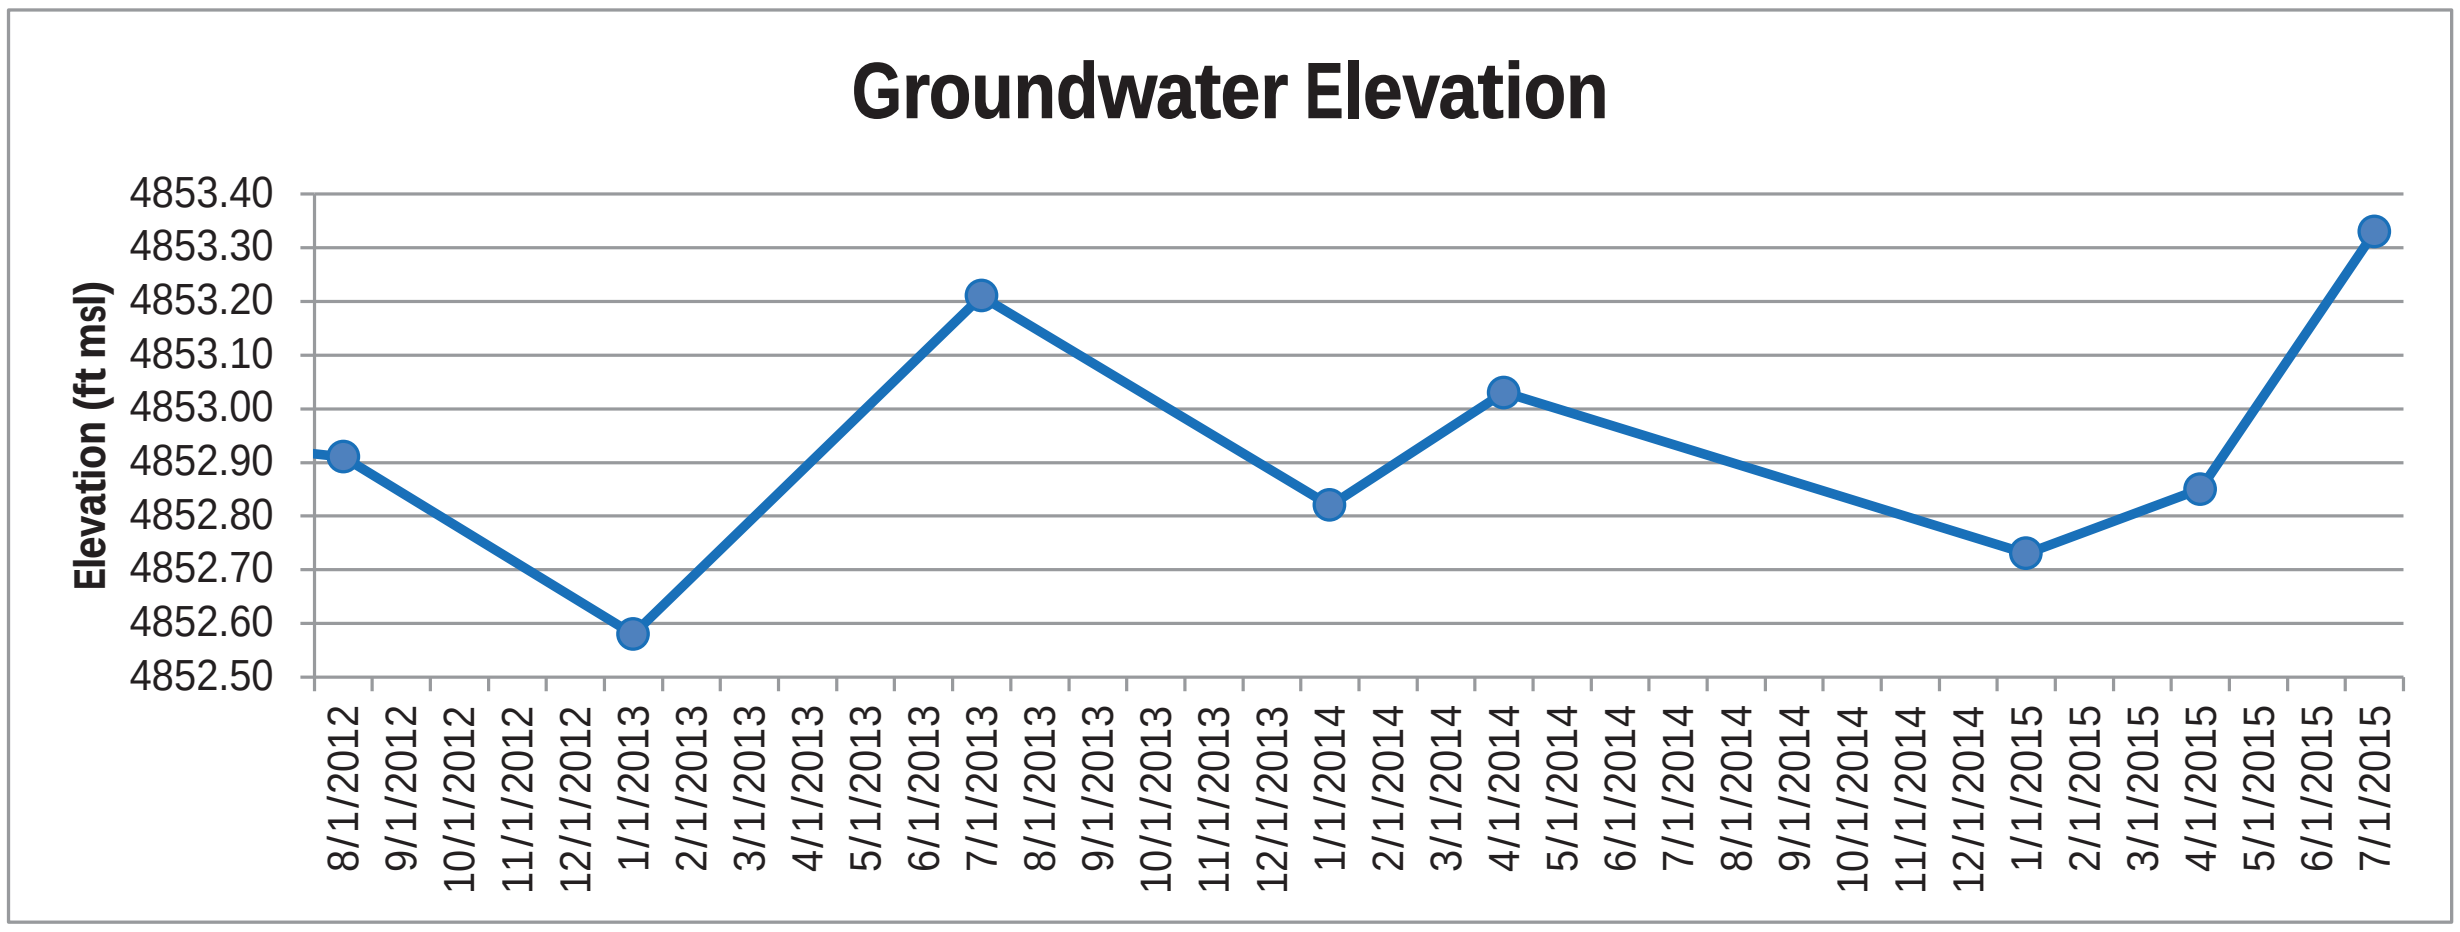
Graph 1
MW-8/MW-8R/MW-8A Dissolved BTEX and Naphthalenes Concentrations Vs Time
Chevron Isleta Site, Albuquerque, New Mexico

MW-8A – From August 2012 to July 2015, dissolved benzene, total xylenes and/or total naphthalenes have exceeded NMWQCC standards at MW-8A with concentrations ranging from10 to 100 µg/L; 120 to 7,800 µg/L; and 21 to 1,300 µg/L, respectively. Total xylenes and total naphthalenes have fluctuated above and below their respective NMWQCC standards (Graph 1). Between April 29 and July 20, 2015, dissolved benzene decreased from 100-85 µg/L. During the same period, total naphthalenes also decreased slightly from 195 to185 µg/L (Graph 1).
