August 2015

2015 3rd Quarter Groundwater Monitoring Report:

Chevron Isleta Site
3401 Isleta Boulevard
Albuquerque, New Mexico
Bernalillo County

NMED PSTB Facility No. 30681

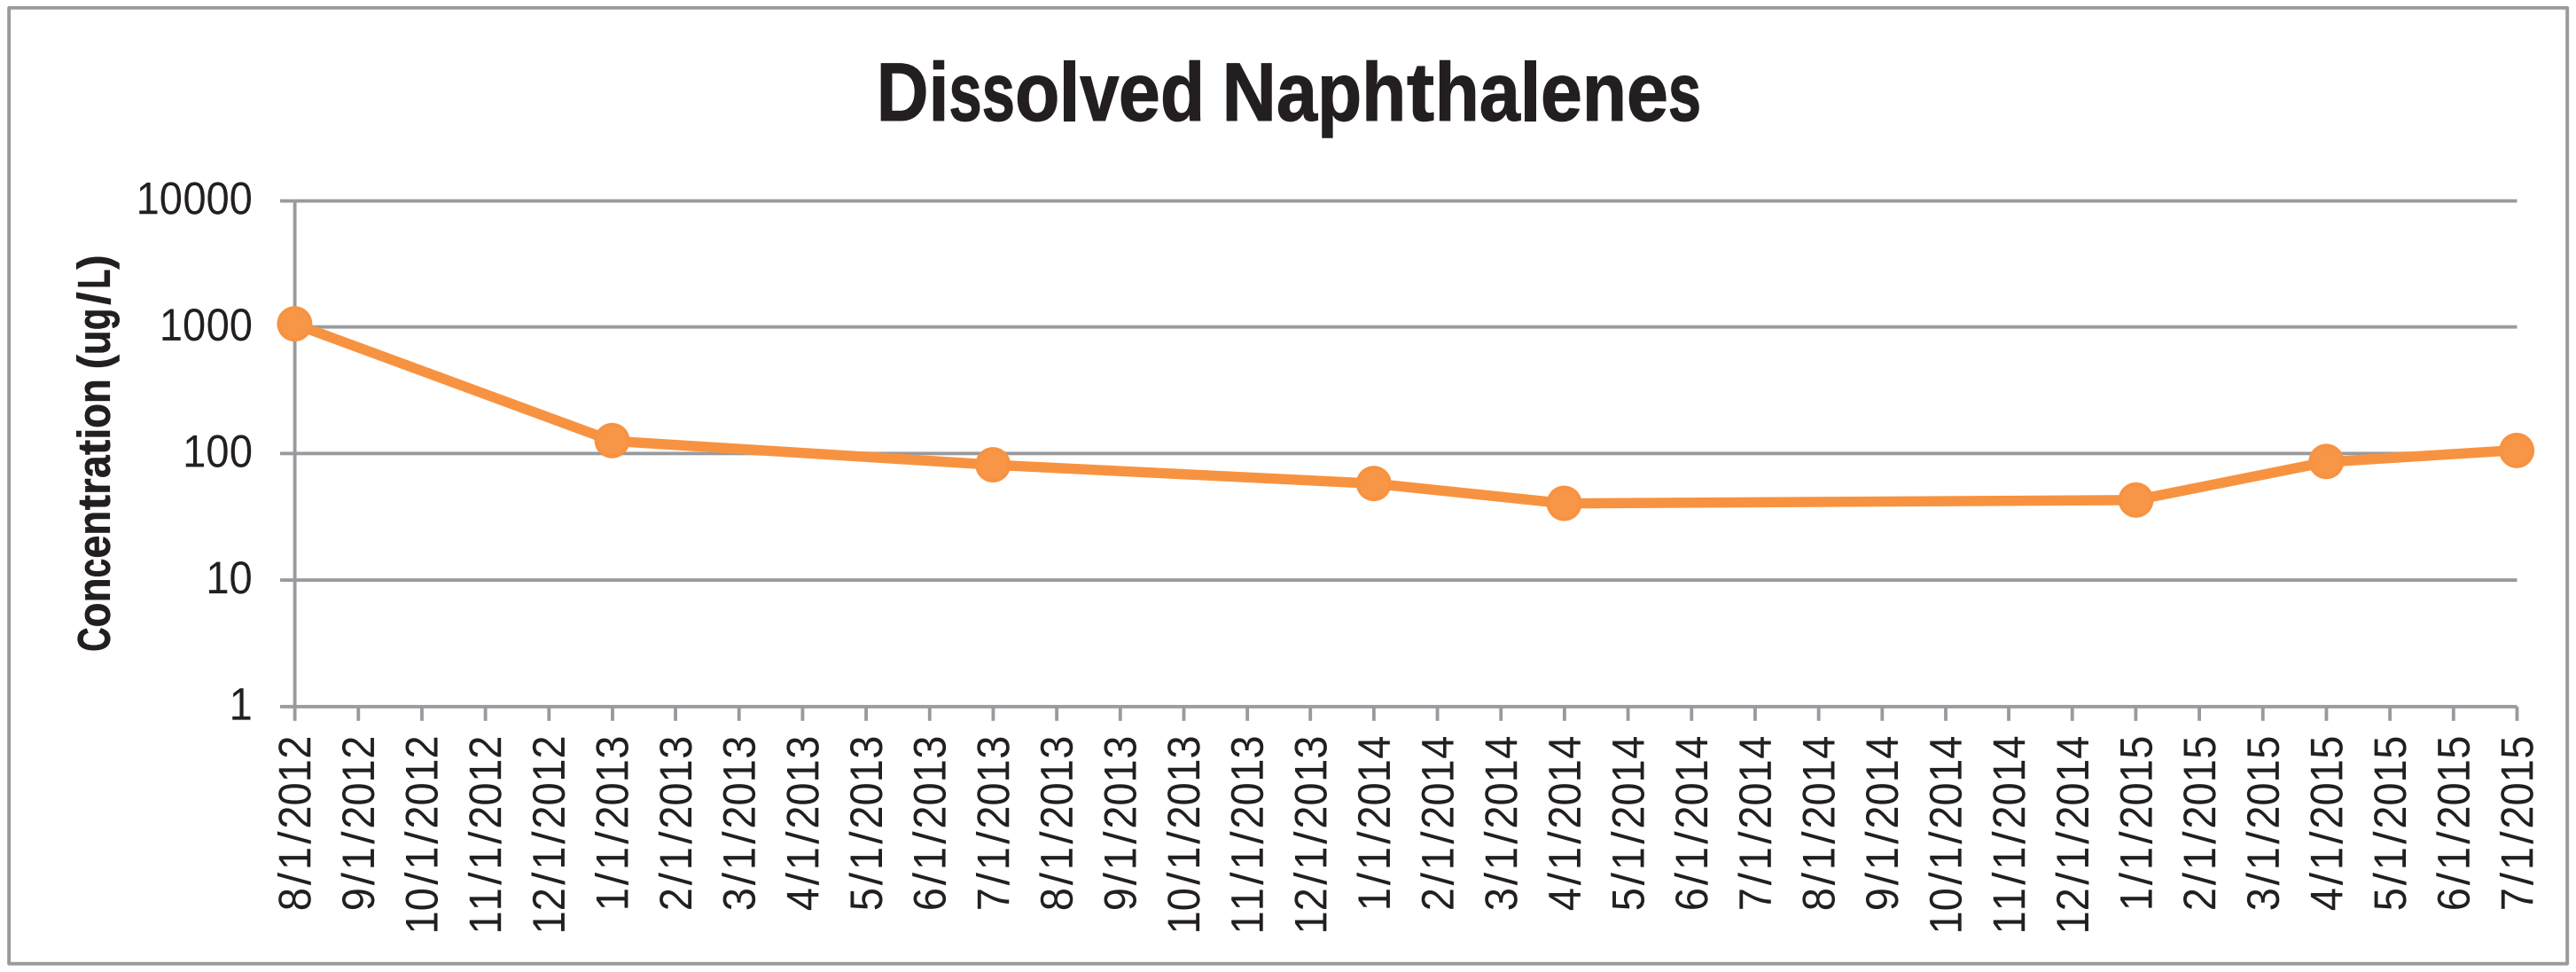
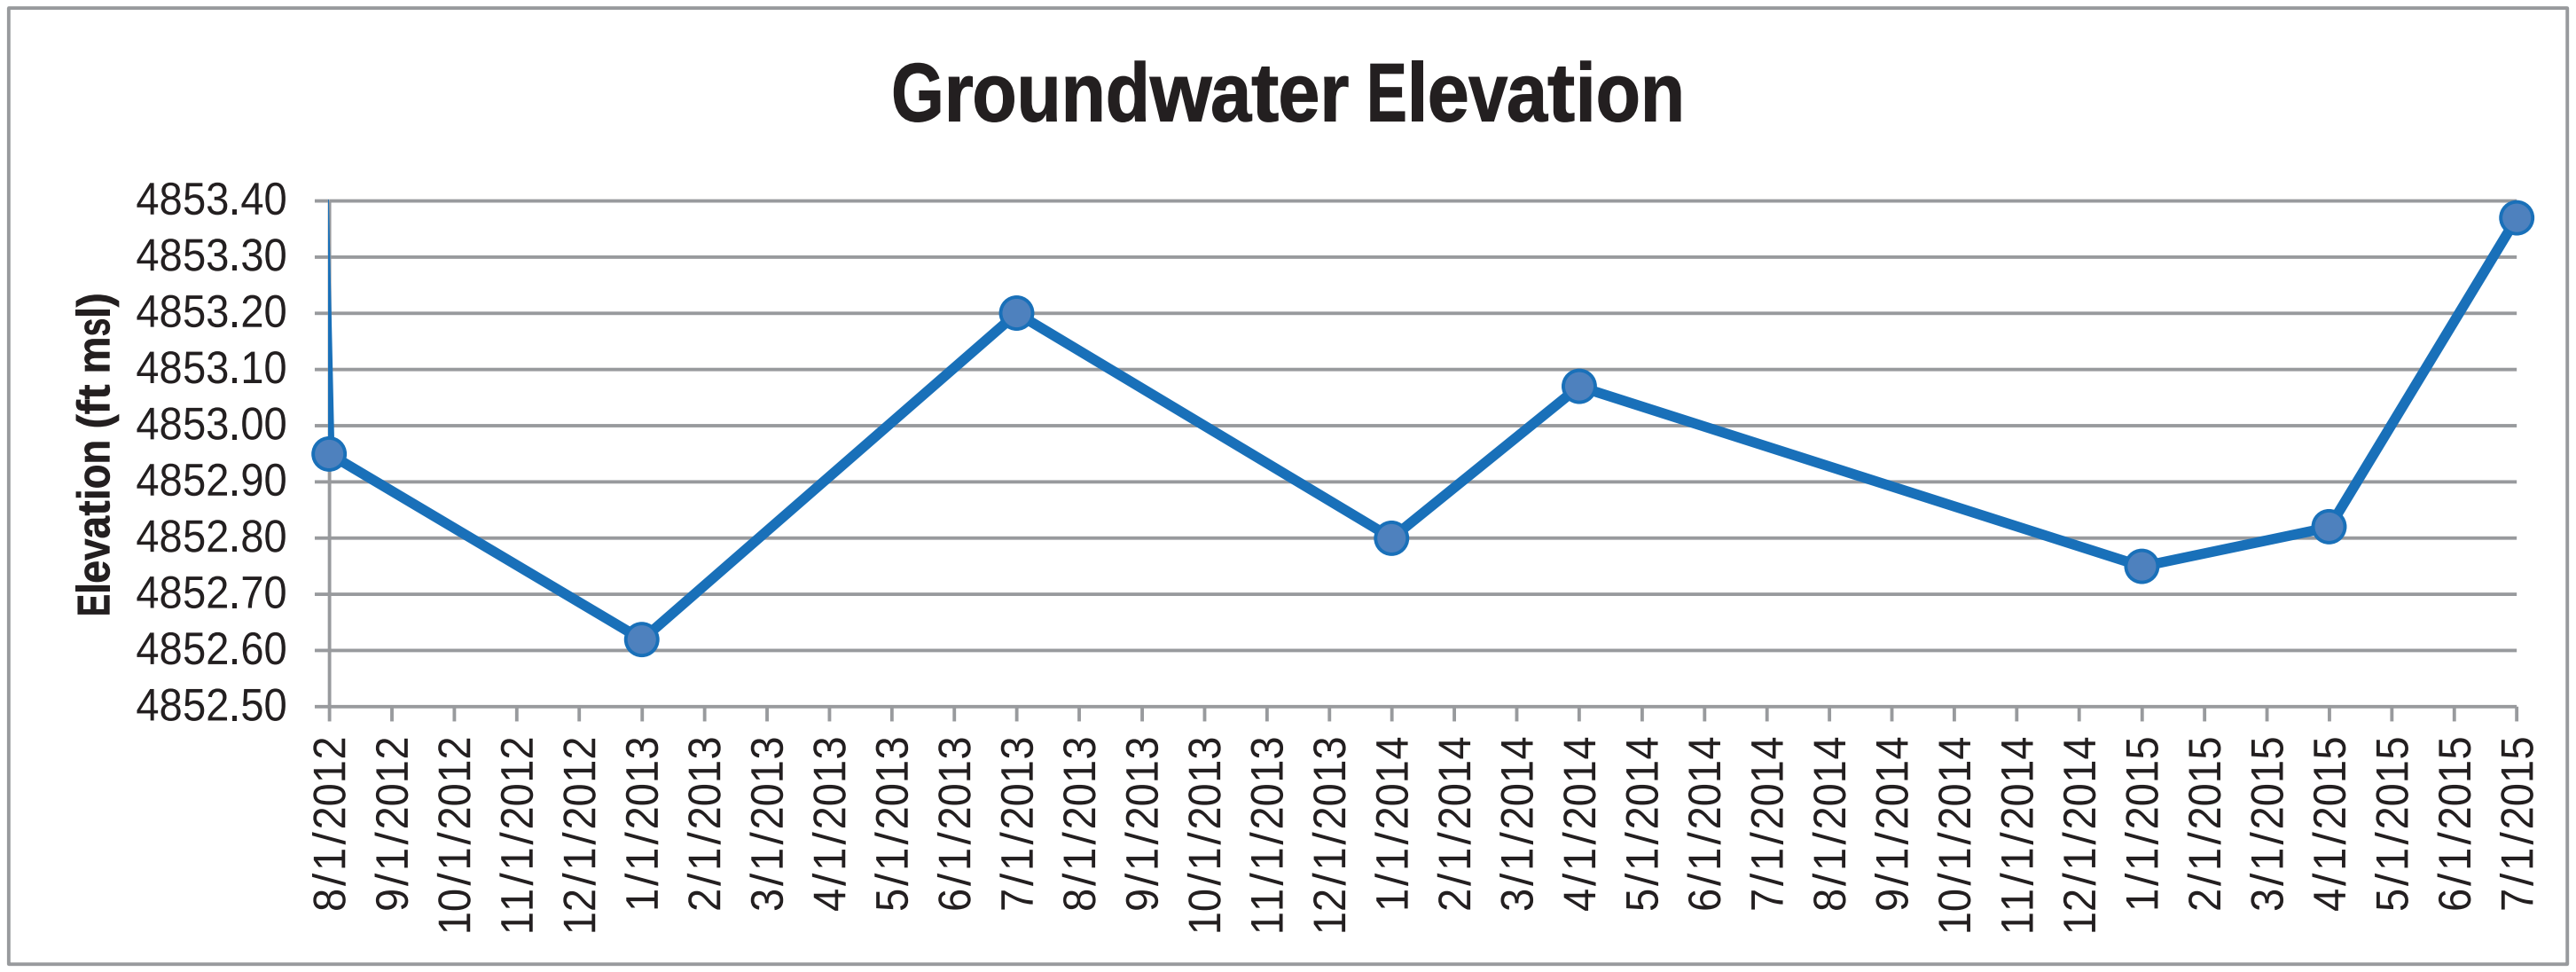
Graph 2
MW-11/MW-11R/MW-11A Dissolved Naphthalenes Concentrations Vs Time
Chevron Isleta Site, Albuquerque, New Mexico

MW-11A – Dissolved benzene concentrations have exceeded the NMWQCC standard three times since August 2012. Since August 2012, dissolved napthalenes have consistently exceeded the NMWQCC standard ranging from 40.5 to 1,060 µg/L. On July 20, 2015, dissolved benzene at MW-11A decreased from 13 to 6.6 µg/L, and once again is below the NMWQCC standard. The total naphthalenes concentration (106 µg/L) increased from the April 2015 (86 µg/L) and continues to exceed the NMWQCC standard of 30 µg/L (Graph 2). Both contaminants of concern at MW-11A have exhibited a generally decreasing trend over time with intermittent periods of rebound, as observed during the April 2015 sampling event.
