Stage 1 Abatement Plan Site Investigation Report

D&D Mountain Air Cleaners
309 South Paseo de Oñate
Española, New Mexico

July 27, 2022

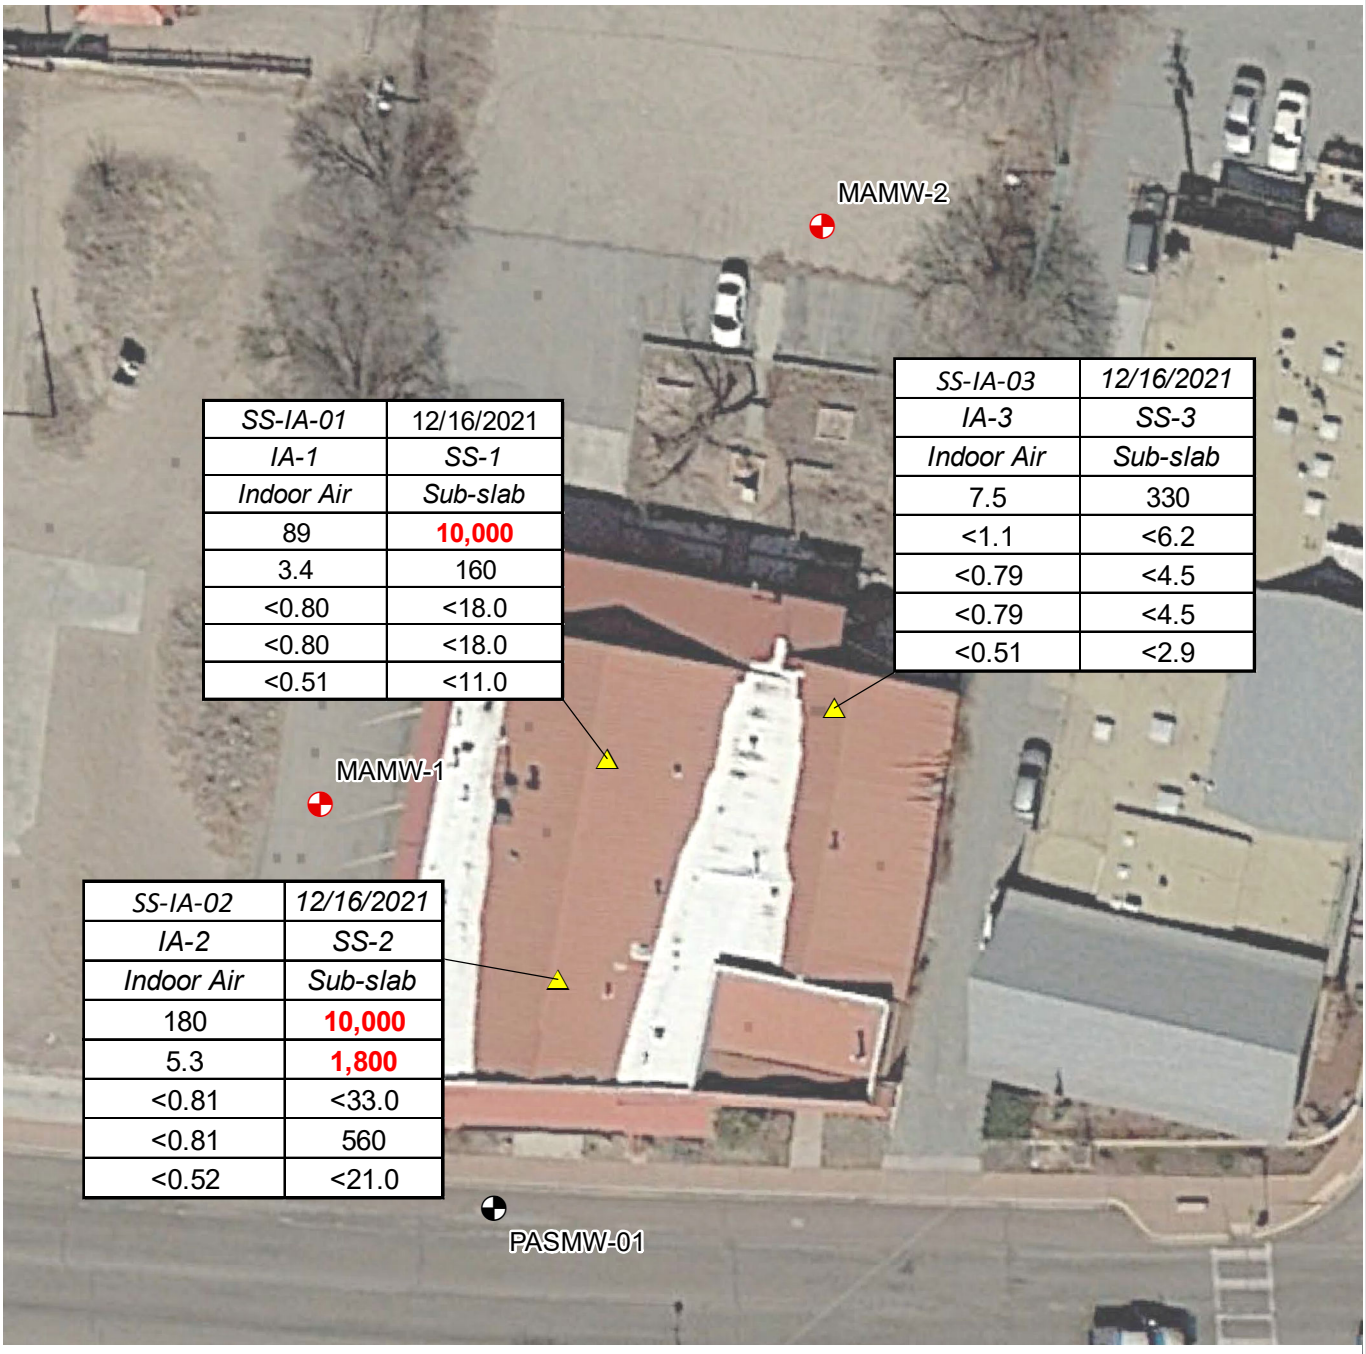
Figure 4

PCE concentrations under the structure slab are significantly lower than those detected in shallow soil vapor to the west near the property boundary, and lower than would be expected given the shallow water table and PCE concentration present in well MAMW-01. This is despite the limited fresh air exchange and corresponding propensity for vapors to accumulate under a relatively impermeable barrier such as a concrete slab. Although a small-magnitude release from the Mountain Air facility cannot be ruled out based on the site data, the observed site conditions clearly indicate a significant primary PCE source near the property line west of the facility.

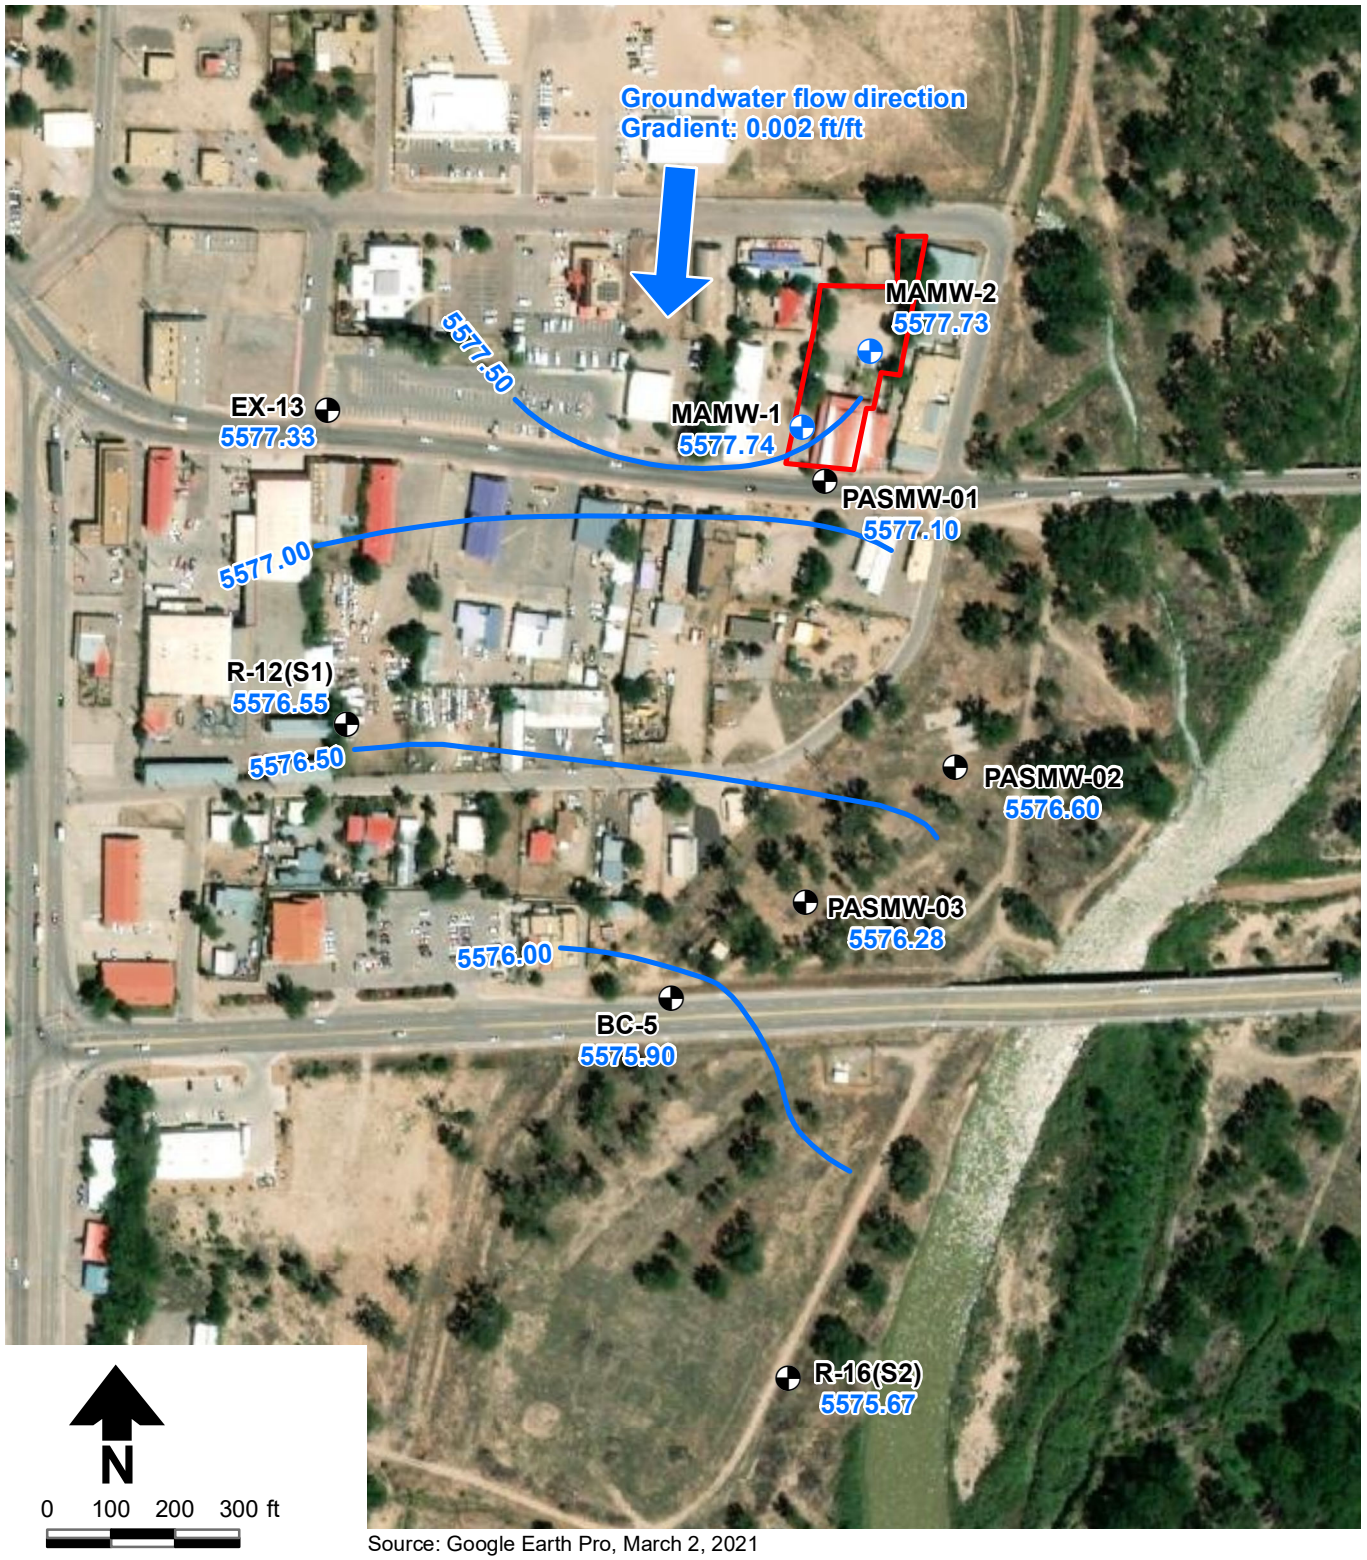
Figure 5

Indoor air PCE and TCE concentrations are below the NMED screening levels for industrial indoor air, but are above residential standards. The Phase I ESA reported that interior slab was sealed following removal of the former PCE-based dry cleaning plant (DBS&A, 2021c). It is noted that the samples were collected during the winter, when ventilation with outside air is at a minimum and vapor-phase constituents are more likely to accumulate in the indoor space. The results therefore likely reflect a worst-case assessment. Based on a sub-slab PCE concentration of 10,000 µg/m^3 and a maximum indoor air concentration of 180 µg/m^3, the site-specific attenuation factor for vapor intrusion into the indoor air space is approximately 0.018, within the range of values reported in EPA's *Vapor Intrusion Database* (U.S. EPA, 2012) and similar to EPA's default value of 0.03 (U.S. EPA, 2015).

- As part of the monitoring program, additional organic and inorganic water quality parameters should be collected from the impacted aquifer to evaluate contaminant degradation processes, potential multiple sources, and support feasibility assessment of remedial options.
- Although concentrations of COCs in indoor air are below NMED industrial screening levels, concentrations in the sub-slab space are well above the applicable VISLs. In order to mitigate the risks associated with the vapor intrusion pathway over the long term, DBS&A recommends improving indoor air ventilation and circulation, and removing the potential exposure source by installing a sub-slab depressurization system.

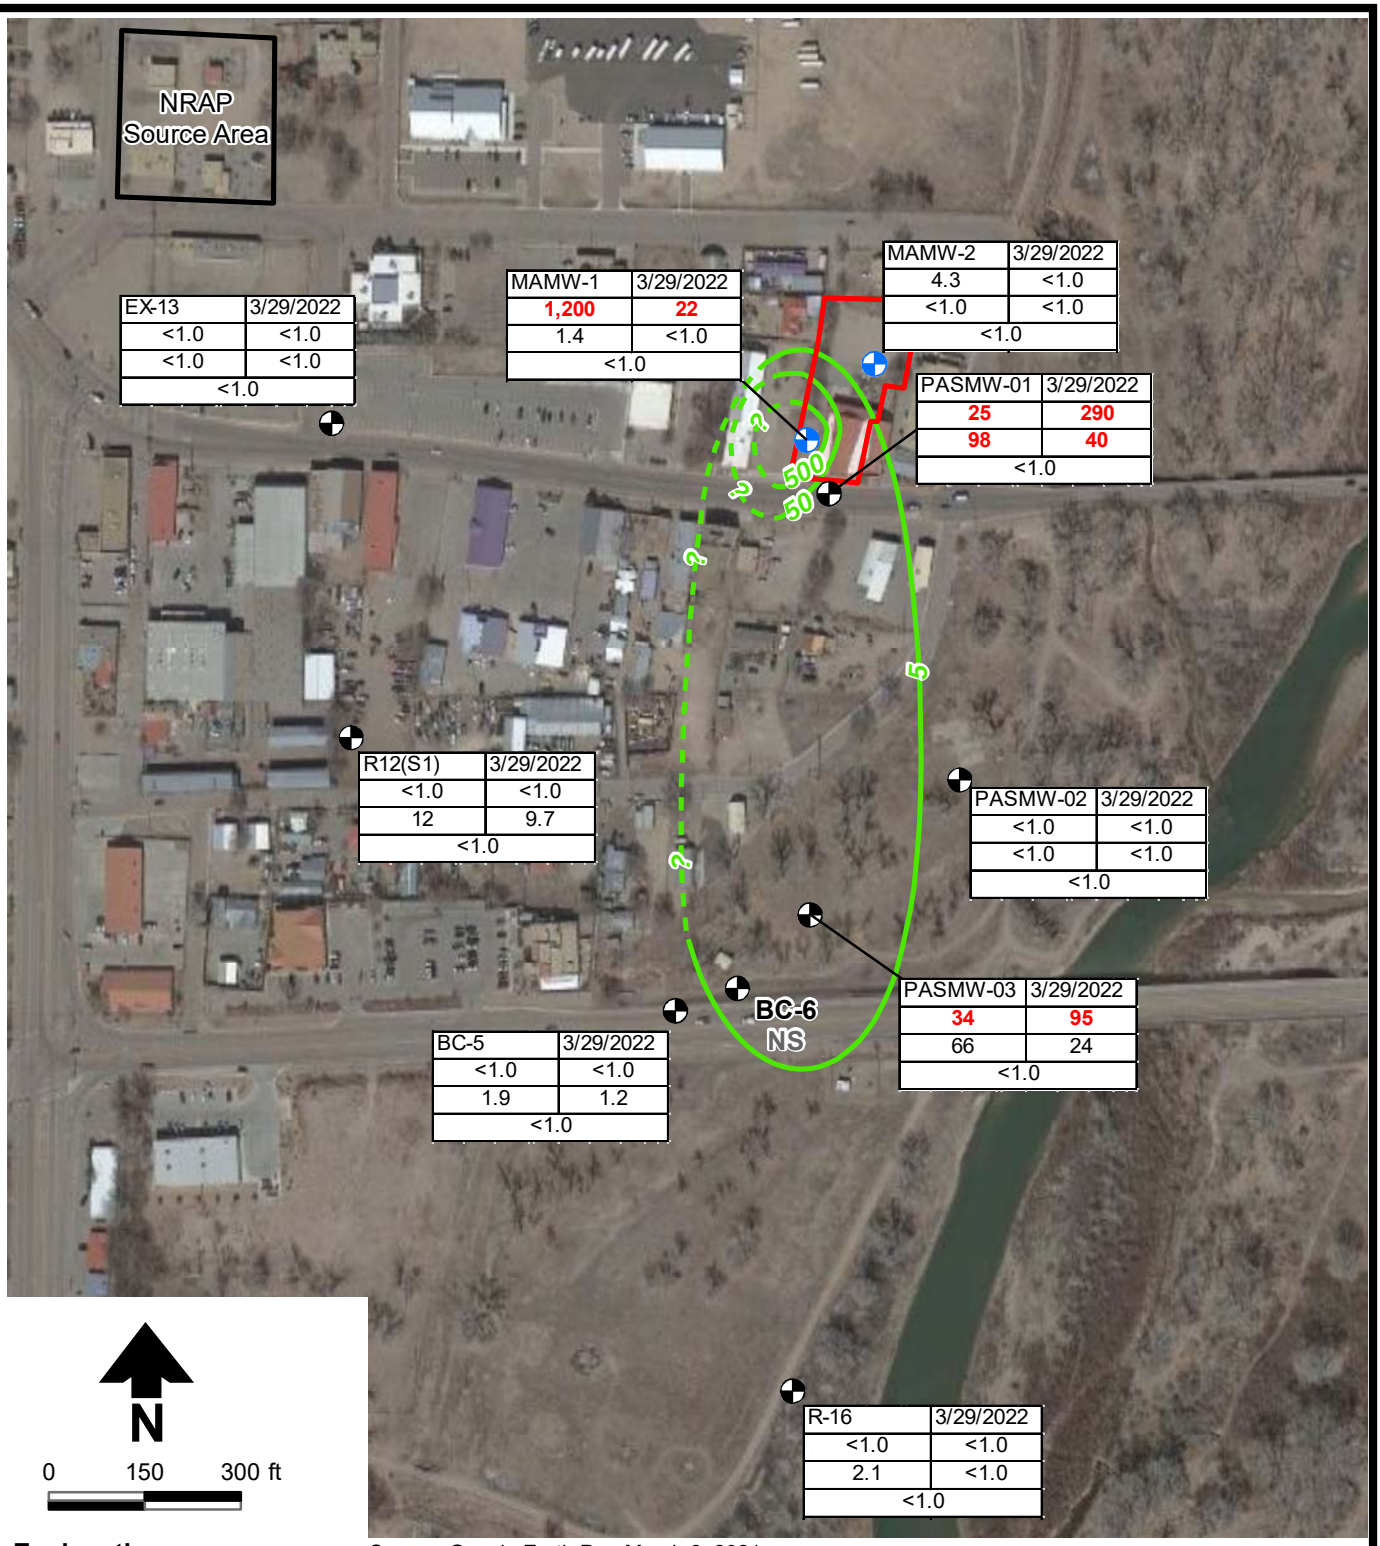
Figure 6

Groundwater was present in site wells at depths of approximately 9 to 10 feet bgs. The selected monitor wells cover a large area (Figure 3), within which depths to water ranged from approximately 7 to 12 feet bgs. Measured water levels were used to construct a potentiometric surface map, which is provided in Figure 6. The groundwater flow direction in the site vicinity was generally southward, with a relatively flat gradient of 0.002 feet per foot. This finding is consistent with previous monitoring conducted in the site vicinity (e.g., NMED, 2019; EA, 2020). Measured depths to water and water table elevations during the March 29, 2022 monitoring event are summarized in Table 5.

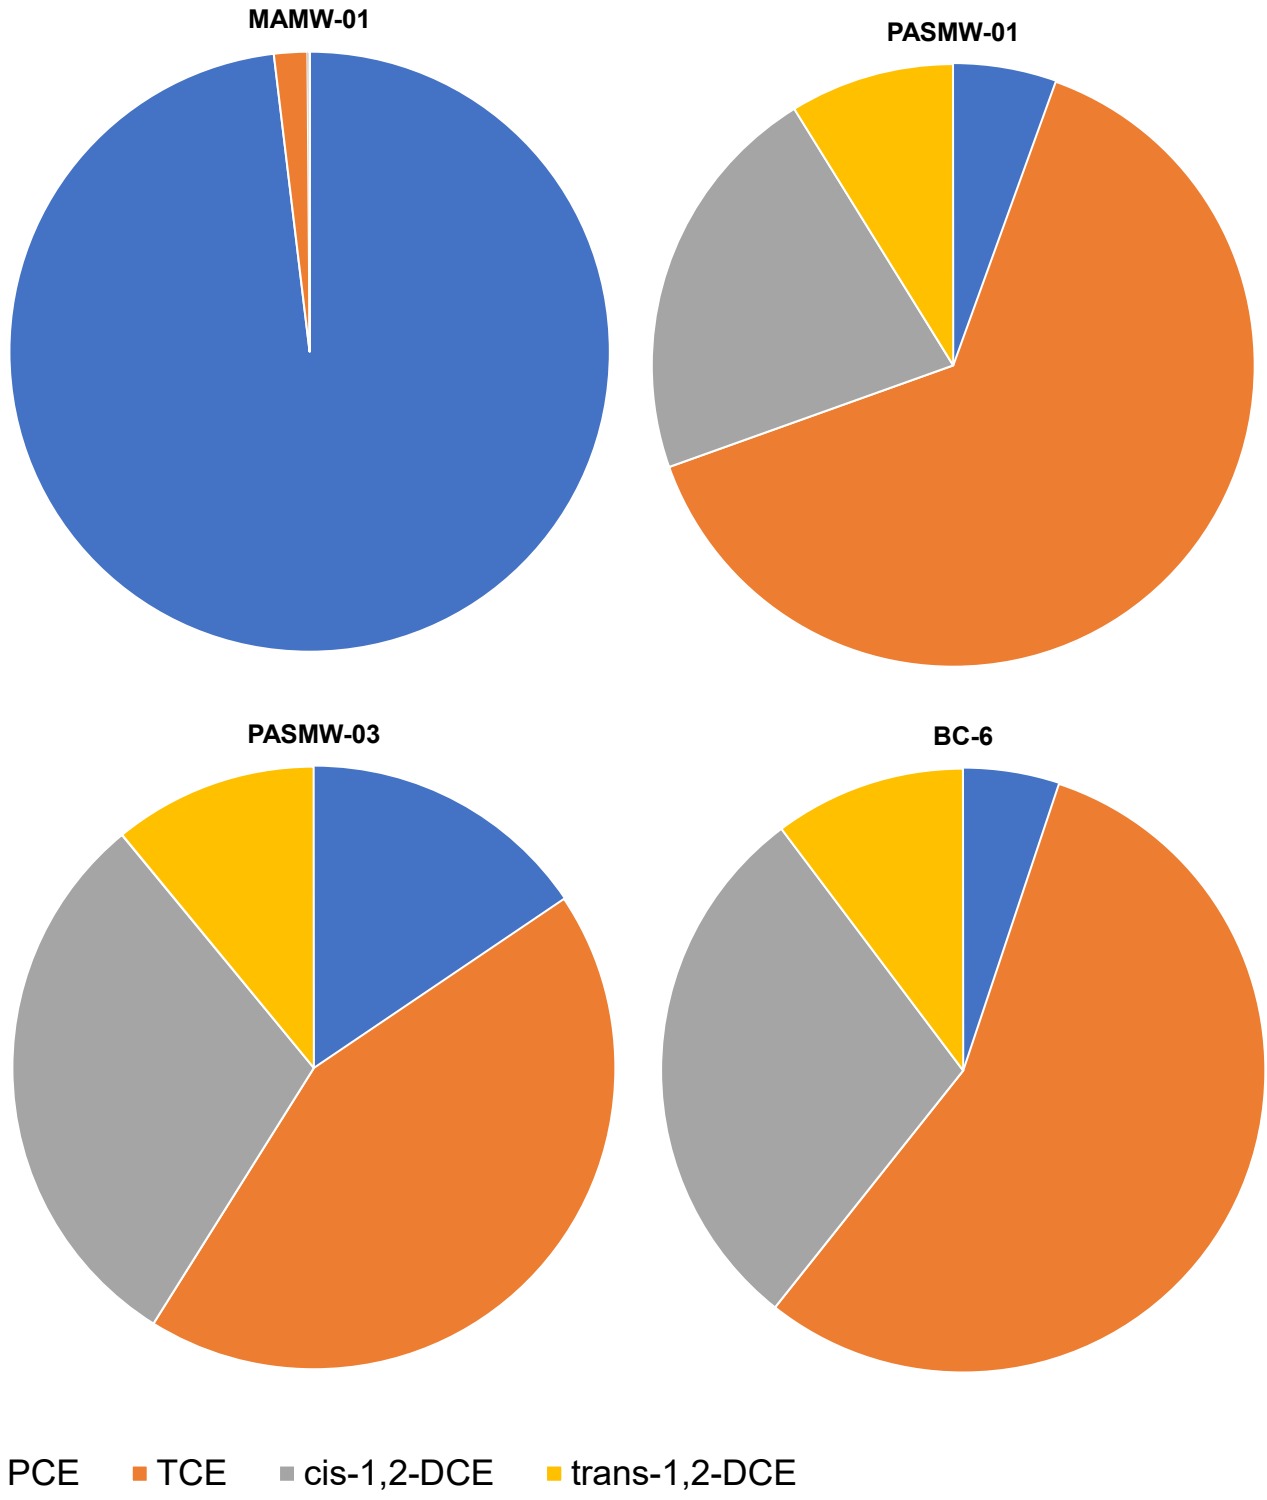
Groundwater analytical results from the current monitoring event are summarized for the site COCs on Figure 7 and in Table 6. Historical water quality analytical data for COCs in the selected monitor wells are provided in Table 4. The complete laboratory report and chain of custody are included in Appendix D.

The sampling conducted during this investigation expands upon sampling conducted in the Calle Chavez plume vicinity in 2019 and 2021 (Table 4), with the addition of new wells MAMW-01 and MAMW-02. Results are largely consistent with those previous investigations, indicating the presence of a chlorinated solvent plume in shallow groundwater under the site and extending approximately 800 feet to the south. Since the PASMW wells were installed in 2018, TCE has dropped below the laboratory reporting limit at PASMW-02, and new well MAMW-02 bounds the plume to the north, resulting in a slightly reduced plume footprint compared to previous interpretations (EA, 2020). The actionable groundwater plume does not extend north of the Mountain Air facility, but is only loosely constrained to the west by NRAP monitor wells EX-13 and R-12(S1) (Figure 7).
