Stage 1 Abatement Plan Site Investigation Report

D&D Mountain Air Cleaners
309 South Paseo de Oñate
Española, New Mexico

DB21.1167

June 27, 2022

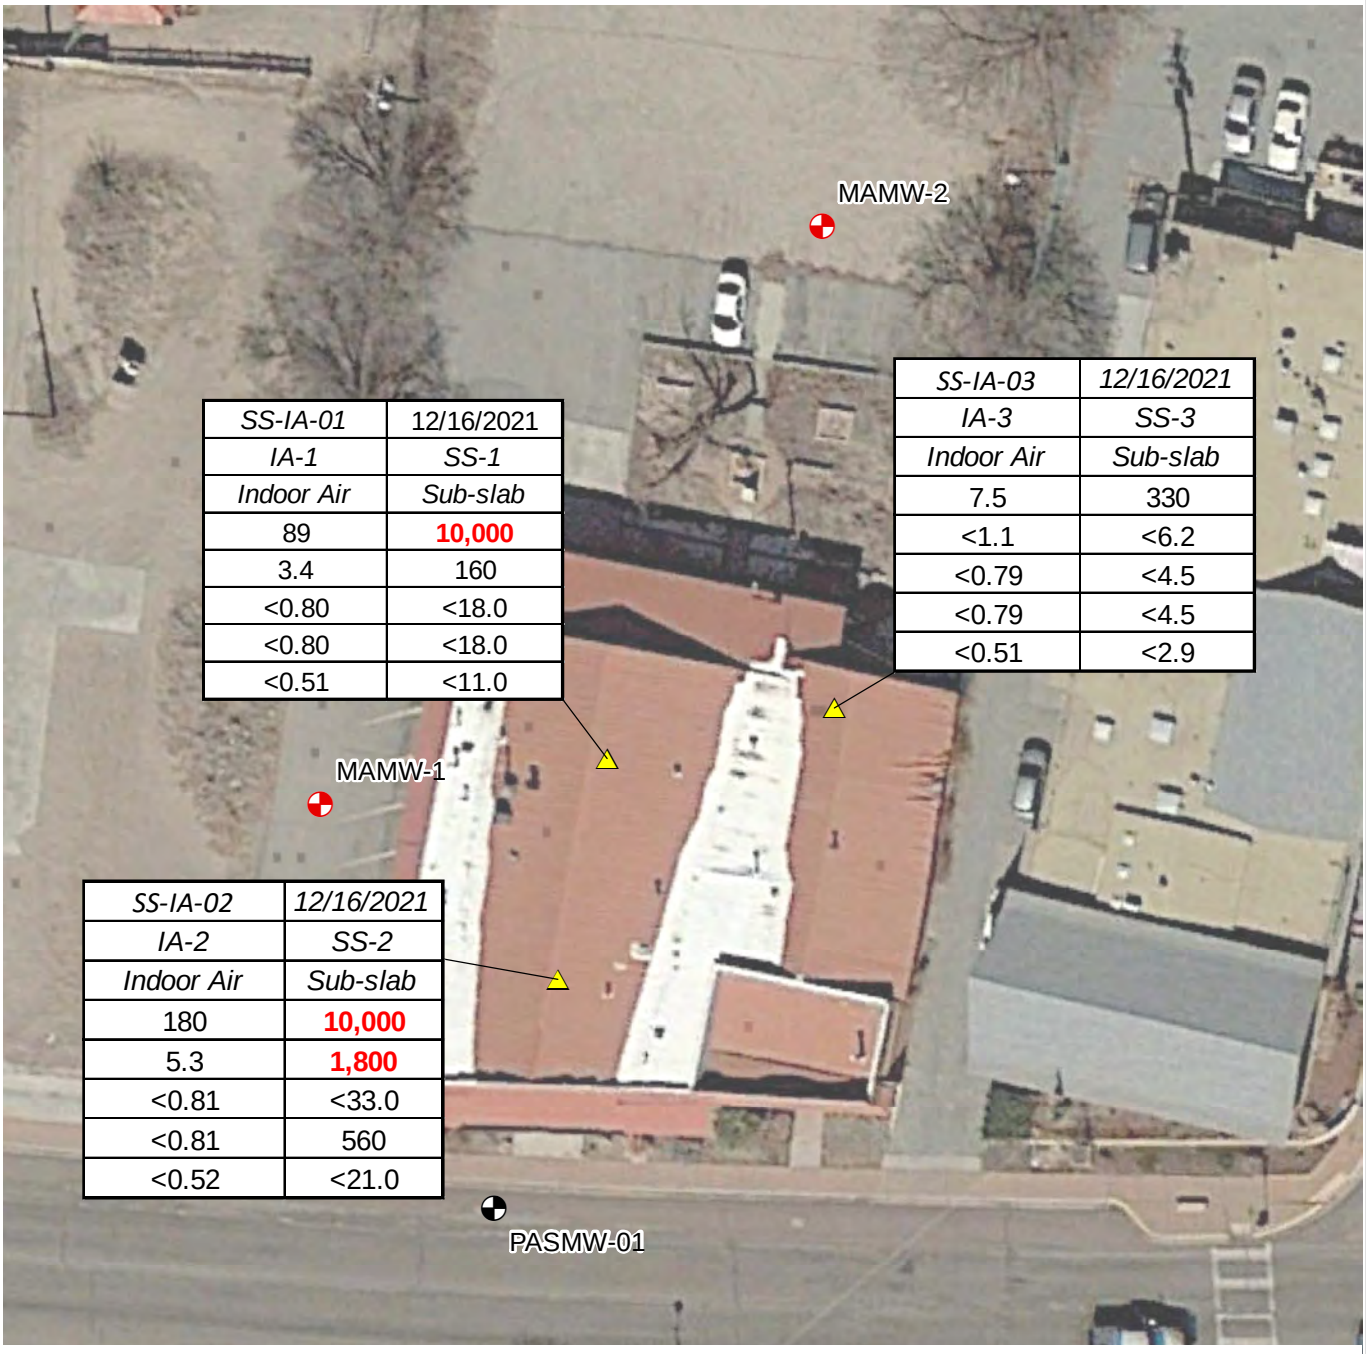
Figure 4

Only very low detections of COCs were noted at locations PSG-01 and PSG-02, despite the shallow water table and the presence of elevated concentrations of TCE and other COCs in groundwater samples from nearby monitor well PASMW-01. Intera (2019) reported a clay layer above the water table at PASMW-01, which is not present on-site based on borehole observations at new on-site wells. The clay layer may discourage migration of vapor-phase COCs from the water table to the shallow subsurface near PASMW-01. Soil gas data previously collected from properties located to the south of the site were consistent with the presence of volatile COCs in shallow groundwater and the plume extent indicated by groundwater sampling (EA, 2018 and 2019).

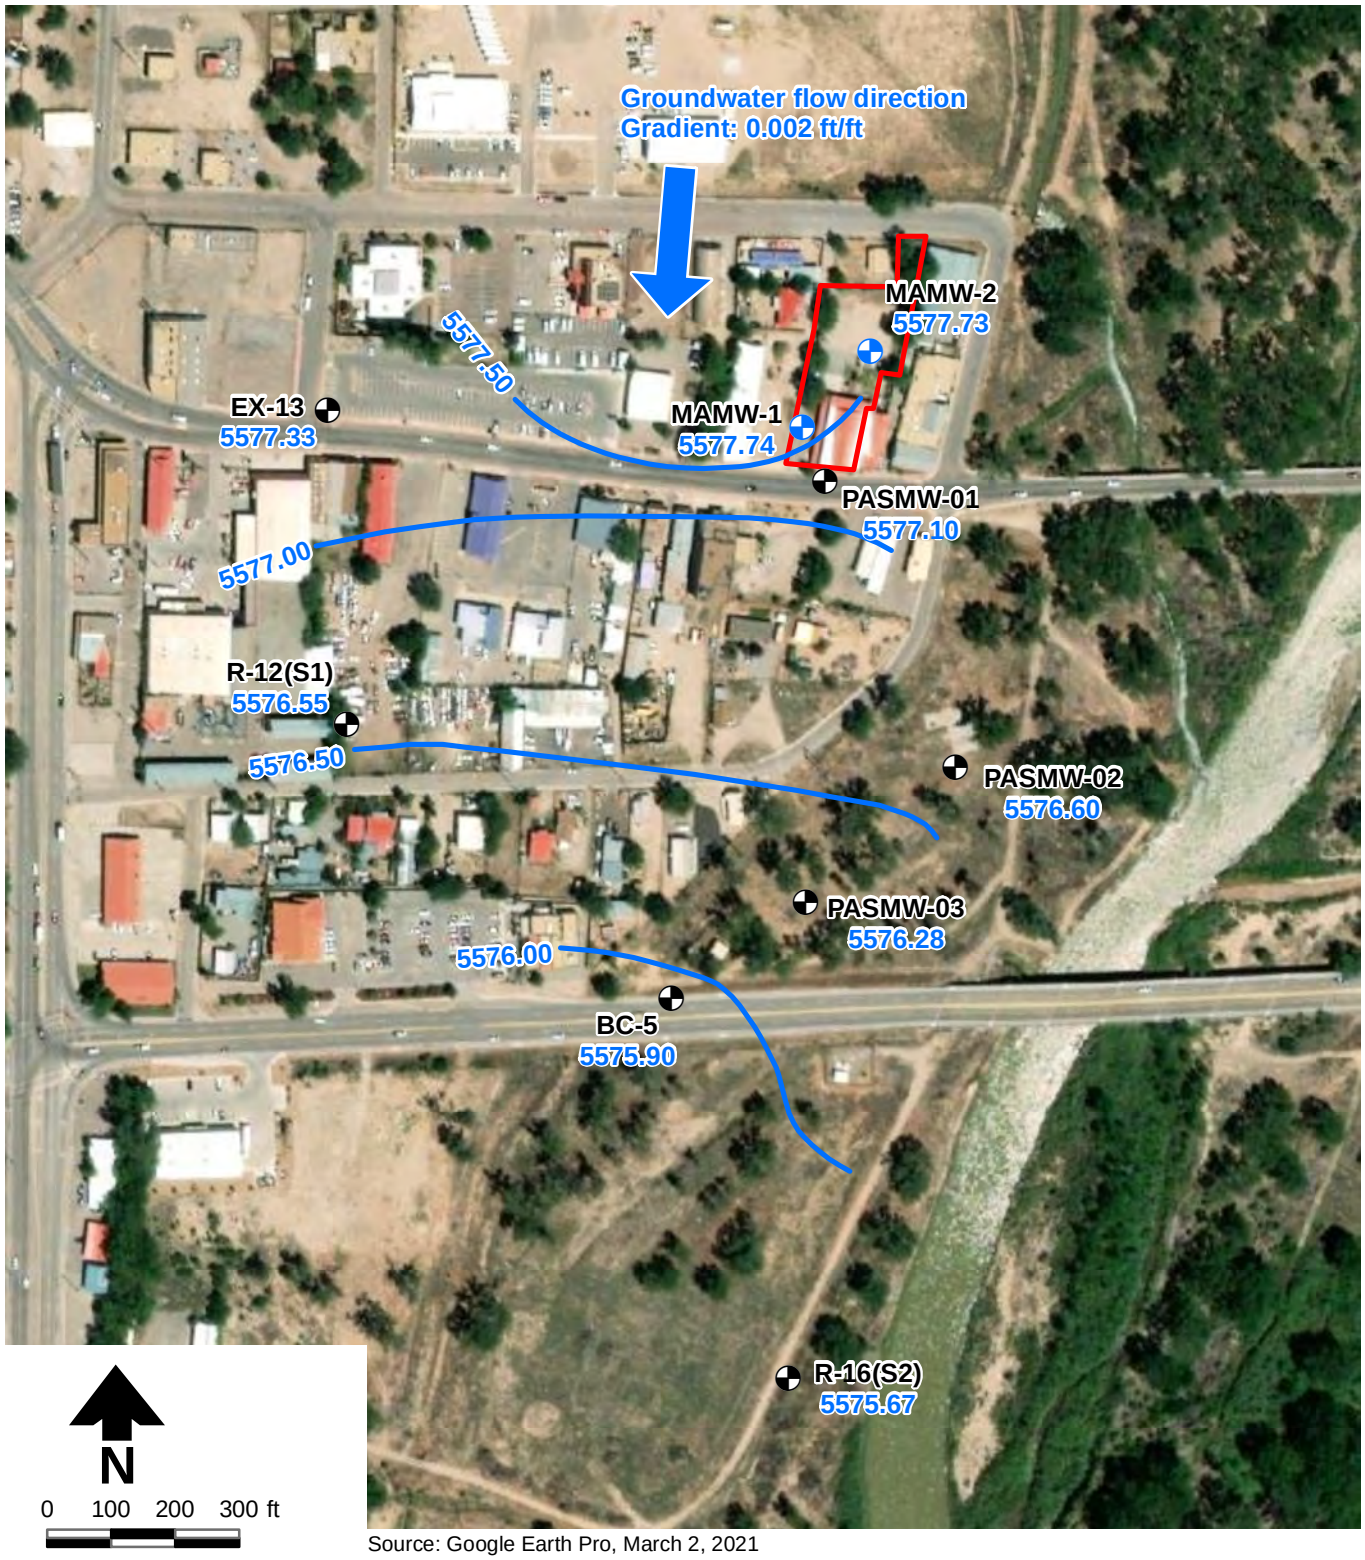
Figure 5

PCE concentrations under the structure slab are significantly lower than those detected in shallow soil vapor to the west near the property boundary, and lower than would be expected given the shallow water table and PCE concentration present in well MAMW-01. This is despite the limited fresh air exchange and corresponding propensity for vapors to accumulate under a relatively impermeable barrier such as a concrete slab. Although a small-magnitude release from the Mountain Air facility cannot be ruled out based on the site data, the observed site conditions clearly indicate a significant primary PCE source near the property line west of the facility.

Indoor air PCE and TCE concentrations are below the NMED screening levels for industrial indoor air, but are above residential standards. The Phase I ESA reported that interior slab was sealed following removal of the former PCE-based dry cleaning plant (DBS&A, 2021c). It is noted that the samples were collected during the winter, when ventilation with outside air is at a minimum and vapor-phase constituents are more likely to accumulate in the indoor space. The results therefore likely reflect a worst-case assessment. Based on a sub-slab PCE concentration of 10,000 µg/m^3 and a maximum indoor air concentration of 180 µg/m^3, the site-specific attenuation factor for vapor intrusion into the indoor air space is approximately 0.018, within the range of values reported in EPA's *Vapor Intrusion Database* (U.S. EPA, 2012) and similar to EPA's default value of 0.03 (U.S. EPA, 2015).

- As part of the monitoring program, additional organic and inorganic water quality parameters should be collected from the impacted aquifer to evaluate contaminant degradation processes, potential multiple sources, and support feasibility assessment of remedial options.
- Although concentrations of COCs in indoor air are below NMED industrial screening levels, concentrations in the sub-slab space are well above the applicable VISLs. In order to mitigate the risks associated with the vapor intrusion pathway over the long term, DBS&A recommends improving indoor air ventilation and circulation, and removing the potential exposure source by installing a sub-slab depressurization system.

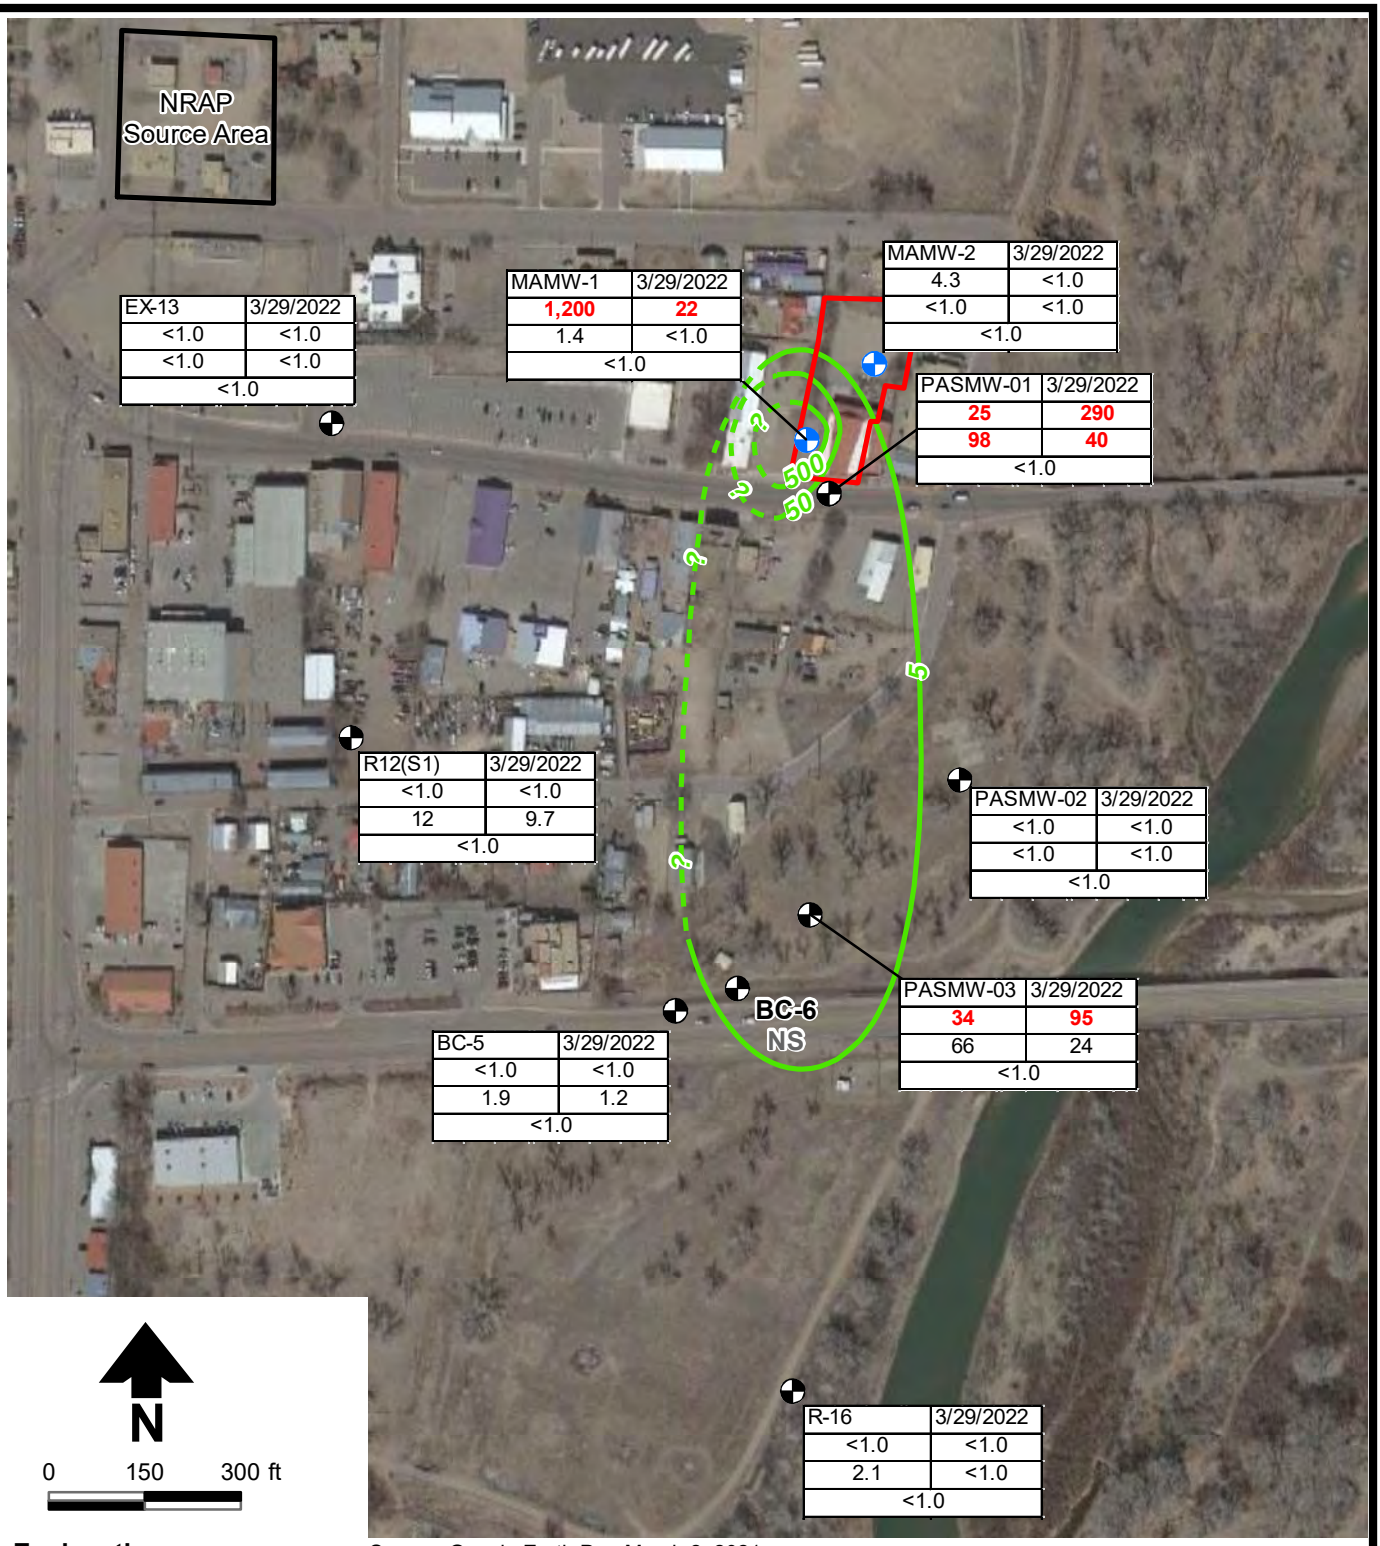
Figure 6

Groundwater was present in site wells at depths of approximately 9 to 10 feet bgs. The selected monitor wells cover a large area (Figure 3), within which depths to water ranged from approximately 7 to 12 feet bgs. Measured water levels were used to construct a potentiometric surface map, which is provided in Figure 6. The groundwater flow direction in the site vicinity was generally southward, with a relatively flat gradient of 0.002 feet per foot. This finding is consistent with previous monitoring conducted in the site vicinity (e.g., NMED, 2019; EA, 2020). Measured depths to water and water table elevations during the March 29, 2022 monitoring event are summarized in Table 5.

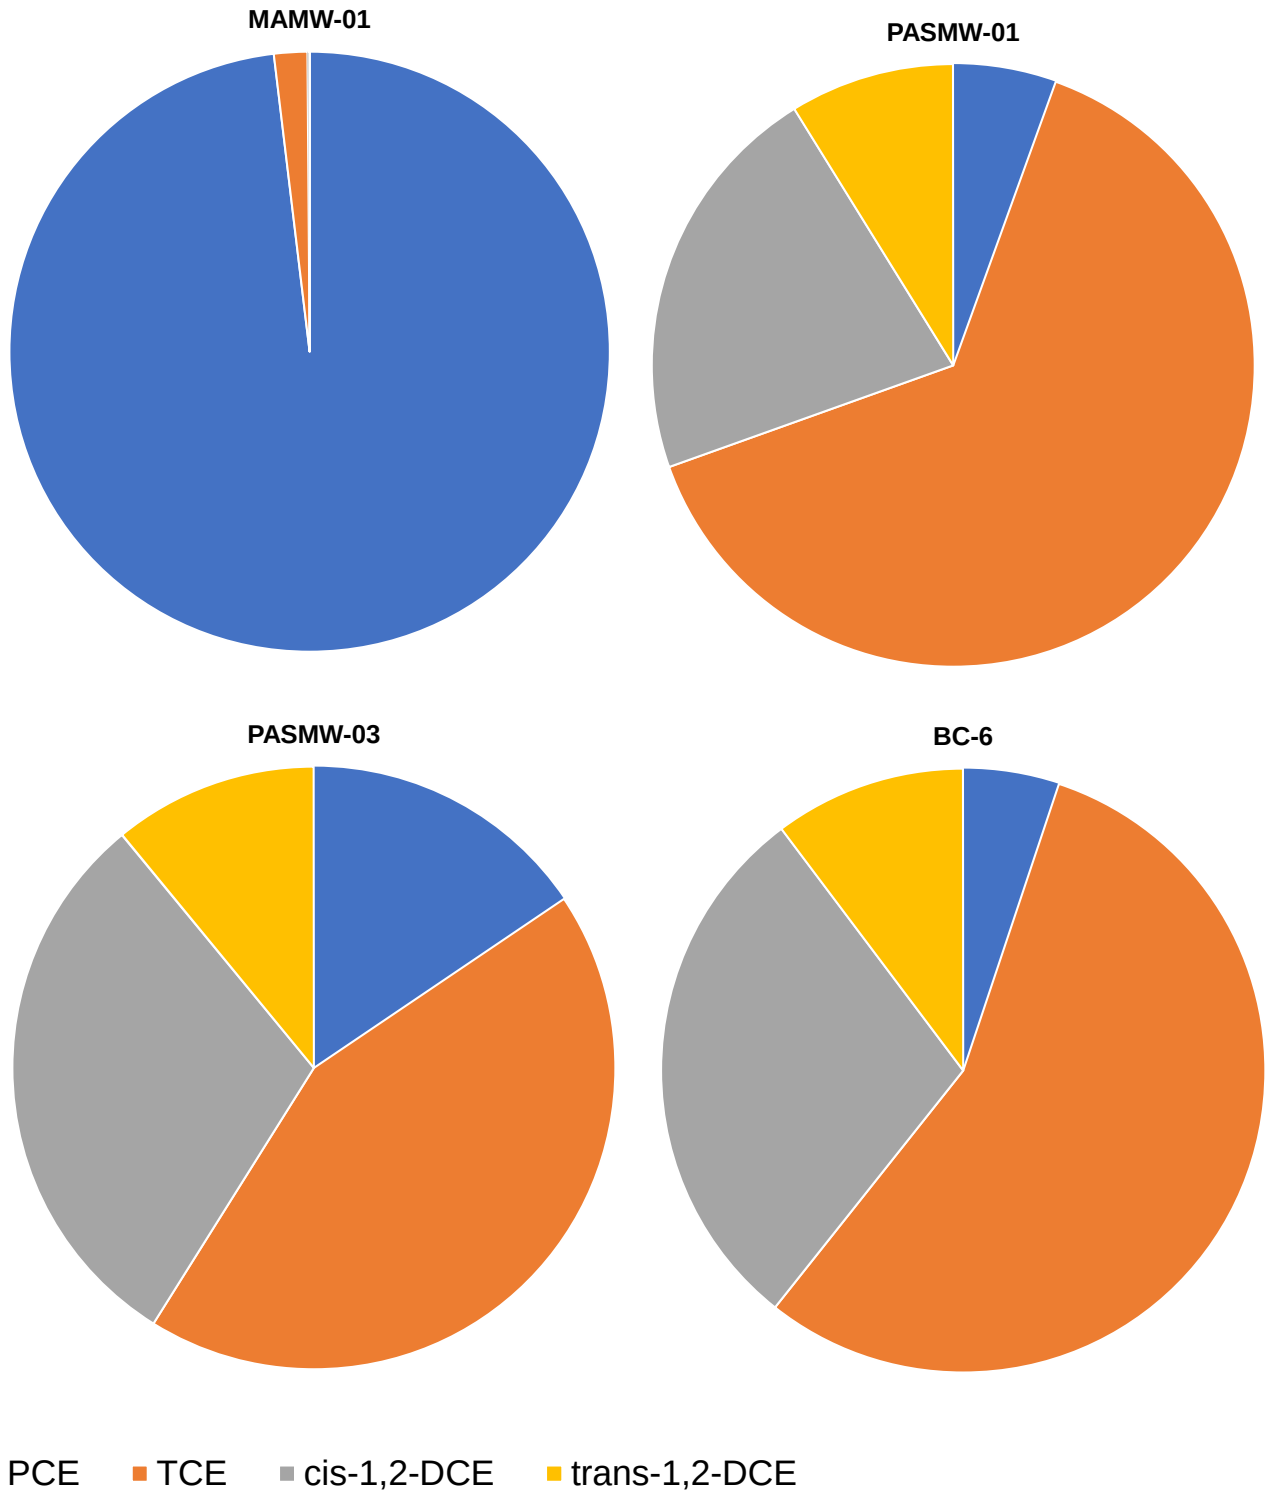
Groundwater analytical results from the current monitoring event are summarized for the site COCs on Figure 7 and in Table 6. Historical water quality analytical data for COCs in the selected monitor wells are provided in Table 4. The complete laboratory report and chain of custody are included in Appendix D.

The sampling conducted during this investigation expands upon sampling conducted in the Calle Chavez plume vicinity in 2019 and 2021 (Table 4), with the addition of new wells MAMW-01 and MAMW-02. Results are largely consistent with those previous investigations, indicating the presence of a chlorinated solvent plume in shallow groundwater under the site and extending approximately 800 feet to the south. Since the PASMW wells were installed in 2018, TCE has dropped below the laboratory reporting limit at PASMW-02, and new well MAMW-02 bounds the plume to the north, resulting in a slightly reduced plume footprint compared to previous interpretations (EA, 2020). The actionable groundwater plume does not extend north of the Mountain Air facility, but is only loosely constrained to the west by NRAP monitor wells EX-13 and R-12(S1) (Figure 7).
