Report No. 052010/2

## **SURFACE EROSION AND STABILITY ANALYSIS QUESTA TAILINGS FACILITY, NEW MEXICO**

July 2000

**SURFACE EROSION AND STABILITY ANALYSIS**  
**QUESTA TAILINGS FACILITY, NEW MEXICO**  
**(MINE CLOSEOUT PLAN PROGRAM TASK B – SUBTASK B1)**

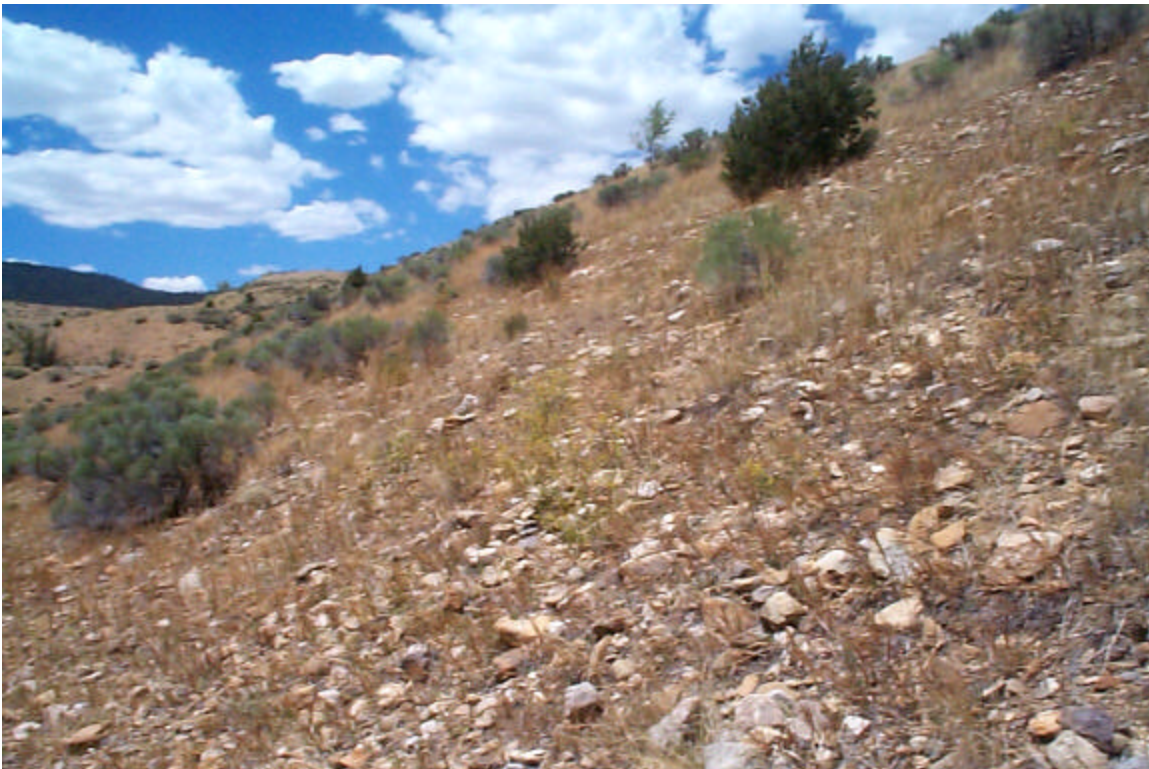
Photo 2: Upper slope of Dam 1 looking west.

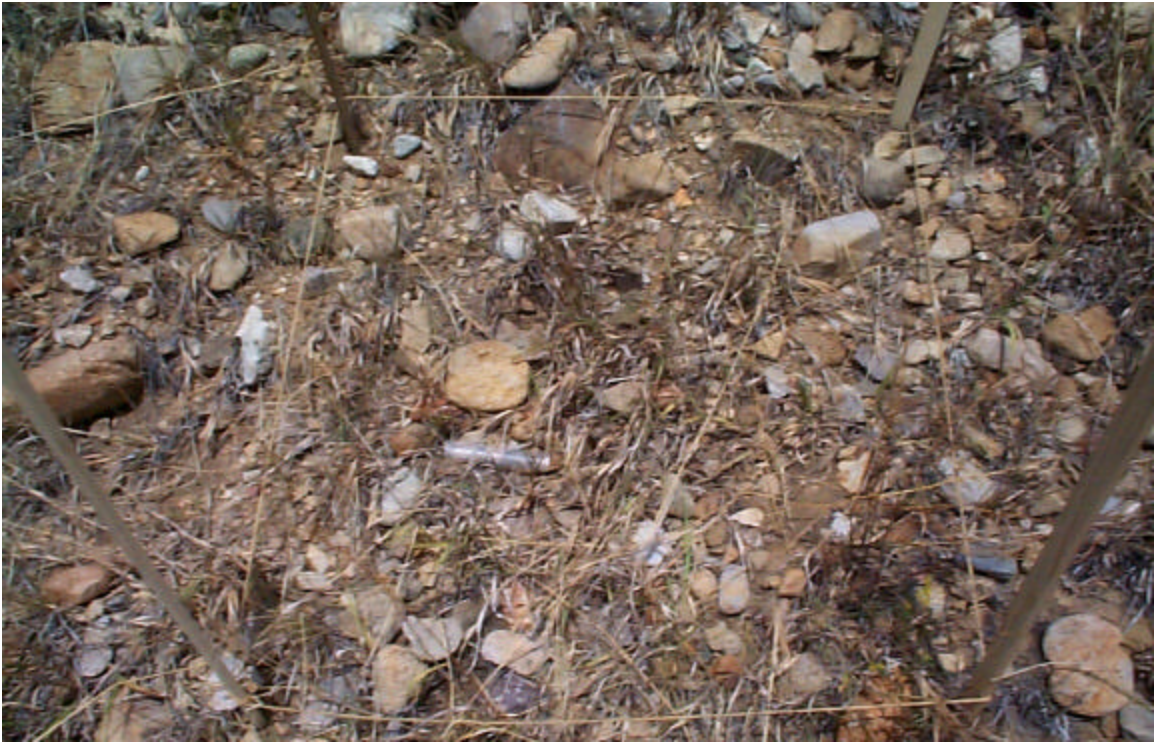
Photo 3: A 3 ft x 3 ft test plot created on the lower slope of Dam 1; representative only of the coarse rock (i.e. not vegetation) on the dam slope.

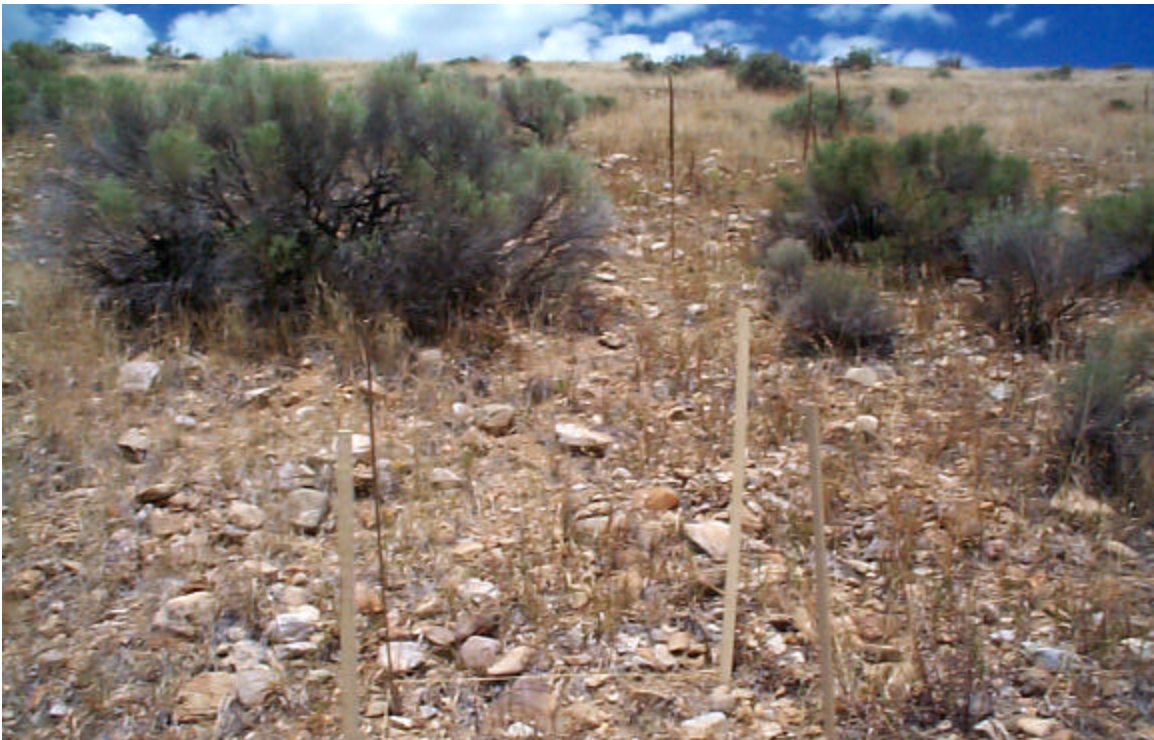
Photo 4: Looking upslope of the 3 ft x 3 ft test plot on the lower slope of Dam 1.

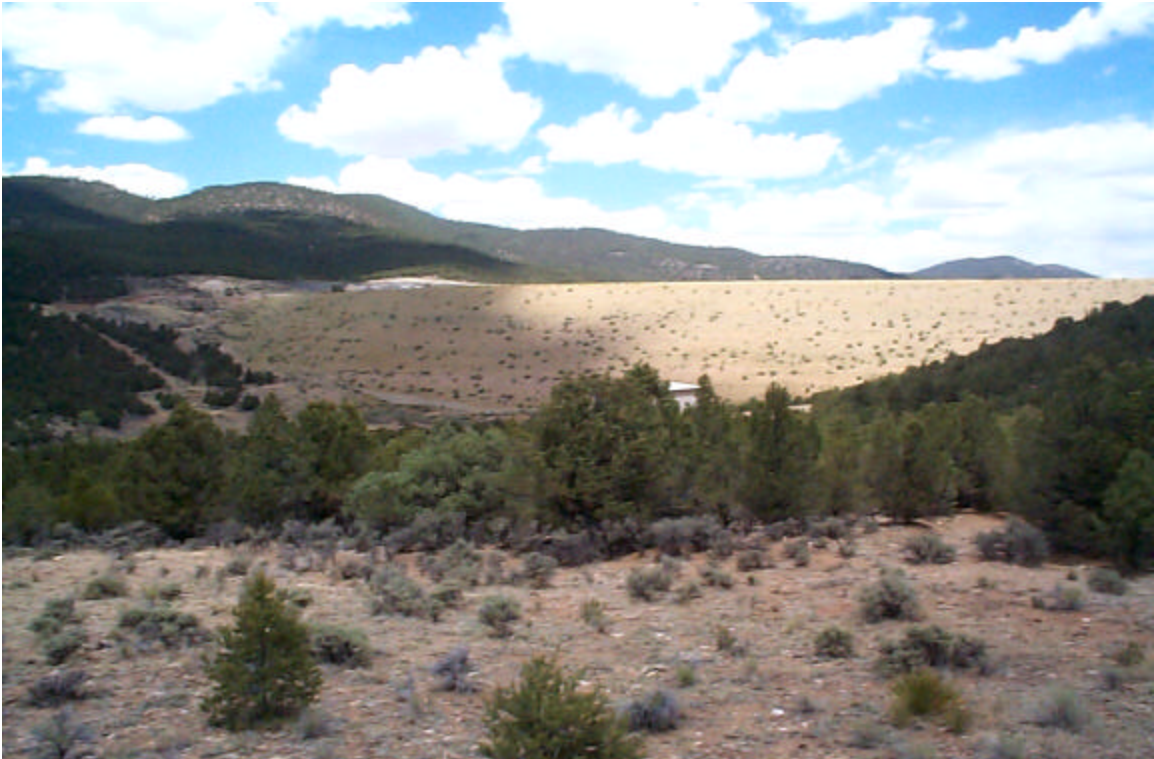
Photo 7: Looking north showing the downstream face of Dam 4.

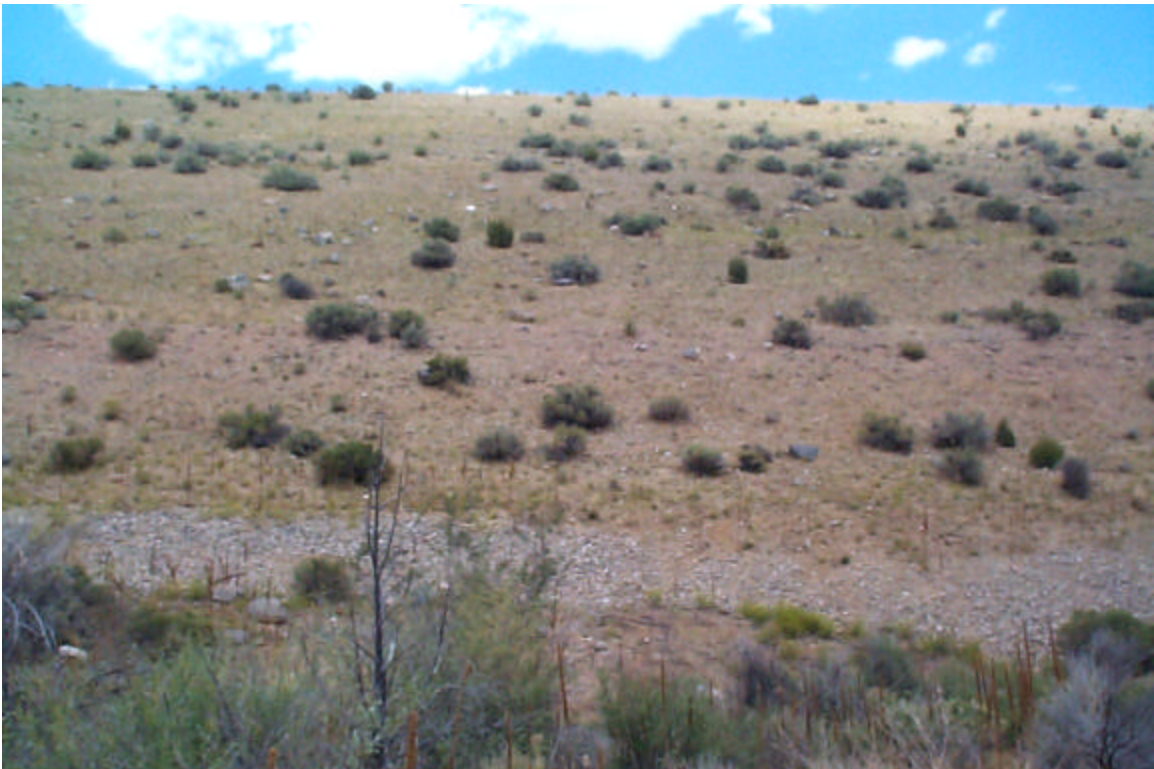
Coarse rock exists sporadically on the surface of the downstream face of Dam 4 (Photo 9), with the exception of the dam toe (Photo 10). Excluding the layer of coarse rock along the toe of Dam 4, the coarse rock coverage is only about half that observed on the downstream slope of Dam 1. In addition, the average size of coarse rock on the slope surface is smaller compared to the coarse rock observed on the Dam 1 slope surface.

Photo 8: Middle section of the downstream face of Dam 4; coarse rock layer at the toe.

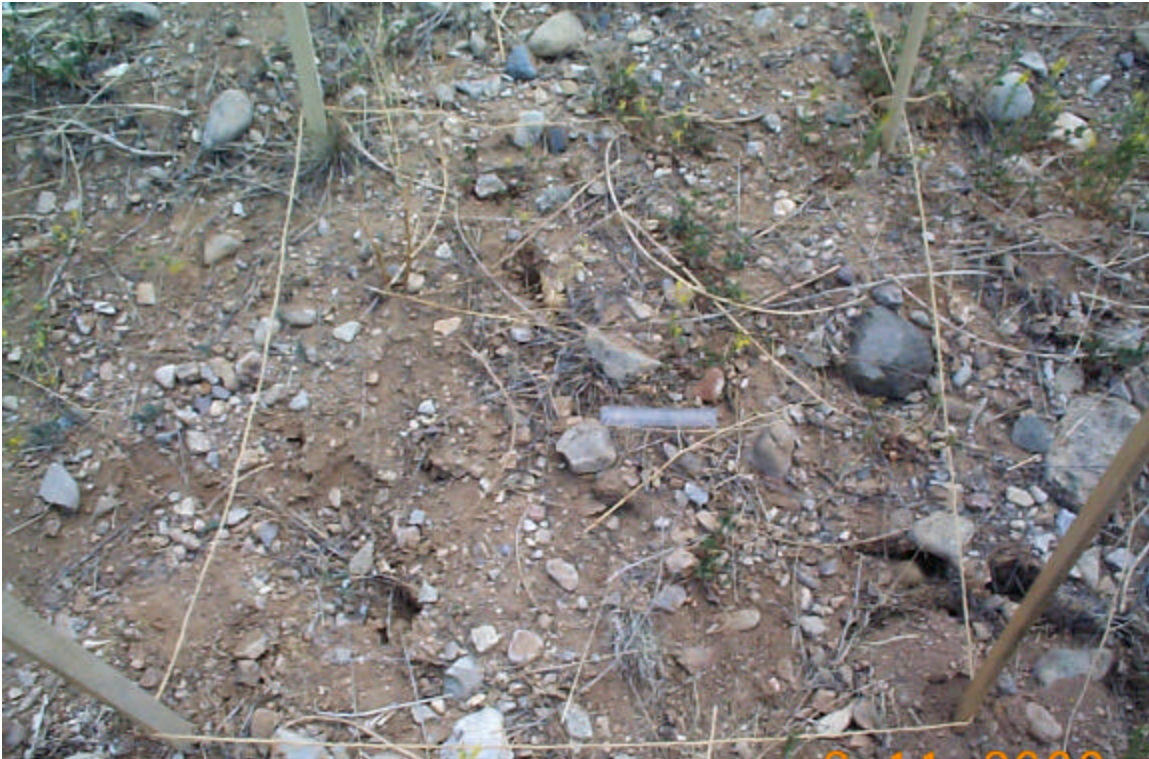
Photo 11: A 3 ft x 3 ft test plot created on the lower slope of Dam 4; representative only of the coarse rock (i.e. not vegetation) on the dam slope.

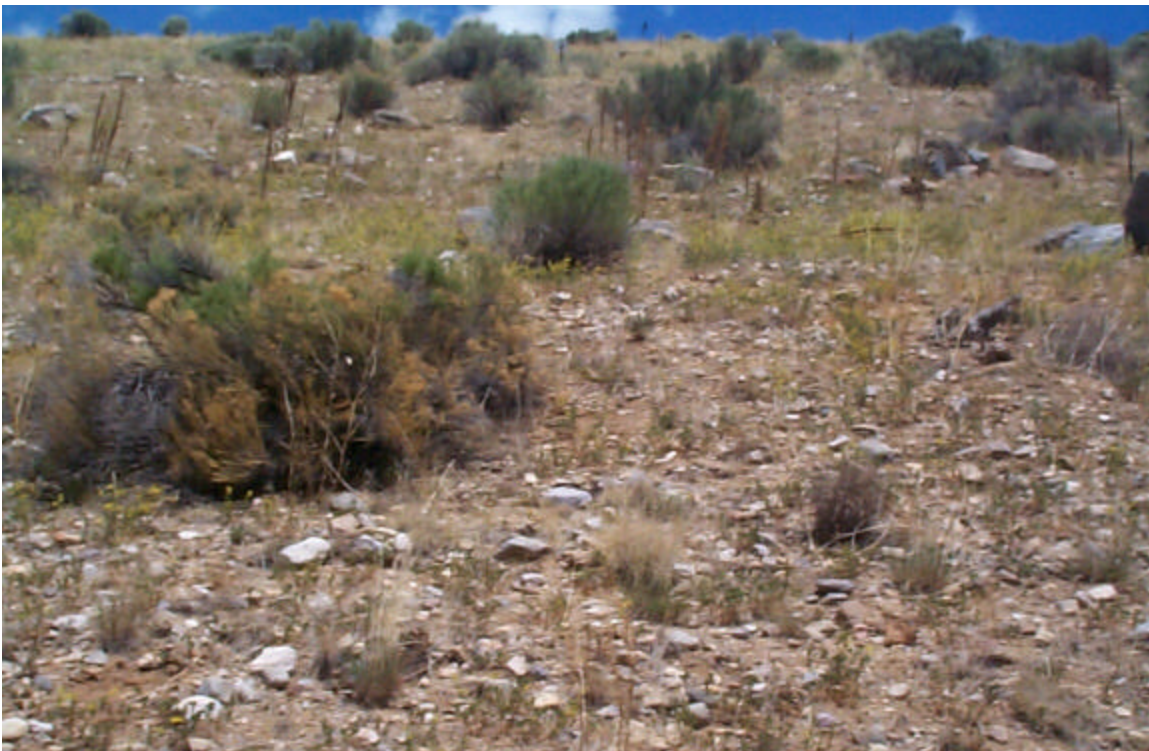
Photo 12: Looking upslope of the 3 ft x 3 ft test plot on the lower slope of Dam 4.

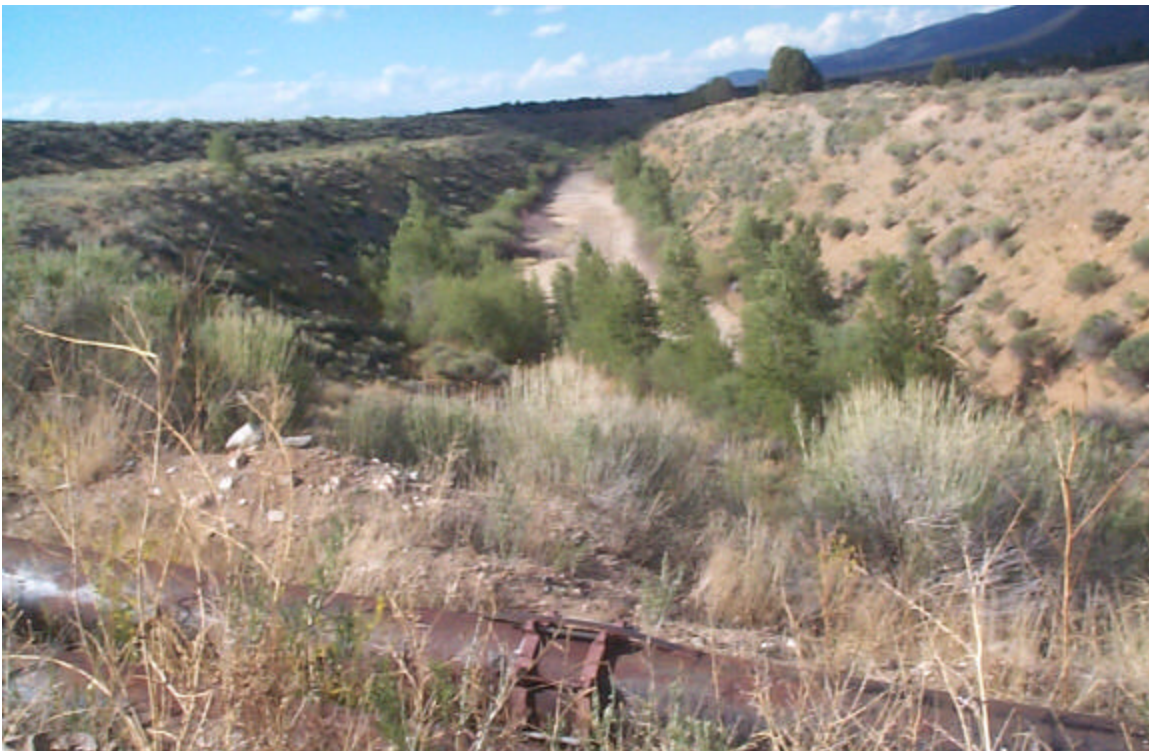
Stop E-4: This stop occurs on the road crossing over the diversion ditch (Photo 20). The area is a continuation of Stop E-3 and has similar characteristics. The ditch is still approximately 15 feet at this point.

Photo 20: East Diversion Ditch looking north from the road crossing at survey stop E-4.

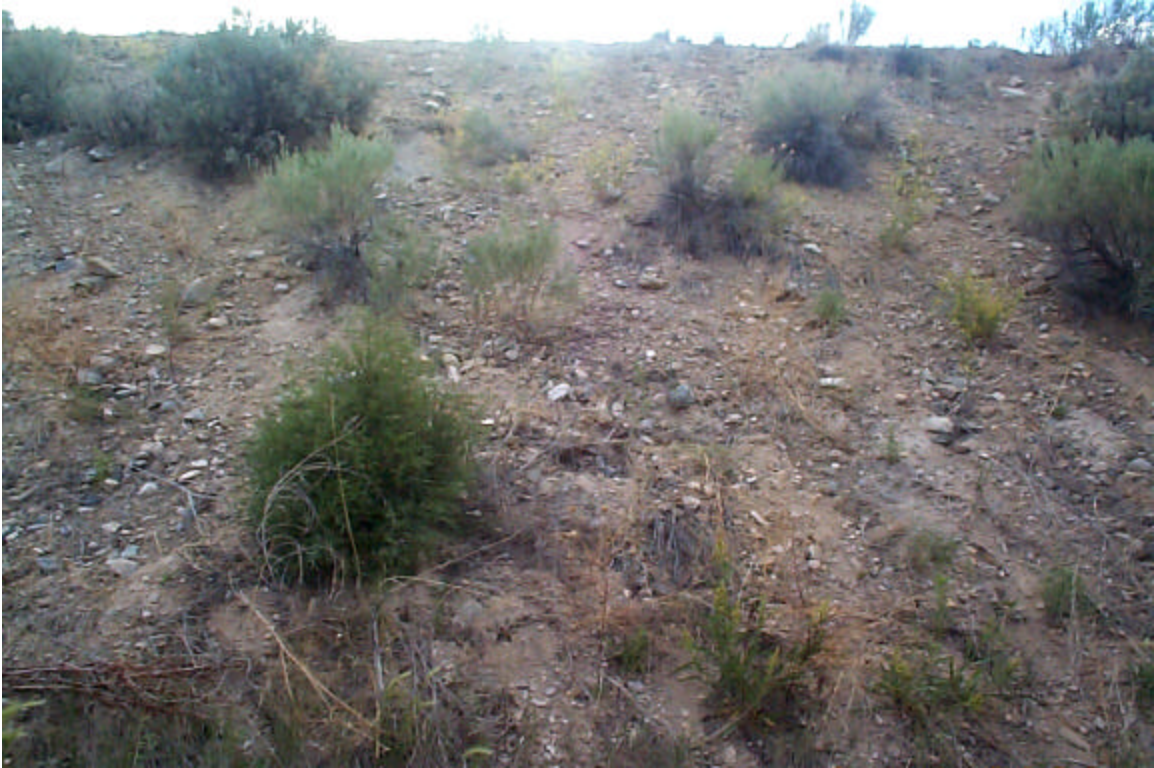
Photo 21: West slope of the East Diversion Ditch at survey stop E-5 (no erosion).

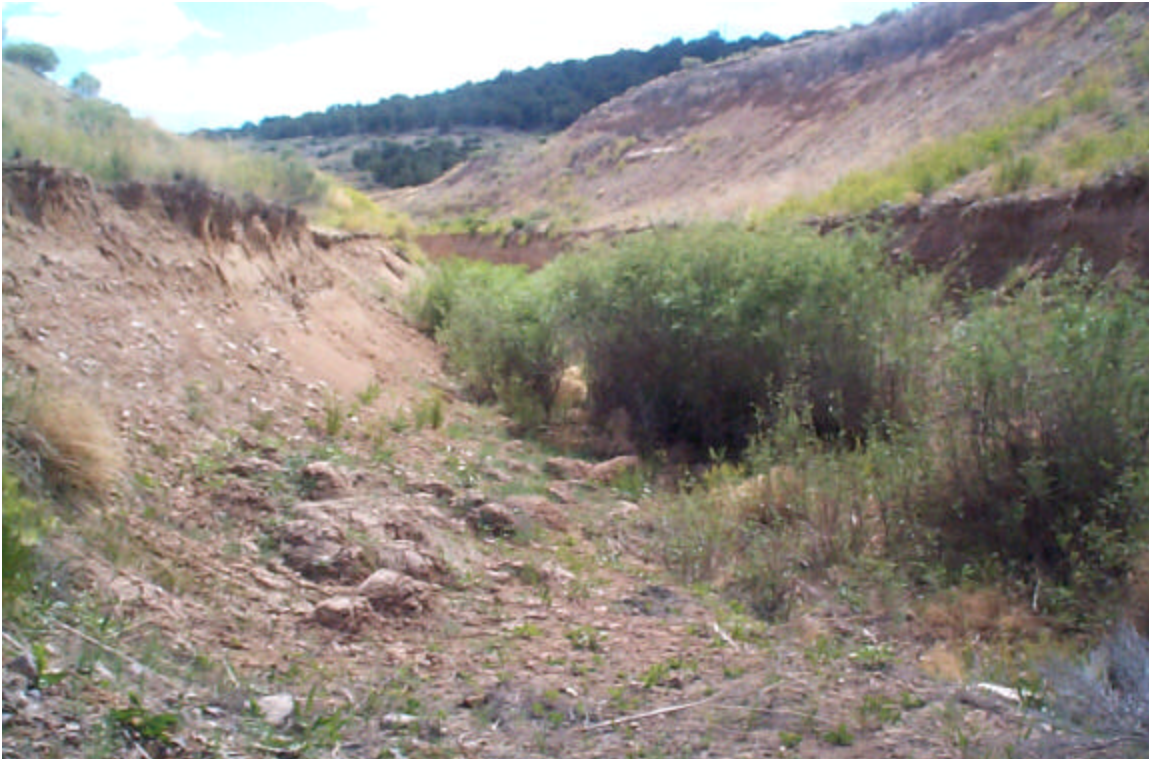
Photo 27: West Diversion Ditch looking south from the north end of the ditch (survey stop D-1).

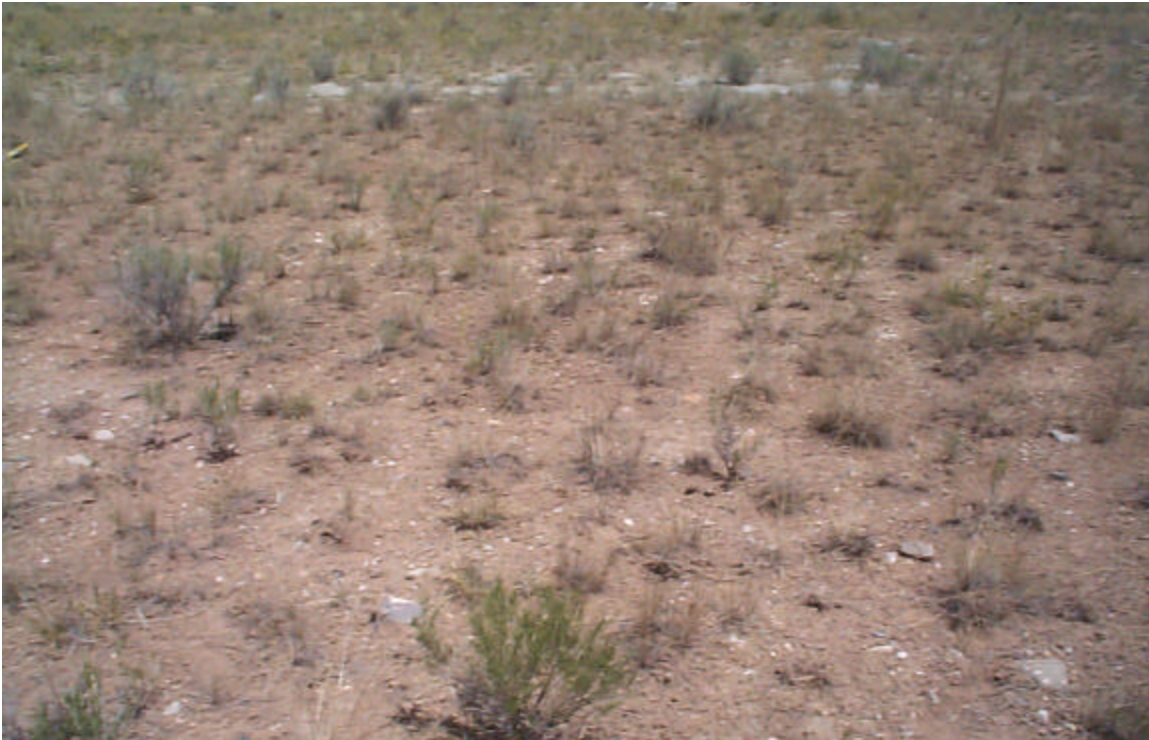
Photo 32: Example of the vegetation and cover material on the tailings area surface between Dam 1 and 1C.

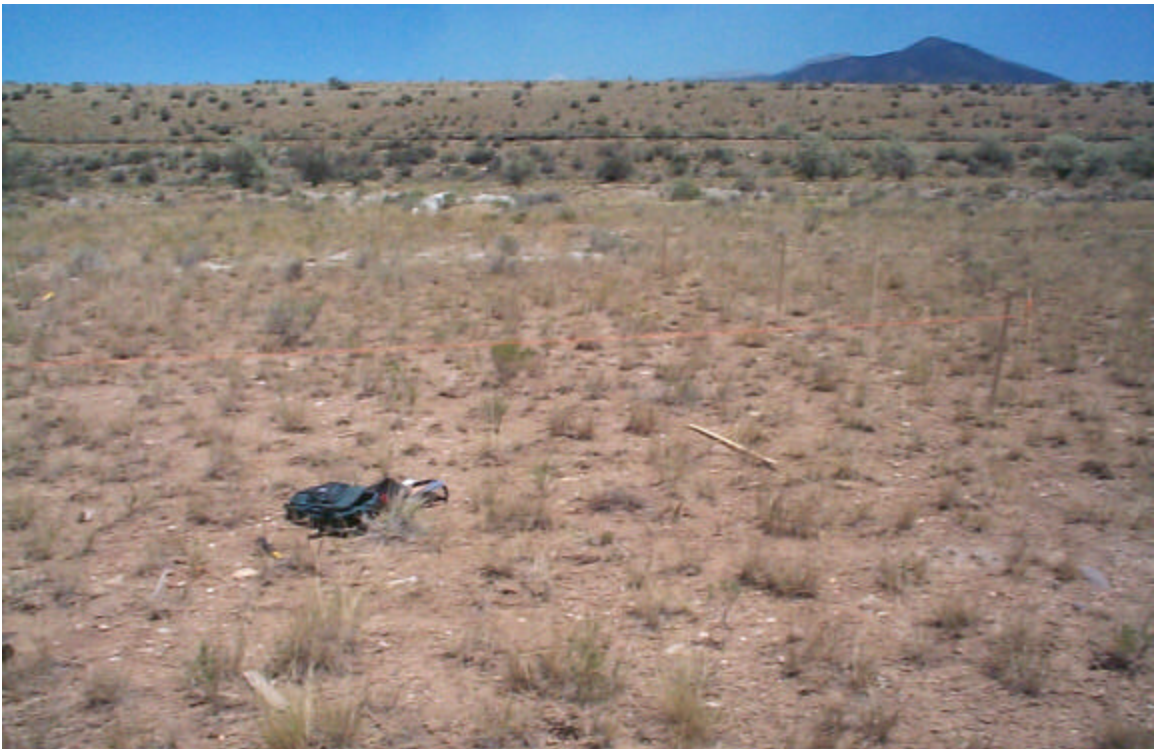
Photo 34: The 30 ft x 30 ft test plot representative of “typical” conditions on the surface of a tailings area covered and revegetated prior to 1974 (between Dam 1 and 1C).

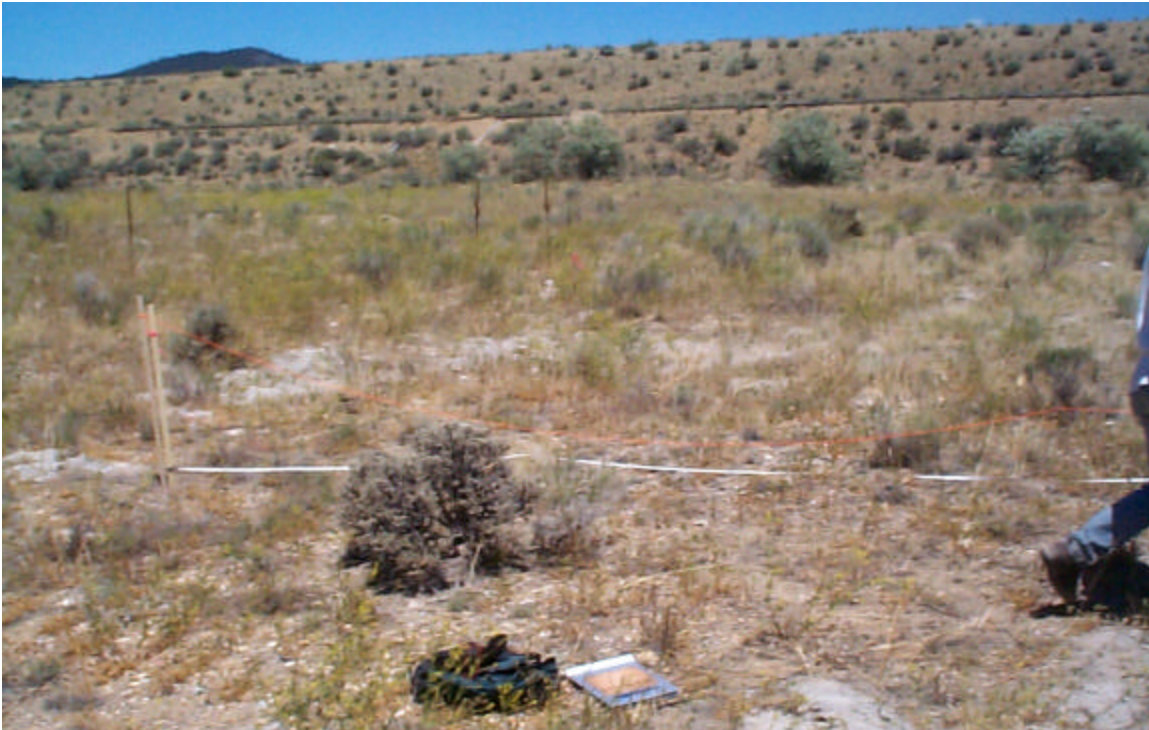
Photo 35: The 30 ft x 30 ft test plot representative of “more erosive” conditions on the surface of a tailings area covered and revegetated prior to 1974 (between Dam 1 and 1C).

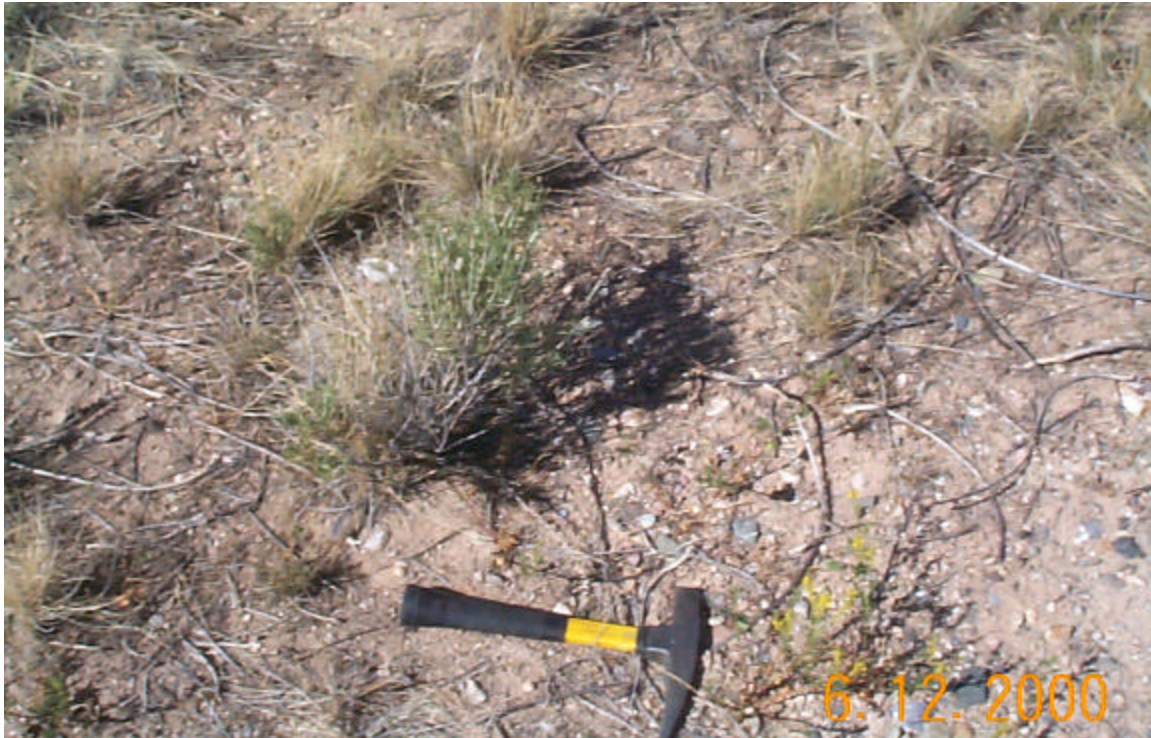
Photo 37: Close-up of the surface of the “typical” test plot on the surface of a tailings area covered and revegetated in 1993 (Dam 1 tailings area).

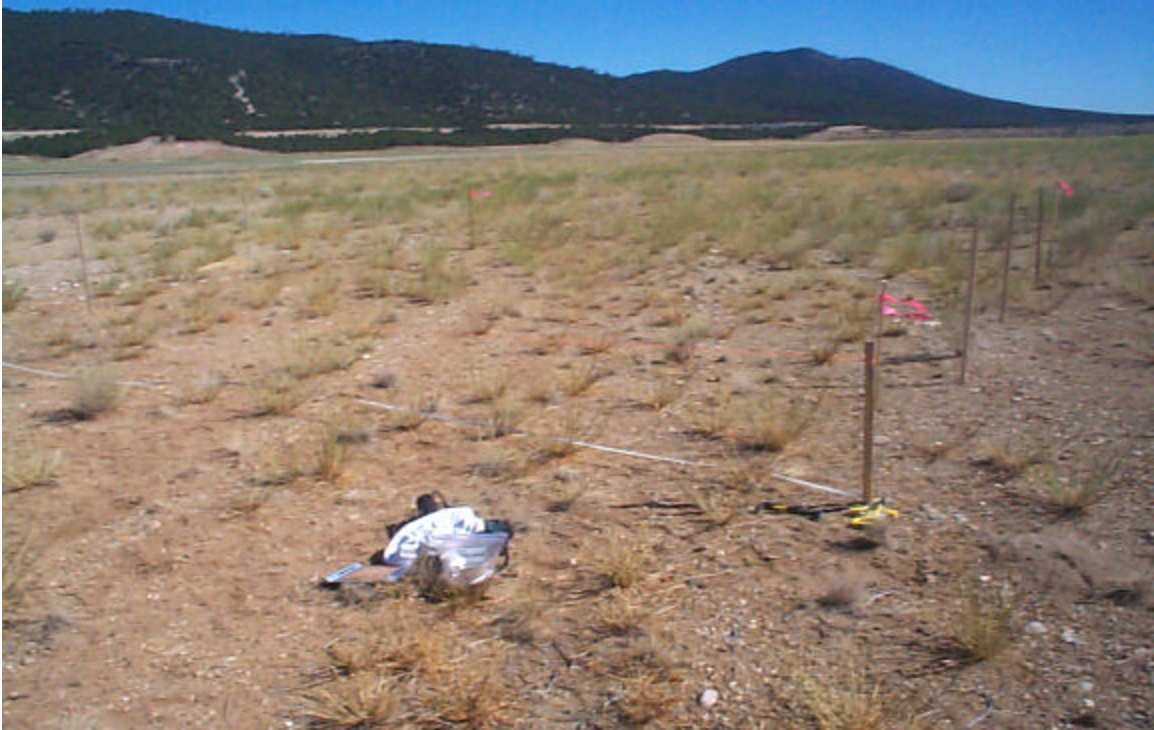
Photo 39: The 30 ft x 30 ft test plot representative of “typical” conditions on the surface of a tailings area covered and revegetated in 1993 (Dam 4 tailings area).

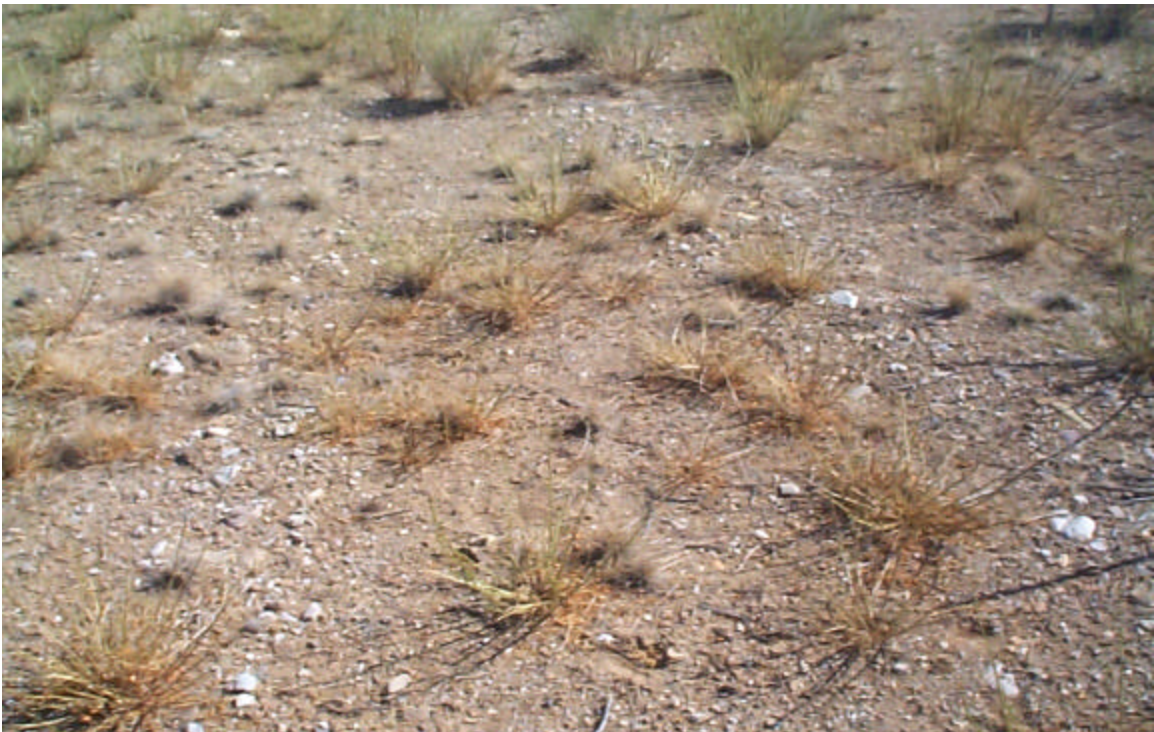
Photo 40: Close-up of the surface of the “typical” test plot on the surface of a tailings area covered and revegetated in 1993 (Dam 4 tailings area).

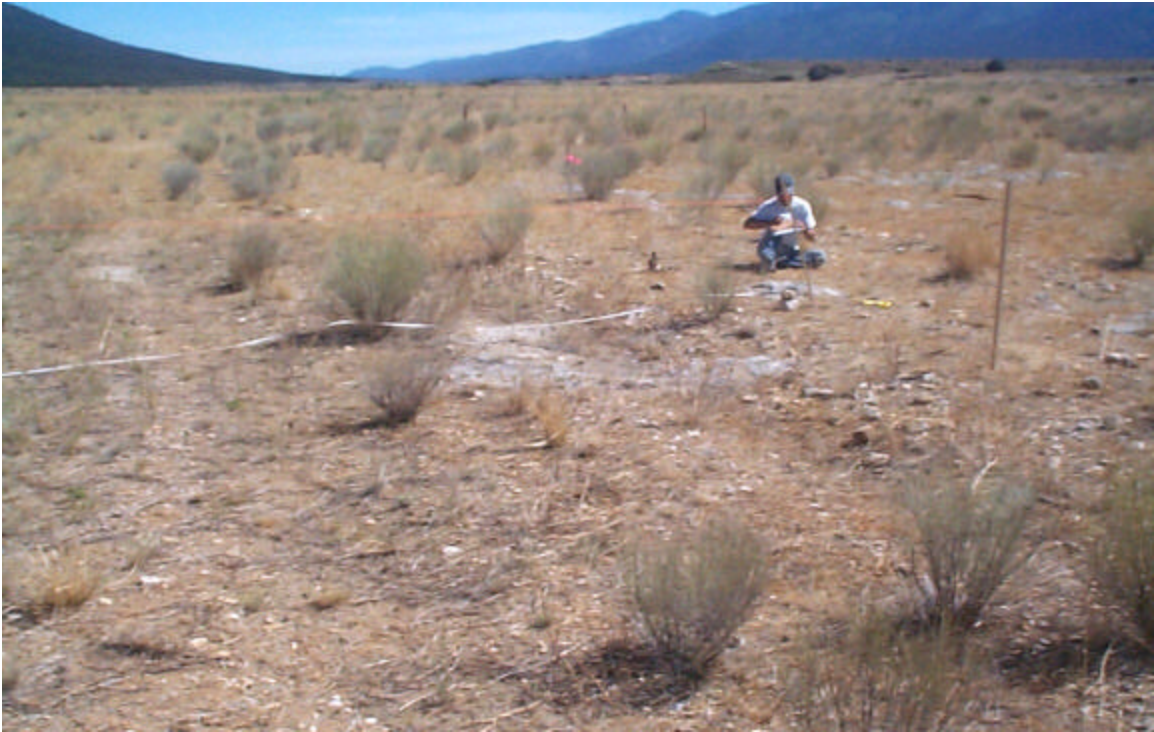
Photo 41: The 30 ft x 30 ft test plot representative of “more erosive” conditions on the surface of a tailings area covered and revegetated in 1993 (Dam 4 tailings area).

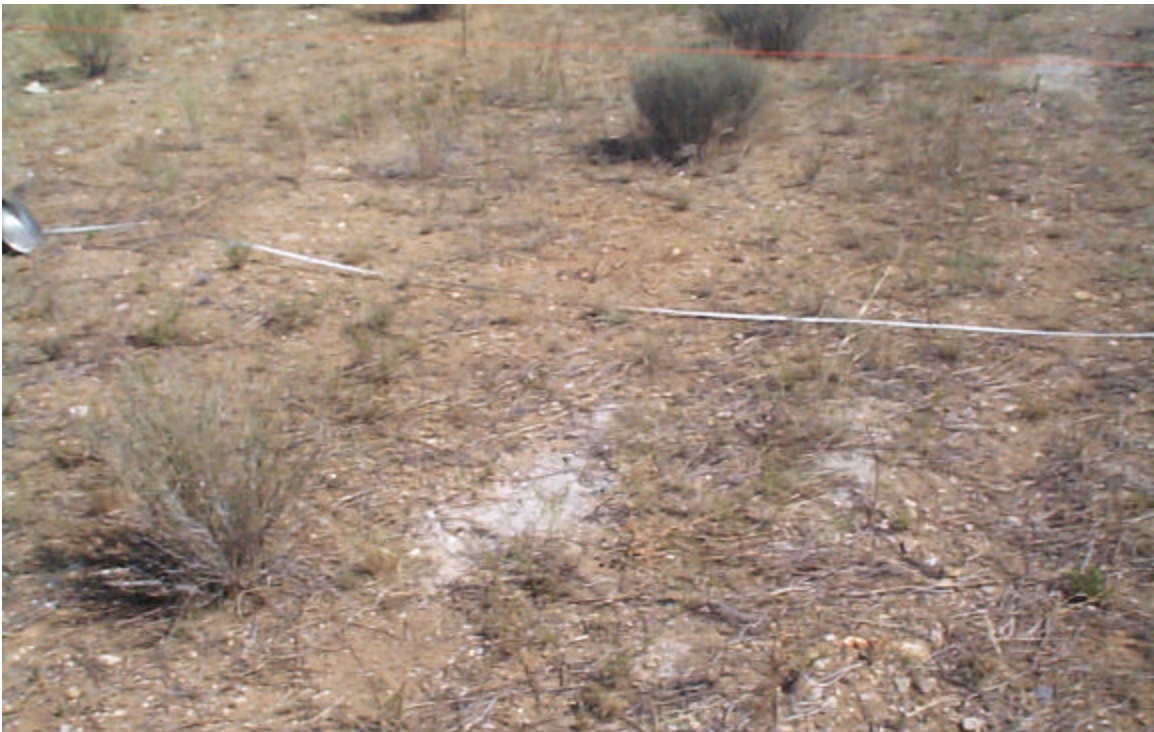
Photo 42: Close-up of the surface of the “more erosive” test plot on the surface of a tailings area covered and revegetated in 1993 (Dam 4 tailings area).

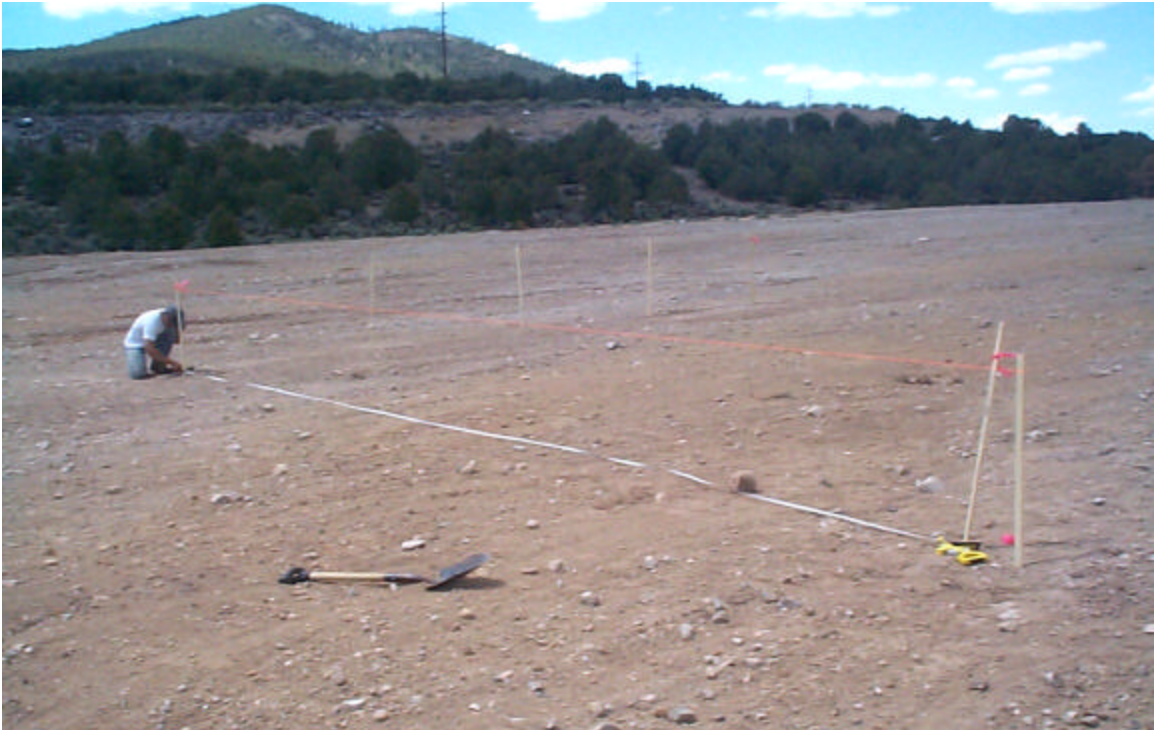
The surface of the area surveyed consists of a sandy-gravel matrix (interim cover borrow material) and virtually no vegetation (seeding of the area occurred in May 2000), as shown in Photo 43.

The locations of the test plots developed on the tailings area covered and seeded in 2000 are shown in Figure 3. The test plots are very similar in appearance. Photo 43 shows the one of the two test plots.

Photo 43: The 30 ft x 30 ft test plot representative of “typical” conditions on the surface of a tailings area covered and revegetated between 1998 and 2000.

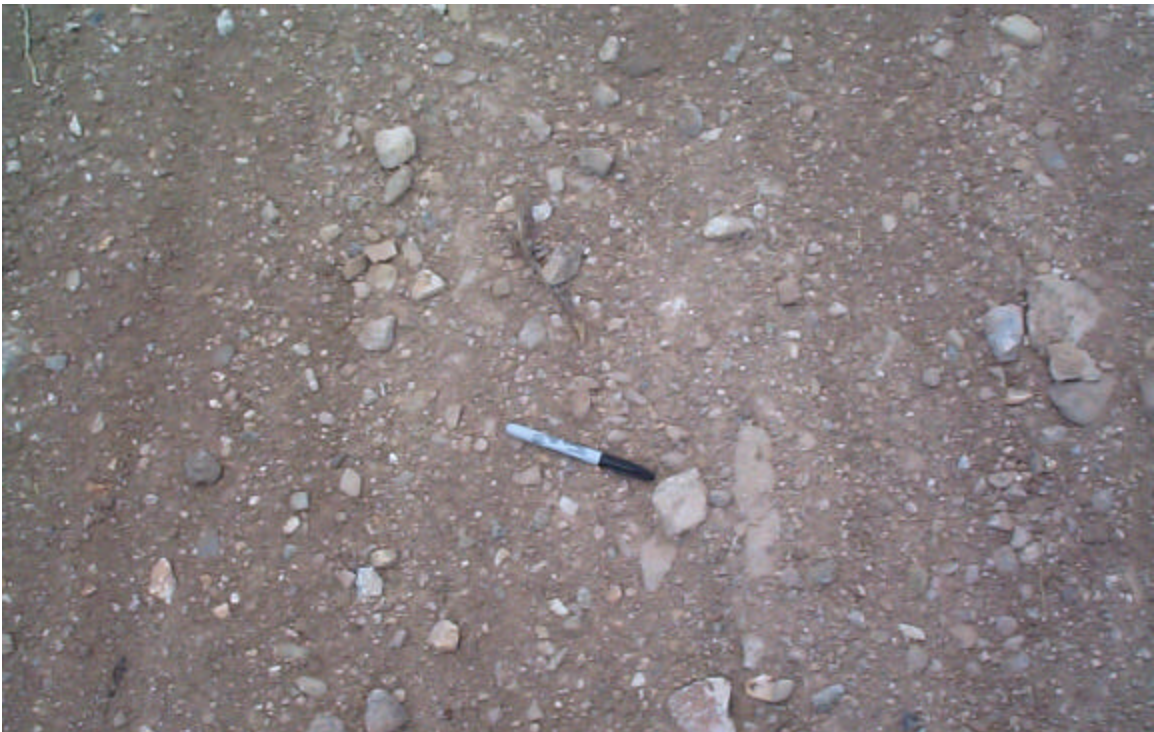
Photo 44: Close-up of the surface of the “typical” test plot on the surface of a tailings area covered and revegetated between 1998 and 2000.
