Abandoned Uranium Mine Field Survey Project

prepared for
New Mexico Energy, Minerals and Natural Resources Department
Mining and Minerals Division

July 18, 2008

RE: Final Report - Abandoned Uranium Mine Field Survey Project

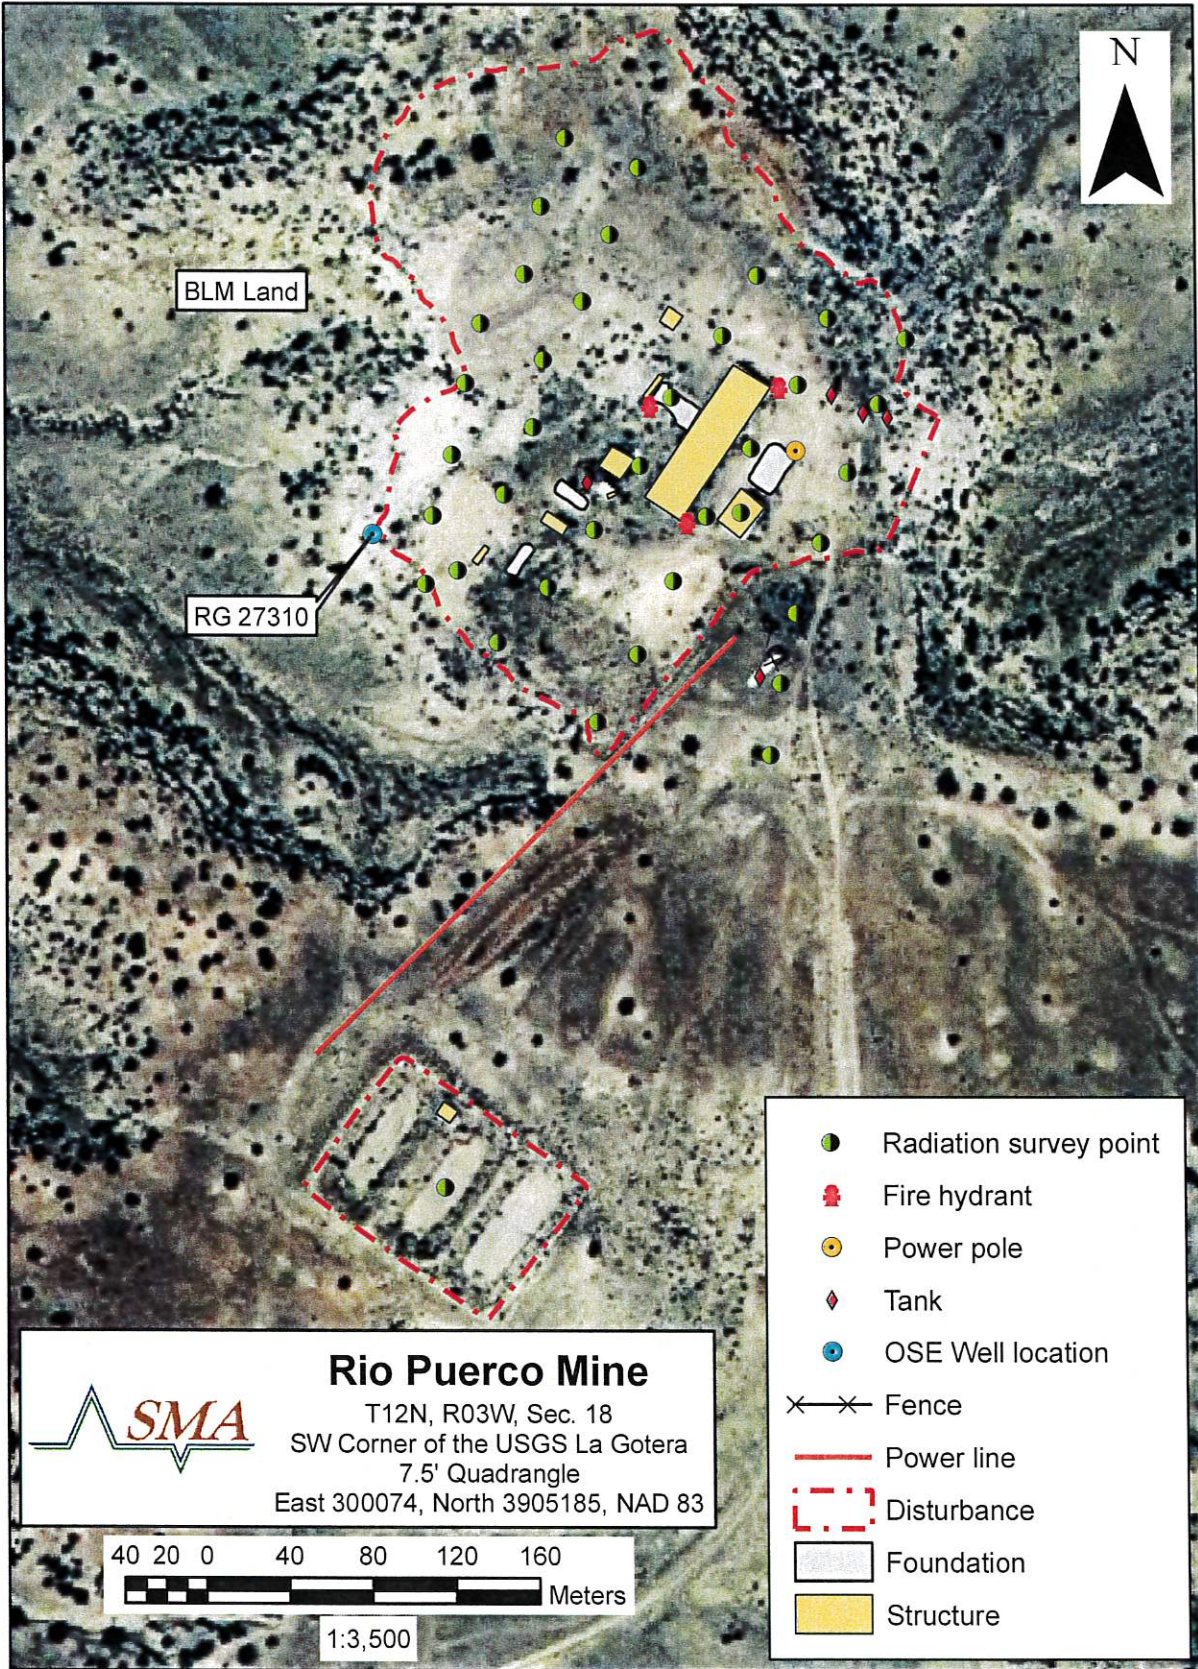
AUM Field Survey Data Sheet

Radiological Survey			
GPS#	Description	Reading Surface	Reading 4 feet
DISTRB Ø	Area around buildings and waste piles ✓	—	—
Found Ø	Power distribution yard. Several transformers w/ spilled oil; ✓	—	—
"	possible PCB contaminated soils. ✓	—	—
STRUC Ø	House air and power generation 4 cyl. CHT compressor & 16 cyl. ✓	—	—
"	generator (locomotive scale) ✓	17	17
Genit Ø Arc	Fire hydrant	—	—
STRUC-1	Main building; consists of offices, showers, headframe lifts, etc. ✓✓✓		
STRUC-3	Quonset-hut ✓		
STRUC-4	headframe ✓		
ARC-1	Fire hydrant		
STRUC-5	Pump house ✓		
TANK-0	16 x 16' ✓		
STRUC-6	Unknown 1/2" plate steel structure ventilated w/ two locked doors. ✓		
FOUND-2	unknown		
STRUC-7	Multi-celled tank and pump structure. ✓
