Field Compliance Order

Facility Name: NMDOT D 2 Service Center	Facility Number: 29673
Facility Address: 4505 West Second Street, Roswell, NM 88201	
Owner Name: New Mexico (State of) NMDOT District 2	Owner Number: 14093
Operator Name: New Mexico (State of) NMDOT District 2	Operator Number: O1988

Aboveground Storage Tank Systems Inspection Report

Inspection Type: Compliance	Case Number: 22 20190715 0078	Inspection Start Time: 1:30:00 PM	Date: 15-Jul-19
------------------------------------	--------------------------------------	-----------------------------------	-----------------

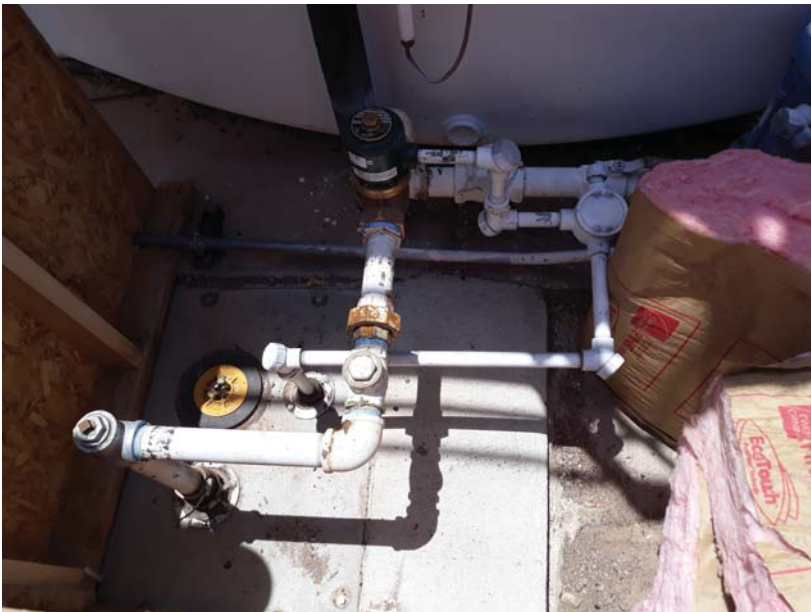
Picture Number: 11

Detail of Box Over Unleaded Piping & Transition Sump

Note: No hinge on lid & box is screwed together prohibiting easy access.
