# Abandoned Uranium Mine Site Assessment for the Good Luck Site (NM0175)

**FINAL REPORT**

**April 20, 2010**

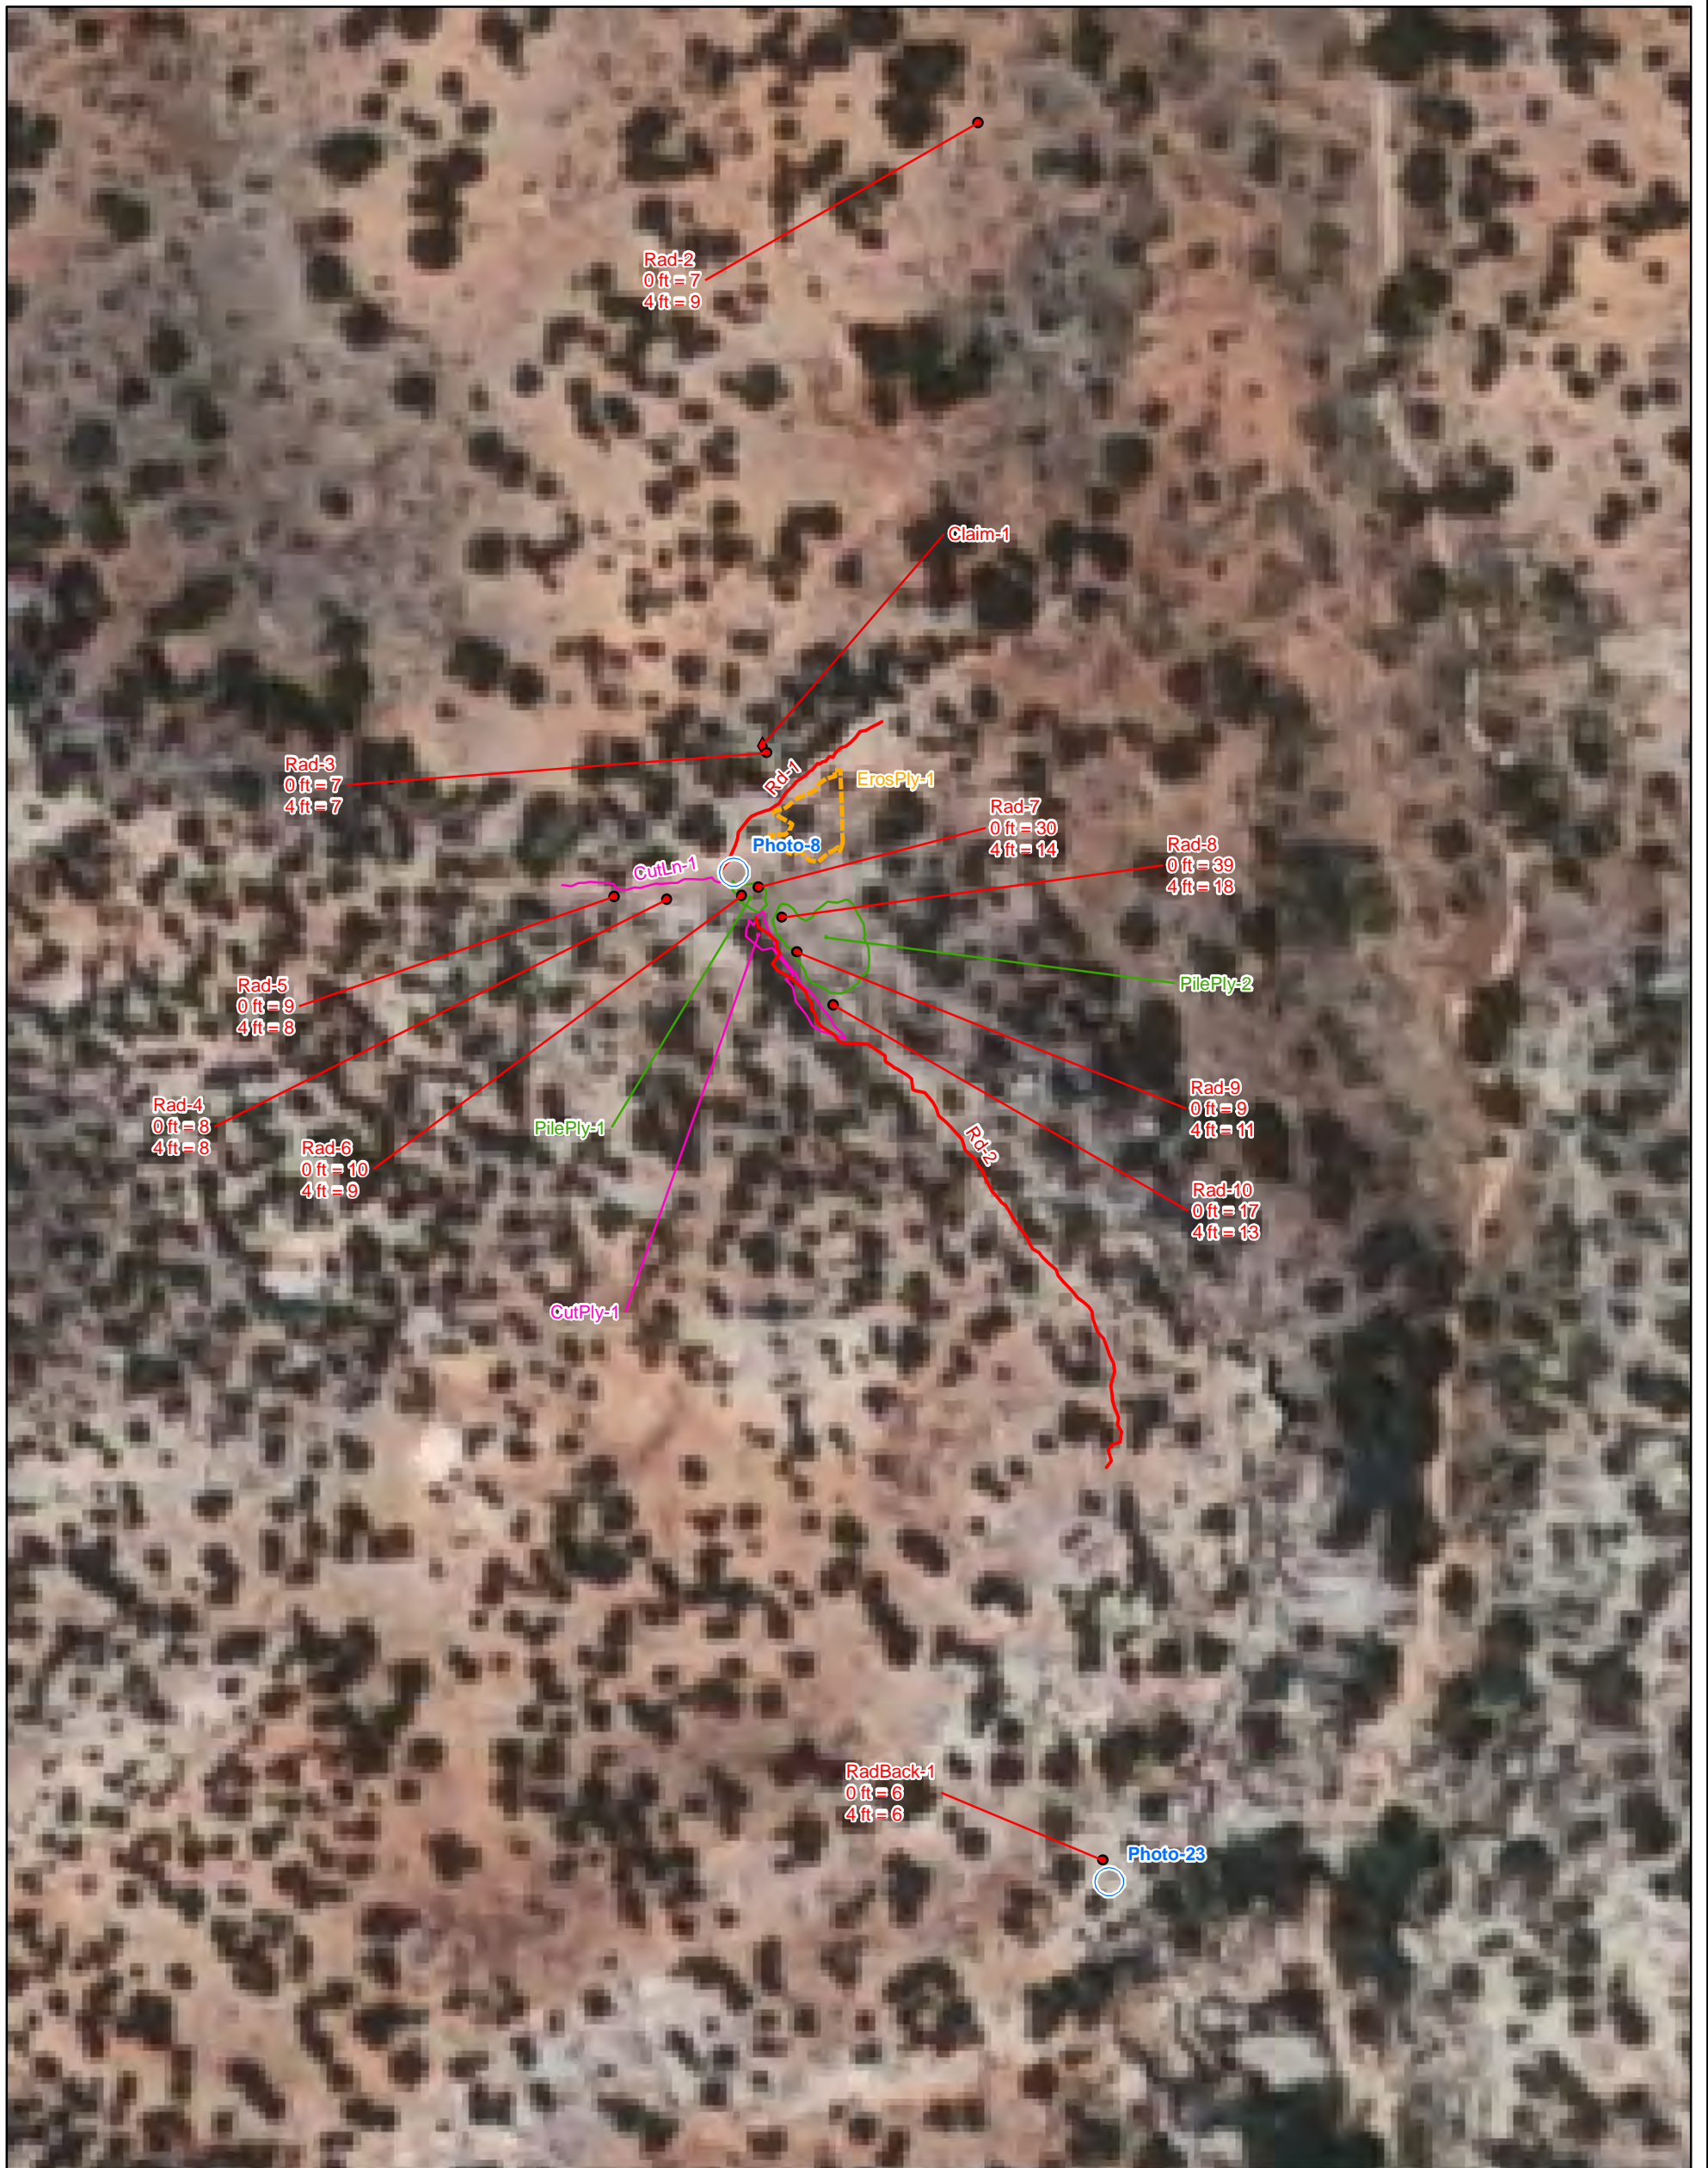
**Figure 4a**  
**Site Map on**  
**Aerial Photo**  
**NM0175-Good Luck**  
 Abandoned Uranium  
 Mine Assessment

The mine features described below are based on the features provided to INTERA by MMD in the GIS Data Dictionary (MMD, 2009). INTERA marked the locations of the AUM Site features using a Trimble Global Positioning System (GPS), and entered details about the features into the GPS using the MMD data dictionary. Two open cuts and two piles were found onsite. In addition, two mining roads, a possible claim marker, and a large erosional feature were found at the AUM Site. A stock tank (water catchment) was also discovered about a quarter mile northeast of the mine features. Please see the Photo Log in Appendix A, Table 1 for a list of AUM Site features, and Figure 4a and 4b for the locations of the AUM Site features. Note that the scale differs between Figure 4a (aerial photo) and 4b (ownership map).

One background gamma radiation reading was taken at the AUM Site, recording 6  $\mu\text{R/hr}$  at contact and 6  $\mu\text{R/hr}$  at 4 ft above ground. Please see Table 2 for all of the gamma radiation readings taken at the AUM Site and Figure 4 for the locations of the radiation readings.

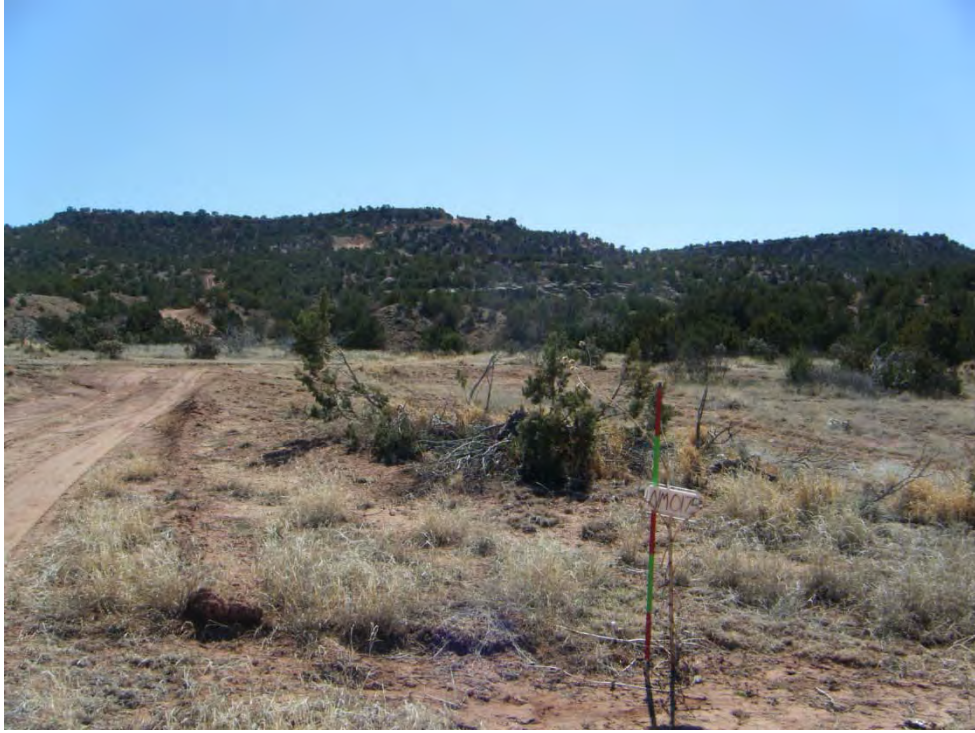
Photo 1-Site photo, looking south.

Photo 1 - site photo, looking S

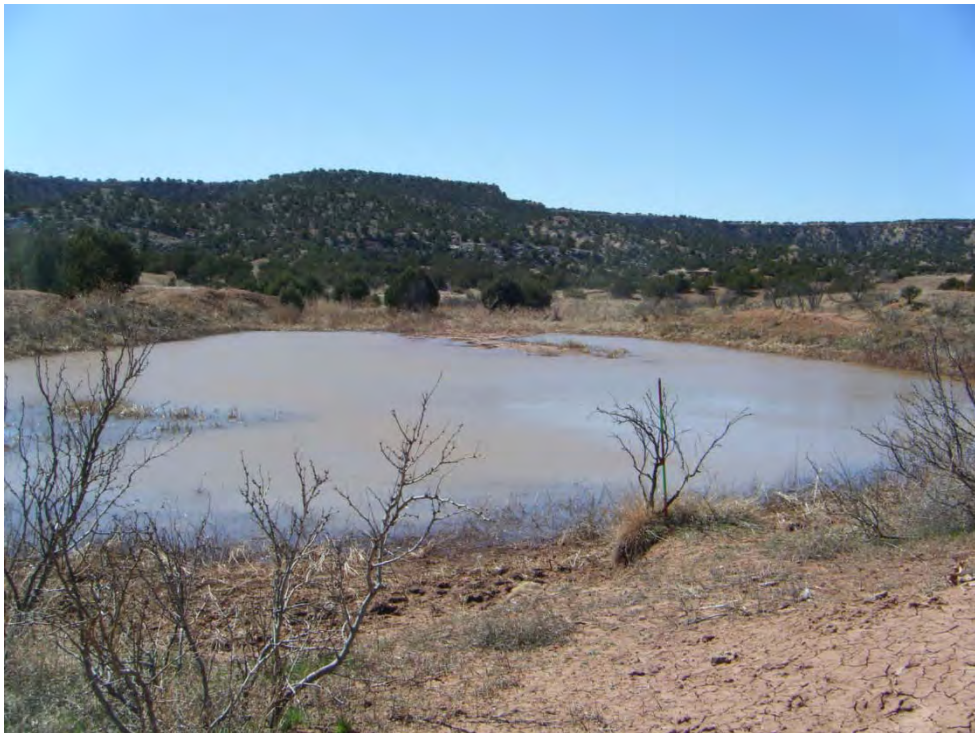
Cow droppings were noted in the area and a local rancher holds a grazing lease on the Site. A stock tank is located about a quarter mile northeast of the mine features.

Photo 2-A stock tank (Imp-1) below the AUM Site, looking southwest.

Photo 2 - Imp 1, looking SW

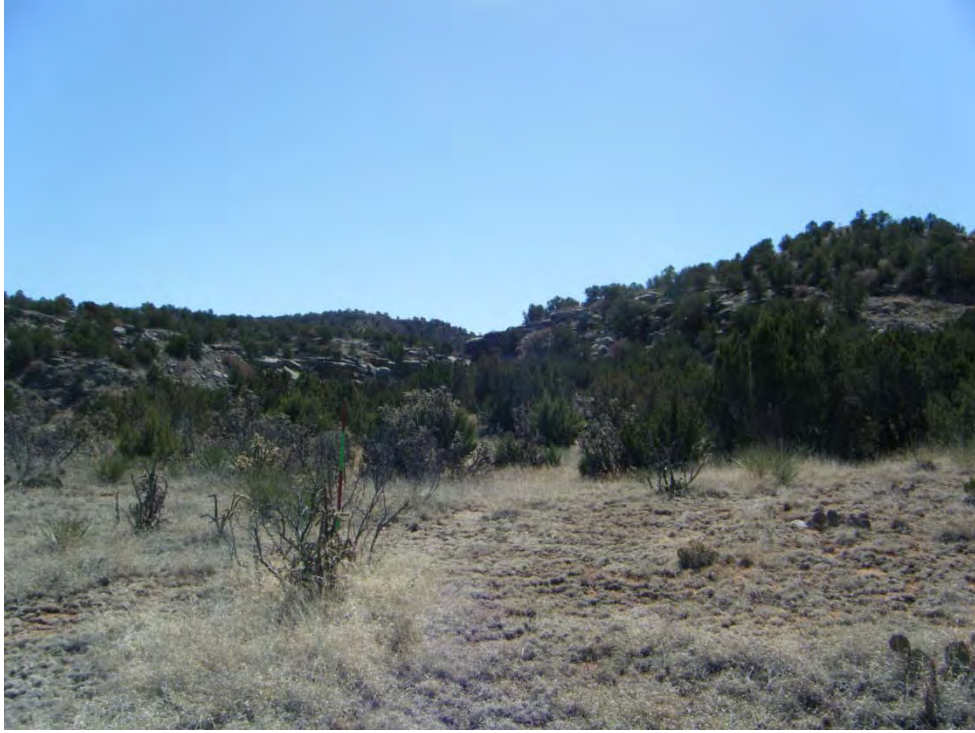
Photo 3-Site photo, looking south.

Photo 3 - site photo, looking S

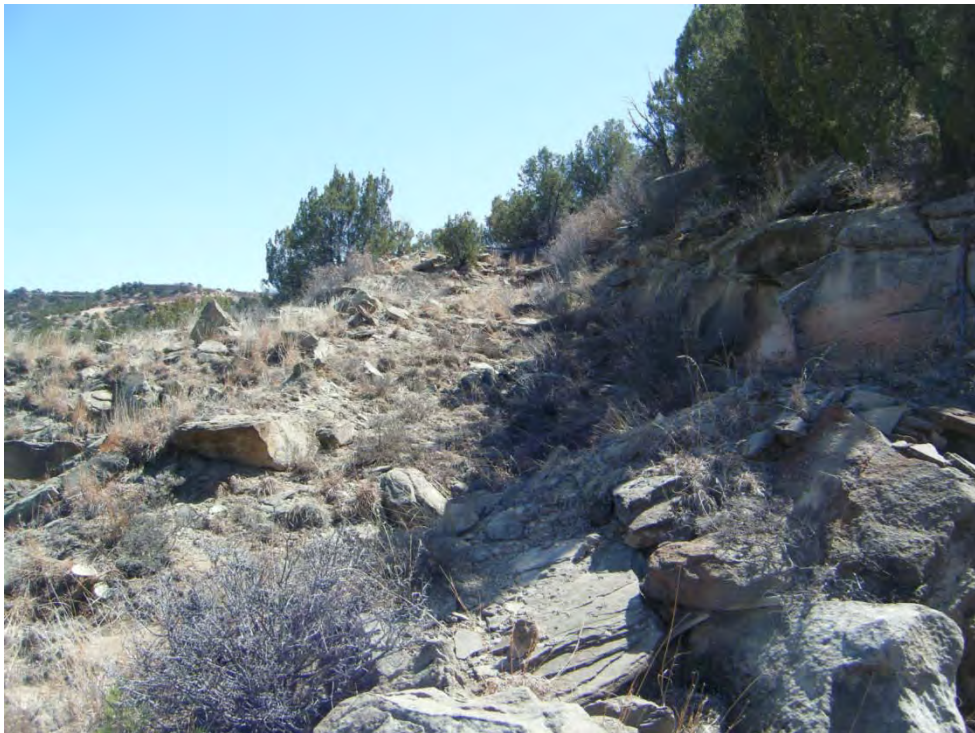
Two mine roads (Rd-1 and Rd-2) exist at the AUM Site. Both of these roads are no longer passable. A possible claim marker was discovered (Claim-1, see Photo 4 in Appendix A).

Photo 8-Looking southeast at Rd-2, replicating Anderson photo "b".

Photo 8 - replicating Anderson photo  
of access road, looking SE

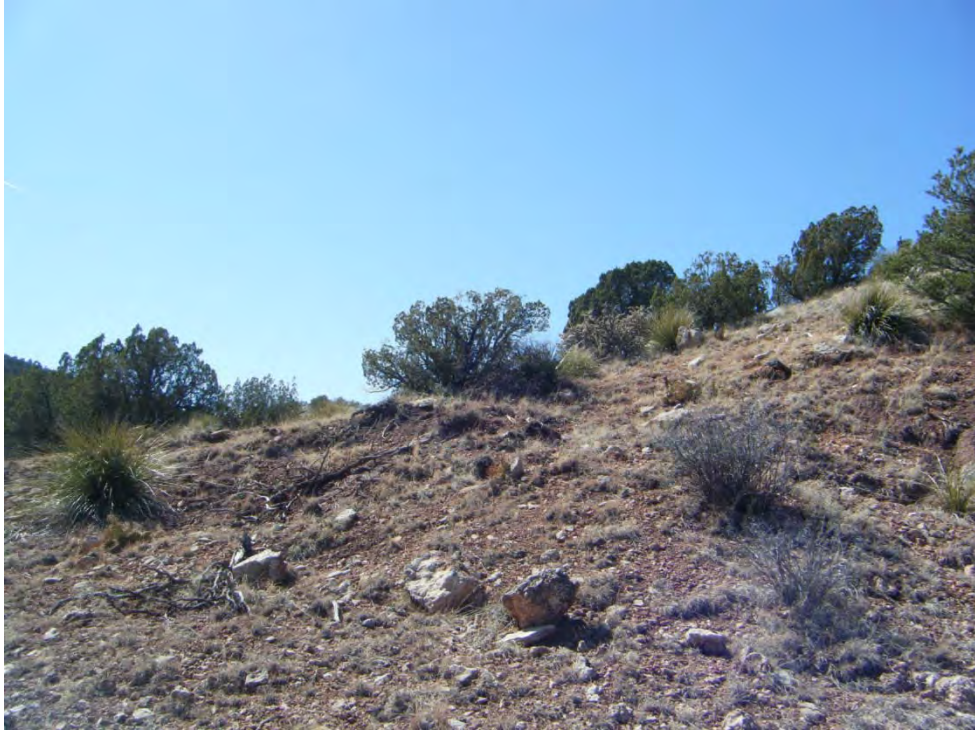
Photo 22-AUM Site vegetation.

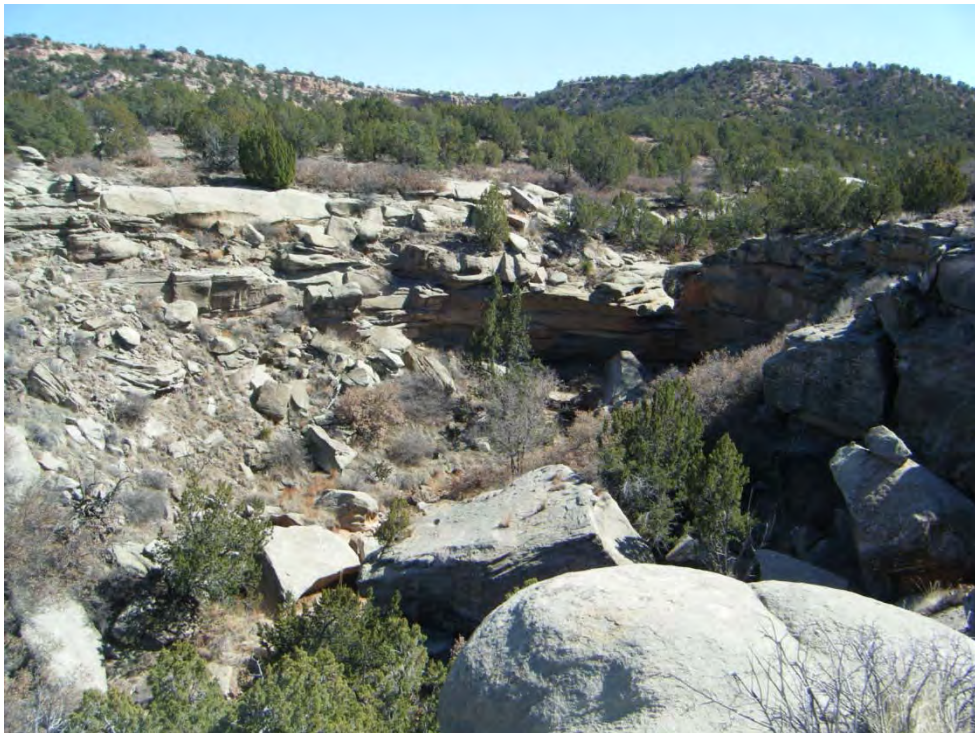
Photo 23-Looking southeast at location of MMD shapefile.

Photo 23 - canyon S of mine features, looking SE, where MMD shape file is located
