**NEW MEXICO  
ENVIRONMENT DEPARTMENT**

RE: Tanker Spill into the Cimarron River and Associated Clean-Up near Cimarron, New Mexico

### **Inspection Findings**

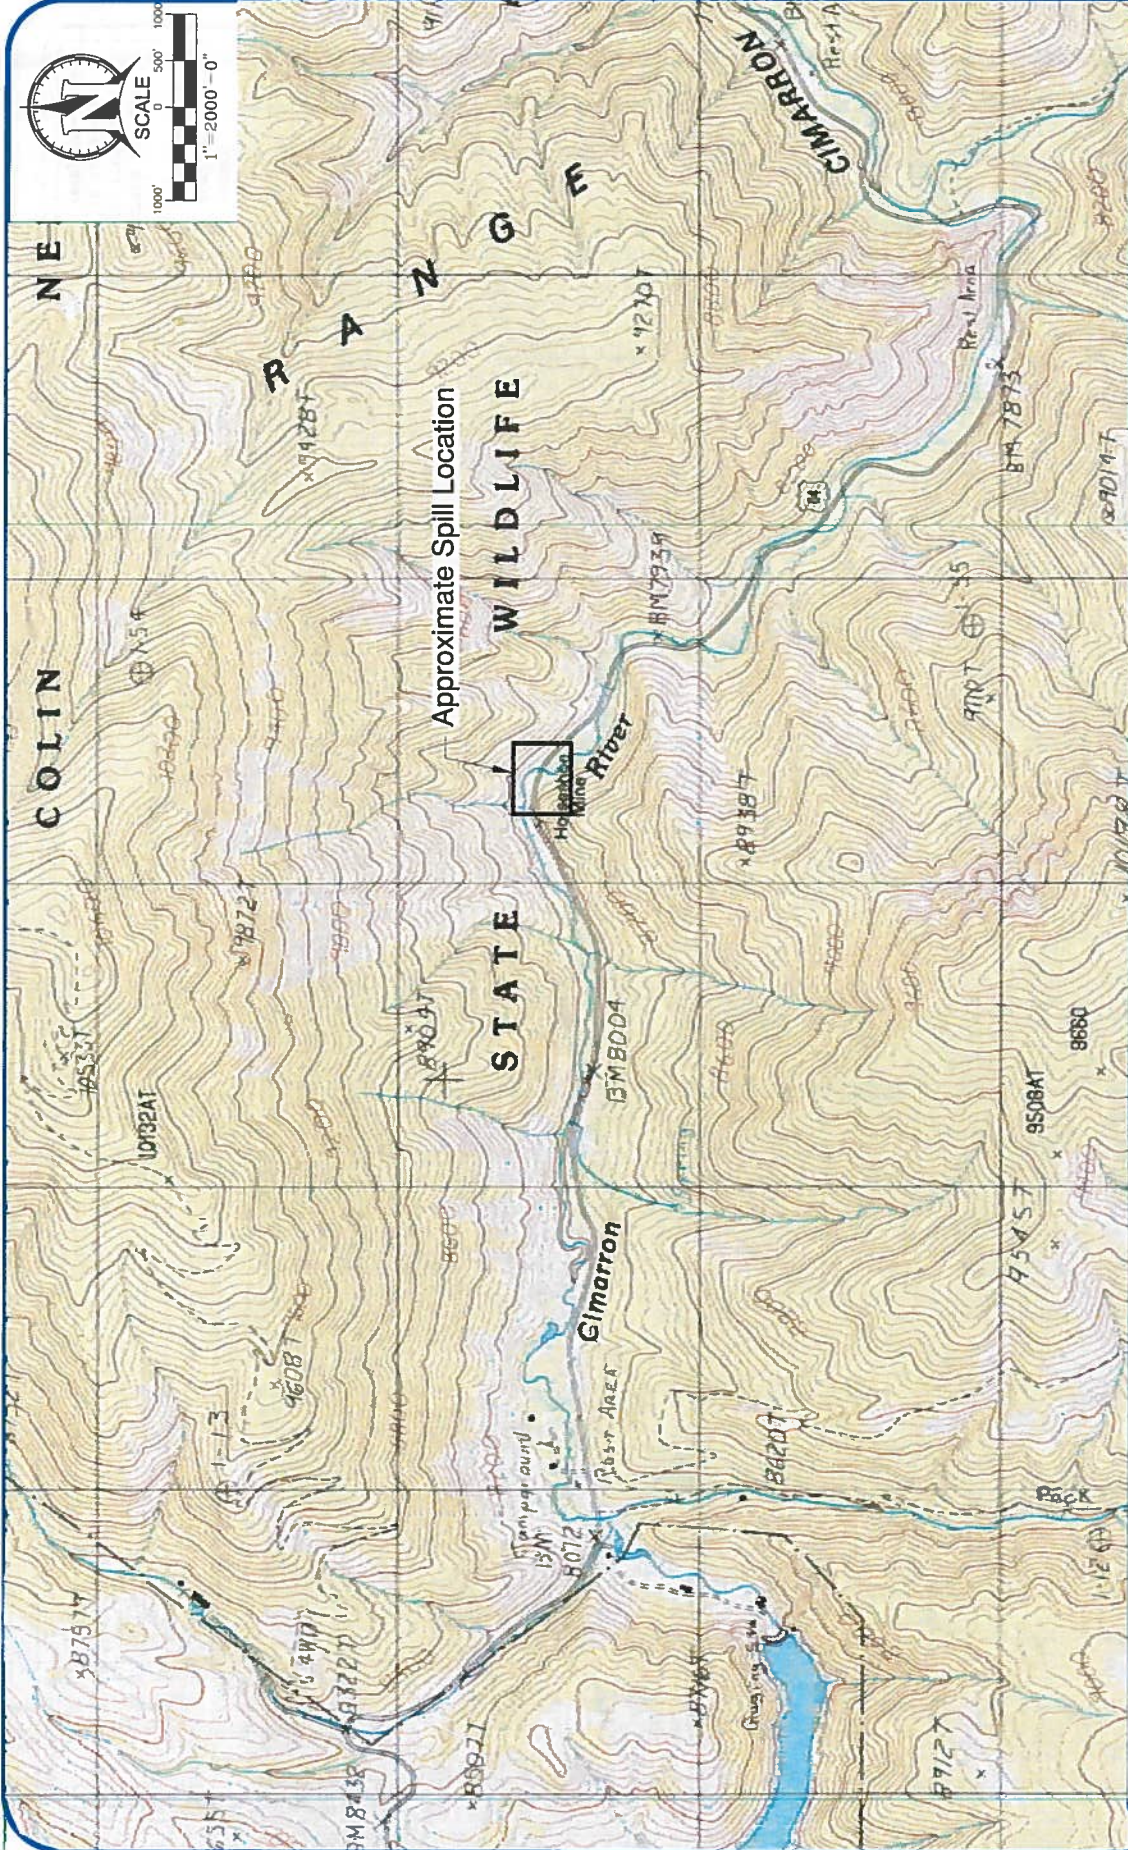
Photographer: Daniel Valenta	Date: 2-9-17	Time: Unknown
City/County: Cimarron/Colfax County		
Location: In the Cimarron River below the highway culverts.		
Subject: A sheen on the water is still evident as fuel entrained in the ice is being released during melting events.
