# Abandoned Uranium Mine Site Assessment for the Napane Site (NM0137)

**FINAL REPORT**

**February 23, 2010**

NM0137

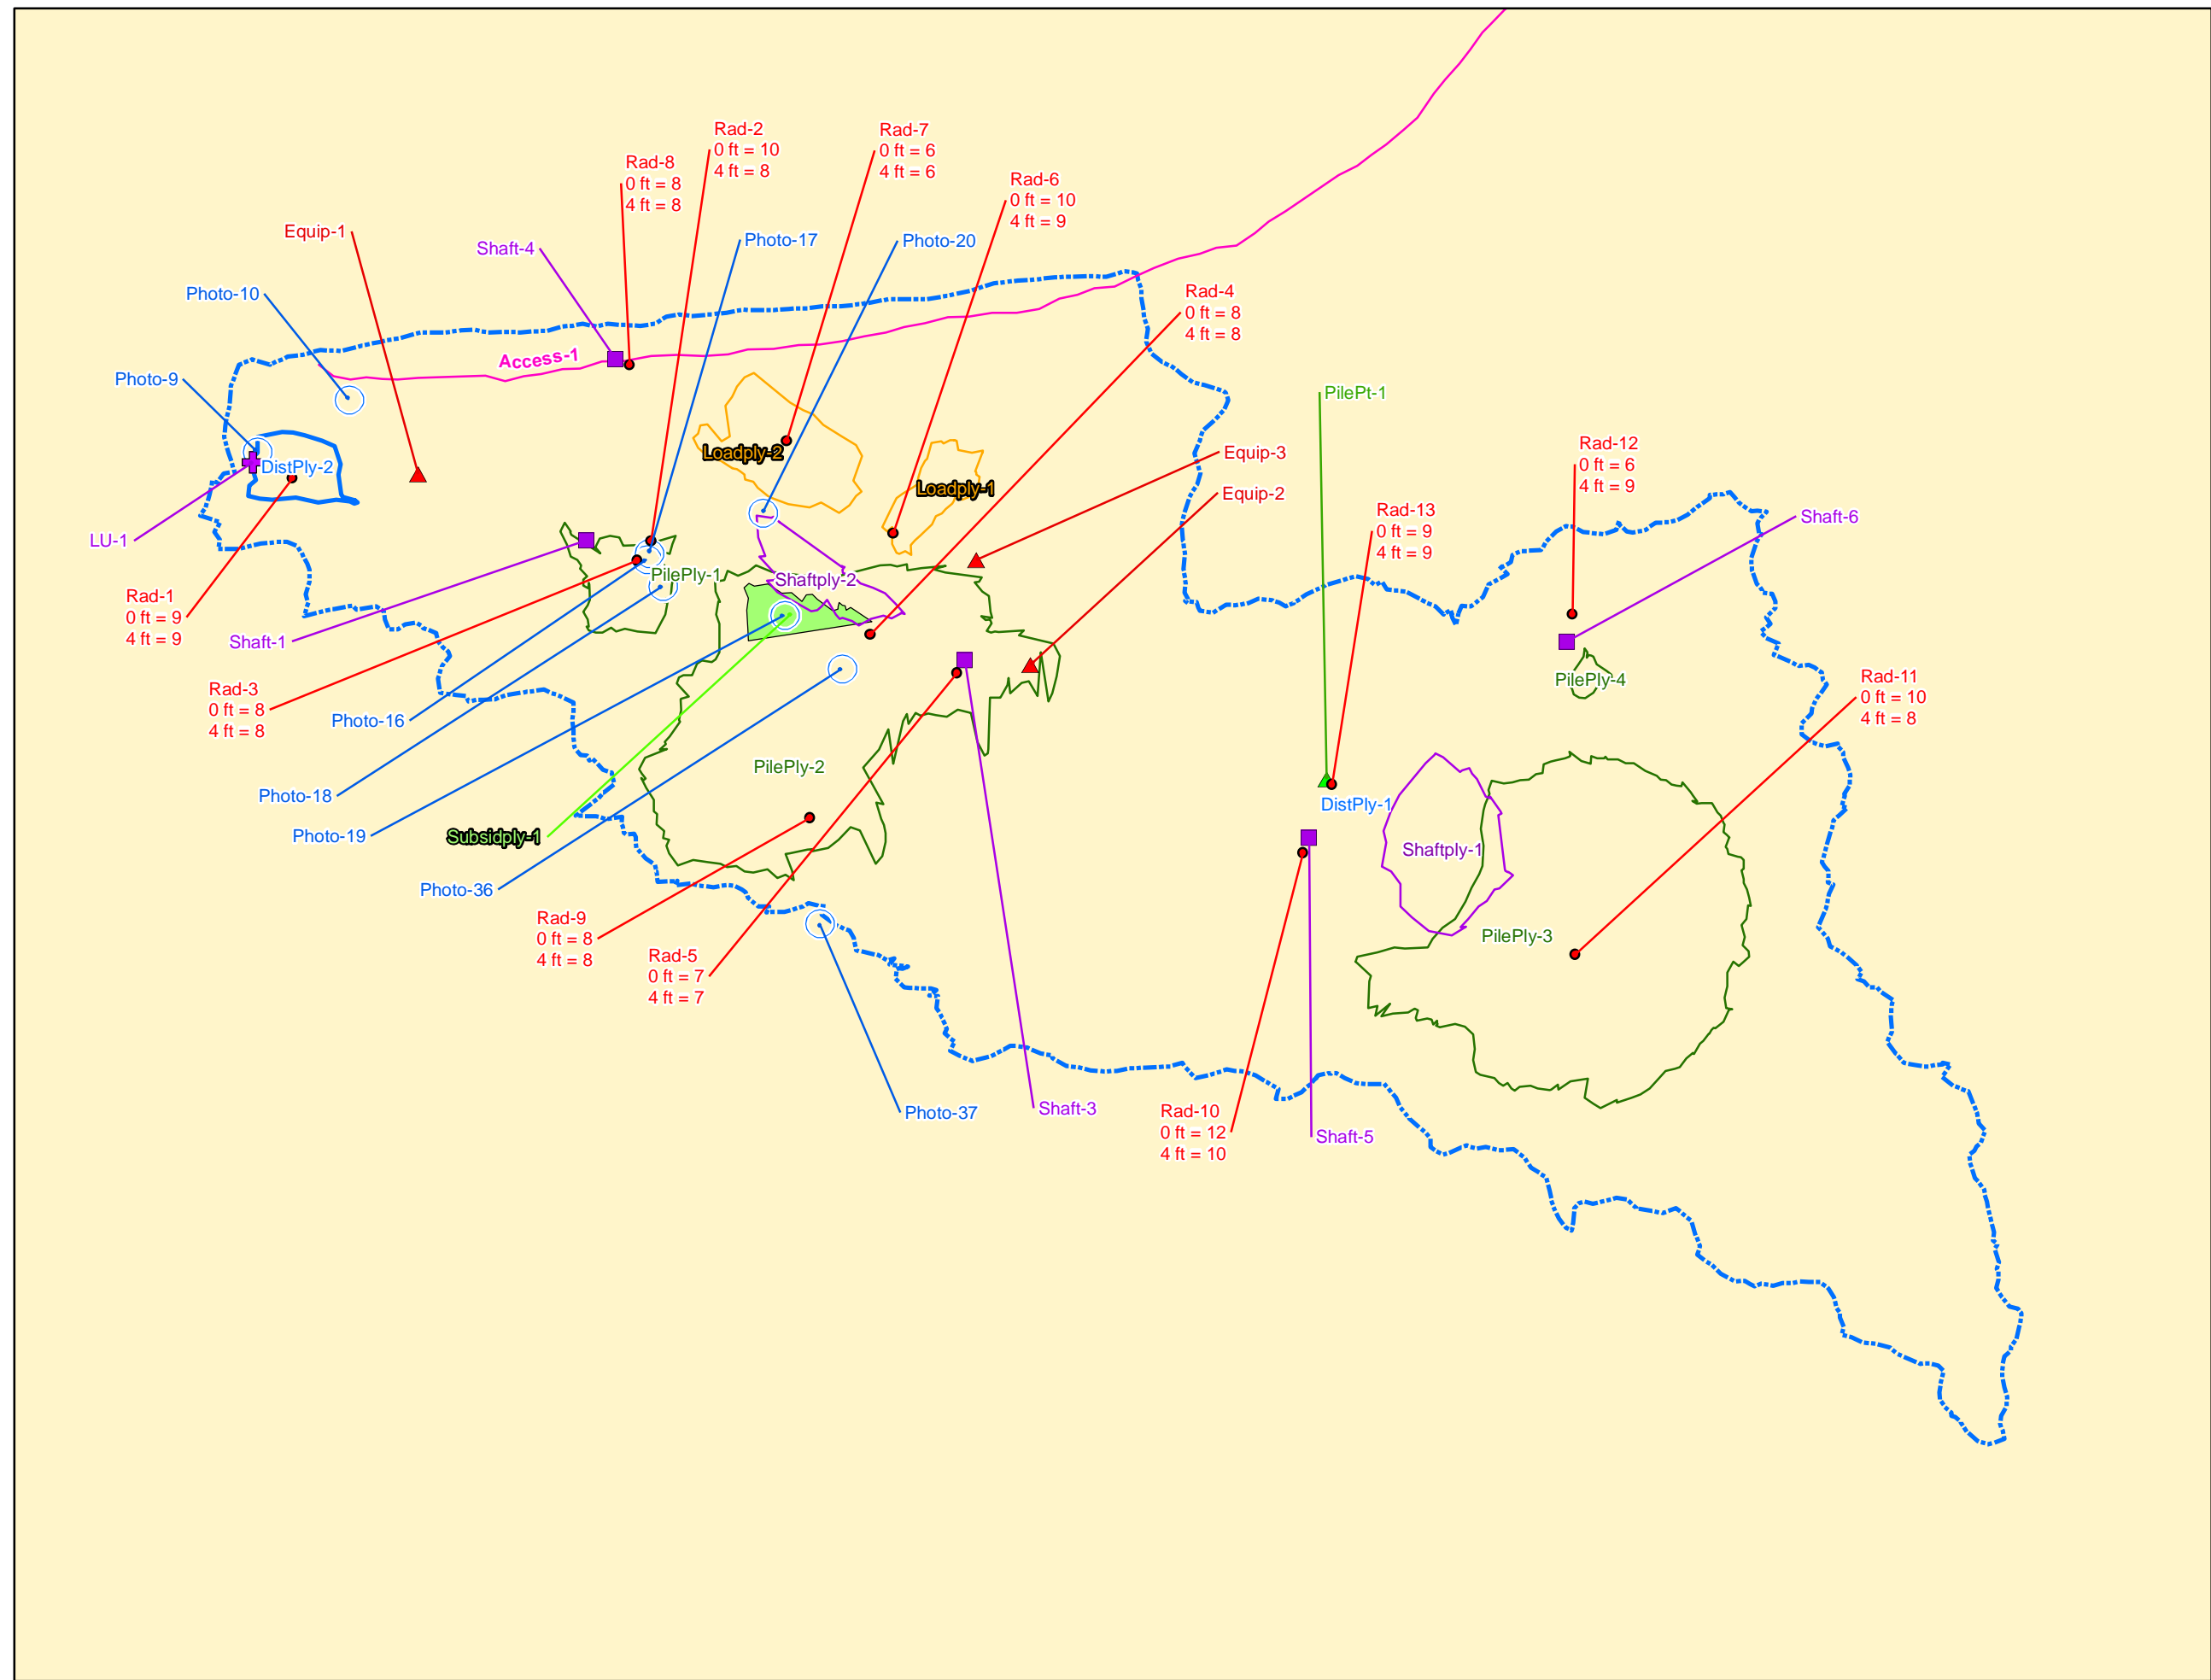
An access road runs along the northern extent of the AUM Site. Two load out features consisting of a ramp (Loadply-1) and a series of terraces (Loadply-2) were found northeast of a large shaft (Shaftply-2).

Two 55 gallon drums (Equip-2 and Equip-3) were found on site. A pile of trash and railroad ties (Equip-1) was found near a disturbance (DistPly-2). A possible vent hole (LU-1) was also found in DistPly-2, but the hole was only 3 ft deep.

Some gullying and downward movement of waste rock was observed on the southeastern portion of the site.

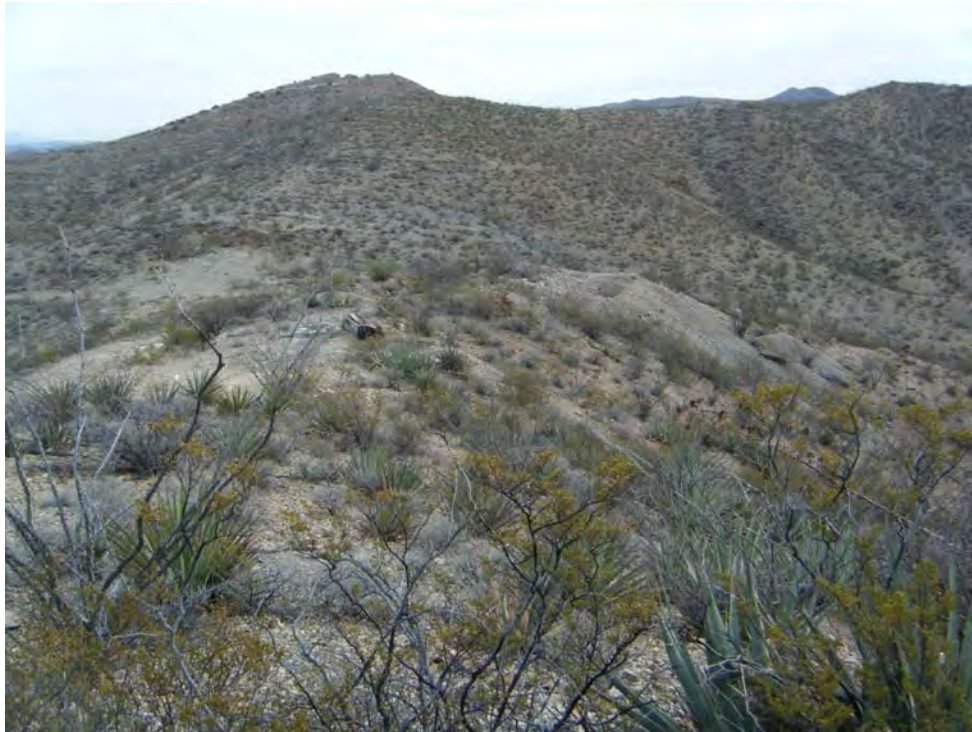
Photo 1 – Looking east at the AUM Site from a hill to the west.

Photo 1 - Looking east from above site

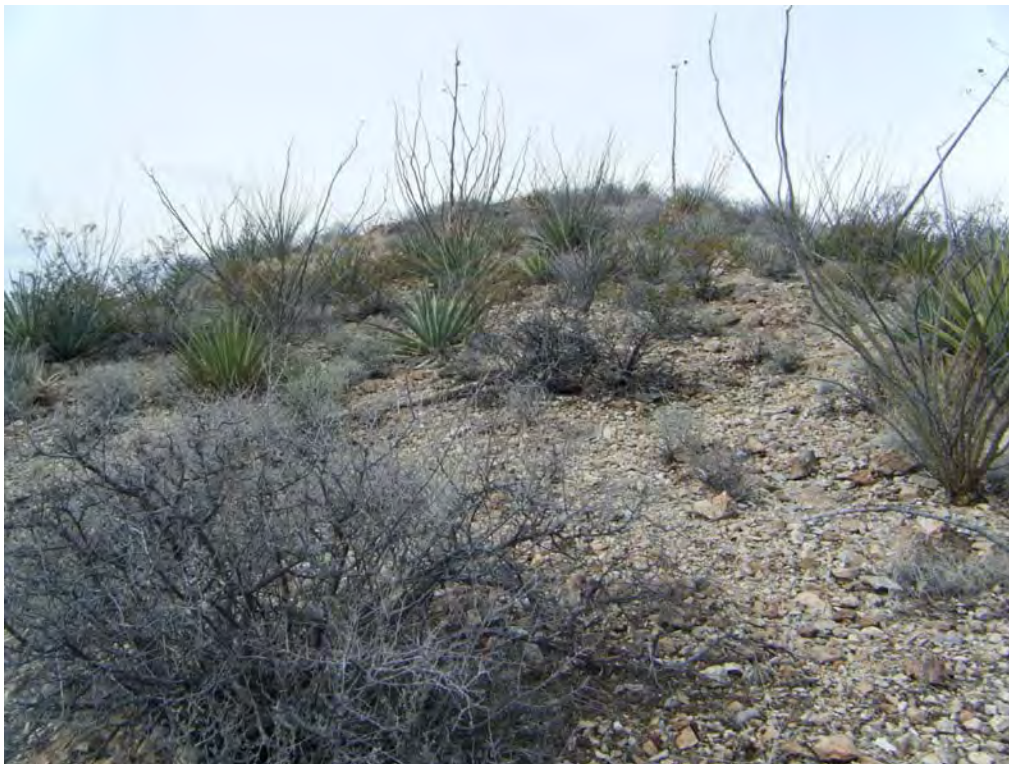
The Napane site is located in the Desert Grassland Ecotone. The site appears to be dominated by creosote with ocotillo, agave, and many different species of cacti making up a substantial component of plant diversity at this AUM Site. Grass species at the AUM Site include black grama and three-awn species. No evidence of noxious weeds was observed onsite.

Photo 3 – AUM Site vegetation.

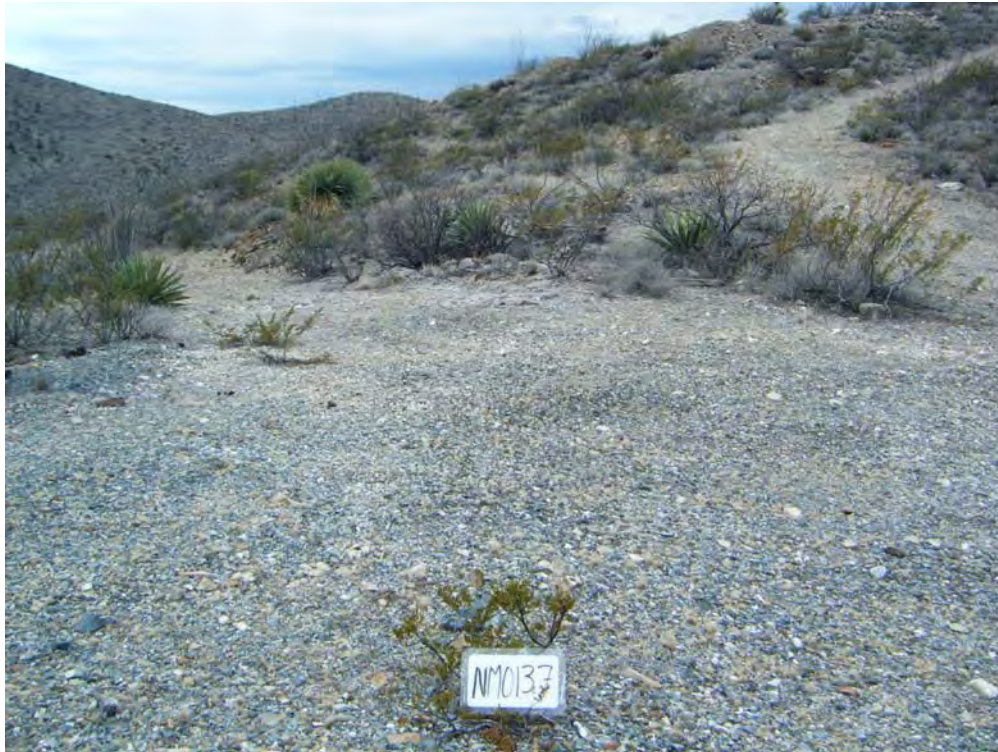
Photo 47 –AUM Site photo, looking west.

Photo 47 - Site Number and site
