Lee Ranch Mine Use Attainability Analysis

May 2018

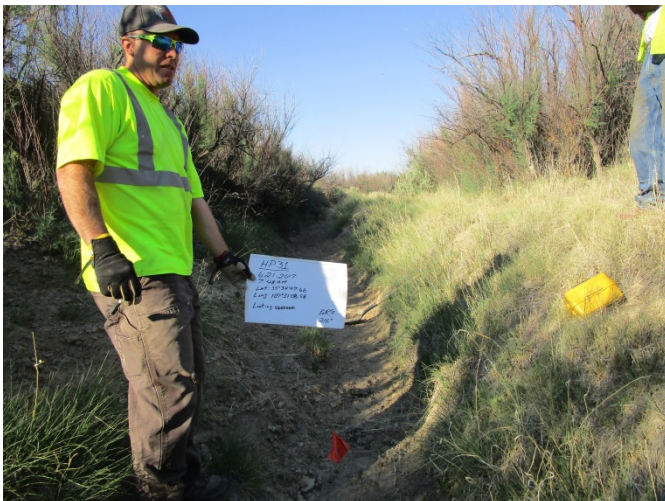
P51 – HP31 Upstream

Various: No water present, no signs of aquatic life. Minimal debris found in vegetation on banks. Sinuosity ration: ~0.5.
